HAILSTORM INVESTIGATION

OKLAHOMA CITY, OK

APRIL 21, 2004

HAILSTORM INVESTIGATION REPORT

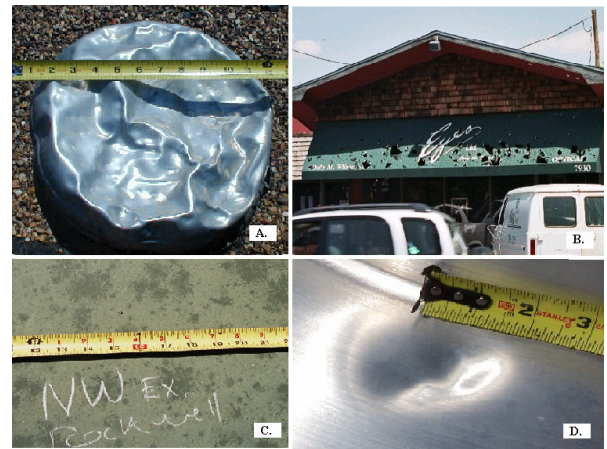
Figure 1. A) Buckled vent cap; B) Awning punctured by hailstones; C) Hail impact spatter marks; D) Large dent in vent hood.

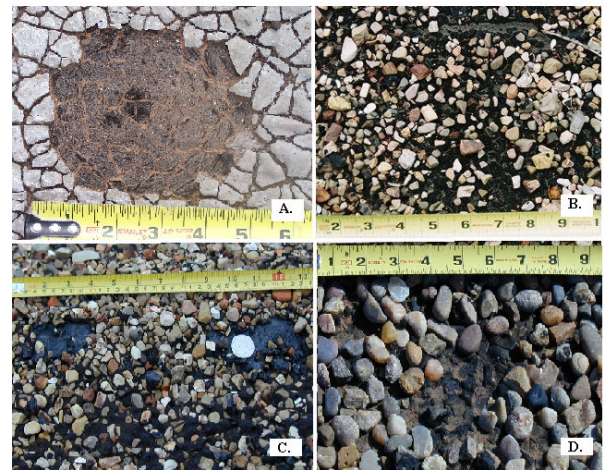
Figure 4. A) Location 33-Aluminum-coated BUR fractured in field; B) Location 76-Gravel aggregate surfaced BUR sustained 2.0 inch diameter hailstone impacts with no visible damage or reported leaks; C) Location 95-Wrinkle in coal tar BUR punctured in two locations; D) Location 94-Large hailstone displaced gravel, but BUR membrane did not appear to be damaged.

Common damage modes were fracturing or puncturing of unsupported regions including blisters, wrinkles, and curb flashings. In one case of a wrinkled and brittle membrane, isolated damage was found to unsupported regions with hail as small as 1.0 inch in diameter. Damage to the flood coat was found in supported areas (non-blistered) in the field of the roof with hailstones 2.0 inches in diameter on a pea-gravel aggregate surfaced roof. Fracturing of the built-up membrane was observed. Hail size of about 2.5 inches in diameter caused hairline fracturing through all plies of an aluminum-coated built-up membrane and a gravel aggregate surfaced built-up membrane. This damage was visually determined by probing the impact site from the external surface; there were no test cuts. Some gravel aggregate surfaced roofs sustained hail impacts of 1.5 to 2.0 inches in diameter without apparent damage in the field of the roof. On the gravel aggregate surfaced roofs that sustained damage, the gravel was propelled out of the impact areas and the flood coat was fractured, with no instances observed of gravel being driven into the roof membrane. Roofs of advanced age suffered greater damage, although the difference often related to the amount of blistering rather than strictly age.

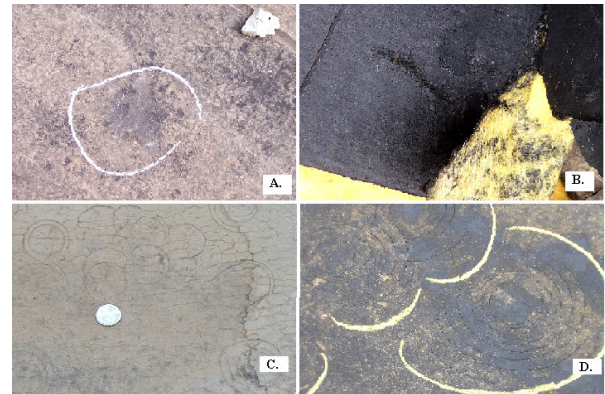
Figure 5. A) Location 34-Hail impact-caused bruise in APP membrane at seam overlap; B) Location 34-Fracture observed in underside of photo A after test cut; C) Location 88-Multiple circular fractures in surface of APP membrane in ponding region of roof; D) Location 74-Multiple concentric circular fractures in surface.

There were two levels of damage identified on the membranes from hail impact; loss of granule surfacing or fracturing / bruising. Granule loss was not found to cause water infiltration. The bruising that was found was related to the fracturing of the membrane and could allow water infiltration. Destructive analysis of two single application modified bitumen roofs confirmed that impact areas that had some visible granule loss and also felt “bruised,” or soft under finger pressure, had been fractured on the underside of the membrane, although the fractures were not visible on the surface.

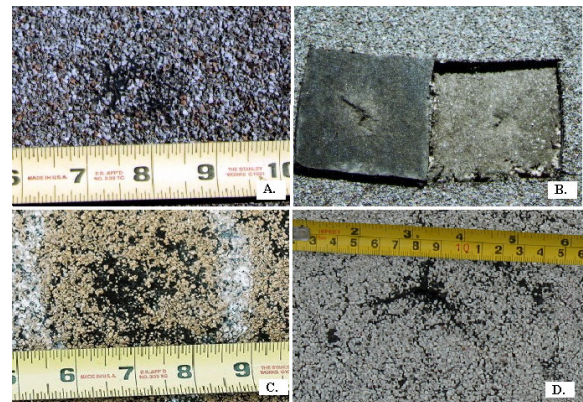
Figure 6. A) Location 26-Impact-caused bruise observed on surface of SBS membrane; B) Location 26-Fracture in underside of membrane at Photo A; C) Location 76-Impact-caused bruise with recent granule loss on surface of SBS membrane; D) Location 95-Impact-caused fracture observed on surface in blistered location.

fractures and which resulted in immediate leaks. On roofs with maximum hail sizes in the range of 1.5 to 2.0 inches in diameter, the extent of damage varied from no damage observed to significant damage. Bruising or fracturing of the membrane often occurred in this size range when the underlying substrate was a compressible substrate, such as polyisocyanurate board insulations or wood fiberboard.

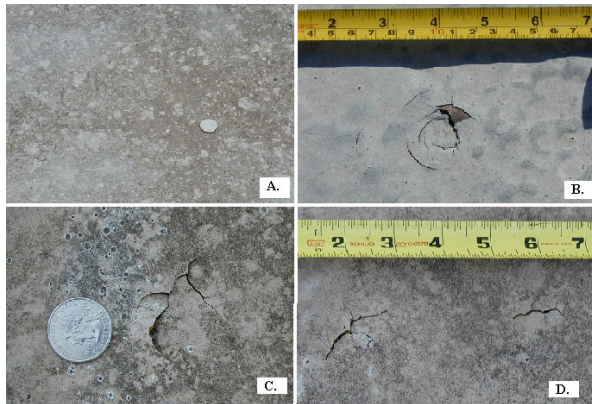
Figure 7. A) Location 100-Hailstone impacts had removed surface grime, but not fractured SPF coating; B) Location 94-Impact-caused concentric circular fractures; C) Location 97-Hail impact spatter mark at starburst fracture on indentation in SPF; D) Location 97-Two adjacent hail-caused fractures in SPF coating.

Immediate leaks into the buildings would not be expected from the hail-caused fractures in the coating as the foam is closed-cell and would not allow liquid water to pass through. In addition, the underlying built-up membranes may have offered additional protection from leaks. The two roofs without hail-caused fractures in the coating had been struck with hailstone sizes of 0.5 to 1.0 inch in diameter. Although moderate to severe (foam) blistering was found on some roofs, the blistering did not appear to have a material affect on the amount of hail-caused fracturing of the surface coating.

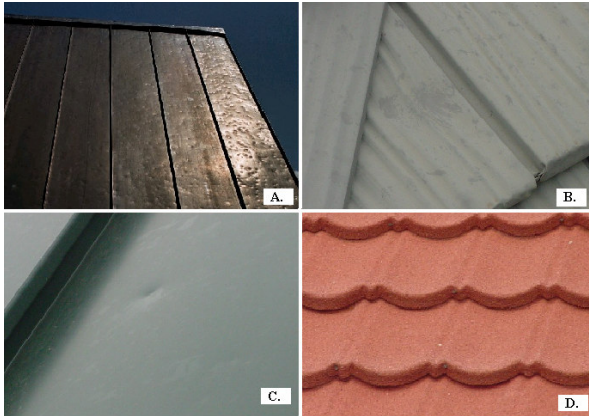
Figure 8. A) Multiple dents in copper standing seam from survey; B) Location 17-Hail-caused spatter mark at dent in aluminum shake panel; C) Location 59-Hail-caused spatter mark with dent in painted standing-seam metal; D) Location 66-No impact-caused dents visible in stone-coated steel panels.

from the painted surfaces. Dents occurred from hail impact on three of the four roofs, with one metal shingle panel having no dents with 1.25 inch diameter hail. On the other roofs, the hail-caused dents were found to be a cosmetic issue, with no functional damage. Panel joints had not been distorted sufficiently to affect the water shedding ability of the panels.

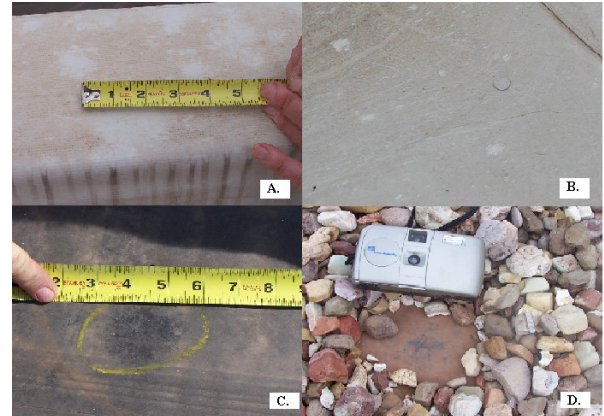
Figure 9. A) Location 35-Large hail impact on PVC-covered parapet with no apparent damage; B) Location 88-Hail impact marks visible on TPO membrane surface, but no fractures visible; C) Location 27-Insulation dented, but no fracture in EPDM membrane at 2.0 inch diameter impact; D) Location 31-No fracture visible in EPDM membrane where stone ballast had been displaced by large hailstone impact.

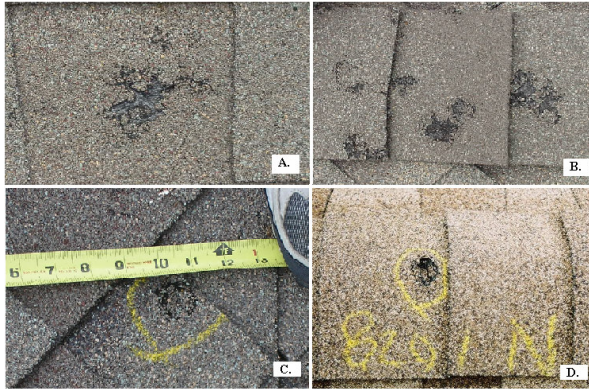
Damage modes were primarily fracturing or rupturing of the shingle mats or broken shingle edges. Areas with fractured mats generally displayed loss of granules sufficient to expose asphalt, and the recently exposed asphalt was dark in color with limited oxidation. The nine shingle roofs without damage had been struck with hail sizes from 0.5 to 1.25 inches in diameter, while

Figure 10. A) Location 21-Hail impact puncture in laminated shingle that overlaid wood shingles; B) Location 25-Multiple hail impact-caused bruises in hip shingles; C) Location 72-Hail-caused bruise in unsupported valley shingle; D) Location 82-Hail-caused puncture of unsupported region of high-profile ridge shingle.

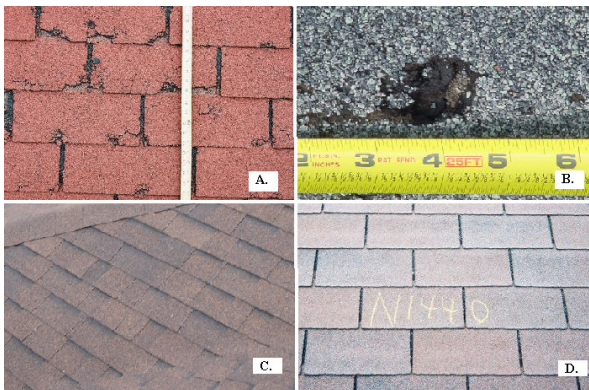
Figure 11. A) Location 76-Multiple fractures in old organic shingles; B) Location 16-Hail impact puncture in shingle that overlaid wood shingles; C) Location 5-No hail impact damage to modified bitumen shingle; D) Location 81-No hail impact damage to shingle in area with a large quantity of small hailstones.

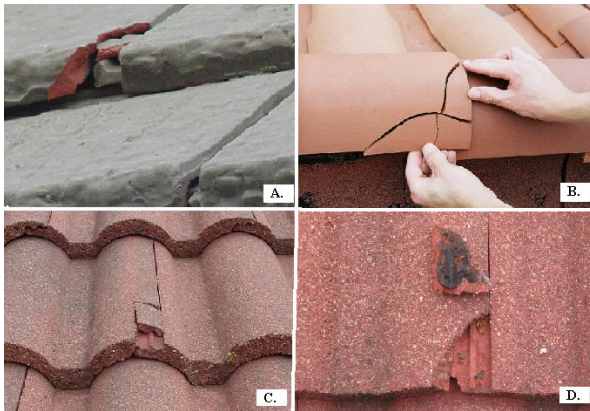
Damage mode was fracturing of the tile field or edge when struck with relatively large hailstones. Fracture surfaces from the recent hail displayed unweathered (clean) surfaces, while older fractures (from foot traffic or other previous damage) observed on the roofs often had grime or mildew darkening the surface. A common pre-existing crack pattern was a single fracture near the lower right corner of interlocking tiles. In contrast, hail-caused cracking typically resulted in

Figure 12. A) Location 58-Multiple fracture at corner of clay tile; B) Location 76-Starburst fracture in barrel ridge tile (clay); C) Location 62-Multiple fracture in right overlap of concrete tile from hail impact; D) Location 19-Right corner fracture in concrete tile that had been repaired previously (prior to hailstorm).

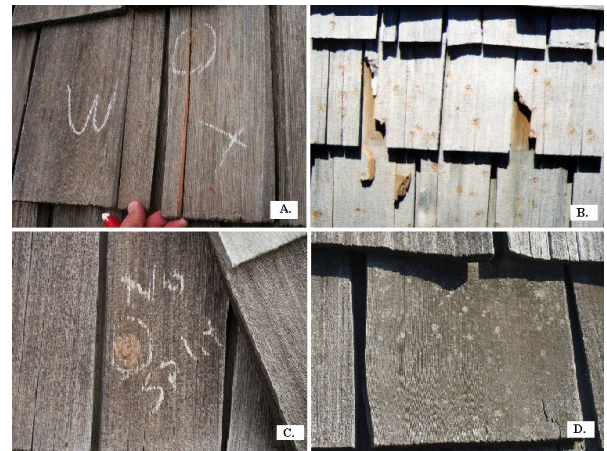
Damage modes were primarily fracturing (splitting) or puncturing of the wood when struck with relatively large hail. The hail-caused splits were coincident with, or closely associated with, bright-colored indentations in the wood from hail impact, and the wood fracture surfaces were bright-colored. Bright hail-caused splits could be contrasted with gray-colored interior surfaces of splits due to natural weathering. Often, surface marks from hail impact and indentations in the wood did not result in splitting of the wood. Punctures occurred in areas of the wood that were eroded or thinner than average, and fresh color in the underlying wood and broken wood pieces confirmed the impact damage. Hail-caused splitting or puncturing of the wood generally was found when hailstones exceeded 1.0 inch diameter on thinner wood and 1.5 inches in diameter on standard dimension wood (0.5 inch or thicker).

Figure 13. A) Location 105-Gray split from weathering (left) and fresh split from hail impact (right); B) Location 86-Shake pieces broken off by hail impact; C) Location 105-Large hail impact without a split; D) Location 15-Small impact marks on shake surface (no hail impact damage).
