# **RICOWI, Inc.**

Roofing Industry Committee on Weather Issues, Inc.

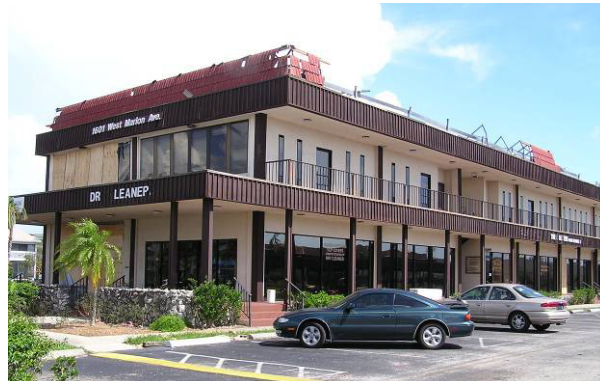
View of the NW corner of 1601 W. Marion.

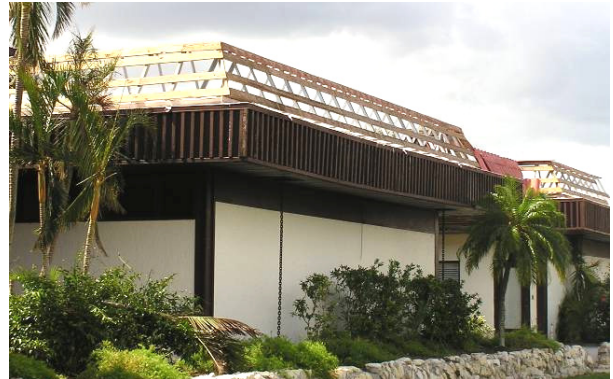
View of the NE corner of 1625 W. Marion.

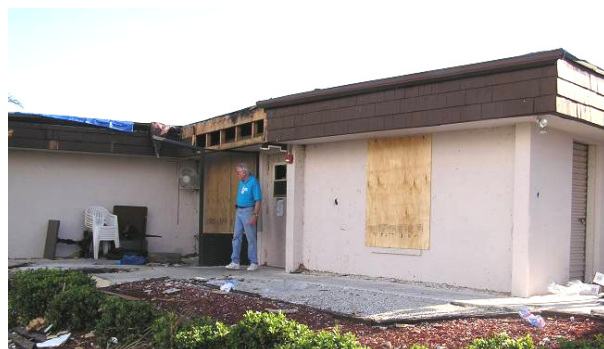
View of 1780 Marion.

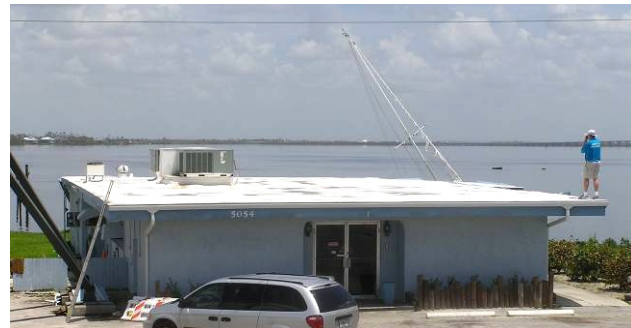
View of the west side of 5054 N. Hwy. 41.

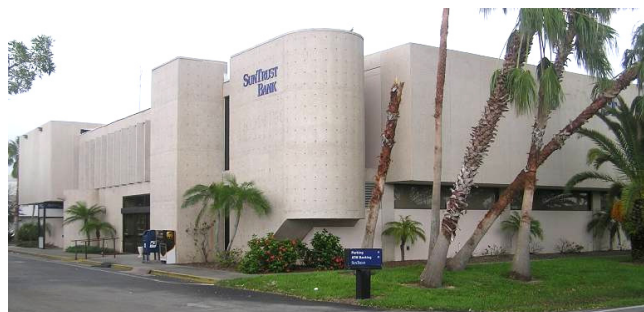
View of the SE corner of 21260 Olean Blvd.

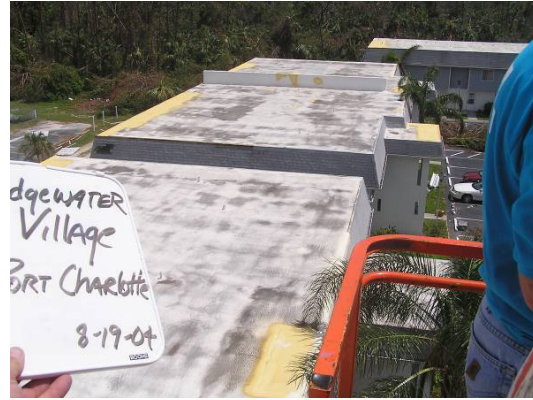
View to the east at 22375 Edgewater.

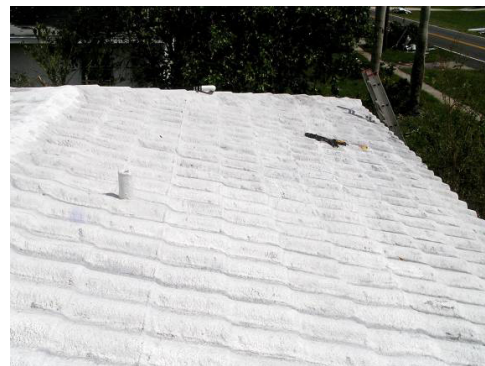
View of the north slope of 21062 Edgewater.

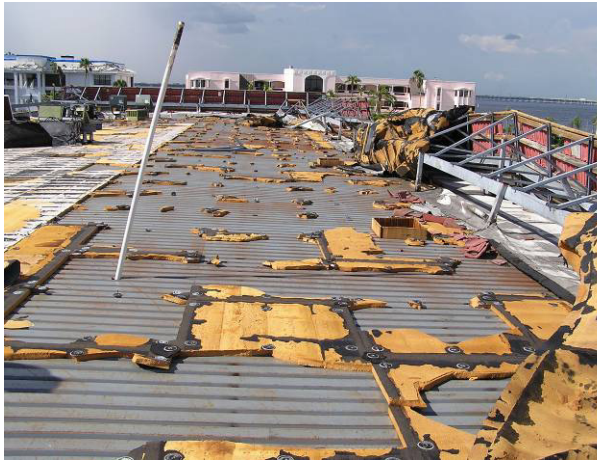
2-01-1. Extensive roof loss on east half of building.

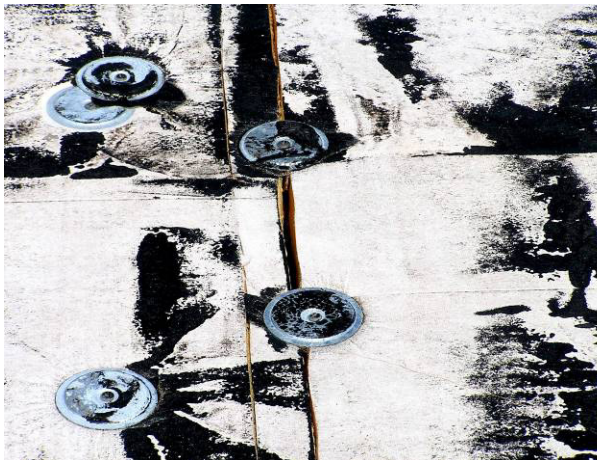
2-01-3. The typical random insulation fastening pattern used here was not in compliance with manufacturer recommendations. Note that fastener disks span two pieces of insulation, which is inconsistent with industry standards and good workmanship.

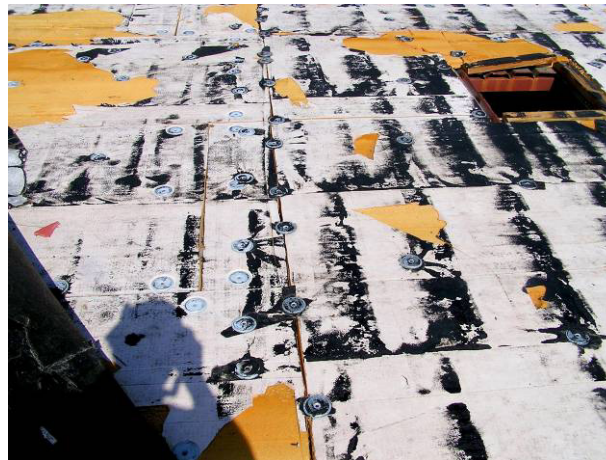
2-01-4. More poor insulation fastening is visible here.

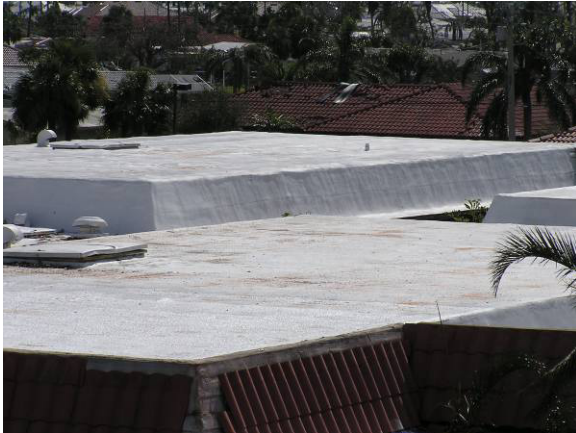
**2-02-1. This area had very little damage to SPF roofing.**

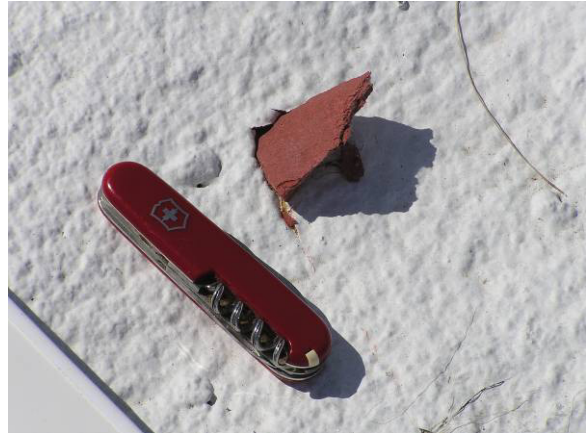
**2-02-2. This is a typical example of damage from wind-borne debris.**

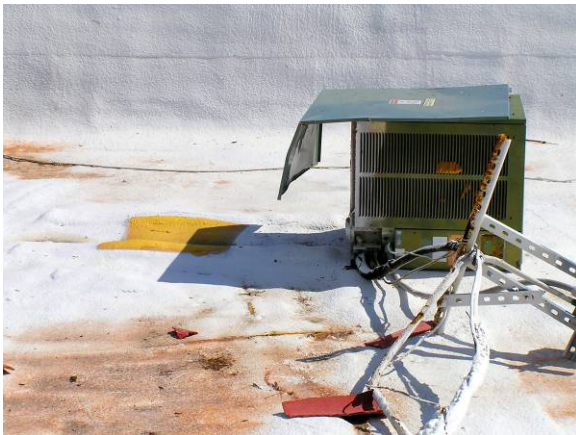
**2-02-3. This mechanical equipment was not properly fastened. Also, there was improper detailing of SPF at equipment stand.**

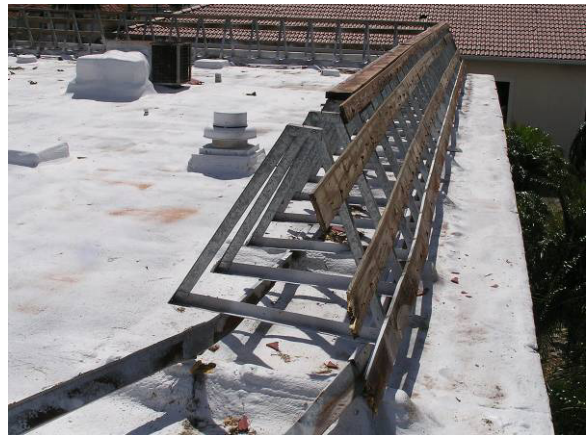
**2-02-4. Synthetic tile (not clay or concrete) was blown off this screen/fence. SPF edge flashing was intact and undamaged.**

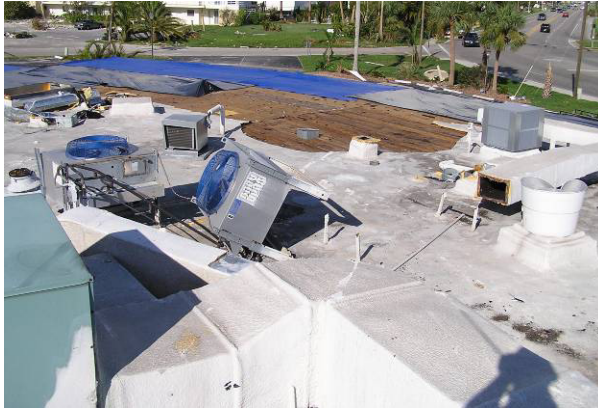
**2-03-1. Edge flashing damage at the east side initiated roof blow-off. Inadequate anchoring of mechanical equipment also damaged the SPF roof.**

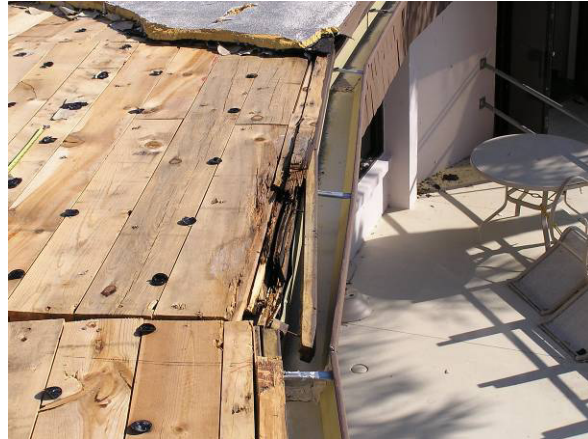
**2-03-2. Old built-up roof edge flashing was used in lieu of installing new foam stop edge flashing. Nails pulled loose from decayed wood at fascia.**

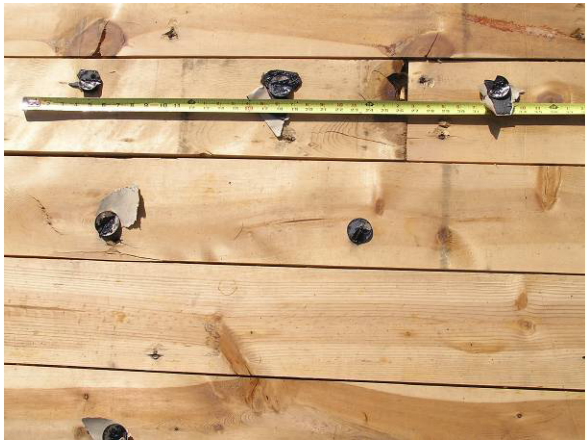
**2-03-3. Fastening of original BUR sidelaps at 13 to 14 in. o.c., rather than 9 in. o.c., contributed to the blow-off.**

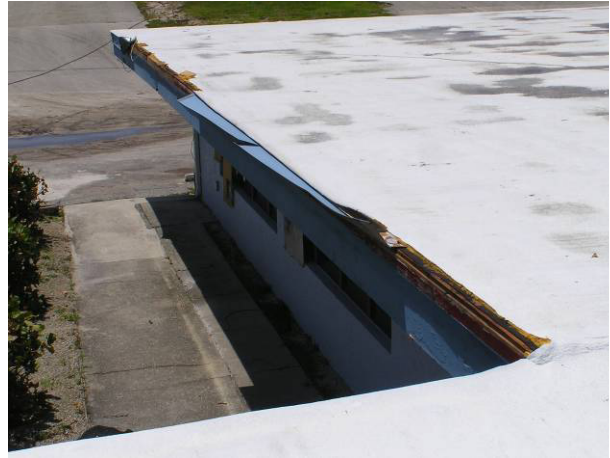
**2-04-2. Damage was limited to edge flashing with no damage to field of roof.**

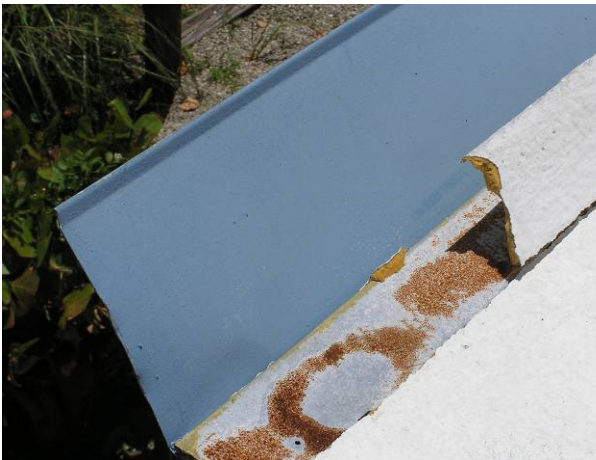
**2-04-3. This metal edge flange was not primed prior to SPF application.**

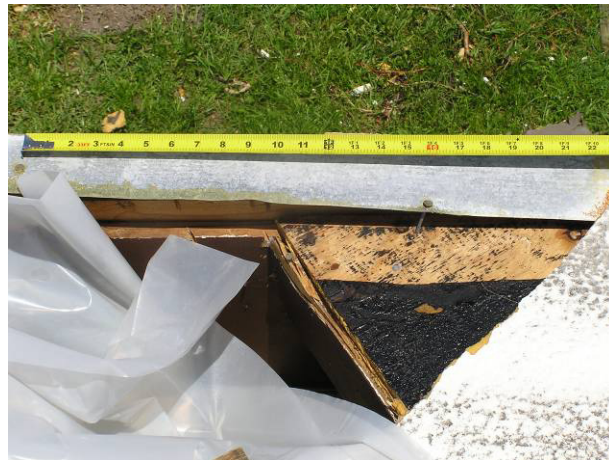
**2-04-4. Inadequate nailing of this metal edge resulted in flashing damage.**

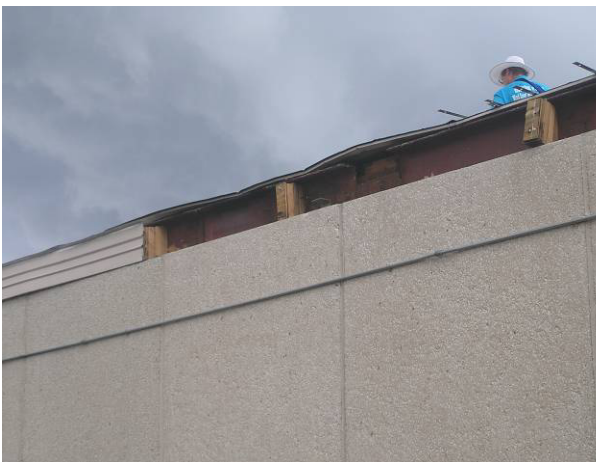
**2-05-1. Edge flashing damage.**

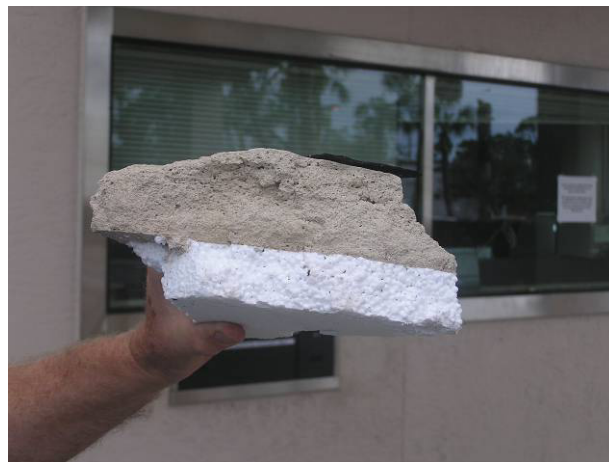
**2-05-2. This roofing substrate consisted of LWIC over EPS insulation, over a steel deck.**

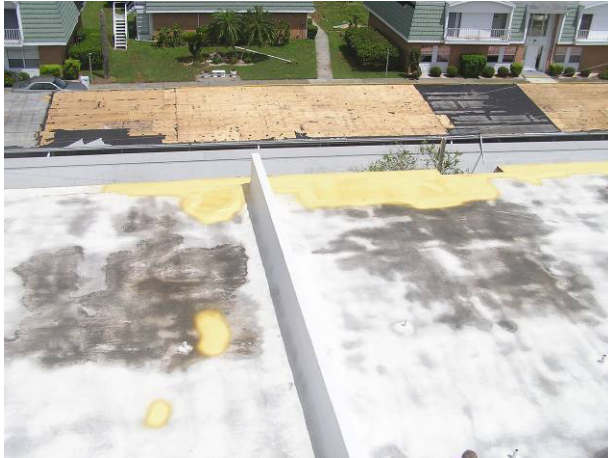
**2-06-1. Built-up roofing blew off a separate building below this SPF roof, but the SPF roof suffered only edge damage.**

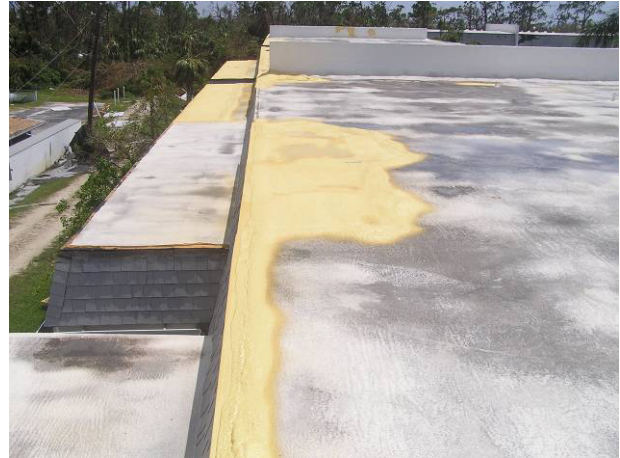
**2-06-2. SPF edge repair was in progress during our visit (note yellow foam).**

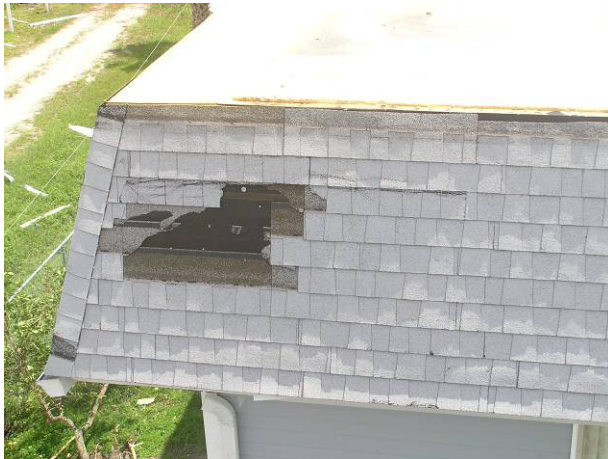
**2-06-3. Asphalt strip shingle-clad mansard suffered minor damage on some windward exposures.**

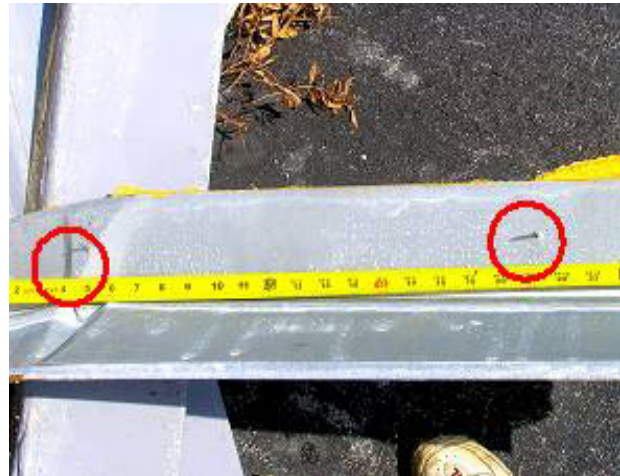
**2-06-4. This foam stop edge flashing was fastened at 16 in. o.c. instead of the industry standard of 3 to 6 in. o.c.**

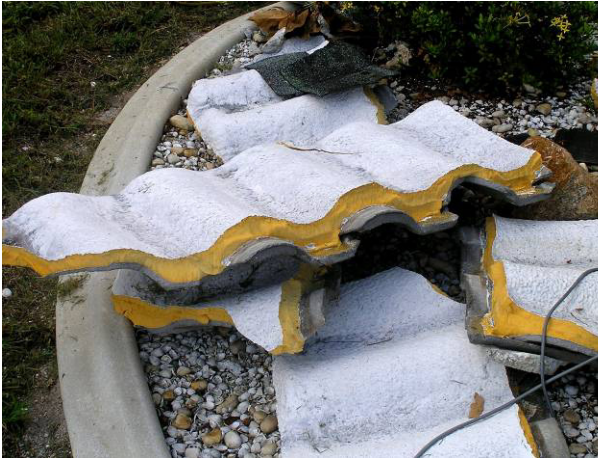
**2-07-1. Some pieces of tile were broken off at the windward eave.**

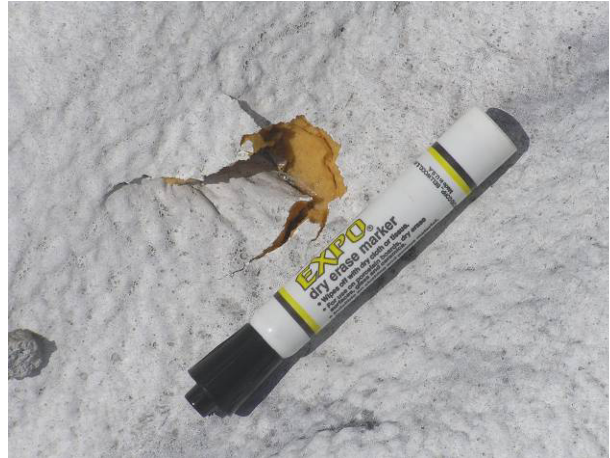
**2-07-2. Minor wind-borne debris damage occurred at a few points on the roof.**

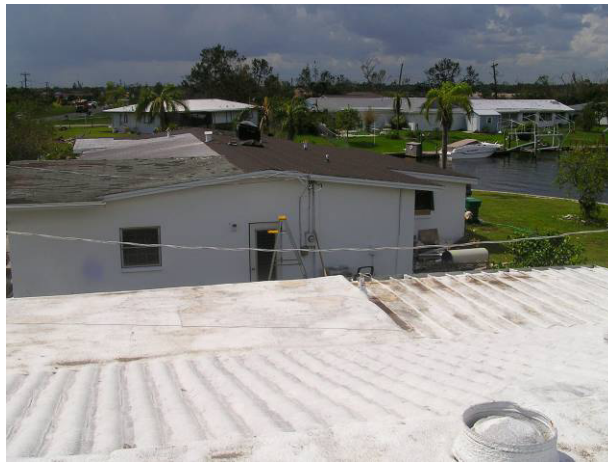
**2-07-3. Note the extensive asphalt 3-tab strip shingle loss on the neighbor's roof (near top of photo).**

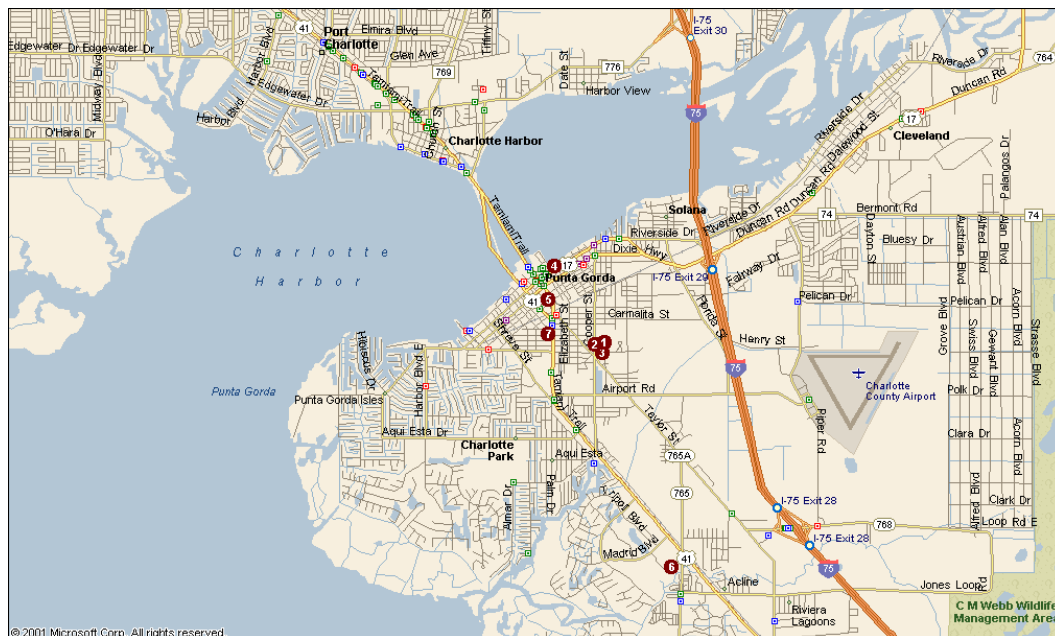
Figure 1. Locations of sites 1–7.

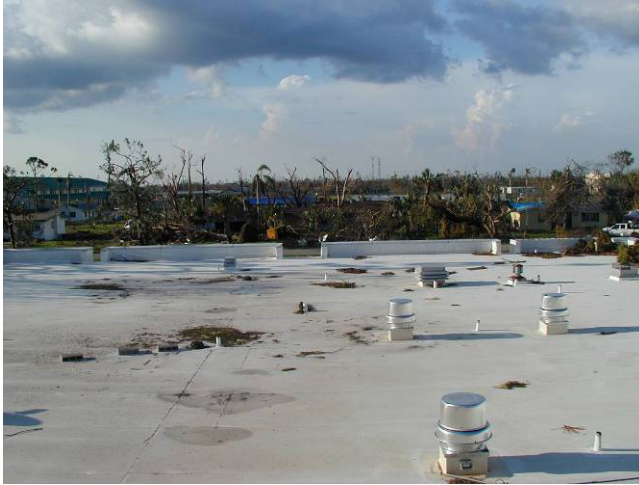
**3-01-1. Charlotte County facility, main roof.** Wind debris is visible on roof.

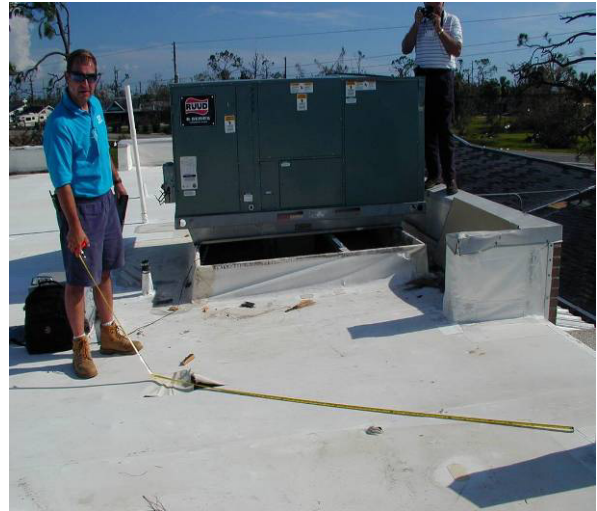
**3-02-2. Charlotte County facility, west roof.** Surface damage from HVAC unit is noted. (Note: HVAC unit was reset on the curb shortly after the hurricane.)

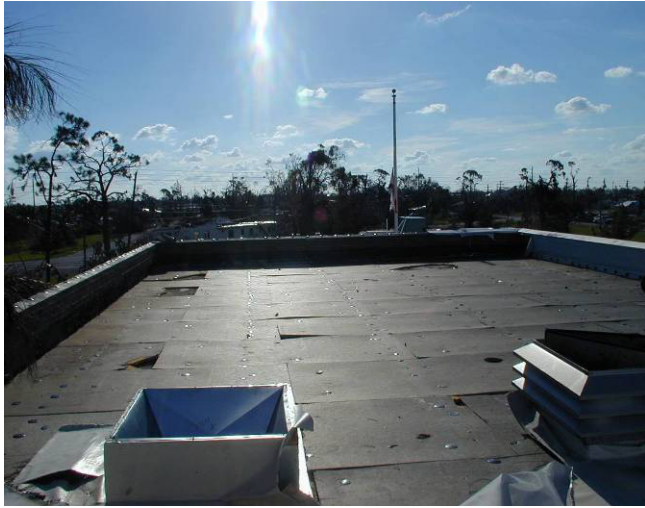
**3-03-1. Charlotte County facility, upper roof.** PVC base membrane nearly 100% blown off roof; more than 95% of insulation remained in place.

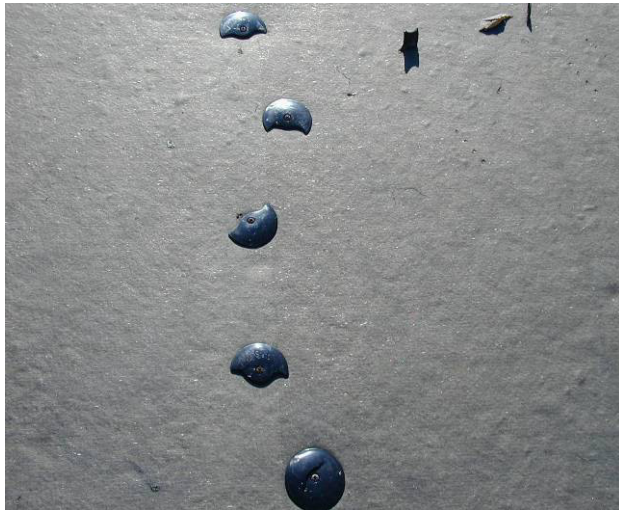
**3-03-3. Charlotte County facility, upper roof.** Most of the plastic fastener plates attaching the membrane were broken.

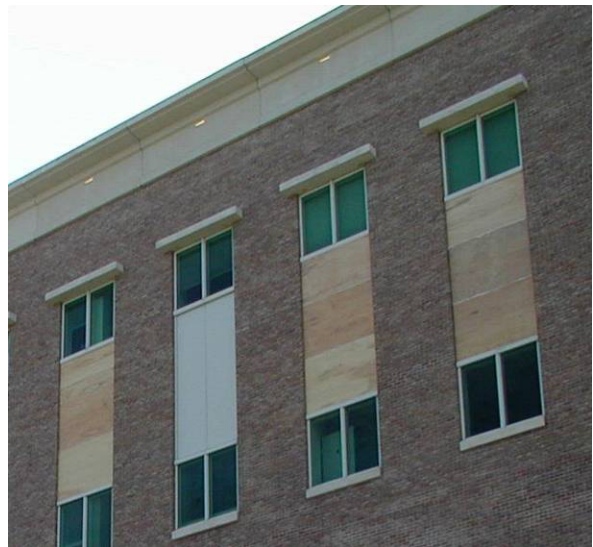
**3-04-1. Charlotte County government facility, high-rise.** Two-foot wide exterior overhang and through-wall scuppers were a feature of the parapet.

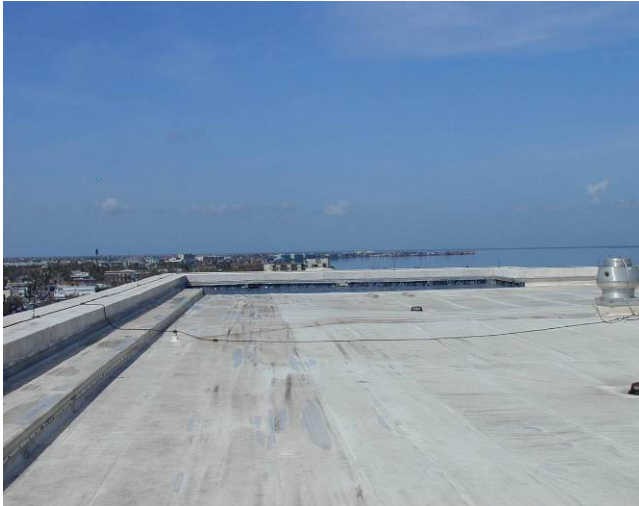
**3-04-2. Charlotte County government facility, high-rise.** This is the wind-damaged SW corner.

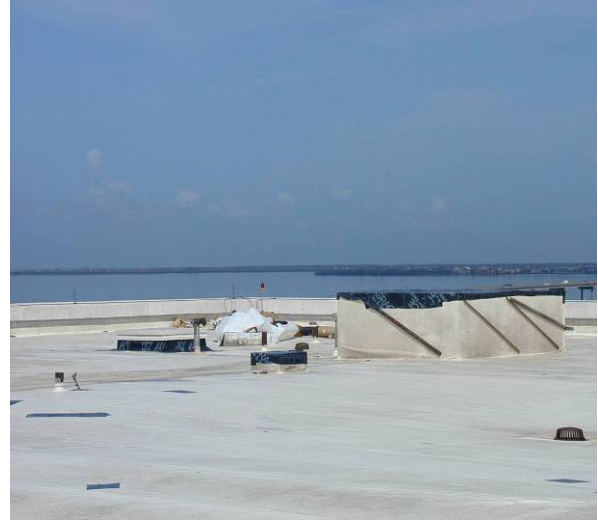
**3-04-3. Charlotte County government facility, high-rise.** It was estimated that over 50% of the air handling equipment was blown off the roof.

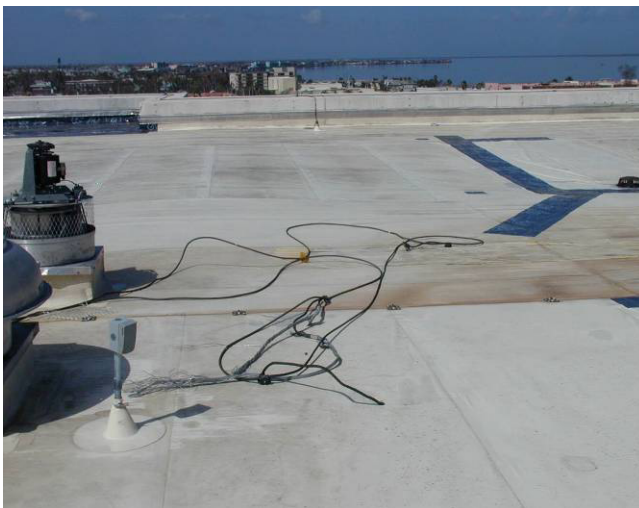
**3-04-4. Charlotte County government facility, high-rise.** The lighting protection system remained on the roof, but the loose cables whipped around, damaging the membrane system.

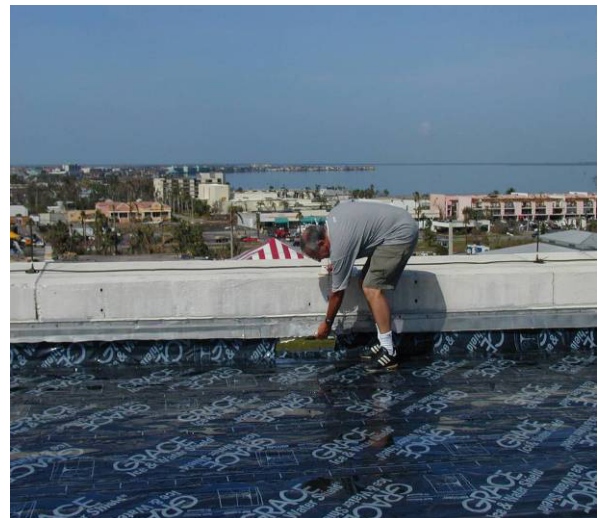
**3-04-5. Charlotte County government facility, high-rise.** This photo shows a scupper at the wind-damaged SW corner.

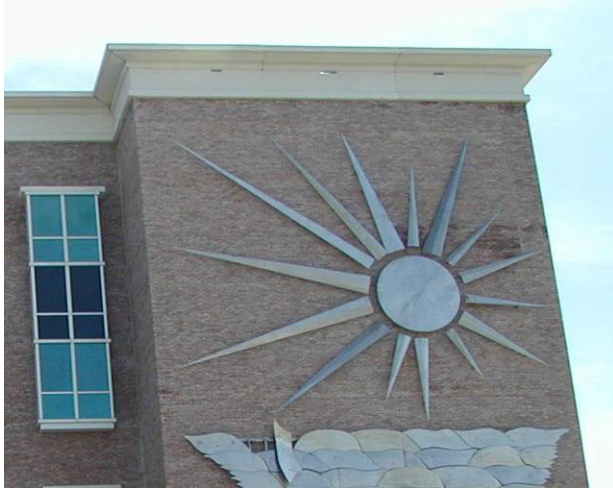
**3-04-6. Charlotte County government facility, high-rise.** This is the SW corner with a through-wall scupper and an overhand.

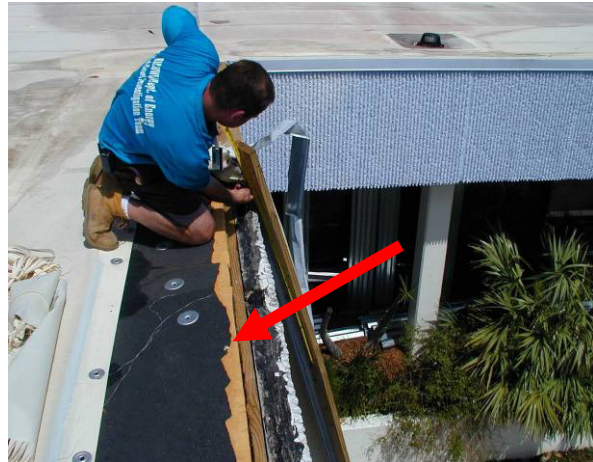
**3-05-3. County Office Building.** Failed 2×6 nailers were fastened with 16D common nails spaced approximately 2 ft. o.c. along only the inside edge of nailer.

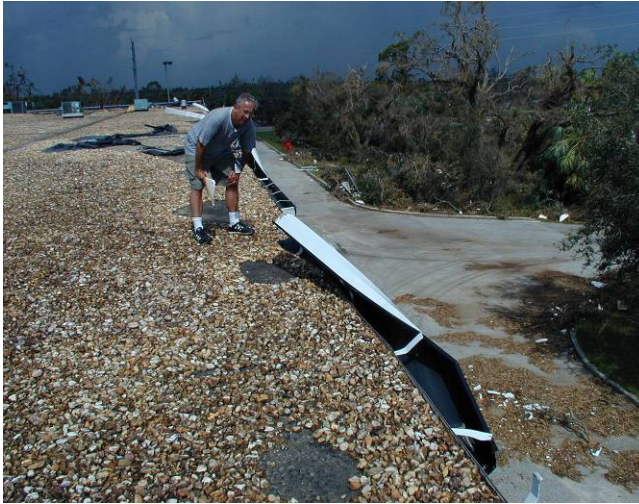
**3-06-1. Large retail building.** Uplifted gutter, roof membrane, and ballast remained in place in some locations along south perimeter.

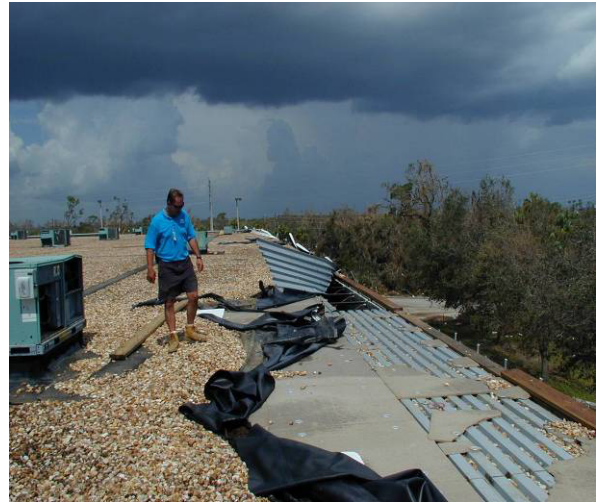
**3-06-2. Large retail building.** Typical damage along south perimeter.

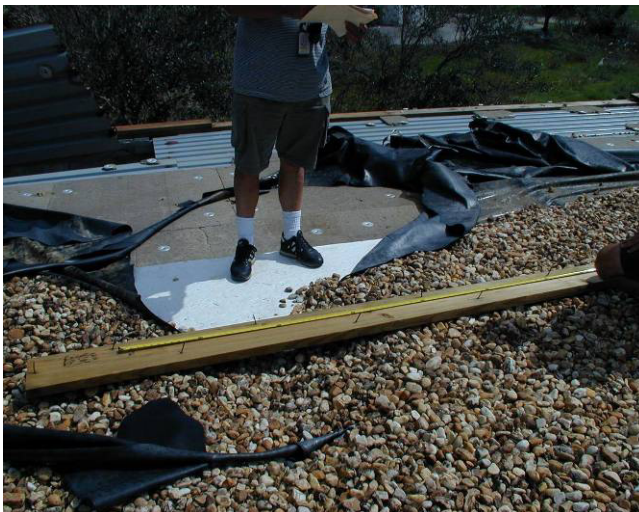
**3-06-3. Large retail building.** Top nailer attachment: 1 ft. o.c. with hot-dipped galvanized 16D nails.

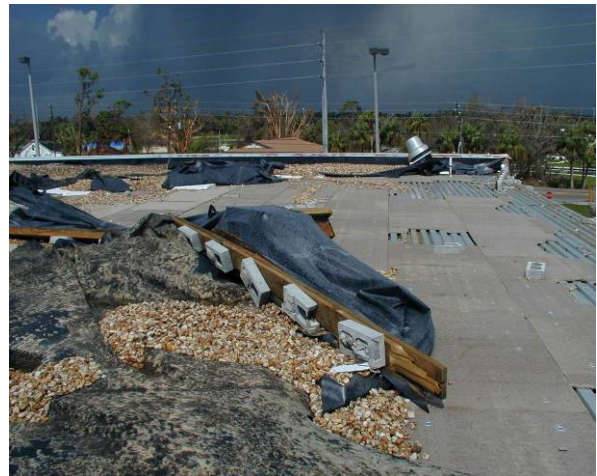
**3-06-4. Large retail building.** The worst damage occurred at SE corner.

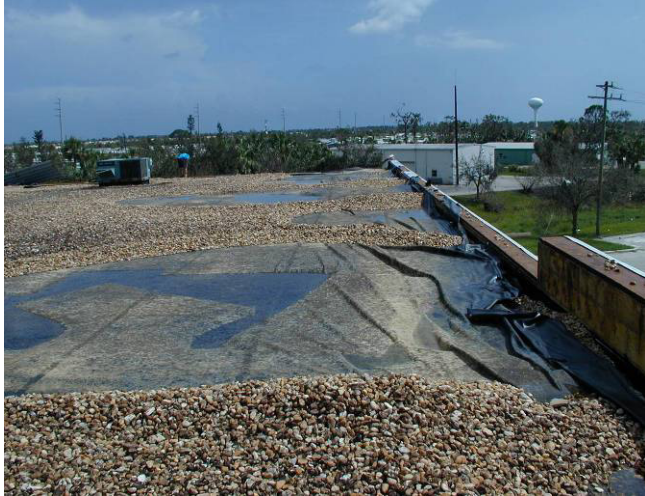
**3-06-5. Large retail building.** Damage along parapet.

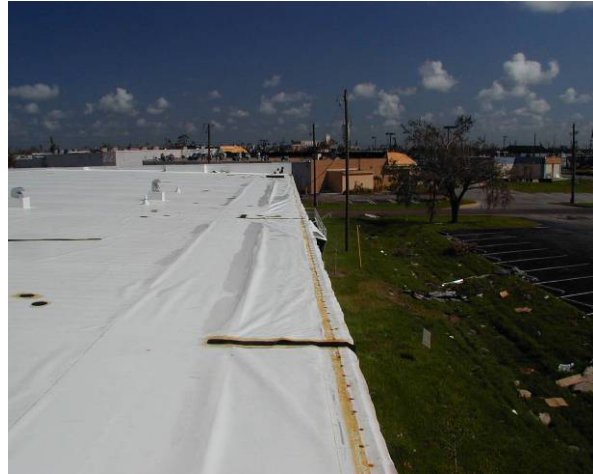
**3-07-1. Commercial office building.** Damage along east perimeter.

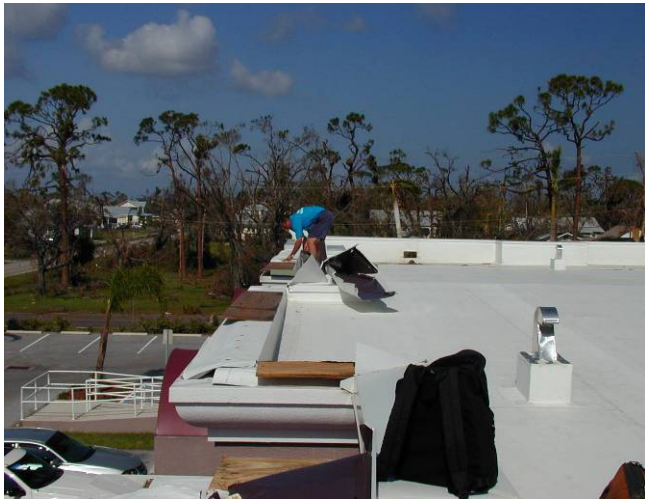
**3-07-2. Commercial office building.** Typical coping damage.

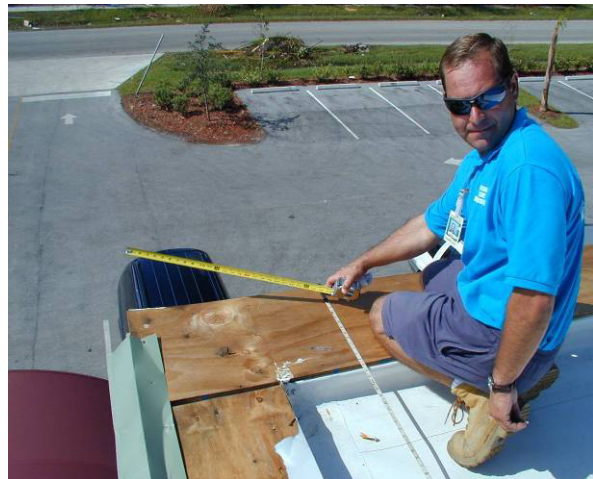
**3-07-3. Commercial office building.** Verifying coping attachment.

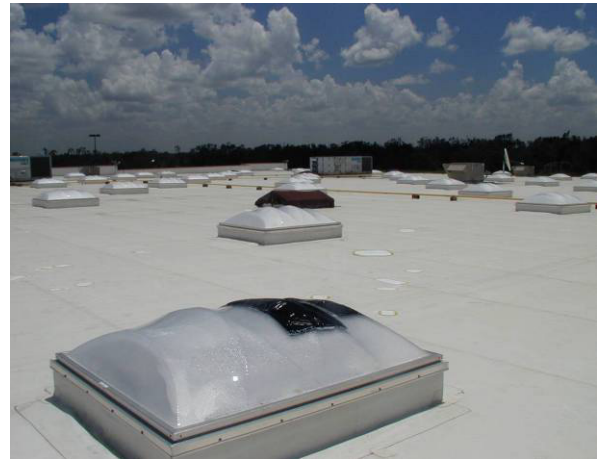
**3-09-3. Large retail building.** Broken skylights became wind-borne debris, puncturing roof membrane—SE view.

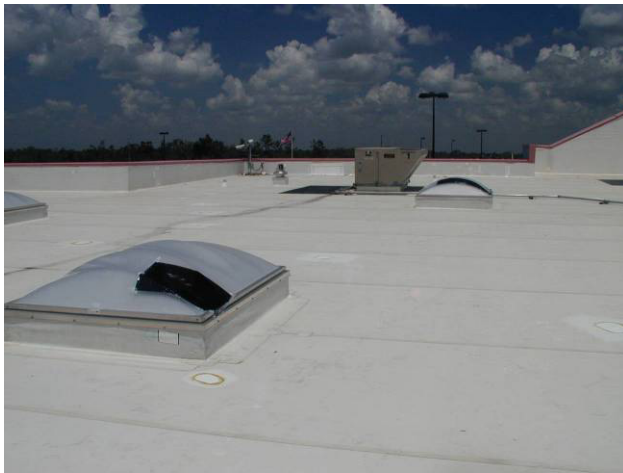
**3-09-4. Large retail building.** More broken skylights and subsequent punctured membrane—NW view.

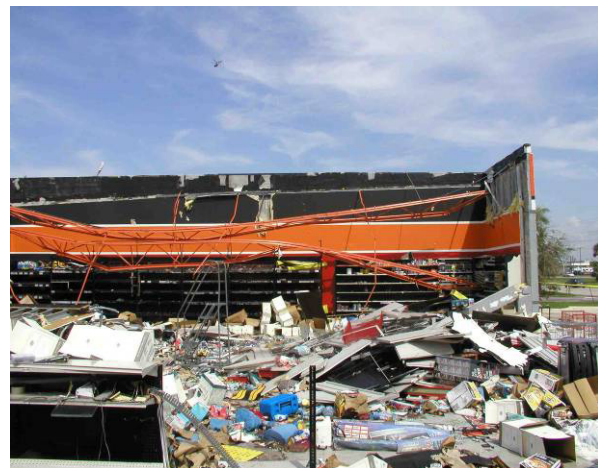
**3-10-1. Auto parts business:** windward side.

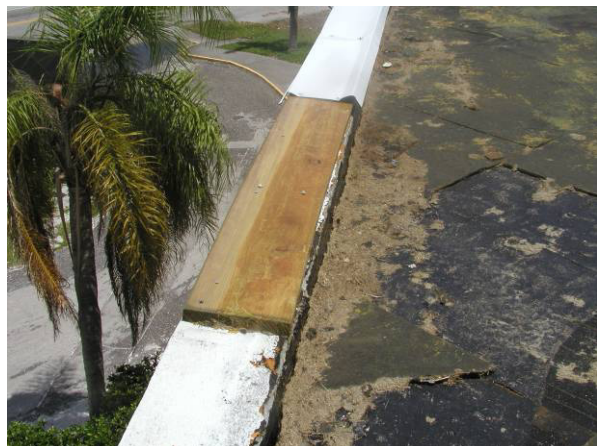
**3-11-2. Missing edge metal, progressing to missing wood nailer.**

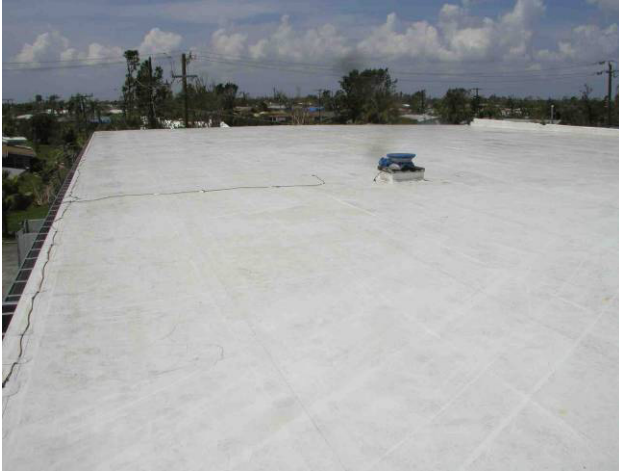
**3-12-1. Telephone exchange.** This roof performed well, except for lost fan. Edges did not fail.

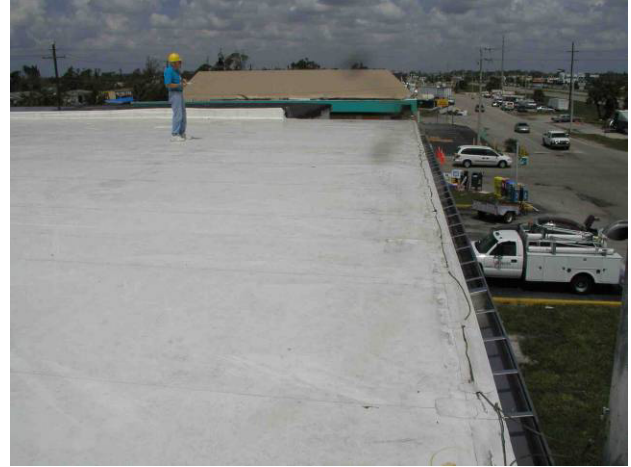
**3-12-2. Telephone exchange.** Gutter and edge details survived intact on leeward side.

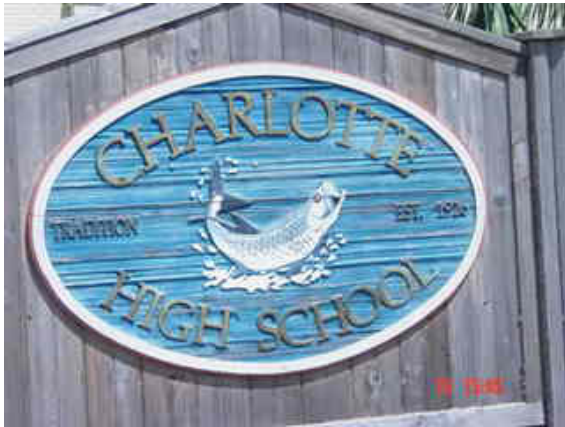
**5-01-1. Charlotte High School complex.**

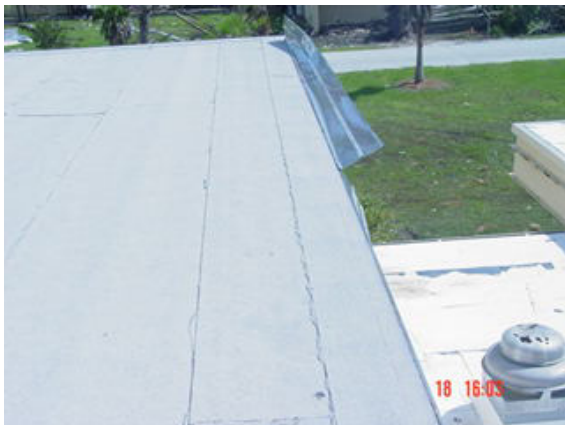
**5-01-3. Edge metal damage on modified bitumen membrane roof.**

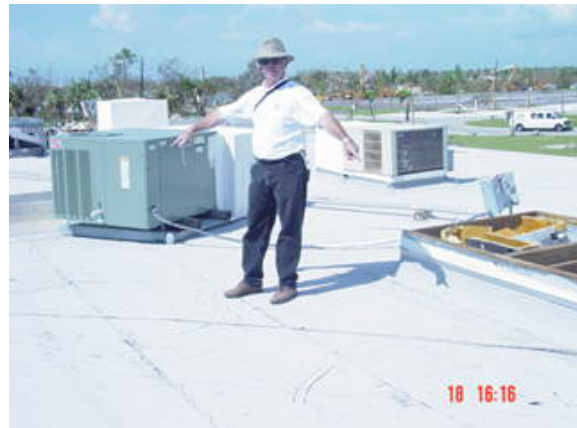
**5-01-4. Displaced air handler.**

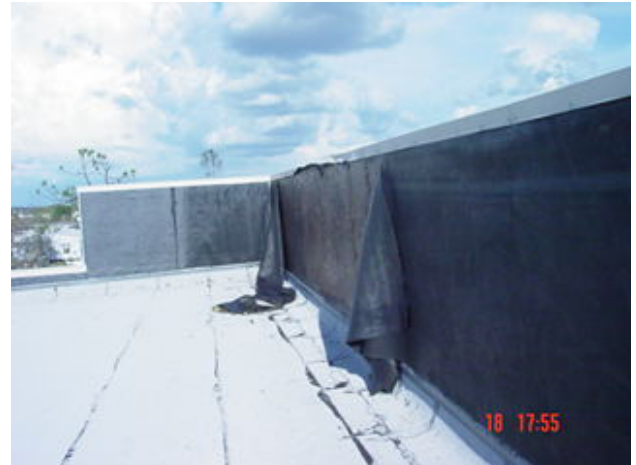
**5-03-2. Membrane came loose from high parapet wall.**

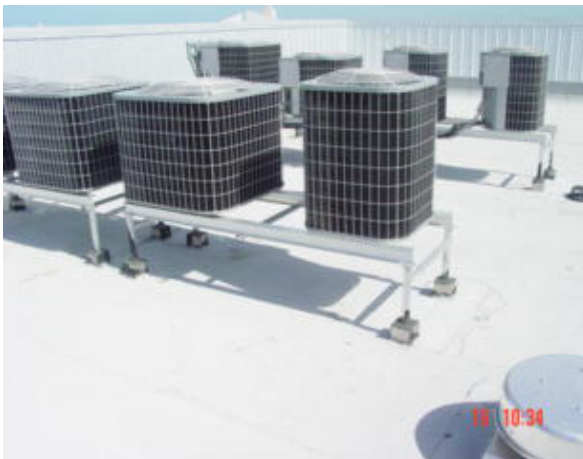
**5-04-1. Well installed air handling units, also 5-ft. parapet wall.**

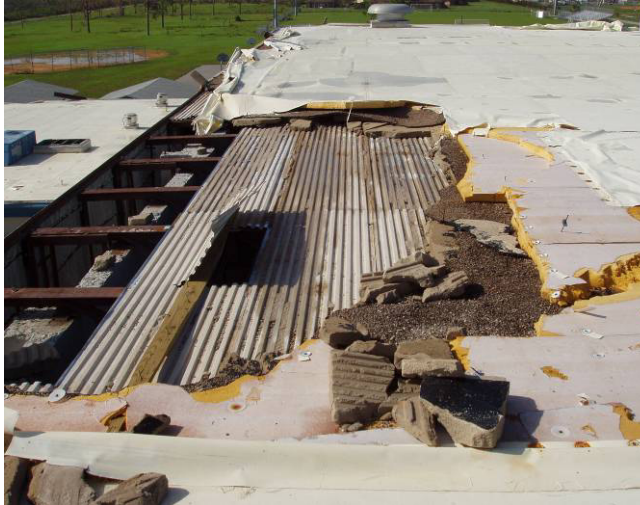
**5-08-1. Complete system including old membrane and recover foam and single-ply damage.**

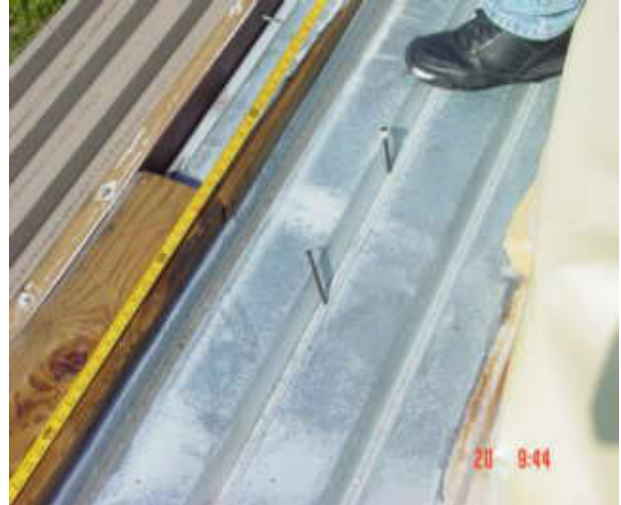
**5-08-2. Fasteners in the bottom of the flute.**

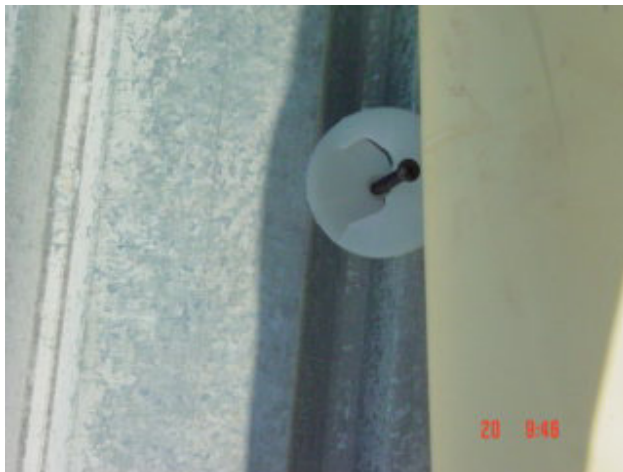
**5-08-3. Damaged plastic plate.**

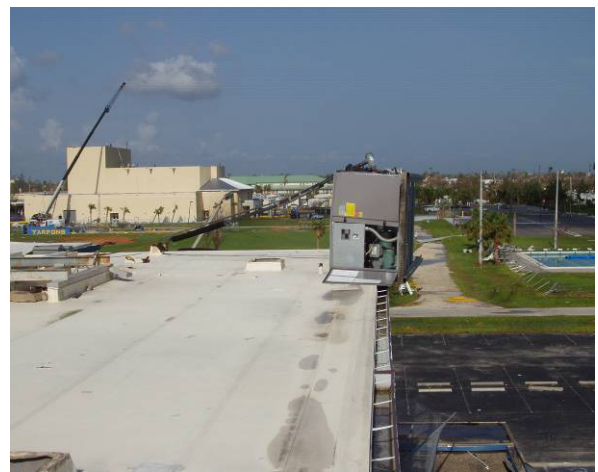
**5-08-4. Air handler on the edge.** The power lines are keeping it on. Also note the repairs under way at the building in the background.

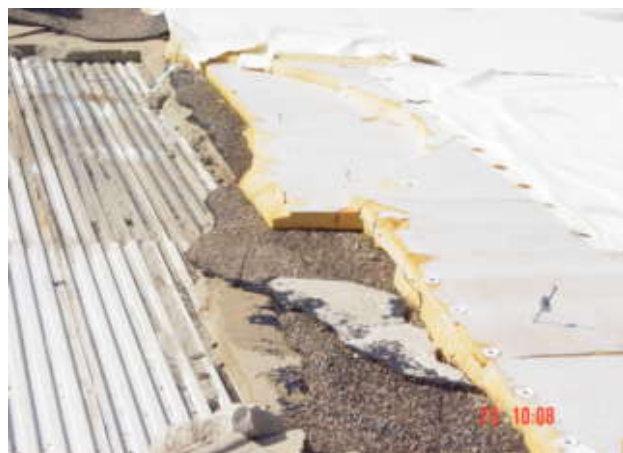
**5-08-5. Note fastener pattern.**

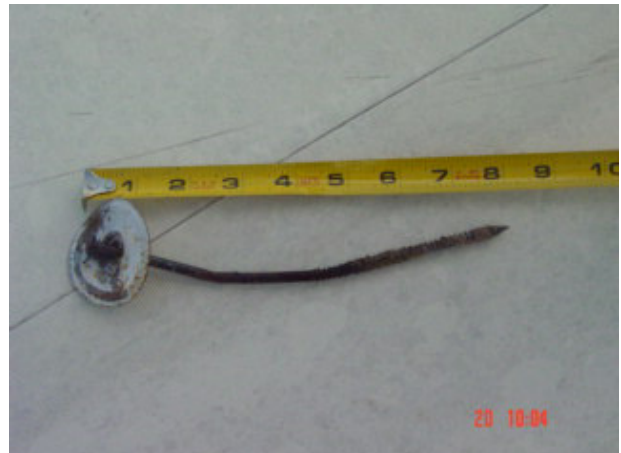
**5-08-6. Corroded fastener.**

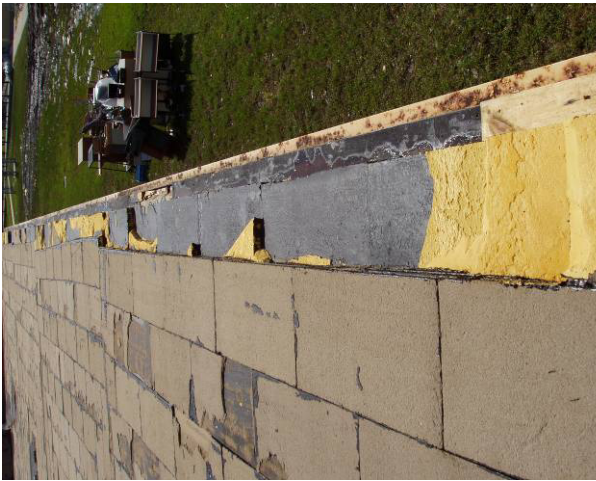
**5-09-1. Edge failure.**

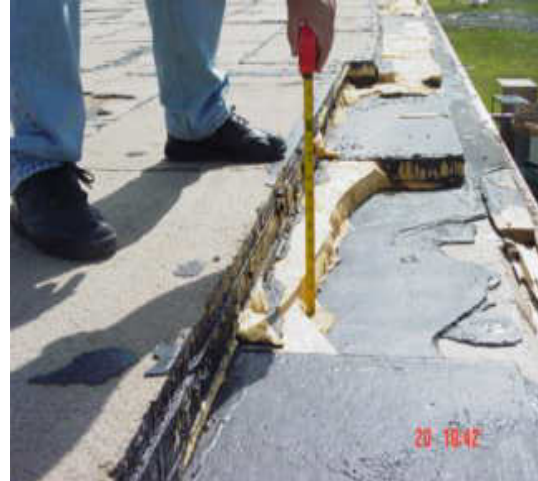
**5-09-2. Recover system.**

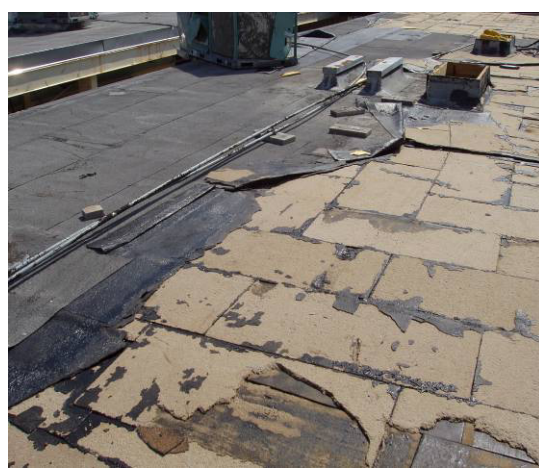
**5-09-4. Peel is stopped by drain lines and a missing air handling unit.**

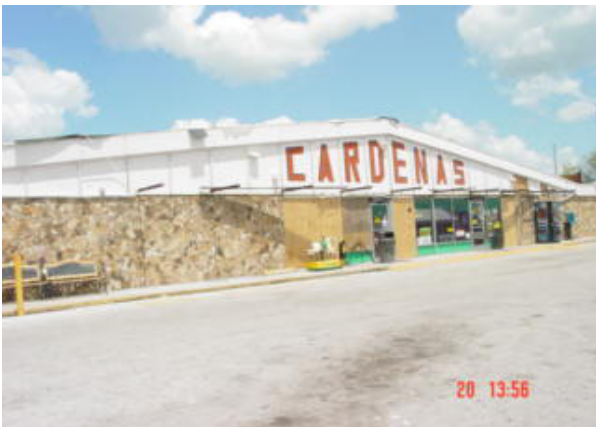
**5-10-1. Overview showing where windows were breached and where roof damage occurred directly above windows.**

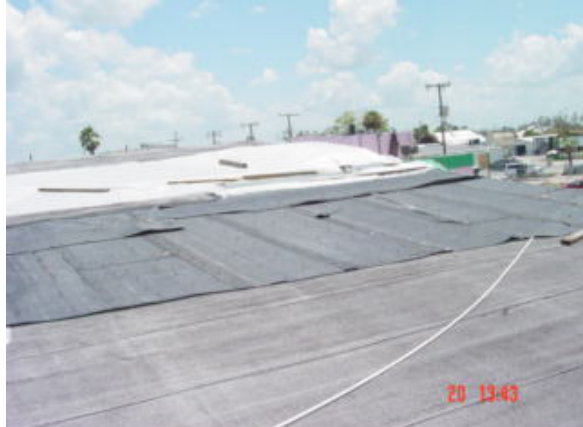
**5-10-2. Temporary repairs on modified bitumen roof directly over breached windows.**

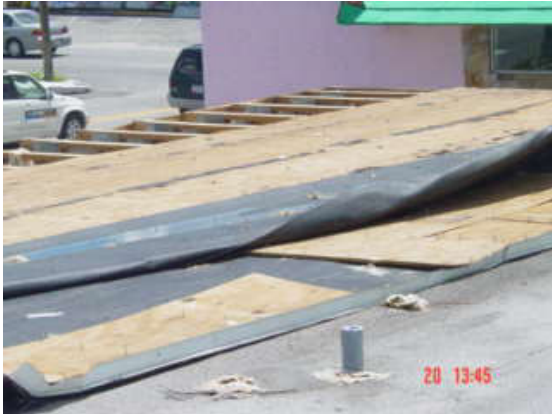
**5-10-3. Deck and membrane blow-off on south side.**

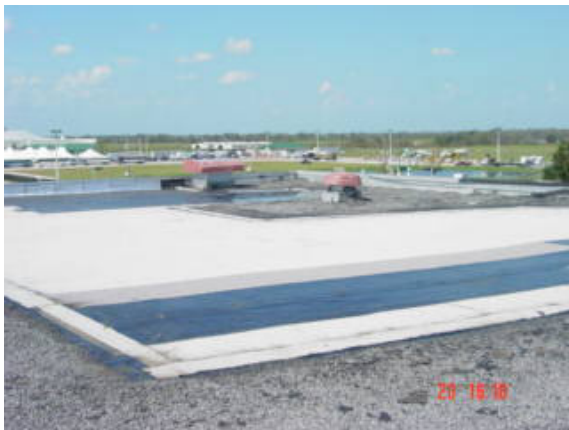
**5-12-1. Area of temporary repairs on gymnasium roof.**

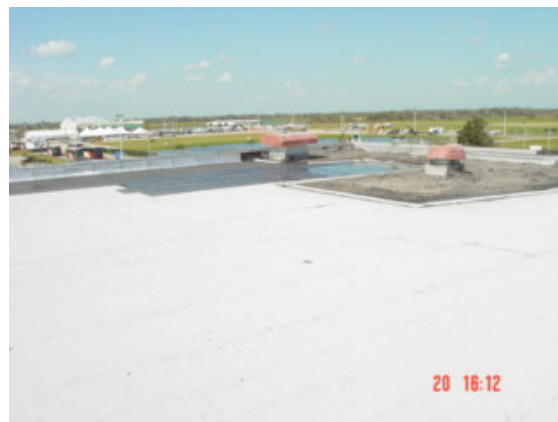
**5-12-2. Area of temporary repairs.**

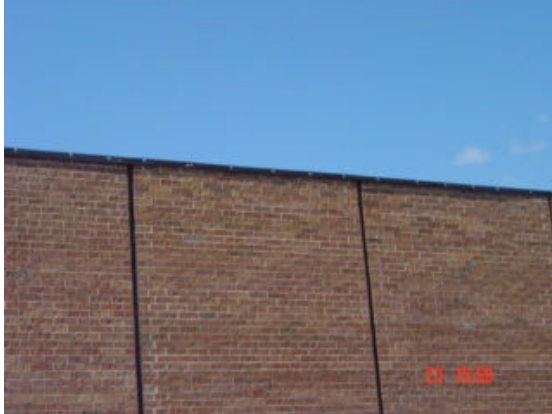
**5-12-3. Coping loss.**

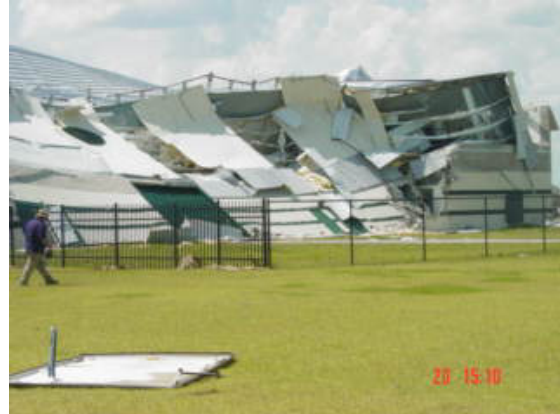
**5-13-1. Overview of Agra-center damage.**

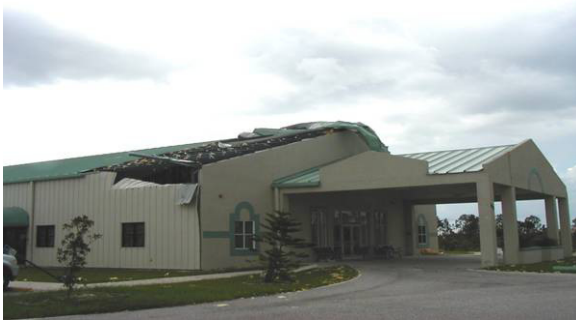
**6-01-1. Deep Creek Elks Lodge.** Front (windward) side showing panel displacement.
