# **RICOWI, Inc.**

Roofing Industry Committee on Weather Issues, Inc.

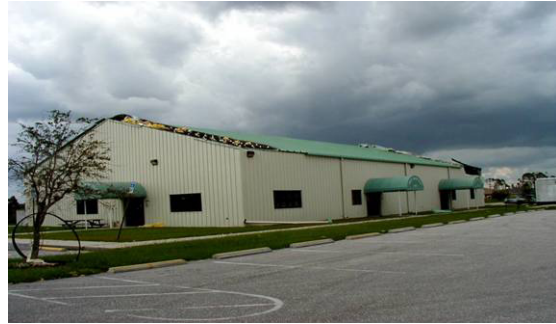
**6-01-2. Deep Creek Elks Lodge.** Rear (leeward) side roof damage.

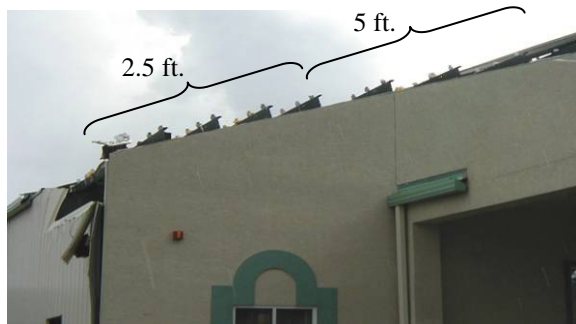
**6-01-3. Deep Creek Elks Lodge.** Note varied purlin spacing, affecting edge uplift.

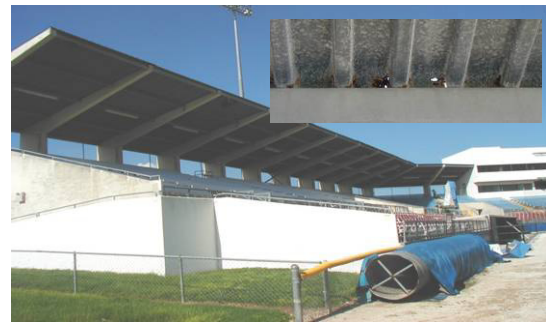
**6-02-1. Charlotte County Stadium.** First base canopy shows corrosion in subdeck (inset).

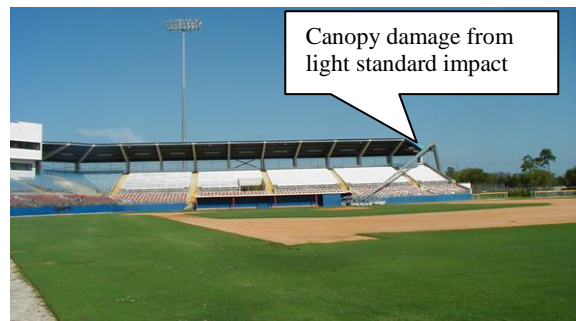
**6-02-2. Charlotte County Stadium.** Third base canopy damage.

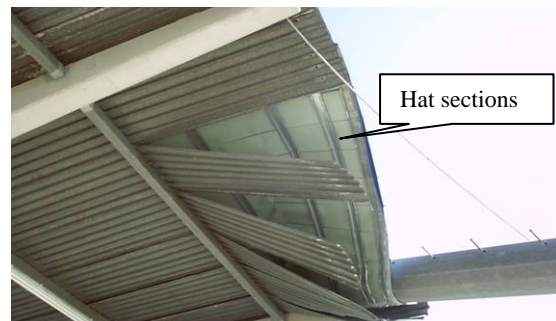
**6-02-3. Charlotte County Stadium.** Canopy with hat sections between covering and subdeck.

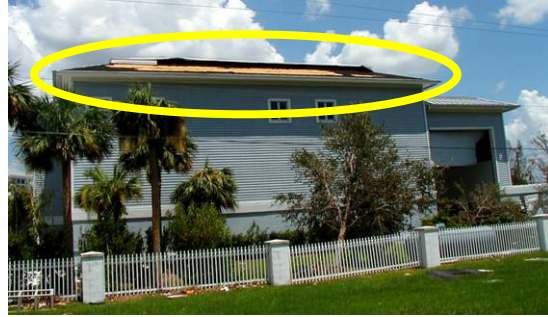
**6-03-2. IMPAC University.** Area where roof failure occurred.

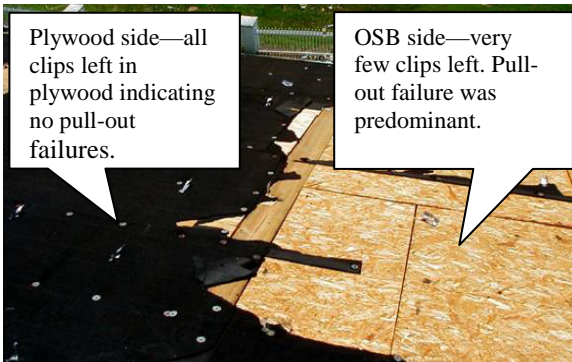
**6-03-3. IMPAC University.** Plywood and OSB substrate comparison, regarding holding power.

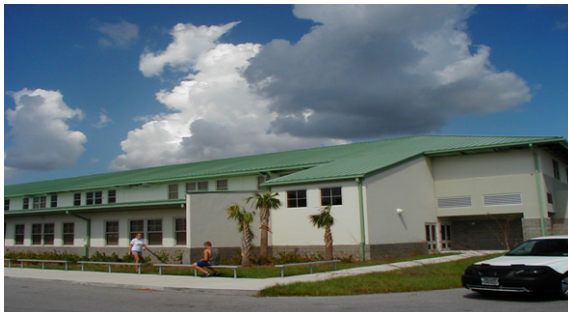
**6-04-2. Sallie Jones Elementary School.** No damage noted in this photo.

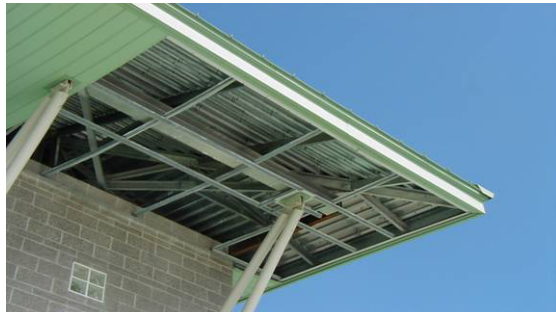
**6-04-3. Sallie Jones Elementary School.** The only problem was some soffit failures.

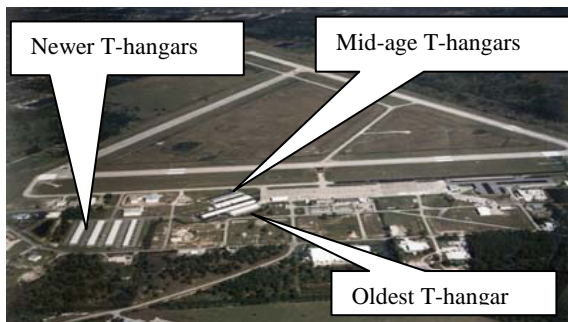
**6-05-1. Charlotte County Airport T-hangars.** Pre-hurricane view of airport.

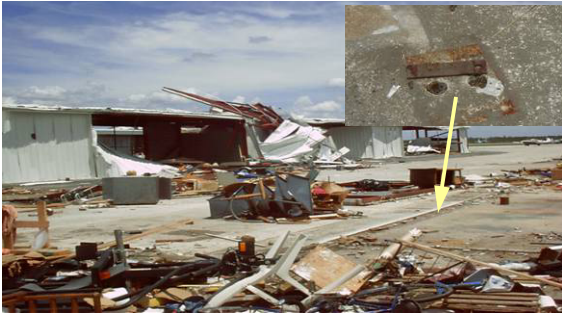
**6-05-3. Oldest T-hangar** (circa 1940s–50s). Anchor bolt failures led to total destruction.

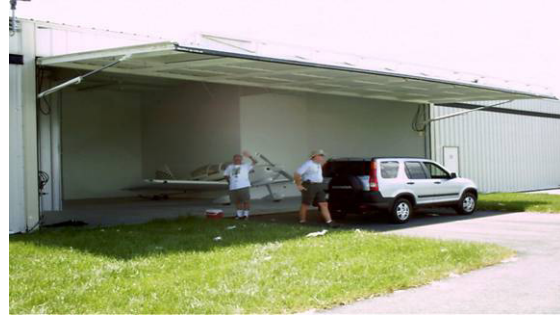
**6-05-4. Newest T-hangar.** Hydraulic lift doors without damage.

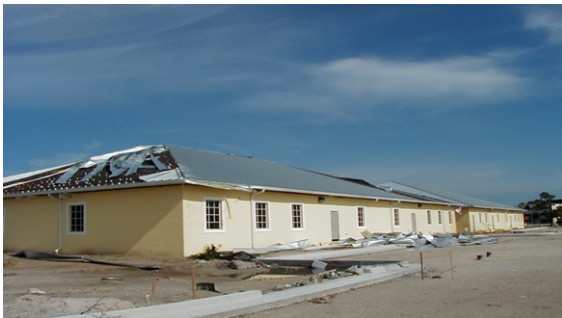
**6-6-1. Central Park Medical Center.** Note damage to roof (windward side) of rear building.

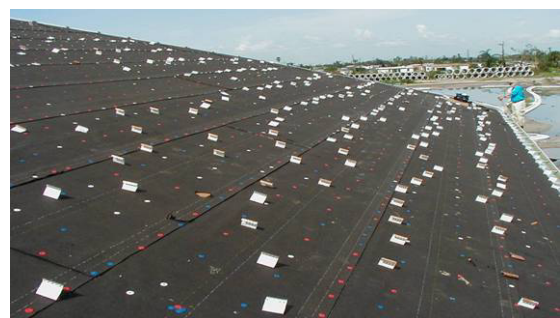
**6-6-2. Central Park Medical Center.** Note erratic clip spacing.

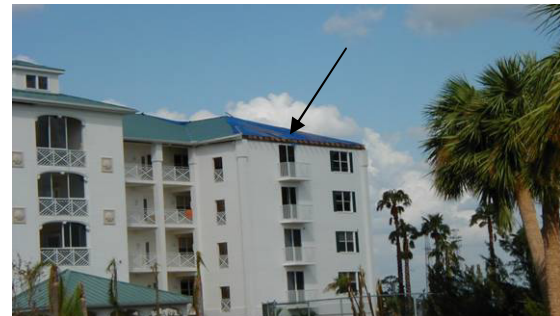
**6-07-2. Harbor Walk condos.** A closer view shows some roof damage (note arrow).

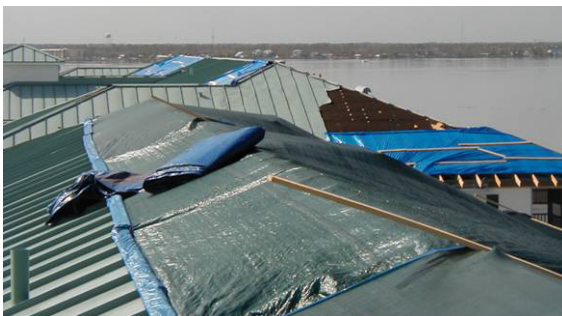
**6-07-3. Harbor Walk condos.** Standing seam roof damage.

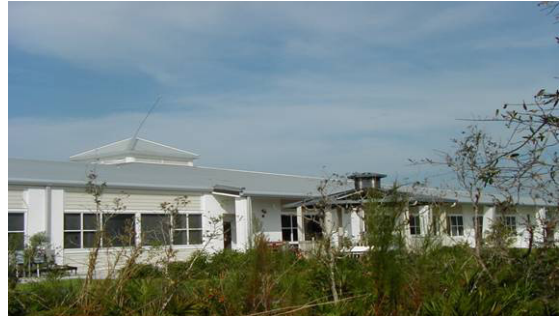
**6-08-1. Charlotte County Extension.** Standing seam roof on office building.

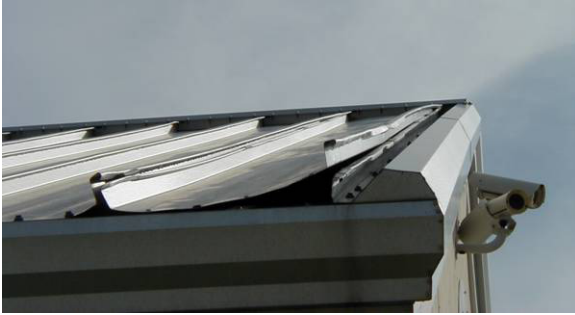
**6-08-2. Charlotte County Extension.** Damaged standing seam panels due to poor end seaming.

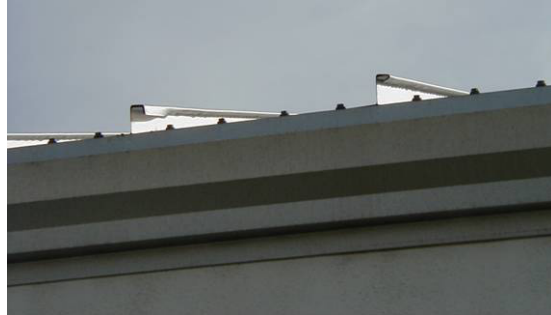
**6-08-3. Charlotte County Extension.** Note poor end seaming.

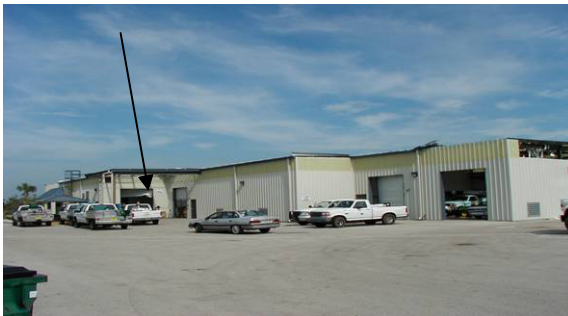
**6-09-1. Mosquito control.** Failed overhead door in end bay—canopy area shown under arrow.

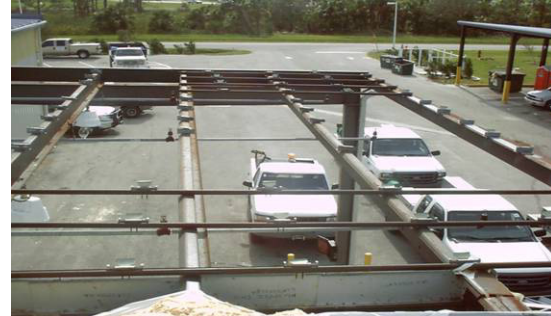
**6-09-2. Mosquito control.** Canopy area with missing panels at failure initiation point.

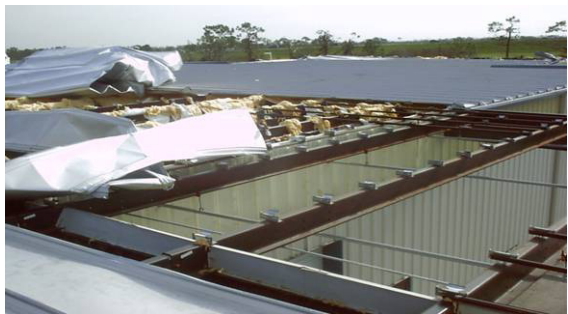
**6-09-3. Mosquito control.** This standing seam roof was peeled back over canopy and onto field of roof.

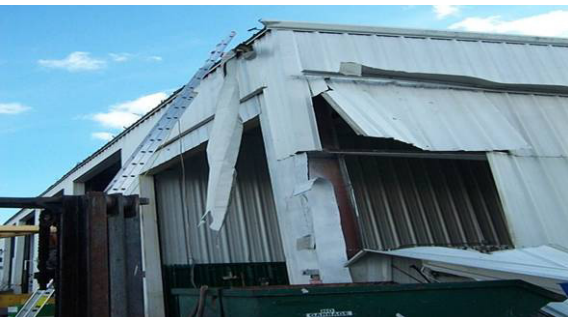
**6-10-2. Waste management.** End-wall damage.

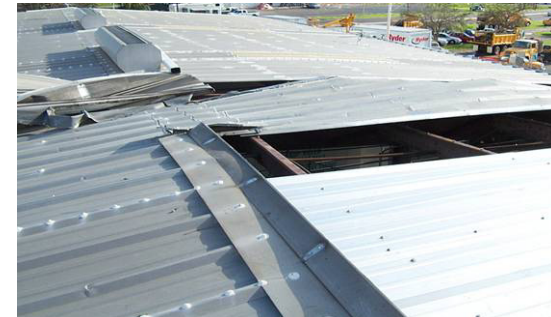
**6-10-3. Waste management.** Standing seam roof damage.

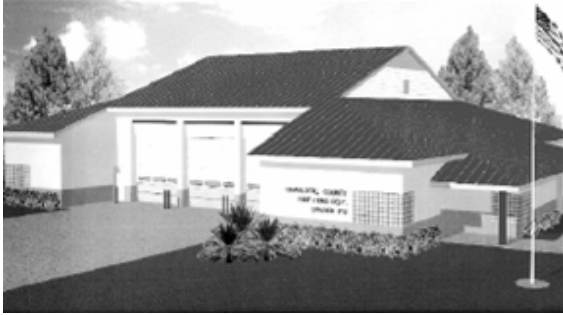
**6-11-1. Charlotte County EMS station.** Pre-Charley appearance.

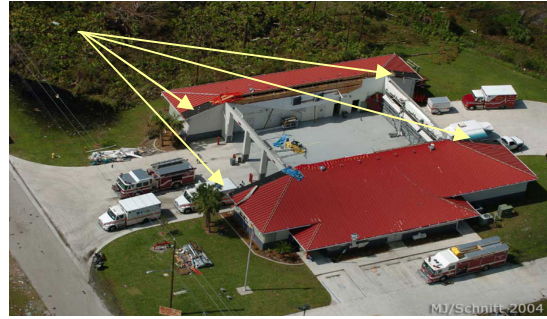
**6-11-2. Charlotte County EMS station.** View of failed center roof and corner damage (arrows).

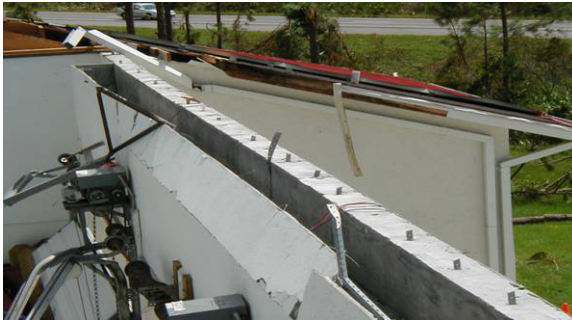
**6-11-3. Charlotte County EMS station.** Roof truss tie-down anchor straps failed in tension.

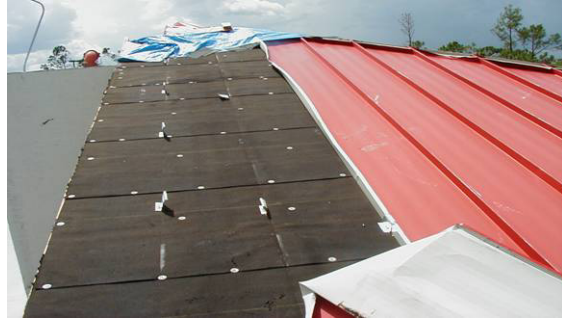
**6-11-4. Charlotte County EMS station.** Standing seams failed at all four corners.

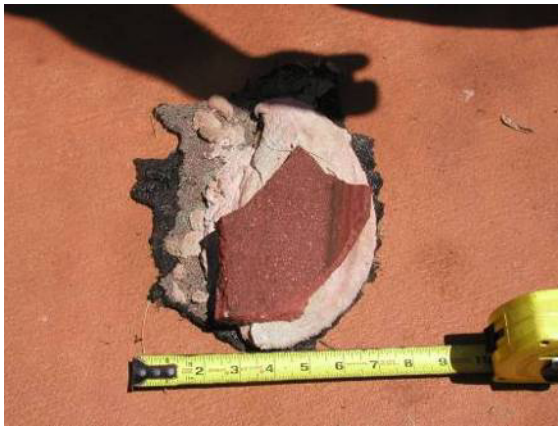
**1-04-1. Residence in Punta Gorda Isles.** Mortar failures found included loss of bonding of mortar-to-substrate-to tile, or in this case, underlayment broken apart. There are currently no test requirements for underlayments that address the bonding capabilities for use as a “bondable” underlayment for roofing material. Photo shows tile mortar and underlayment.

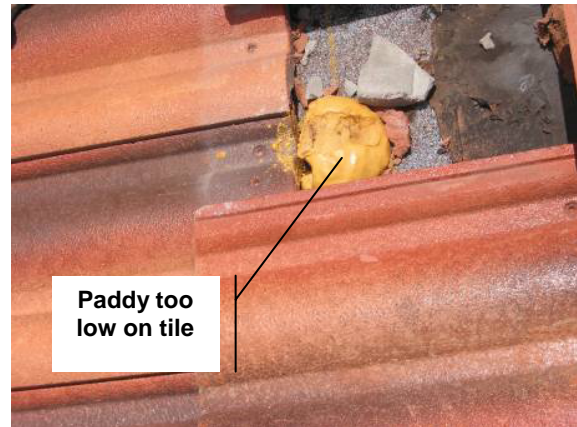
**1-11-1. Burnt Stores Marina.** Adhesive system with a paddy that is too small and in the wrong location.

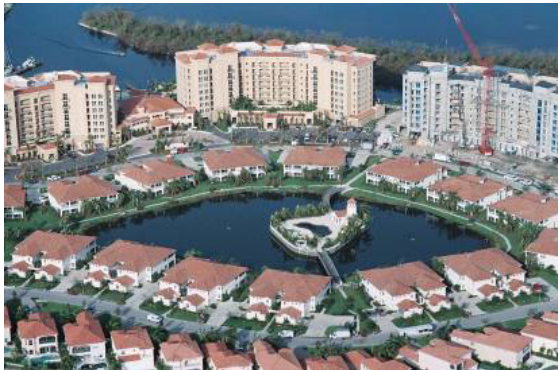
**1-11-2. Burnt Stores Marina.** Foam adhesive-set system with good results.

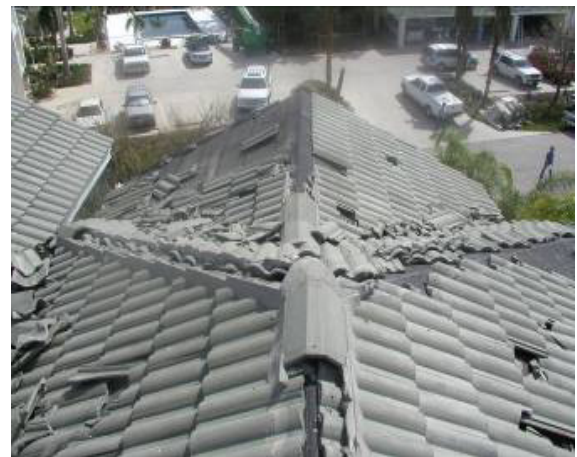
**1-13-1. Punta Gorda Isles.** Four-story high-rise, hip and ridge tile damage.

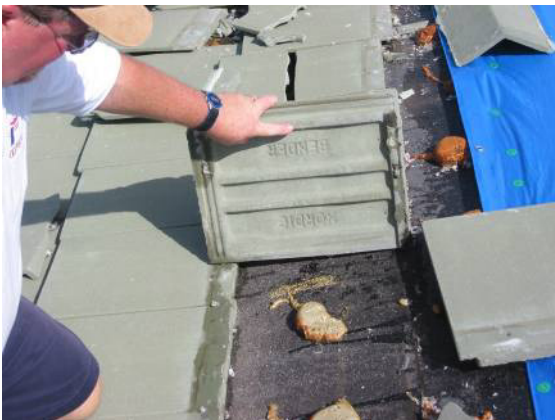
**1-19-1. Punta Gorda Isles.** Adhesive system with paddies that are too small and improperly located.

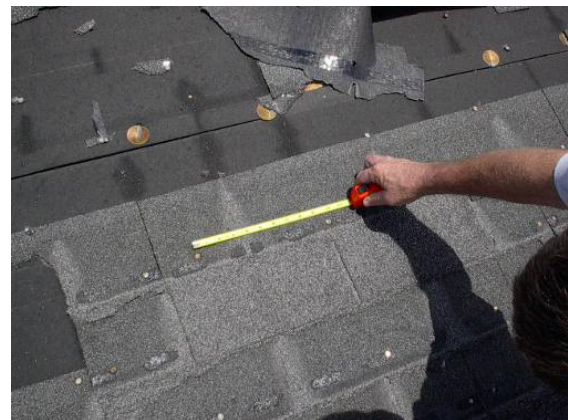
**1-21-1. Harbor Heights.** Fasteners here are 10 in. o.c. rather than six per shingle, as required by code.

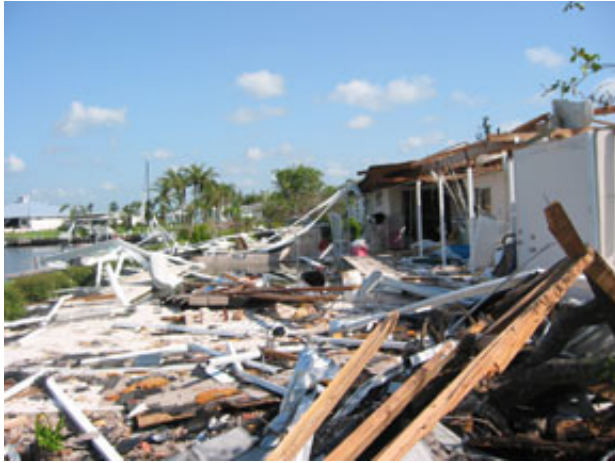
**1-21-6. Harbor Heights, Port Charlotte.** This photo shows the magnitude of structural damage that occurred during Hurricane Charley. Note amount of debris that was present.

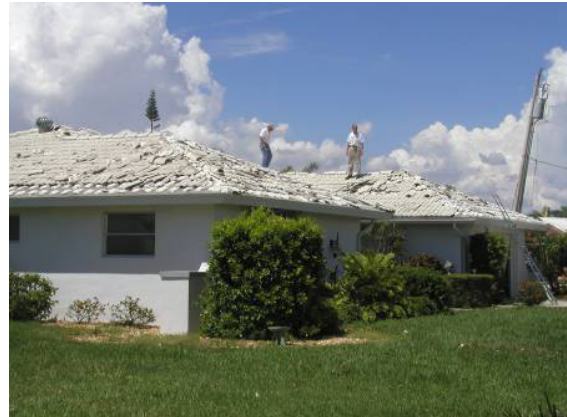
**1-22-1. Punta Gorda Isles.** Mortar-set system tile failure. An estimated 60% of tiles were dislodged.

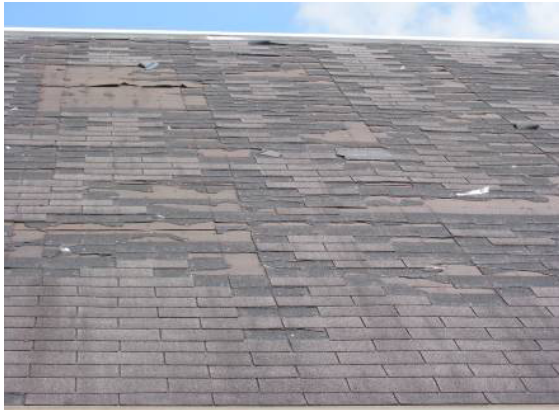
**1-29-1. Harbor Heights-East.** Area of lower wind impact. Photo shows shingle loss.

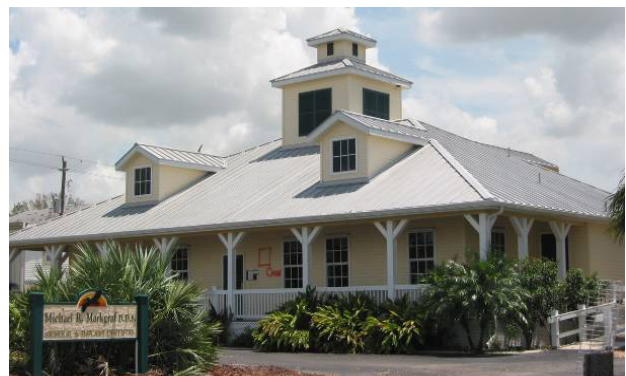
**1-29-4. Punta Gorda.** This photo shows through-fastened metal roof panels with fasteners 6 in. o.c. up seams. Some oil canning of metal panels was noted.

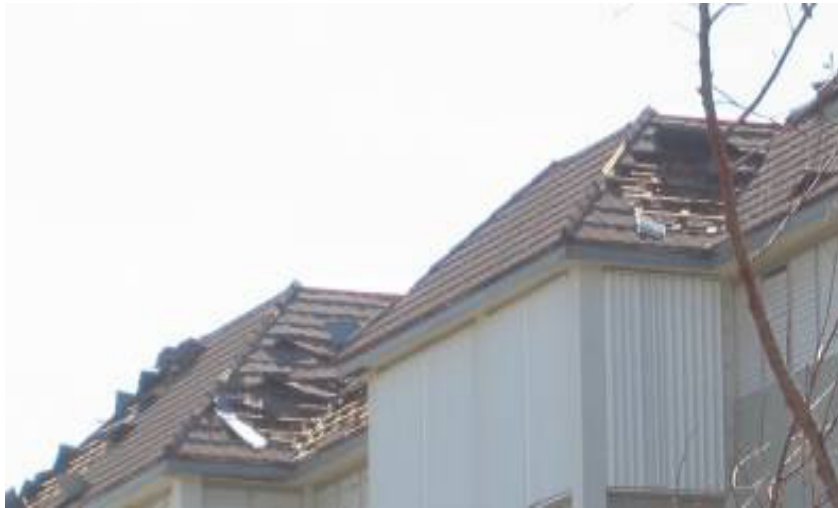
**1-29-5. Stone-coated metal roofing.** Metal tiles rotated on batten as a result of high winds.

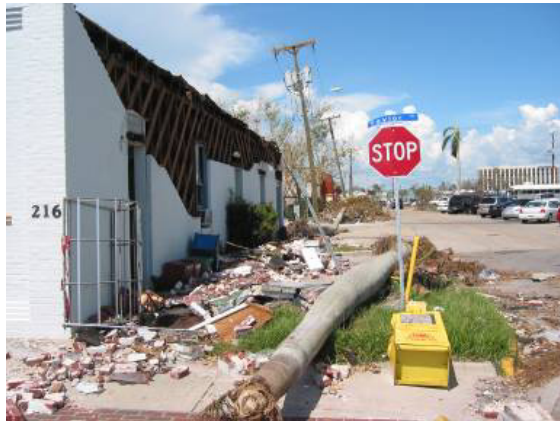
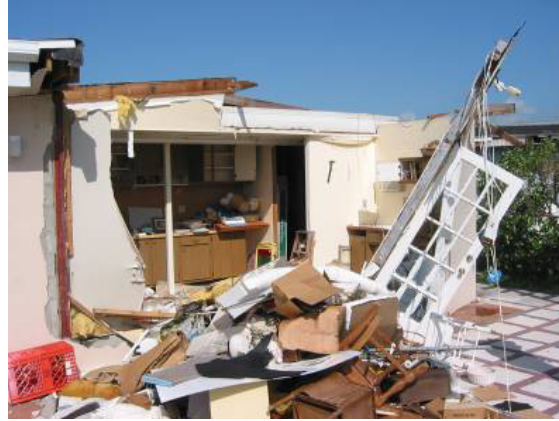
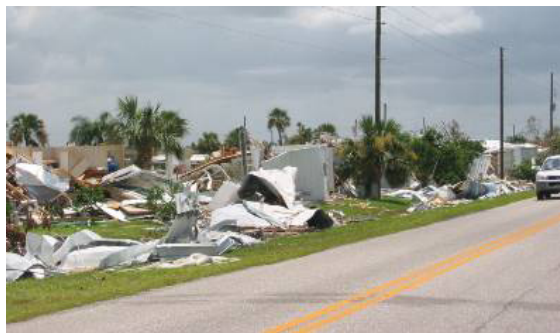
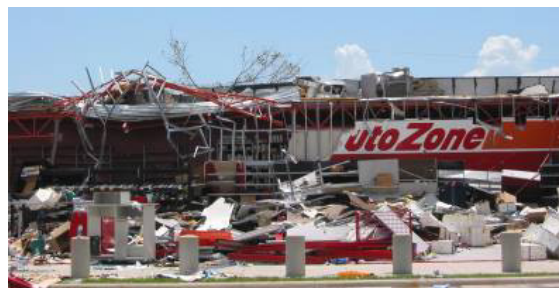
**Debris fields—Harbor Heights and downtown Punta Gorda**

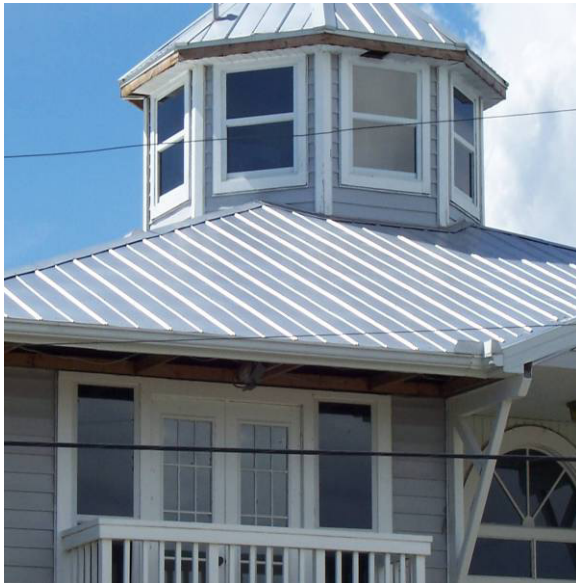
4-01-4. Undamaged through-fastened metal roof.

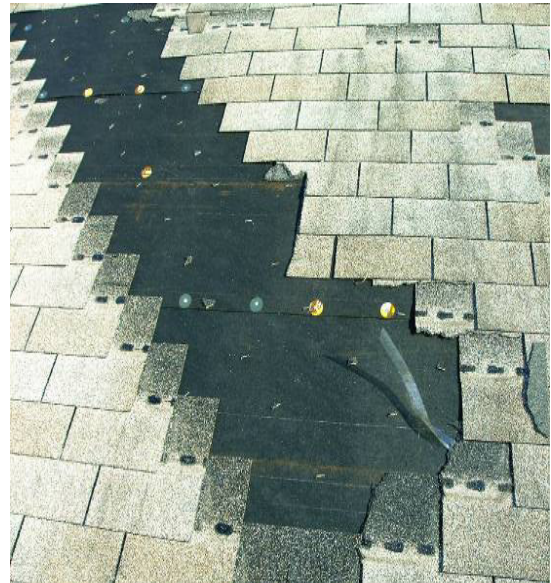
4-03-4. Shingles torn loose from staples.

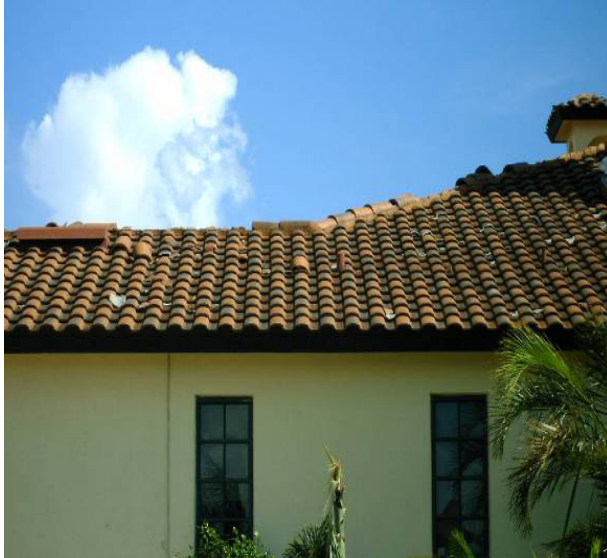
**4-05-2. Hip and ridge pieces missing from cement mortar attachment.**

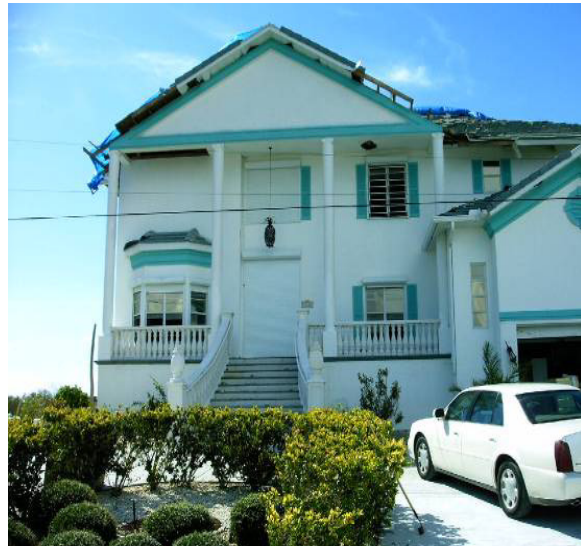
**4-06-2. Soffit, sheathing, and edge damage along with major roof damage.**

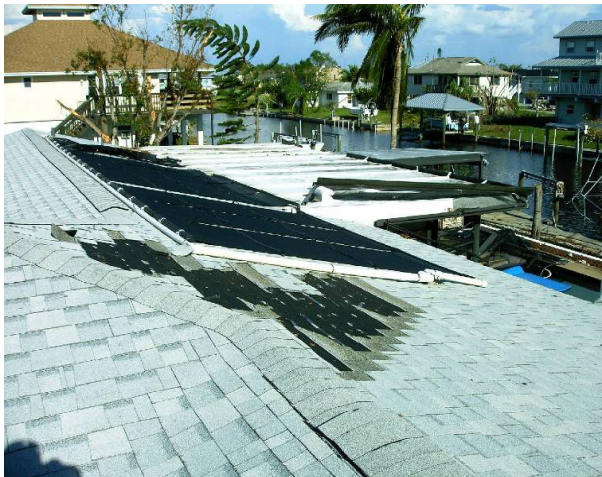
**4-04-4. Note shingles torn from fasteners.**

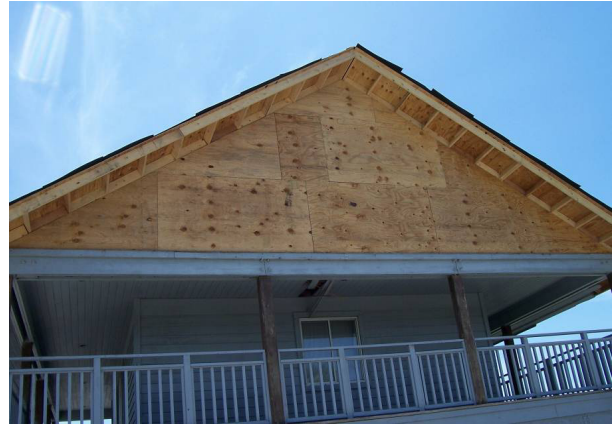
**4-11-2. Another tennis building, located in close proximity to building in photo 4-10-1, had its granular steel roof blown off as a result of structural damage at gable end.**

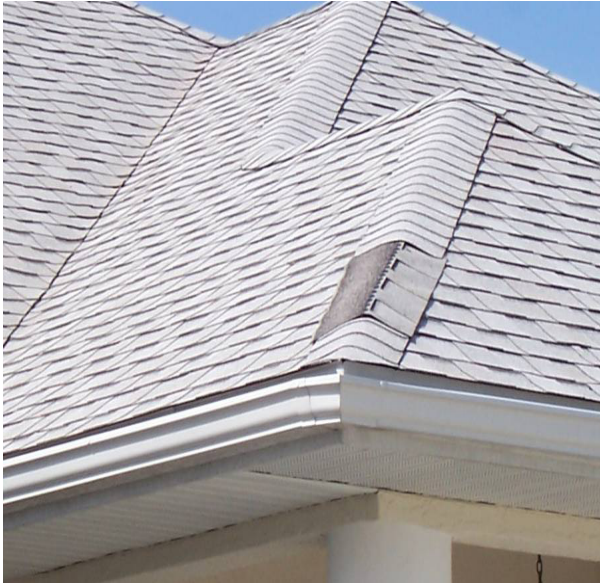
**4-12-2. Minor damage to hip pieces on shingle roof.**

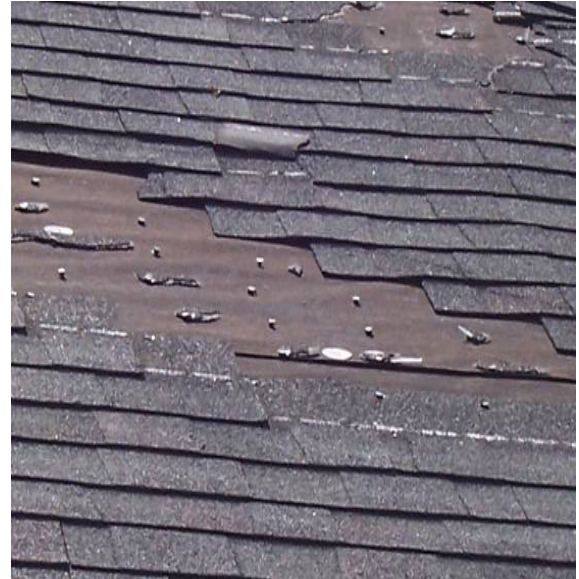
**4-13-3. Damage to shingles in field of roof located near home pictured in photo 4-12-2.**

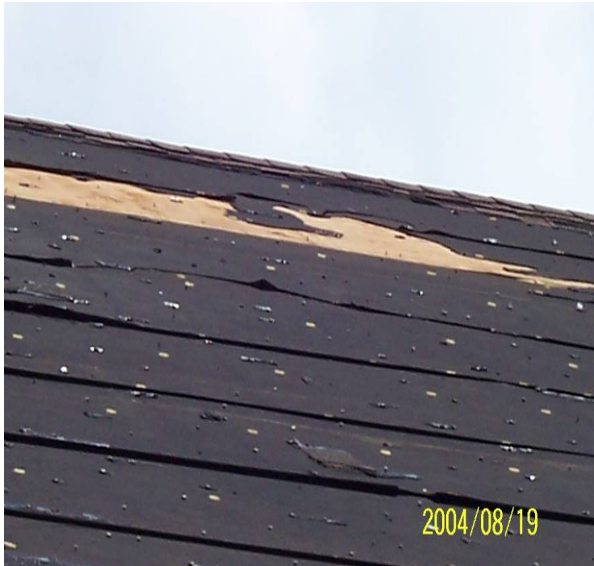
**4-15-4. Major shingle loss as a result of inconsistent nailing (location and/or quantity).**

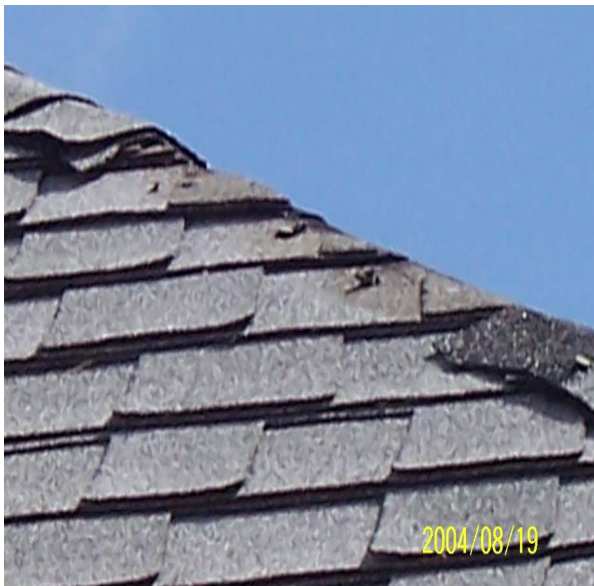
**4-17-2. Hip pieces missing on shingle roof.**

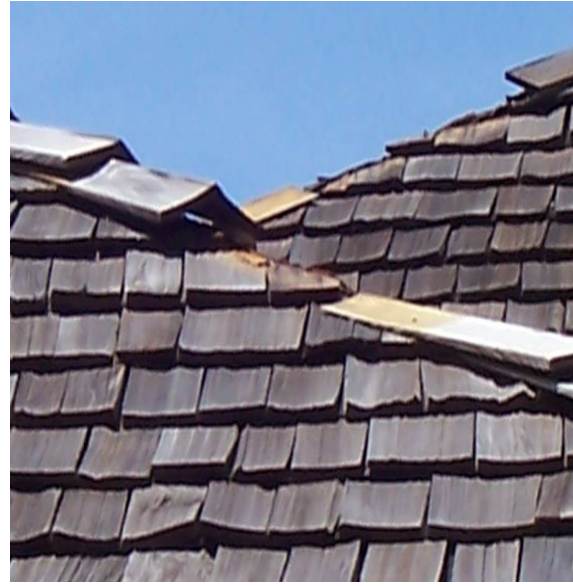
**4-18-3. Hip pieces missing on 7- to 8-year-old wood shake roof.**

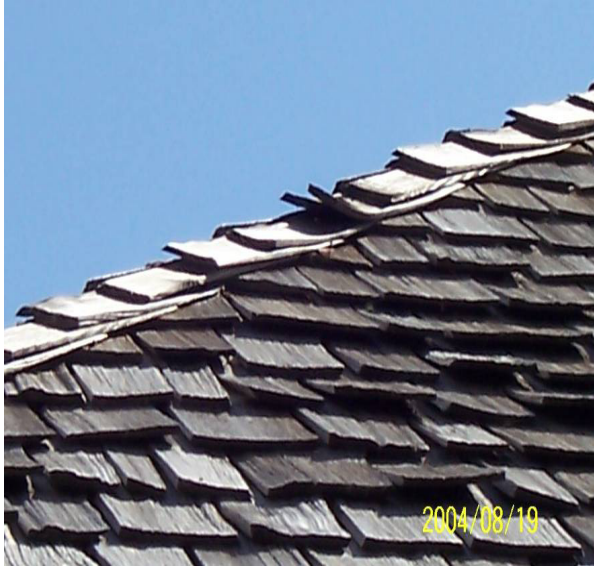
**4-19-2. Raised hip shakes appear to be the result of age and weathering, not strong winds.**

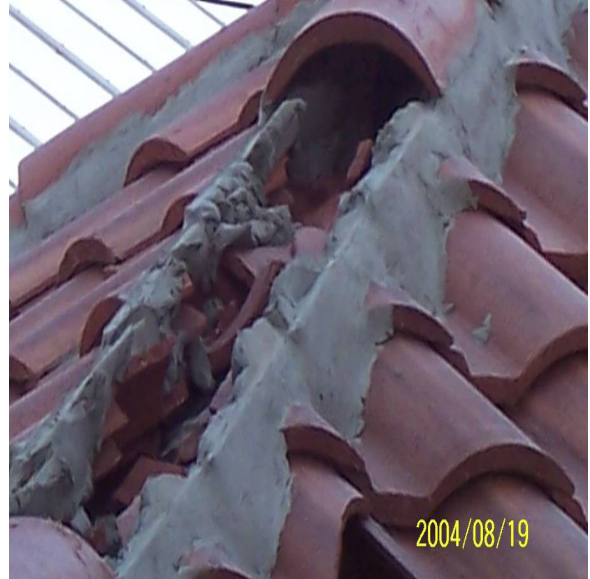
**4-20-2. Clay hip tiles are missing from cement mortar beds.**

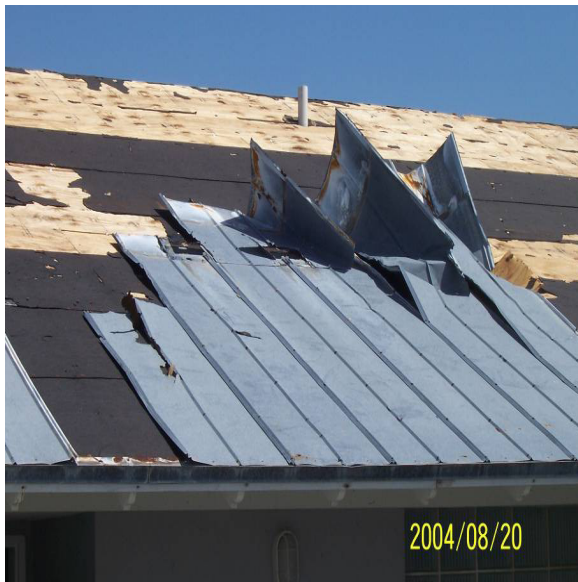
**4-21-7. Old and rusting through-fastened metal panels have pulled loose from roof.**

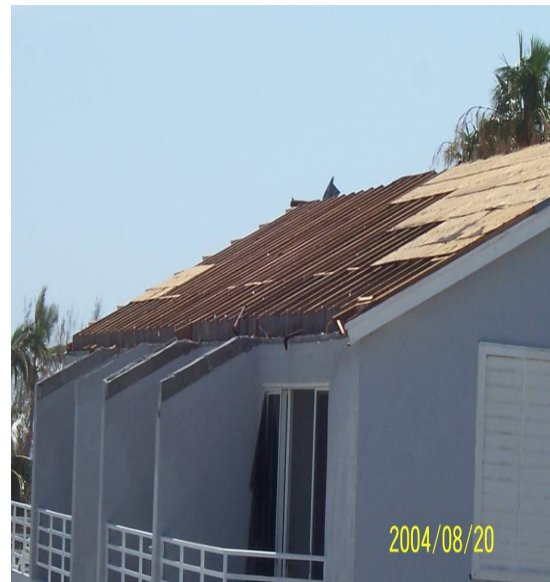
**4-21-8. Opposite side of roof shown in photo 4-21-7 with structural and sheathing problems.**

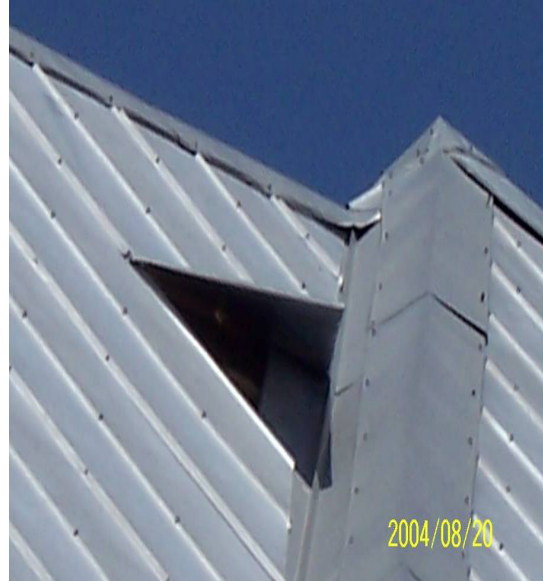
**4-24-3. Intact through-fastened metal roof panels missing one valley panel.**

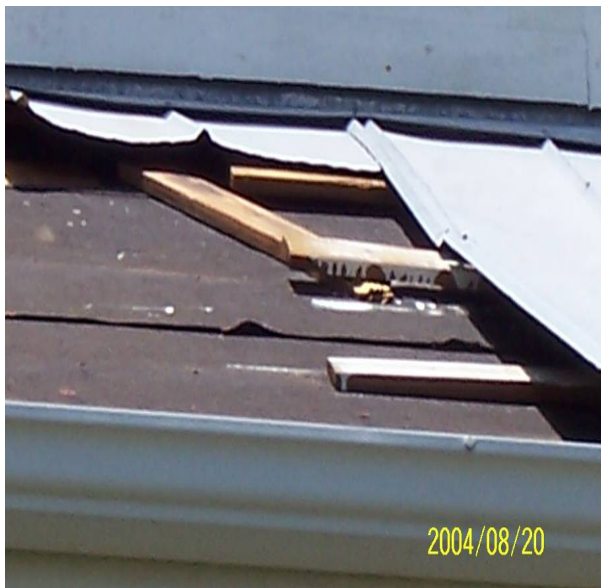
**4-23-3. Through-fastened metal panels became loose because of 1×4-in. stringers pulling from roof.**

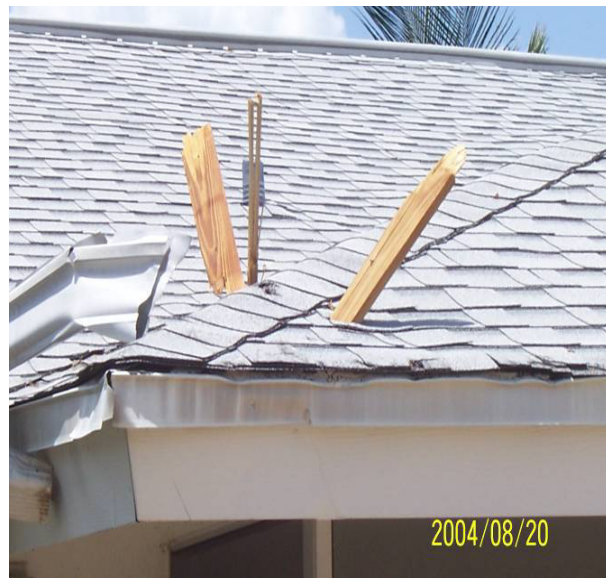
**4-23-8. 1×4-in. stringers from roof in photo 4-23-3 are impaled in this adjacent shingle roof.**

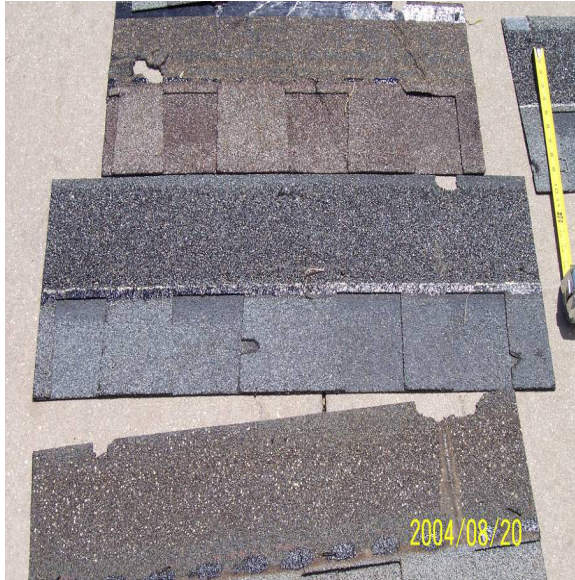
**4-27-7. Some of the five types of shingles found on a roof that was damaged.**

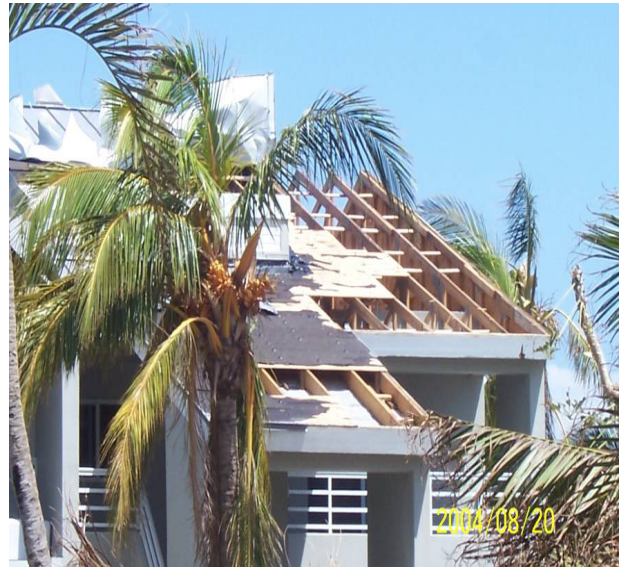
**4-25-6. Standing-seam panels, sheathing, and structure damaged by winds on Sanibel island.**

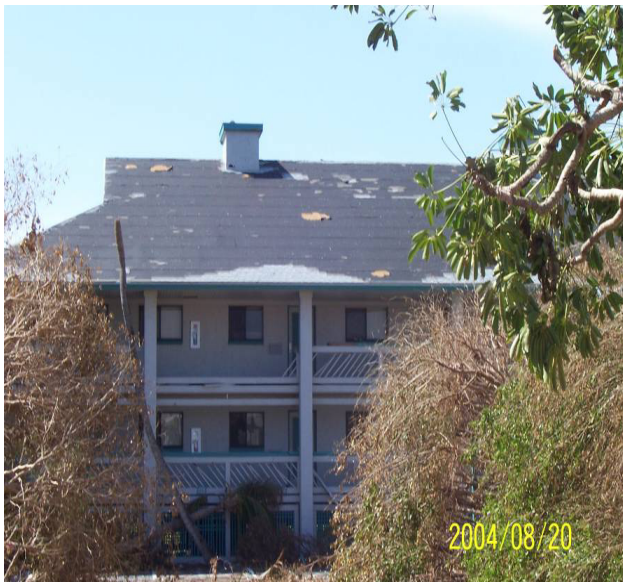
**4-28-4. Major damage to asphalt shingle roof on Sanibel Island.**

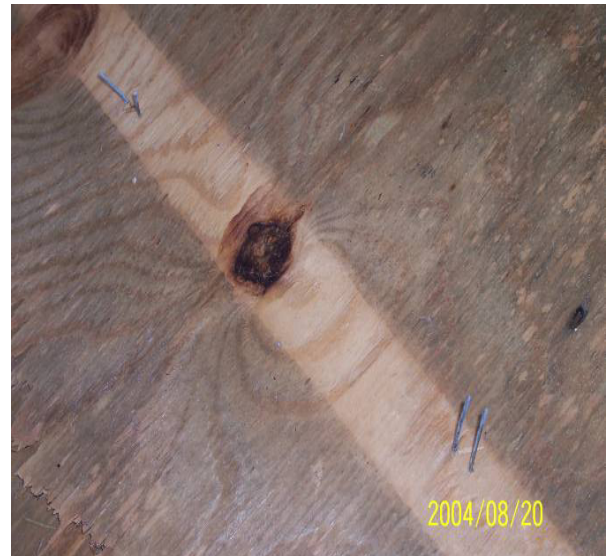
**4-28-8. Photo of plywood attachment method from roof in photo 4-28-4 that lost sheathing.**

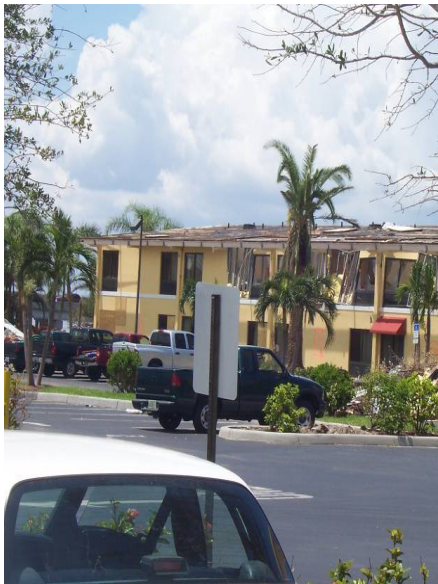
**4-32-5. Major roof and decking damage on hotel.**

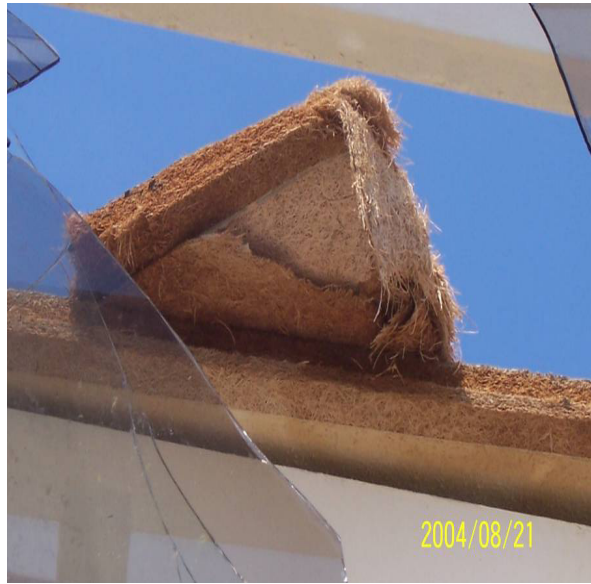
**4-32-10. Roof in photo 4-32-5 was attached to decking material pictured in this photo.**

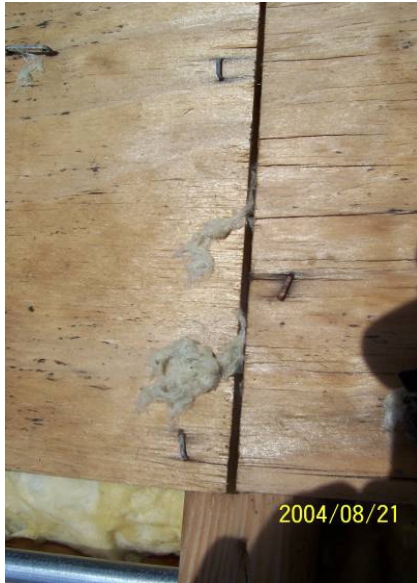
**4-34-8. Plywood attachment on damaged church.**

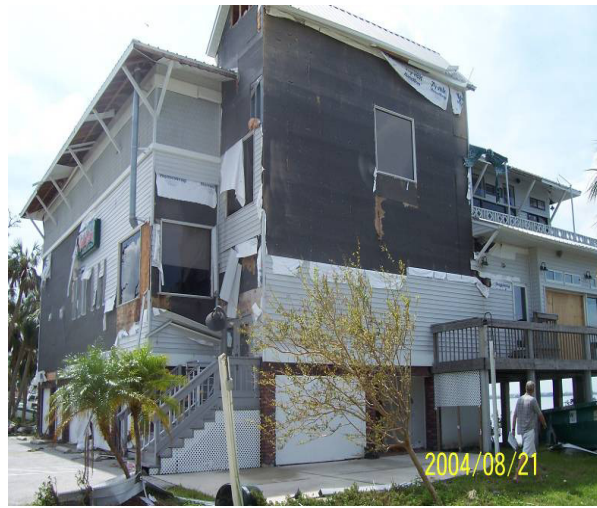
**4-30-2. Most of metal roof still in place on damaged building.**

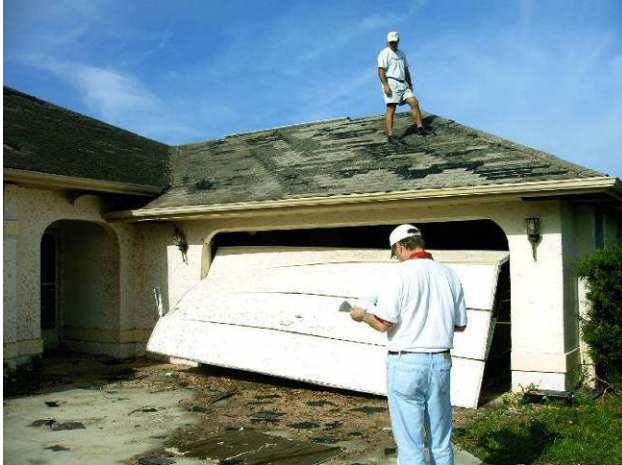
7-01-1. Peachland—garage door blow-out.

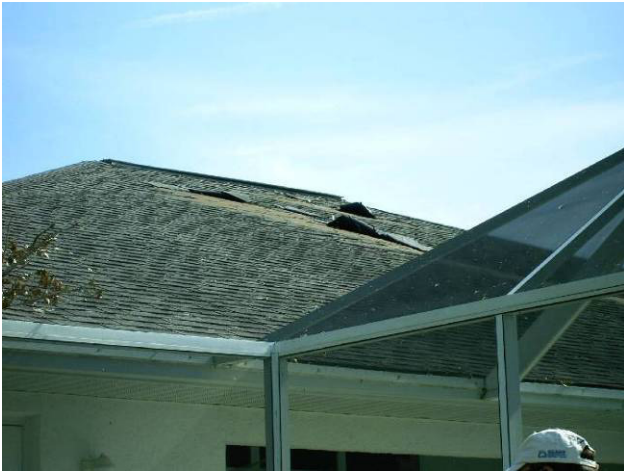
**7-02-3. Peachland—minor roof damage.**

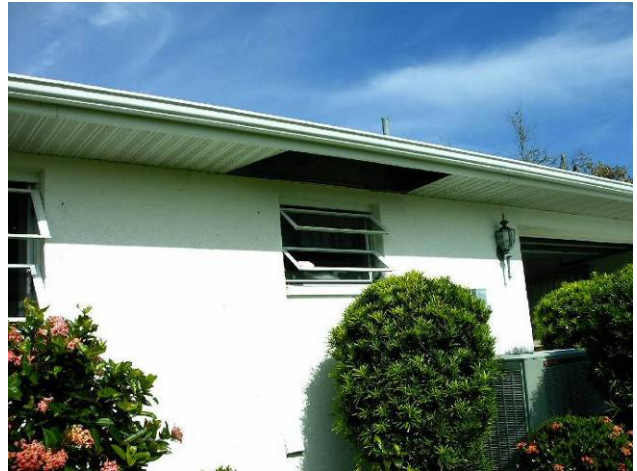
**7-02-4. Peachland—eave damage.**

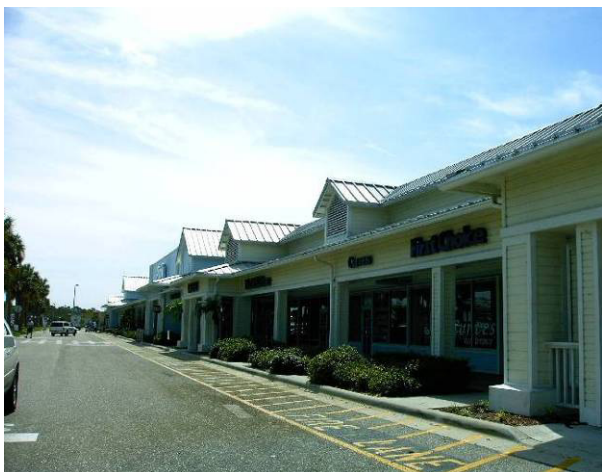
**7-03-1. Publix mall Kings Highway—minor damage.**

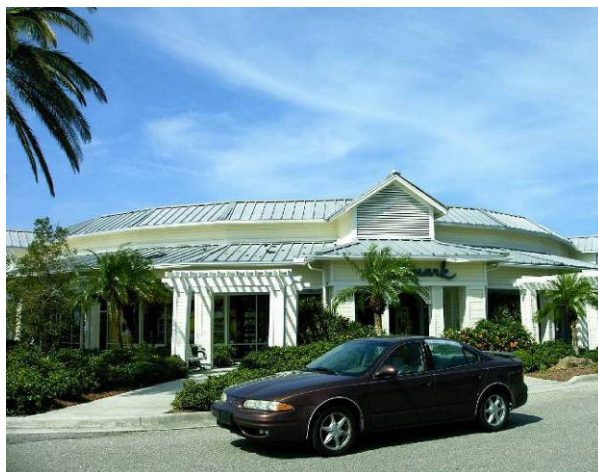
**7-03-2. Publix mall Kings Highway—minor damage.**

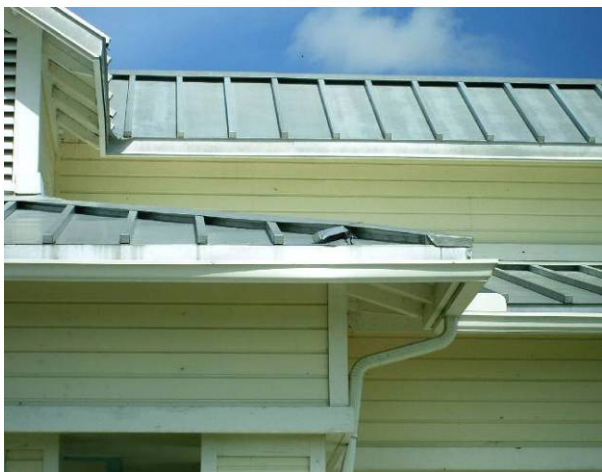
**7-03-3. Publix mall Kings Highway—hip damage.**

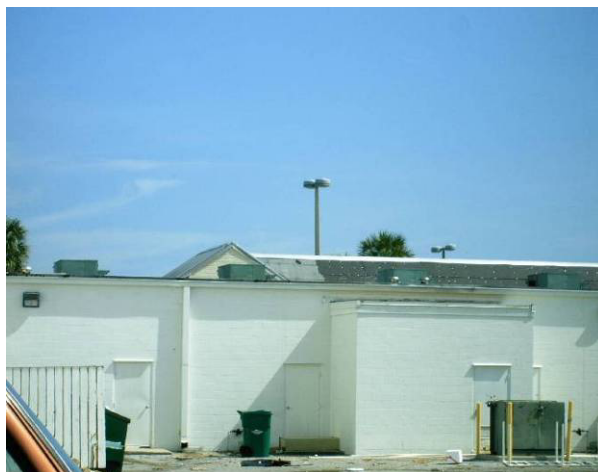
**7-03-4. Publix mall Kings Highway—parapet.**

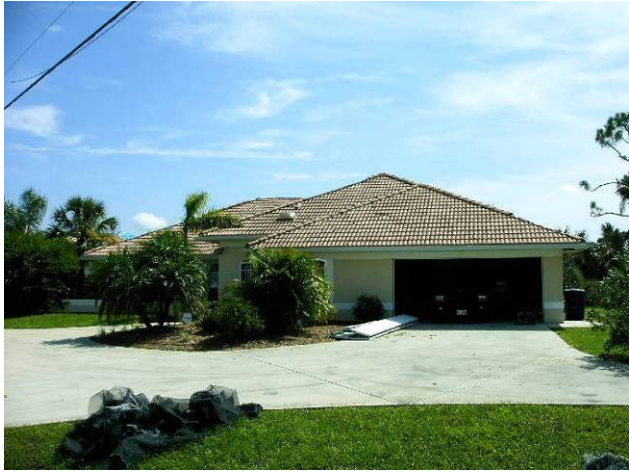
**7-04-1. Torrington—concrete tile damage.**

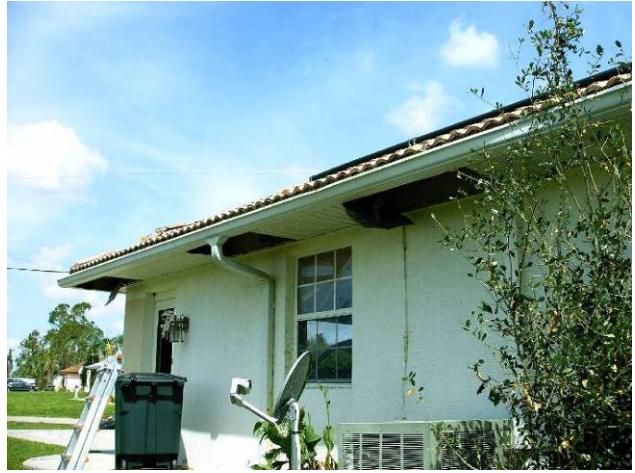
**7-04-2. Torrington—concrete tile eave damage.**

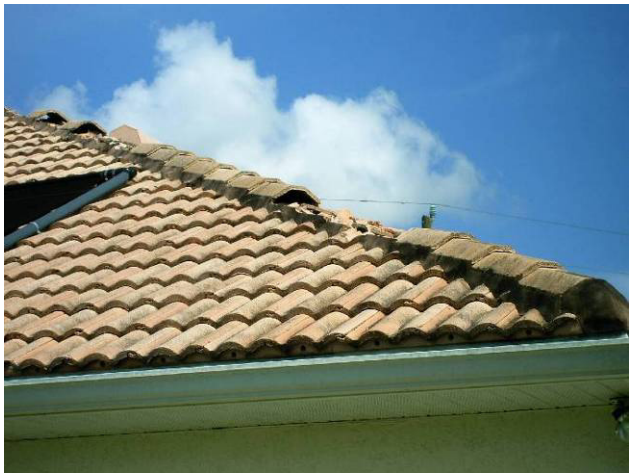
**7-04-3. Torrington—concrete tile hip damage.**

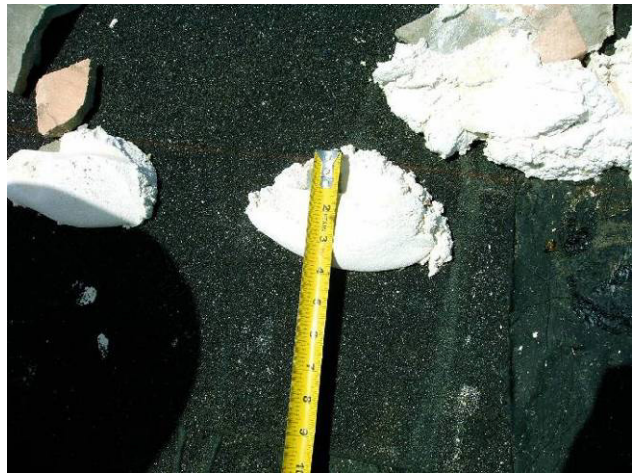
**7-04-4. Torrington—concrete tile mortar blobs.**

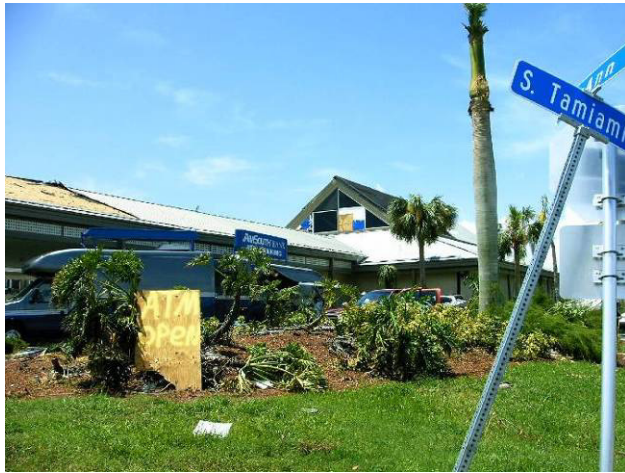
**7-05-1. AMSouth Bank—metal and gable damage.**

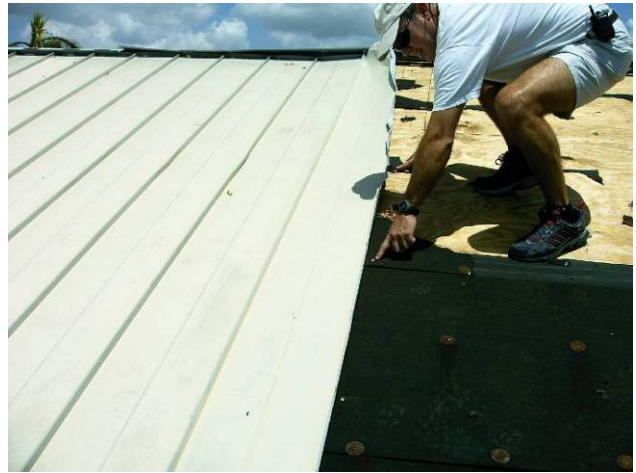
**7-05-2. AMSouth Bank—metal roof, fastener spacing.**

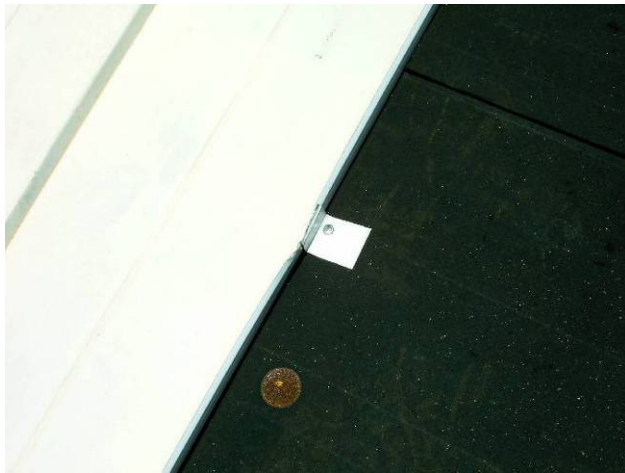
**7-05-3. AMSouth Bank—metal roof, fastener clips damage.**
