# **RICOWI, Inc.**

Roofing Industry Committee on Weather Issues, Inc.

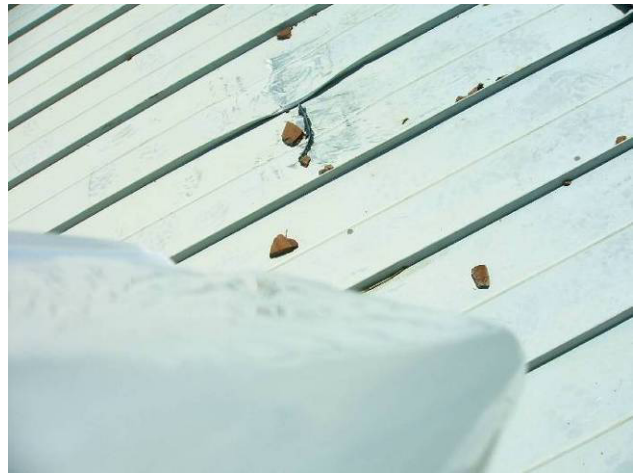
**7-05-4. AMSouth Bank—metal roof with tile impact points.**

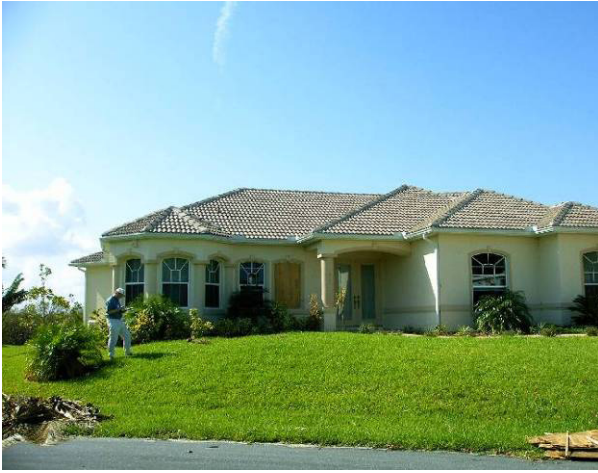
**7-08-1. 19189 Aviation—concrete tile with no damage.**

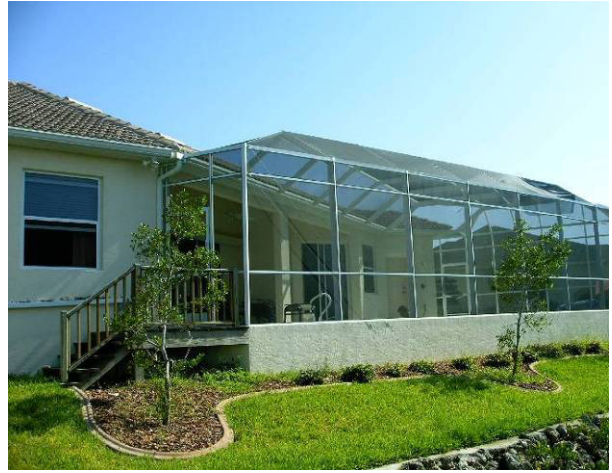
**7-08-2. 19189 Aviation—minor screen damage.**

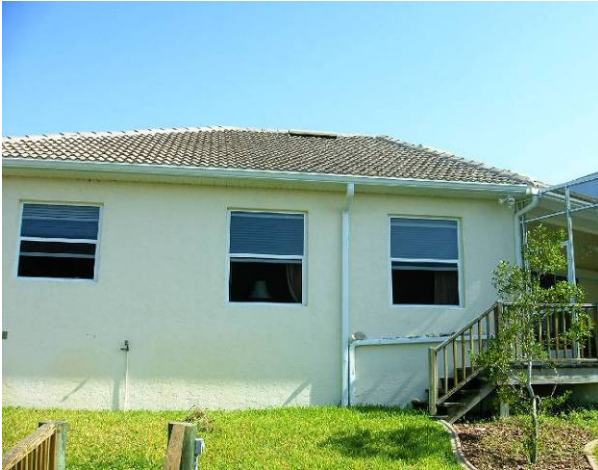
**7-08-3. 19189 Aviation—concrete tile with no damage.**

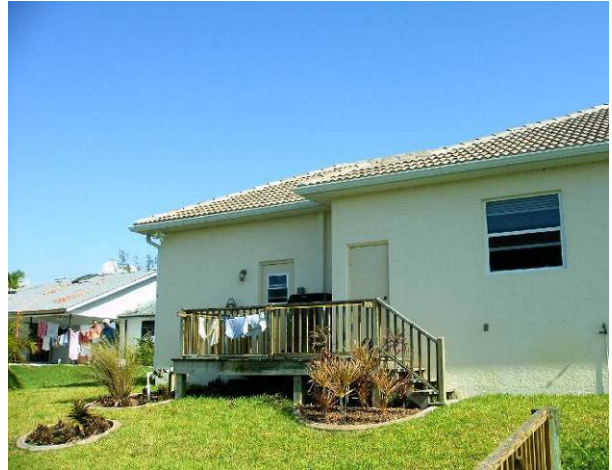
**7-08-4. 19189 Aviation—concrete tile with no damage.**

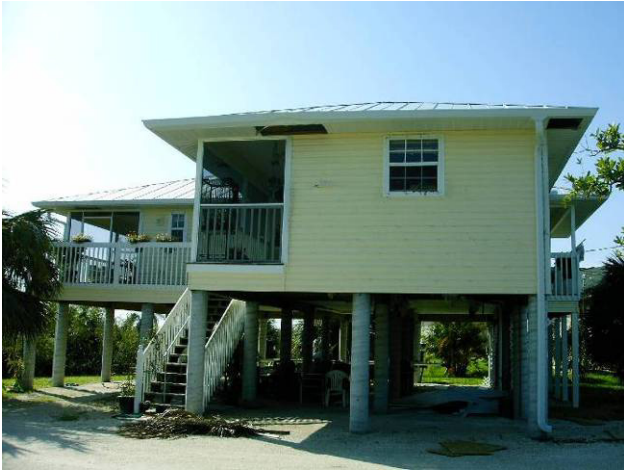
**7-09-1. 19198 Aviation—metal with no damage.**

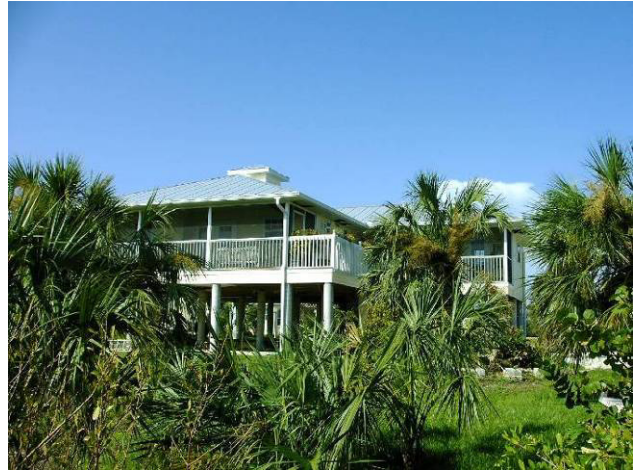
**7-09-2. 19198 Aviation—metal with no damage.**

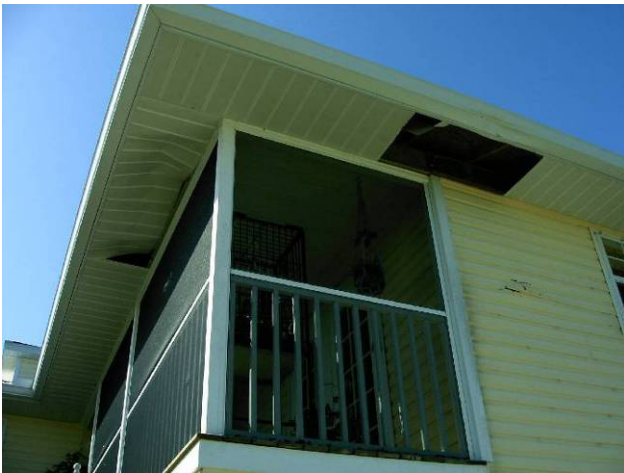
**7-09-3. 19198 Aviation—metal with soffit damage.**

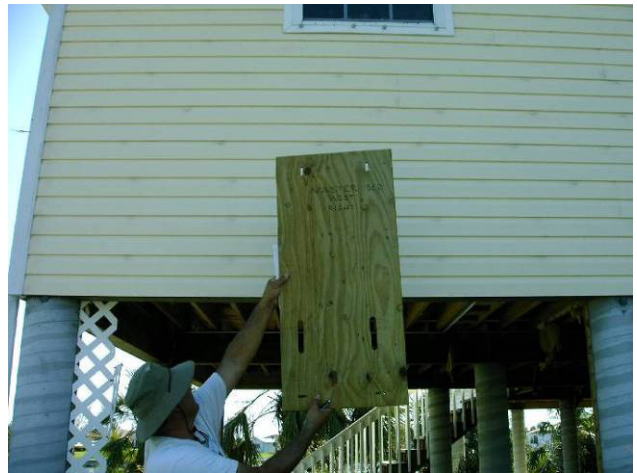
**7-09-4. 19198 Aviation—metal roof, window shutters.**

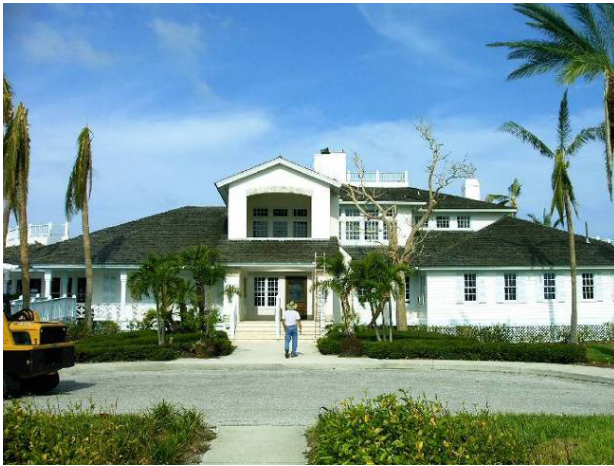
**7-10-1. Boca-Bay Club—wood shakes with minor damage.**

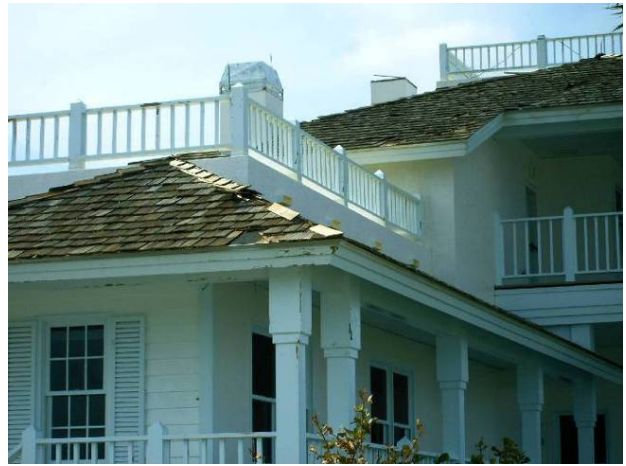
**7-10-2. Boca-Bay Club—wood shakes with minor damage.**

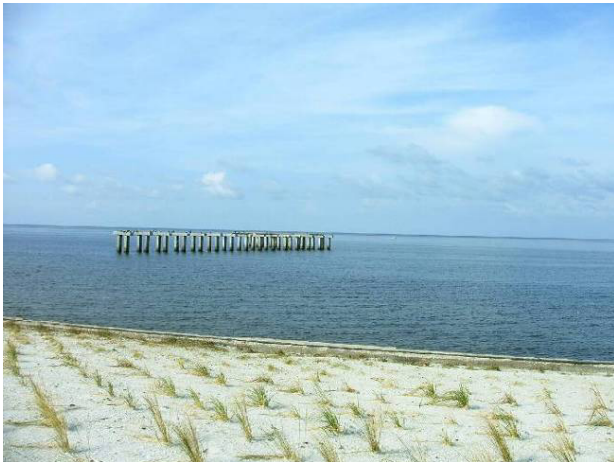
**7-10-3. Boca-Bay Club—winds came from this direction (open terrain and no obstructions).**

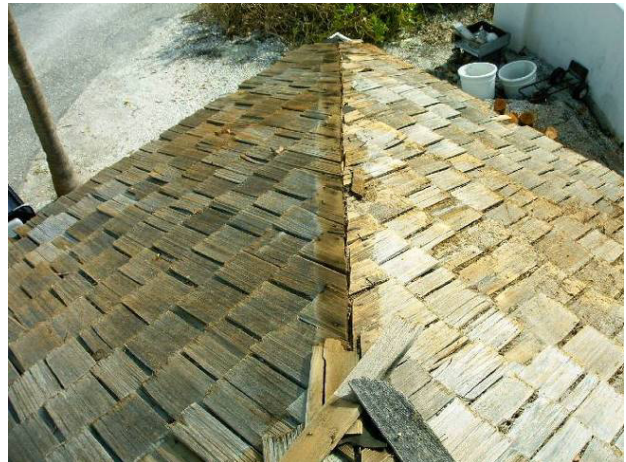
**7-10-4. Boca-Bay Club—wood shakes with minor damage; some hip and ridge blow-off.**

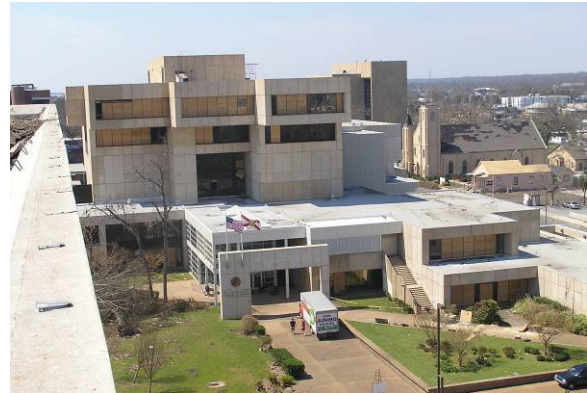
East elevation of the Judicial Center.

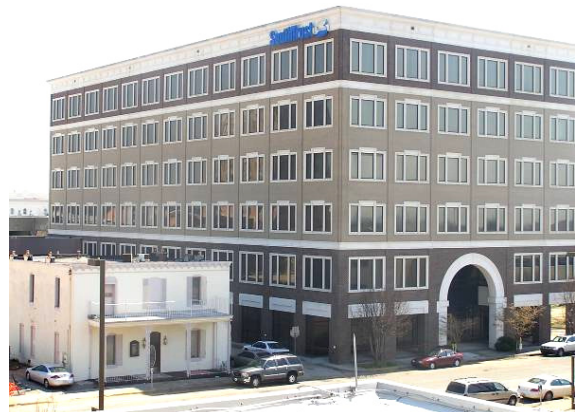
Northwest corner of SouthTrust Bank (side nearest the Judicial Center).

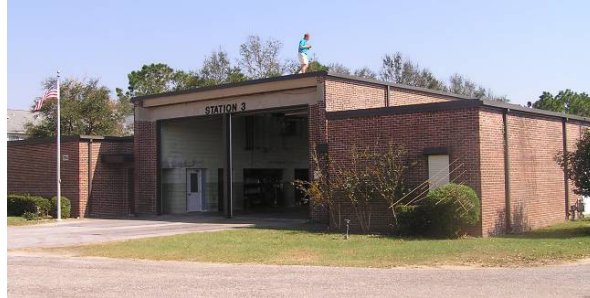
COMMENTS—Date of construction or last roofing application was undetermined.

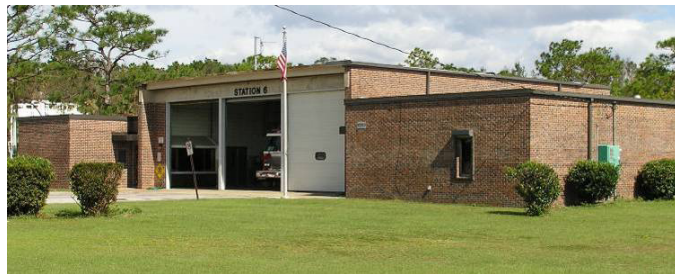
COMMENTS—Date of construction or last roofing application was not determined, although roofing materials appeared to be less than 2 years old.

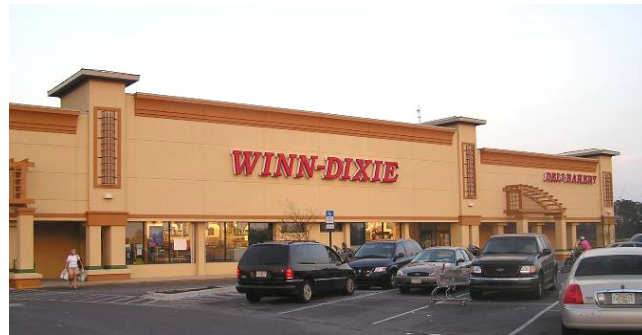
**Winn-Dixie grocery store.****1.06 Gulf Power 1, 75 N. Pace Blvd., Pensacola**

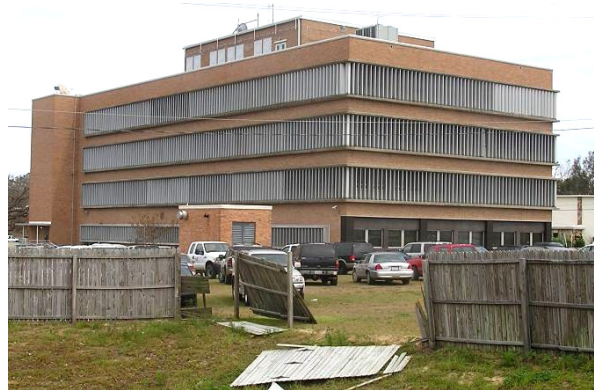
**Gulf Power building 1: view of SW corner.**

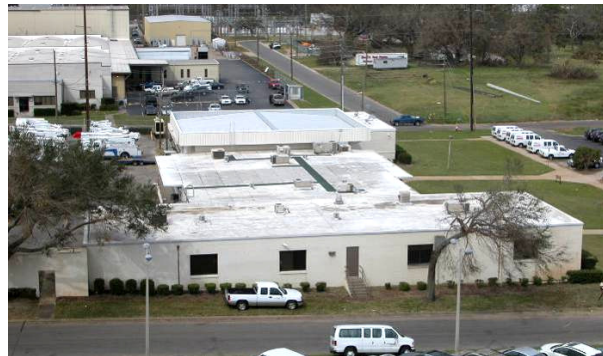
Gulf Power building 2: view of the east side.

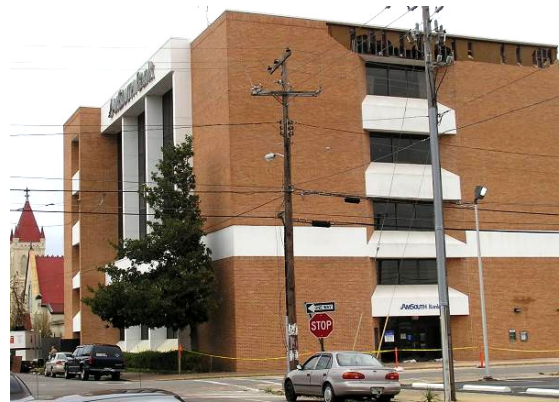
**AmSouth Bank: west side.****1.10 Best Buy, 5480 N 9th Ave., Pensacola**

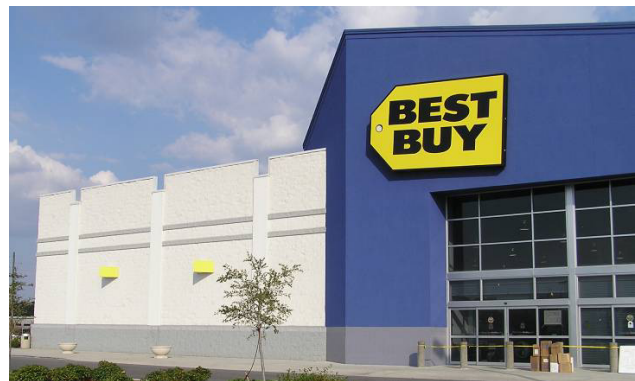
**Best Buy: northwest side.**

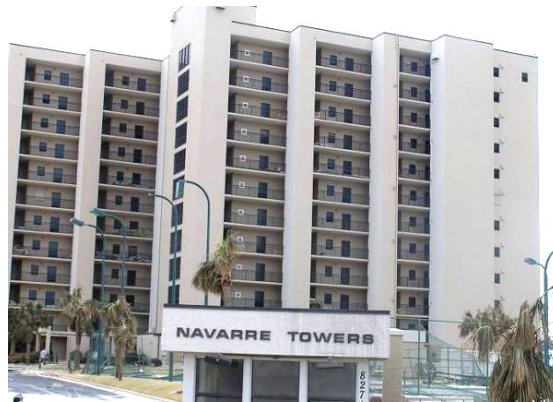
**Navarre Towers: north side.****1.12 Beach Colony, 8515 Gulf Blvd., Navarre**

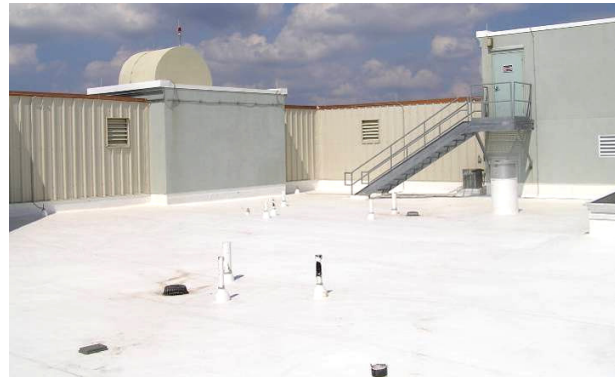
**Roof of Beach Colony.****PHOTOGRAPHS OF ROOF DAMAGE**

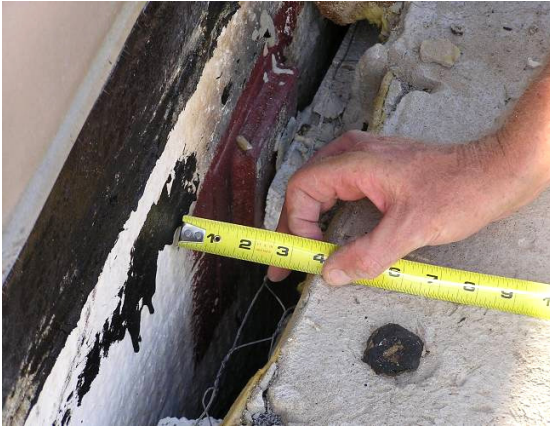
**1-01-1.** A 4-in. gap at wall and deck allowed positive pressure to get under the roof membrane and decking. Glass fiber board insulation was found in the gap.

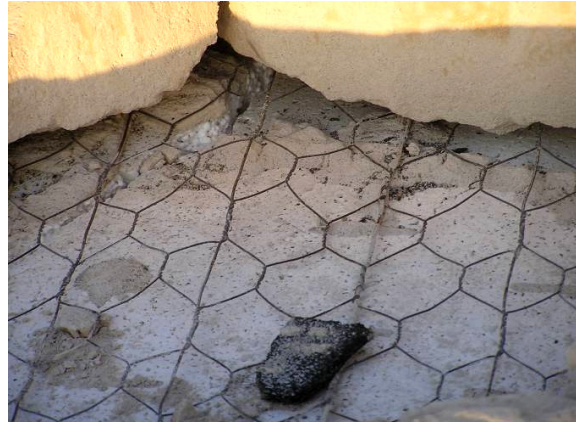
**1-01-2.** Wire lath was not embedded in LWIC during original placement, allowing air to travel between the pours of LWIC.

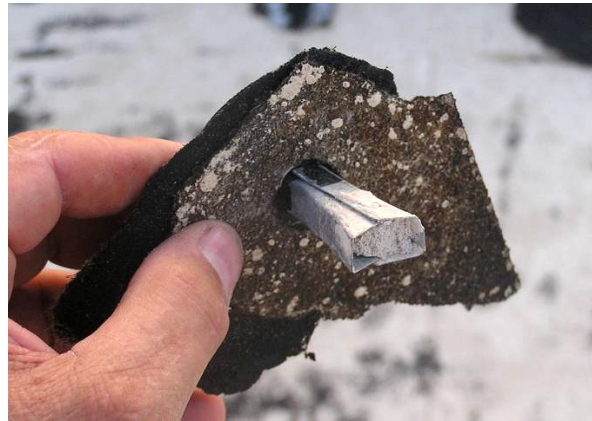
**1-01-4.** Many fasteners were found in mostly closed position—an indication of poor holding power of split-shank fastener in dry LWIC.

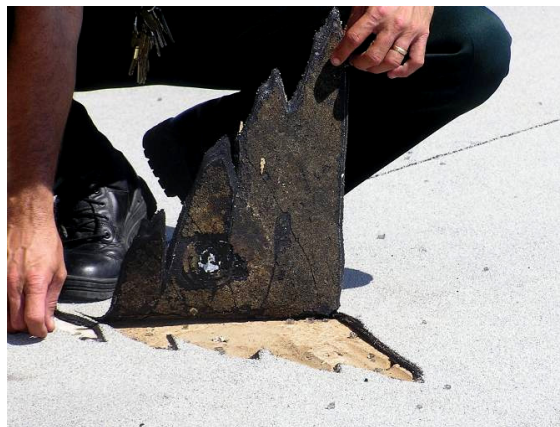
**1-01-5.** Fastened base sheet with 2-ply MB membrane cut through by wind-borne debris.

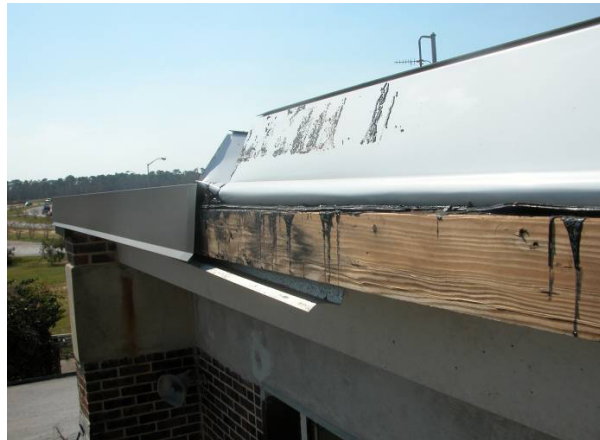
**1-03-3.** Damage was limited to edge metal pulled loose from cleat. Note that part of the continuous cleat is missing on the right side.

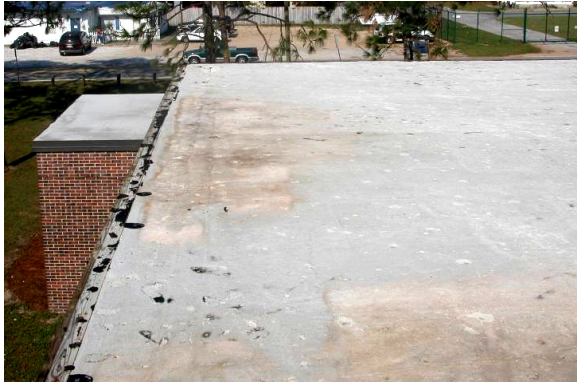
**1-04-1. Edge flashing damage on the top roof resulted in complete membrane loss.**

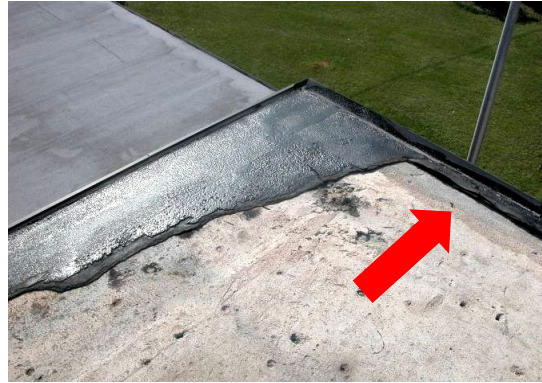
**1-04-2. The only section of membrane remaining was found at the leeward edge. The perimeter nailer could not be located.**

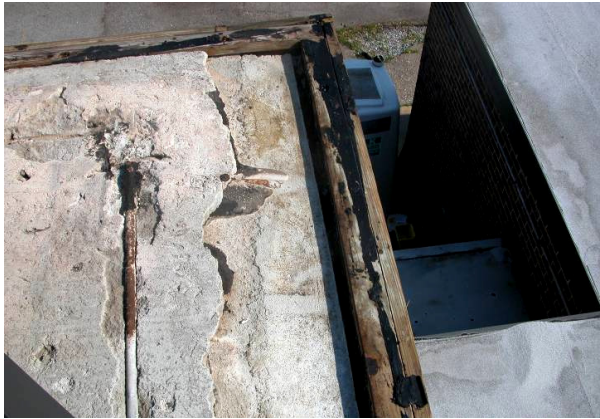
**1-04-3. Damage included portions of the LWIC deck.**

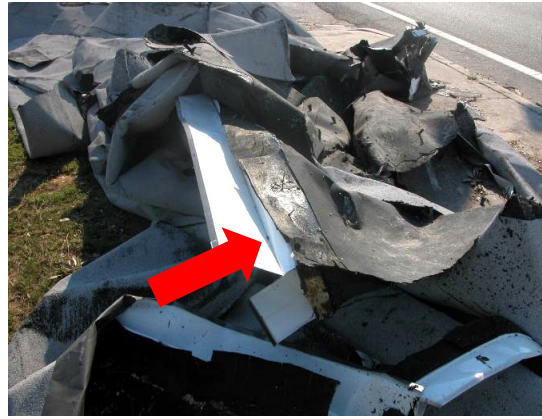
**1-04-4. Examination of metal edge flashing revealed fastening at distances of greater than 8 in. o.c.**

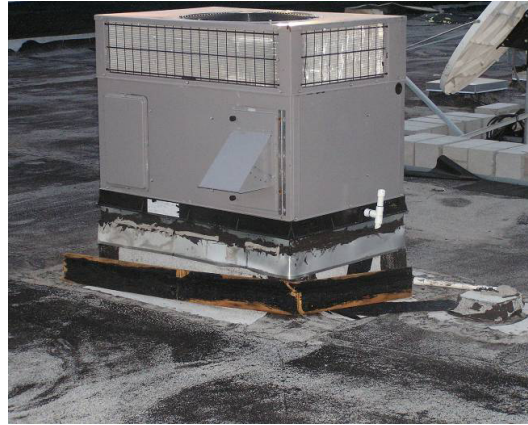
**1-05-2. Flashings at equipment curbs were damaged.**

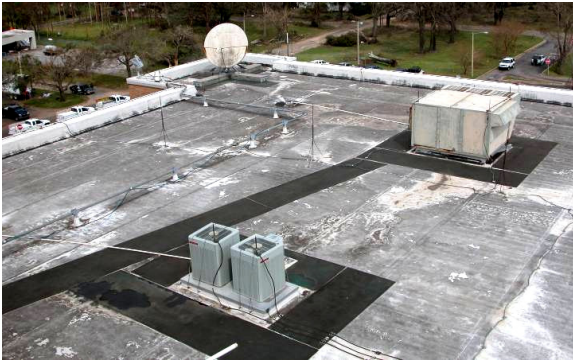
**1-06-1. View of the northwest corner. Dish antenna was installed using non-penetrating concrete block ballast, without curb or mechanical attachment.**

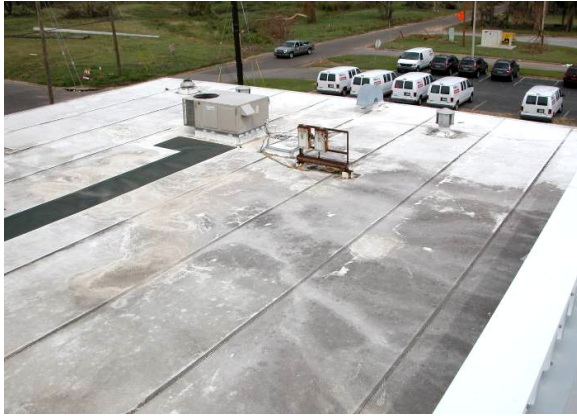
**1-07-1.** The only puncture damage from wind-borne debris was observed on this mechanically fastened single-ply PVC system.

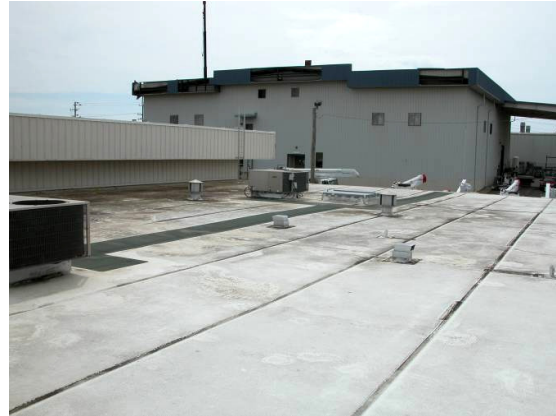
**1-07-2.** View to the southwest. No damage was observed on the fastening mechanisms of this batten-fastened single-ply membrane.

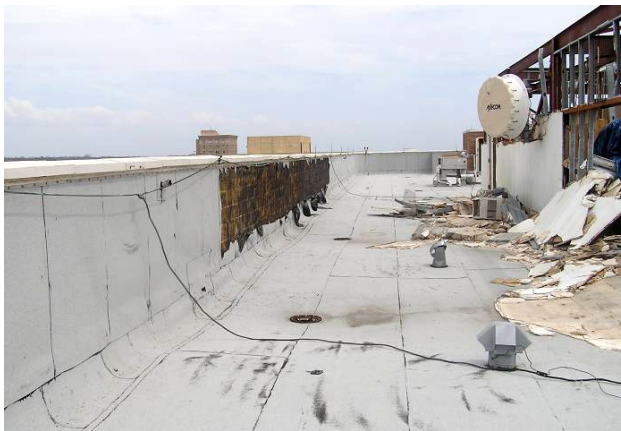
**1-08-1.** Heat-welded wall flashing blew off. It was not fully adhered to the concrete masonry unit wall.

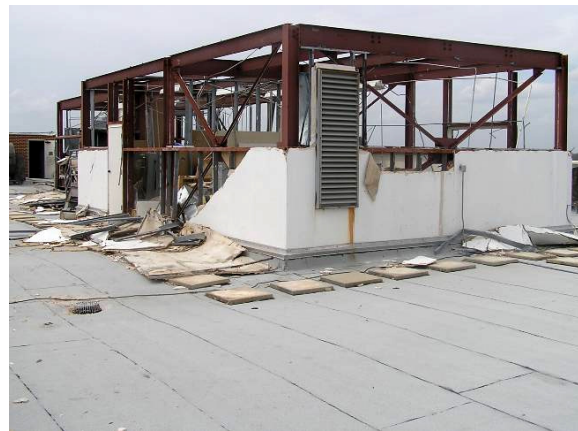
**1-08-2.** Wall/roof blow-out of the penthouse was due to wind infiltrating through metal louvers (top, center) and pressurizing the interior. This resulted in complete loss and contributed to airborne damage to surrounding buildings.

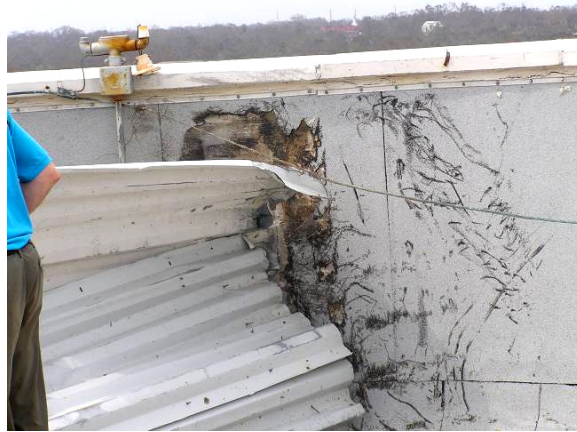
**1-08-3. Steel roof decking from the penthouse contributed to MB roof and flashing damage.**

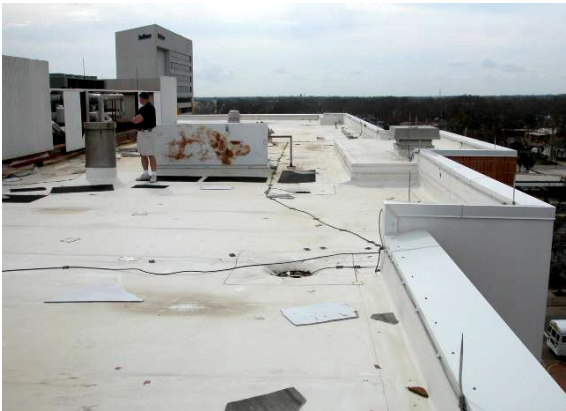
**1-09-1. Damage to equipment screens caused many membrane punctures. Equipment dislodged from curbs also resulted in membrane punctures.**

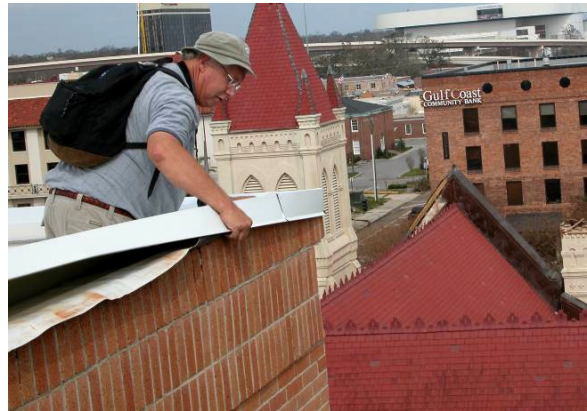
**1-09-2. Coping was not installed with continuous cleats. Portions were loosened or blown off.**

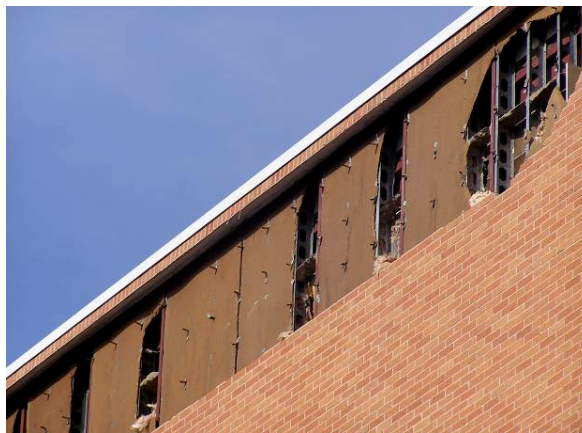
**1-09-3. Extensive masonry curtain wall damage on the west (leeward) side of the building. Significant corrosion of steel connections was evident.**

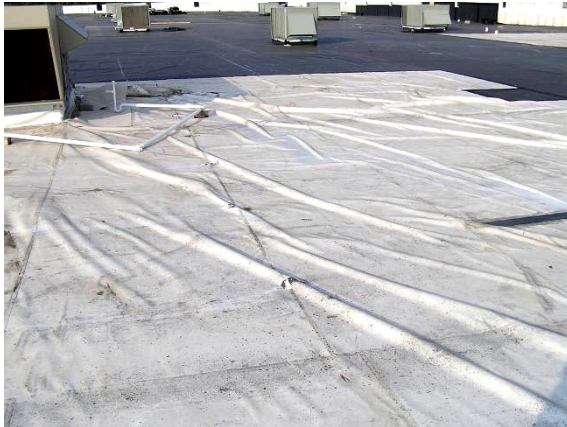
**1-10-1. Loose section of old thermoplastic single-ply membrane.** The fully adhered membrane peeled from the insulation facer. Black EPDM (background) was used as a temporary membrane.

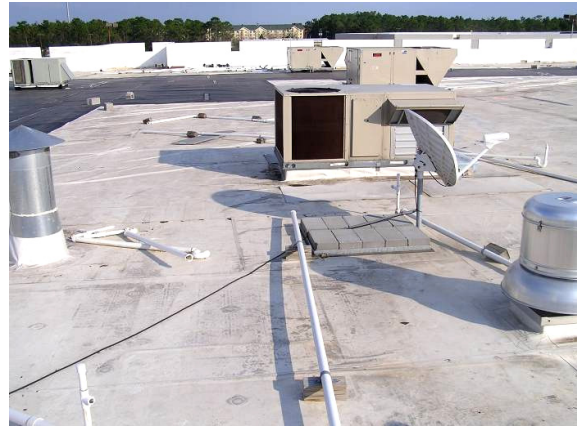
**1-10-2. Section of the old membrane.**

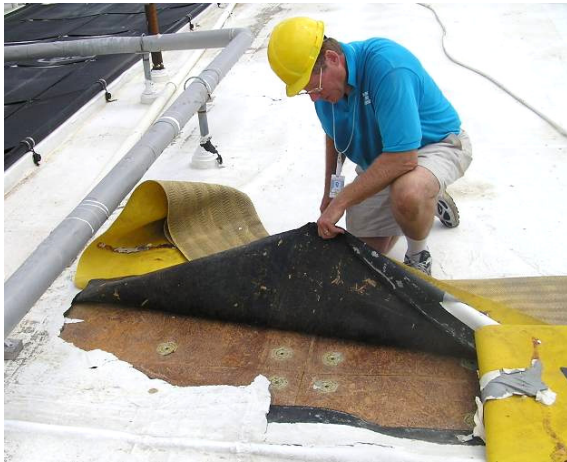
**1-11-1. One small area on the south side, near the center of the roof, appears to be wind-damaged.** This was the extent of observed roof damage. OSB was mechanically fastened to the deck, and the EPDM membrane was fully adhered to the OSB.

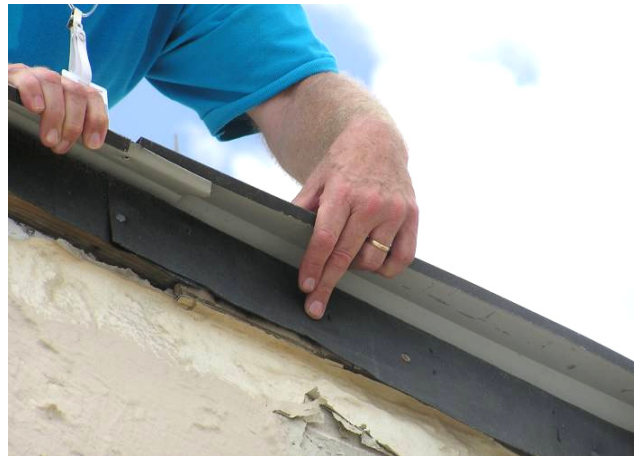
**1-11-2. Penthouse coping was installed without a continuous cleat and was deflected in some areas.** EPDM roof membrane was wrapped over the parapet and mechanically fastened.

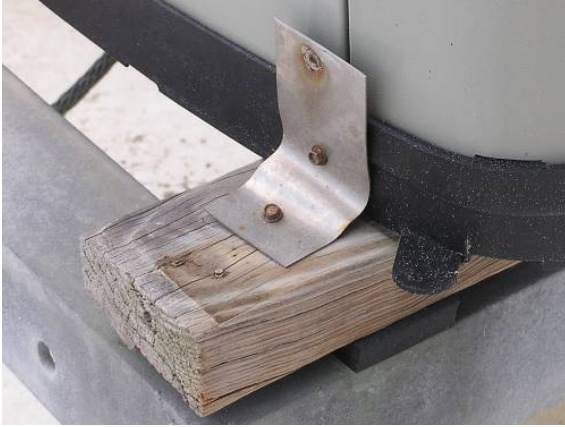
**1-11-3. Most air-conditioning condenser units stayed in place with this minimal fastening at four corners.**

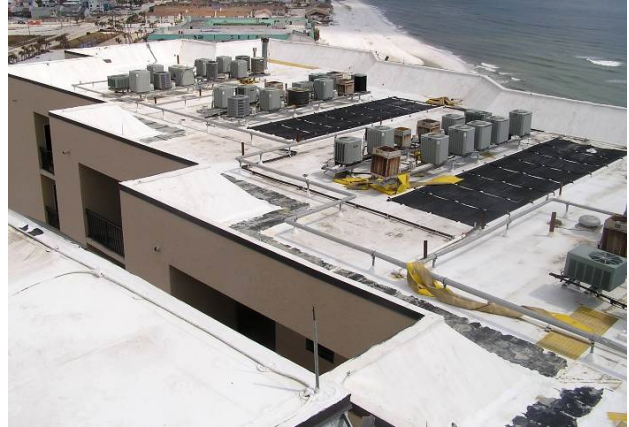
**1-11-4. Yellow “spaghetti” traffic pads delaminated and became detached from the EPDM.**

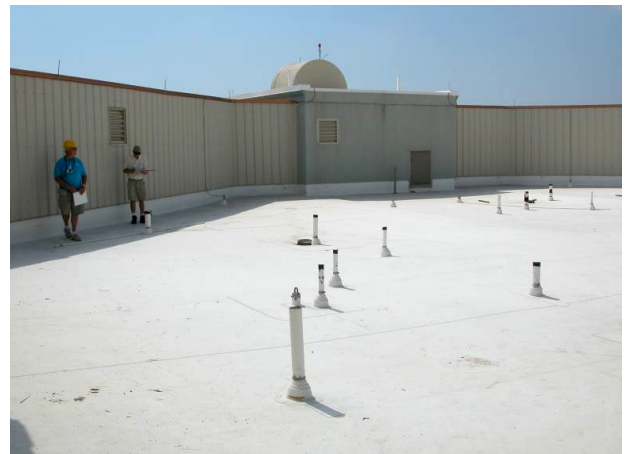
**1.12-2 – No damage was observed to this fully adhered thermoplastic single-ply membrane.**

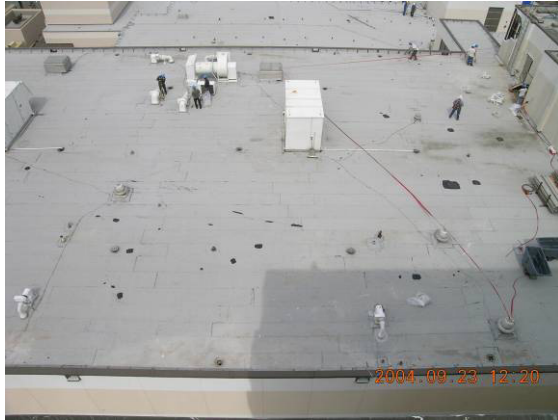
2-01-1. Damage to roof by debris from wall above roof.

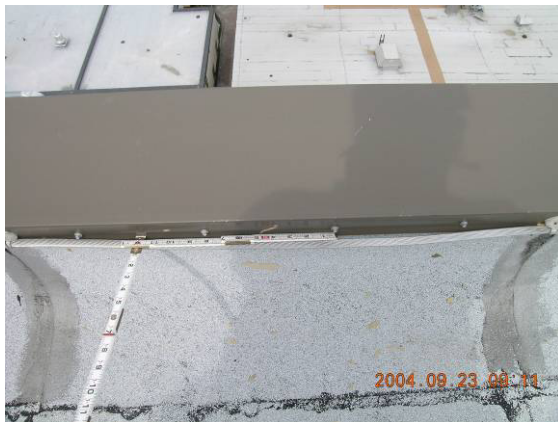
2-01-2. Well-attached coping.

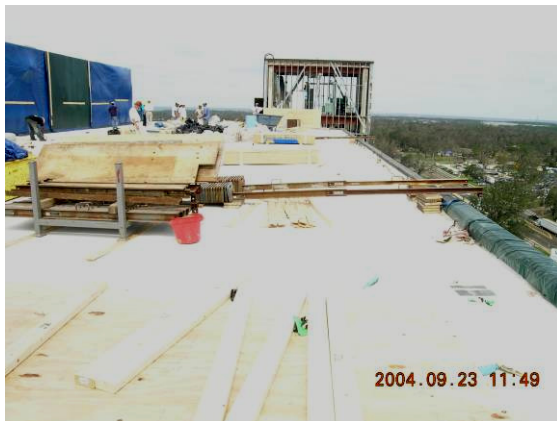
2-03-2. Looking northeast: missing coping.

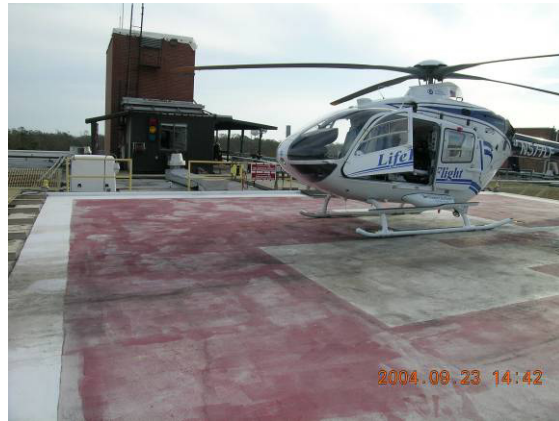
2-04-2. Tower roof with anemometer.

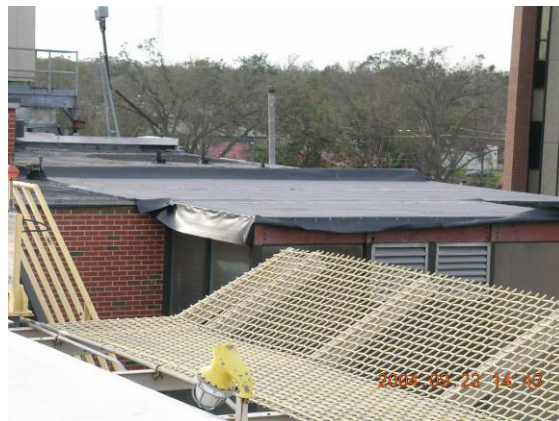
2-04-3 Temporary repairs over stairwell; note vents.

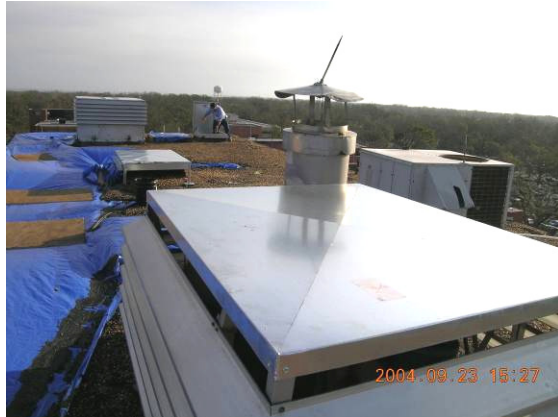
**2-06-1. Tower roof.**

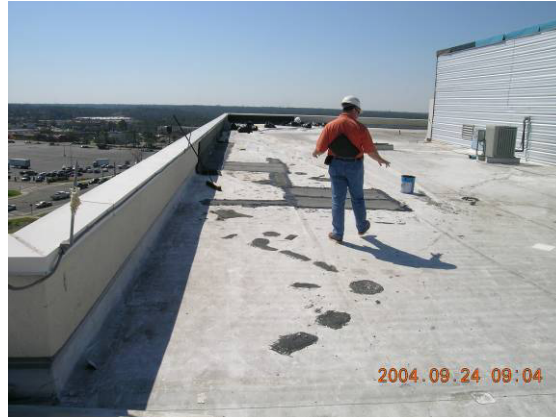
**2-07-1. Repaired tear.**

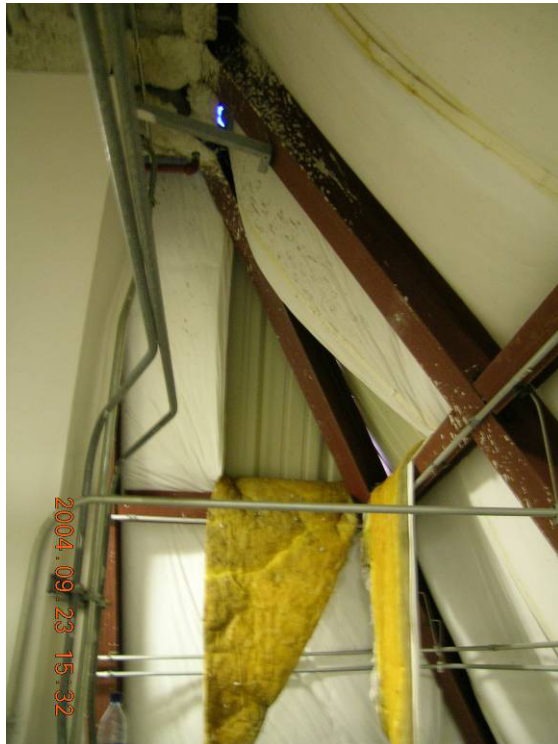
**2-06-2. Inside penthouse; light is from open areas  
on hips of metal roof.**

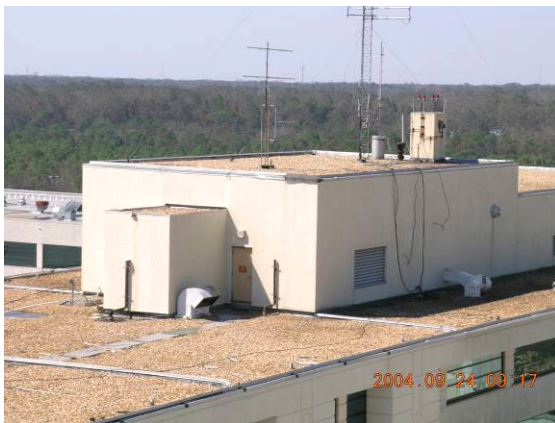
**2-08-2. Edge metal missing from penthouse.**

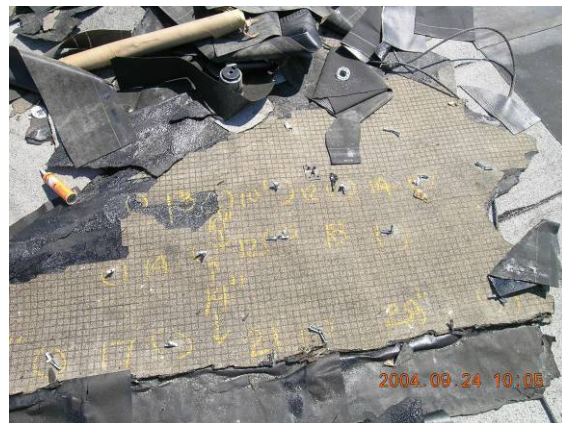
**2-09-2. Base layer fastening pattern.**

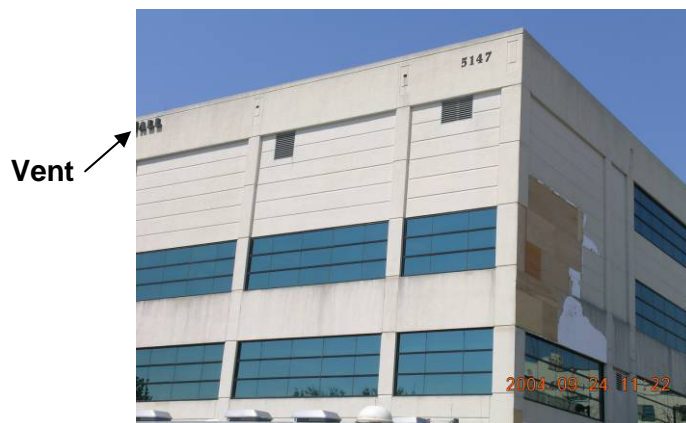
**2-09-3. Vent and cladding failure below blow-off.**

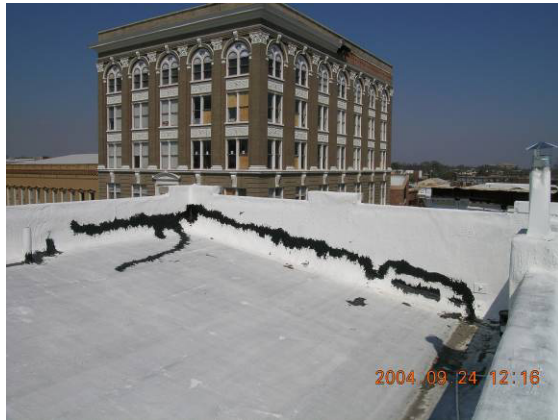
**2-10-1. Membrane tear due to detachment.**

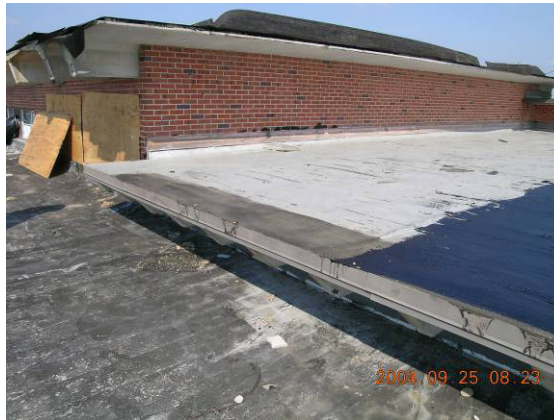
**2-12-1. Missing flashing from upper roof.**

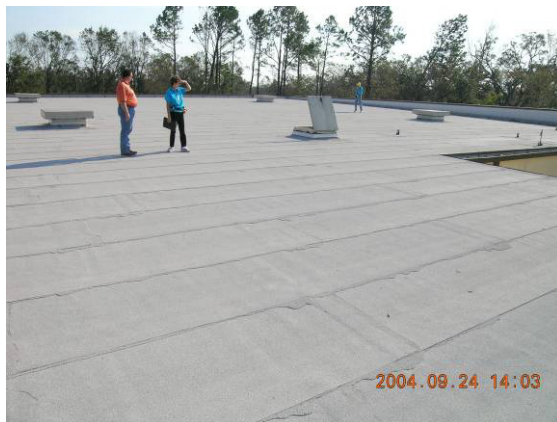
**2-11-1. Undamaged roof.**

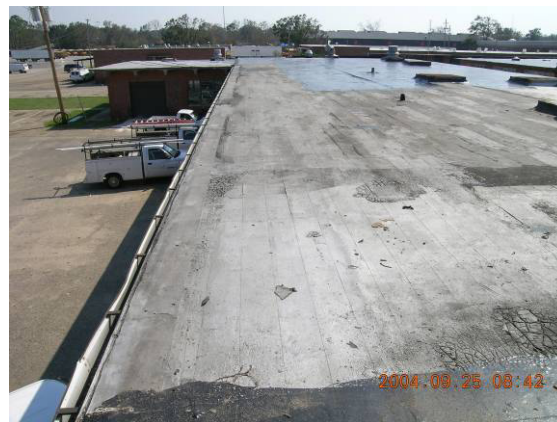
**2-12-2. Note large repaired area on this and adjacent roof.**

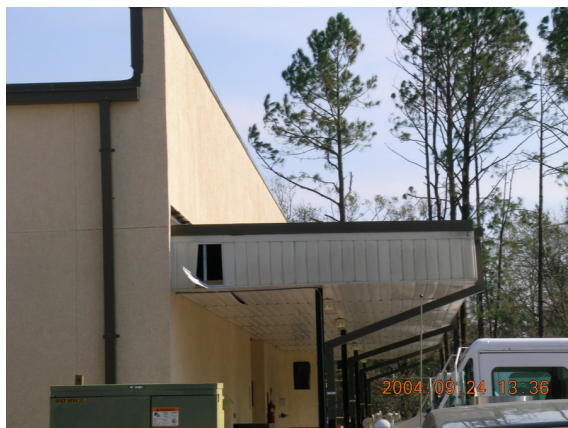
**2-11-2. Soffit damage.**

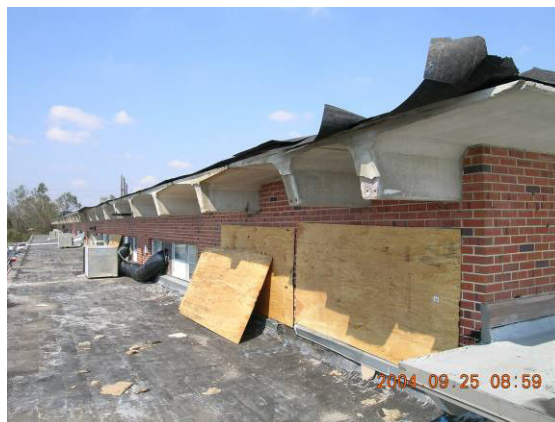
**2-12-3. Missing windows and missing edge metal.**

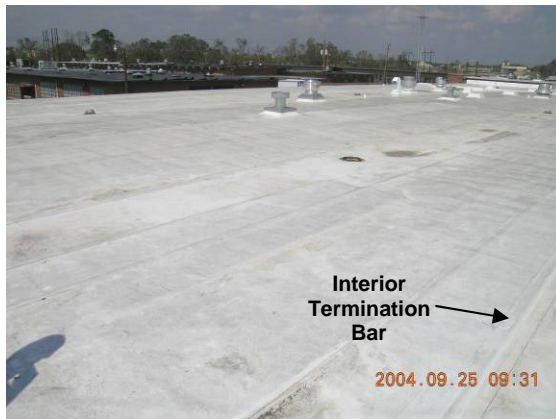
**2-14-1. Missing drain covers directly behind old gymnasium.**

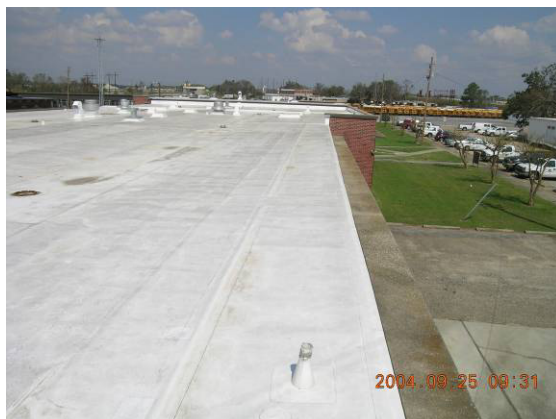
**2-14-2. Directly behind old gymnasium.**

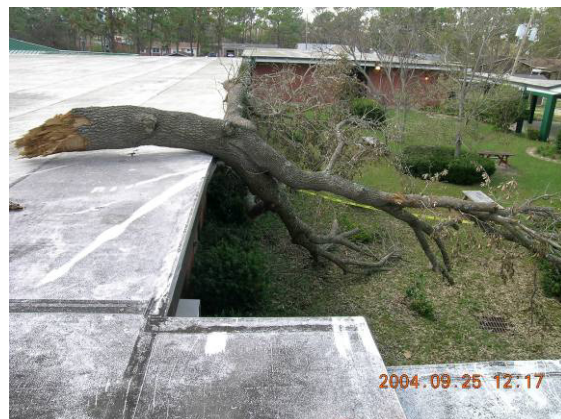
**2-15-2. Debris damage caused by tree.**

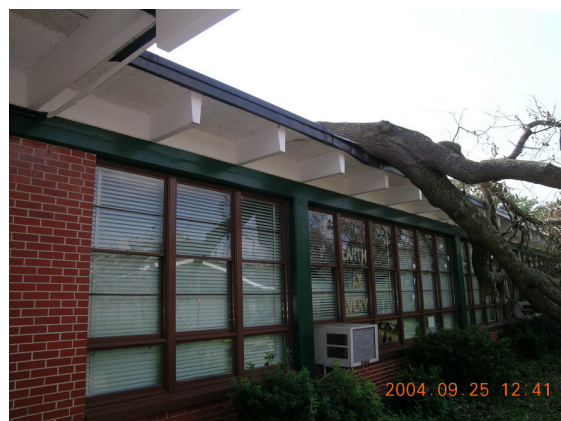
**2-15-3. Minor damage caused by tree debris and damage to metal roof.**

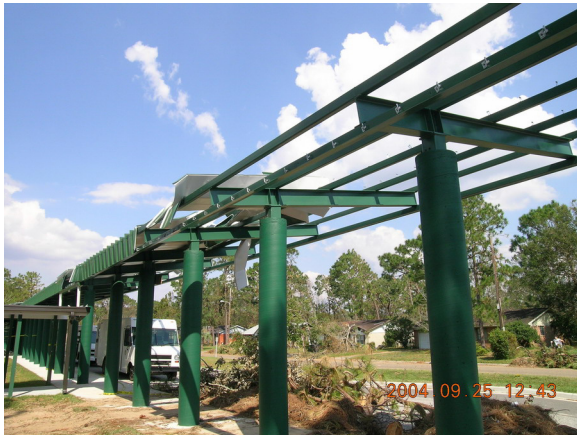
**2-15-4. Walkway roof with displacement.**

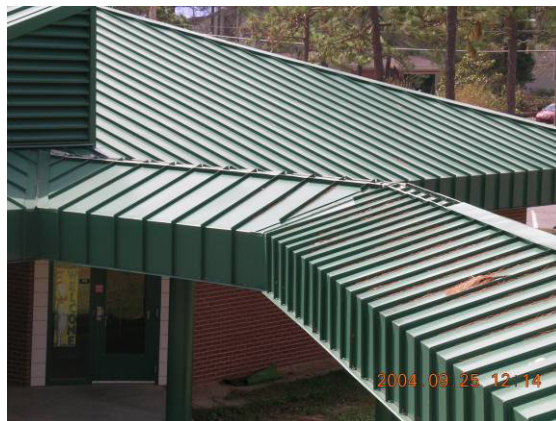
**2-15-6. Missing hip and ridge.**

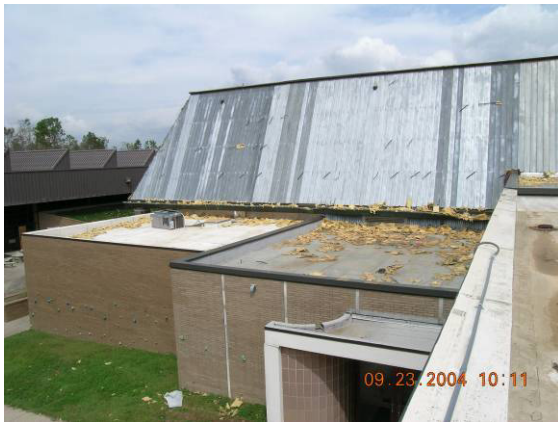
**4-03-1. Overview of roof looking north. Note proximity of steeply sloped roof with wind-displaced metal panels.**

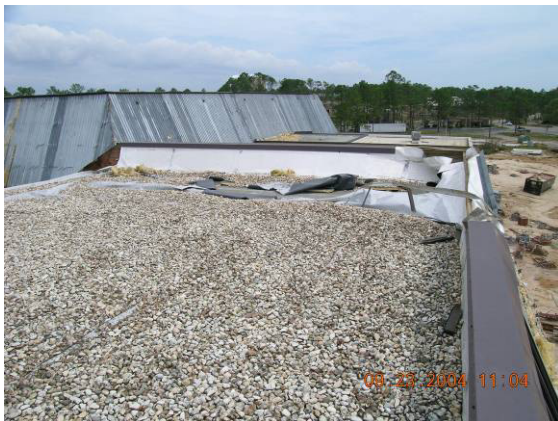
**4-04-1. Wind damage near southeast corner.**

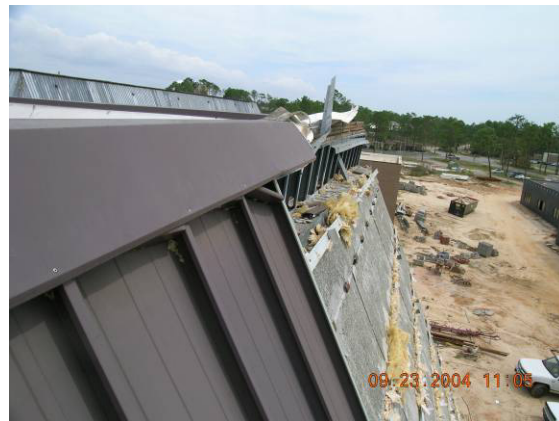
**4-04-2. Displaced metal roof panels near southeast corner.**

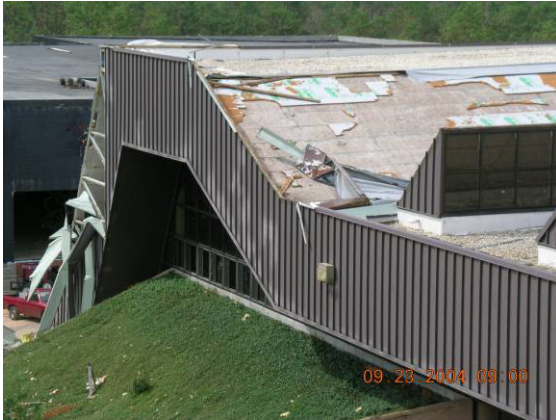
**4-05-1. Overview of wind damage on roof looking southwest.**

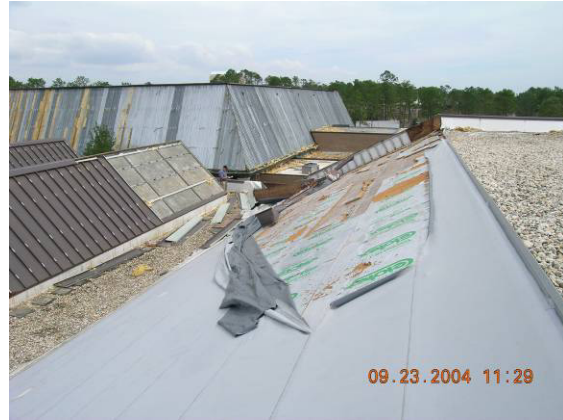
**4-05-2. Overview of wind damage on roof looking east.**

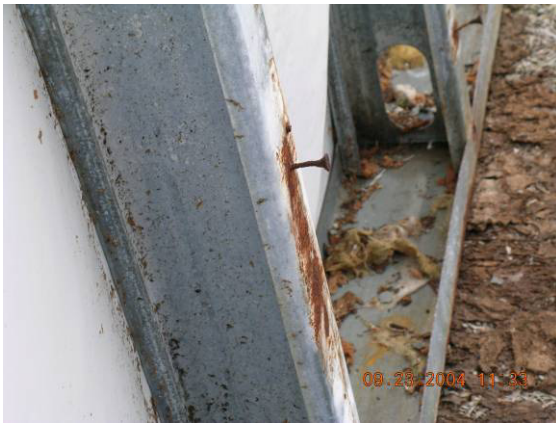
**4-05-3. East parapet wall with roof membrane and sheathing displaced by winds.**

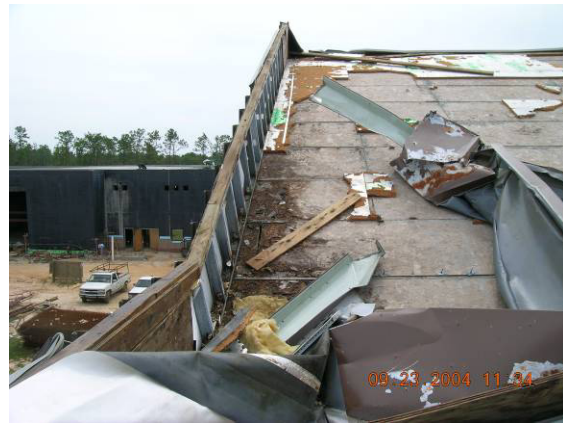
**4-05-4. Area where wind damage began. Note stains on substrate.**

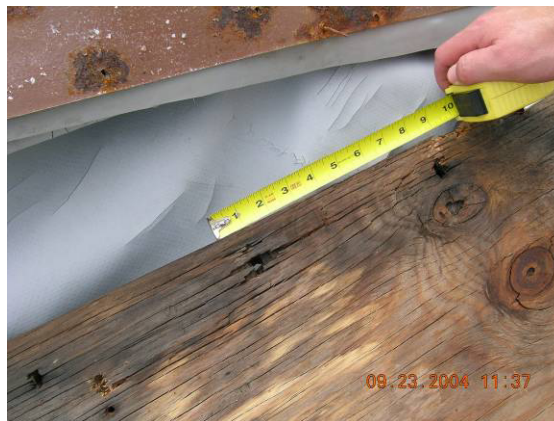
**4-05-5. A piece of displaced parapet sheathing. Note advanced deterioration.**

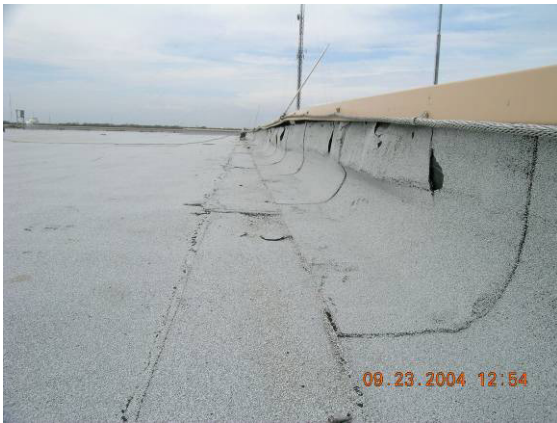
**4-06-1. Delaminated and torn base flashings along windward side.** Base flashings had been repositioned and temporarily re-secured.

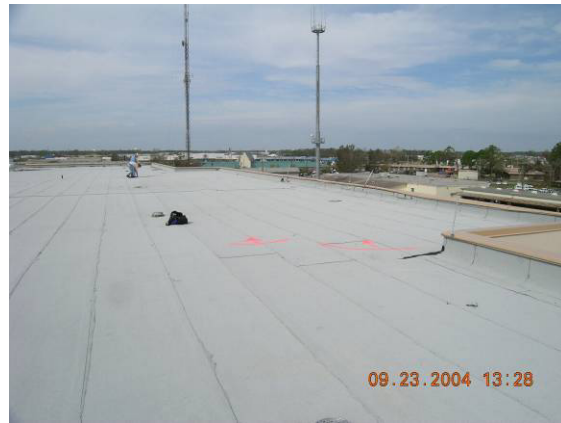
**4-06-2. Overview of wind-damaged area on roof looking northeast.** Orange marks approximate southern limit of membrane billowing.

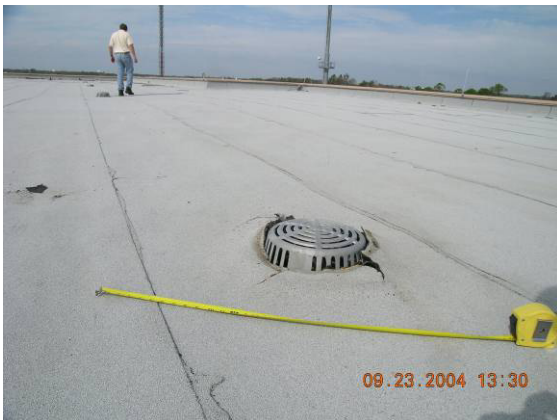
**4-06-3. Roof membrane torn and lifted around drain.**

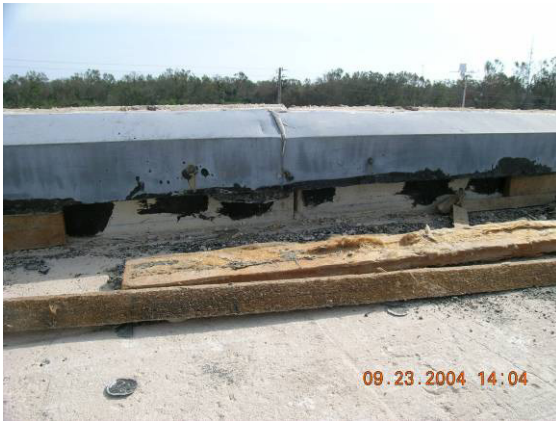
**4-07-3. Short perimeter curb with base flashings and membrane displaced near initiation point of damage.** Note open joint between pre-cast wall panels.

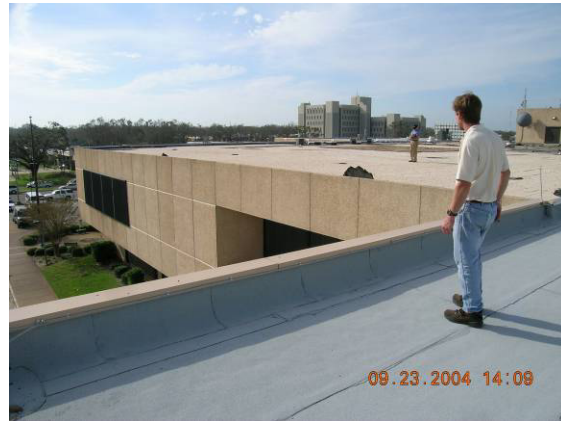
**4-07-4. Overview of roof looking northwest.**
