# **RICOWI, Inc.**

Roofing Industry Committee on Weather Issues, Inc.

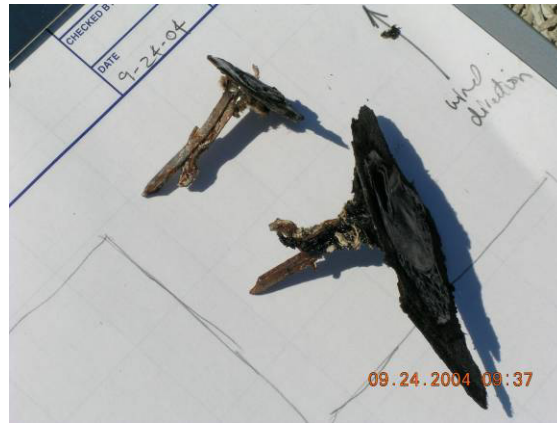
**4-08-2.** Base sheet fasteners. Note corrosion.

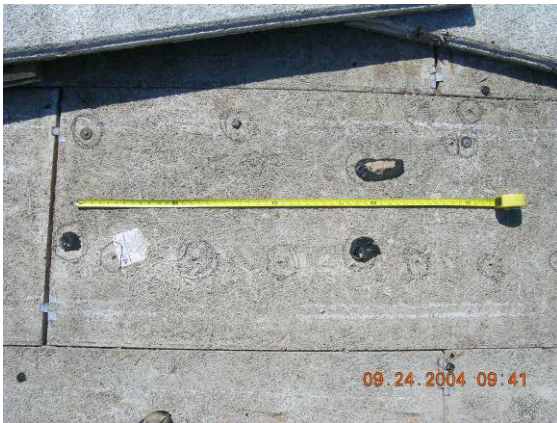
**4-08-3.** Typical pattern of base sheet fasteners.

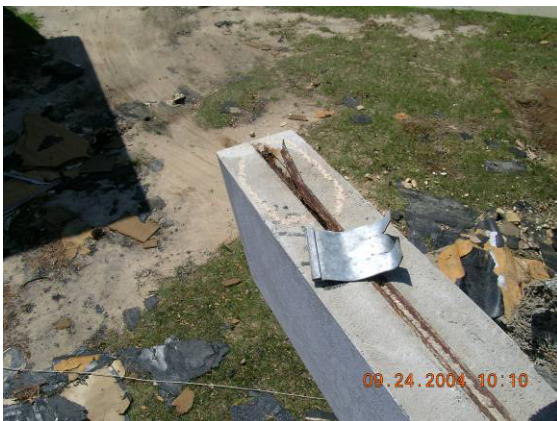
**4-08-5.** Deck clip placed next to embedded reglet receiver. Note advanced corrosion of receiver.

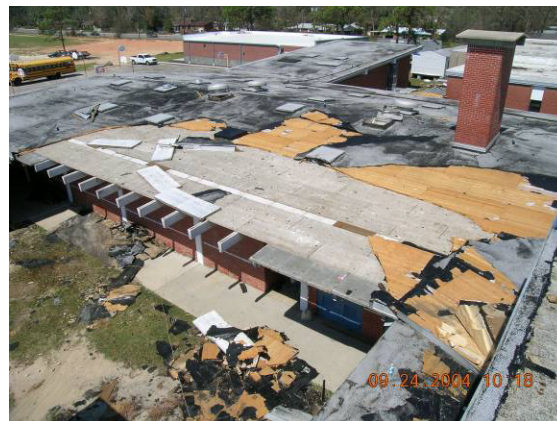
**4-08-6.** Overview of wind damage on roof looking north.

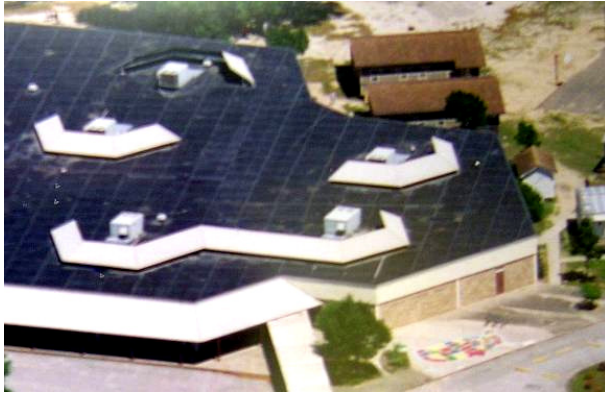
**4-11-1. Aerial view of Building 1 roof before hurricane; date unknown.**

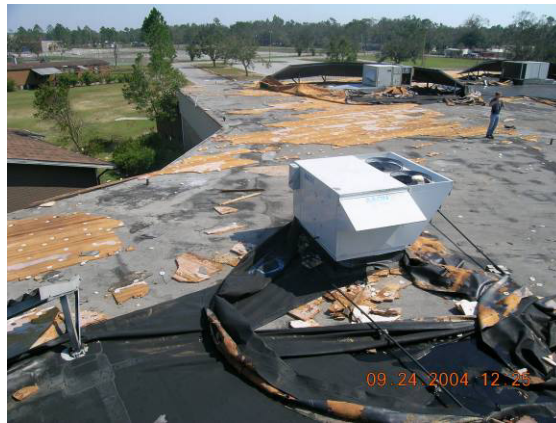
**4-11-3. Overview of wind damage on roof looking south.**

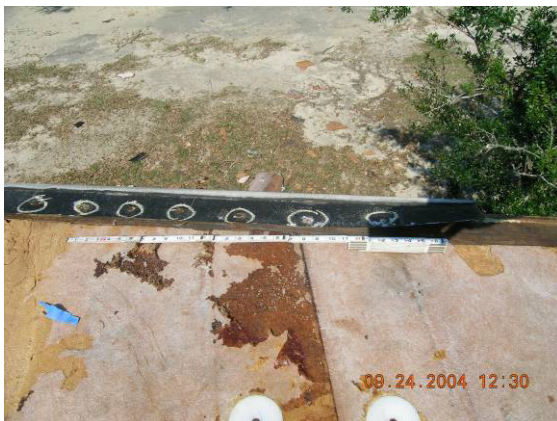
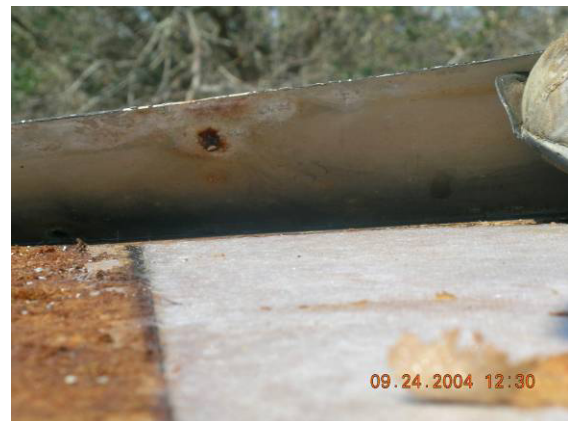
**4-11-4 and 4-11-5. Roof edge construction. Note that fasteners securing flange of edge metal are corroded through.**

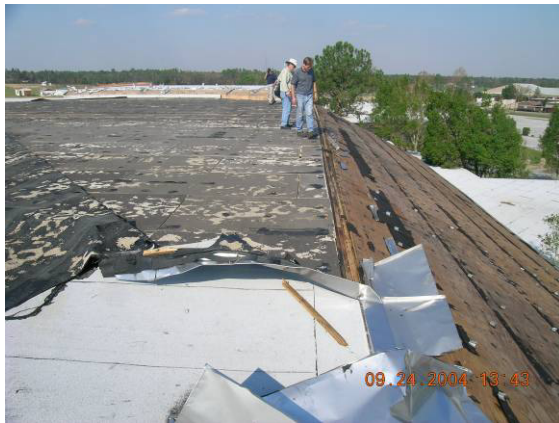
**4-13-1. Displaced roof covering looking east.** Note adjacent steeply sloped roof section with metal roof covering completely removed by winds.

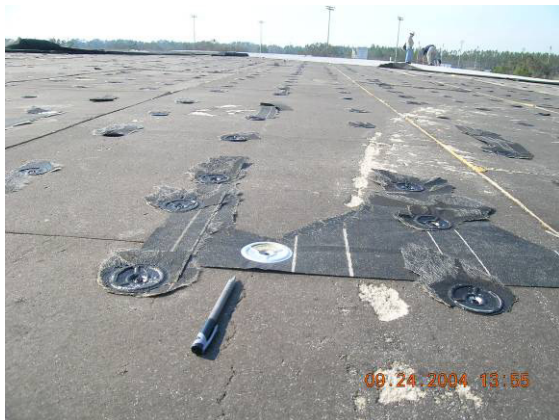
**4-13-3. Remnant piece of base sheet over loose-laid insulation boards secured with insulation plate and screw fasteners.**

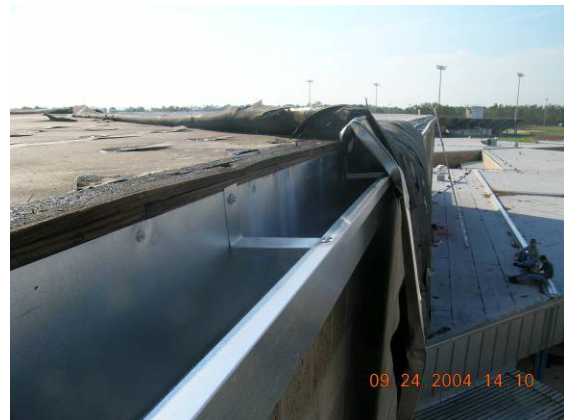
**4-13-4. Roof edge construction.** Note thin layer of wood installed over what are believed to be original wood nailers.

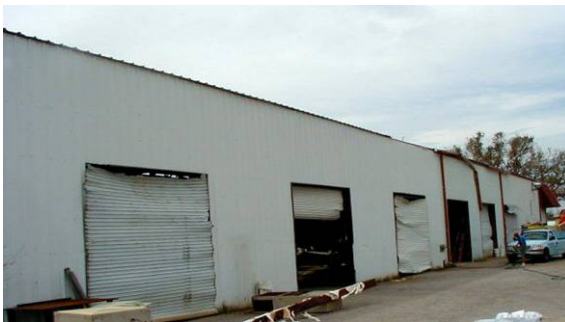
**5-01-1. McNorton building.** Left side showing overhead door damage.

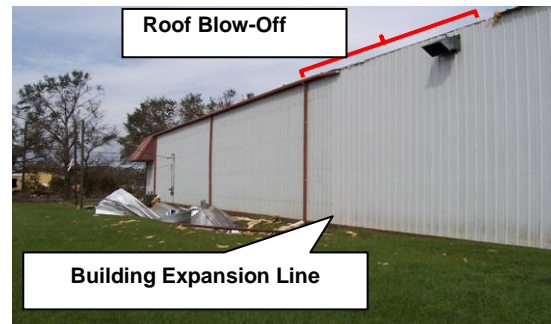
**5-01-2. McNorton building.** Right side of building showing expansion and roof failure area.

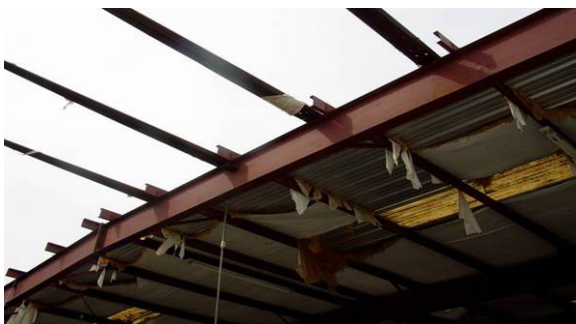
**5-01-3. McNorton building.** Lapped purlins at building extension.

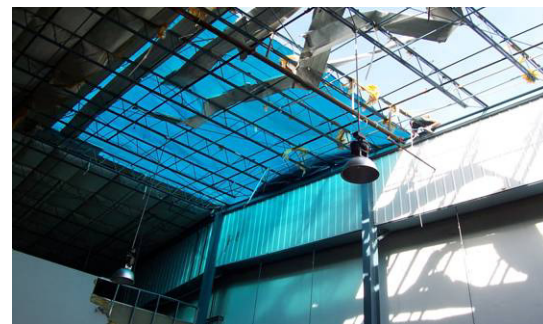
**5-02-1. Dana building.** Interior view of roof damage at windward end.

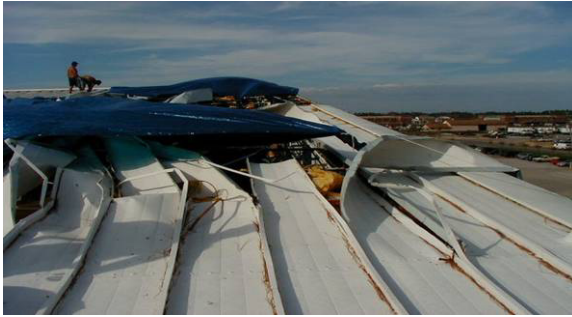
**5-02-2. Dana building.** Standing seam roof damage showing dislodged batten caps.

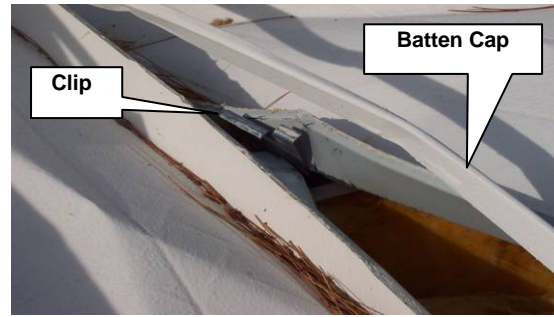
**5-02-3. Dana building.** Open seam showing dislodged batten cap and clip.

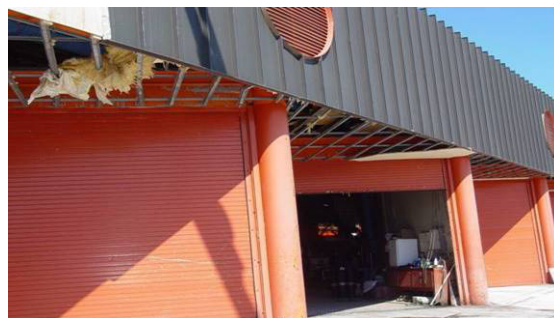
**5-04-1. Escambia School Maintenance building.** Sidewall—overhead door and soffit failure.

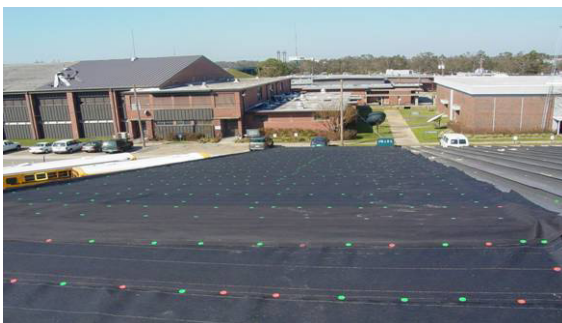
**5-04-2. Escambia School maintenance building.** End bay roof failure area, temporary repair in place.

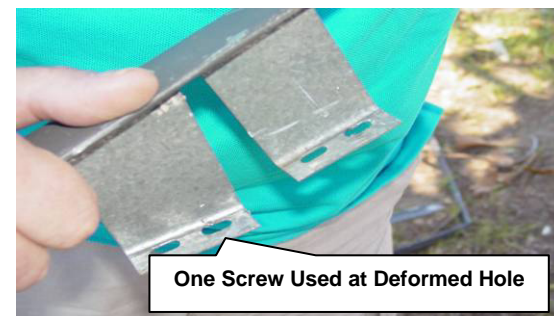
**5-04-3. Escambia School maintenance building.** Clips in batten cap.

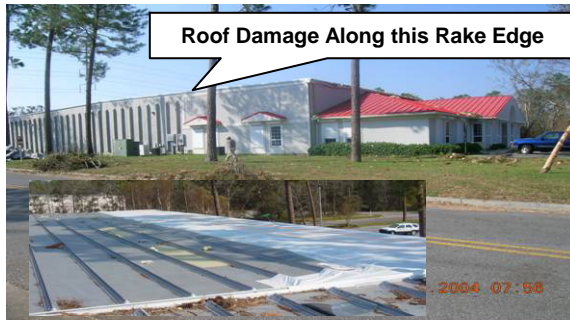
**5-05-1. Folkers Window Company.** End of building where roof damage occurred.

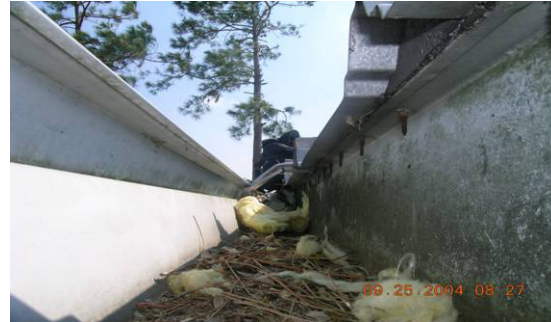
**5-05-2. Folkers Window Company.** View from below showing screws penetrating eave trim.

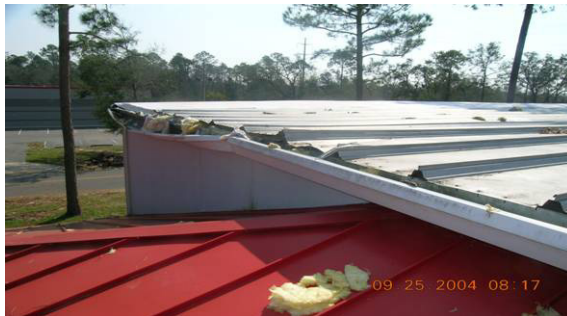
**5-05-3. Folkers Window Company.** Gutter damaged by falling tree.

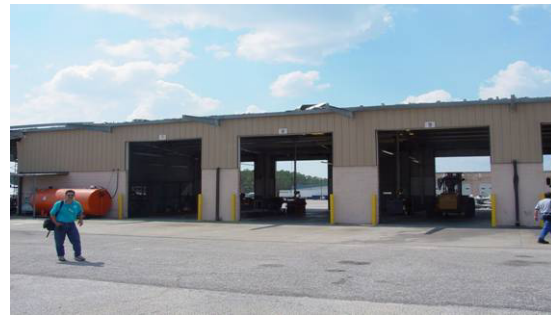
**5-06-1. Empire Truck Sales.** Failed roll-up doors on east side of building.

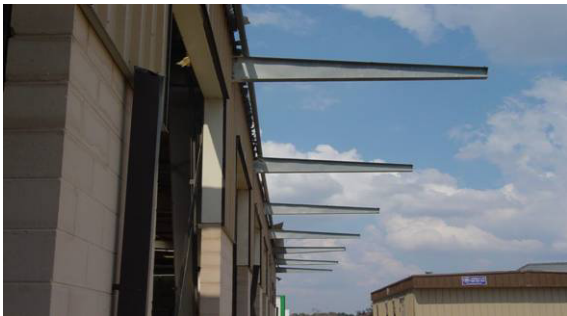
**5-06-2. Empire Truck Sales.** Structural canopy on east side of building that lost sheeting.

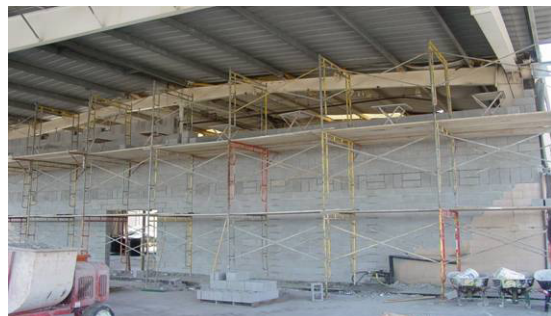
**5-06-3. Empire Truck Sales.** CMU wall on south end that was blown out and repaired.

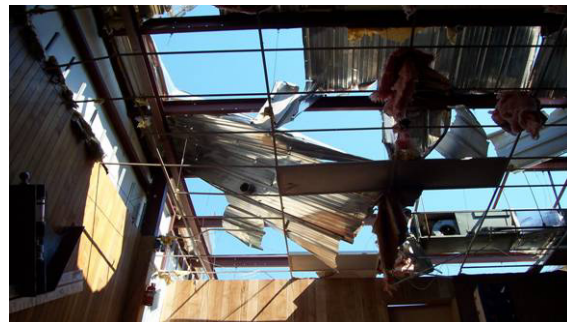
**5-07-1. Hope Lumber office.** Roof blown off at north end of building (windward).

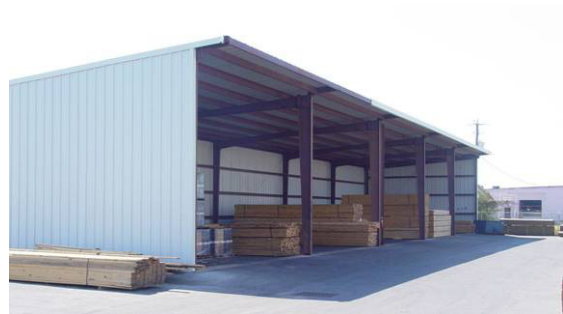
**5-08-3. Hope Lumber storage shed.** Shed on other side of yard with only minor trim damage.

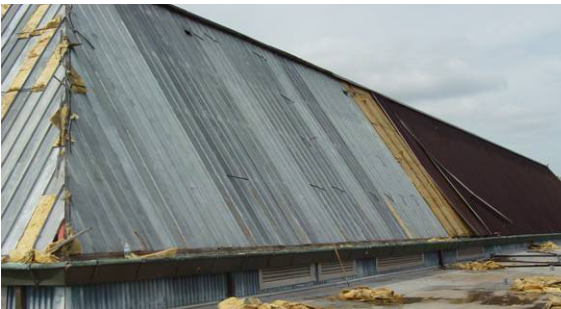
**5-09-1. Bldg 54—University of West Florida.** Failed mansard covering—strap attachments shown.

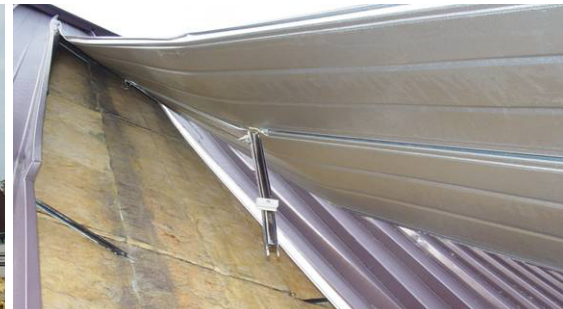
**5-09-2. Bldg 54—University of West Florida.** Failed connection of aluminum panel to steel liner.

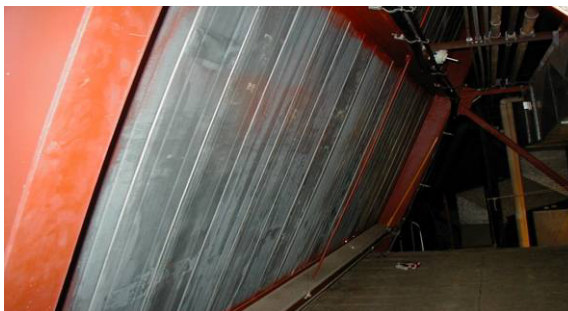
**5-09-3. Bldg 54—University of West Florida.** Inner side of steel deck on structural framework.

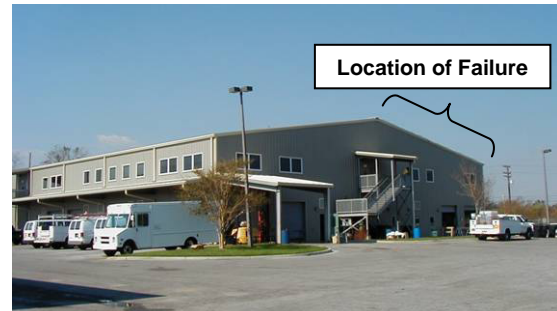
**5-10-1. Pensacola Public Works.** End of building where roof failure occurred.

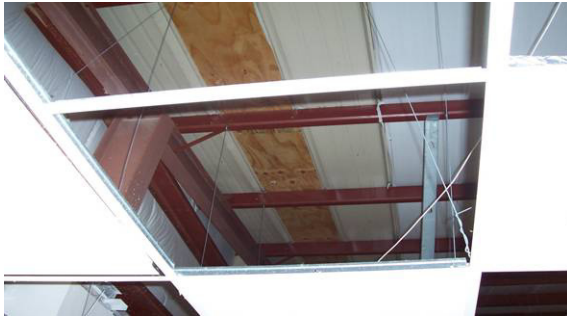
**5-10-2. Pensacola Public Works.** Inside showing panels blown off and repaired with plywood.

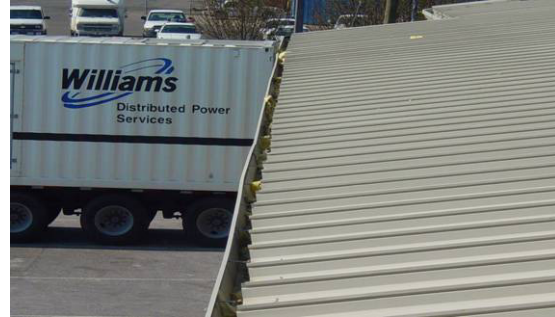
**5-10-3. Pensacola Public Works.** Uneven alignment of panels at eave.

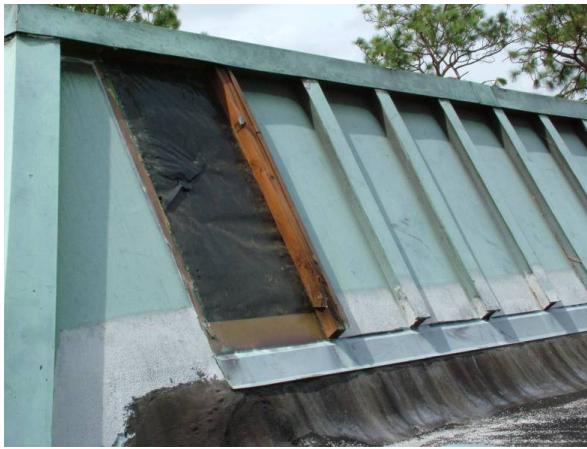
**3-01-1. Raised seam copper panels attached to battens came off because battens came loose.**

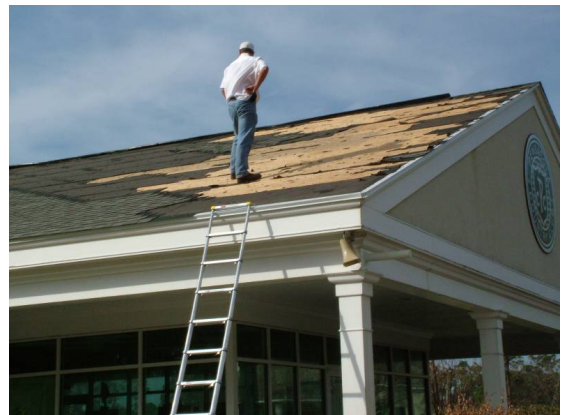
**3-02-1. Damage to composition shingle roof began at corner and rake edge.**

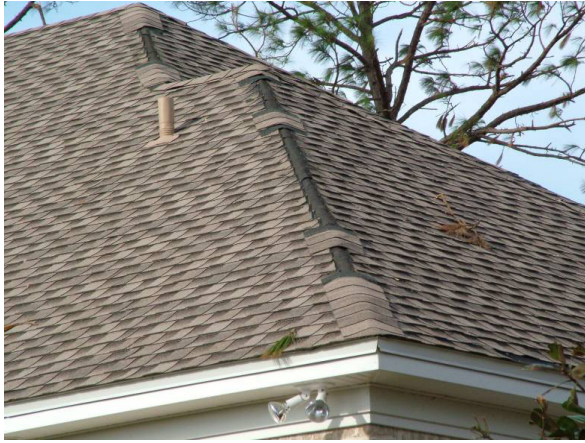
**3-03-1. Damage to composition shingles was limited to hip section.**

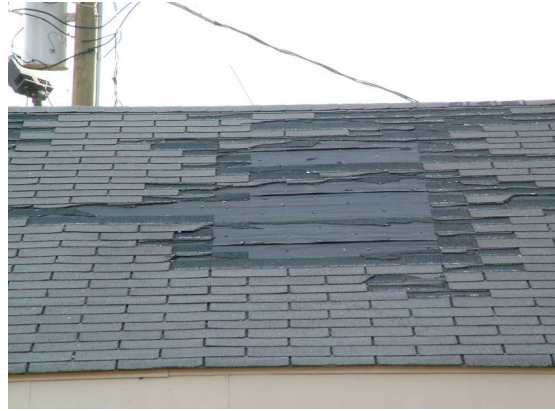
**3-04-1. Tabs that were not sealed down tore loose from 10-year-old shingle roof.**

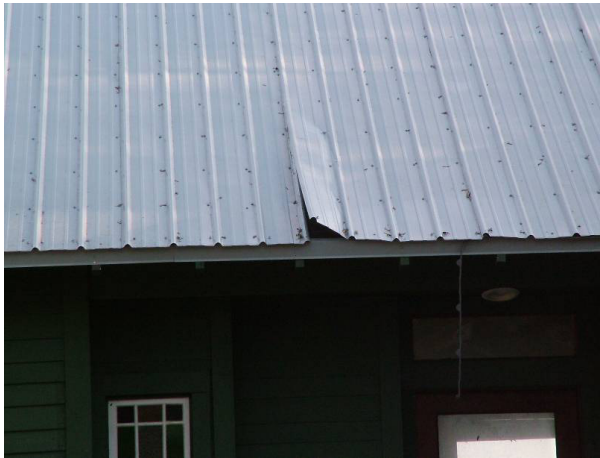
**3-05-1. Through-fastened metal roof with lifted panel missing fasteners at seam.**

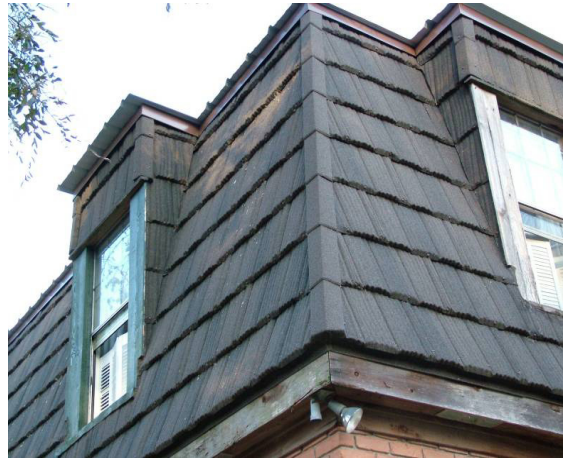
**3-06-1. Undamaged steel shingles and metal panels.**

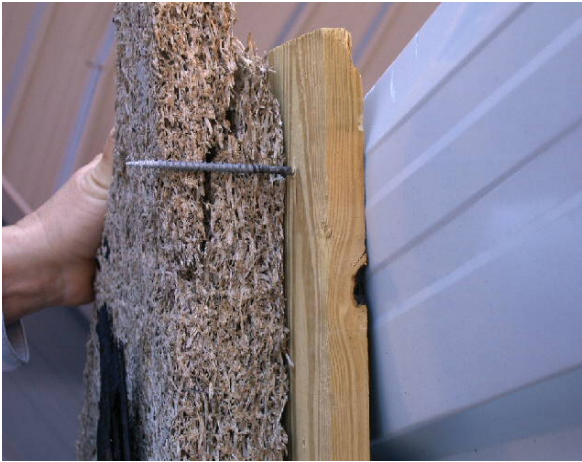
**3-07-1. Metal panels attached to 1×4 battens pulled loose from composite fiber decking.**

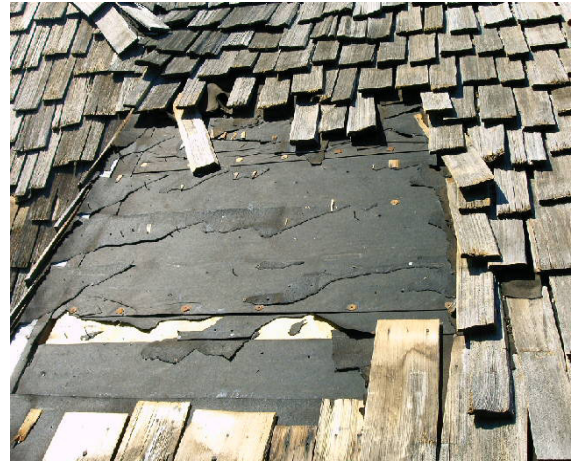
**3-09-1. Missing wood shakes that had been laid in staggered pattern to enhance aesthetics.**

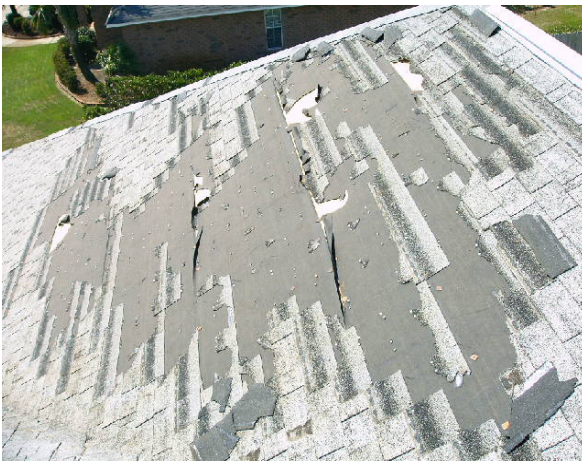
**3-10-1. Shingle tabs lifted and tore loose on 10-year-old roof.**

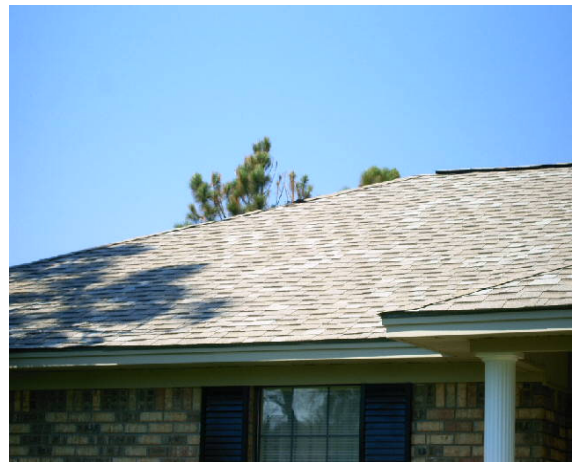
**3-11-1. Shingle roof missing only six hip pieces.**

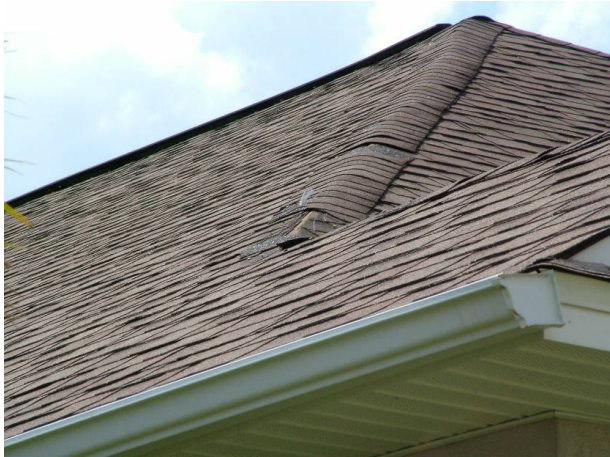
**3-12-1. Home next door to house shown in 3-13-1 lost only a few hip pieces.**

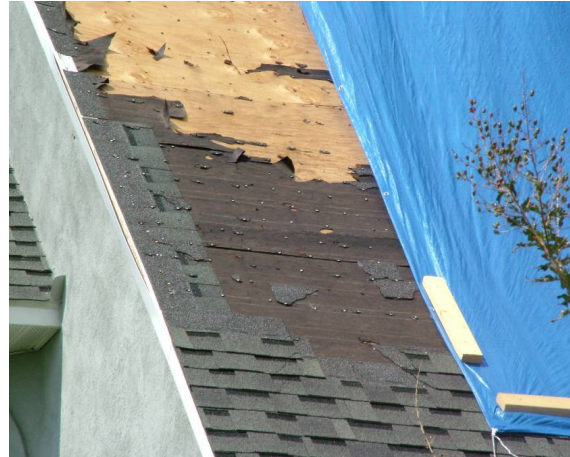
**3-13-1. Wind damage to shingles at rake edge.**

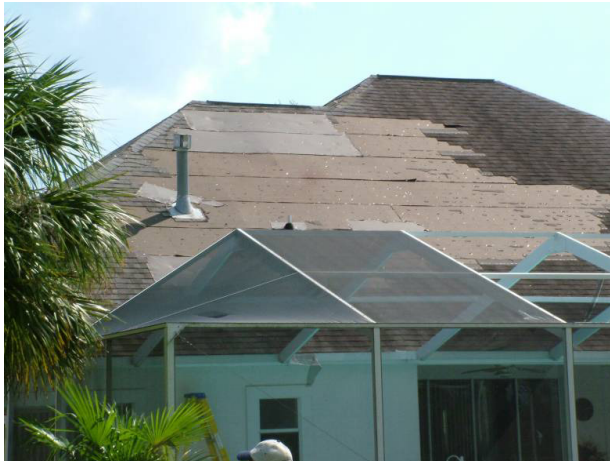
**3-14-1. Damage to 5-year-old shingle roof where tabs lifted and tore loose.**

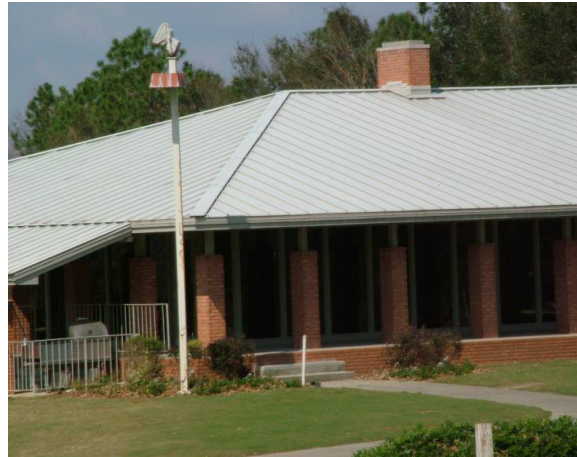
**3-15-1. Undamaged standing seam roof on clubhouse.**

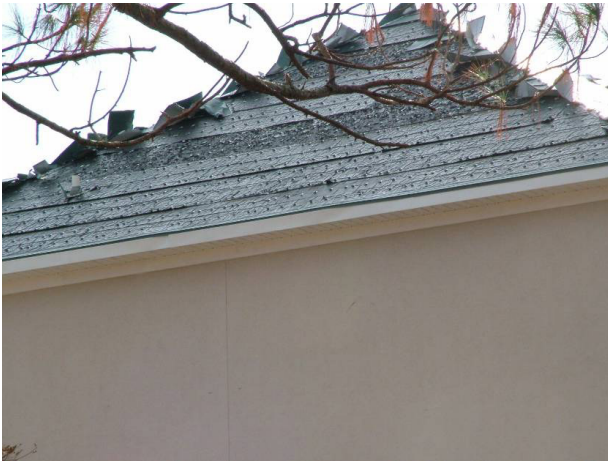
**3-17-1. Steel shingles blown loose from attachment clips.**

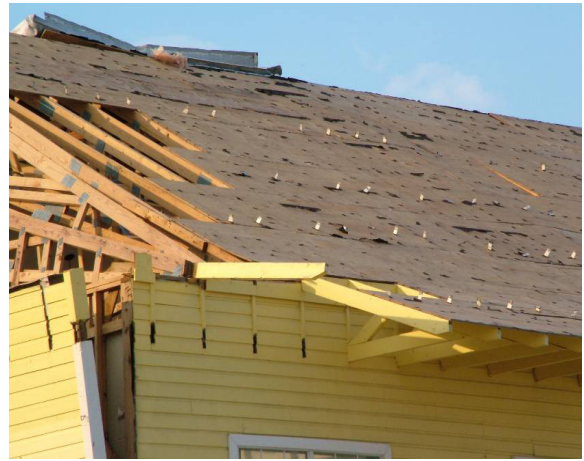
**3-18-1. Beach-front building suffered damage to structure and standing seam roof.**

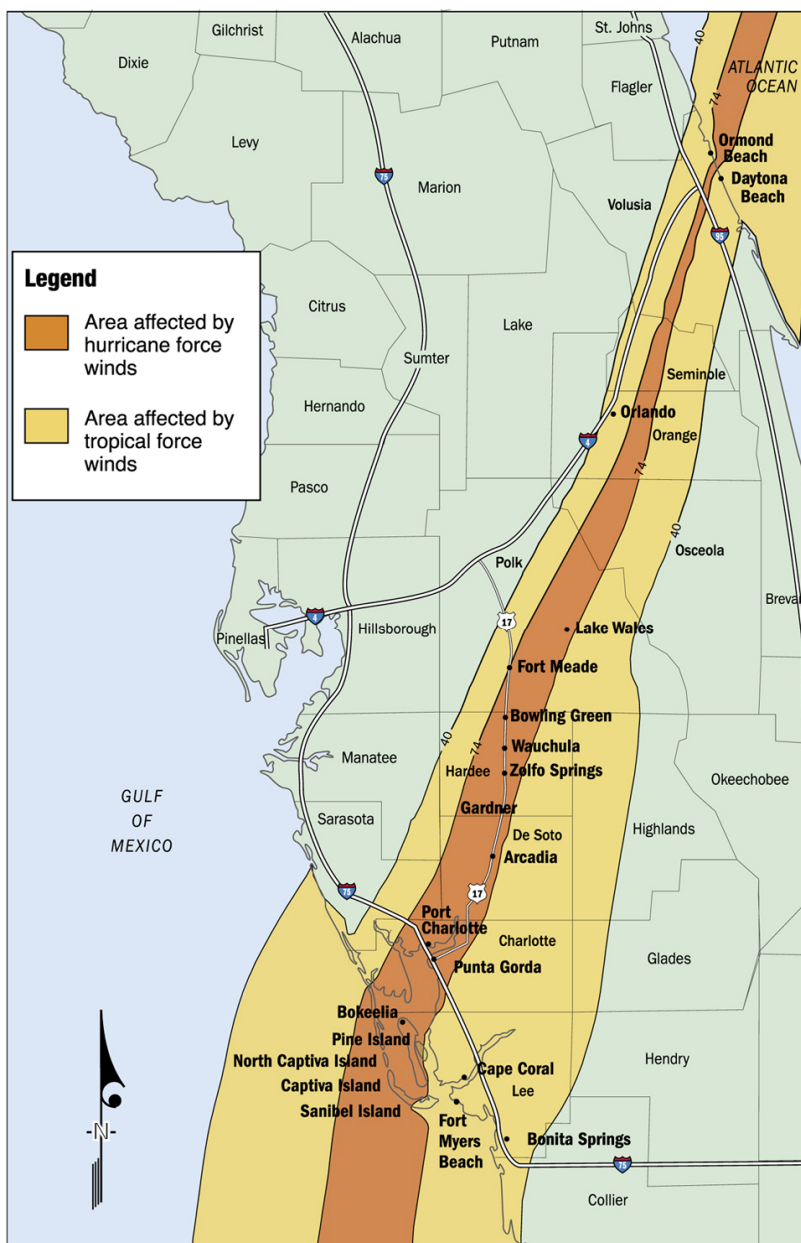
Extent of the hurricane and tropical storm force winds for Hurricane Charley as estimated by the NOAA H-wind model.
