# RICOWI, Inc.

Roofing Industry Committee on Weather Issues, Inc.

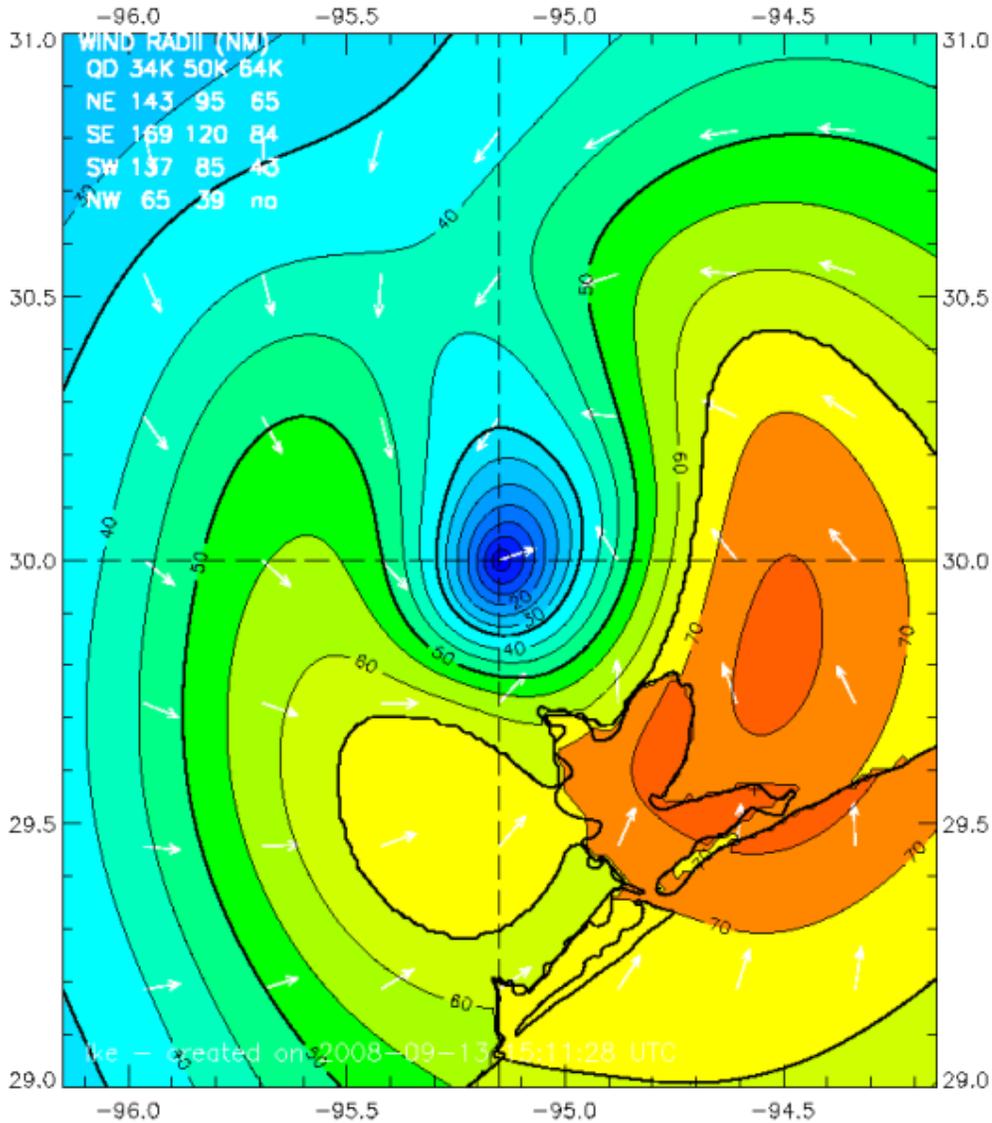
Integrated Kinetic Energy: for Winds > TS force: 49 TJ, for Winds > Hurricane Force: 16 TJ  
 Destructive Potential Rating(0-6) Wind: 2.6, Surge/Waves: 3.7  
 Observed Max. Surface Wind: 83 kts, 37 nm NE of center based on 0758 z SFMR\_AFRC  
 Analyzed Max. Wind: 79 kts, 42 nm SE of center  
 Uncertainty -> mean wind speed error: 1.68 kt, mean direction error: -0.92 deg  
 rms wind speed error: 6.67 kt, rms direction error: 8.97 deg  
 Experimental research product of [NOAA / AOML / Hurricane Research Division](#)

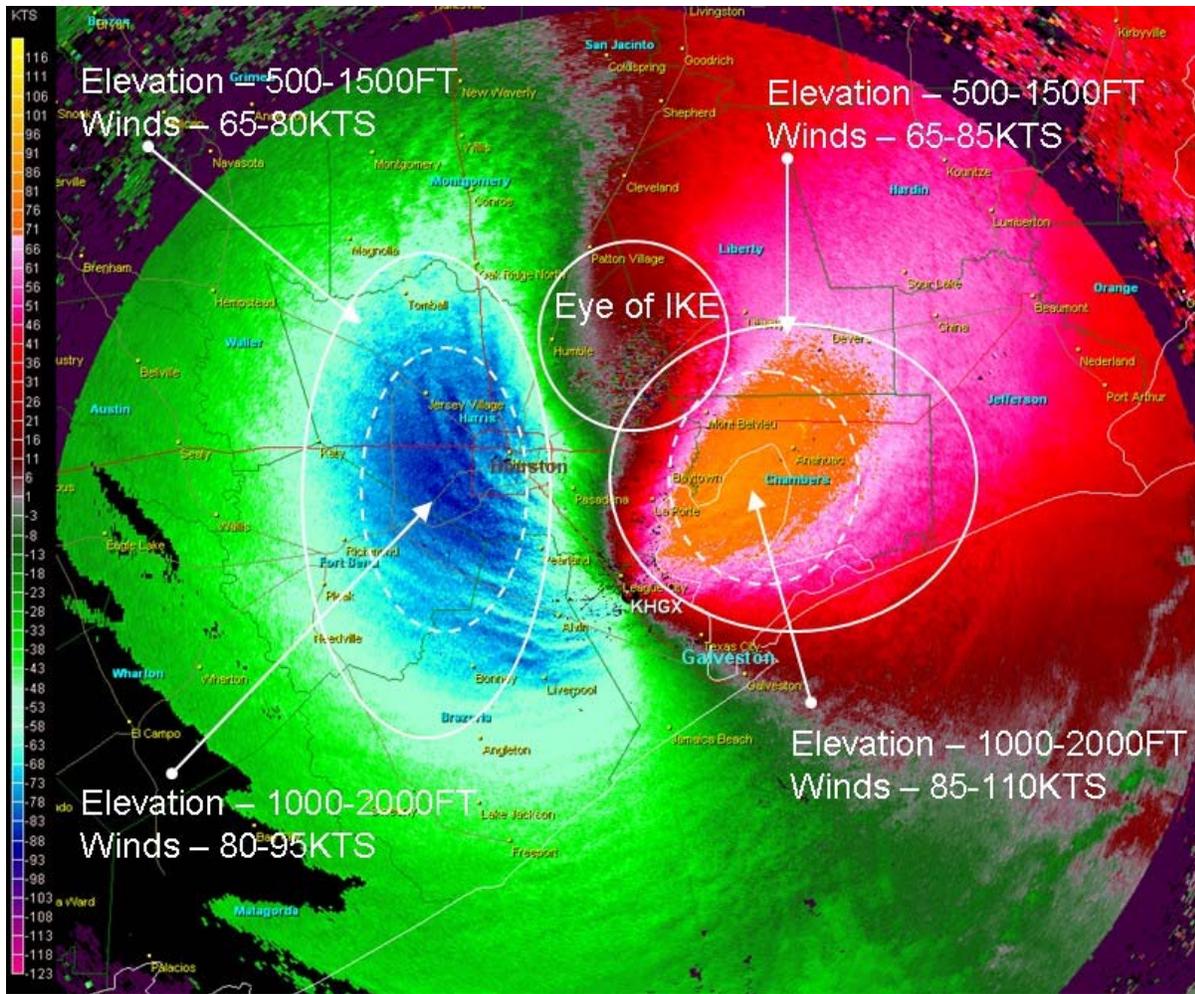
**Figure 3. Hurricane Ike Wind Map**

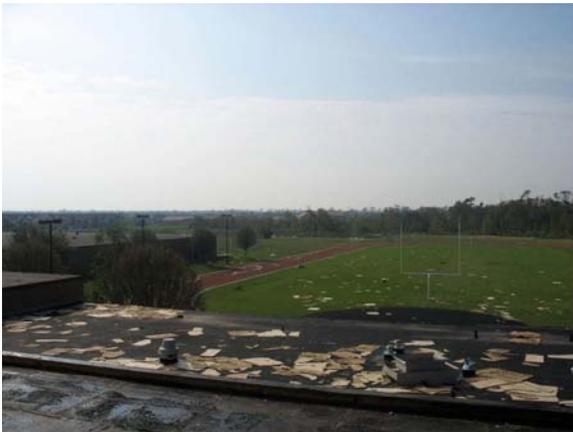
**2.01-1. A debris field extended nearly a half mile south- southeast from the building.**

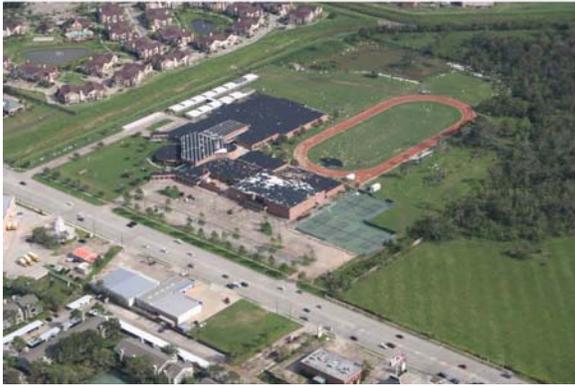
2.01-3. Aerial photo showing overview of roof damage.

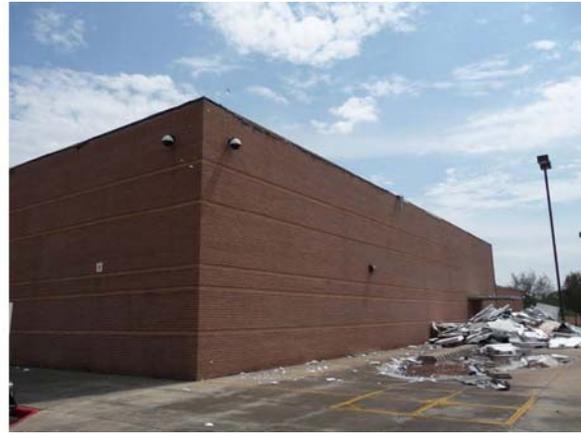
2.01-4. View of displaced edge metal at west side and northwest corner.

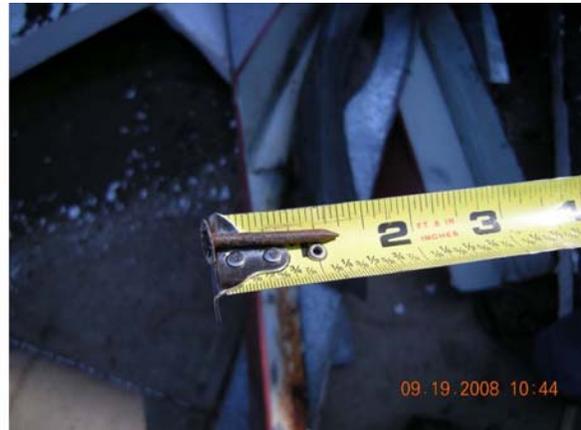
2.01-8. Edge metal fasteners were 1-1/4 in. roof nails with varying amounts of rust.

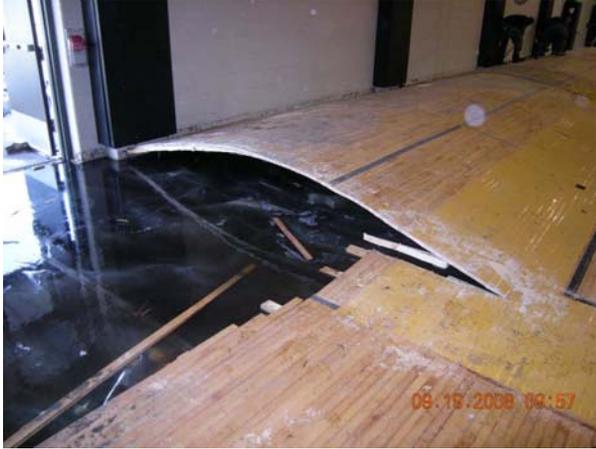
**2.01-9. Interior water damage included a buckled gymnasium floor.**

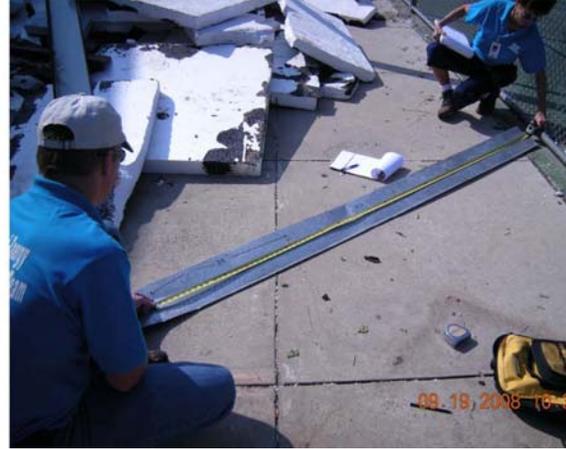
**2.01-10. This insulation board had too little asphalt adhesive for a strong bond.**

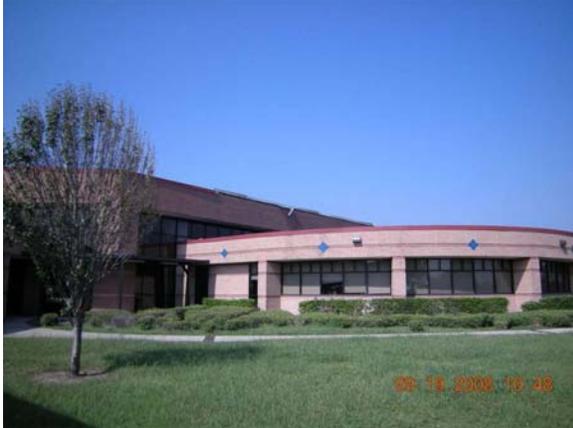
2.02-1. Overview of roof with damaged metal edge.

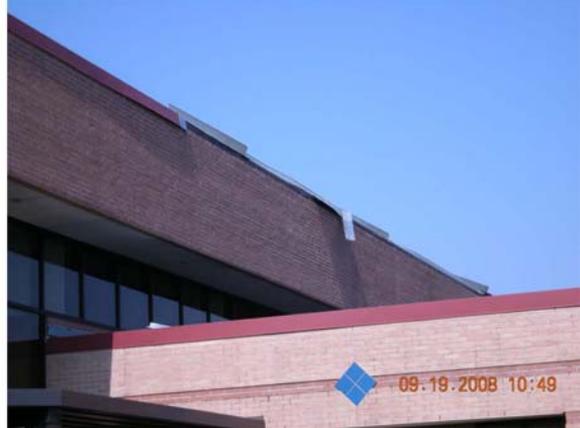
2.02-2. Closer view of disengaged metal edge and cleat.

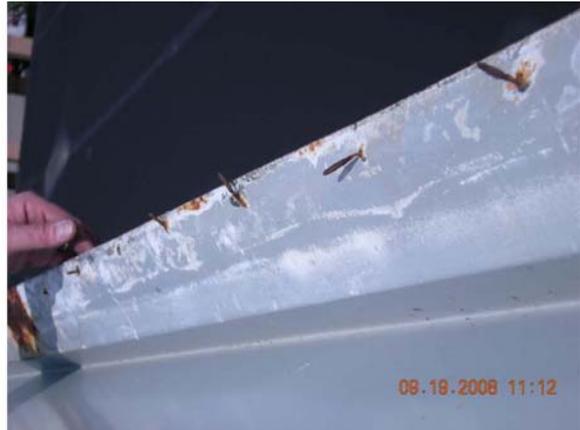
2.02-4. Roofing nails used to secure the metal have significant rust.

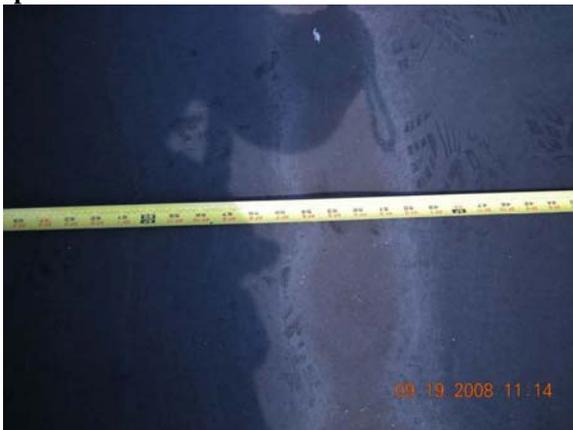
2.02-5. Roof had additional fastening at 5 ft from roof edge.

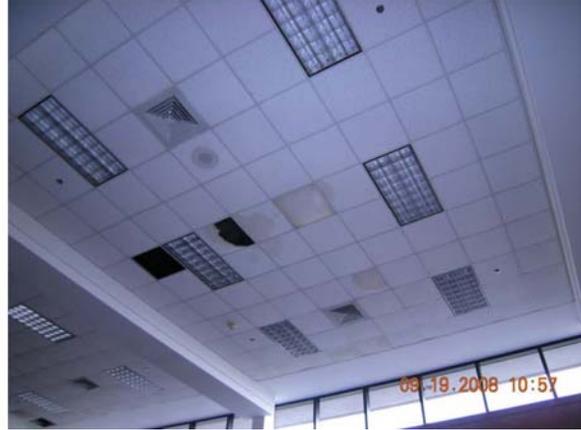
**2.02-8. There was minimal interior damage from the metal edge problems.**

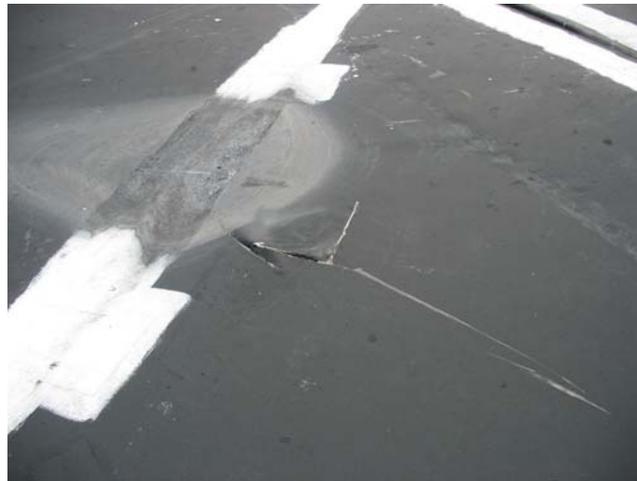
**2.02-9. This is a small patch at an expansion joint.**

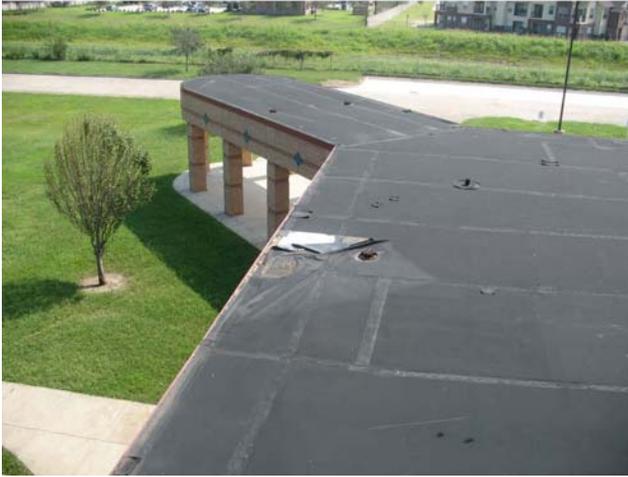
2.03-1. An overview of localized damage.

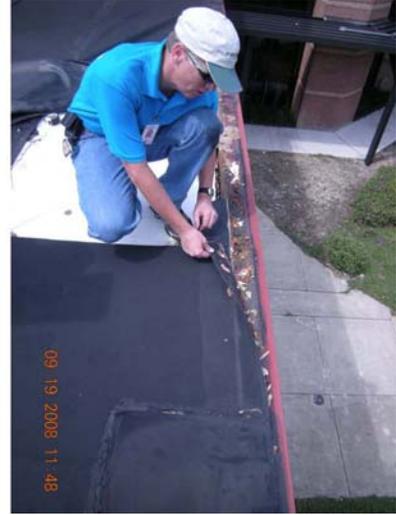
2.03-2. Edge metal was bonded with adhesive.

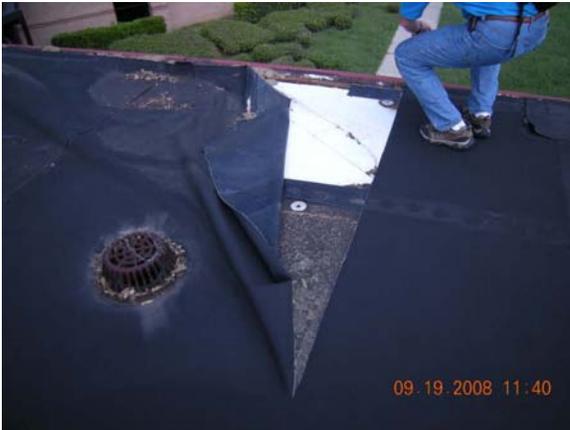
2.03-3. Loss of bond at roof edge caused tearing of the EPDM.

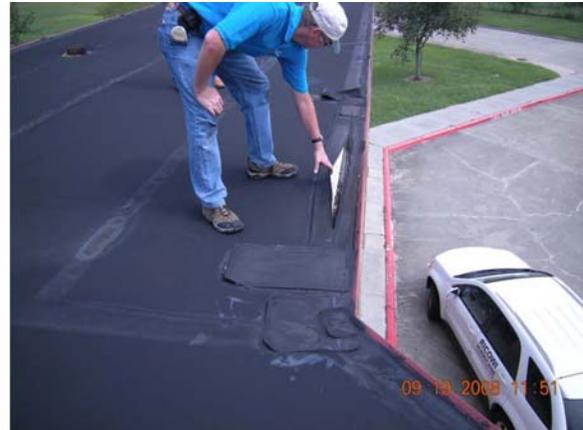
2.03-4. This photo shows torn membrane in an adjacent area.

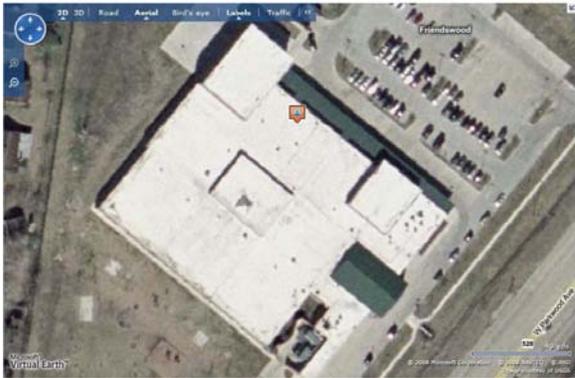
**2.04-1. Aerial photo of the roof.**

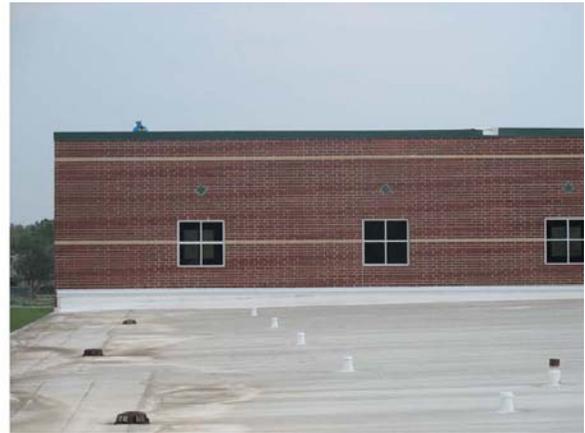
**2.04-2. Excellent slope was noted on this roof, with no membrane detachment.**

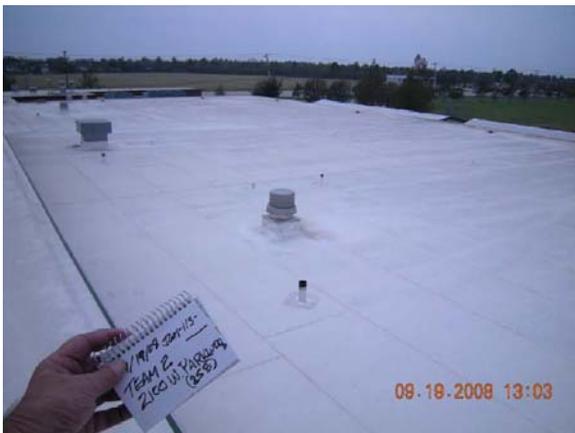
**2.04-3. This low elevation roof had eleven cuts and/or tears.**

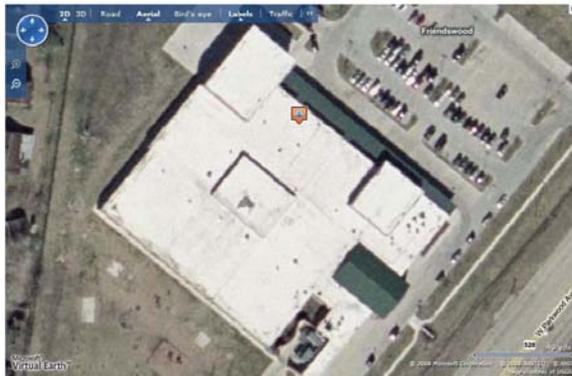
**2.05-1. Aerial view of school shows all roofs investigated.**

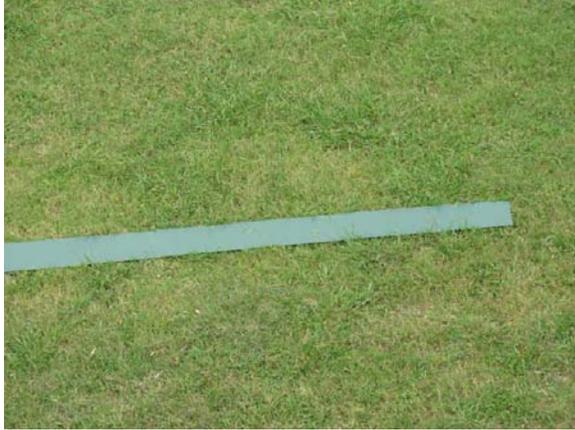
**2.05-3. Metal edge trim was found at various locations on the ground.**

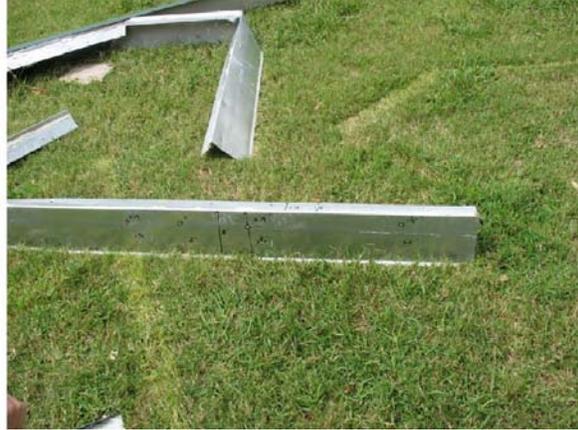
**2.05-4. This 8 in. cleat had fasteners approximately 2-1/2 in. from the upper edge.**

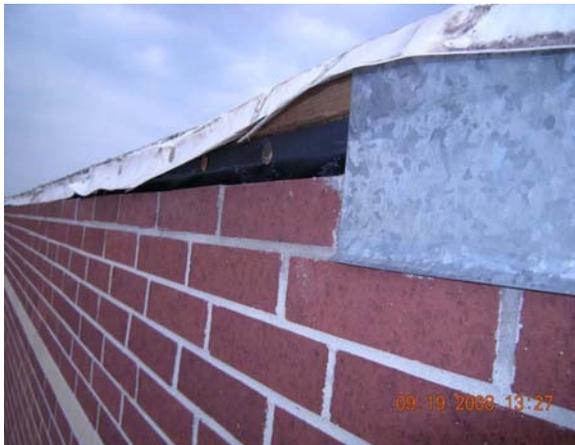
**2.05-7. Some cleats were missing along this edge; note that air can infiltrate behind cleat. Also note high position of nail at upper right.**

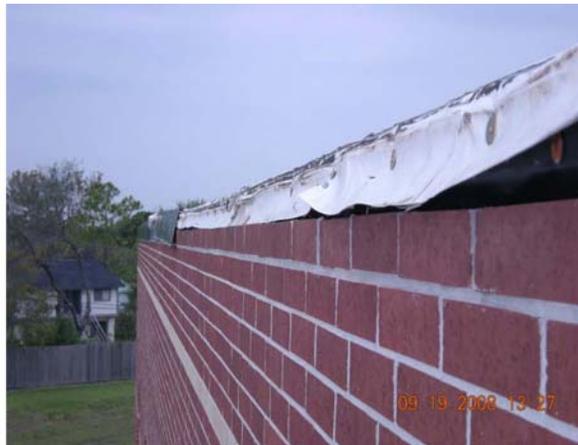
**2.05-8. Another view shows that cleat is missing, allowing air infiltration behind cleat position.**

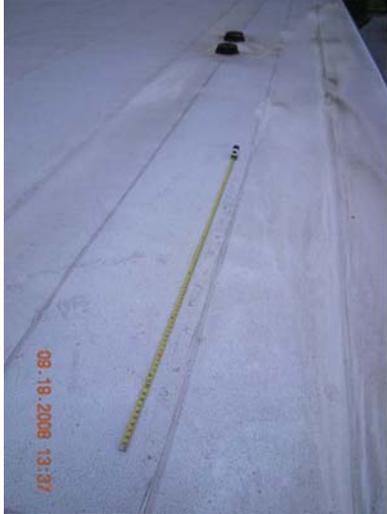
**2.05-9. The perimeter sheet attachment pattern helped prevent system loss.**

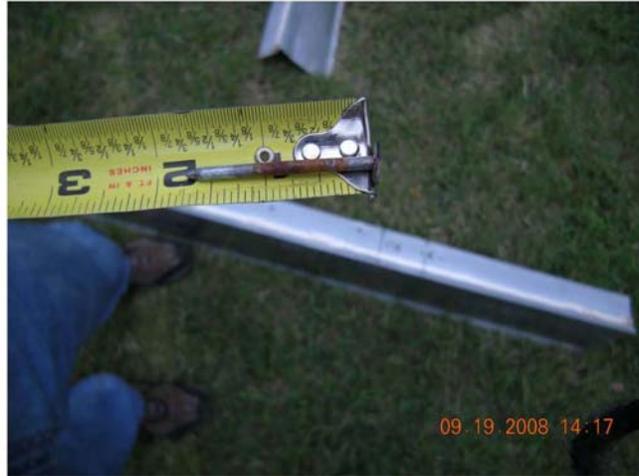
**2.05-10. Note a 2 in. cleat fastener with oxidized shank did not appear to be a factor in failure.**

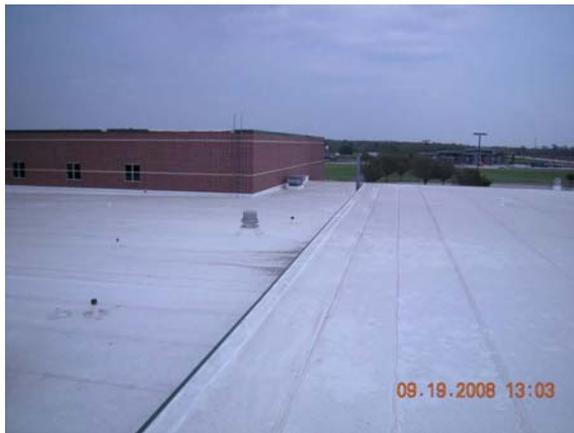
**2.06-1.** The one puncture on this roof was from metal edge flashing on the upper gymnasium roof to the north.

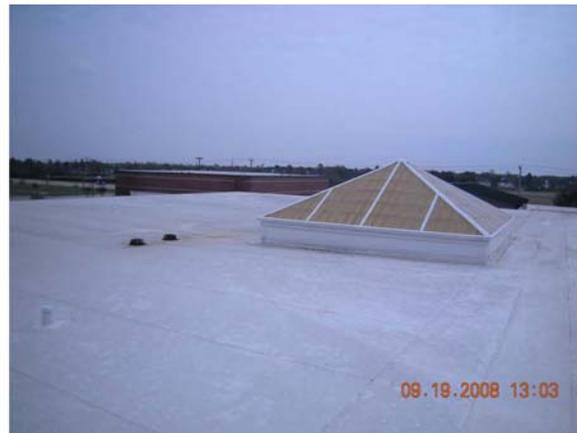
**2.06-2.** A temporary repair from a cut or tear is visible at left.

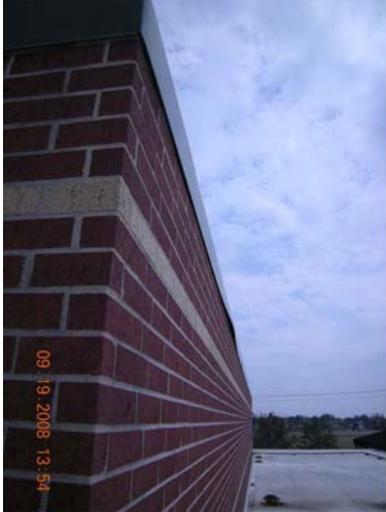
**2.07-1.** A slight bulge is visible in this metal edge.

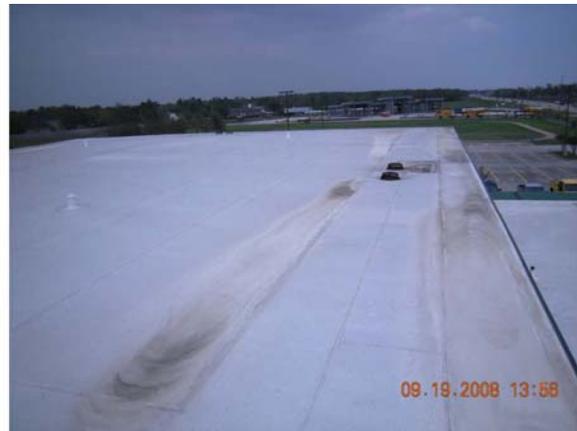
**2.07-4.** The absence of airborne debris probably helped prevent damage to this roof.

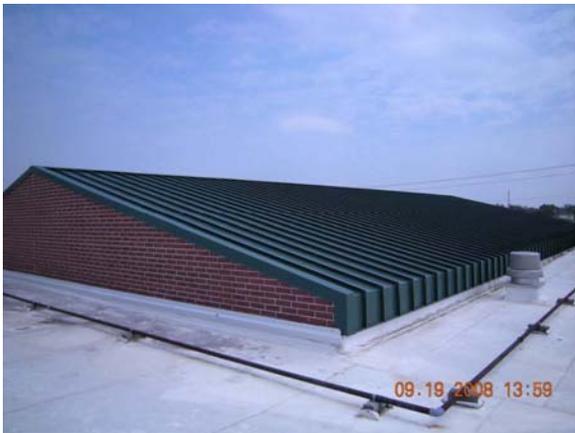
2.08-1. An undamaged metal standing seam roof.

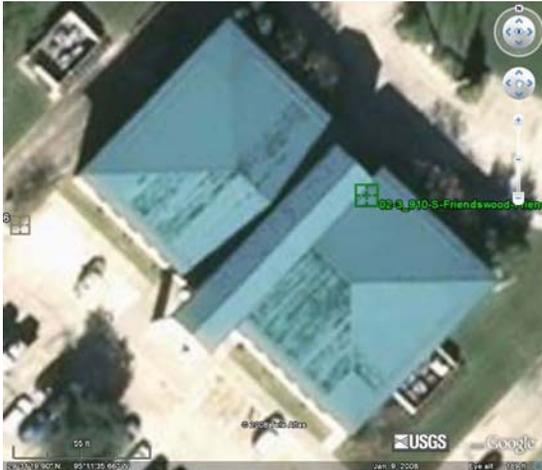
2.09-1. Aerial view of Friendswood City Hall.

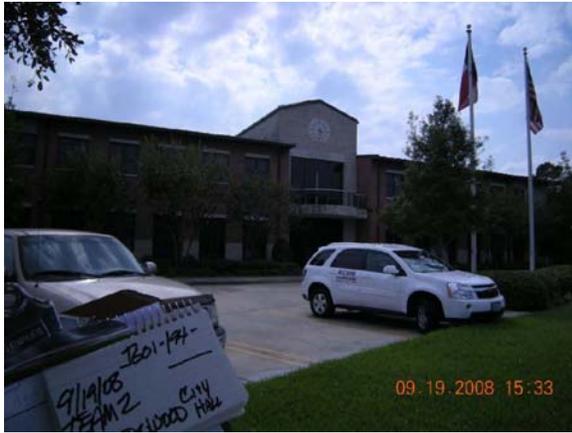
**2.09-3.** Over the front of the building was a raised section with a slightly damaged rake edge.

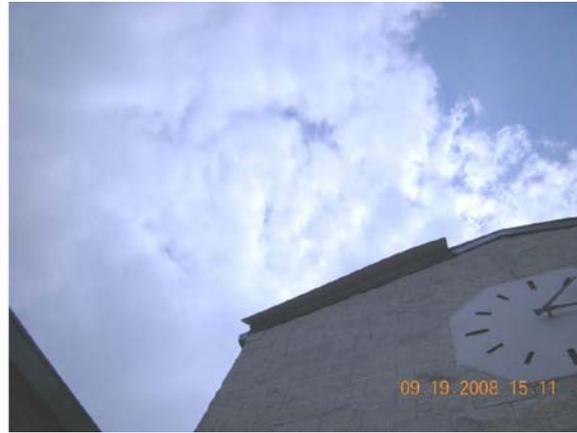
**2.09-4.** A closer look at the damaged edge.

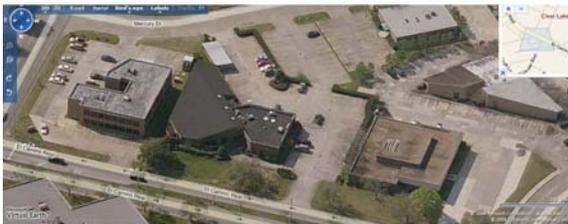
**2.10-1. Aerial view of the Mitch Foster Building - the only one in the area with damage.**

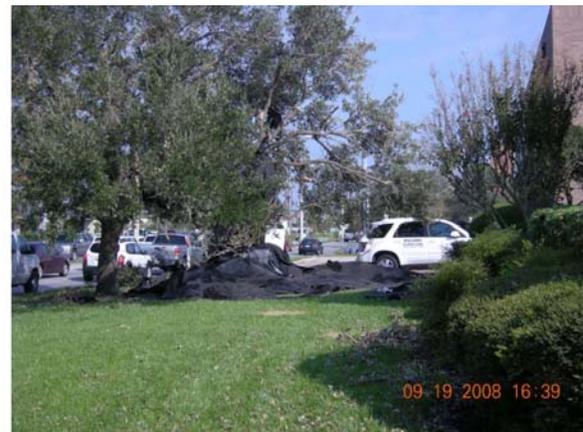
**2.10-2. Part of the roof membrane was blown to the ground.**

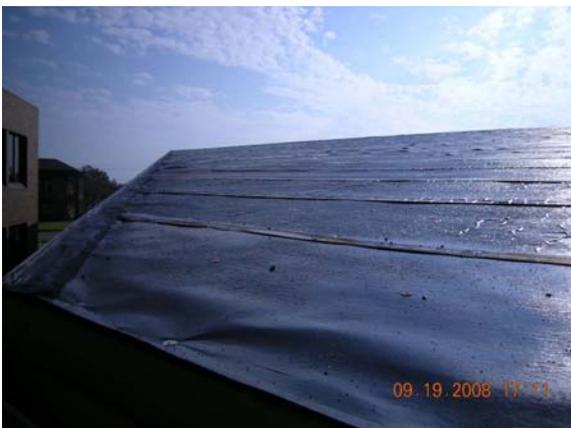
**2.10-7.** Temporary repairs can be seen on this roof section.

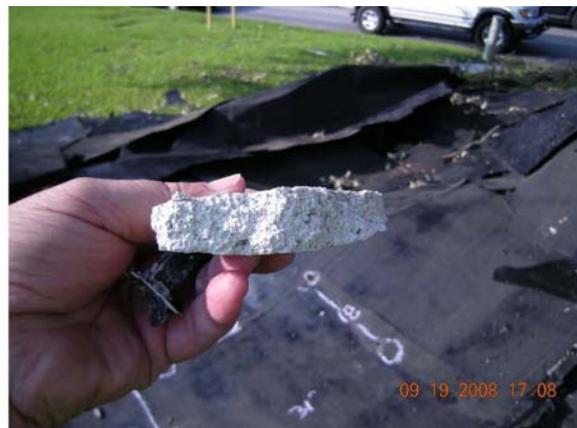
**2.10-8.** Lightweight concrete decking in this photo was broken and detached.

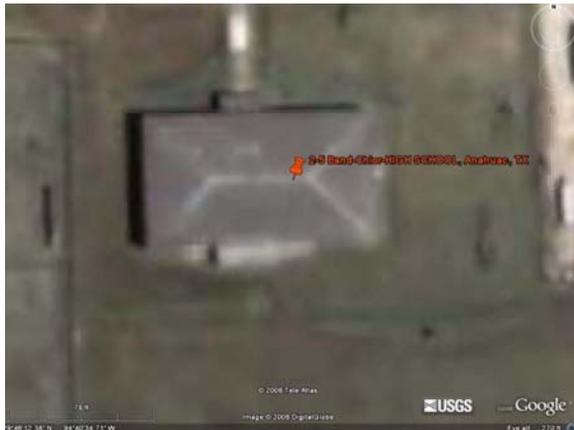
**2.11-1. Aerial view of the Band Choir Building.**

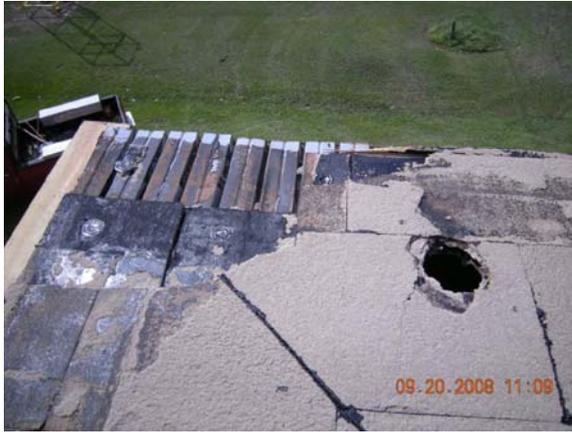
**2.11-3. Roof membrane and insulation tore loose from the deck in this corner. Note rusted deck.**

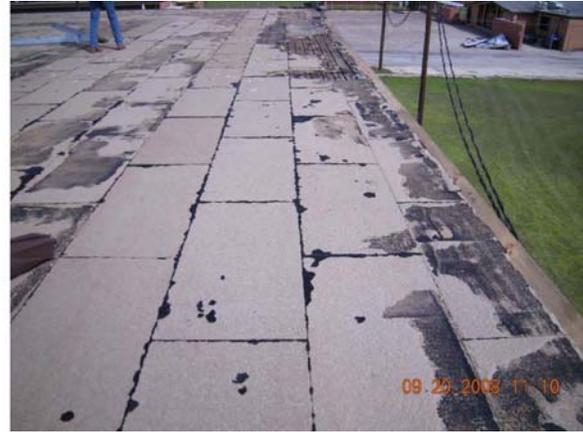
**2.11-4. On the windward edge (south side), metal edge was nearly completely dislodged.**

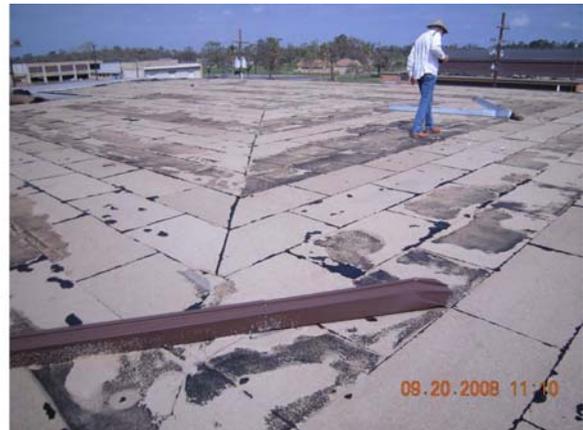
**2.11-6. In addition to damage described in 2.11-2, tapered insulation is visible.**

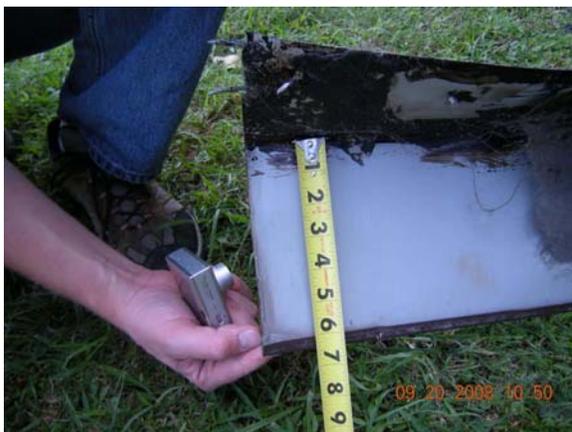
**2.11-7. Fascia metal was relatively wide.**

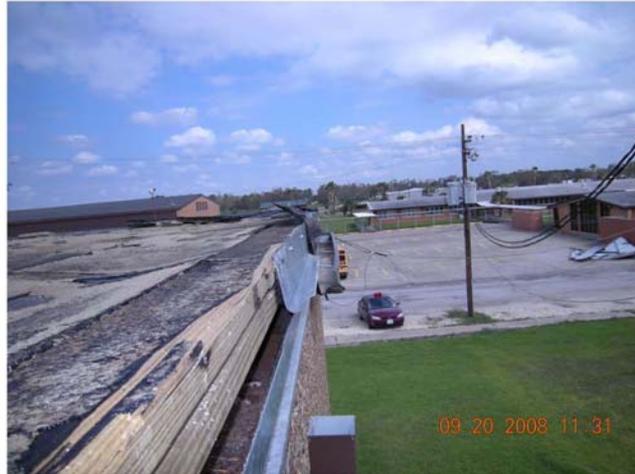
**2.11-10. Photo of gutter/cleat attachment is a good example of damage progression.**

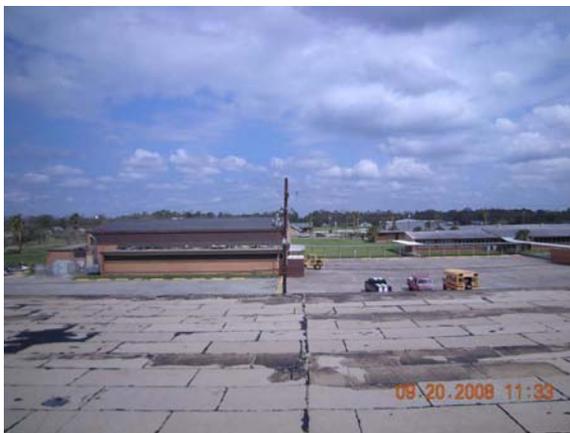
**2.12-1. Distant view of a steep slope roof that has been displaced. The structure was temporarily covered.**

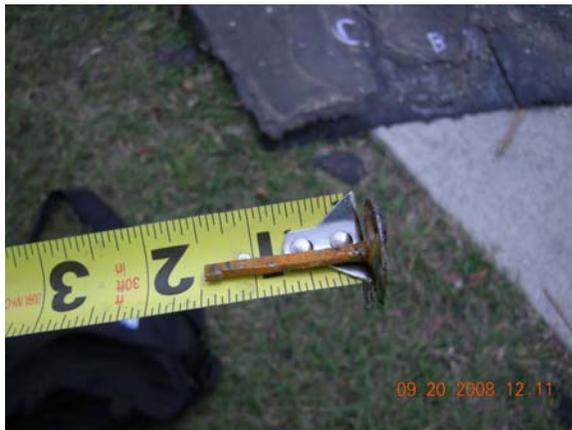
2.12-5. Rusted fasteners did not hold in CWF decking. Also, the fastener hook is missing.

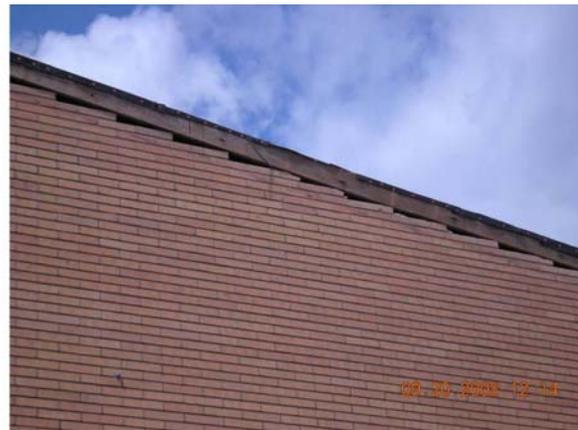
2.12-6. Edge metal became detached at this windward edge.

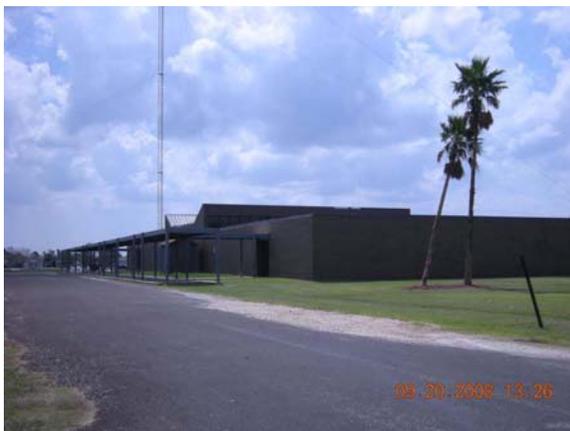
**2.13-1. Overview from ground level.**

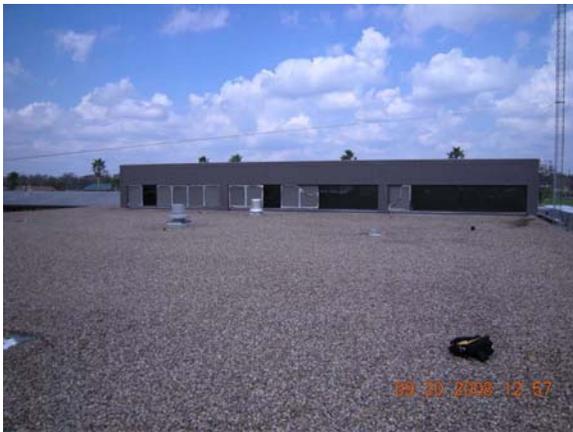
**2.13-7. Broken windows were noted on this portion of the building.**

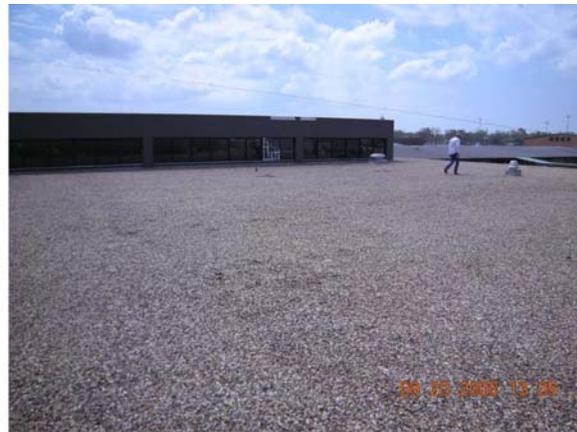
**2.13-8. Metal damage occurred in this area.**

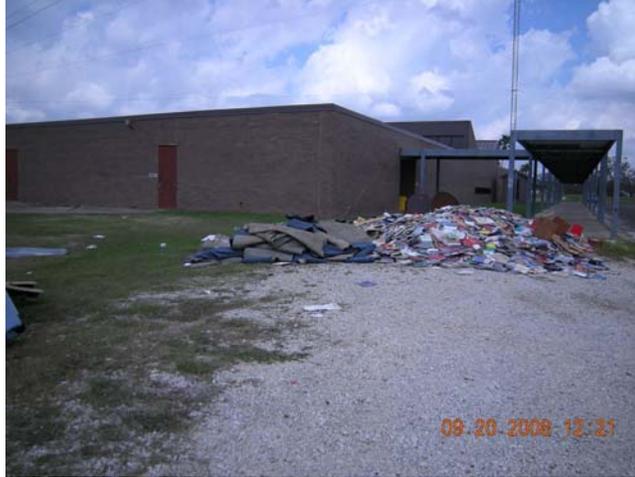
**2.13-9. Water damaged books are piled on the ground outside the building.**

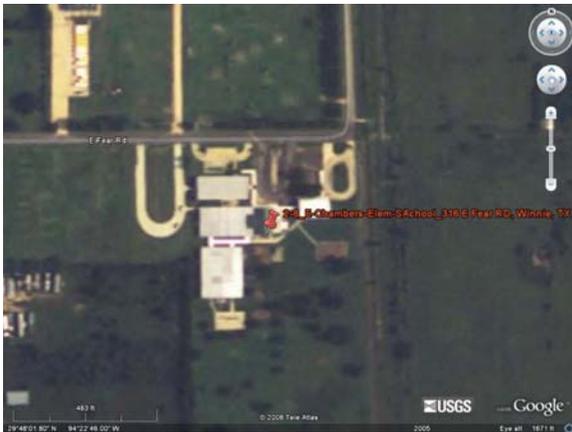
2.14-1. Aerial view of site.

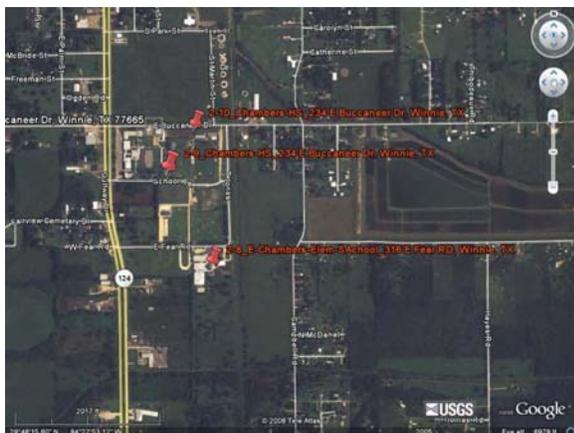
2.15-1. Aerial photo (middle building) shows one of three sites in this district with damaged metal roofs.

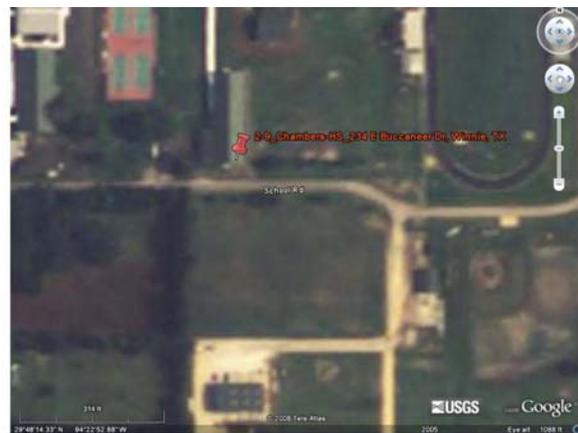
2.15-2. Another aerial photo of this site.

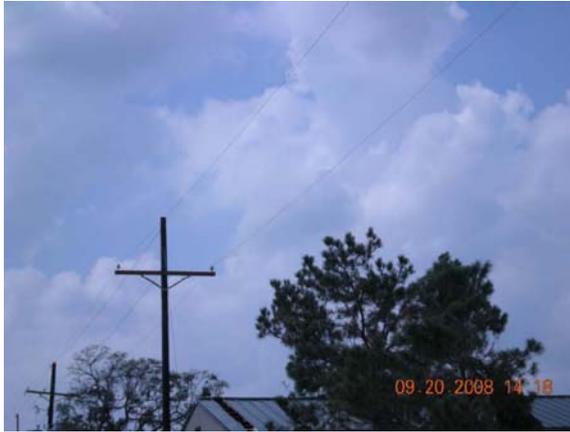
2.15-3. At the bottom of this photo, note missing metal panels.

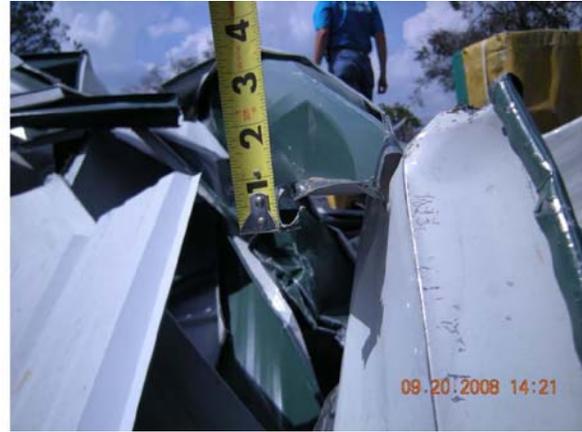
2.15-4. No clips were found on these displaced panels.

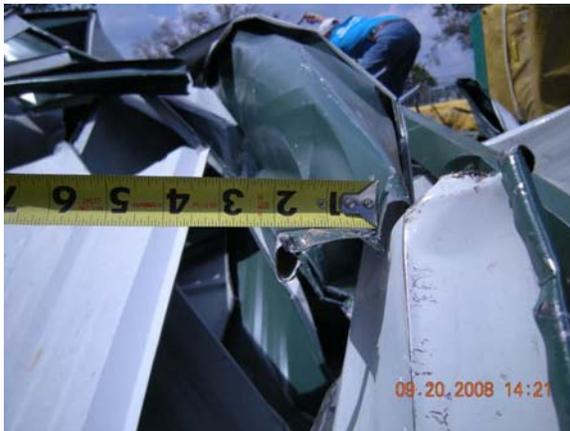
2.15-5. Seam height was 2 in.

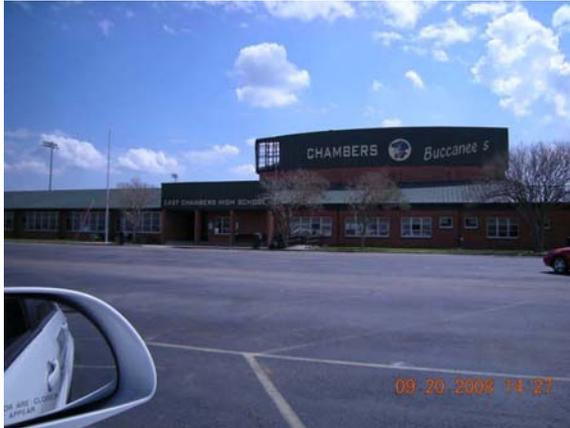
**2.16-1. Front elevation of the school.  
Note missing metal from parapet and roof.**

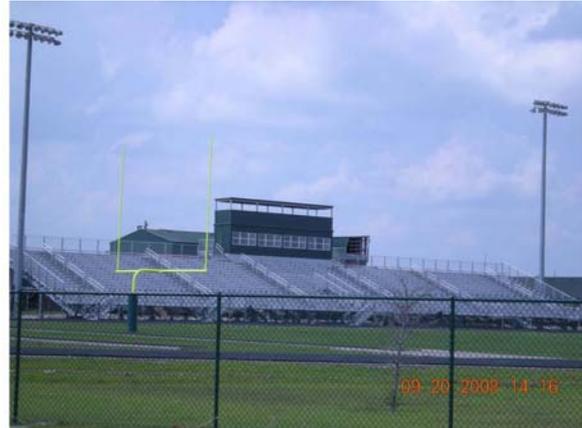
**2.16-2. View of the back of the building showing missing metal.**

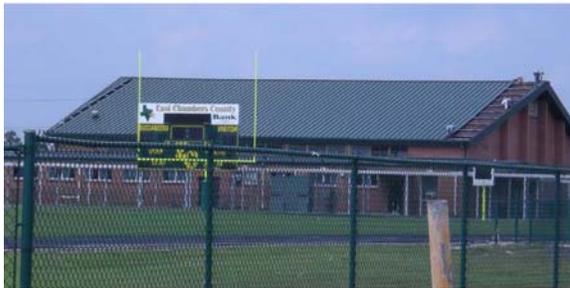
**2.16-3. Another rear view of the school.**

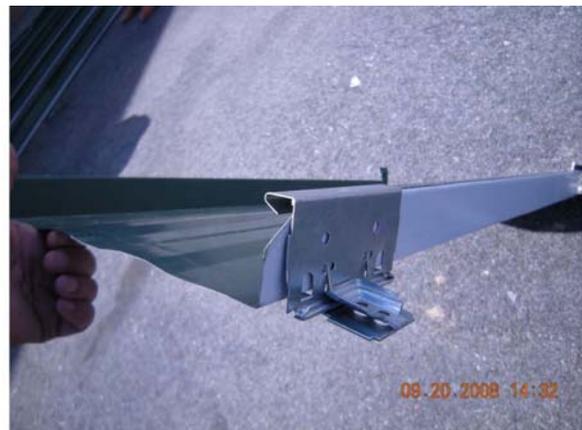
**2.16-6. This metal clip was used in the roof replacement.**

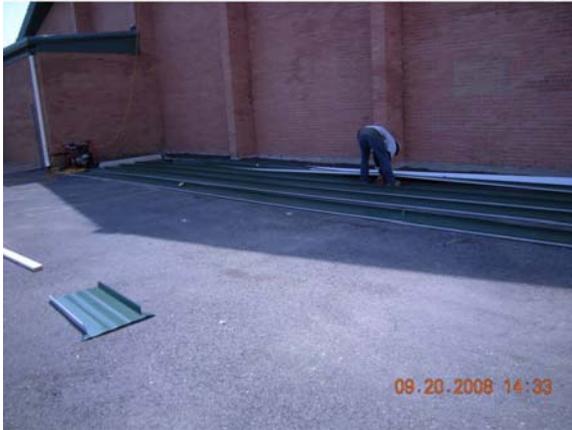
2.16-7. View of metal readied for roof replacement.

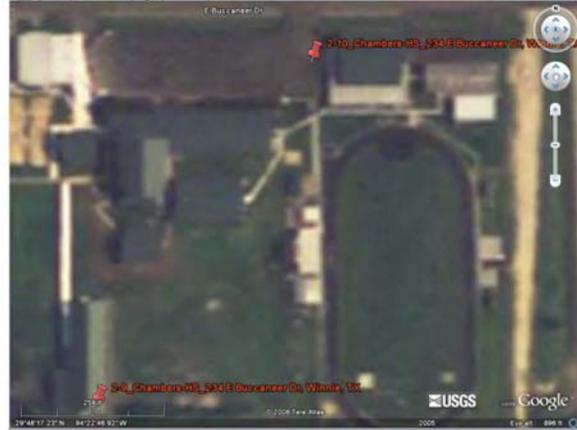
2.16-8. Aerial view of Chambers Campus; upper label is the high school.

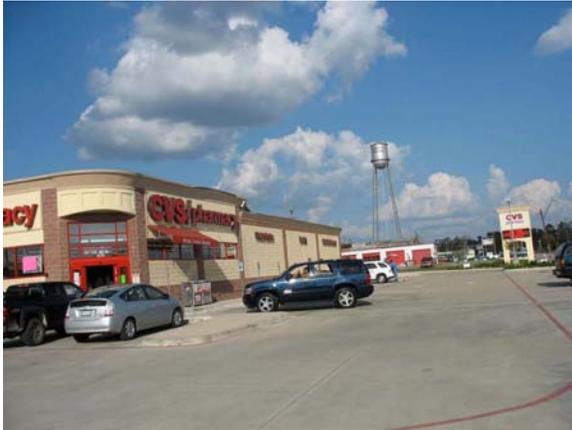
**2.17-1. Overview of this shopping center.**

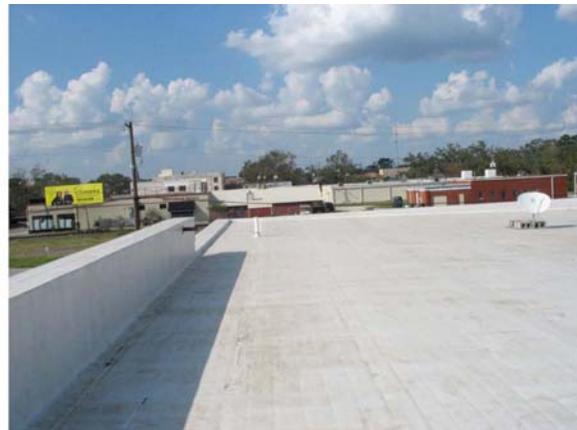
**2.17-6. Another damaged parapet.**

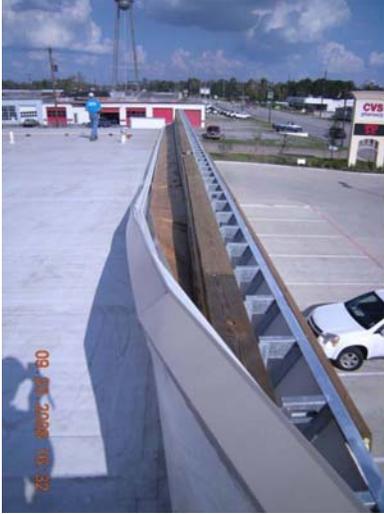
**2.17-7. On this damaged parapet, wind forced the coping system over the parapet and back toward roof.**

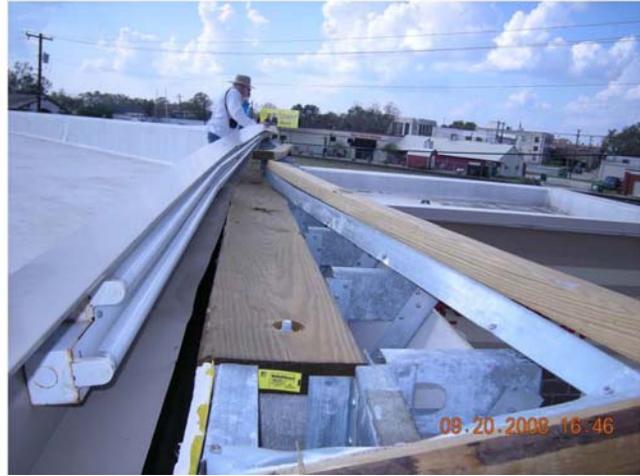
**2.17-8. On the opposite elevation wall from the one in photo 2.17-7, wind caused similar damage to coping.**

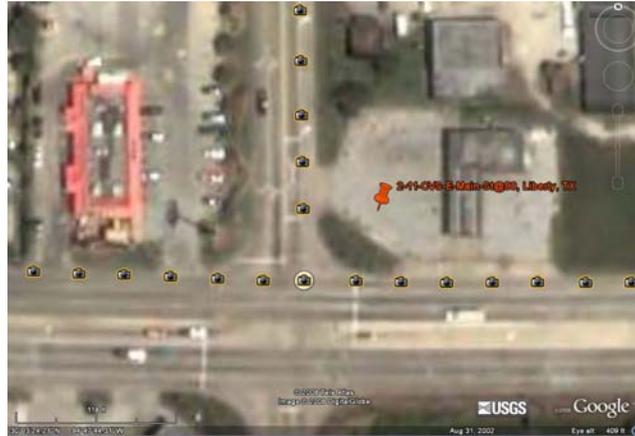
**2.17-9. Aerial photo was taken before this store was built. A label shows the store location.**

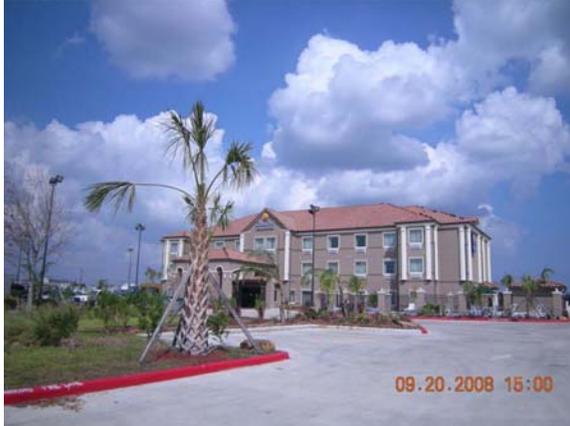
2.18-1. Overview of Comfort Inn.

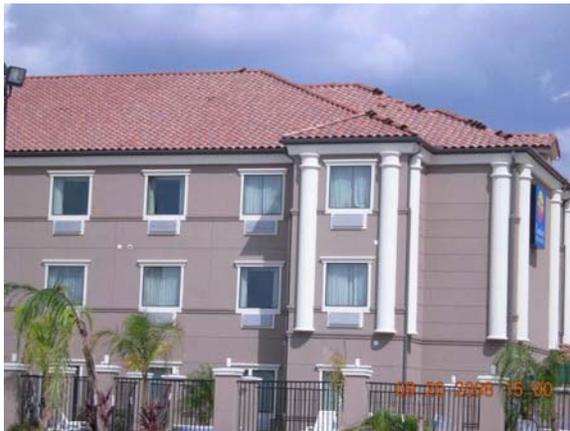
2.18-3. Damage occurred in the field of the roof as strong winds lifted tiles.

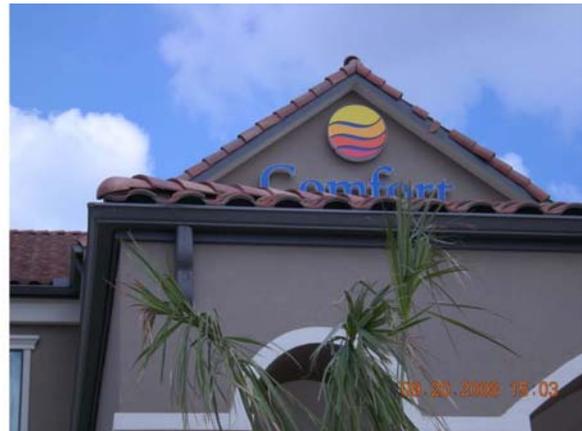
2.18-4. Note rake edge tile damage.

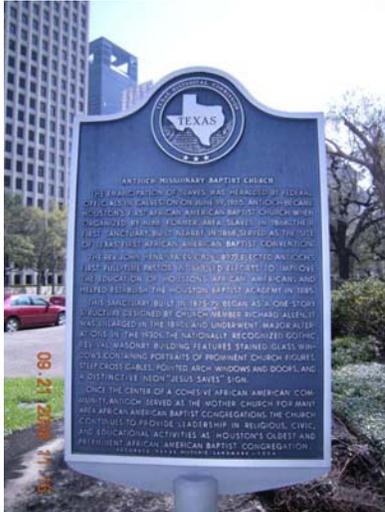
**2.19-1. Texas historic plaque indicates that the church was built in 1875.**

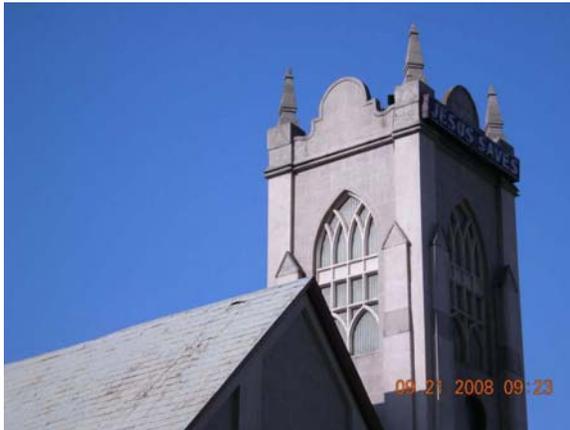
**2.19-3. The metal shingle interlock disengaged, causing failure.**

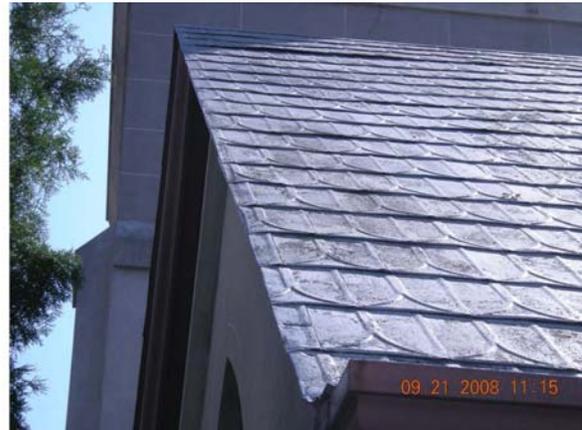
**2.19-4. A closer look at a rake edge.**

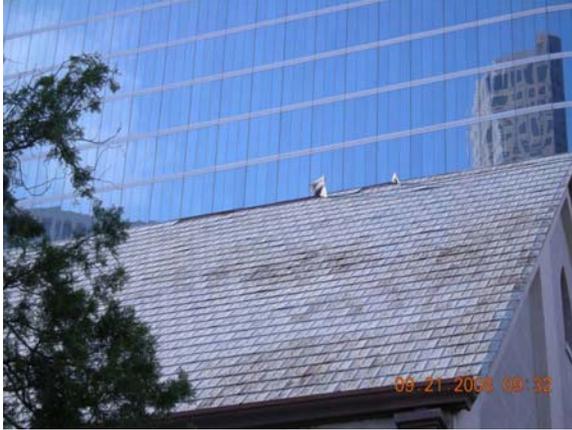
**2.19-5. Failure of ridge and field metal shingles was due to shingle interlock disengagement.**

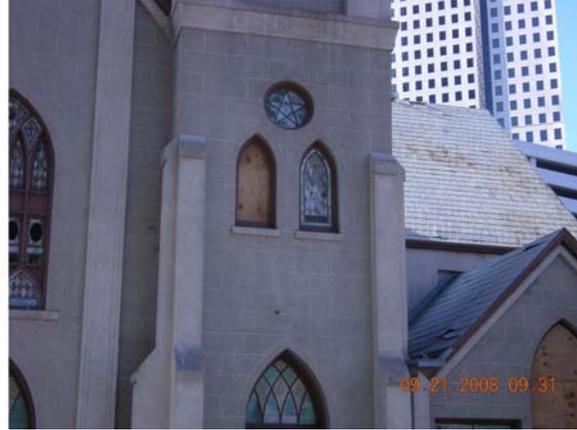
**2.19-6. Large and small window breakage was also noted.**

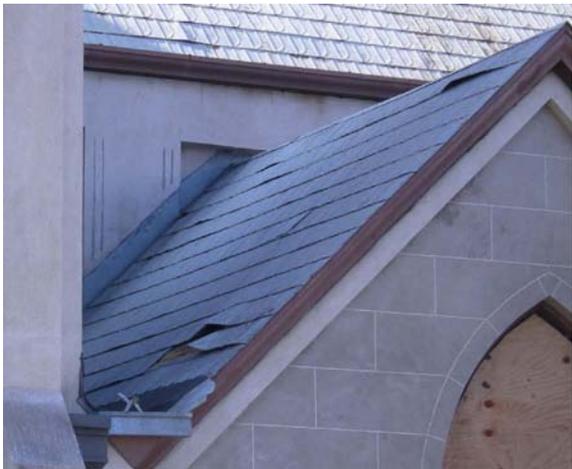
**2.19-7. Note damaged shingles along this rake edge.**

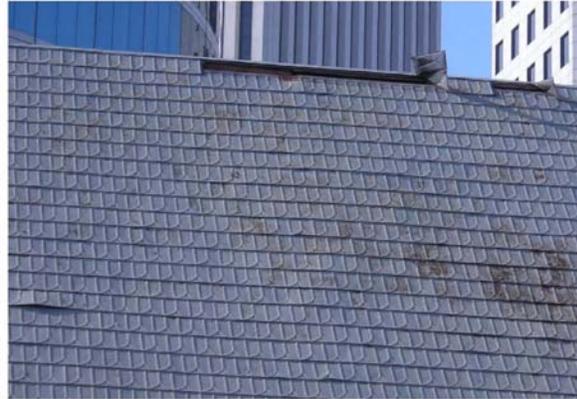
**2.19-8. Slight damage can be seen here, again as a result of interlock disengagement.**
