# RICOWI, Inc.

Roofing Industry Committee on Weather Issues, Inc.

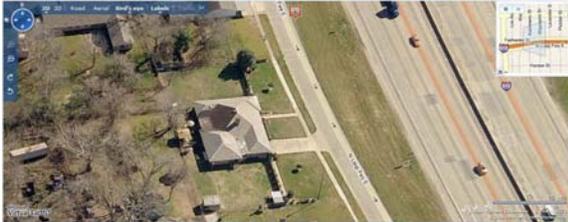
2.20-1. Aerial view of the residence.

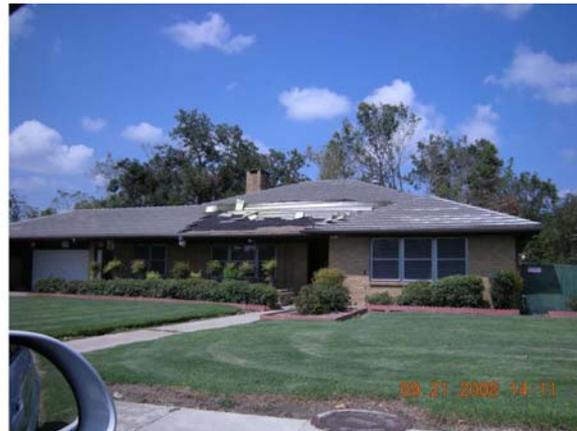
2.20-4. Primary damage was in the middle of the field of the main roof.

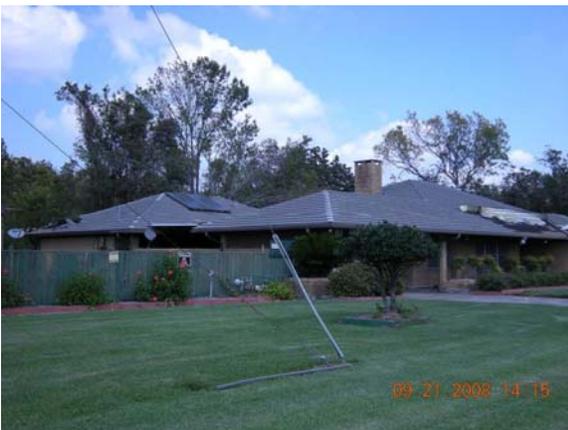
2.20-5. Additional damage was noted on a back corner.

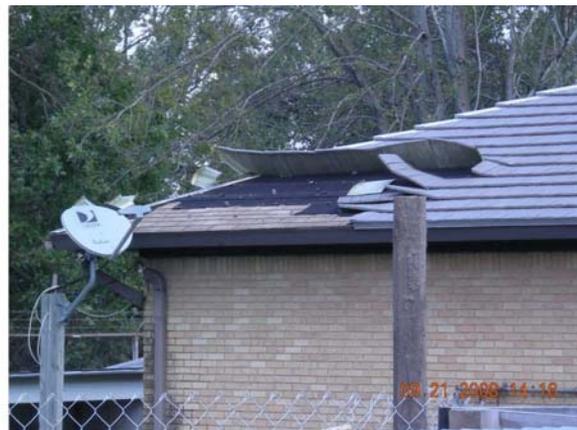
2.20-6. A closer view of the back corner damage.

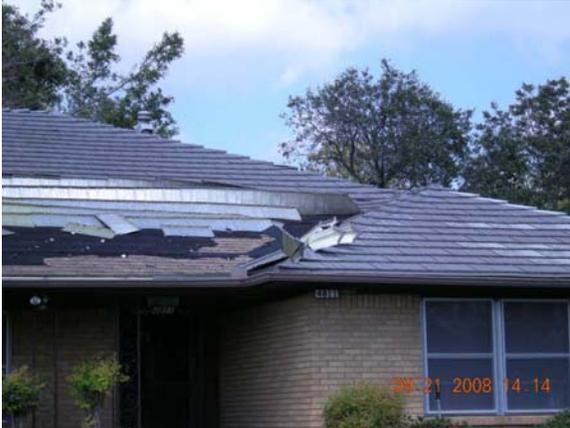
**2.20-7. Damage ended at this hip trim line.**

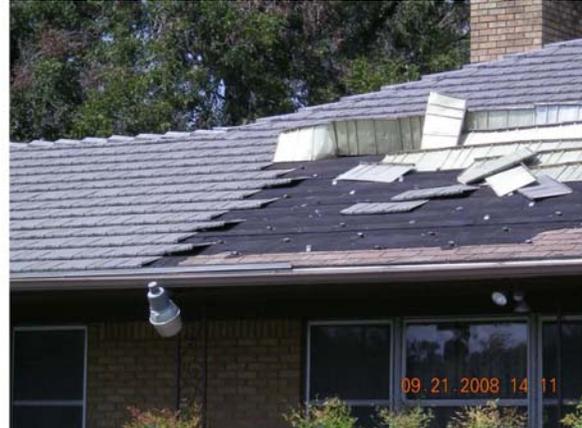
**2.20-8. Note the components of the system, original shingles, overlay and fasteners.**

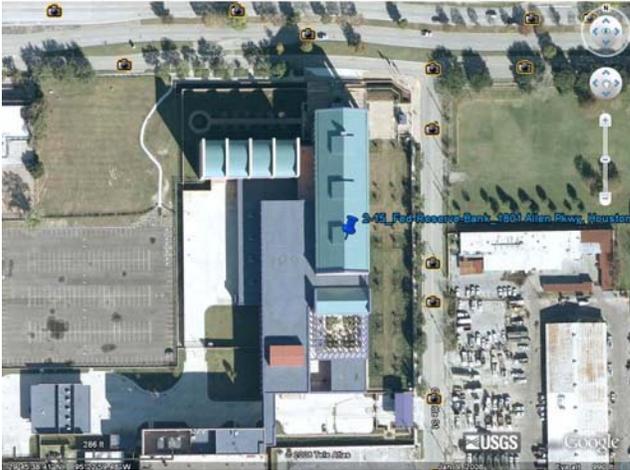
2.21-1. Aerial view of the complex.

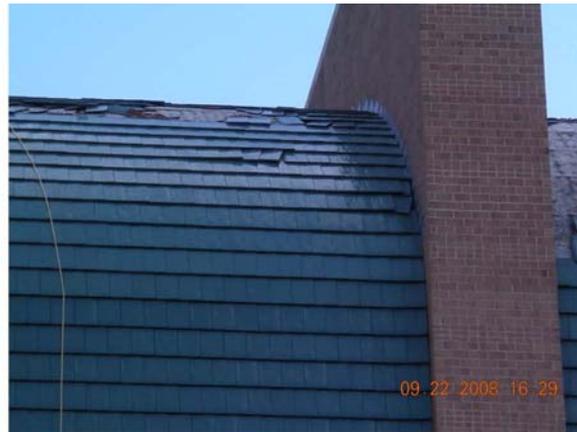
**2.21-8. Another look at damaged tile.**

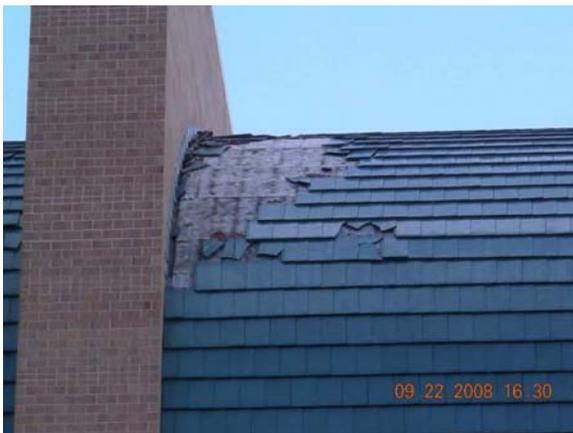
**2.21-9. Tile damage in a western section.**

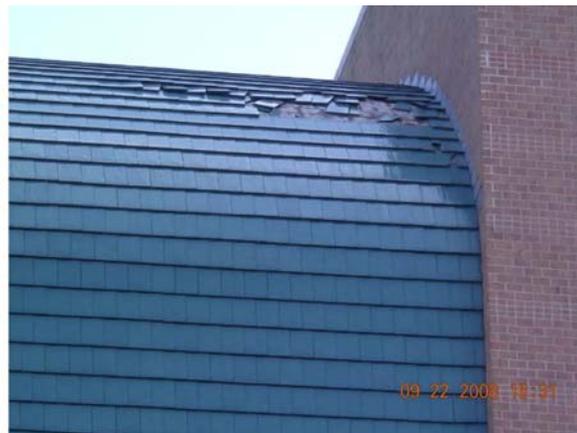
**2.21-10. More displaced tile can be seen near the top of this western section.**

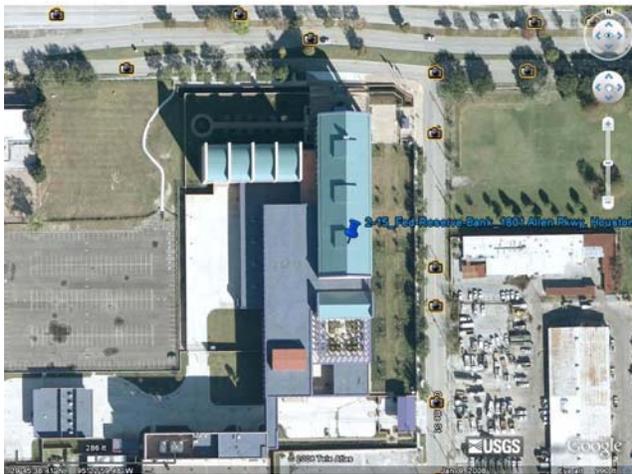
2.22-1. Aerial view of the complex.

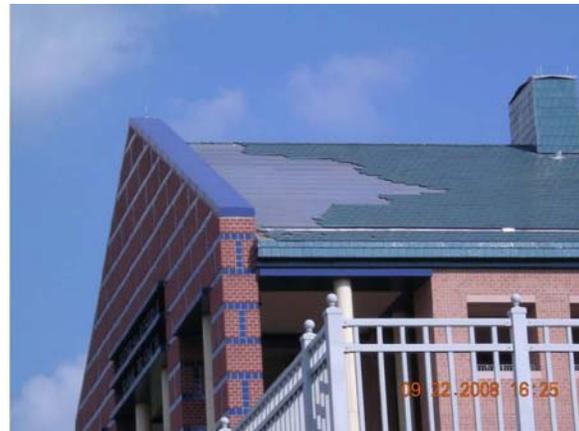
2.22-4. In this closer view, note the proximity of the damaged area to the parapet.

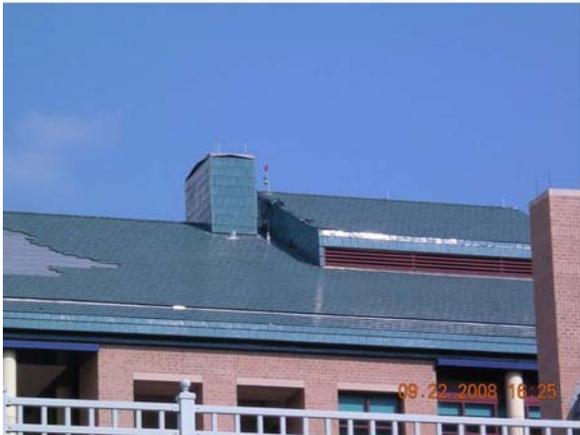
**2.22-5. Damage at the chimney chase cover, rake edge, and headwall confined ridge tile.**

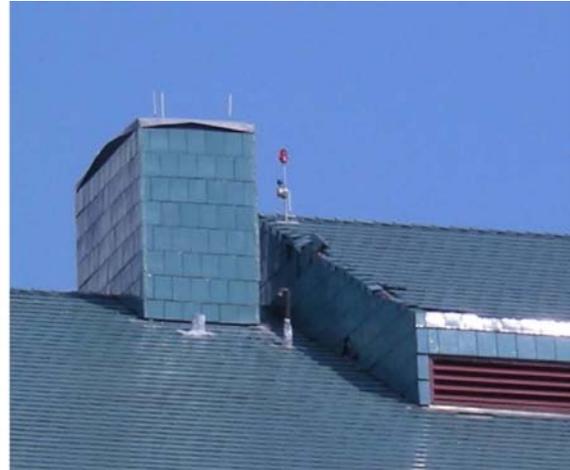
**2.22-6. This is a closer view of damage shown in photo 2.22-5.**

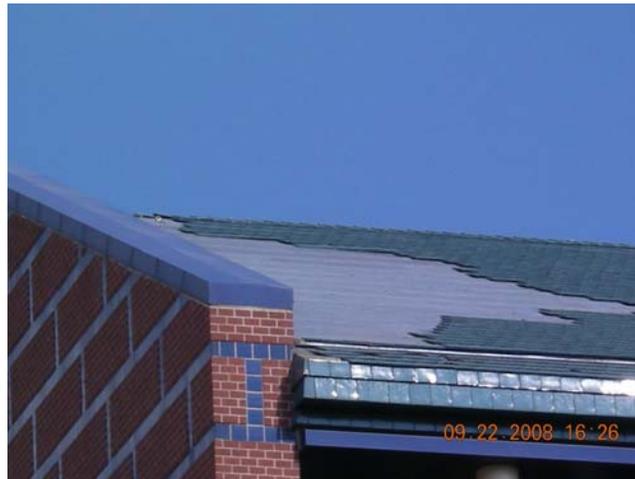
**2.22-7. This close-up of the west elevation, north end, shows displaced tile by the parapet.**

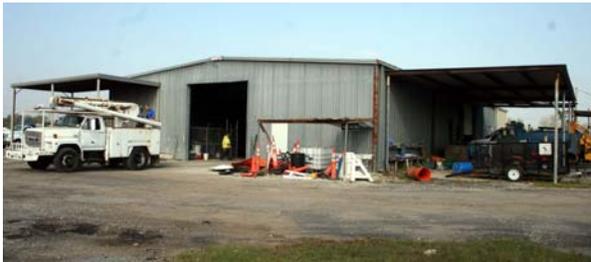
**3.01-1. View of the southern elevation. The large overhead door (center) was blown up and over the top.**

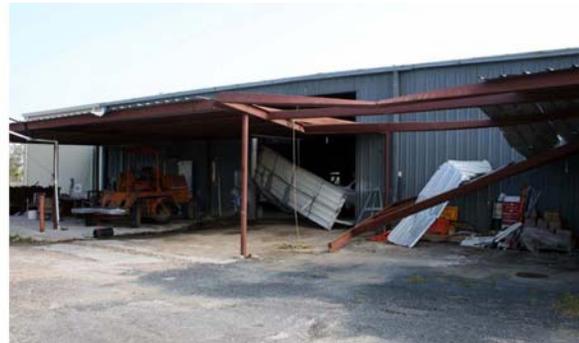
**3.01-6. West side of the building, where overhangs and an overhead door were damaged.**

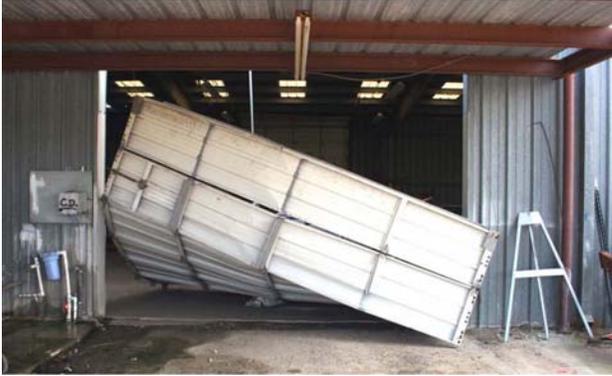
**3.01-7. An overhead door that was blown in on the west side.**

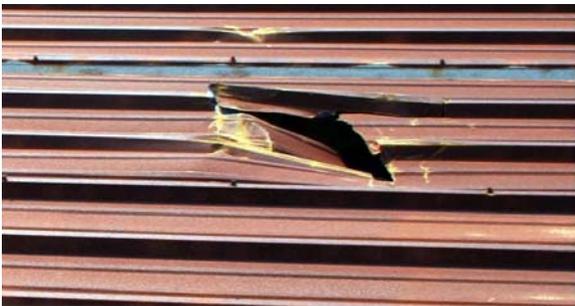
**3.01-9. Damage to the roof caused by an overhang that blew onto, then over the roof.**

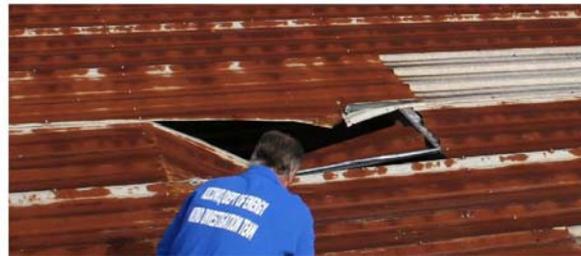
**3.01-10. More surface roof damage is visible here, caused by an overhang blowing across the roof.**

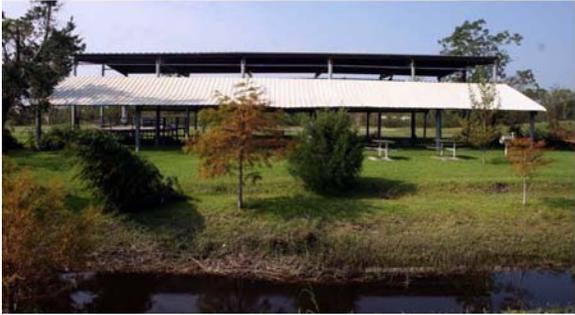
**3.02-1.** East to west view of the pavilion. The damaging winds came mainly from this side.

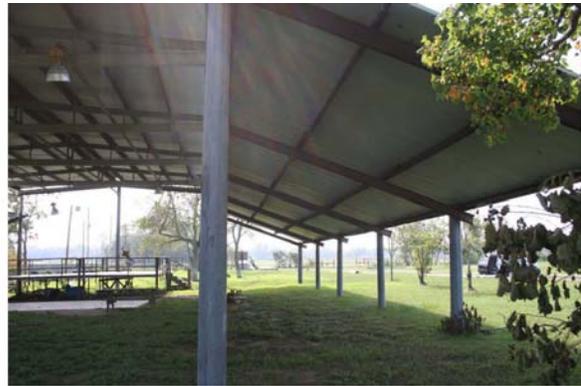
**3.02-4.** Roof damage was limited to this lower section on the east side. Winds approached from the northeast side (far end).

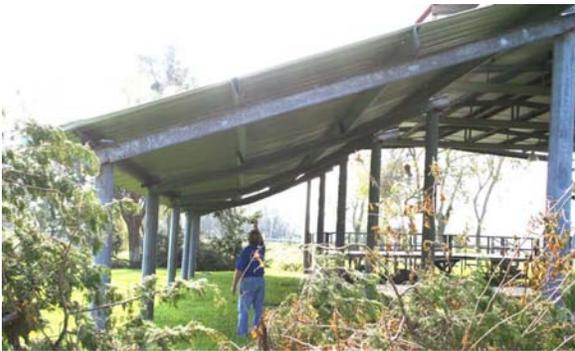
**3.02-5.** North to south view of the east side shows wind-damaged roofing and purlins.

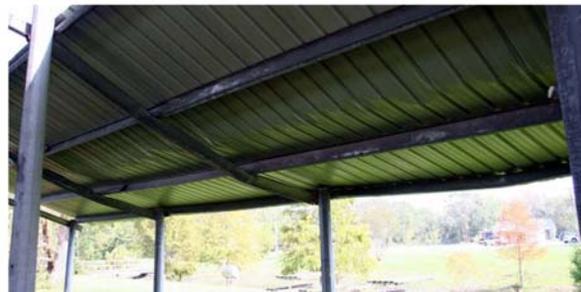
**3.02-6.** Looking eastward from inside the pavilion, deflected panels can be seen along the eave.

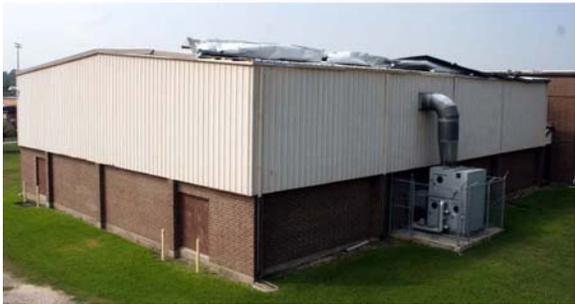
**3.03-1.** At the southeast corner, winds were too strong for the metal edge securement, allowing the roof to peel back.

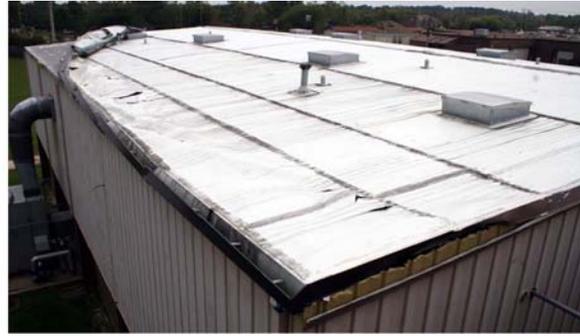
**3.03-4. Once the top, left corner attachment failed, it allowed further failure of the membrane and adjoining fascia.**

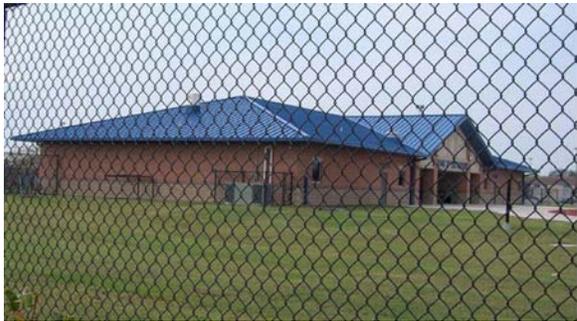
3.04-1. View from south to north.

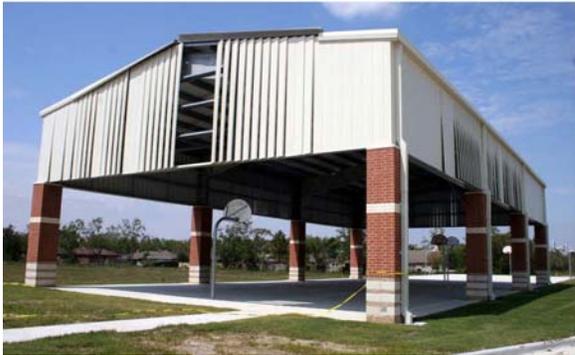
**3.05-1. Structure is an open-air pavilion over a basketball court. Note the missing and dislodged wall roof and wall panels.**

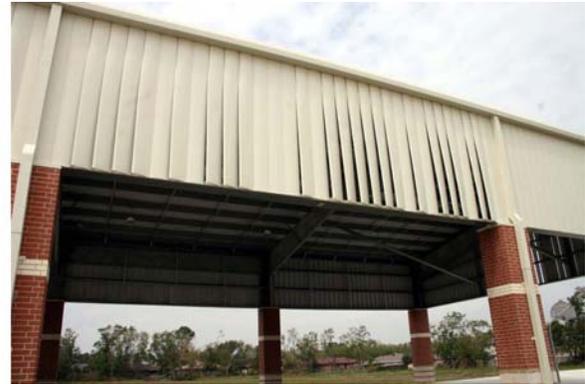
**3.05-2. Winds blew through and beneath the unprotected roof and wall panels.**

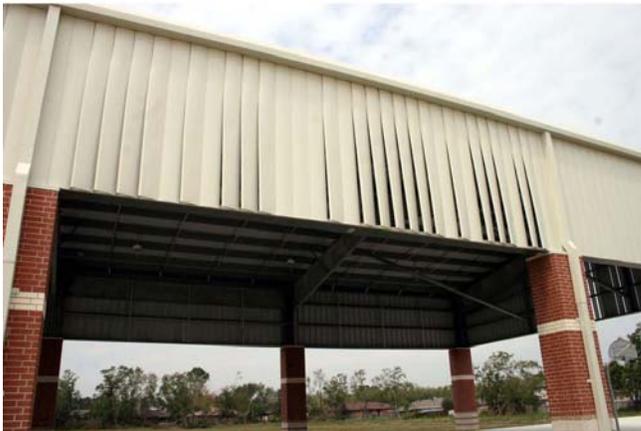
**3.05-3. The only damage occurred to the wall panels, which were not secured as well as the roof panels.**

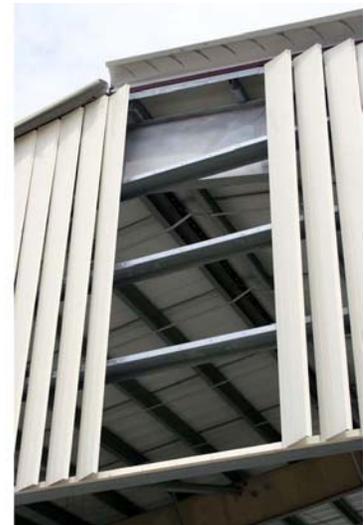
**3.05-4. A closer view of one area of damage shows horizontal purlins (girts) to which the panels were attached.**

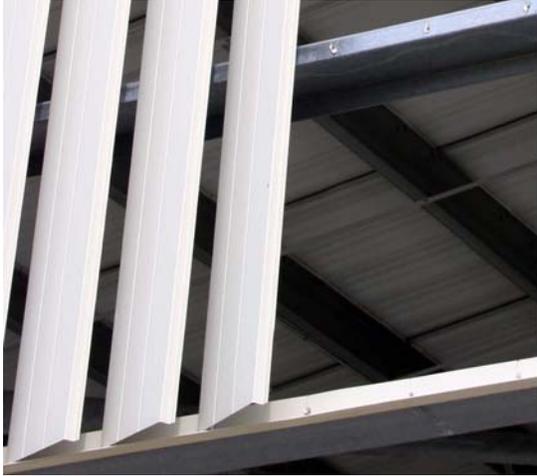
**3.05-5.** Wall panels were clipped to each other, and then secured along their left sides.

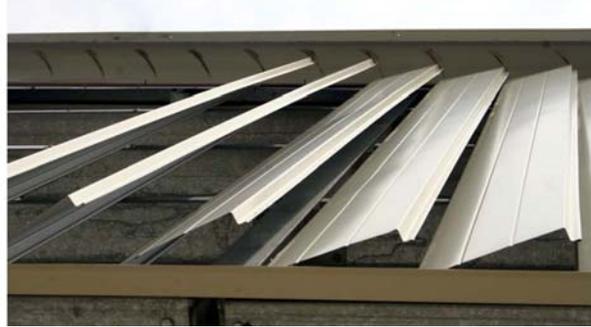
**3.05-6.** As side connections failed, panels hinged outward and, in some cases, were torn off (at the screw attachments) from high winds.

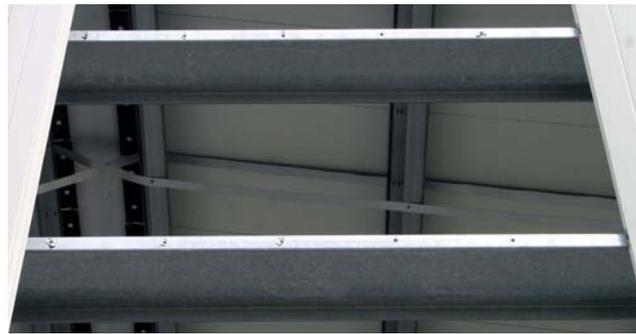
**3.05-7.** A close-up view of secondary support members to which wall panels were attached. Screws and bits of panel metal are still visible.

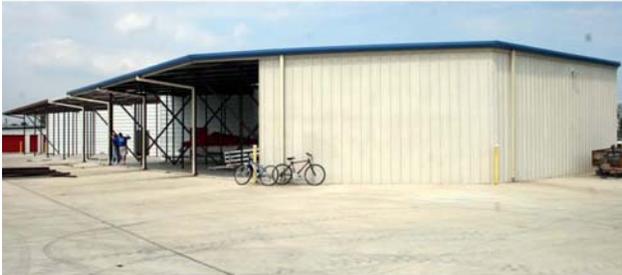
**3.06-1.** These storage units are typical metal structures topped with low slope metal roofs.

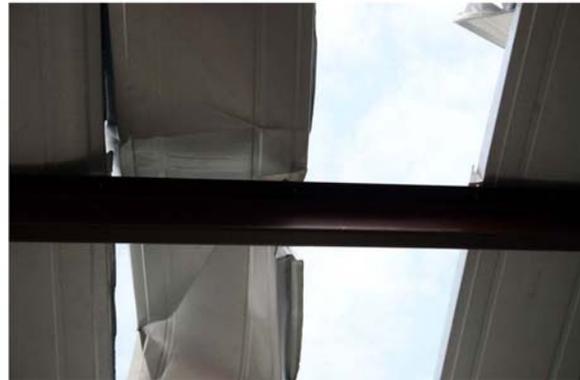
**3.06-4.** Close-up view of metal panels that tore loose from pressurization of the interior.

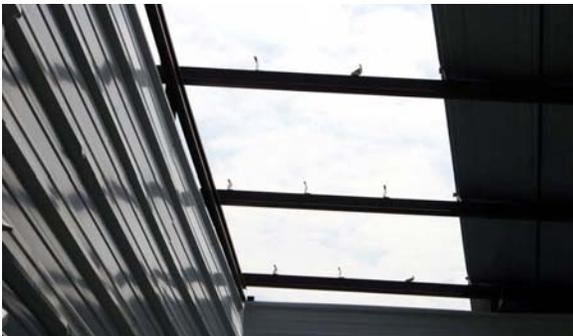
**3.06-5.** Several panels were blown loose in this area.

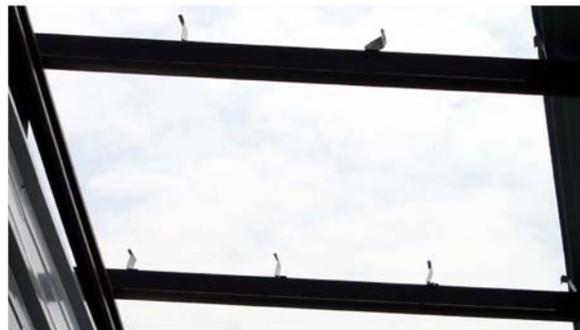
**3.06-6.** A closer view shows clips that remained attached to the purlins.

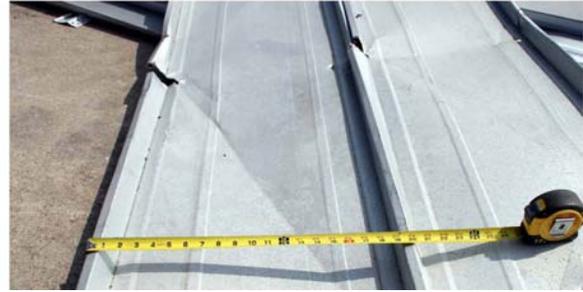
**3.06-8. Close-up of damaged panels.**

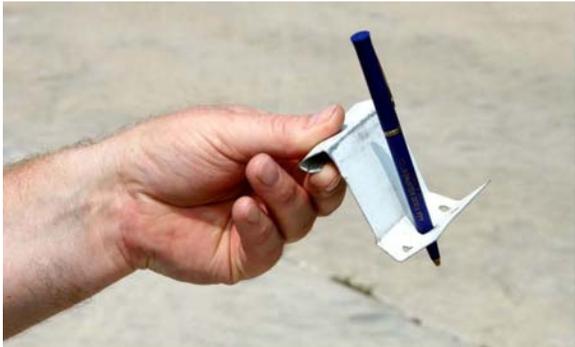
**3.06-9. One of the clips used to attach panels to purlins. Panels were attached with only one screw per clip.**

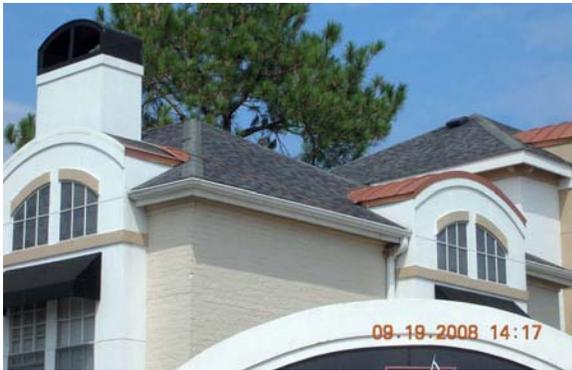
**3.07-1.** These roofs are covered mainly in shingles, but with some standing seam at corners.

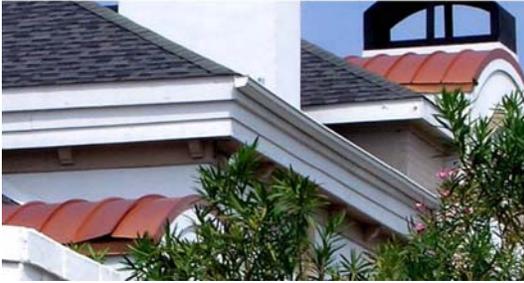
**3.07-3. At lower left, two panels are bowed upward due to inadequate fastening.**

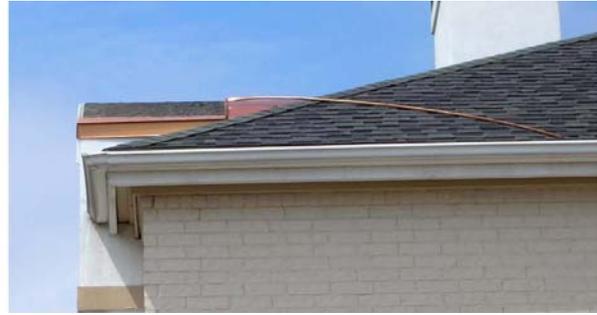
**3.07-4. Photo shows another displaced batten.**

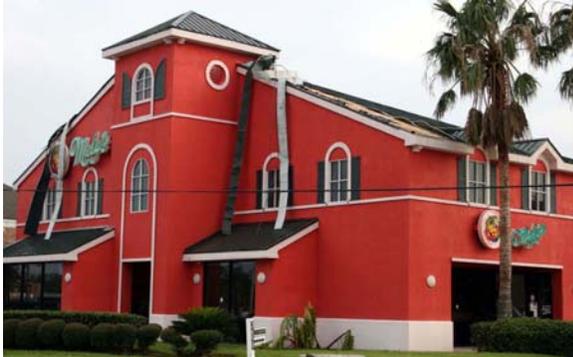
**3.08-1. Long standing seam panels and edge metal disengaged from roof and rake.**

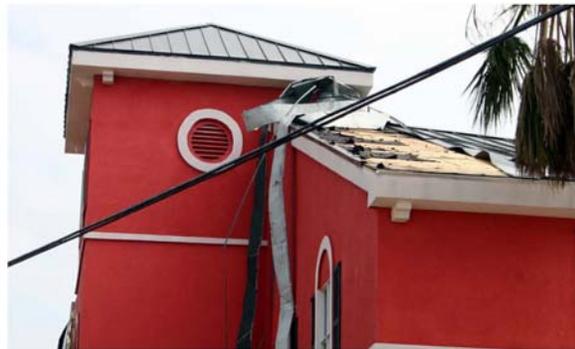
**3.08-2. Exposed wood decking and underlayment are visible here, along with damaged panels.**

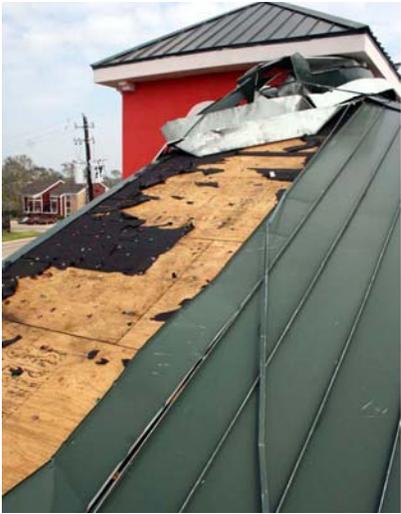
**3.08-3. Some metal panels were blown back onto the roof; others became detached and blew off.**

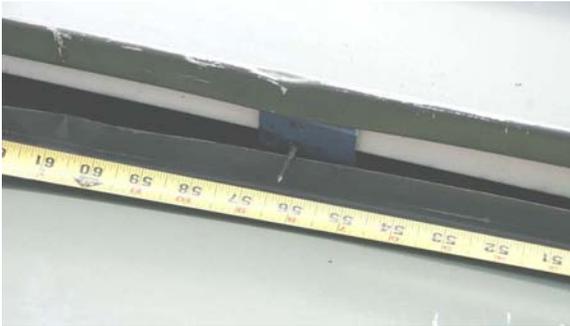
**3.08-5. Fastener spacing was inadequate in most areas; clip shown here has only one fastener.**

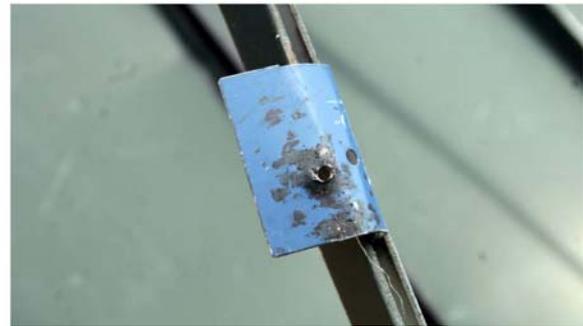
**3.08-6. Clips lifted up allowing panels to disengage because two fasteners were not used on each clip.**

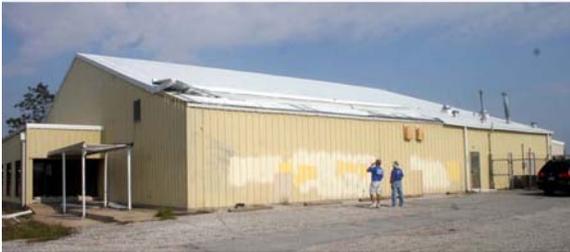
**3.09-1. Northwest to southeast view shows panels that have been blown back onto the field.**

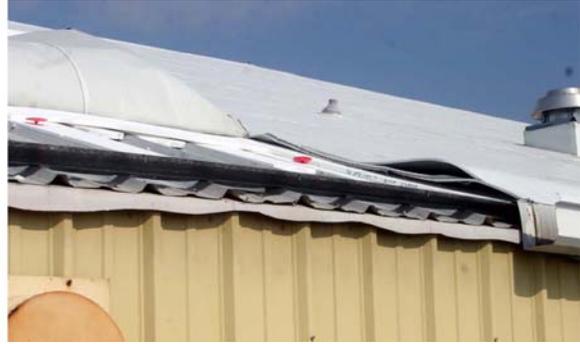
**3.09-4. This is the point along the gutter where damage stopped.**

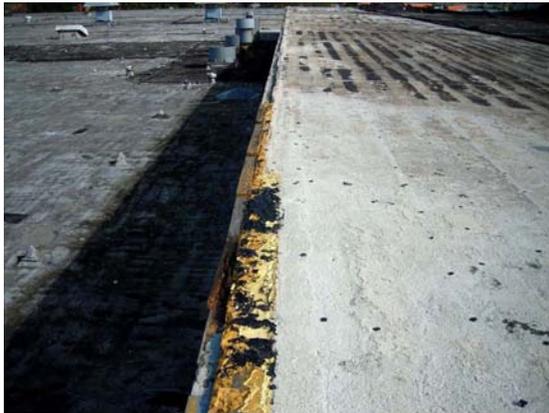
**3.10-1.** Note the rotted edge nailer, foamed-in edge, spacers used instead of blocking, and a nailer secured only to top surface of vertical side wall. Metal edge has 6 in. girth with neither a hemmed edge nor continuous cleat.

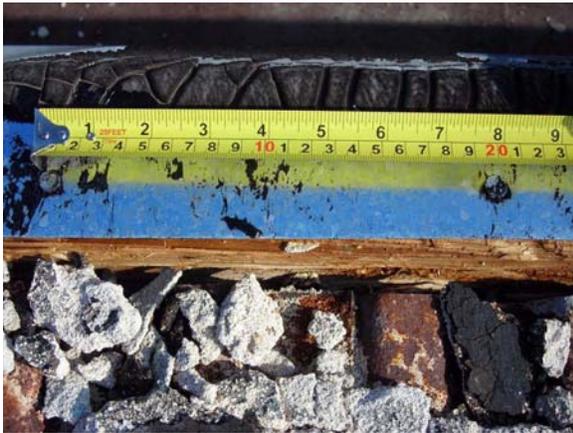
**3.10-5. A close-up of deteriorated metal pan-deck and crumbled LWIC.**

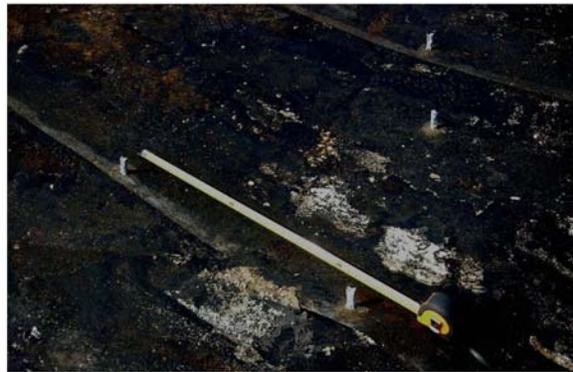
**3.10-6. The base sheet was secured with either two or three fastener rows. Fastener spacing varied from 2 ft to 3 ft o.c. at side laps, and 2 ft o.c. in center rows.**

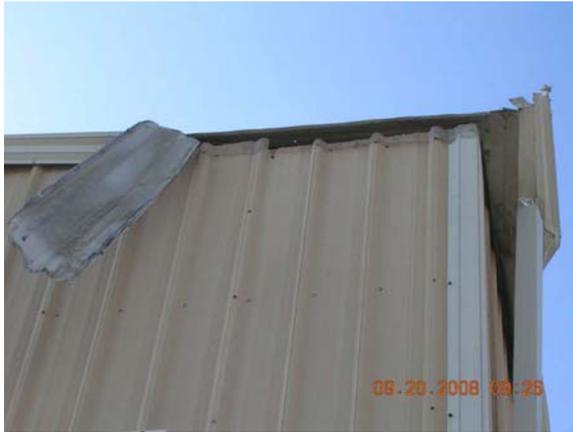
**3.11-1.** Flashing was displaced on both sides of this corner.

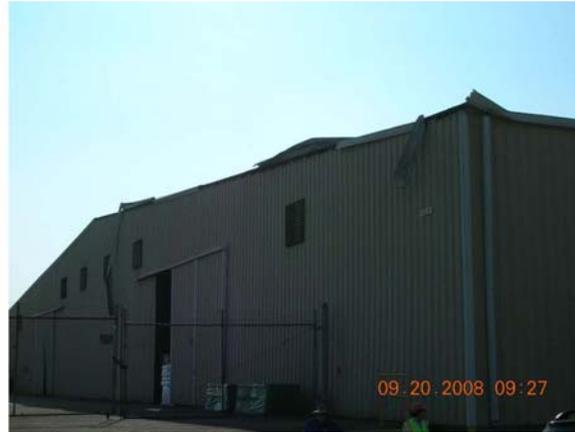
**3.11-2.** Failure of eave and gable flashing can be seen in this photo.

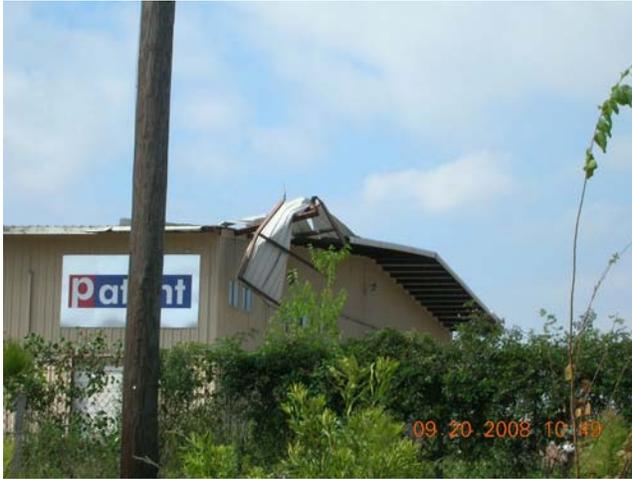
**3.12-1.** Note that some sub-purlins remained attached to panels.

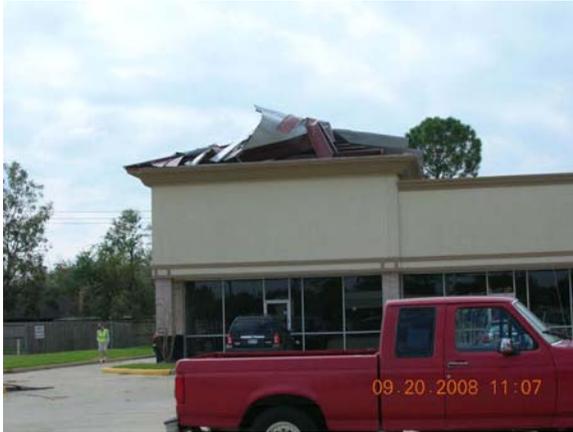
**3.13-1. Overview of damage.**

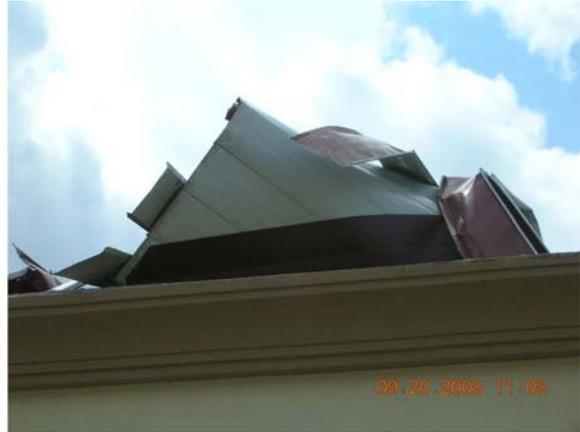
**3.13-2. Peel-back of metal roof panels is visible here.**

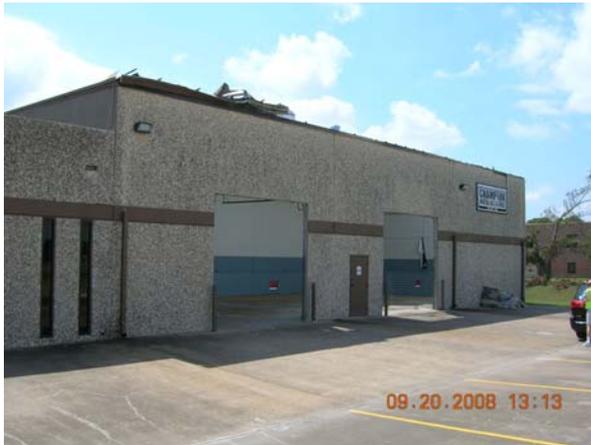
**3.14-1. This building was pressurized following overhead door failure.**

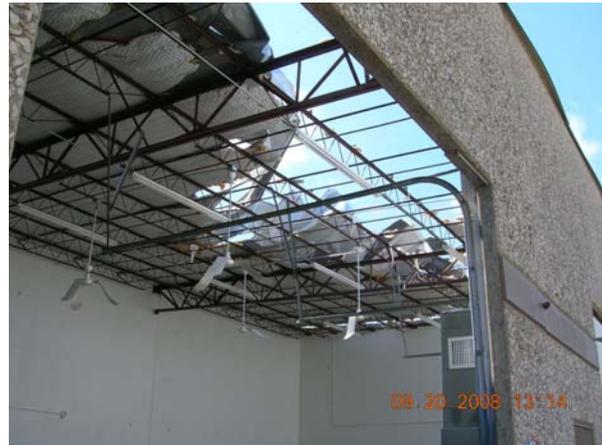
**3.14-2. Panel peel-back at eaves and panel displacement in main field.**

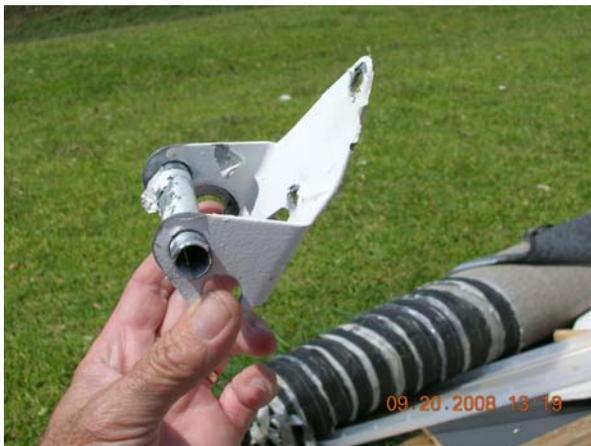
**3.14-3. Door hardware failure may have led to blow-in of the overhead door and subsequent building pressurization.**

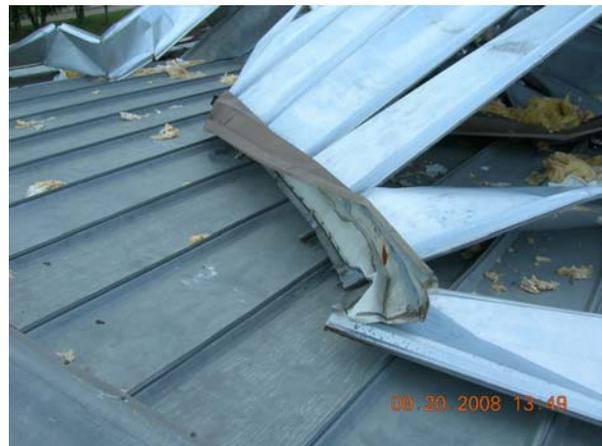
**3.14-4. Peel back of the eave/gutter connection is shown here.**

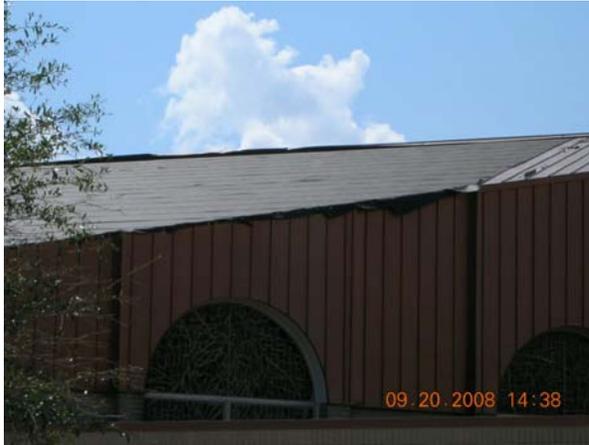
**3.15-1. Overview of roof failure at perimeter and greater field zones.**

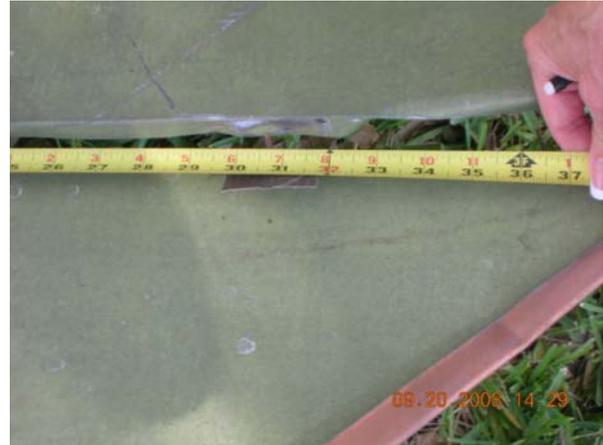
**3.15-2. Clip spacing in many areas was noted to be greater than 30 in. o.c.**

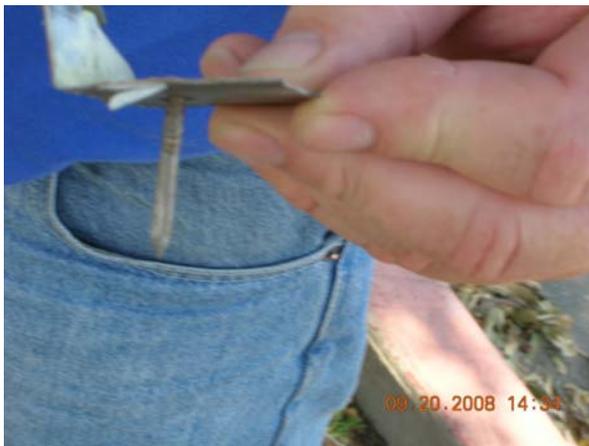
**3.15-3. Clip and inadequate nail fastening noted.**

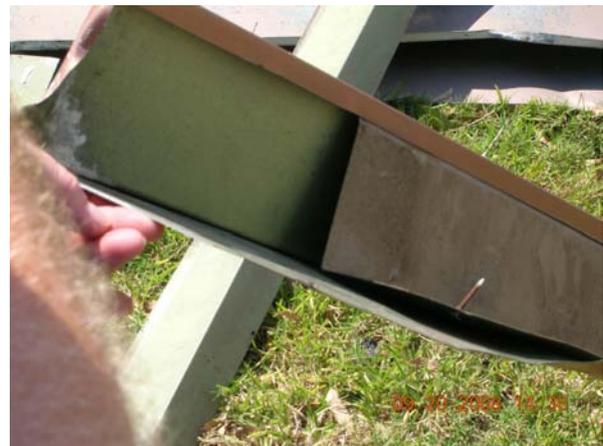
**3.15-4. Eave and cleat connection failure is visible here. Note the fastener pull-out at cleat.**

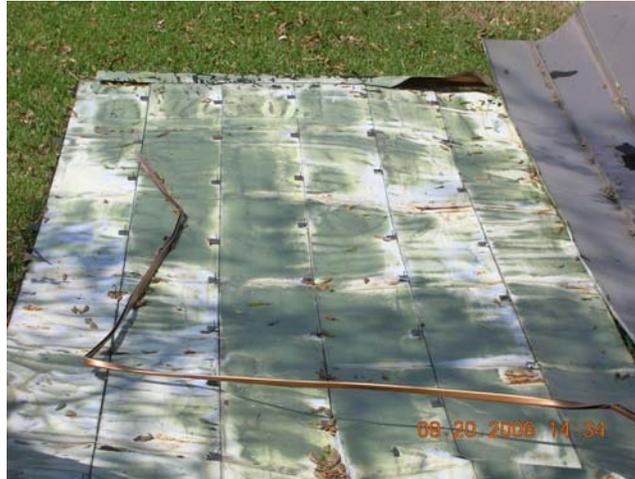
**3.15-5. Note evidence of prolonged moisture infiltration within the roof assembly. This was the wrong type and length of panel for this roof pitch.**

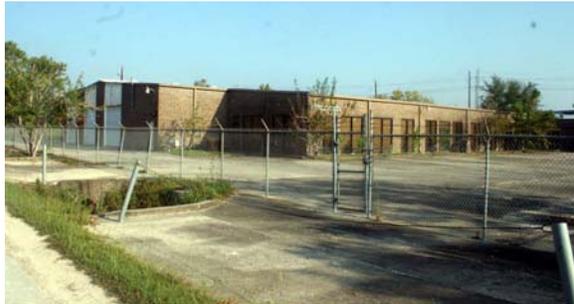
**3.16-1.** View of the building from east to west. Roof damage occurred on the opposite side.

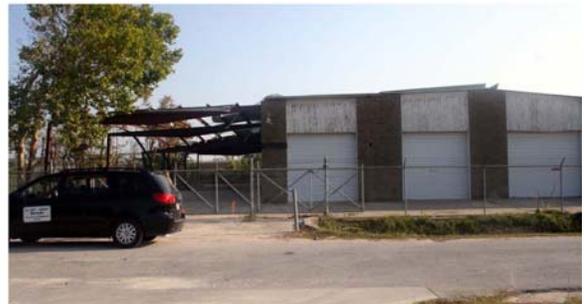
**Roof 3.16-2.** South to north view shows damage along the overhang on the west side.

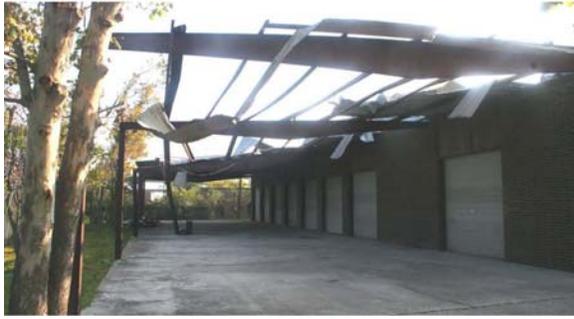
**3.16-3. Metal roof panels are missing along most of the overhang.**

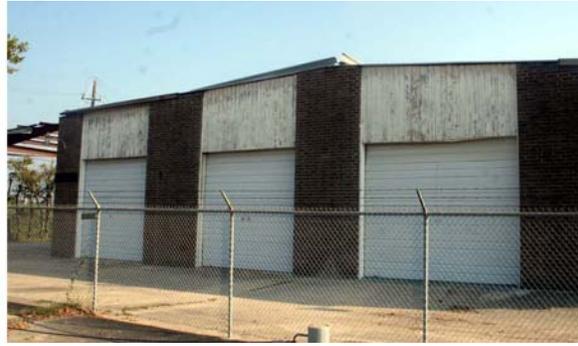
**3.16-4. Some damage occurred along the metal edge on the south side.**

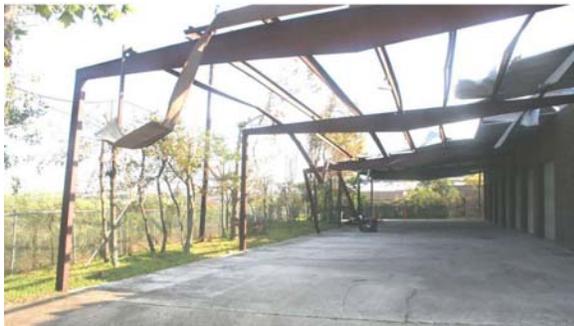
**3.16-5. Winds circling around from the northwest pressurized the area below the overhang, causing panel blow-off.**

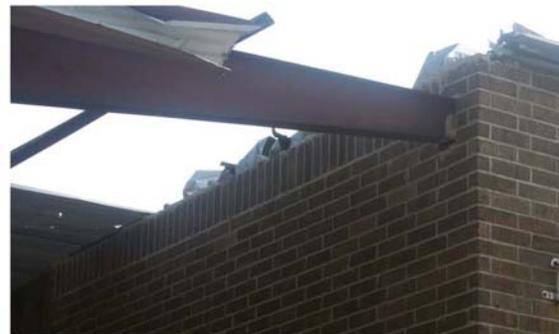
**3.16-8. The blow-off damage was limited to mainly the overhang, due to better securement at the top of the wall.**

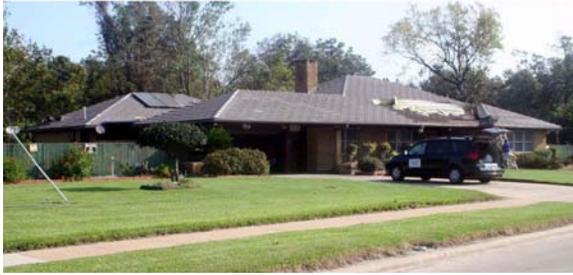
**3.17-1.** The two damaged areas-far left and far right-are visible in this southwest to northeast photo.

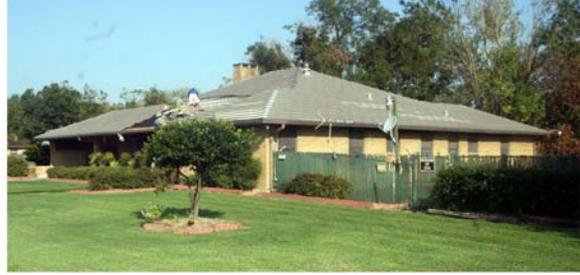
**3.17-2.** View is southeast to northwest. The east side was undamaged.

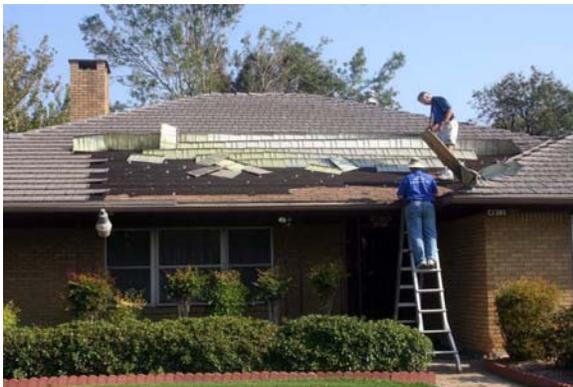
**3.17-3.** The bulk of the damage occurred over the entrance.

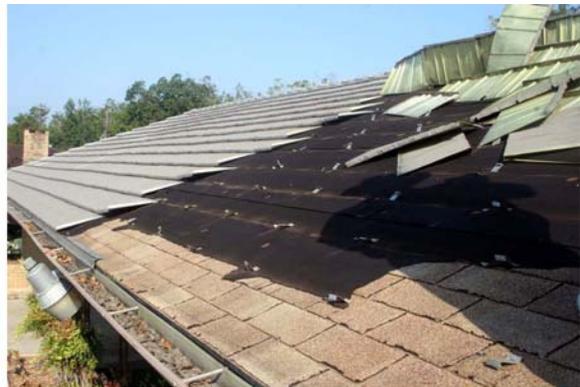
**3.17-4.** Aluminum shingle system installed over asphalt shingles.

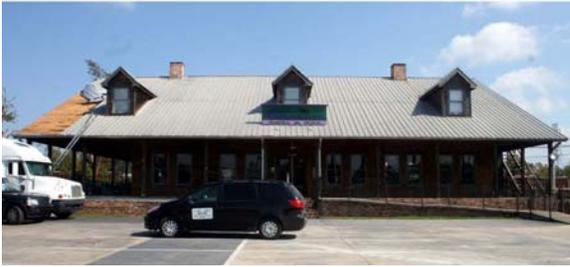
**3.18-1. Front view of the restaurant. Damage occurred along the left edge.**

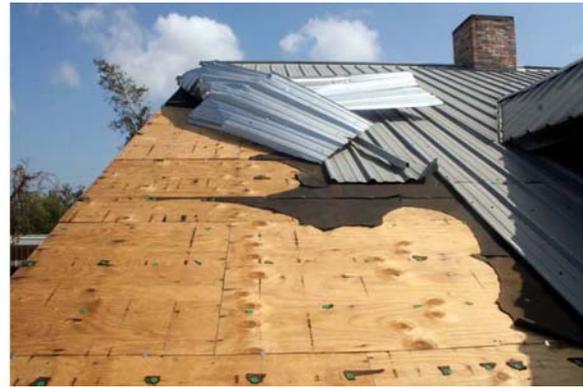
**3.18-2. A closer view of the left edge. Standing seam metal panels blew back from the edge due to storm winds.**

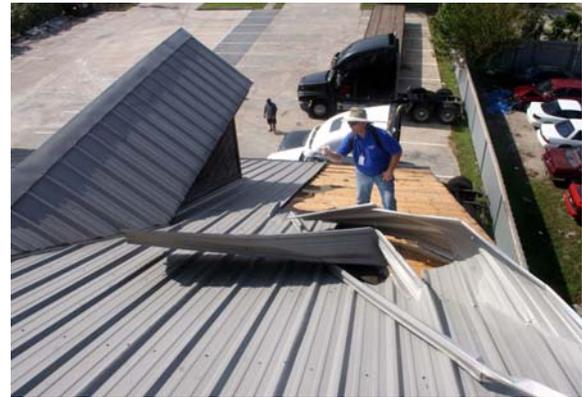
**3.18-4. View from above at roof damage along the rake.**

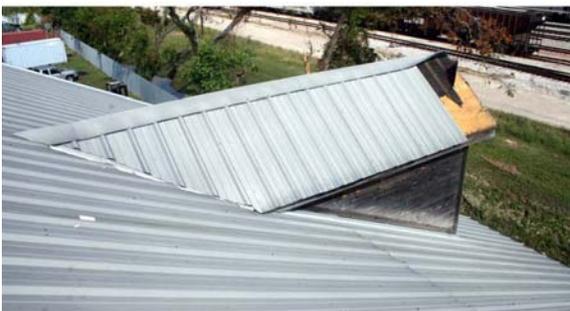
**3.18-5. The only other noted damage was to this dormer on the left rear.**

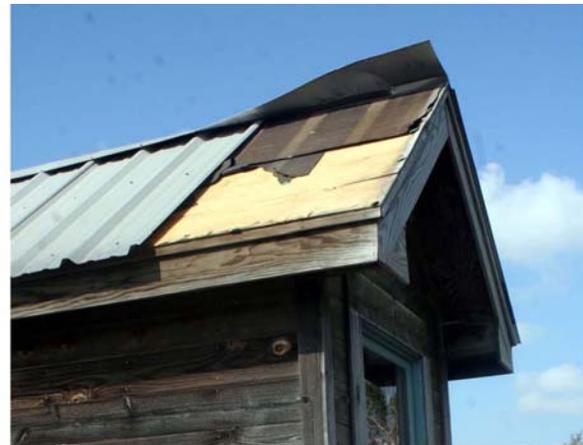
**3.18-6. A closer look at the damaged dormer shows that rake edge metal and panels are missing.**

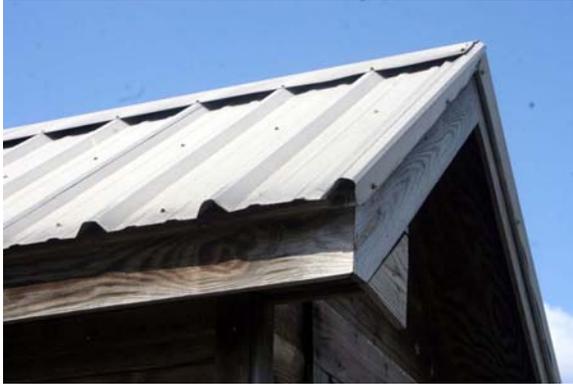
**3.18-7.** This is one of the undamaged dormers. The rake metal has only two screws securing it.

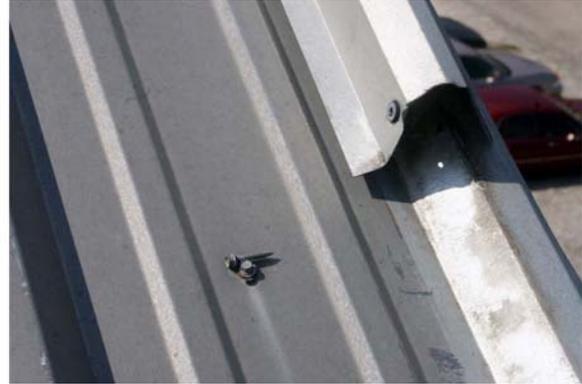
**3.18-8.** Damaged rake edge metal on the main roof.

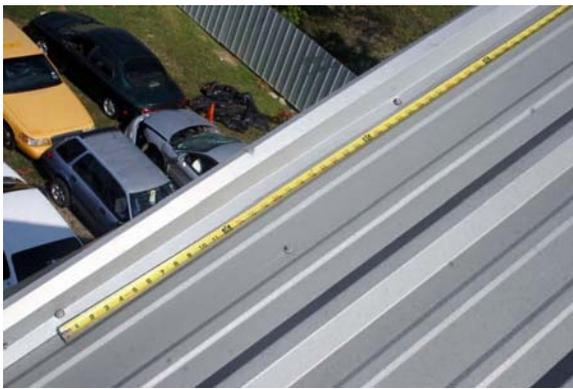
**3.18-9.** Fastener spacing along the rake edge is inadequate e.g., 28 in. o.c.

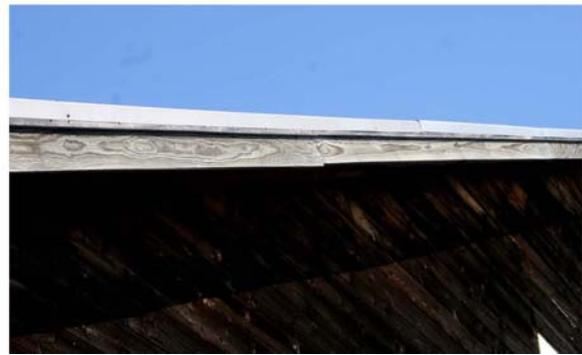
**3.18-10.** Along this exterior rake edge, only one screw is visible in about 9 linear ft of metal.

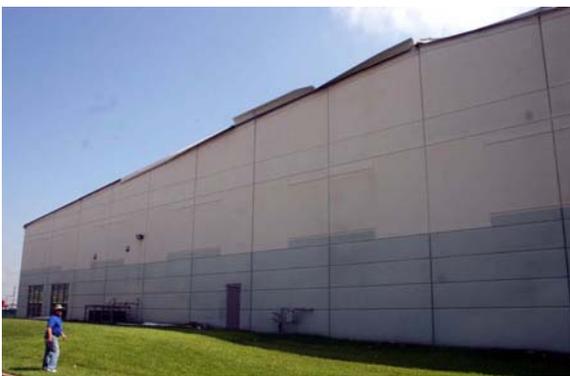
**3.19-1.** Storm winds damaged most of the metal edge of this roof, as well as some roof panels.

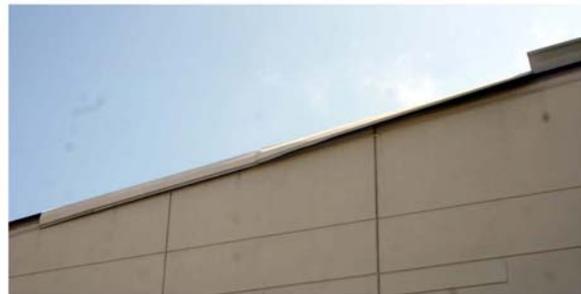
**3.19-2.** This is a closer look at some of the damaged edge system.

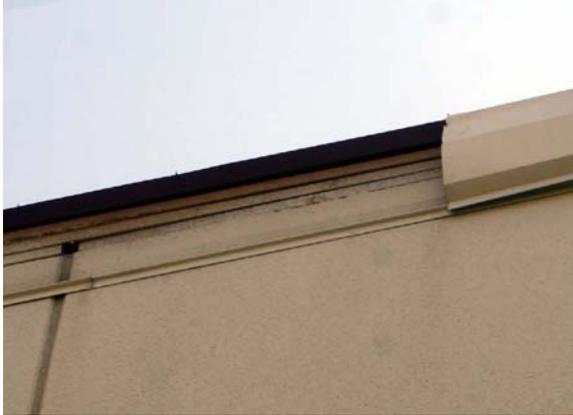
**3.19-3. A cleat approximately 24 in. below the edge provided the means of edge attachment. The fascia relied mainly on spring compression to stay attached.**

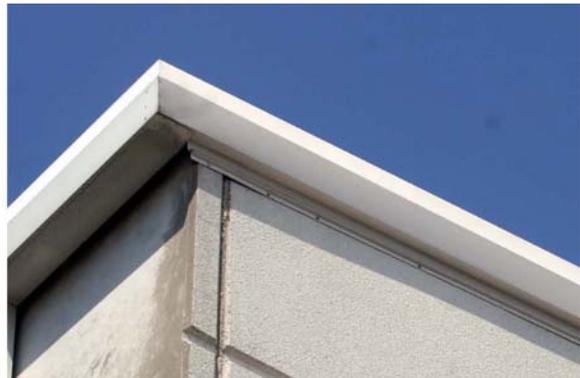
**3.19-8. View of another corner of the same building, with no damage.**

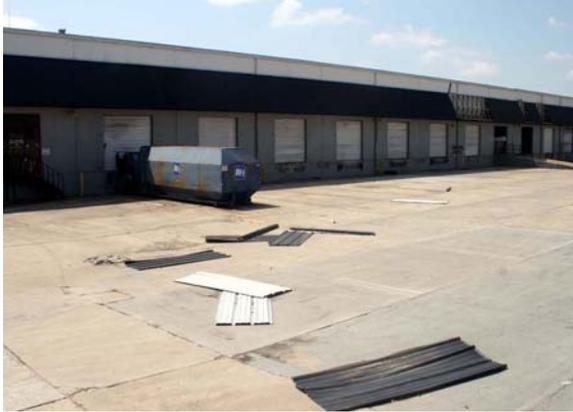
**3.20-1.** Wind-displaced mansard panels are strewn across the parking lot near the damaged mansards.

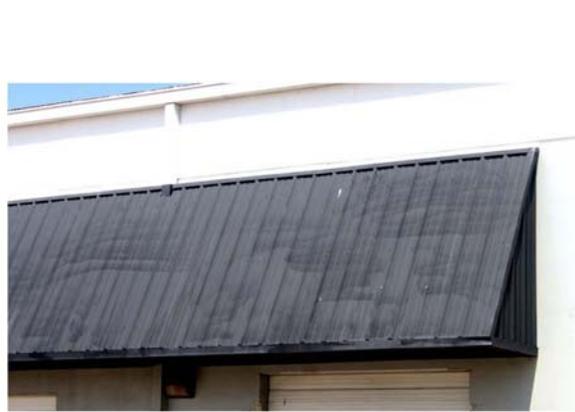
**3.20-2.** Across the parking lot, this is an undamaged mansard similar to those that lost panels.

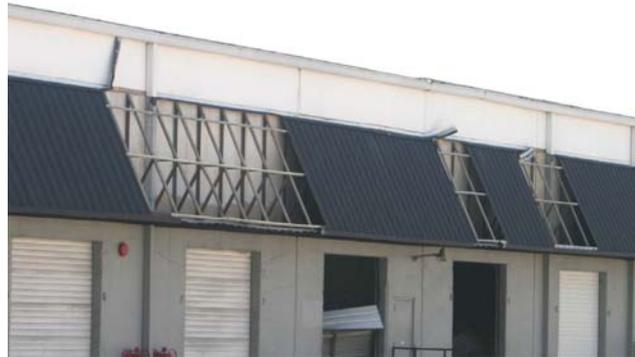
**3.20-3.** A closer view of the damaged mansards.

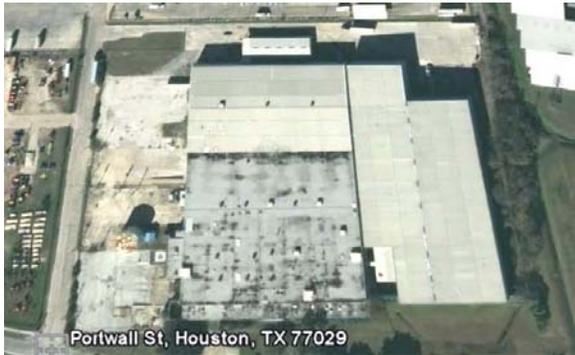
**3.21-1.** These roofs are formed of three adjoining levels and the inspection focused on areas at the northeast (upper right) corner.

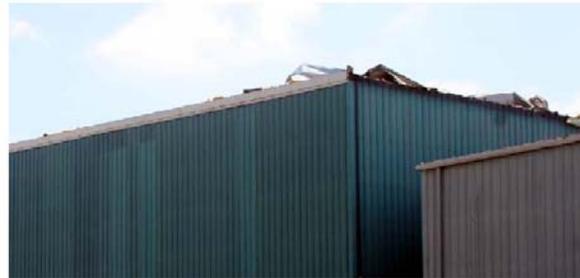
**3.21-2.** Extensive damage to the low slope metal roofing can be seen at the northwest corner.
