# RICOWI, Inc.

Roofing Industry Committee on Weather Issues, Inc.

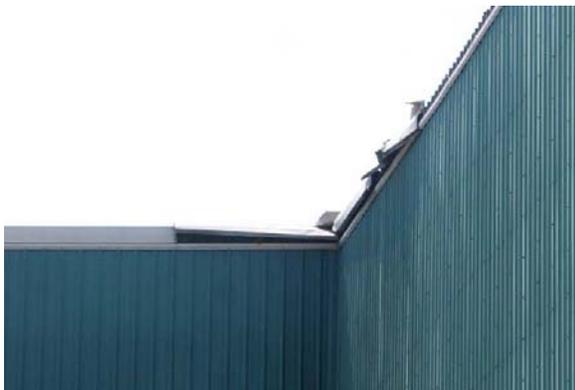
**3.21-3.** East-facing side of the same roof section. Note edge damage.

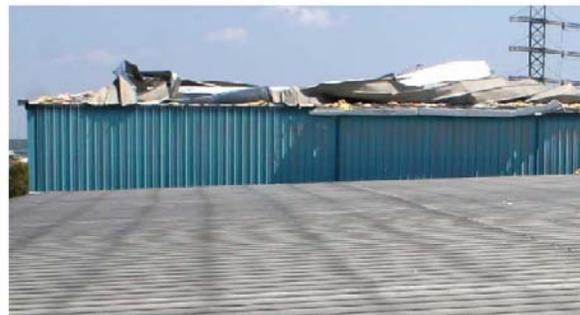
**3.21-4.** West-facing side had the largest amount of damaged roofing still in place.

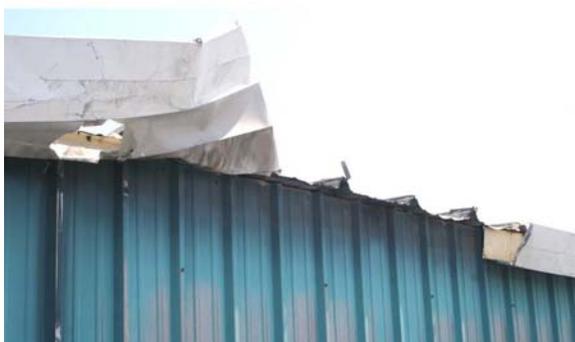
**3.21-5.** Internal pressure and metal edge failure resulted in much of the upper roof blowing off.

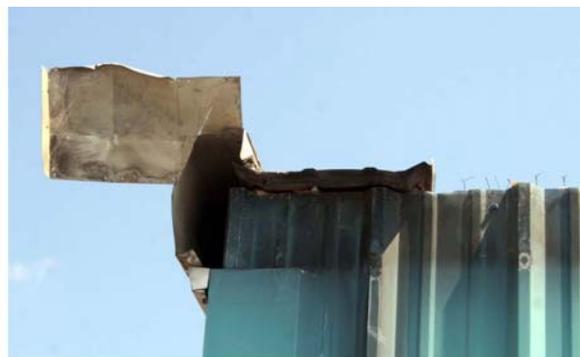
**3.21-6.** A close-up of the remnants of metal edge after roof panels blew off.

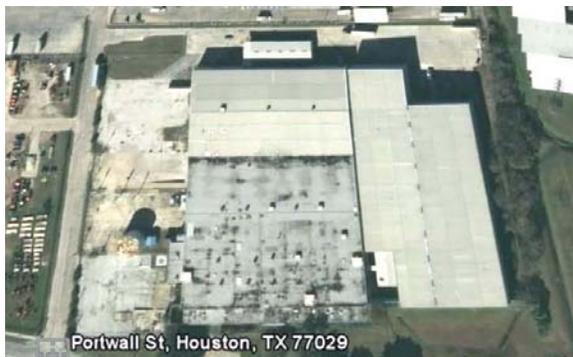
**3.22-1. The upper left roof section of this large building is the focus of this investigation.**

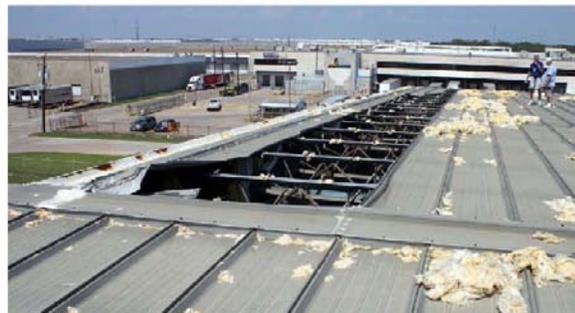
**3.22-2. A long strip of this deck system was blown off, and edge metal was also damaged.**

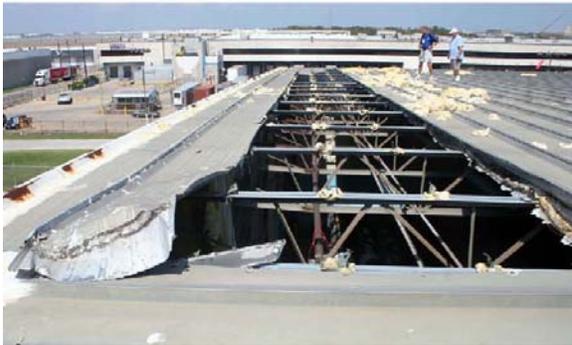
**3.22-3. Roof panels were displaced from the clip attachment to purlins.**

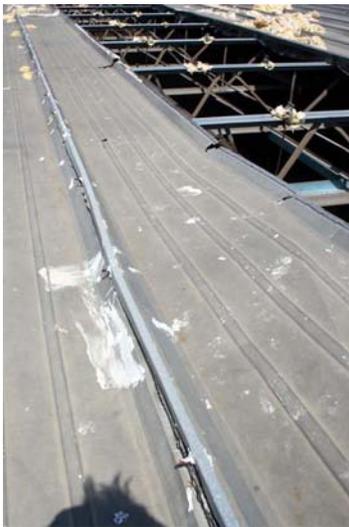
**3.22-5. Previous problems with panel attachment were noted in the damage area.**

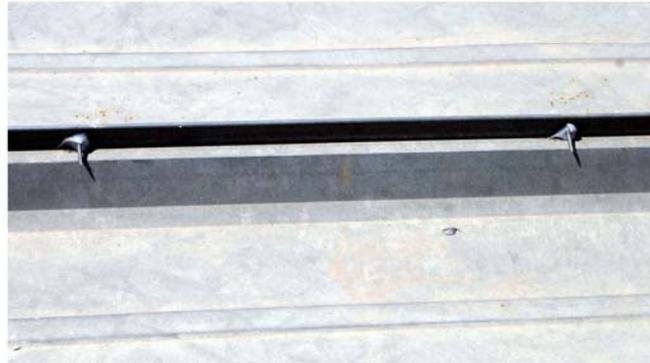
**3.22-6. Note the screws through ribs, used in some places to remedy previous attachment problems.**

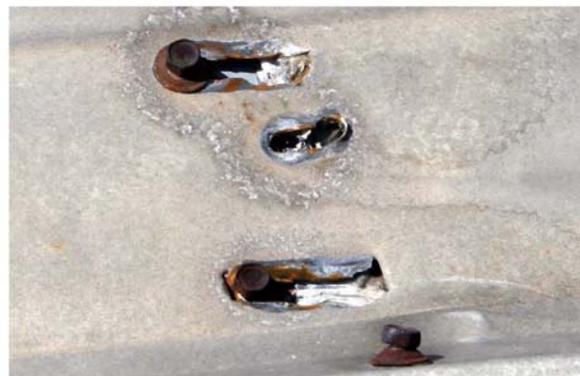
**3.22-8. A closer look at the same attachment point shows severe elongation of screw holes, caused by storm wind forces.**

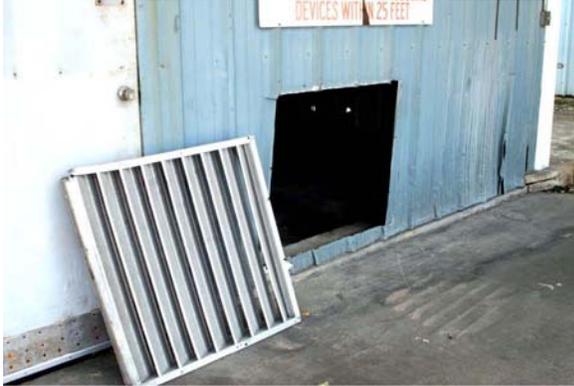
**3.22-9. This wall opening is one point where storm winds infiltrated the building.**

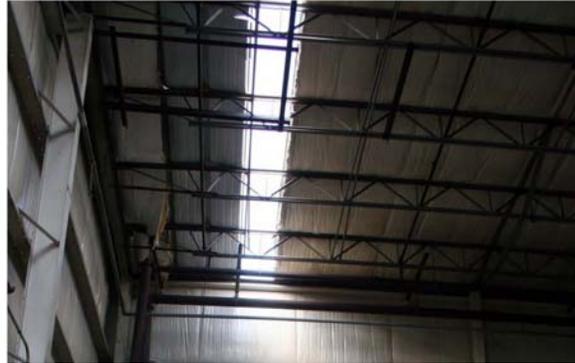
**3.22-10. A view from inside, showing holes left where panels were blown off.**

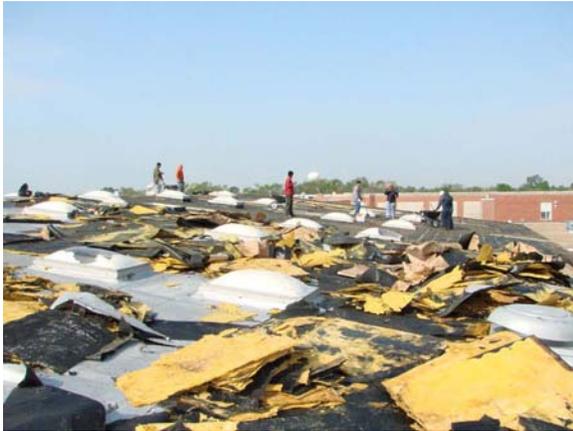
**4.01-1.** Photo shows the dislodged gymnasium roof.

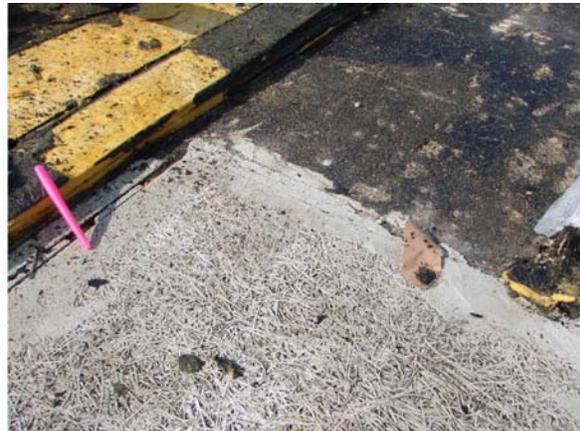
**4.01-4.** A close-up view of the damaged BUR with nailer at upper left (two layers of 1 in. thick fiberglass).

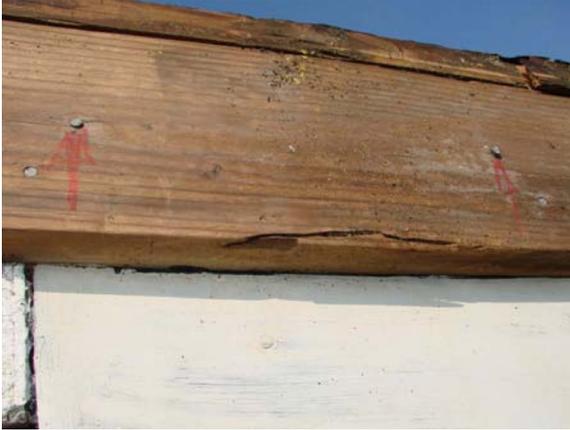
4.01-5. Edge nailer with cleat nails spaced 16 in. o.c.

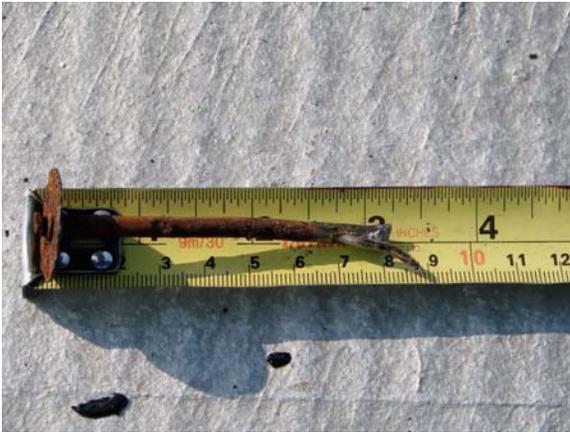
4.01-7. A rusted fastener.

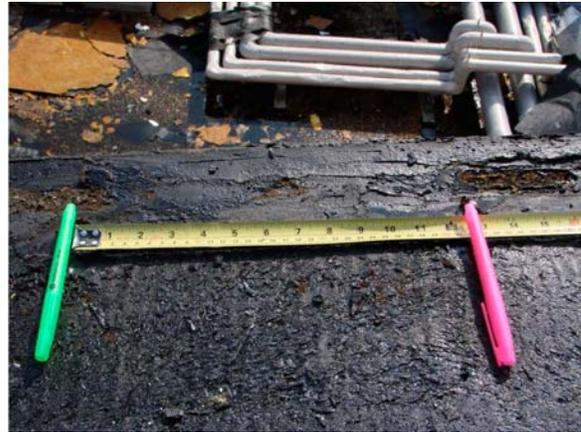
4.01-8. Base sheet fasteners 28 in. o.c. in rows spaced 12 in. apart.

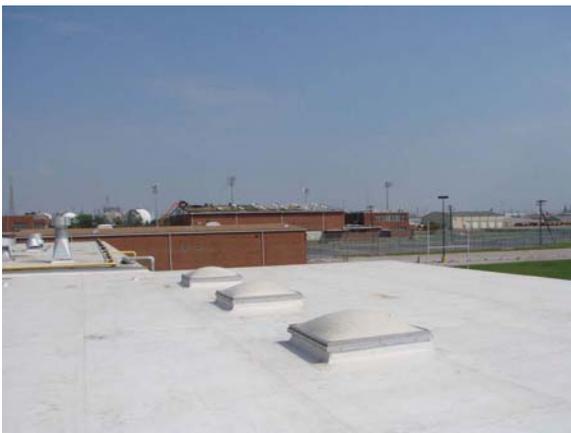
**4.02-1. Hot-mopped fleece-backed PVC membrane.**

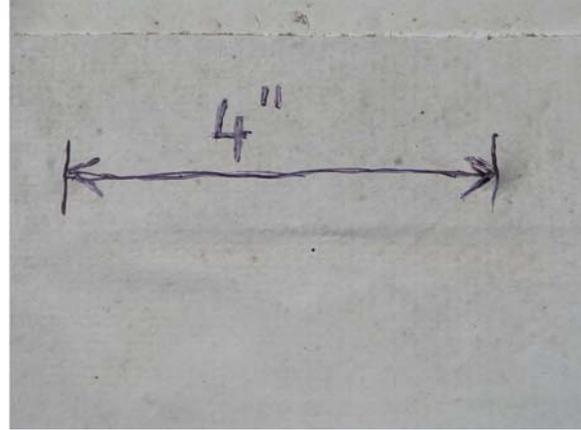
**4.02-4. Edge metal was fastened 4 in. o.c. Such tight spacing may be why no damage occurred.**

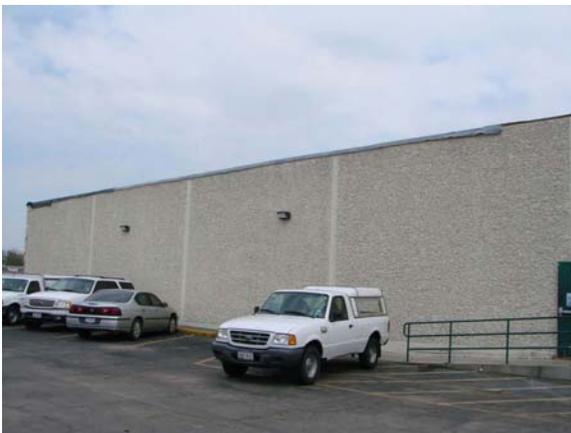
**4.03-1. The edge of a temporary roof.**

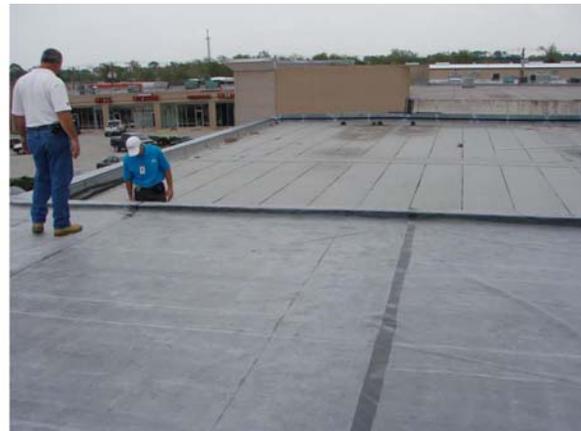
**4.03-6. The failed roof is in the foreground; undamaged areas are in the background.**

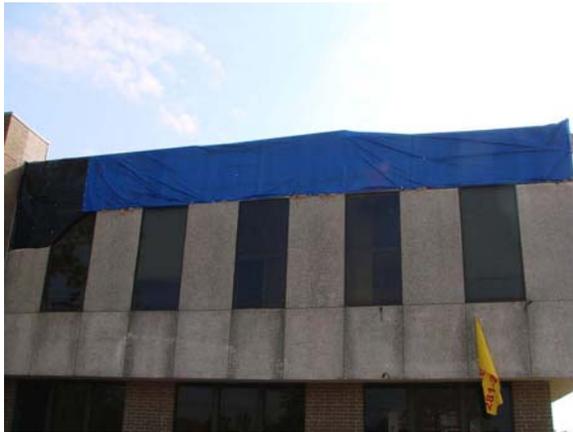
**4.04-1. Front facade failure was covered with blue tarps.**

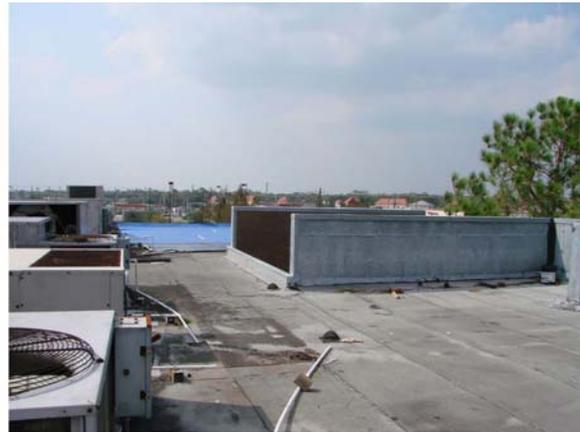
**4.04-2. Overview of the roof with the failed roof in back - a 2-ply BUR.**

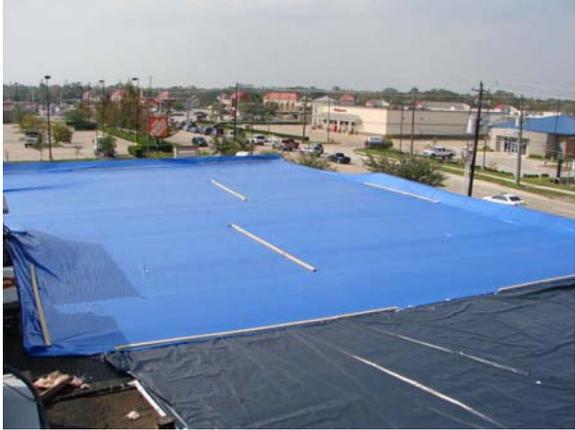
**4.04-3. Protective tarps were used to temporarily cover damaged roofing.**

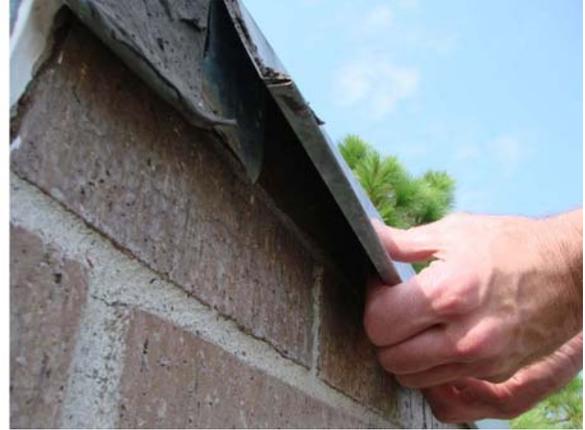
**4.04-4. No cleat was used for perimeter attachment.**

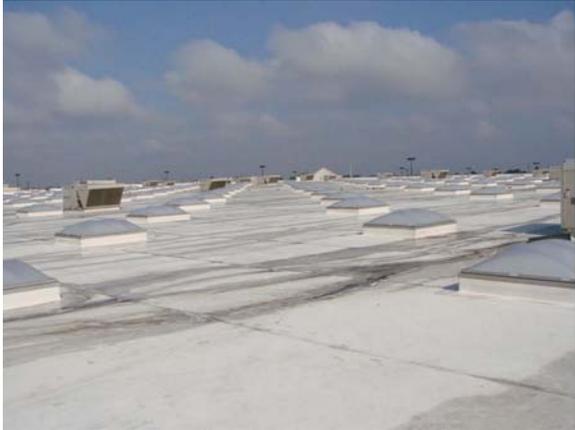
**4.05-1. Mechanically attached TPO system over insulation over steel deck.**

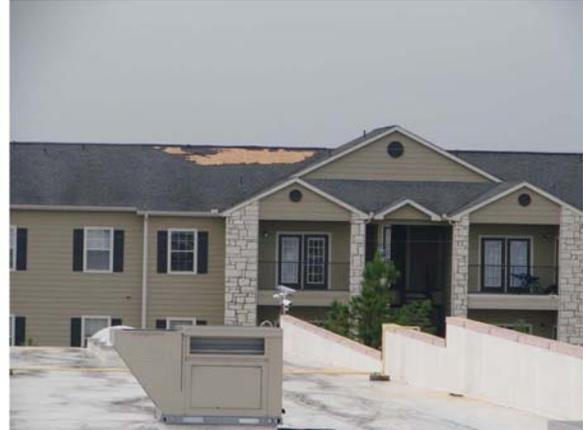
**4.05-2. Wind damage on adjacent property.**

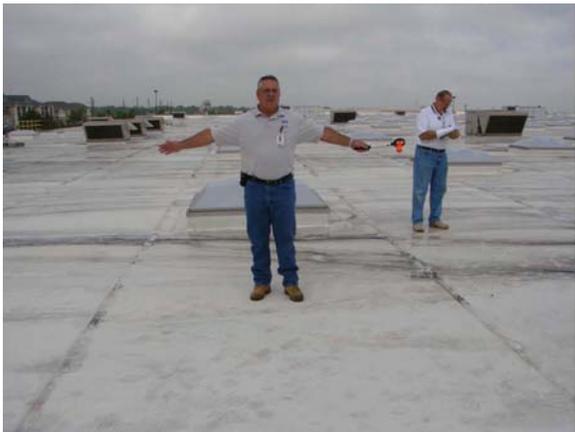
**4.05-3. The 10 ft wide TPO sheets were fastened 12 in. o.c.**

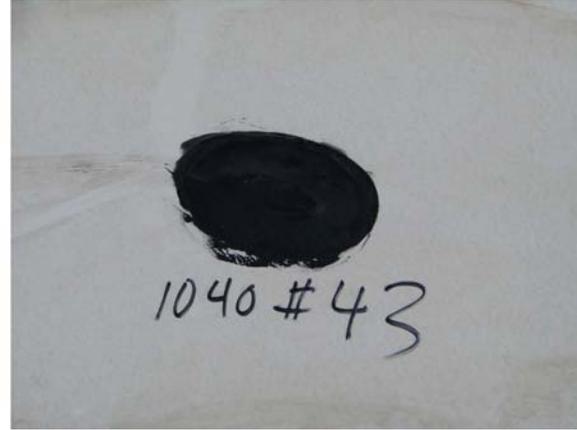
**4.05-6. A temporary repair to the punctured membrane.**

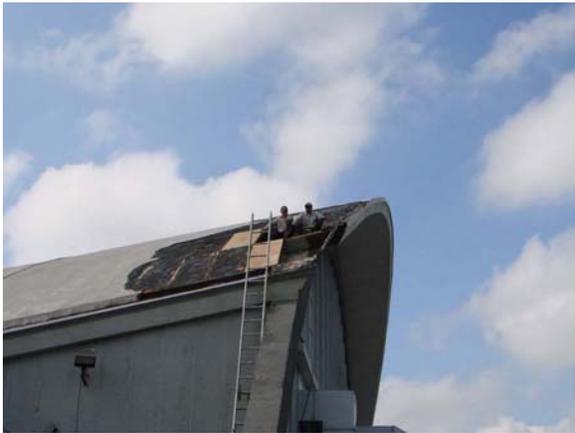
**4.06-1.** This corner was the starting point for roof damage.

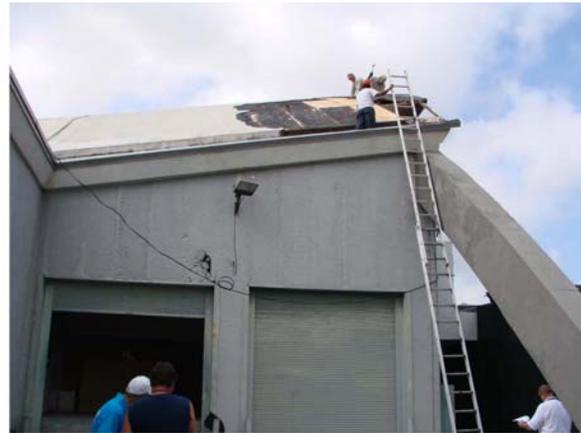
**4.06-2.** Note damaged roofing above eave.

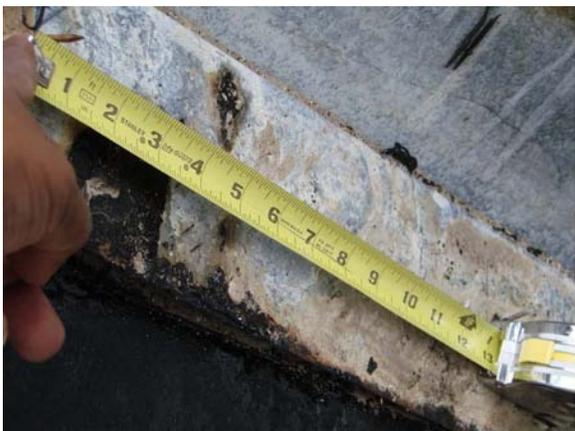
**4.06-3.** This 24 gauge edge metal was attached with nails at 12 in. o.c.

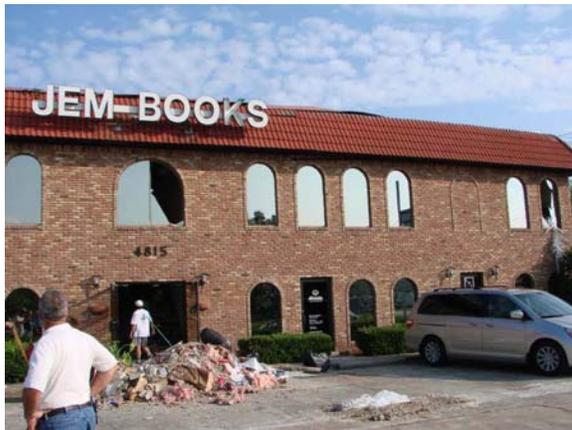
**4.07-1. External damage.**

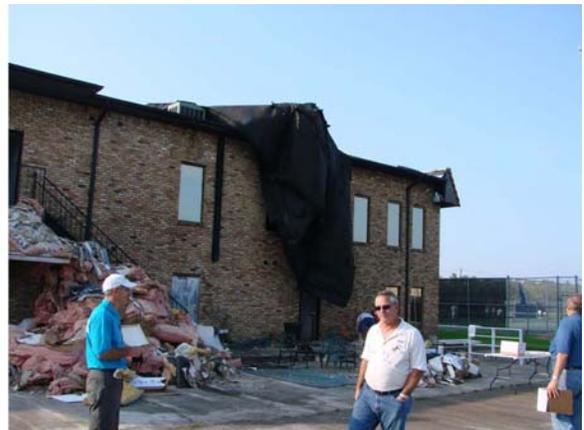
**4.07-2. Complete roof blow-off occurred at the rear of the building.**

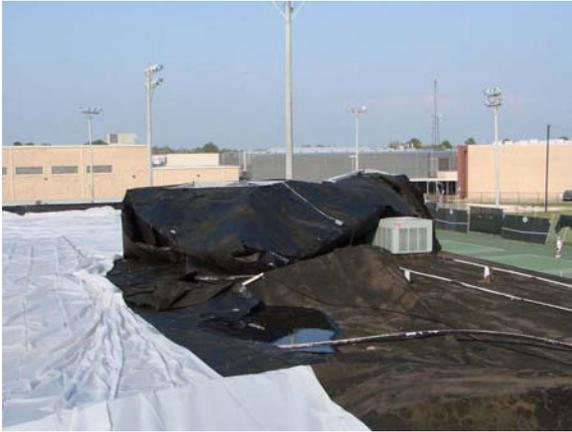
**4.07-3. A rooftop view shows conspicuous damage.**

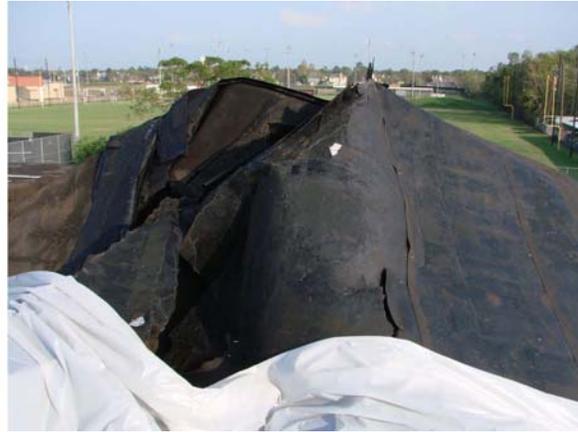
**4.07-4. A pile of detached roof assembly - 2-ply BUR and mineral surfaced cap.**

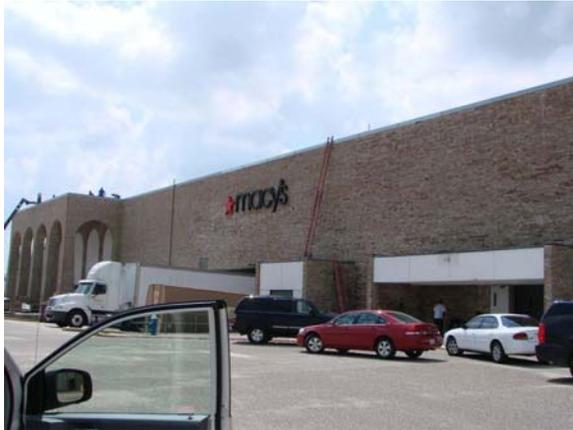
4.08-1. View from the ground.

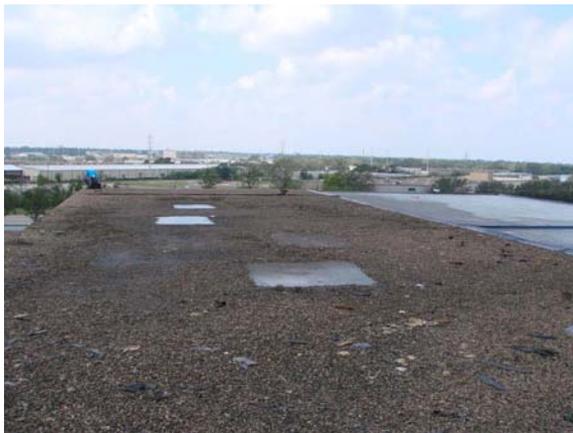
4.08-3. Repairs on the penthouse roof are visible.

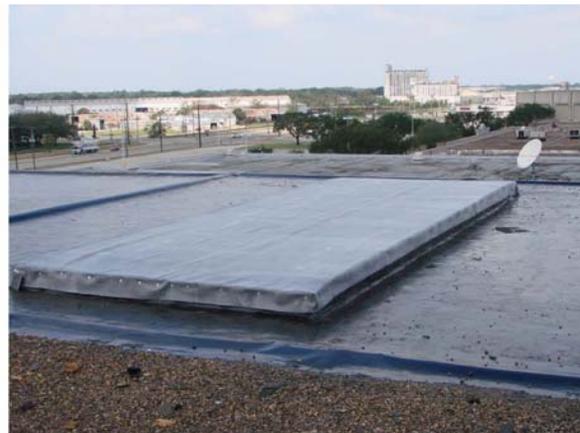
4.08-4. A mechanical unit and screw base.

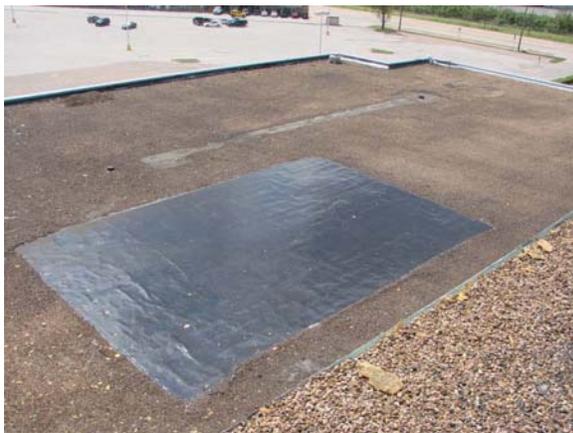
4.08-5. A large puncture repair on the main roof.

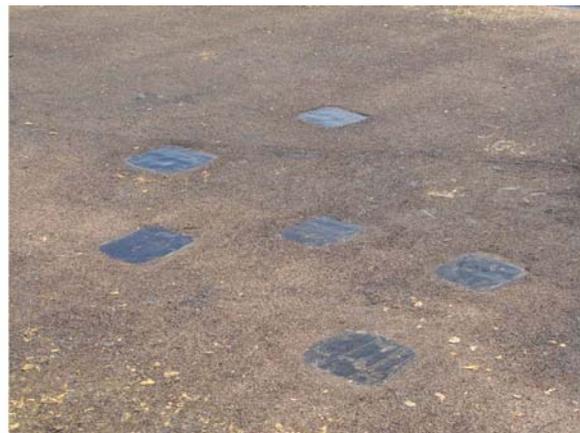
4.08-6. More puncture repairs on the main roof.

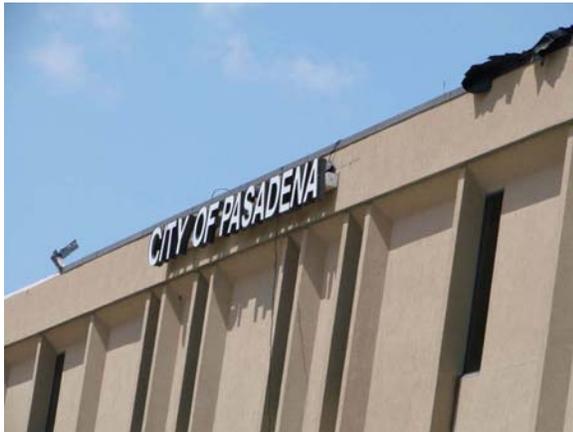
**4.09-1. Edge metal failure is visible at upper right.**

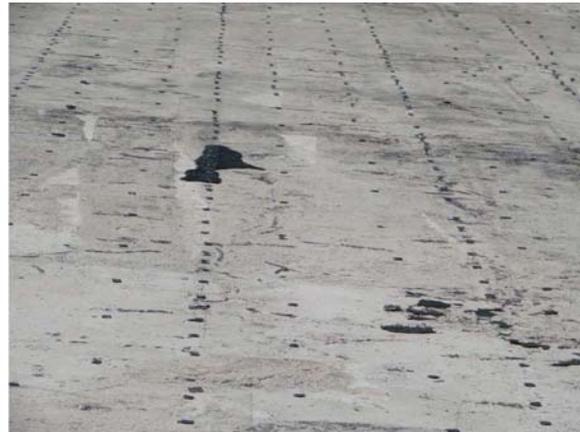
**4.09-2. Photo shows the nailing pattern of the base sheet to the LWIC decking.**

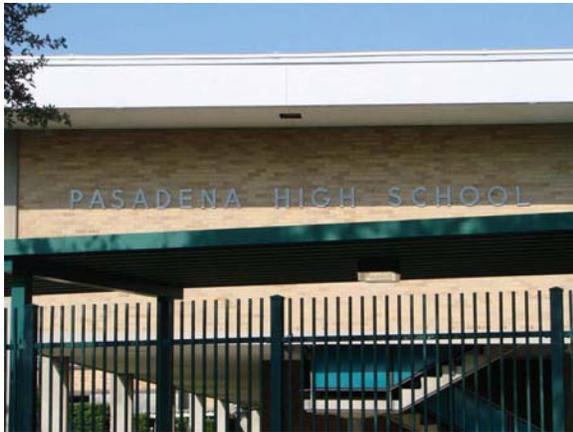
4.10-1. Front view of the school.

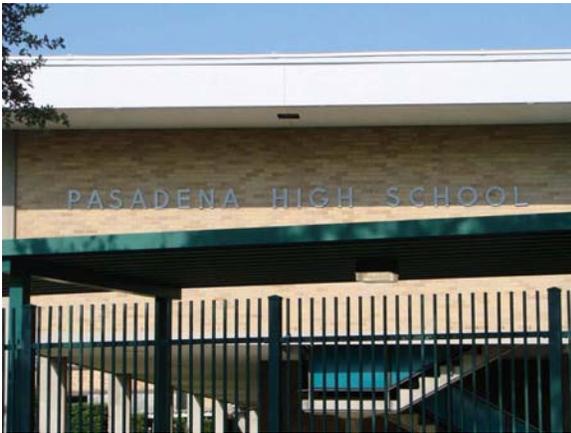
4.11-1. Front view of the school.

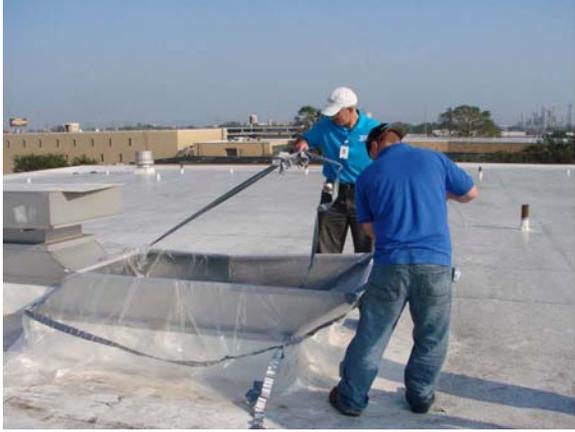
**4.11-3. The mechanical unit is missing from this curb.**

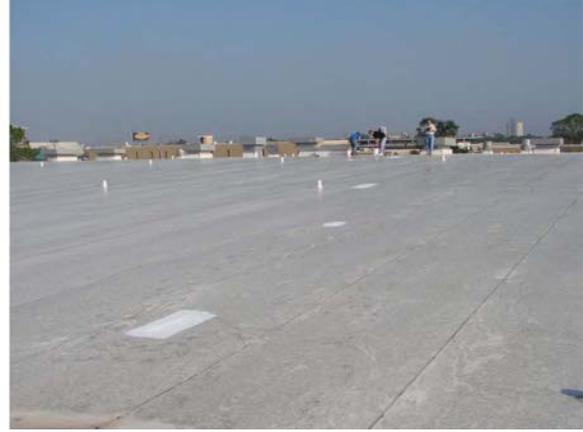
**4.11-4. Note the trail of puncture repairs across the roof surface.**

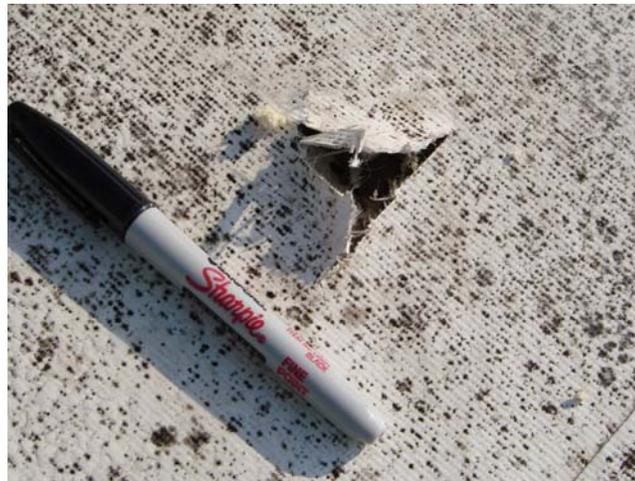
**4.11-5. One of several punctures in the single ply membrane.**

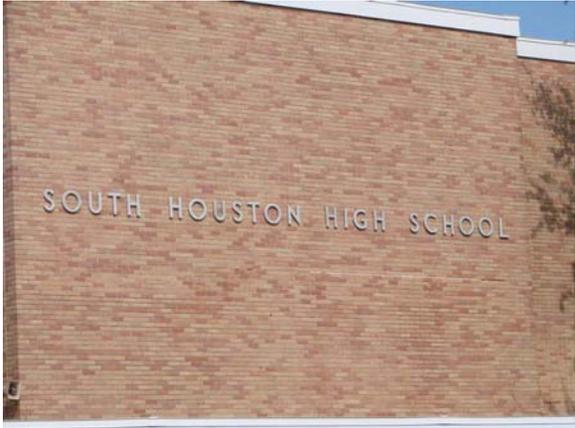
4.12-1. Front view of the school.

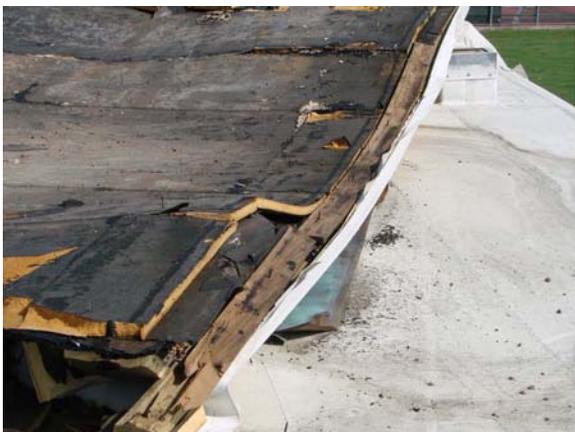
4.12-5. Edge components still attached to this wood nailer suggest inadequate nailer fastening.

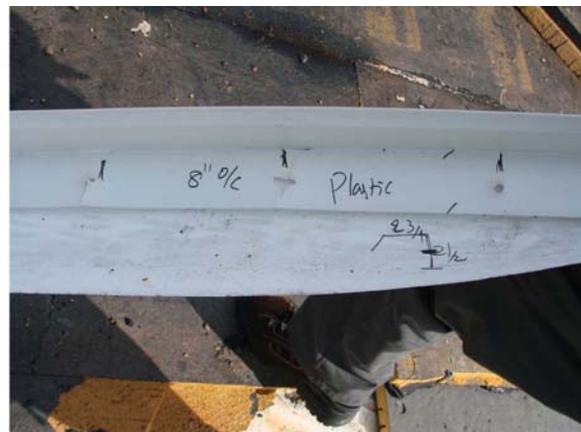
4.12-6. Plastic edging fastener spacing is visible here.

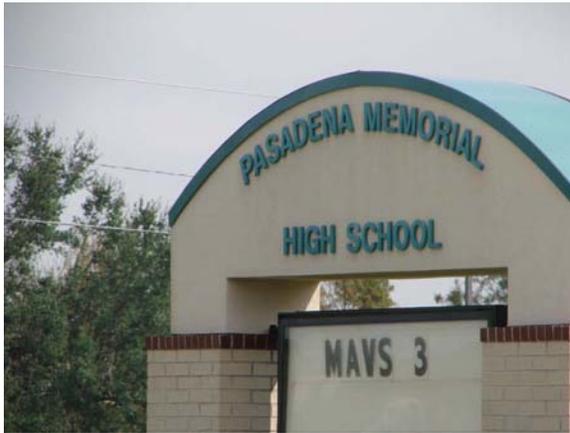
**4.13-1. Front of the high school.**

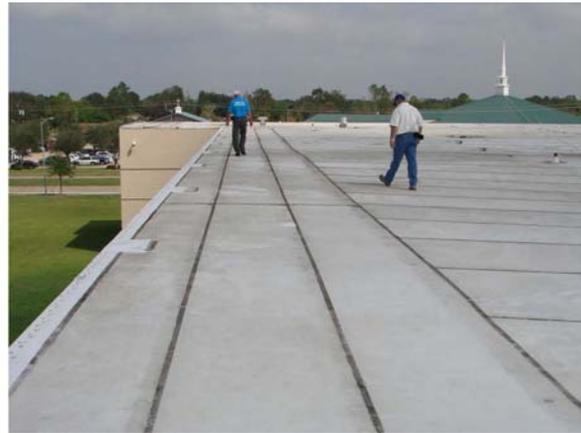
**4.13-2. Overview shows damage to the roof edge.**

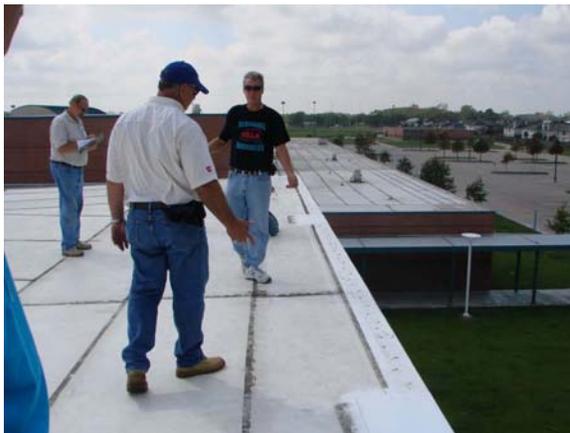
**4.13-3. Damaged edge is inspected.**

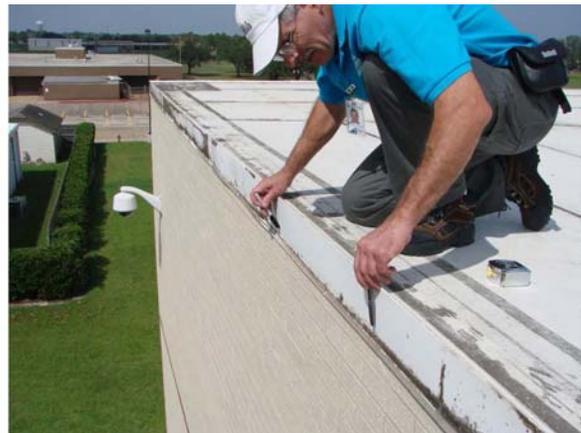
**4.13-4. Photo shows face fastening of edge metal.**

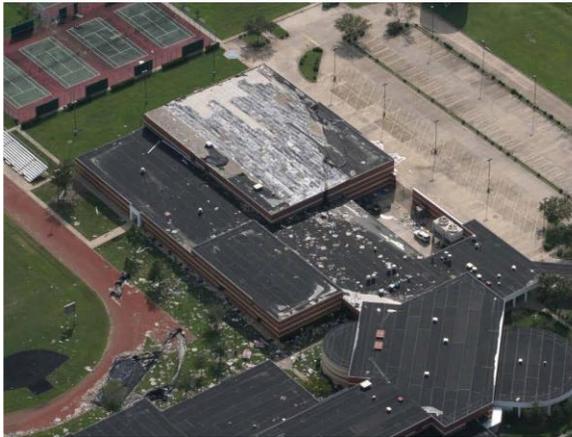
**6.01-1. Aerial view of damage.**

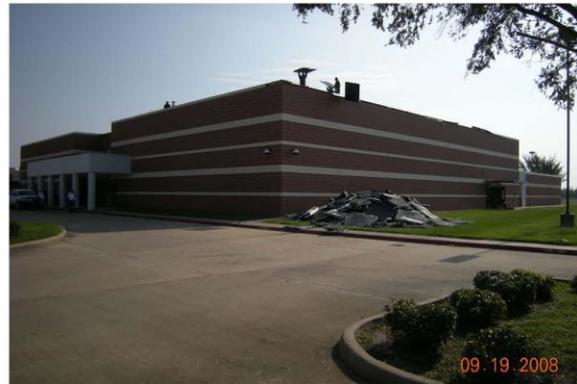
**6.01-2. View of the building looking eastward.**

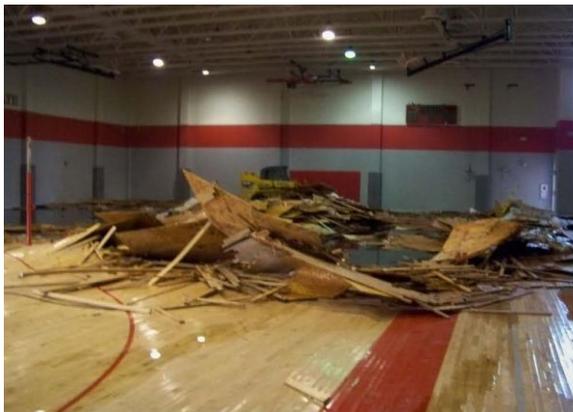
**6.01-5. Water damaged flooring inside building.**

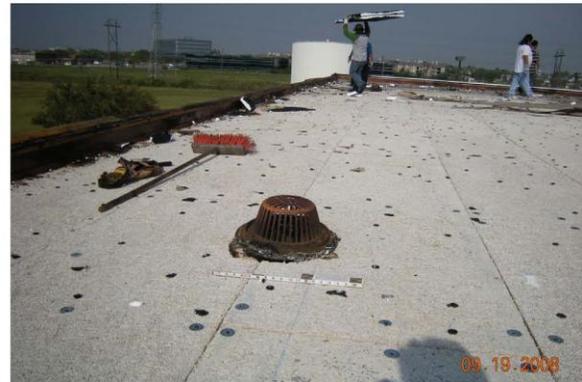
**6.01-6. Openings in deck around drain allowed air to rapidly enter below the roof covering.**

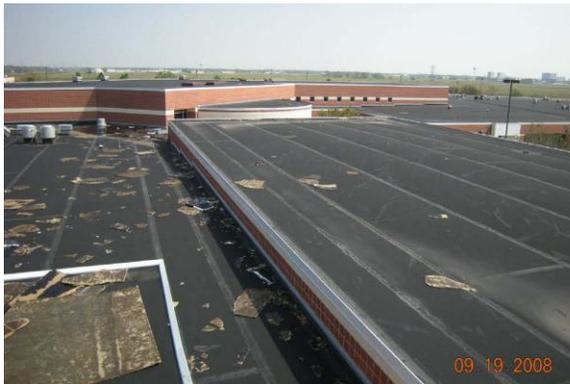
6.02-1. Overview looking east (1 of 2).

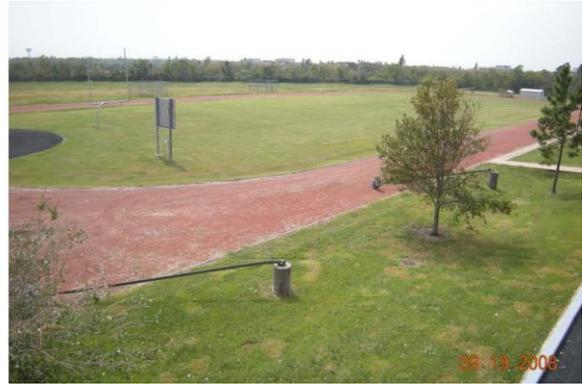
6.02-4. Broken light pole.

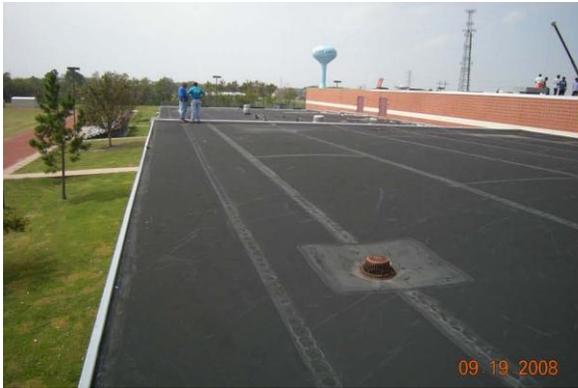
6.02-5. Panorama from the southeast side (1 of 4).

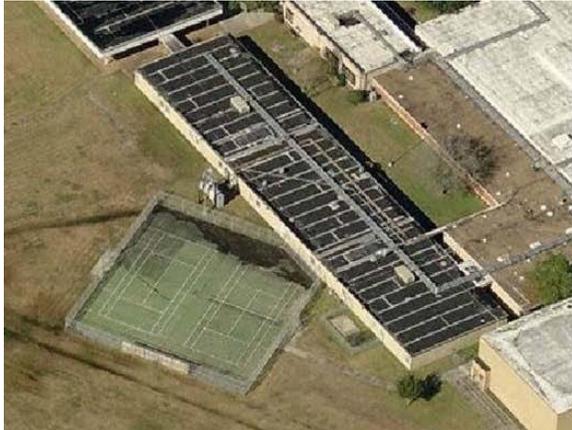
6.03-1. Aerial view of roof before storm.

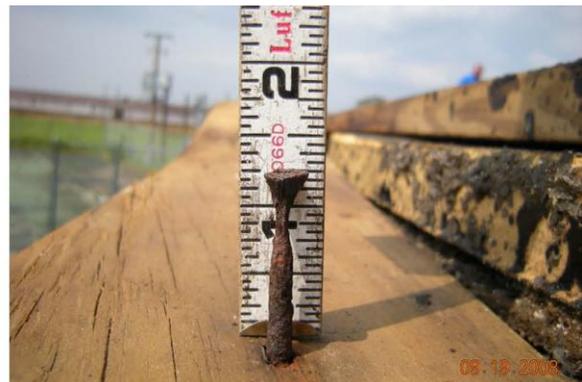
6.03-6. Advanced corrosion of screw used to secure wood nailer.

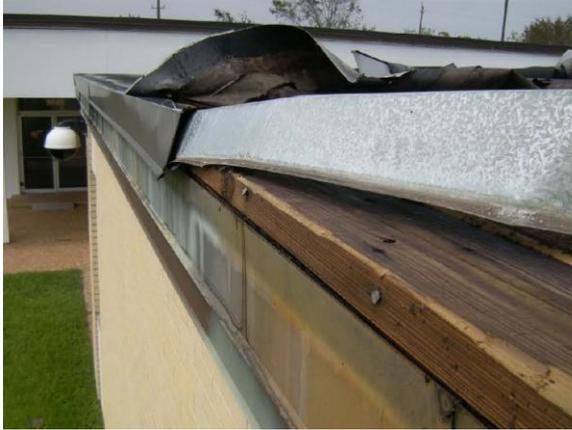
**6.03-7. Partially lifted edge metal. Note cleat secured on top of nailer.**

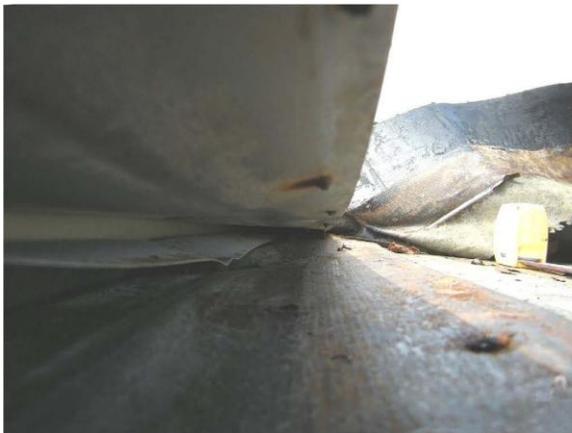
**6.03-9. Edge metal of photo 6.03-7 lifted to show severely corroded fasteners.**

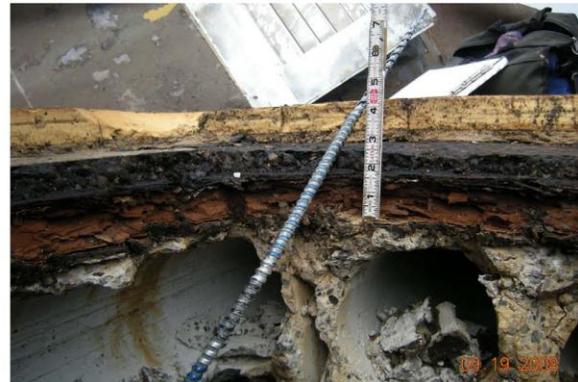
**6.03-10. Overlay- EPDM, ISO insulation, coal tar BUR, phenolic foam, pre-cast plank.**

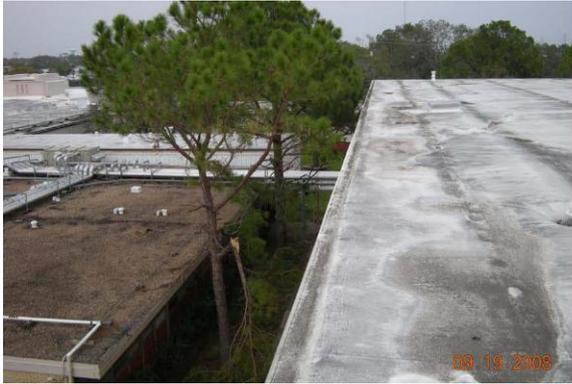
6.04-1. Overview of roof, 1 of 3.

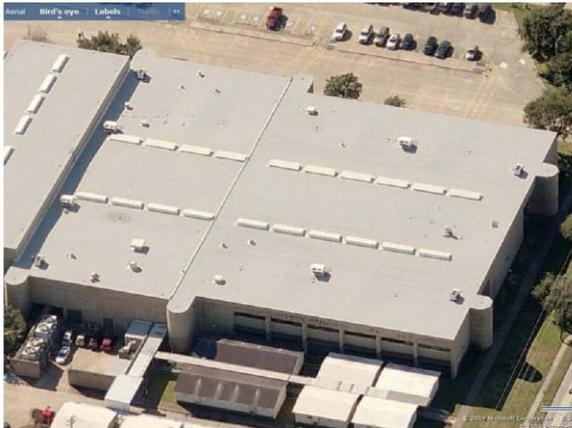
**6.05-1. Aerial view of roof before storm.**

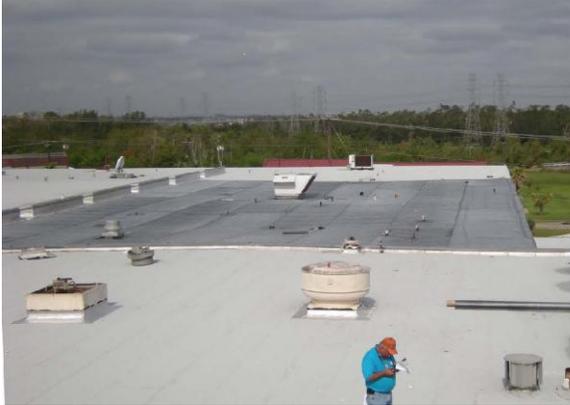
**6.05-3. Overview of damage area covered with EPDM membrane (temporary).**

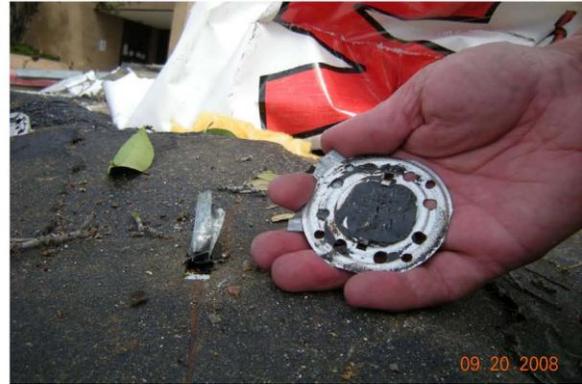
**6.05-4. Expanding shank fastener with 2-1/2 in. diameter plate from debris pile.**

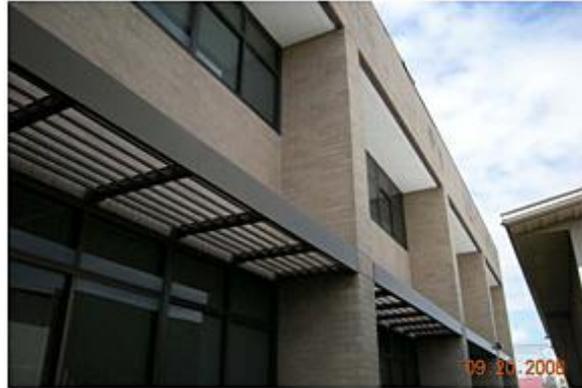
**6.05-9. Louvered vents in soffits located near the area where damage appears to have started.**

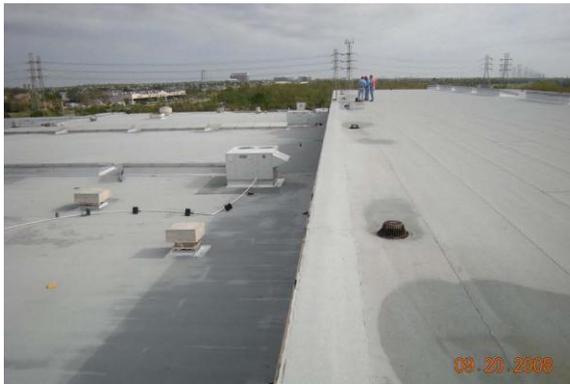
**6.06-1. South-to-north view of the upper roof from the southwest corner.**

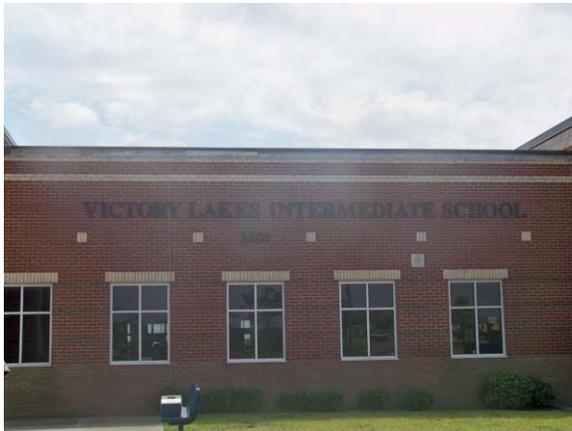
**6.07-1. Metal edge above a masonry wall.**

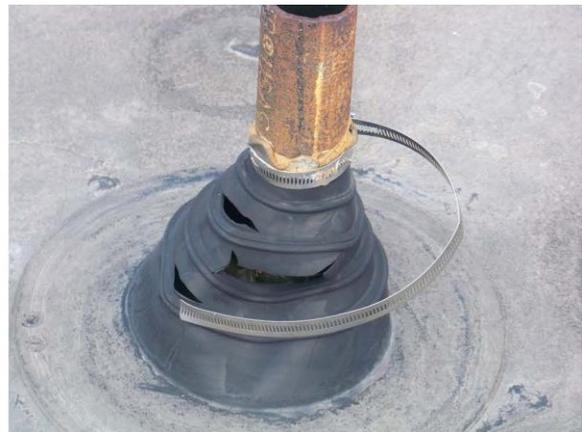
**6.07-6.** A prefabricated pipe boot that is deteriorated and split.

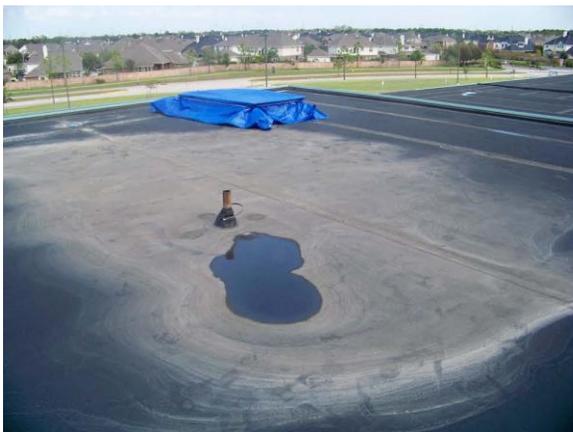
**6.07-7.** Holes and cuts from wind-blown debris are visible in this photo.

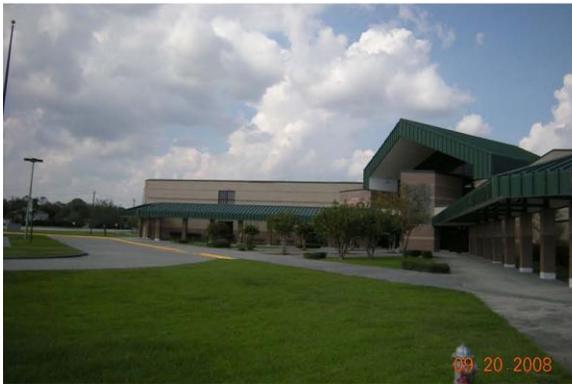
**6.08-1. View near the front entrance.**

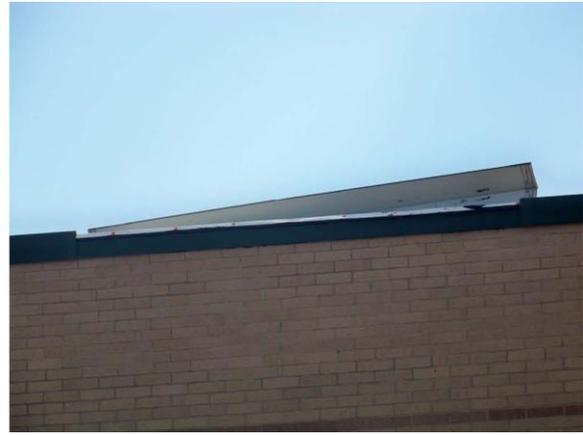
**6.08-6. Displaced roof edge metal was the bulk of the storm damage at this site.**

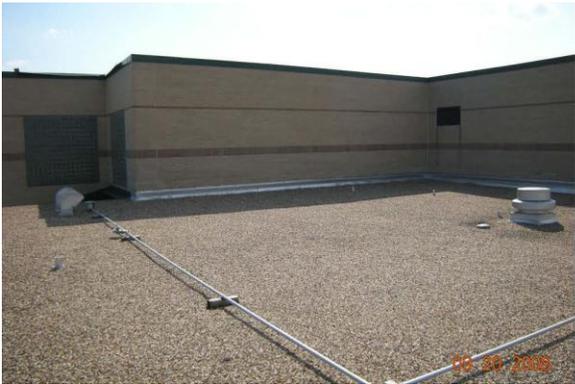
**6.08-7. Photo was taken near the rear of the school.**

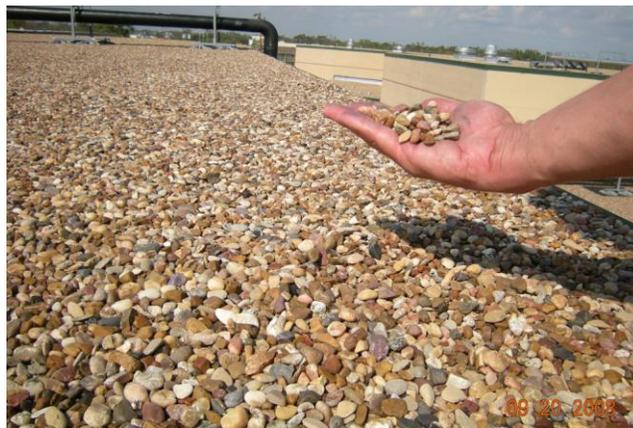
**6.08-9. Loose ballast aggregate.**

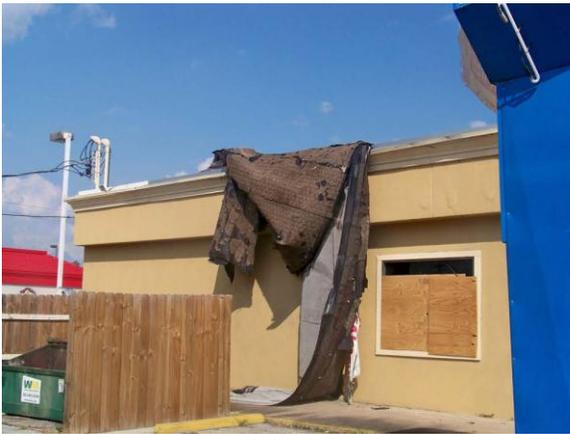
**6.09-1. View looking northeast shows the membrane hanging from the roof edge.**

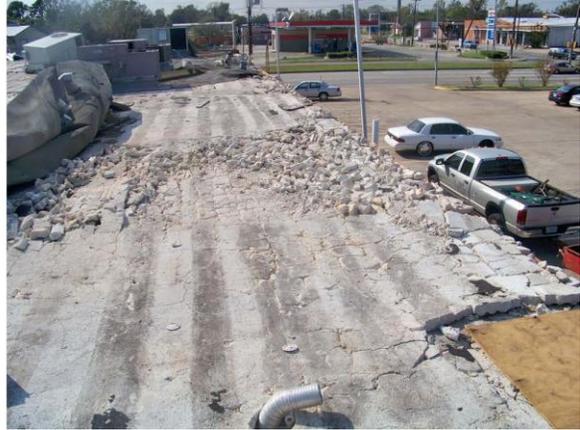
**6.09-6. Damaged LWIC decking.**

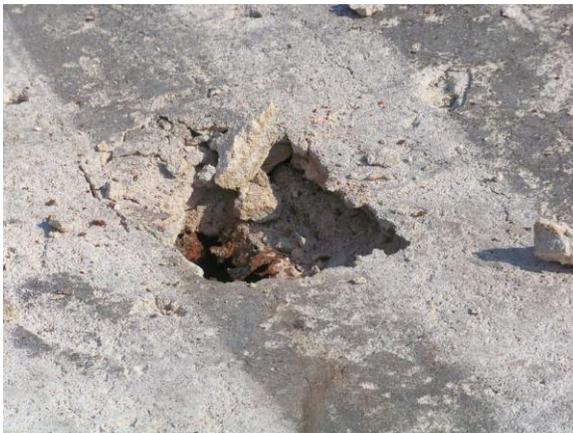
**6.09-7. The deteriorated pan deck was so weak it appears an inspector's foot went through here. This is near the southeast corner.**

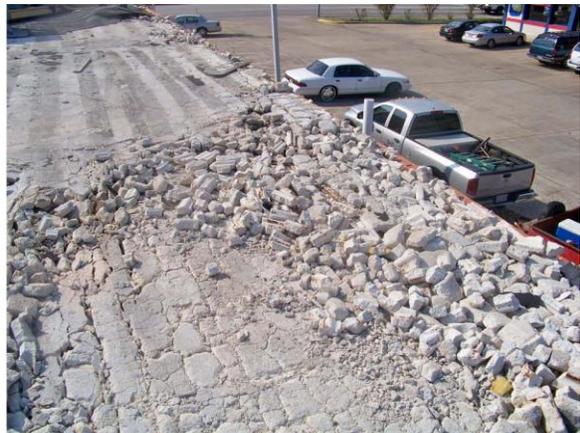
**6.09-8. The roof edge on the north side looking west.**

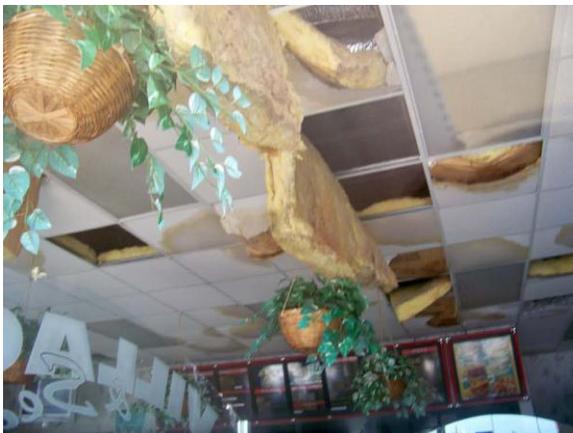
**6.09-9. View of interior damage due to roof failure.**

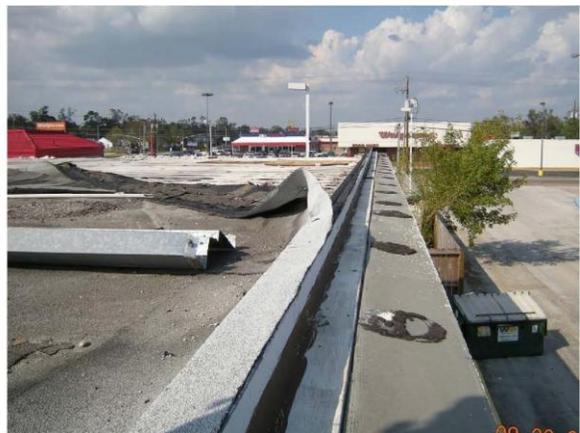
**6.09-10. Edge metal (displaced) extended over EIFS cornice with no mechanical attachment.**

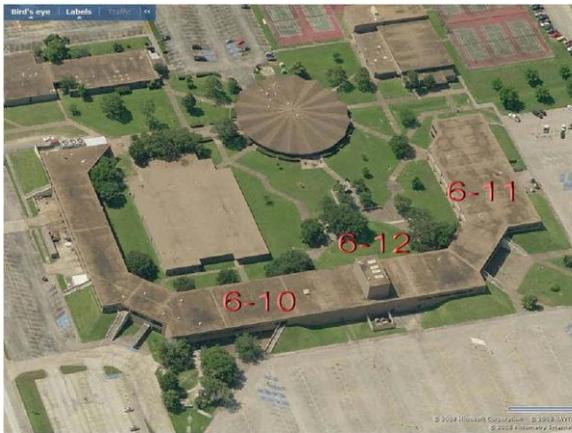
**6.10-1. Aerial view with roof area designations.**

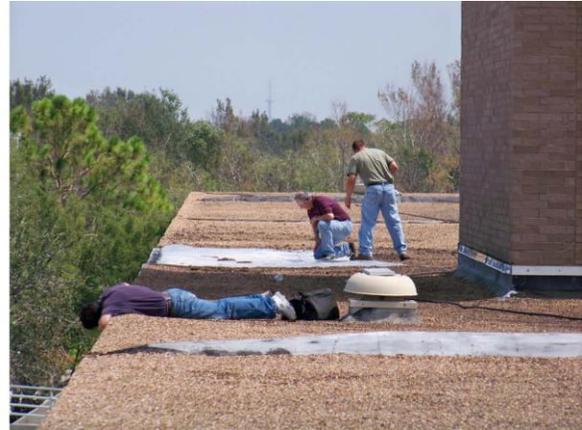
6.10-4. Roof level view of damaged areas near roof edge.

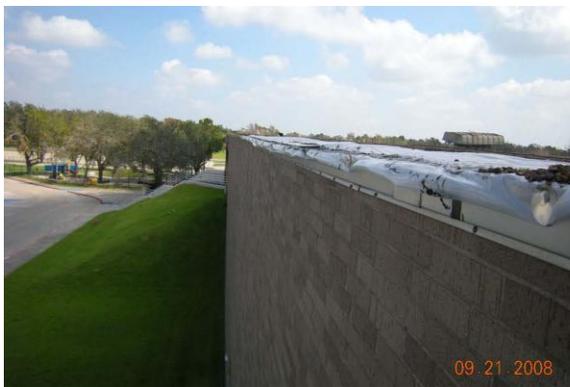
6.10-5. Edge metal remained in place along displacement area.

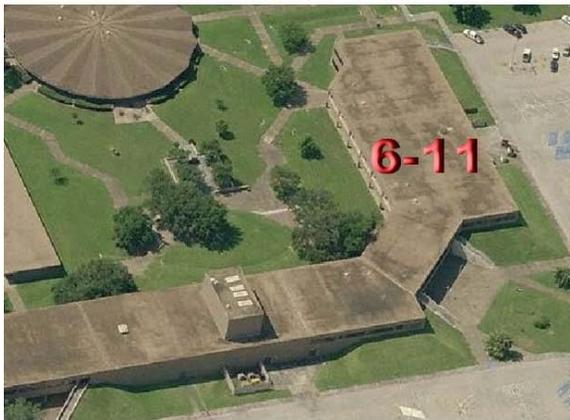
**6.11-1. Aerial view of roof before storm.**
