# RICOWI, Inc.

Roofing Industry Committee on Weather Issues, Inc.

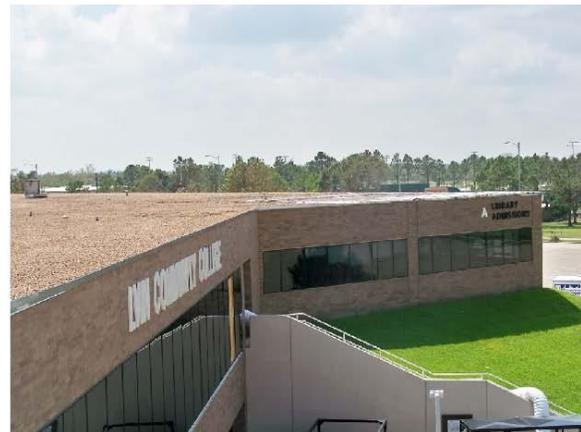
**6.11-2. Overview of damage area near windward corner, 1 of 2.**

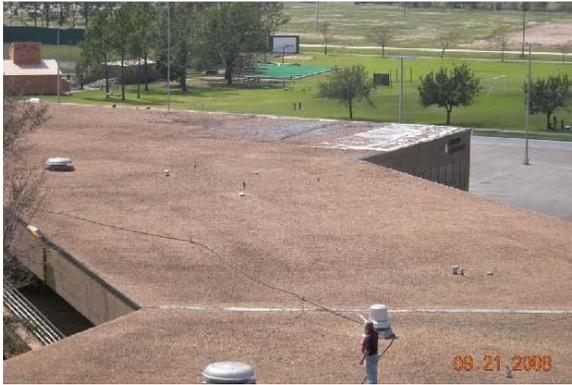
**6.11-3. Overview of damage area near windward corner, 2 of 2.**

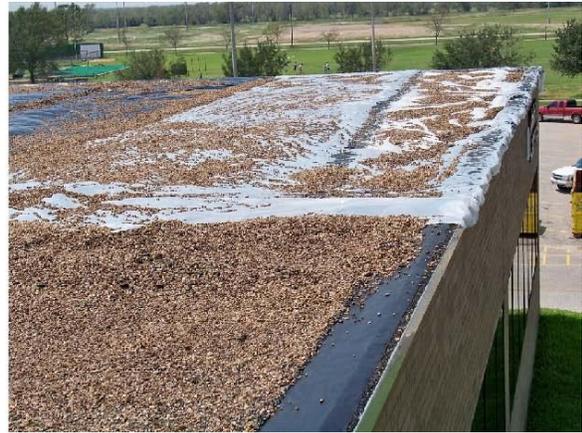
**6.11-4. Membrane displacement area (now covered with plastic sheeting). Roof edge metal remained in place.**

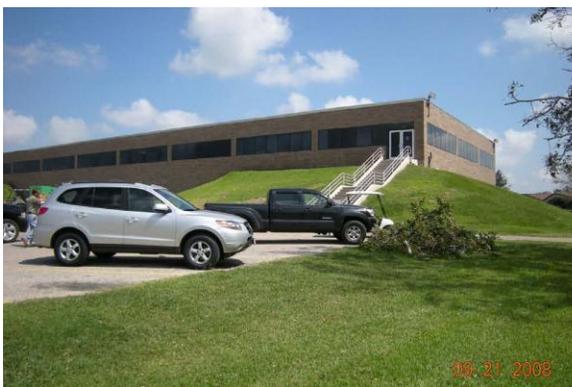
**6.11-7. Elevation view of damaged corner area, 1 of 2.**

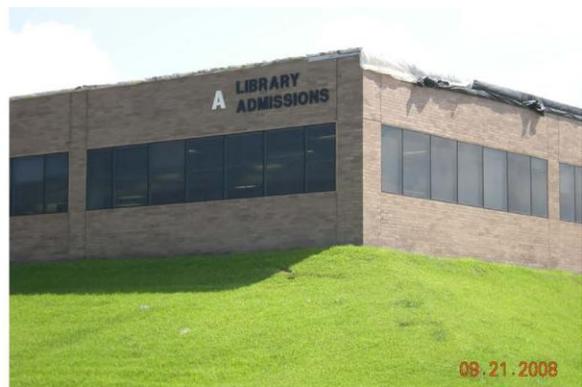
**6.11-8. Elevation view of damaged corner area, 2 of 2.**

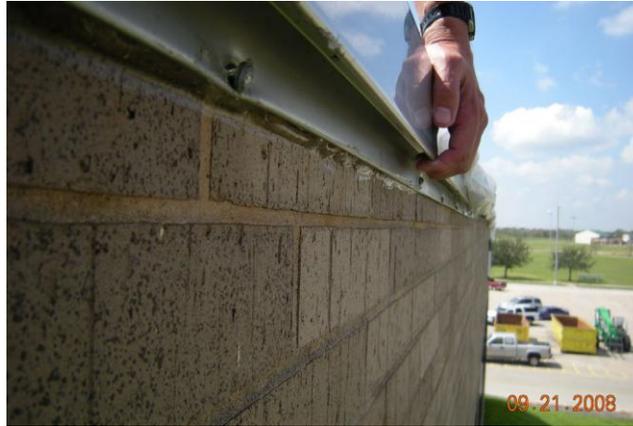
**6.11-9. Roof edge metal construction near damaged area.**

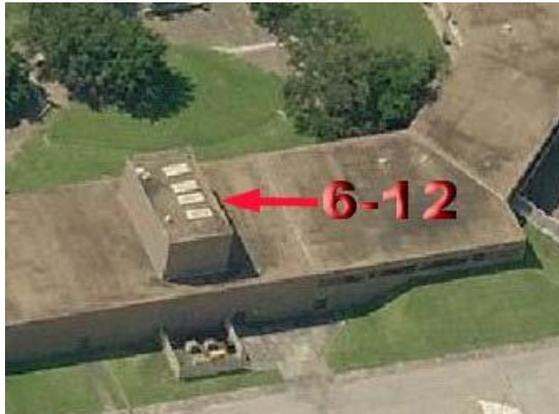
6.12-1. Aerial view of roof before storm.

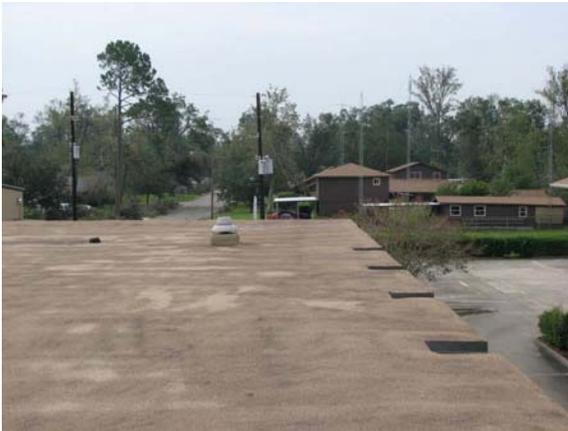
**7.01-1. Indentations along the right edge are evidence of fascia damage.**

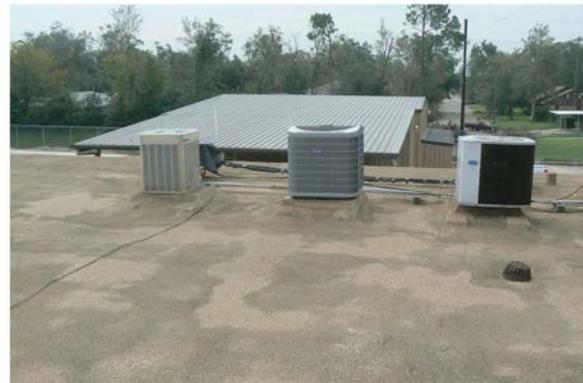
**7.01-2. The SPF in this area appeared to be intact.**

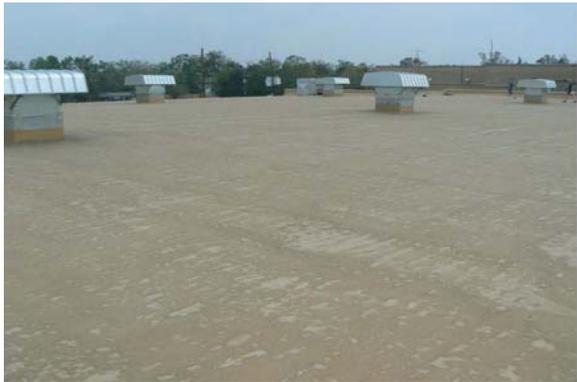
**7.02-1. Overview of the SPF roofing system, which appears to be in good condition.**

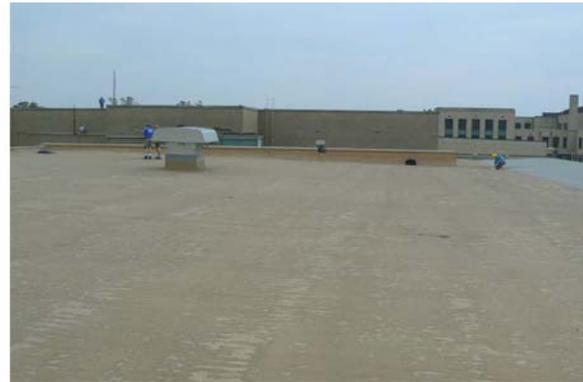
**7.02-2. Another view of the undamaged SPF roof.**

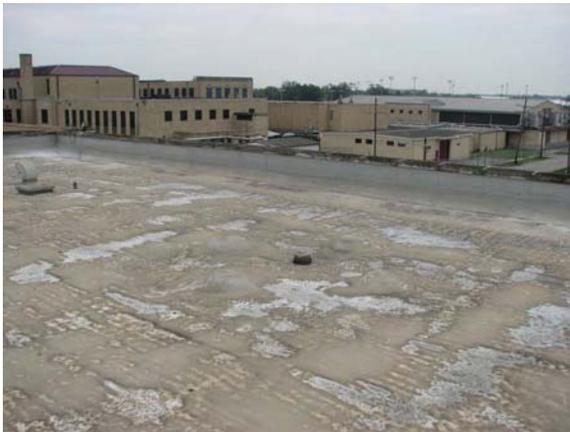
**7.03-1. Overview of the SPF roofing system, which was not damaged.**

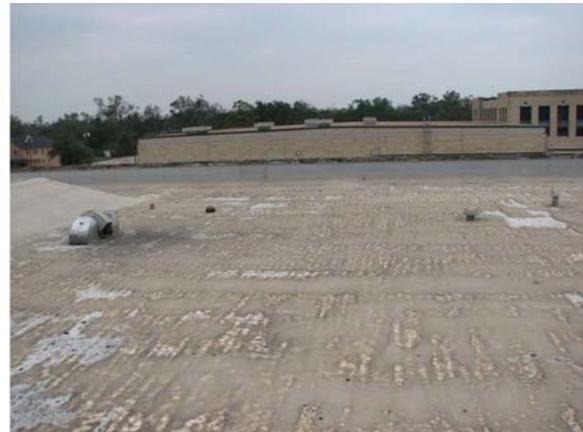
**7.03-2. The round dark spots seen on the surface are due to bird pecks and not to any effects from the hurricane.**

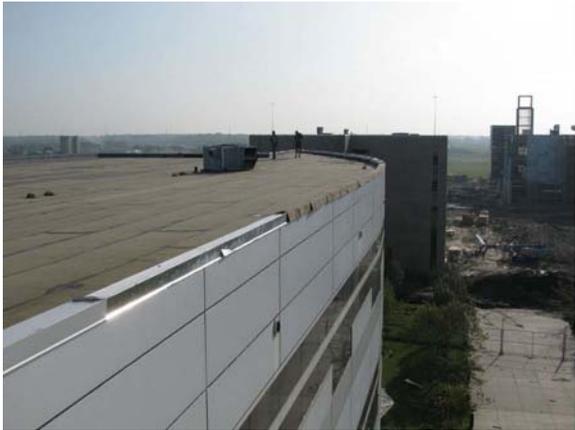
**7.04-1. View of the repaired roof shows the damaged edge detail which was due to an air handler unit blowing off the roof.**

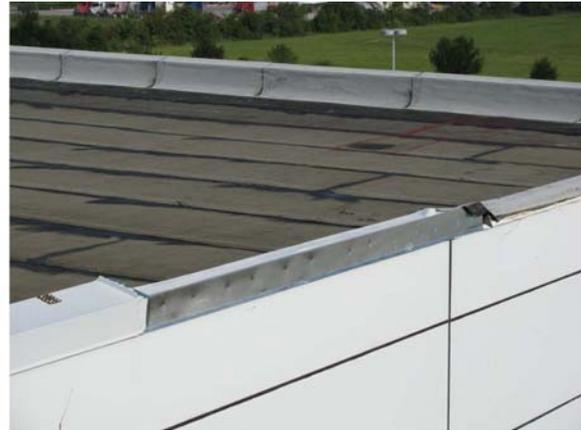
**7.04-2. Northeast edge detail has been partially repaired. The initial damage occurred here.**

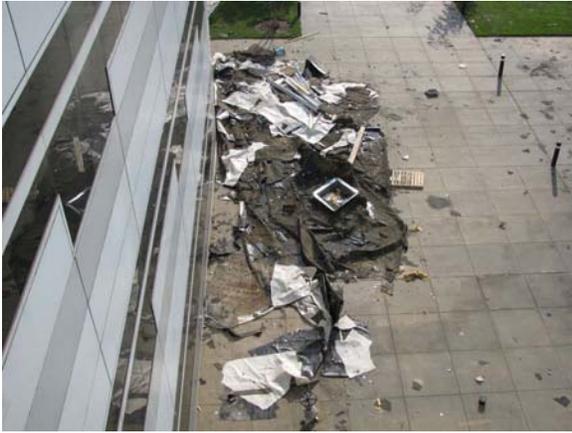
**7.04-3. Debris pile was a result of either hurricane Ike or repair activities.**

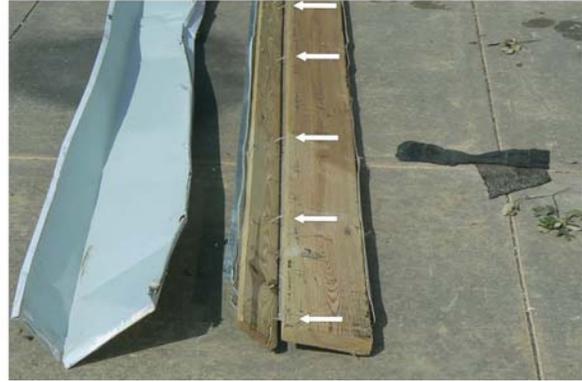
**7.04-4. Note that this damaged 1 in. x 4 in. nailer (from an edge detail) is only fastened into one 2 in. x 8 in. nailer (arrows). No evidence was found of fasteners in a second 2 in. x 8 in. nailer. The second (2 in. x 8 in.) nailer is not visible in this photo.**

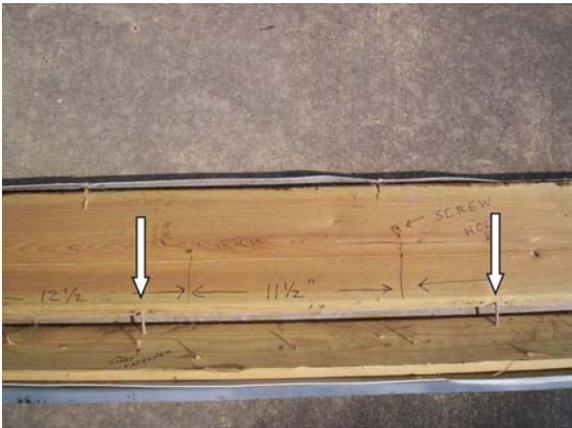
**7.04-5. Damaged nailers from an edge detail. Note that the 1 in. x 4 in. nailer is only fastened into the one 2 in. x 8 in. nailer (arrows). The two nails shown connecting the nailers are 17 in. apart. The second 2 in. x 8 in. nailer is not shown.**

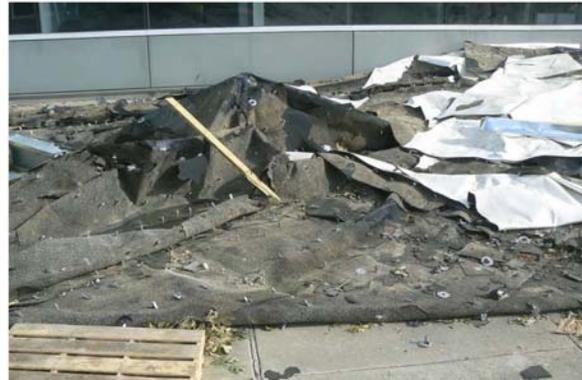
**7.04-6. Another pile of roofing debris.**

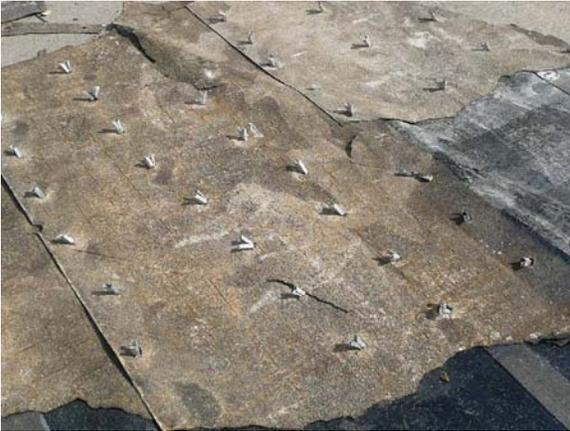
**7.04-7. Fasteners remaining in the damaged roof membrane.**

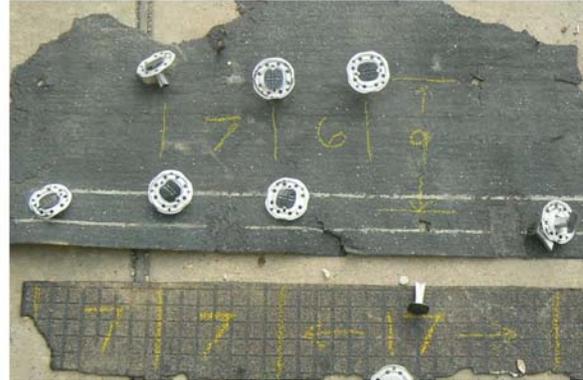
**7.04-8. Base sheet fastener spacing is visible.**

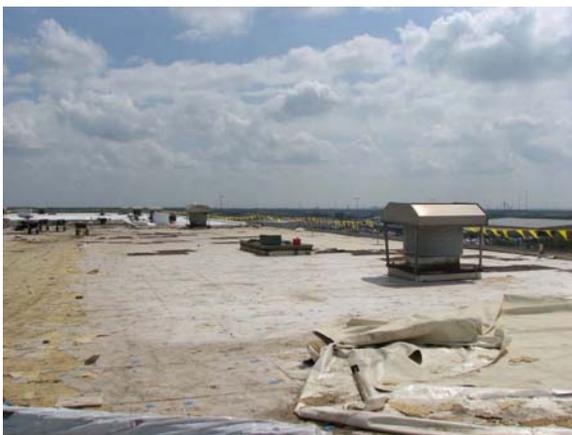
**7.05-1. The single ply membrane was blown to this spot from the west side of the building. Note that most of the re-cover boards in the field remained in place (see 7.05-2).**

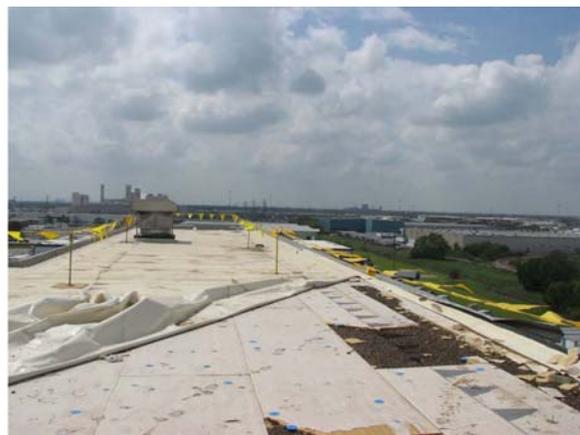
**7.05-2. The recover boards at the west edge of the building were missing, apparently displaced by storm winds.**

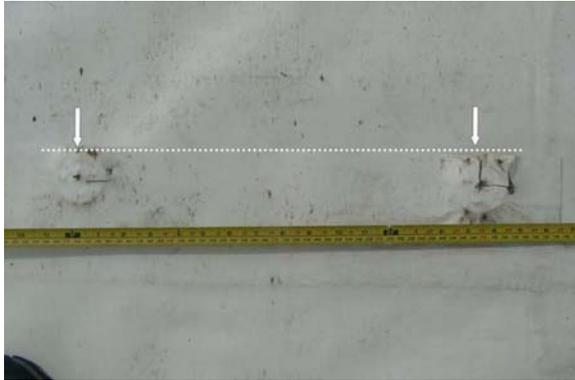
**7.05-3.** Mechanical fasteners and plates were installed with disk edges (arrows) almost flush with the edge of the single ply sheet (dashed line).

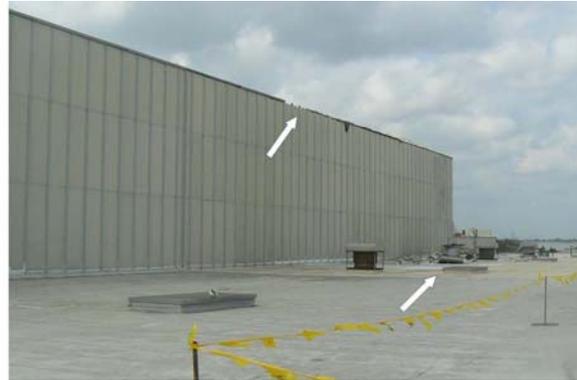
**7.05-4.** The upper arrow highlights a damaged roof edge where an HVAC unit (lower arrow) blew off.

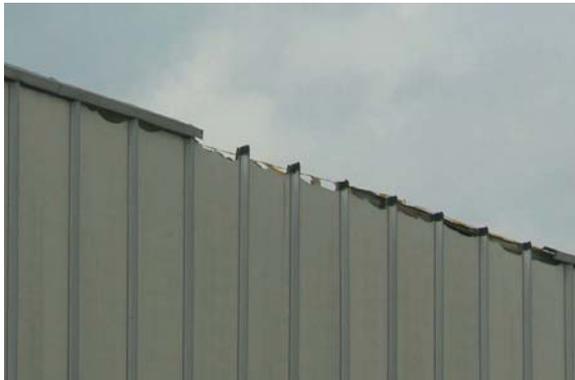
**7.05-5.** A closer view of the damaged roof edge where the HVAC unit blew off.

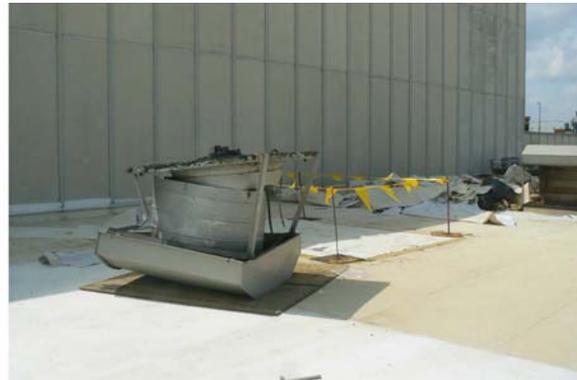
**7.05-6.** The HVAC that blew off the upper roof landed on a lower roof section, causing some damage.

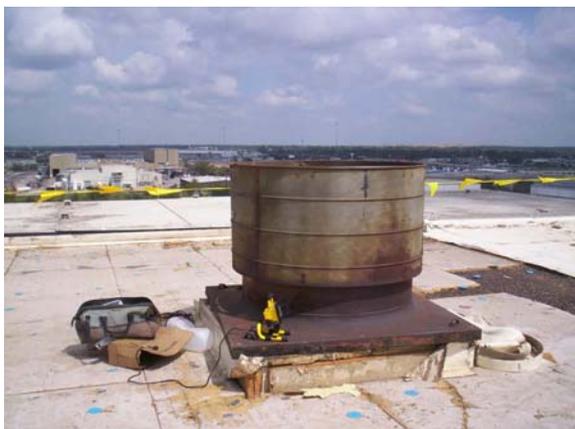
**7.05-7.** This mechanical unit was missing its cover, presumably due to the wind force.

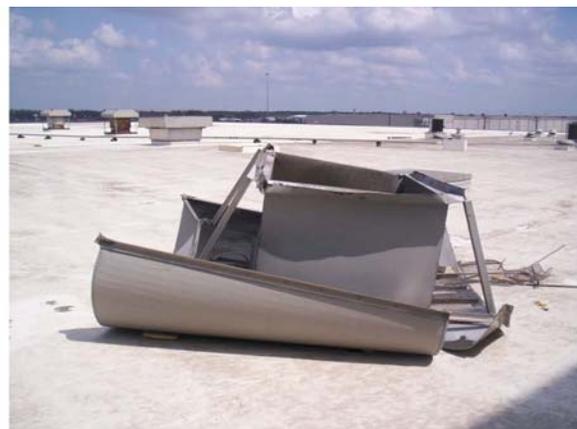
**7.05-8.** This damaged equipment was blown off its curb.

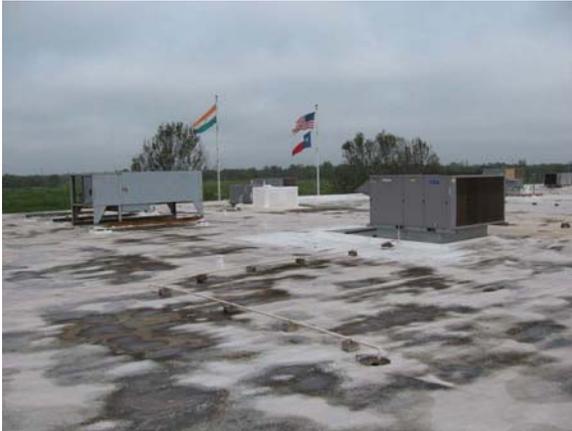
**7.06-1.** This SPF roofing system was not damaged during Hurricane Ike. The roof showed age, which was estimated to be about 15 years.

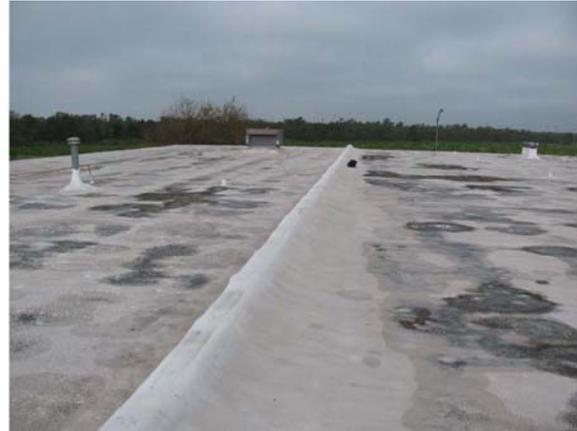
**7.06-2.** This is a different view of the undamaged SPF roofing system.

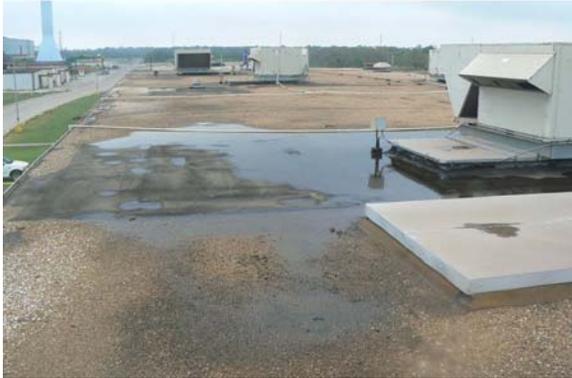
**7.07-1.** This 15-20 year old built-up roof was not damaged by Hurricane Ike.

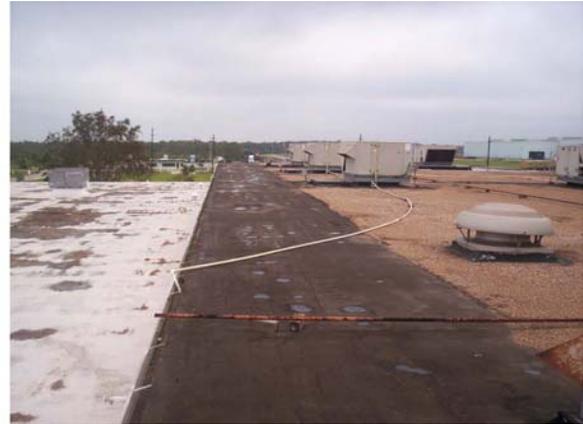
**7.07-2.** Although considered mineral-surfaced, extensive patching had been performed and mineral granules were not always replaced. Note the SPF roof described in report no. 7.06.

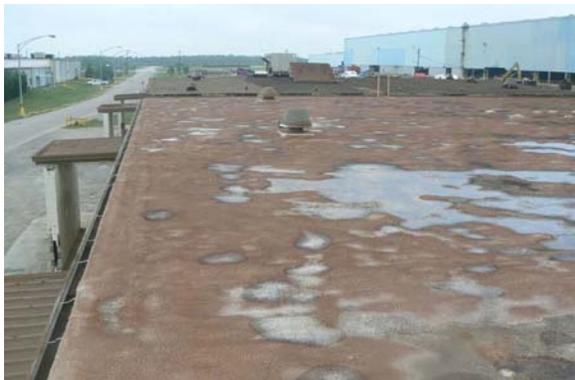
**7.08-1. Overview of the SPF roofing system, which was not damaged in Hurricane Ike.**

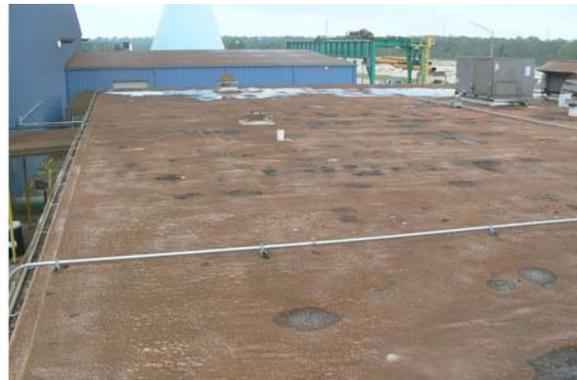
**7.08-2. Another view of this undamaged SPF roofing system.**

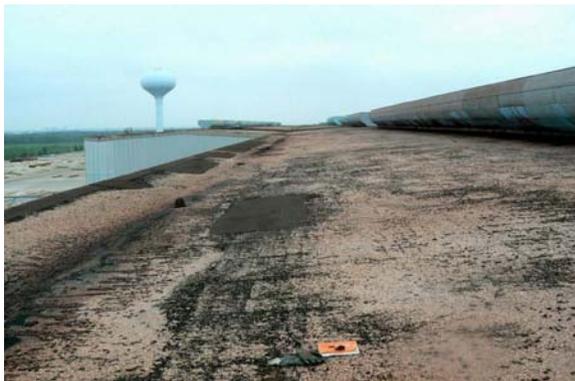
**7.09-1.** This section was undamaged by the hurricane. Some old patches are visible, as are large ventilators set on roof ridges.

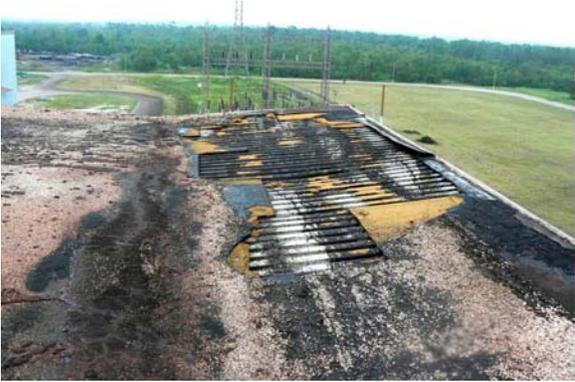
**7.09-3.** View of damaged corner section BUR and wood fiber insulation board. The gravel stop detail is intact in the area of the blow-off, but one section was bent upward, possibly due to the flexing of the BUR as it was blown from the roof.

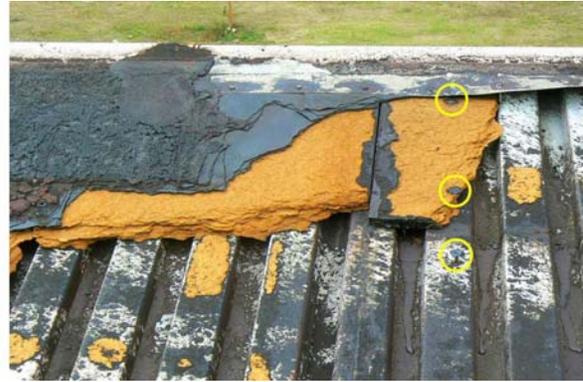
**7.09-4.** A close-up of a damaged corner shown in photo 7.09-3. Note poor attachment of insulation boards due to insufficient fasteners (circles).

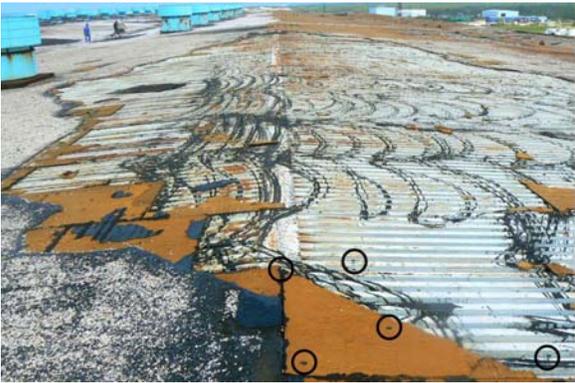
**7.09-5.** Insulation in some areas was secured with fasteners (examples in circles). In other areas, boards were adhered with strip-mopped asphalt. Many fasteners were pulled loose from the steel deck.

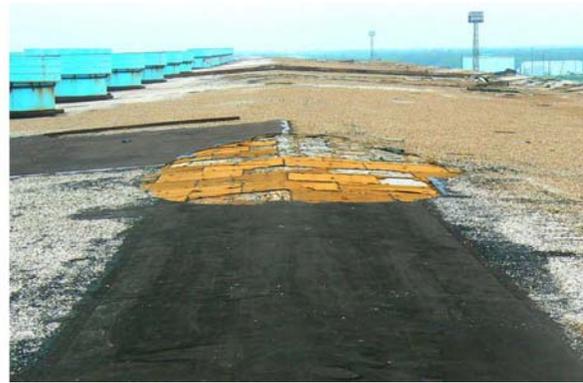
**7.09-6.** A large portion of this roof damage was due to separation of BUR from insulation boards, although some boards also became detached.

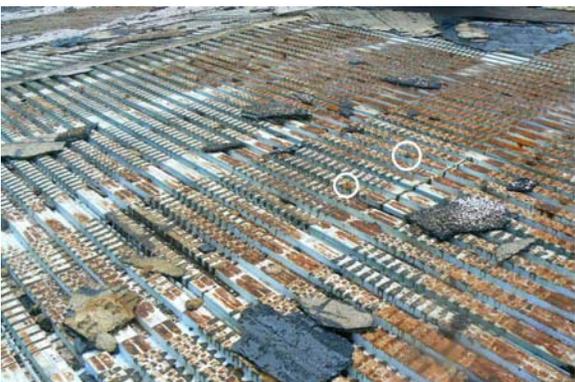
**7.09-7.** Insulation in this area was strip-mopped to the steel deck using hot asphalt. Evidence of mechanical fastening was also observed (examples in circles).

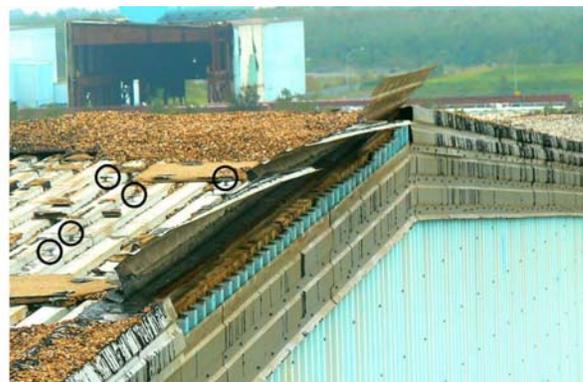
**7.09-8.** This edge detail by a section of detached roofing may have allowed wind to infiltrate the roof assembly. Insulation boards were mostly mechanically fastened here (examples in circles).

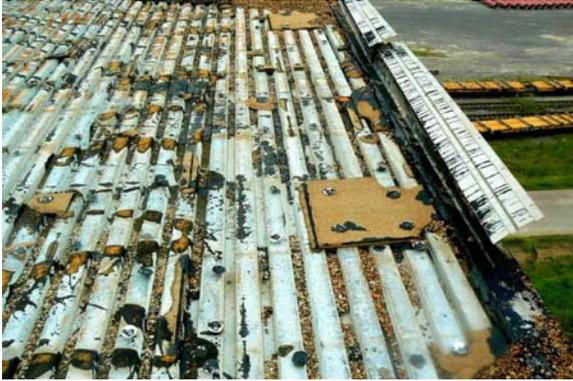
**7.09-9. Evidence was noted of both strip-mopping and mechanical fastening of insulation boards in this area. The use of perlite insulation and different fastening techniques suggested that this area had been previously re-roofed.**

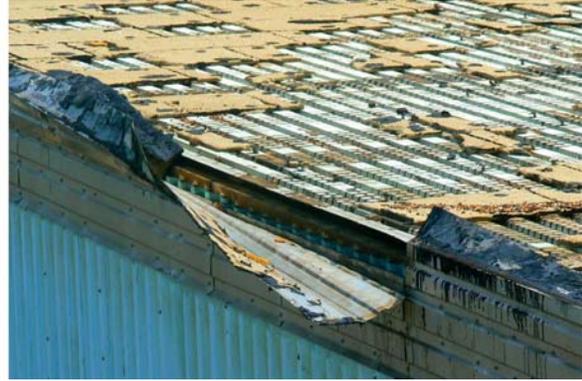
**7.09-10. Damage to this edge detail was attributed to wind-blown roofing debris.**

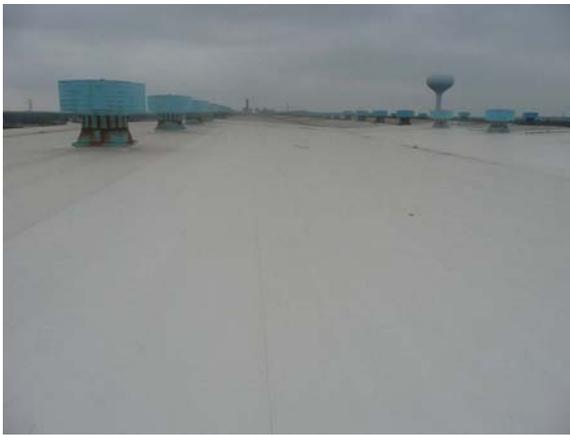
**7.10-1.** This is an overview of the white single ply membrane. It was not damaged by Hurricane Ike.

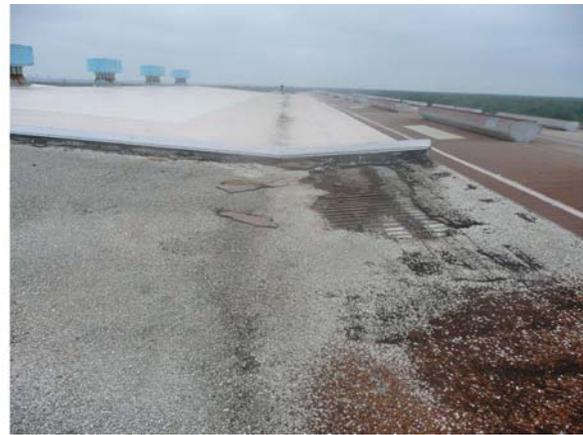
**7.10-2.** This white single ply membrane was adjacent to the built-up roof membrane damaged during the hurricane.

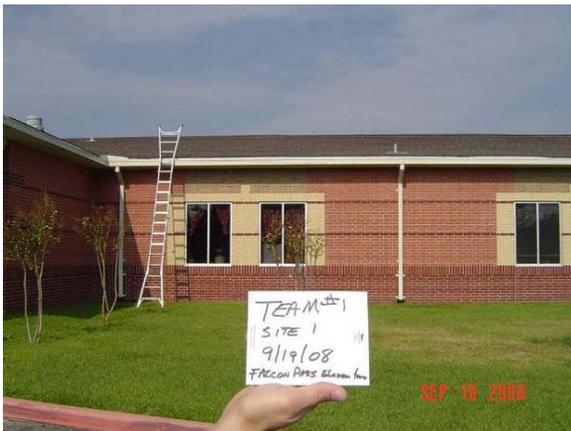
1.01-1. Site identification.

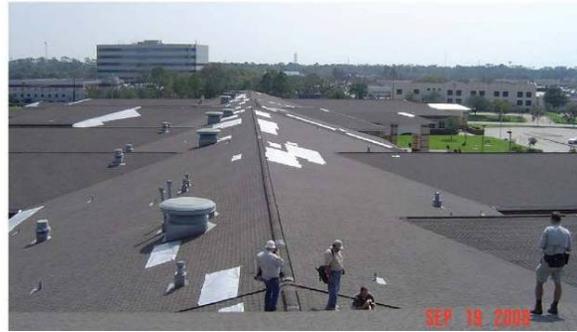
**1.01-4. Overview of most of the damaged areas.**

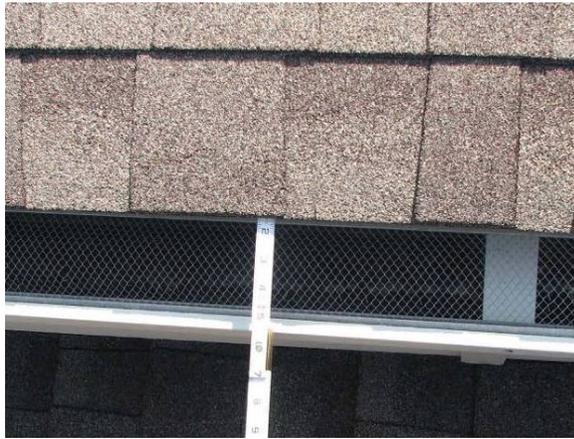
**1.01-5. First course overlapped 1-3/4 in.**

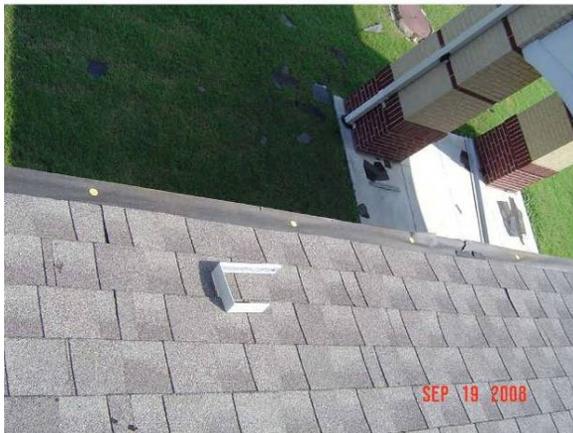
**1.01-7. Gutter and gutter brackets missing; first course blown off.**

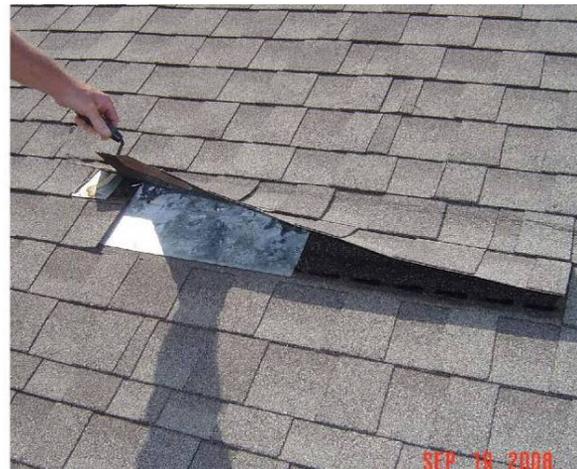
**1.01-8. Previous roof repair using galvanized sheet metal.**

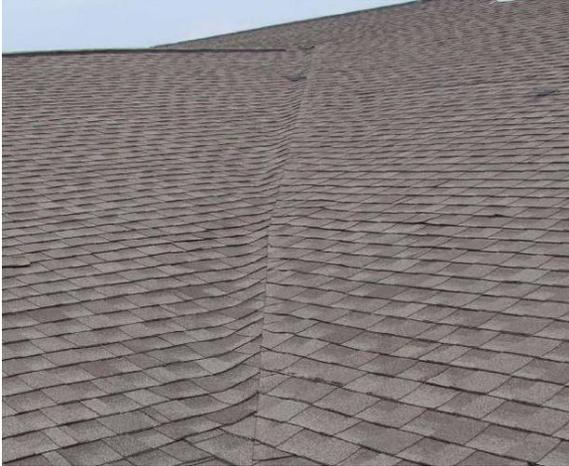
**1.01-9. Crooked valley (workmanship).**

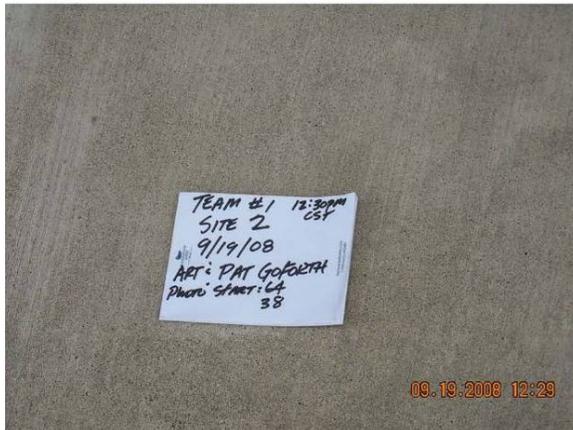
1.02-1. Site identification.

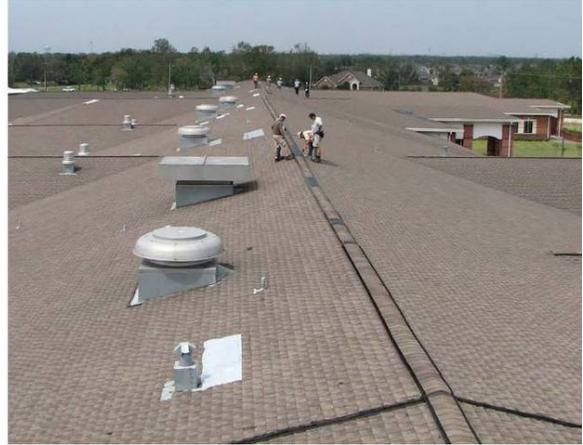
1.02-4. Overview of roof damage. Most damage occurred up-slope from roof penetrations.

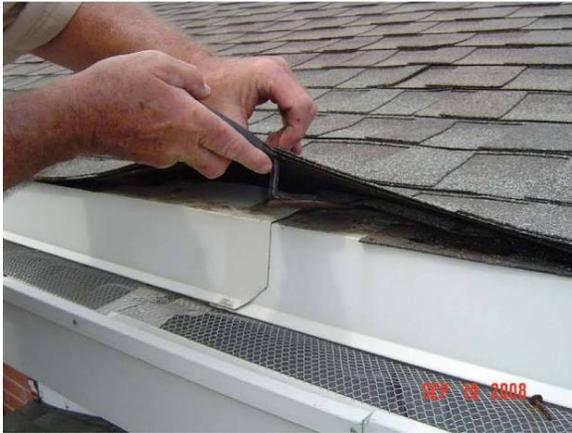
1.02-5. Eave flashing detail.

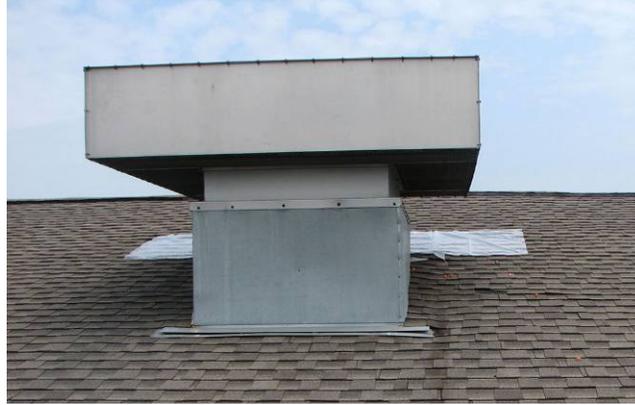
**1.02-9. Shingles damaged up-slope from roof equipment.**

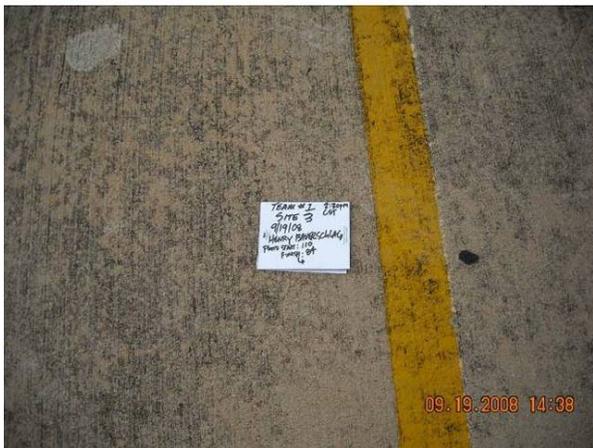
1.03-1. Site identification.

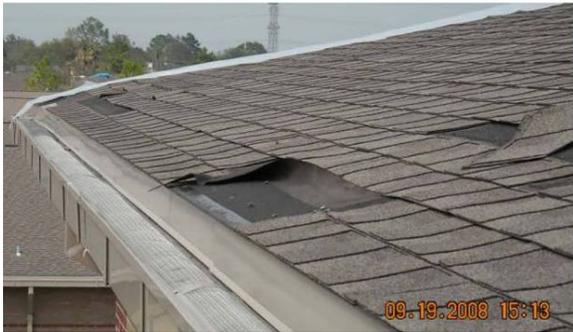
**1.03-3. First course blow-off; starter course improperly applied so release tape is in contact with sealant.**

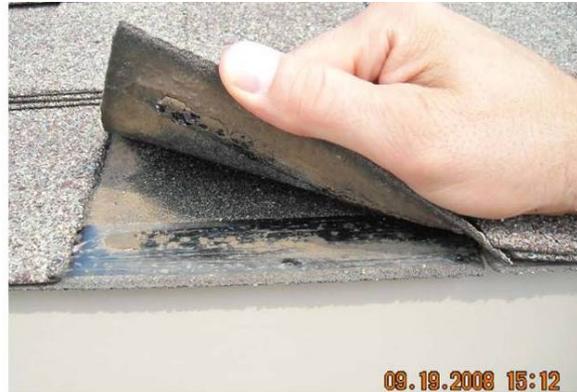
**1.03-4. Starter course with release tape in contact with first course sealant; not sealed.**

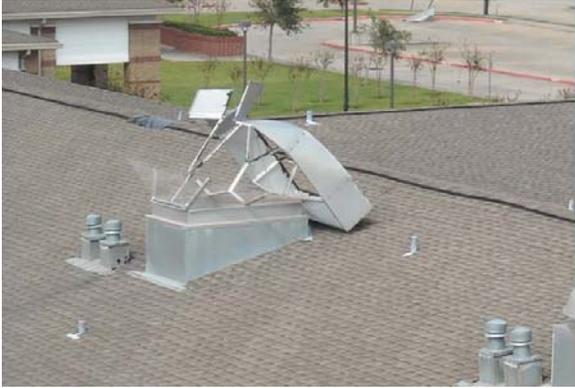
**1.03-9. Small amount of missing hip and ridge shingles and damaged roof equipment; some equipment is located at far end of parking lot.**

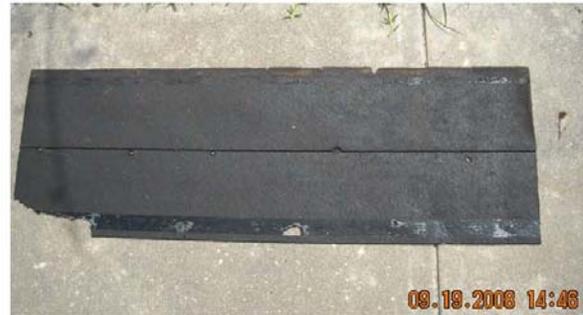
**1.03-10. Poor nail placement i.e., placed too high, with three nails grouped to one side of shingle.**

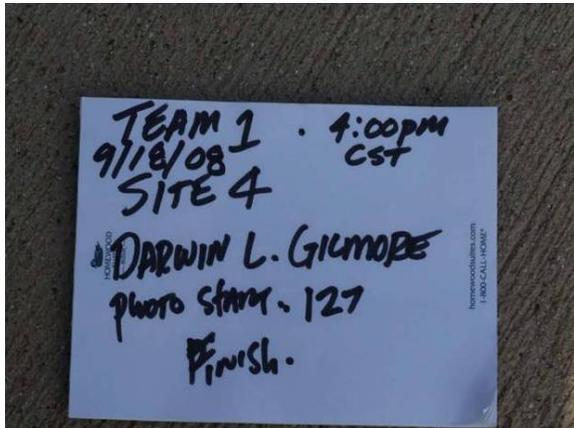
1.04-1. Site identification.

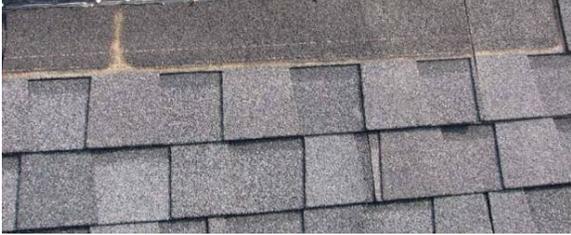
1.04-3. Second area found with no nails.

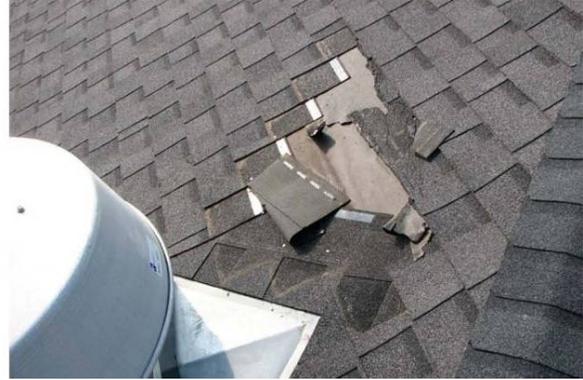
1.04-4. Common blow-off location above roof equipment.

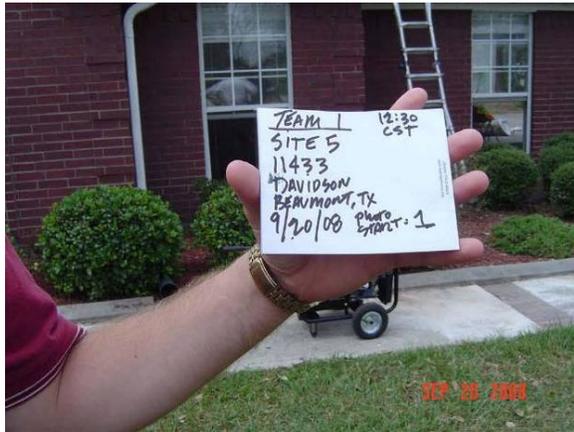
1.05-1. Site identification.

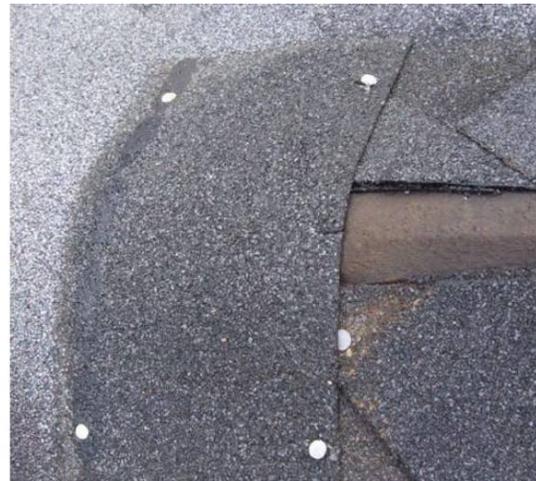
1.05-4. Improper nail location; hip and ridge shingle with nails located in sealant; sealant had a poor seal.

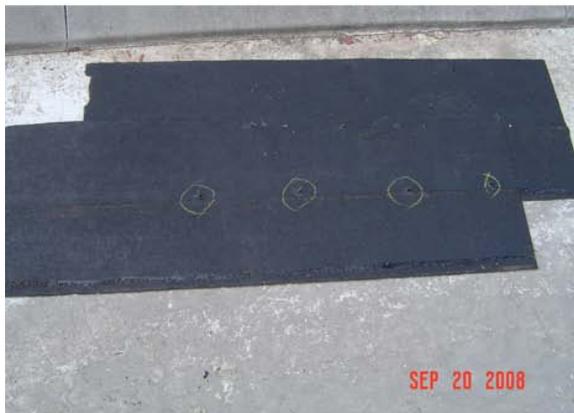
1.05-5. Nailed only on one end from the valley; different shingles from repairs after Hurricane Rita.

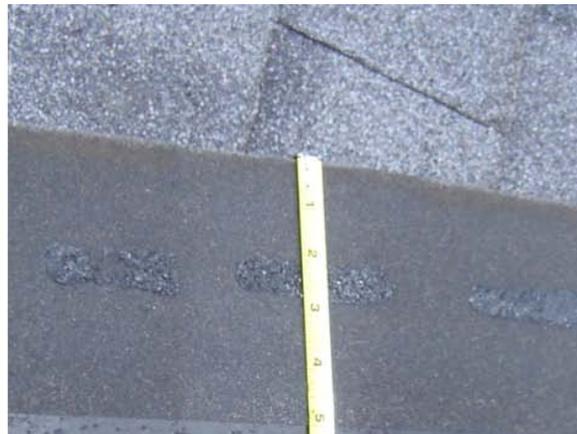
1.05-6. Sealant located 2 in. above leading edge.

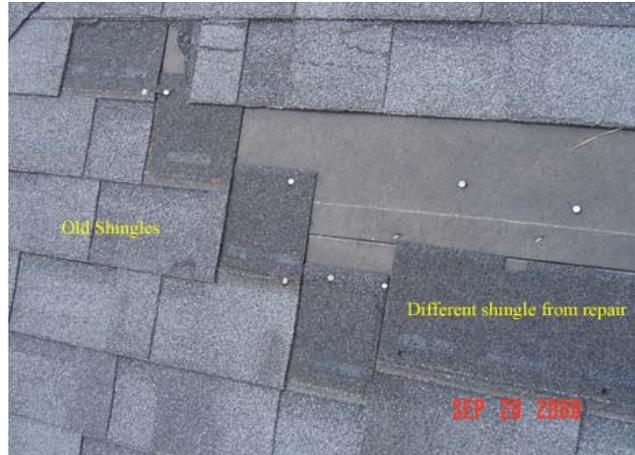
**1.05-7. Repairs are with two different types of shingles; because of different sealant locations some shingles were not sealed.**

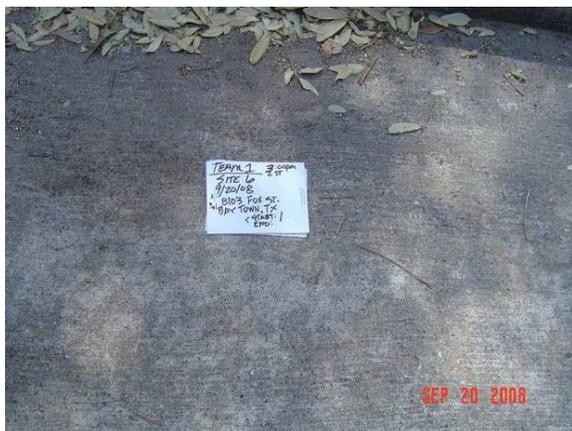
1.06-1. Site identification.

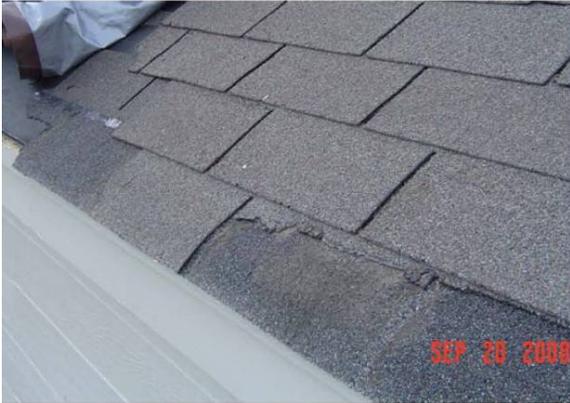
**1.06-3. First course blow-off with starter course staying intact. Starter course is improperly applied so there is no sealant to make contact with first course.**

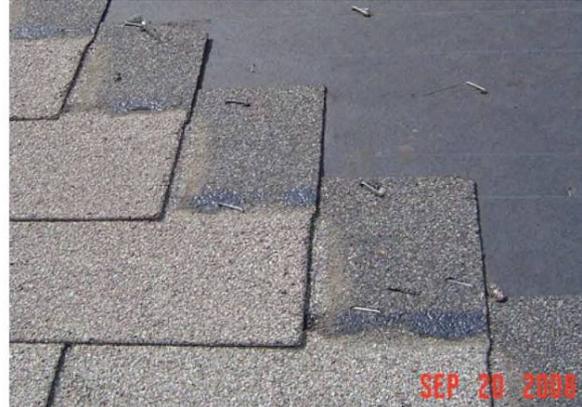
**1.06-4. Staples placed above nailing area and angled. Some staples were overdriven.**

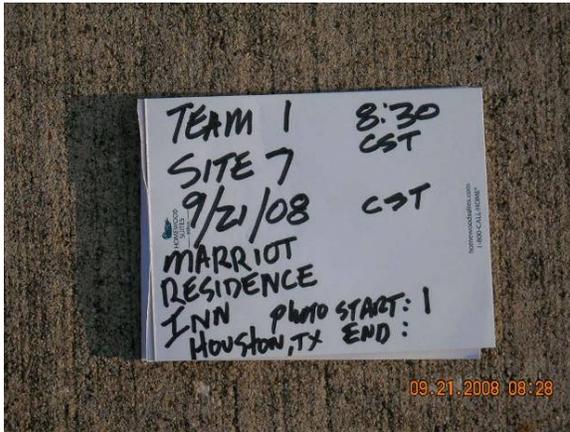
1.07-1. Site identification.

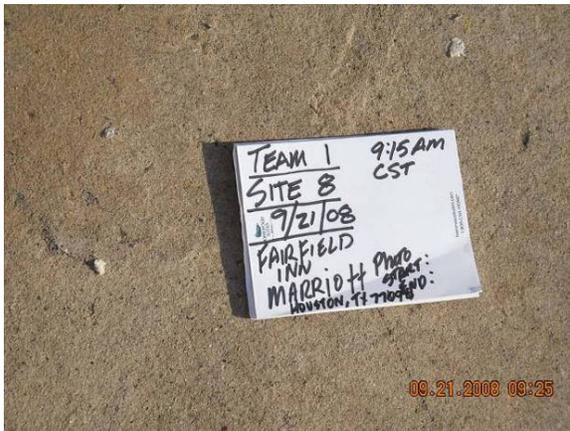
**1.08-1. Site identification.**

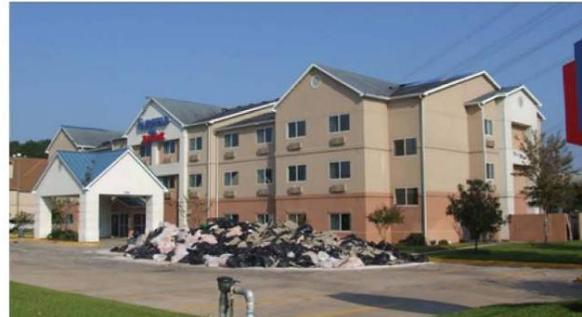
**1.08-2. Overview of facility depicting the water damaged property.**

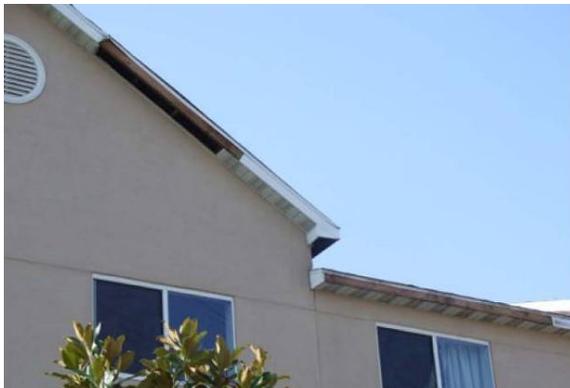
**1.08-3. Soffit and edge metal damage.**

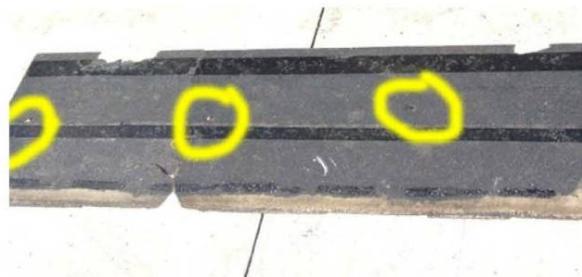
**1.08-4. Nails are placed above the nailing area (high nailed).**

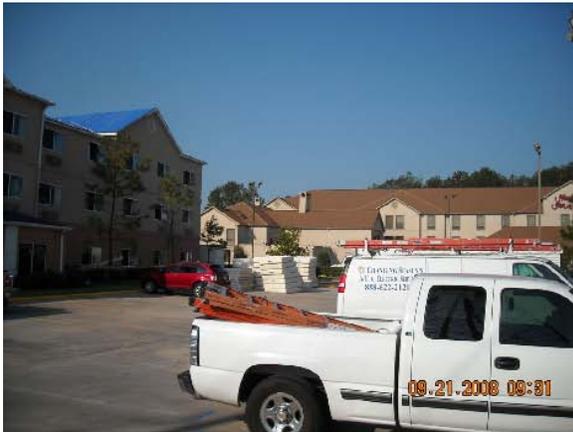
**1.08-7. Back side of hotel with temporary repairs. Water damaged mattresses are piled up outside.**

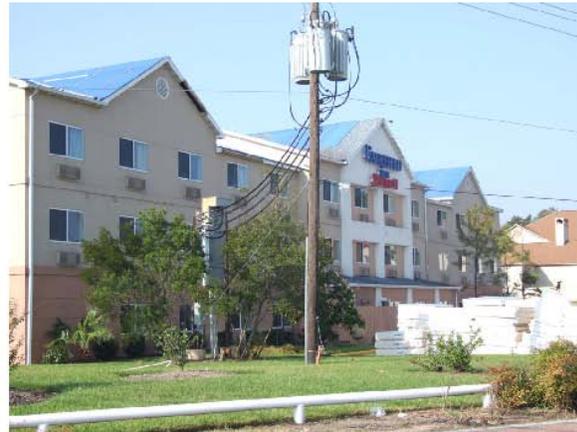
**1.08-8. Additional tarped area and more damaged contents.**

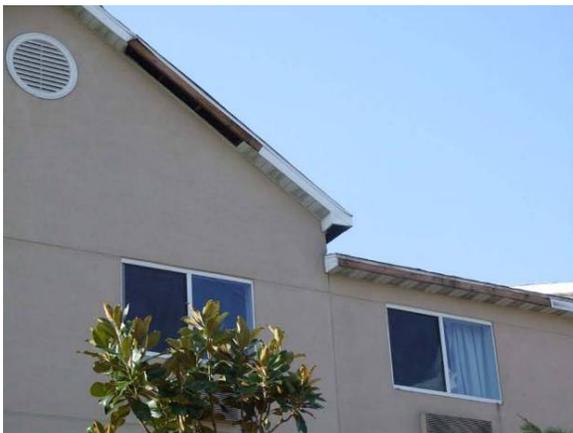
**1.08-9. Soffit damage.**

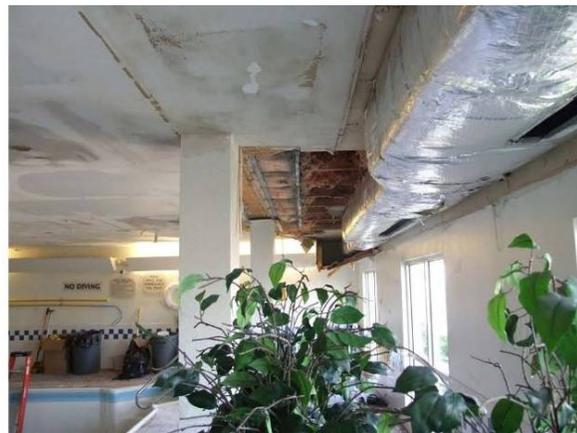
**1.08-10. Interior damage to first floor.**

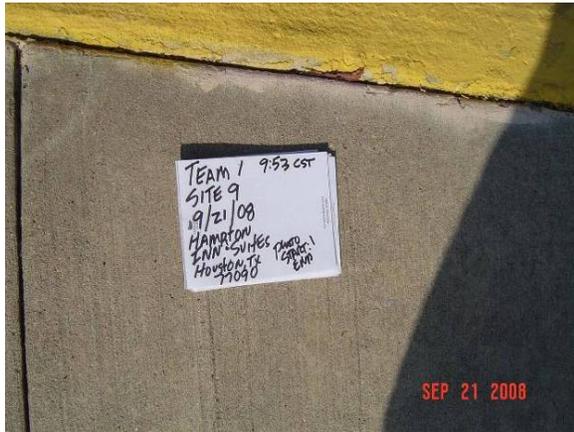
1.09-1. Site identification.

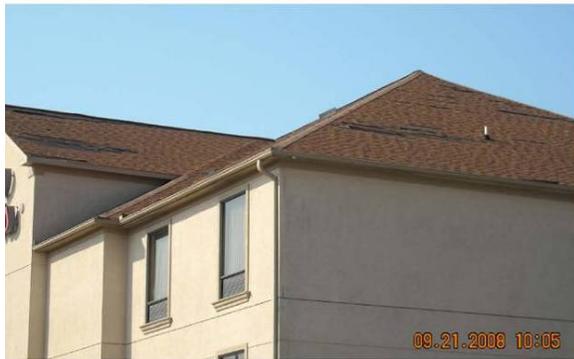
1.09-3. Damaged area.

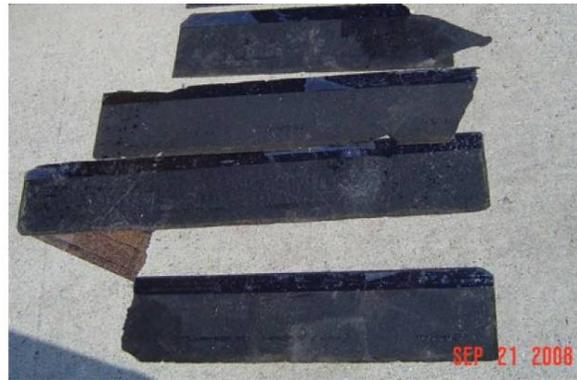
1.09-4. Shingles show little to no sealant transfer.

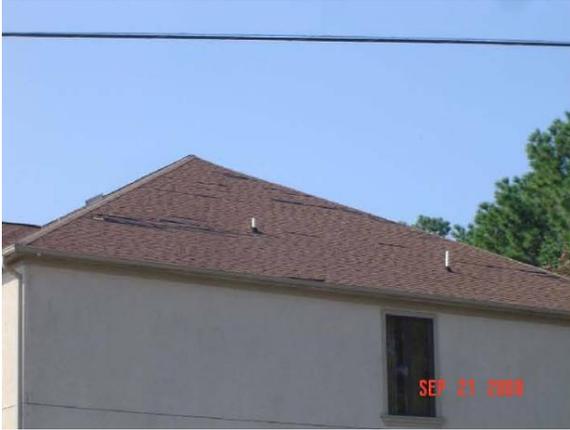
**1.09-7. Slope with damaged area.**

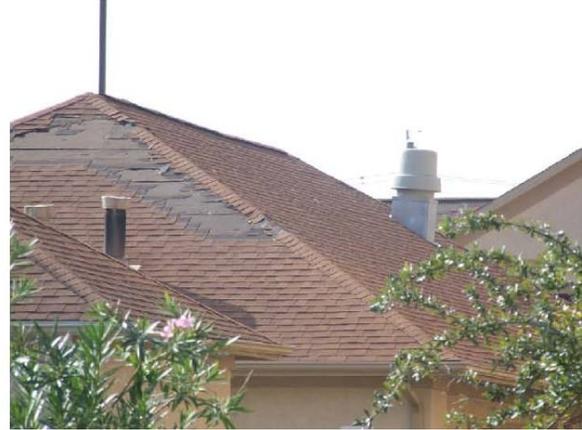
**1.09-8. Additional damaged area.**

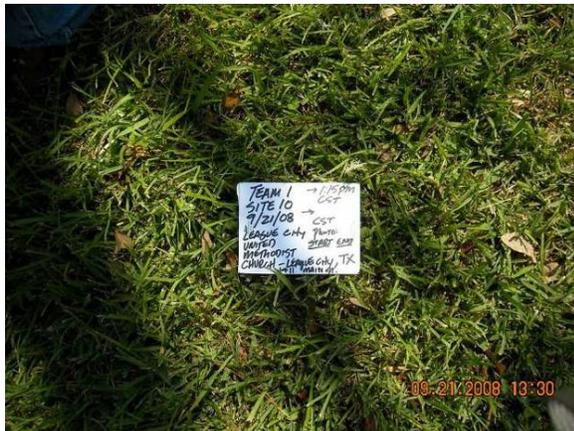
1.10-1. Site Identification.

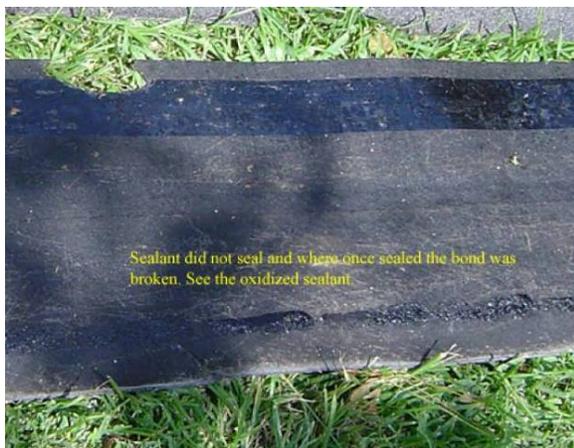
1.10-3. Some of the sealant strips did not bond; in other places where it did, the bond was broken; note oxidized sealant.

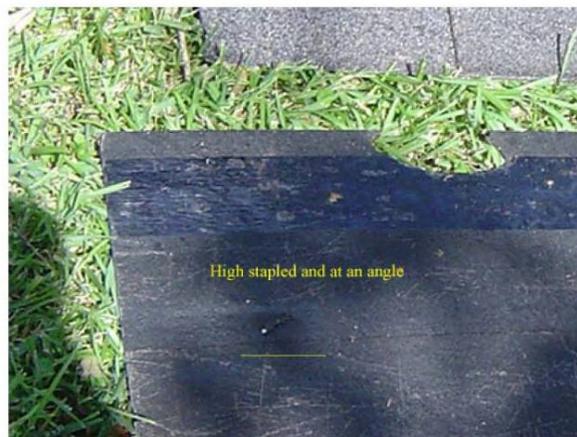
1.10-4. Some staples were installed too high and at an angle.
