# RICOWI, Inc.

Roofing Industry Committee on Weather Issues, Inc.

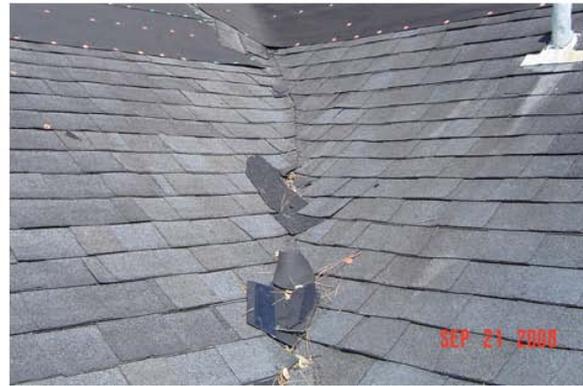
**1.10-6. Valley was previously repaired with mismatched shingles.**

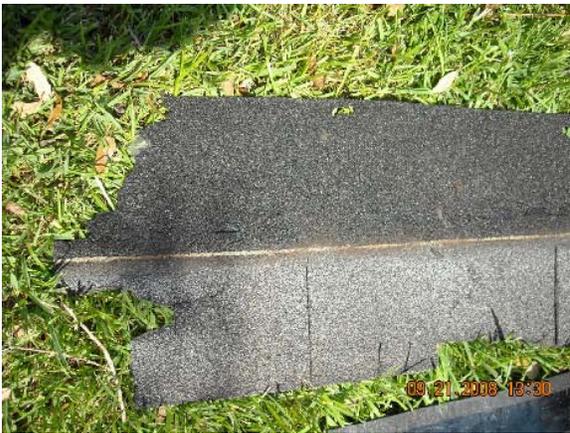
**1.10-7. Shingle with high staple.**

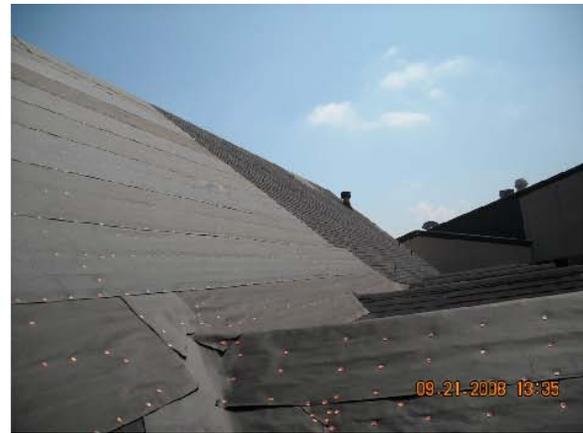
**1.10-8. View of temporarily repaired area.**

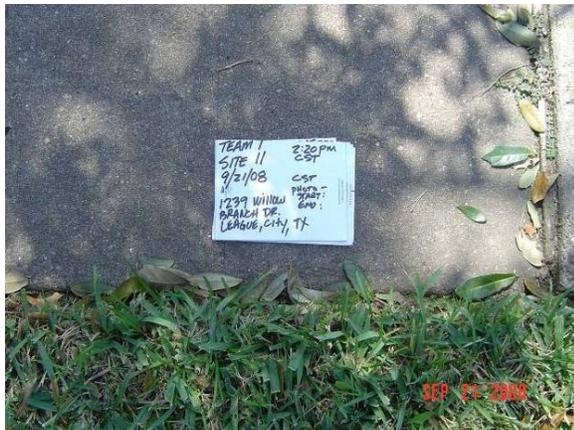
1.11-1. Site identification.

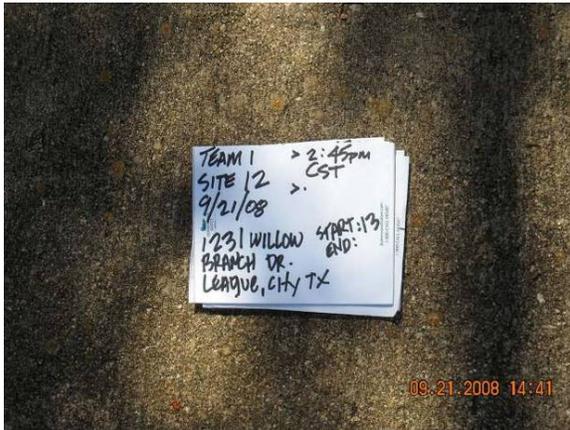
1.12-1. Site identification.

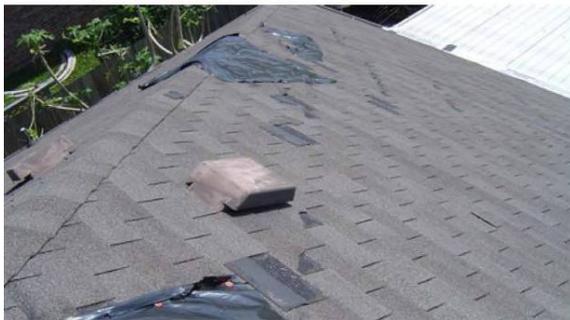
1.12-3. Damaged area of roof.

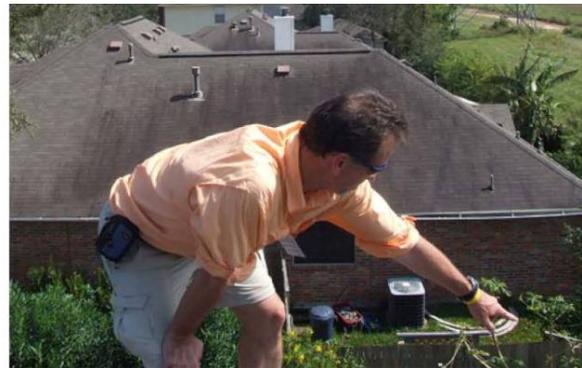
1.12-4. Inspector examines damage.

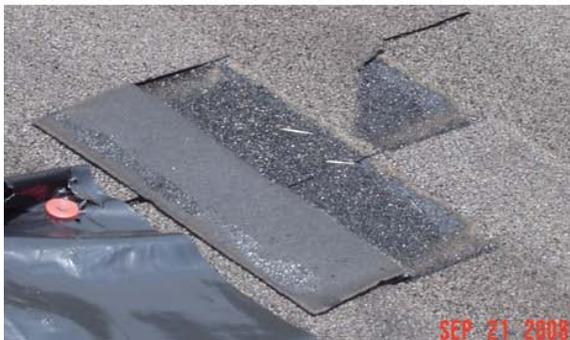
1.12-5. Staples installed in sealant and applied at an angle.

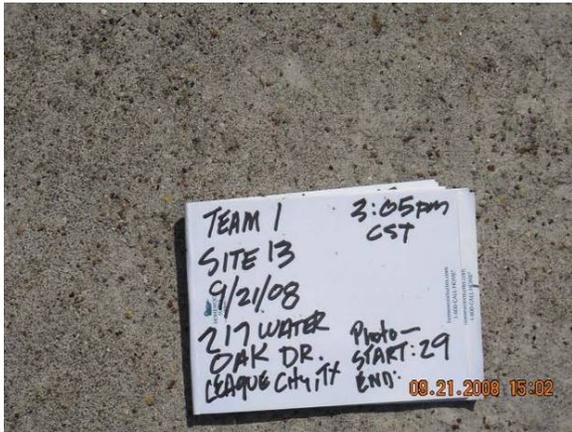
1.13-1. Site identification.

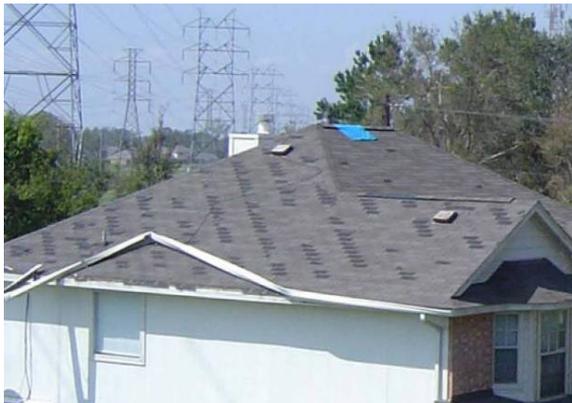
1.13-3. This photo shows a common damage pattern on 3-tab shingles.

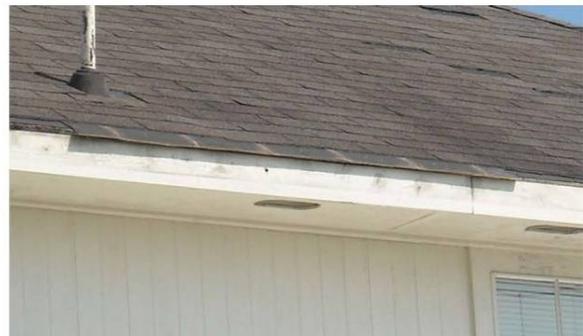
1.13-4. Excessive overhang of starter course. First course not sealed.

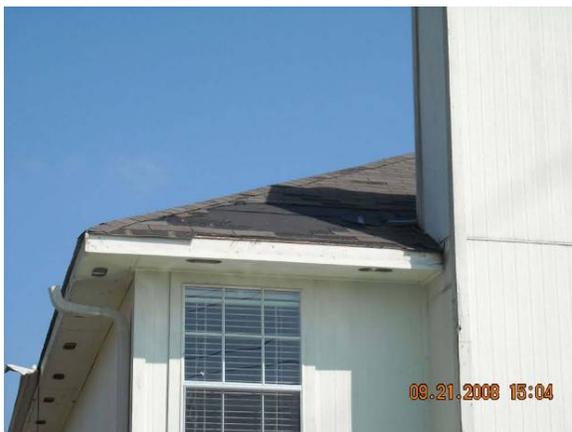
1.13-5. Corner of roof with damage.

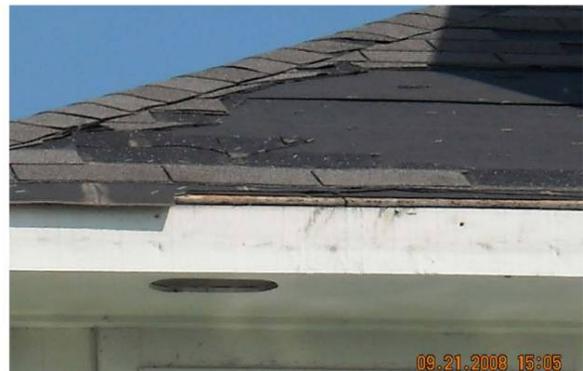
1.13-6. Close up of staple application. Starter course on eave not sealed.

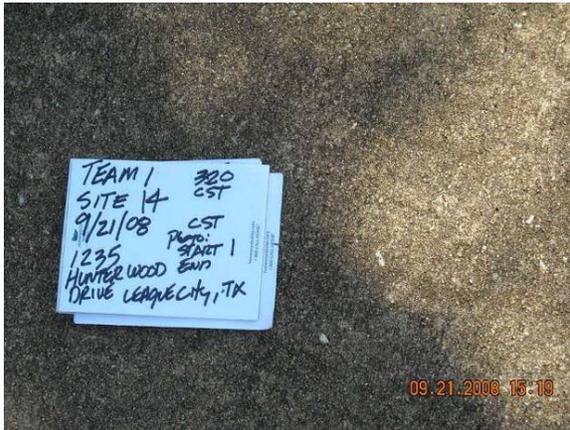
1.14-1. Site Identification.

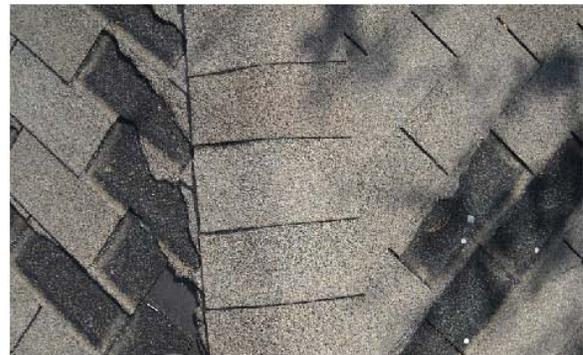
1.14-6. Field shingles damaged; ridge shingles remained intact.

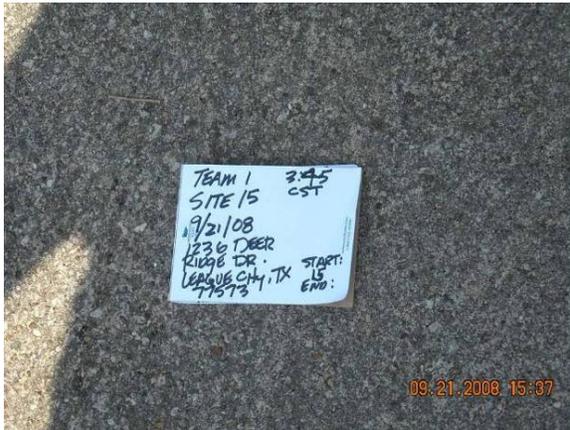
1.15-1. Site Identification.

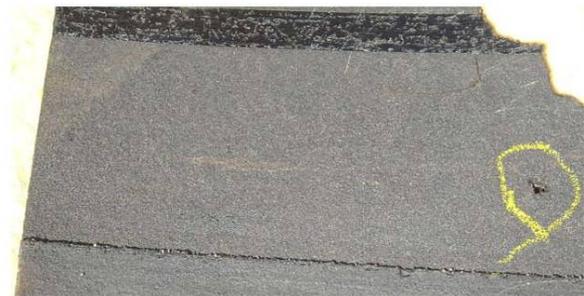
1.15-6. No nails were found within 12 in. of end of shingle.

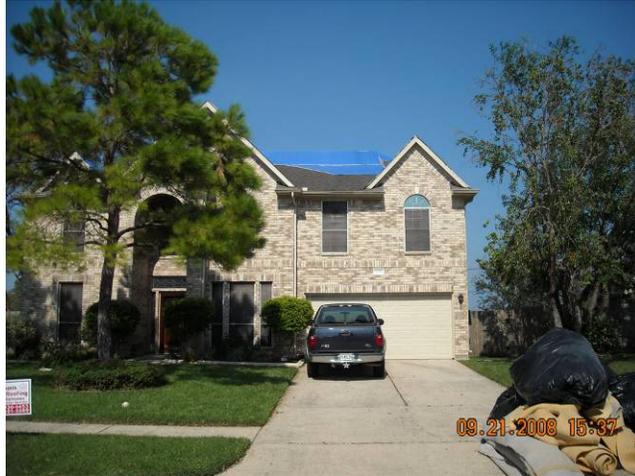
**1.15-7. Homeowner's property at curb damaged by water infiltration.**

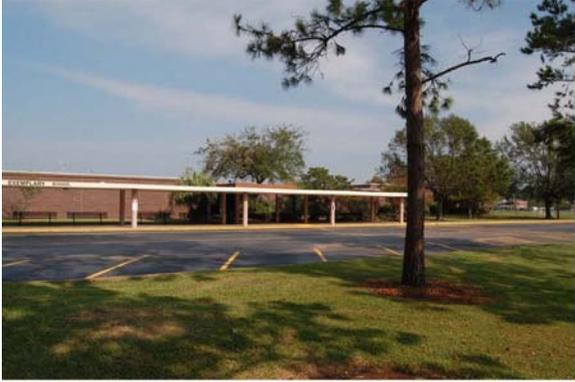
**5.01-1. South elevation of Westwood showing the southeast corner of the building.**

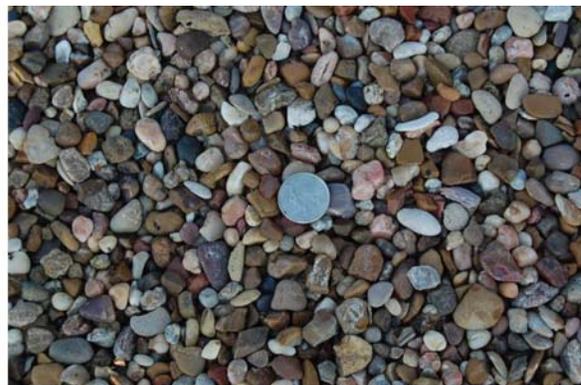
**5.01-6. Most gravel remained in place, although some wind scour was noted.**

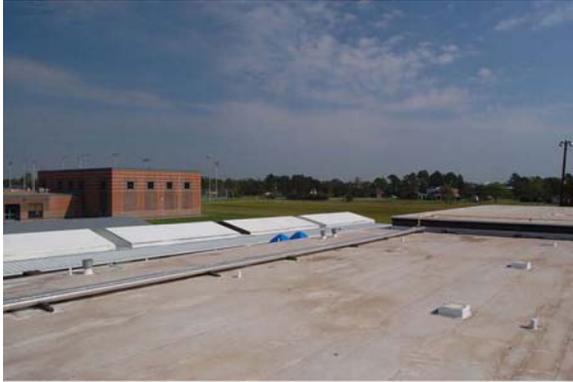
**5.01-7. This is the terrain northwest of the structure.**

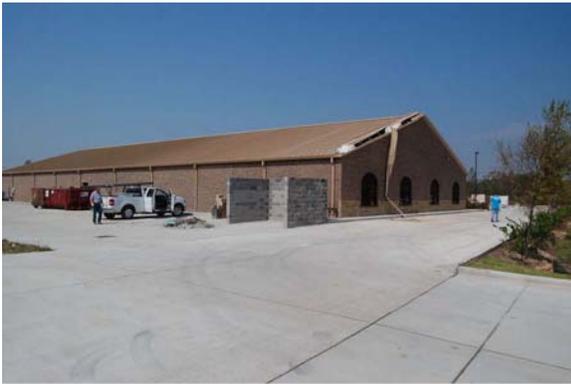
**5.02-1. View of the southeast corner.**

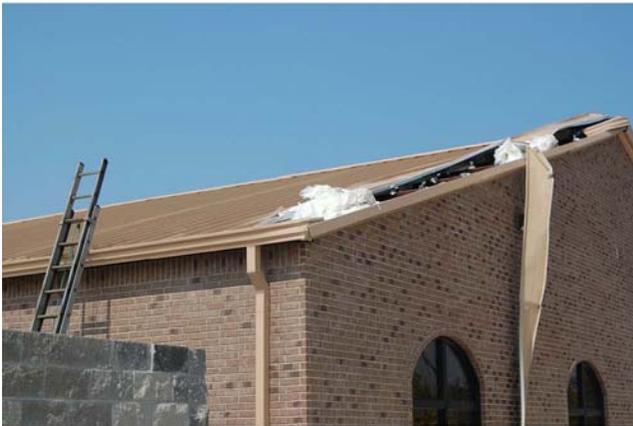
**5.02-3. A closer look of the southeast corner clearly shows panel damage along the rake edge.**

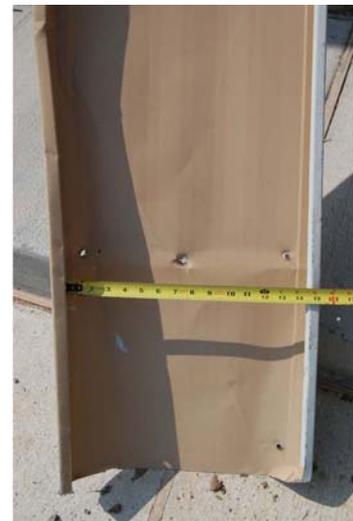
**5.02-4. Fastener (screw) "pull-through" holes can be seen in this panel near its eave end.**

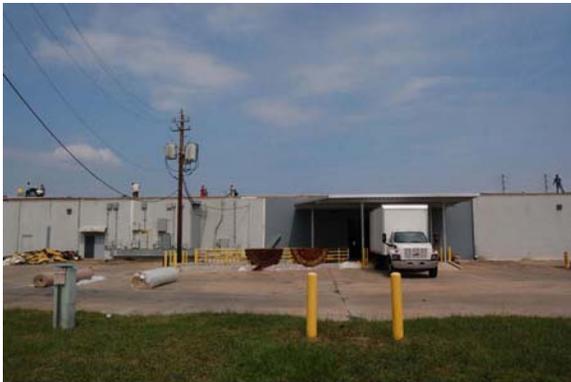
**5.03-1. South (rear) elevation - center section.**

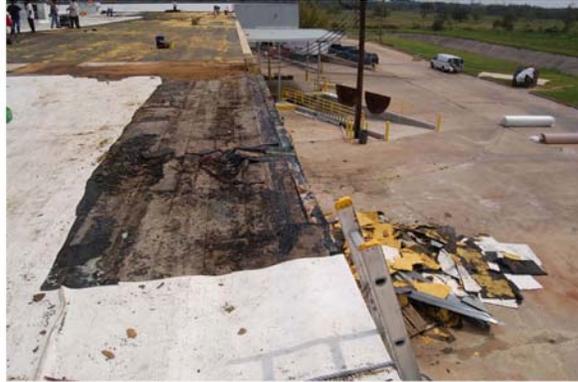
5.03-4. South edge of roof; much of damaged roof removed by re-roofing company.

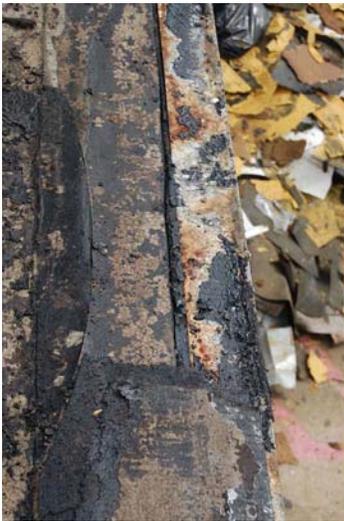
5.03-5. South edge of roof; note rust & deterioration.

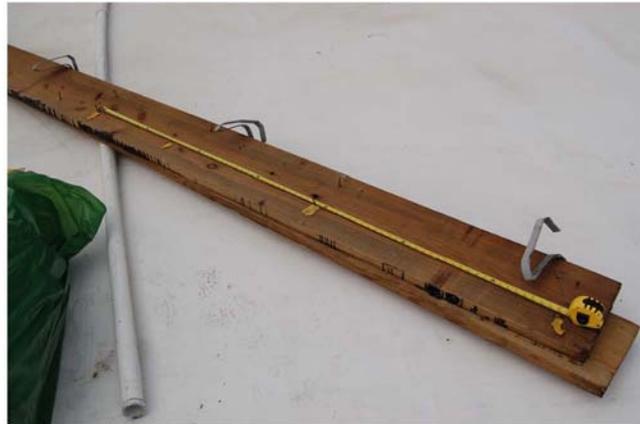
5.03-6. Original 2 in. x 12 in. edge plank.

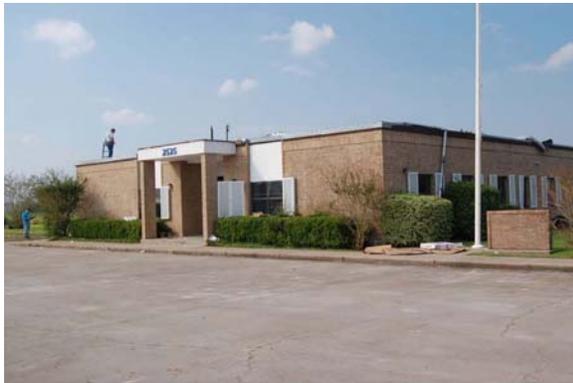
5.04-1. A ground view of the southwest corner.

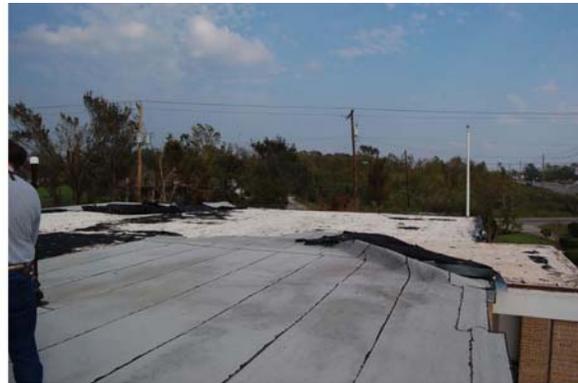
5.04-2. View of the roof is from the southwest corner; note damage at far right.

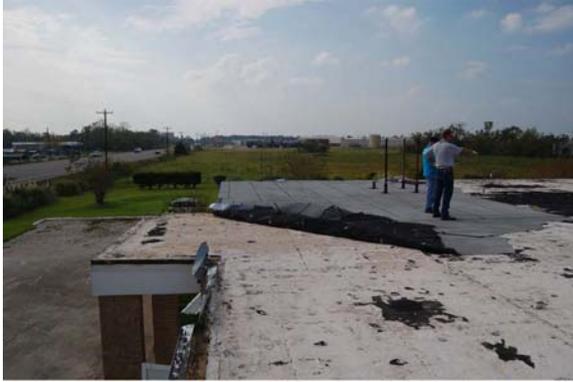
**5.04-3. More damaged roofing is visible from the southeast corner.**

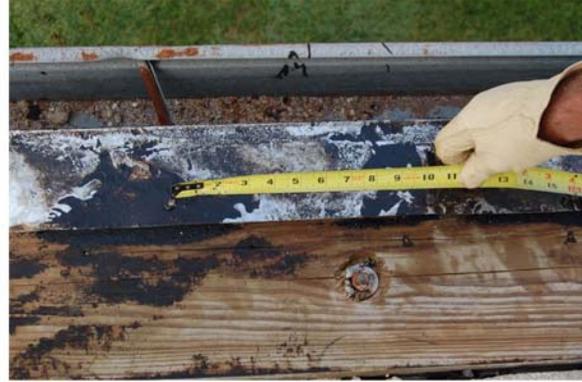
**5.04-4. Remaining edge metal fasteners were spaced 10 in. - 14 in. o.c.**

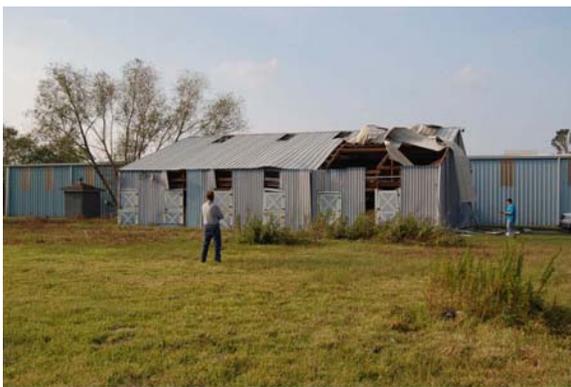
**5.05-1. South elevation; note damage at right end.**

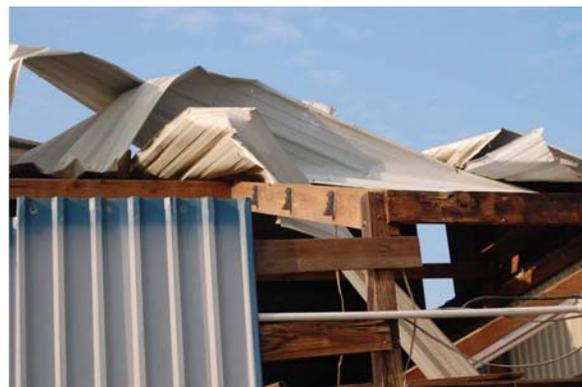
**5.05-2. A roof joist with purlin hangers is visible in the area of loss.**

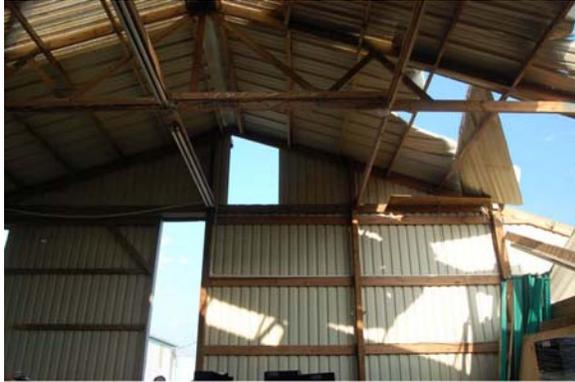
**5.05-3. Interior view of roof damage.**

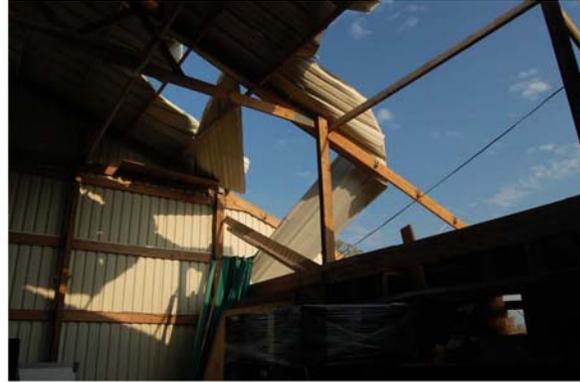
**5.05-4. Joists and purlin hangers are clearly seen from the interior.**

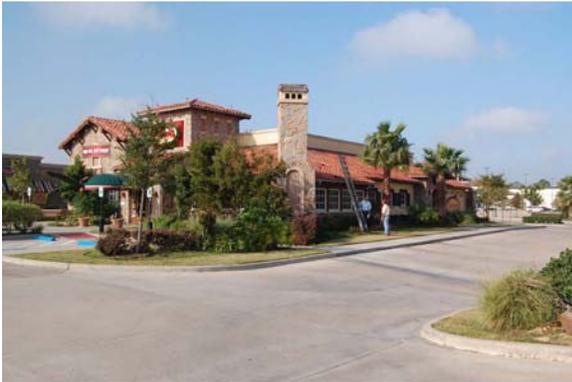
**5.06-1. View of the southeast corner.**

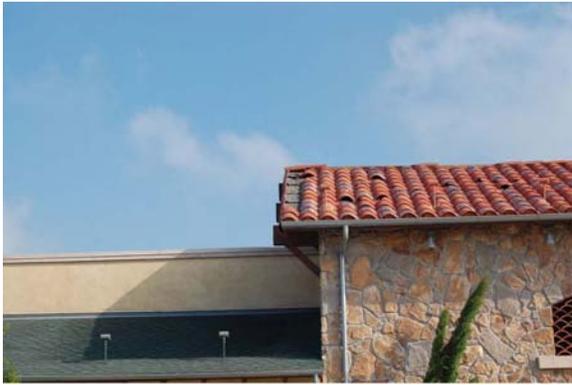
**5.06-3.** Note damage along the rake on the west elevation.

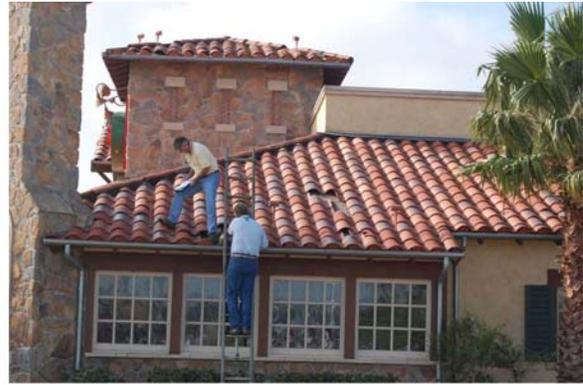
**5.06-4.** East elevation also exhibits damaged tile.

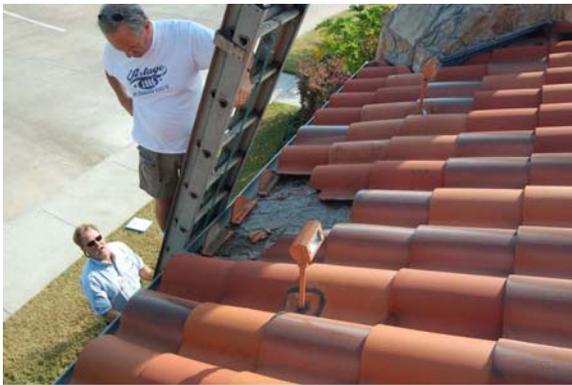
**5.06-5.** A close-up view of the eave on the eastern edge of the main roof.

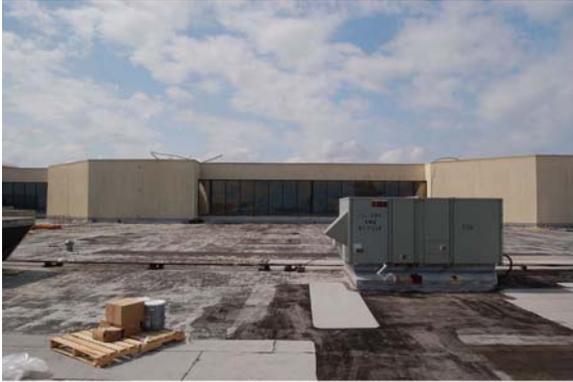
**5.07-1.** A partial south elevation shows damaged upper roofs from a lower level.

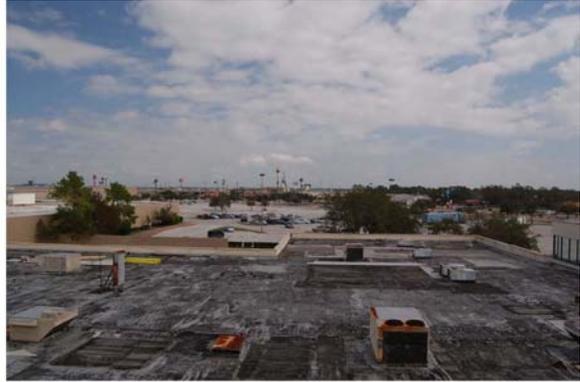
**5.07-2.** A lower, undamaged roof and terrain south of a damaged roof.

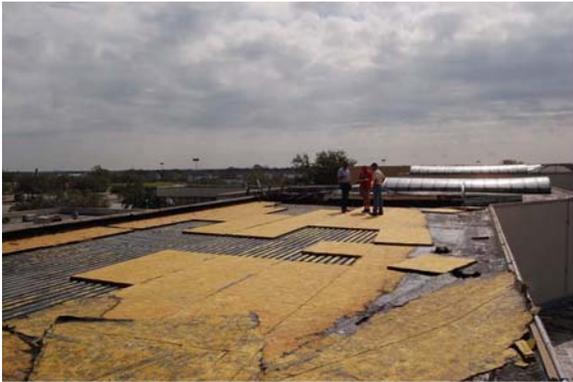
**5.07-3.** View of damaged roof #2 from the northwest corner.

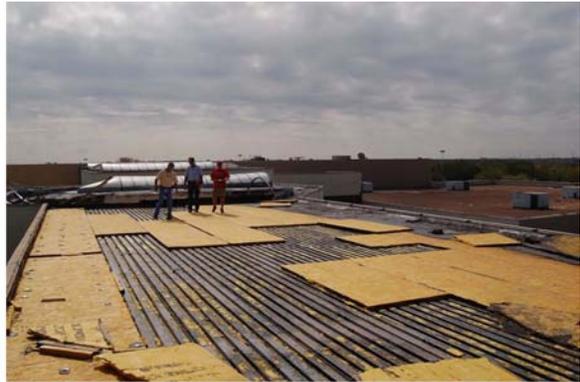
**5.07-4.** This is the same roof from the northeast corner.

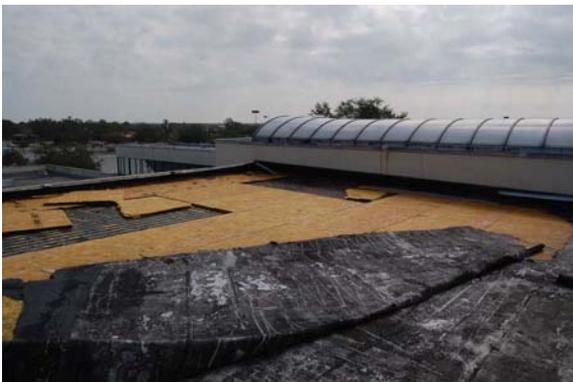
**5.07-5.** Widespread blow-off damage occurred to roof #3 (from northwest corner).

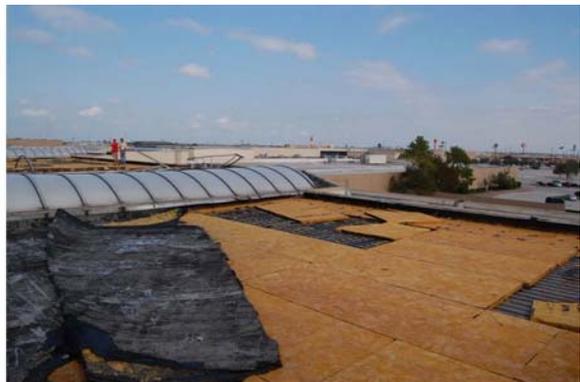
**5.07-6.** This is damaged roof #3 from the southwest corner. Roof #2 is in the background.

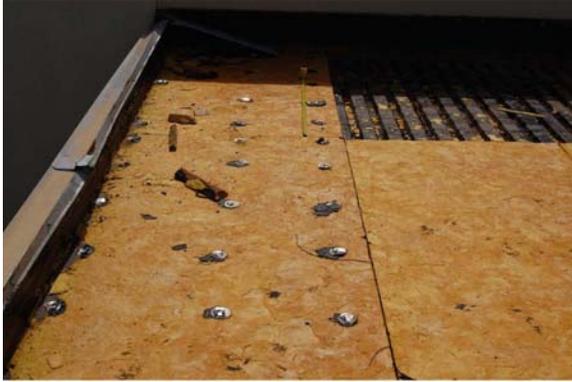
**5.07-7. Fasteners in the first row of insulation panels are visible on the east side of roof #3.**

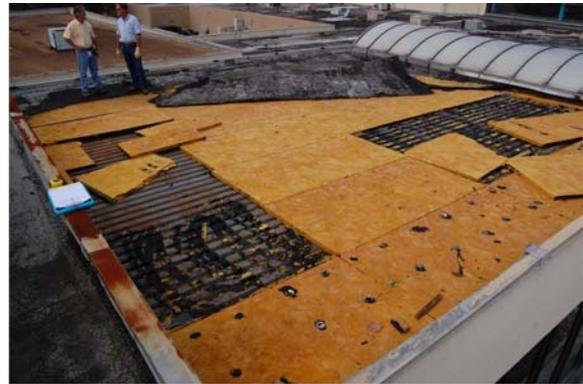
**5.07-10. Damage on roof #3 (southeast to northwest view).**

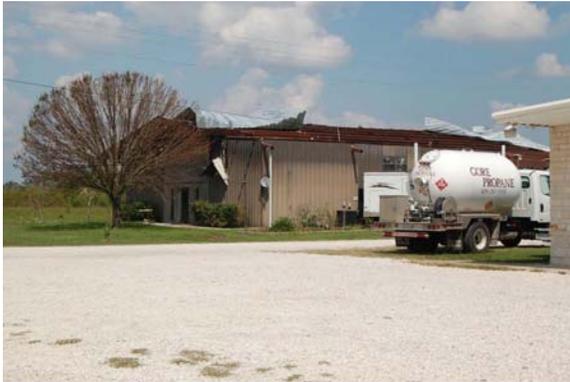
**5.08-1. View of the southwest corner.**

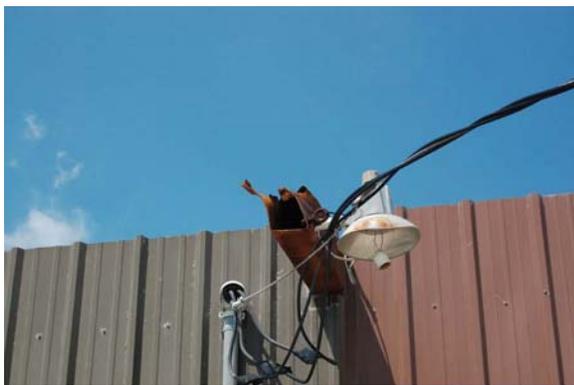
**5.08-9. A broken weld at the connection of eave purlin-to-rafter on the south (front) elevation.**

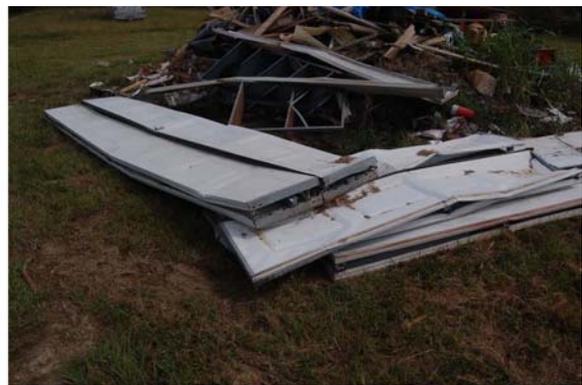
**5.08-10. Blown out garage doors now lie in a "scrap pile."**

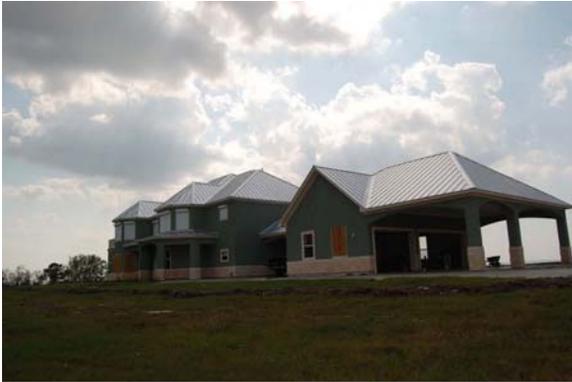
**5.09-1. View from the northeast.**

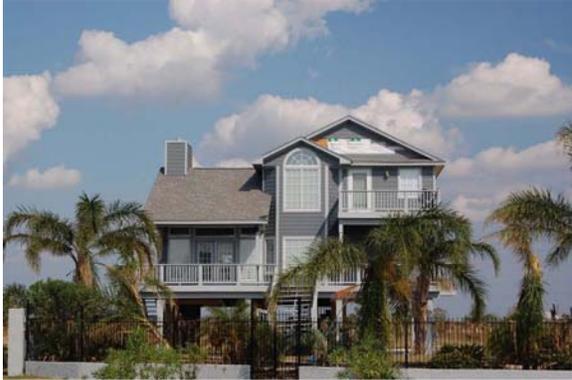
**5.10-1. West elevation had a bay exposure.**

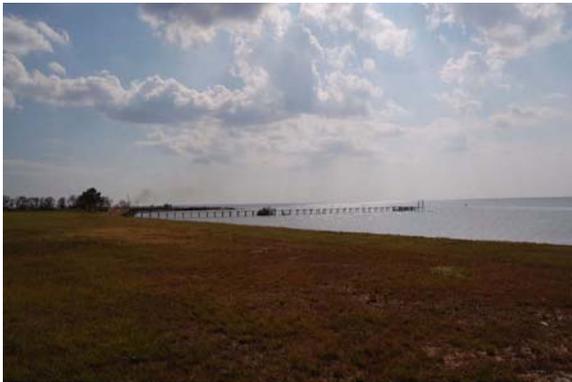
**5.10-3. More open terrain was noted southeast of the house.**

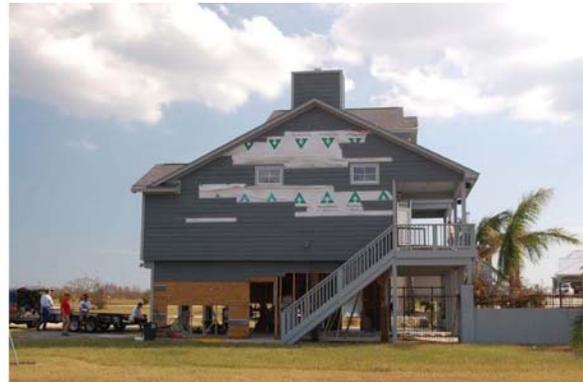
**5.10-4. North elevation. Note conspicuous siding damage.**

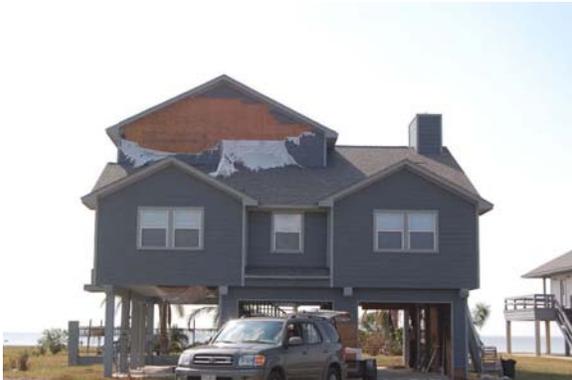
**5.10-5. Photo shows both siding and roof damage on the upper section of the east elevation.**

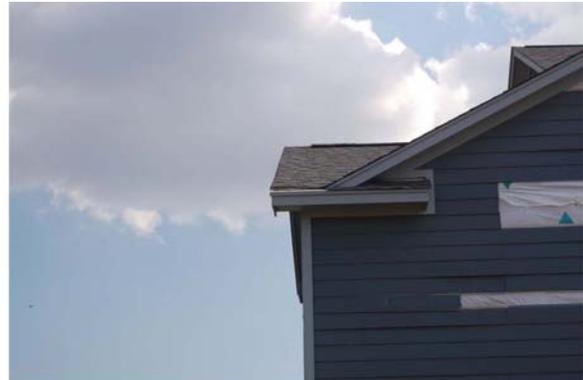
**5.10-6. Minor roof damage is visible at the northeast corner.**

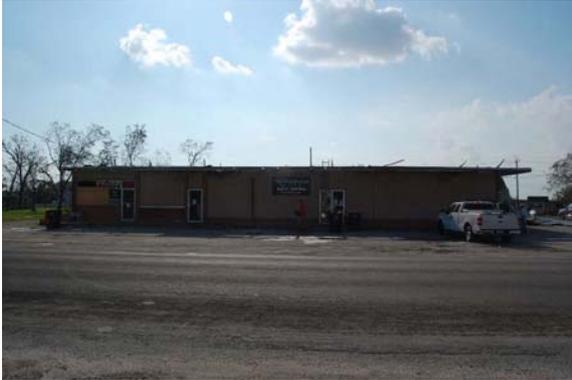
**5.11-1. View of east elevation.**

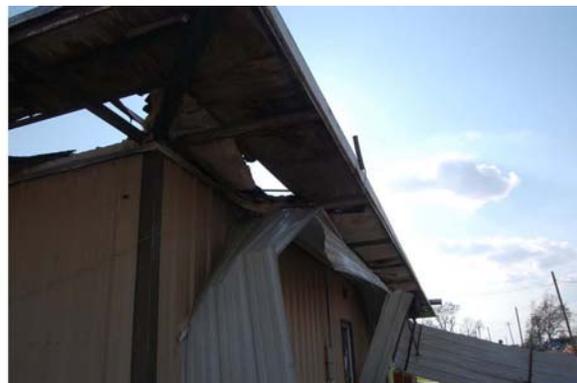
**5.11-4. Tectum soffit panels are visible at the northeast corner. Damage is believed to have started along the east side.**

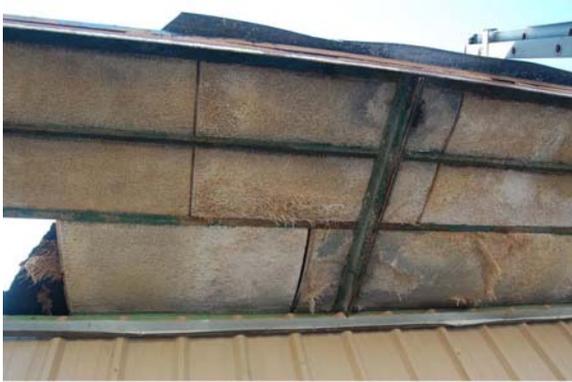
**5.11-5. View of a soffit on the east side. Winds appear to have infiltrated and pressurized the roof through these soffits.**

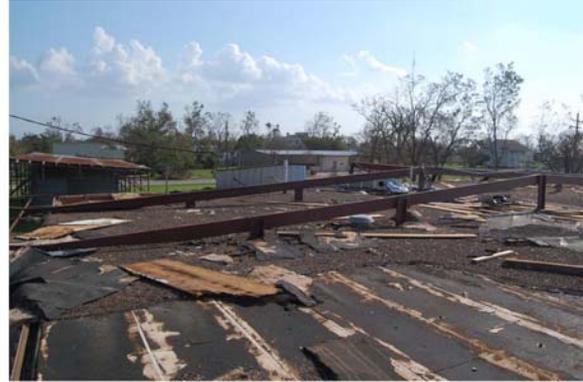
**5.11-6. View from the northeast corner.**

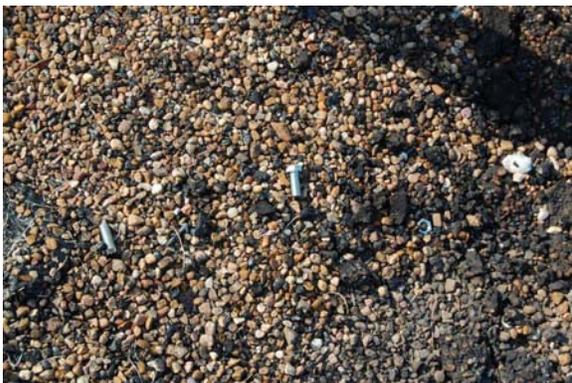
**5.11-9. Loose rafter fasteners found on BUR surface appear to have never been installed, or backed-out prior to roof blow-off.**

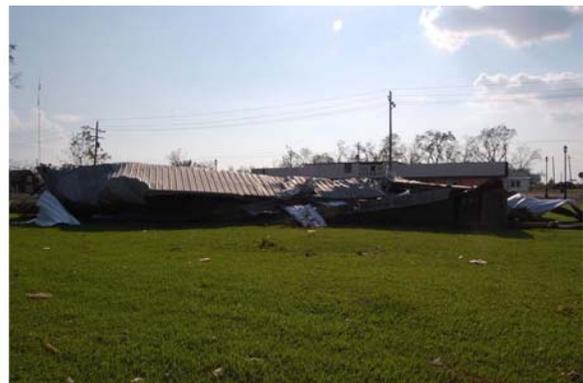
**5.11-10. The blown off roof was found behind the structure.**

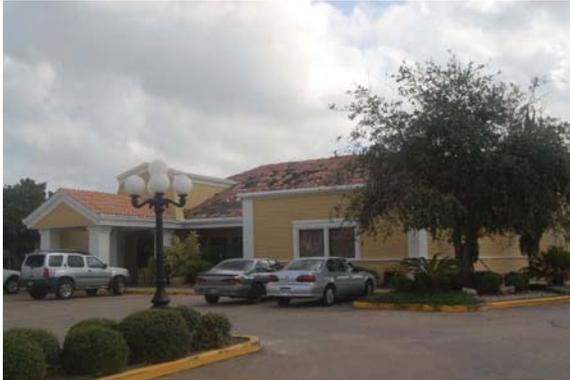
**5.12-1. View of the southwest corner.**

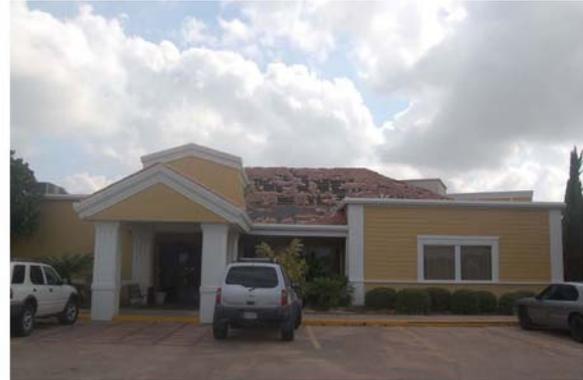
**5.12-2. West elevation; note conspicuous shingle damage (center).**

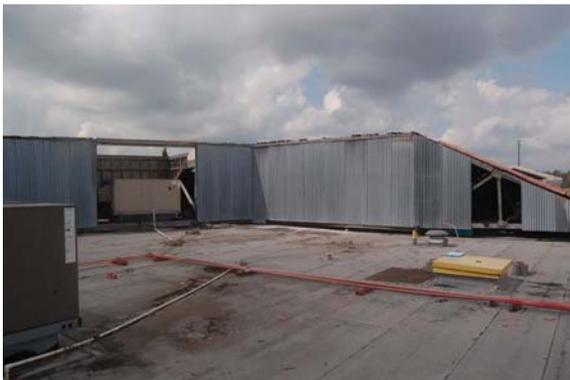
**5.12-3. Rear of the shingled equipment screen.**

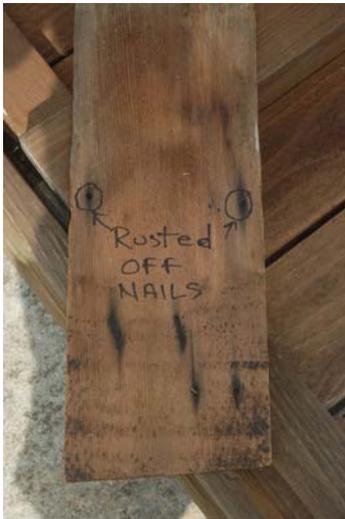
5.12-7. On the underside of this blown-off shingle, fasteners were rusted through, offering little pull-out resistance.

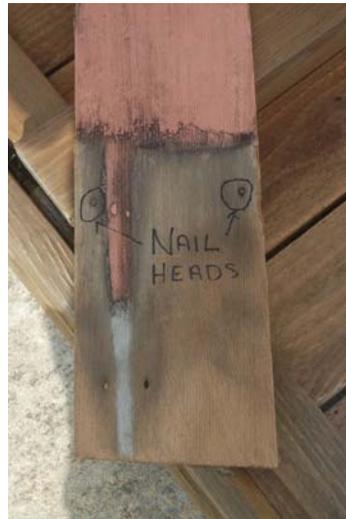
5.12-8. Visible here are nails in a blown-off shingle.

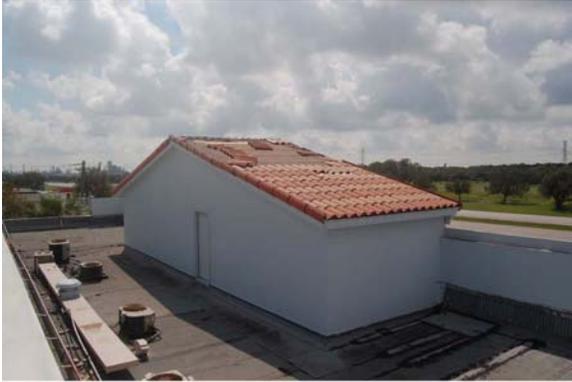
**5.13-1.** View of the pressed fiberboard tile roof is from the northeast corner.

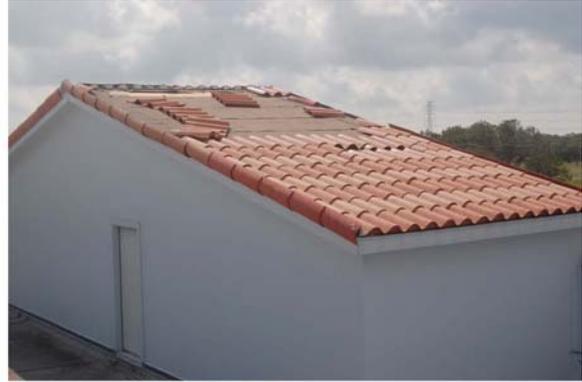
**5.13-2.** A closer look at the tiled roof from the same corner. Note missing tiles.

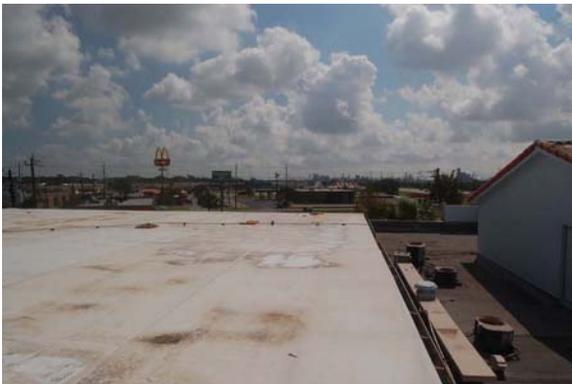
**5.13-3.** View of terrain south of this roof.

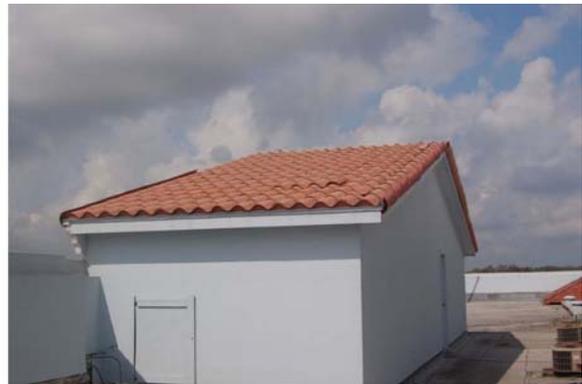
**5.13-4.** View from the southeast corner shows less tile damage on the south elevation.

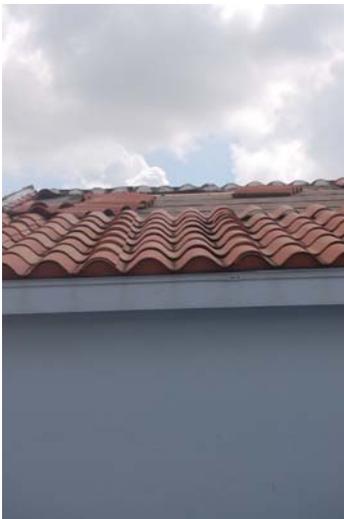
**5.13-5.** The eave and tiled roof on the north elevation.

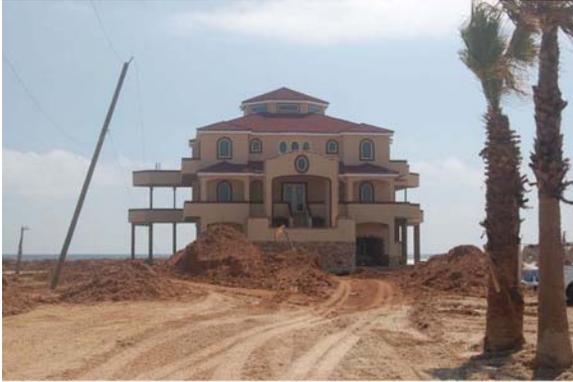
**5.14-1.** North elevation shows the Gulf of Mexico in the background.

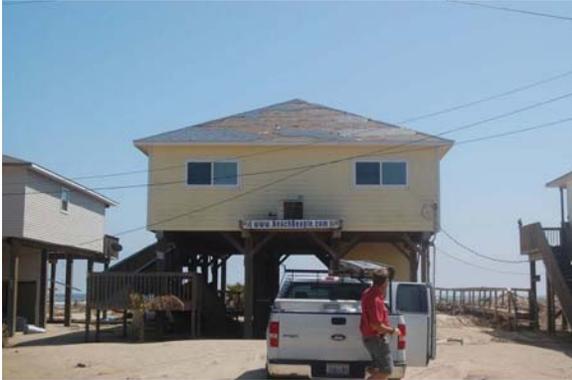
**5.15-1. North elevation.**

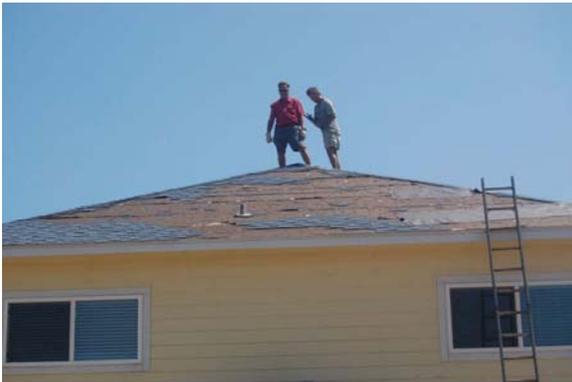
**5.15-3. Damage on the north side of the roof.**

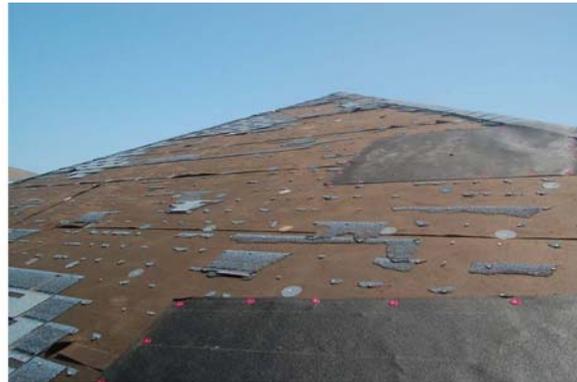
**5.15-4. A closer look at roof damage on the north side.**

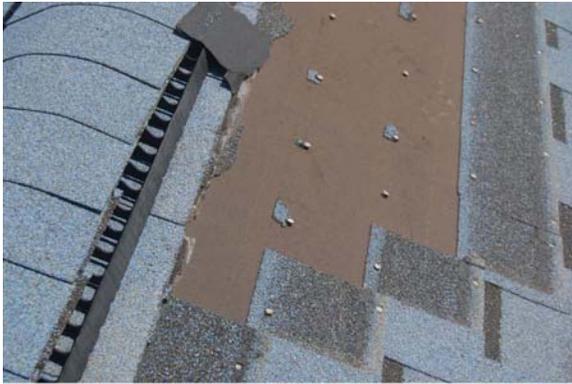
**5.15-5. Over-driven nails near the ridge.**

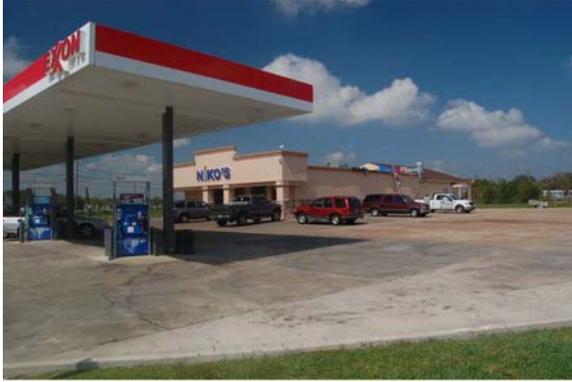
5.16-1. Orientation from the northwest corner.
