Hailstorm Investigation North Texas

Hail size analysis of April 11, 2016, storm courtesy of CoreLogic  
Hail photos courtesy of Sherry & Don Takak

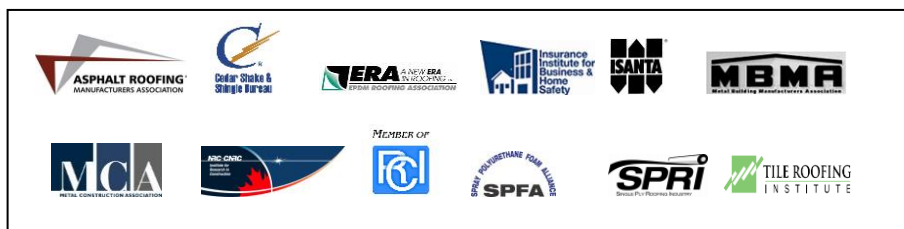
This document is disseminated for informational purposes only and all rights reserved by RICOWI. This document shall not be reproduced in whole or in part without written permission from RICOWI.

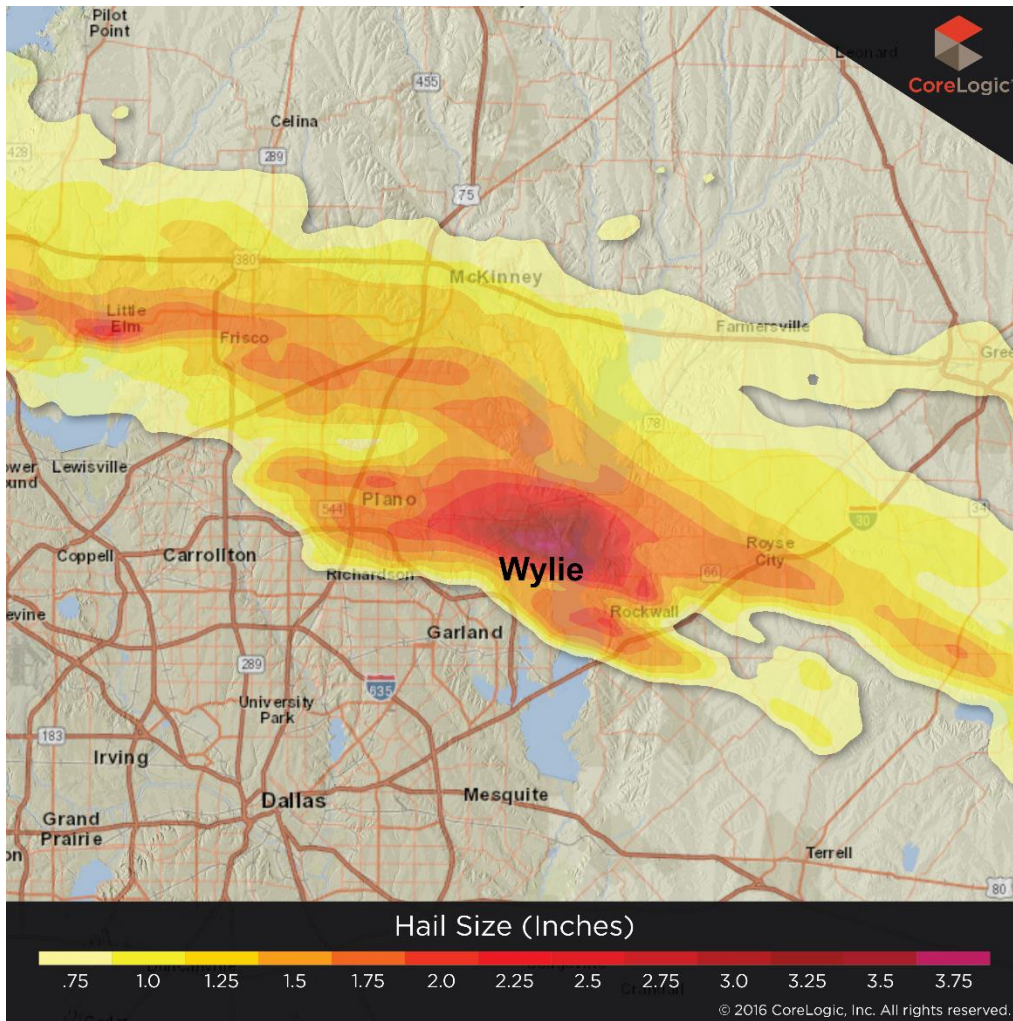
Figure 1. Zoomed view of eastern Collin County where hail size was largest (courtesy of CoreLogic®).

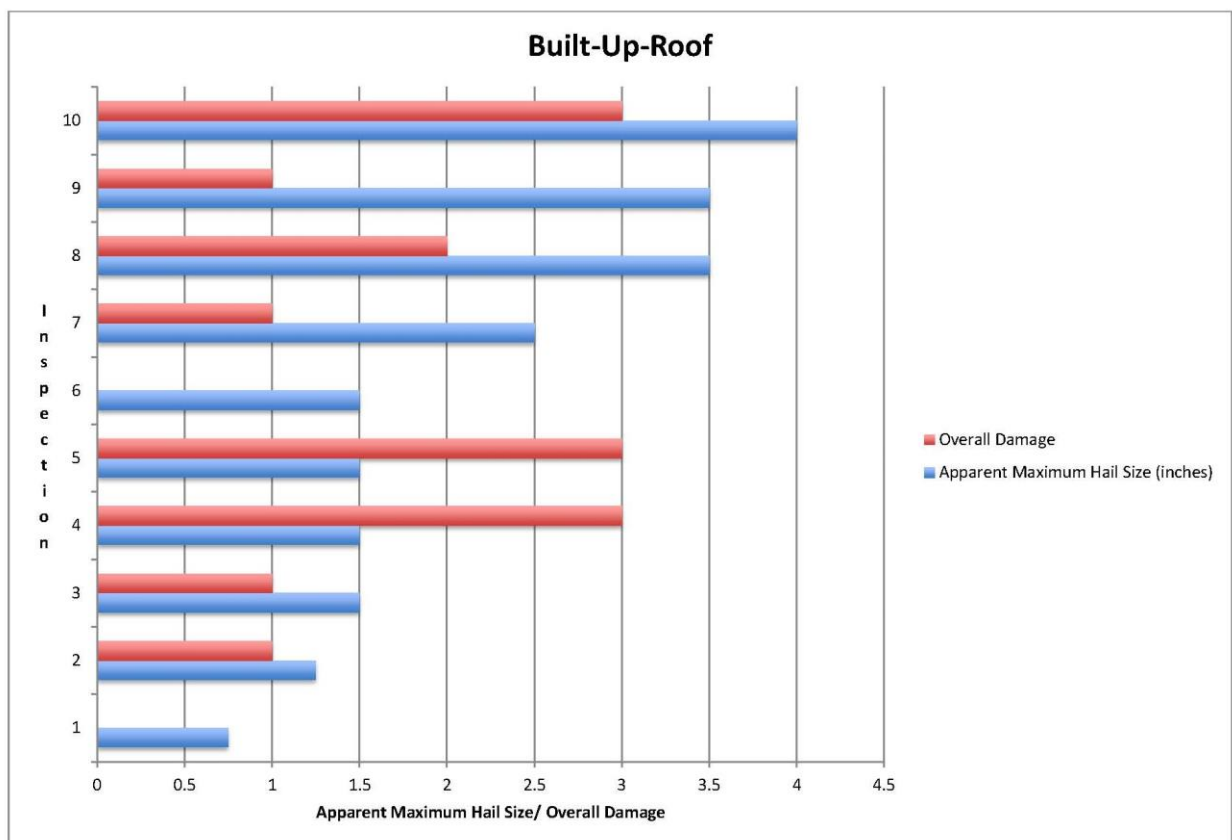
Figure 2. Maximum hail size versus damage rating for built-up roofing inspections.

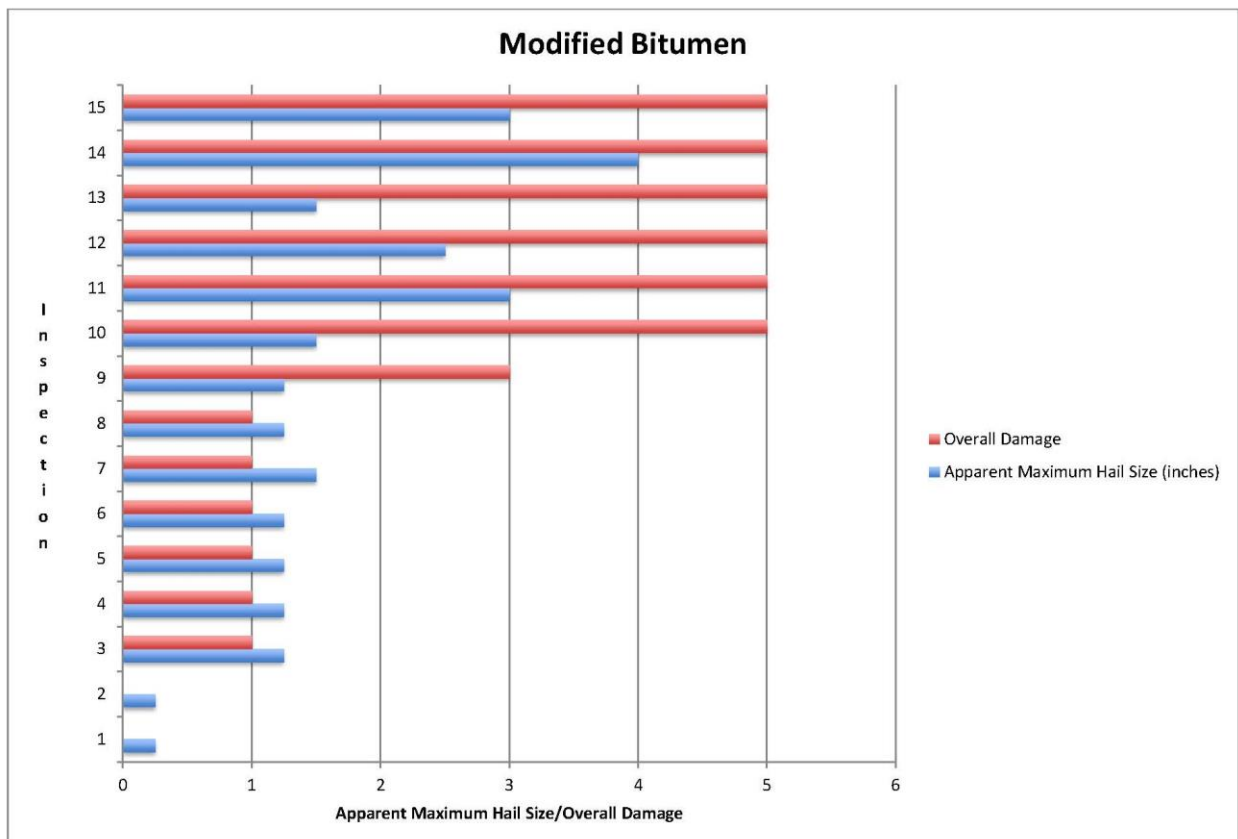
Figure 3. Maximum hail size versus damage rating for modified bitumen membrane inspections

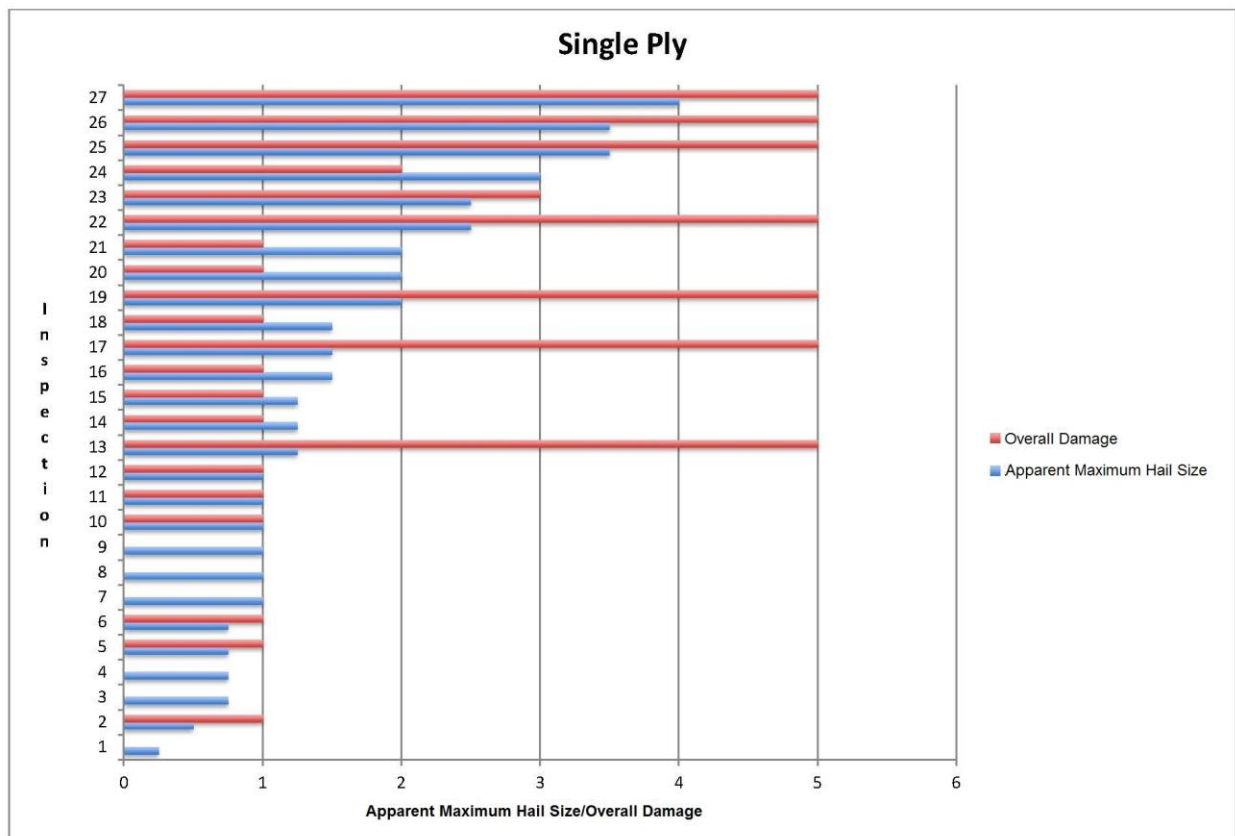
Figure 4. Maximum hail size versus damage rating for single-ply membrane inspections

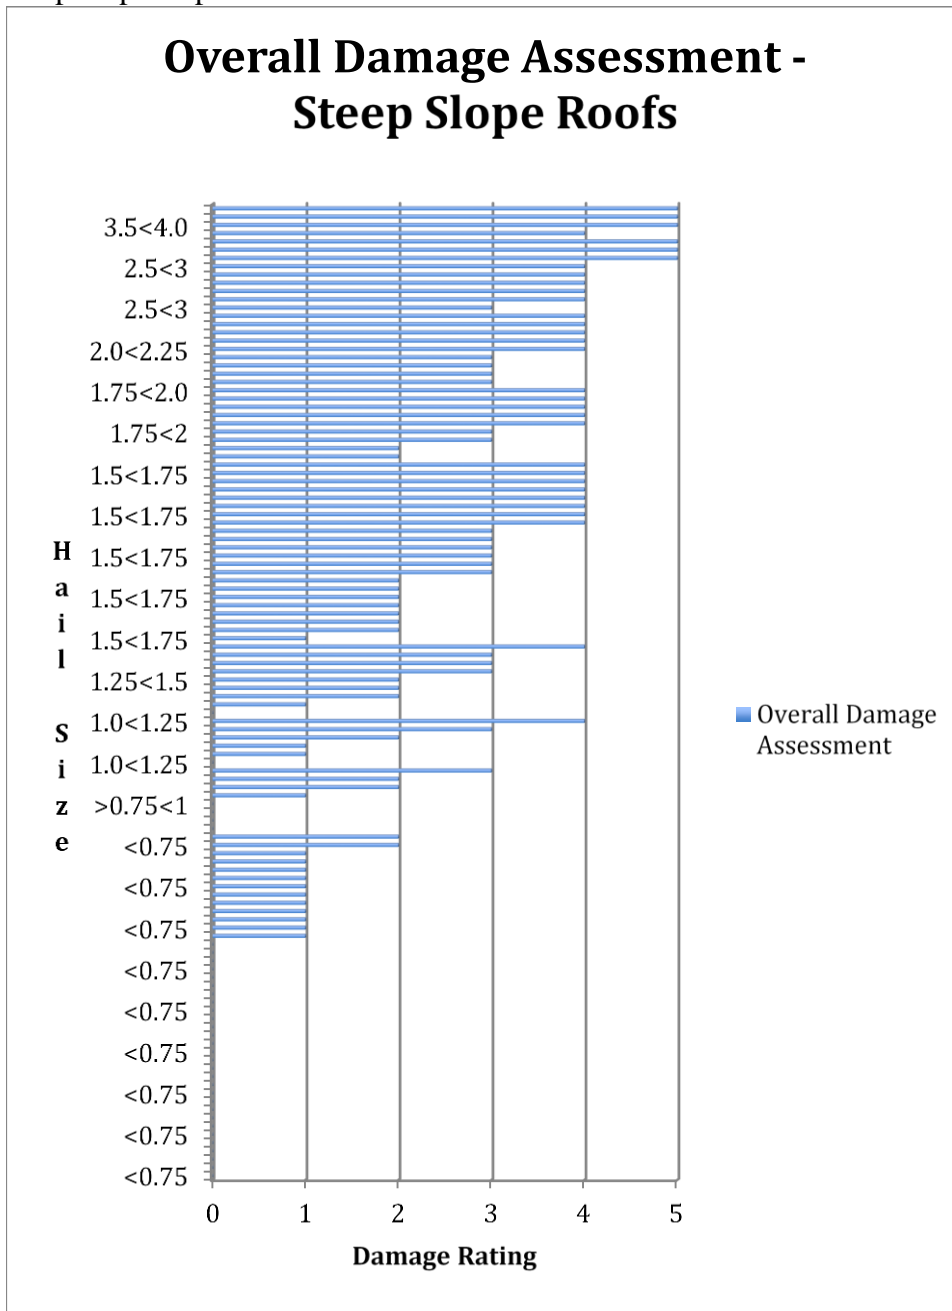
Figure 7. Maximum hail size versus damage rating for steep-slope inspections (nearly all asphalt shingles)

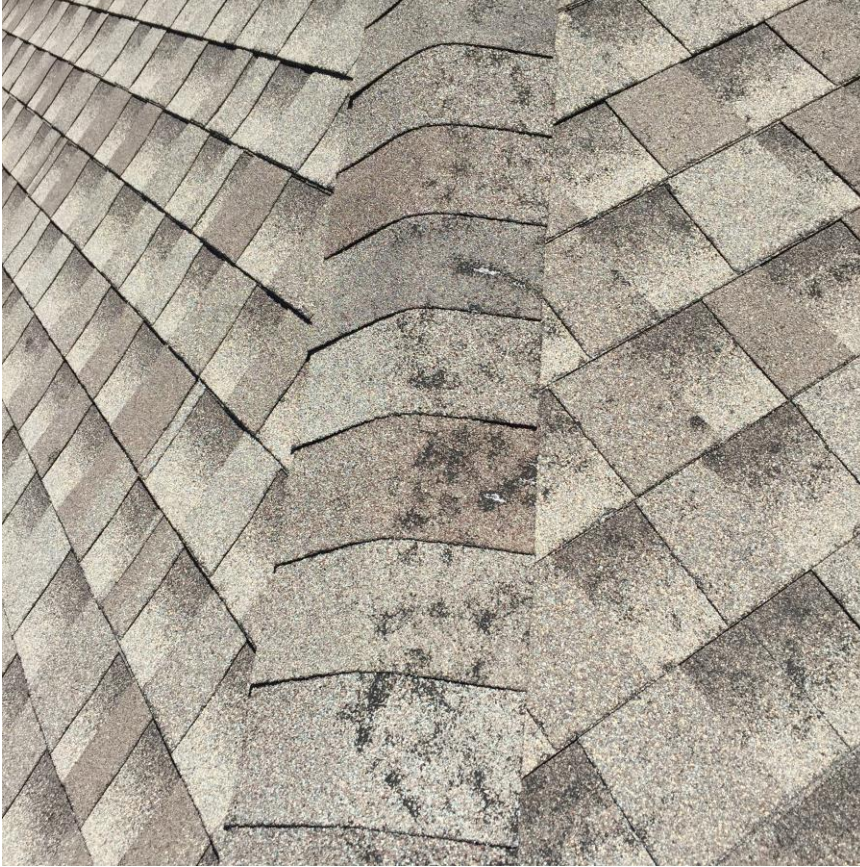
Figure 8. The quantity and wind-driven nature of the hail is visible on the asphalt shingles at a hip.

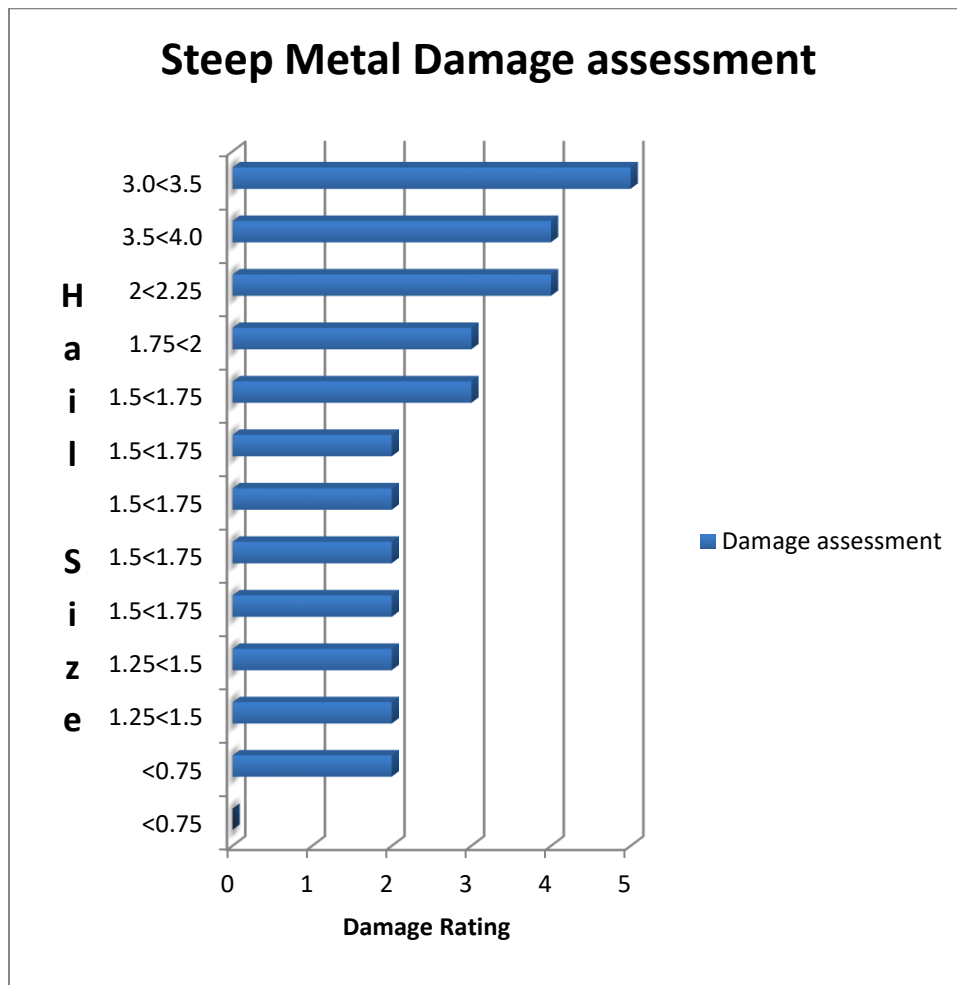
Metal roofing on steep-slopes performed well. Thirteen roofs were inspected; one roof was exposed to hail less than 0.75-inch and was not dented nor otherwise damaged. One roof was exposed to 3.0-3.5 inch hail and was significantly damaged with distortion of the overlap seams. The other 11 roofs had noticeable dents, but no fractures were found in the metal and no seams had been opened. The denting of the metal would be considered a cosmetic condition only.

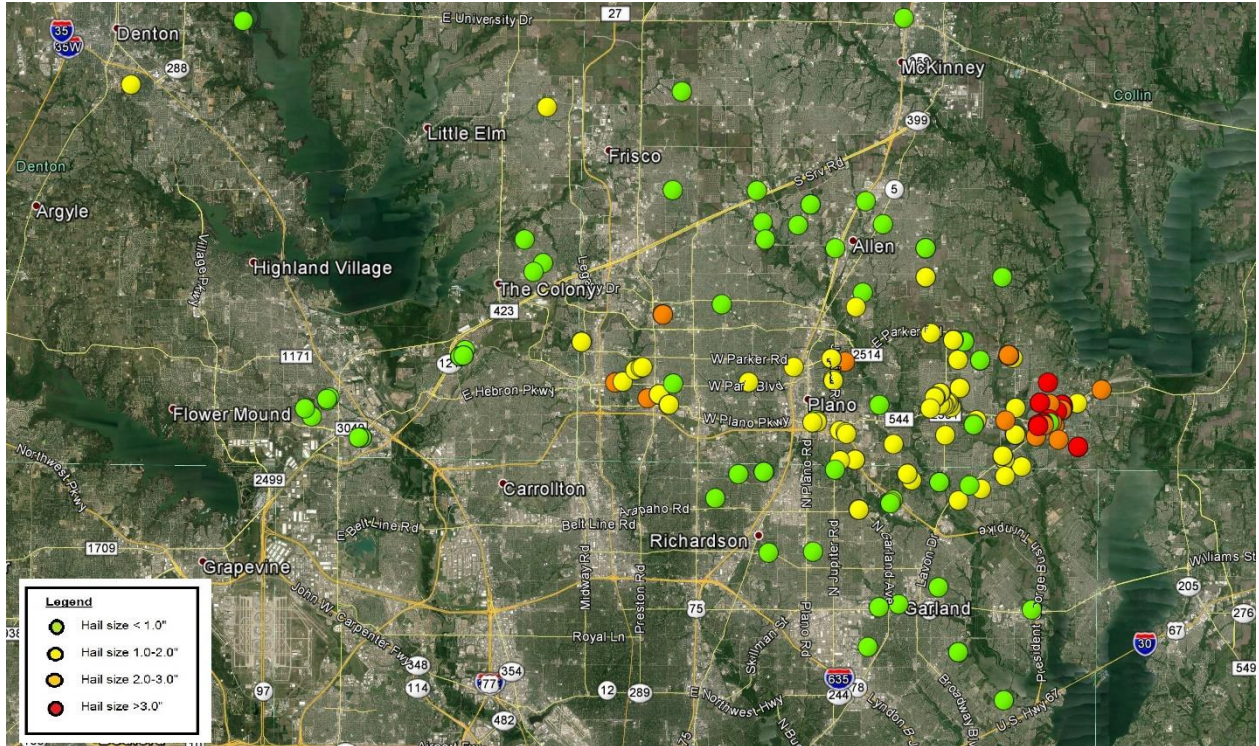
Figure 9. Plot of inspection sites with estimated maximum hailstone sizes.

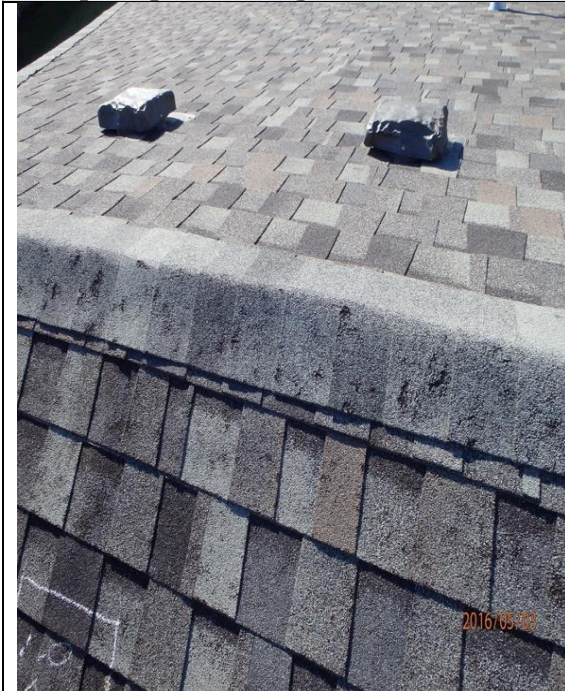
**Ridge units with hailstone impact damage. Note: Damaged vent covers.**

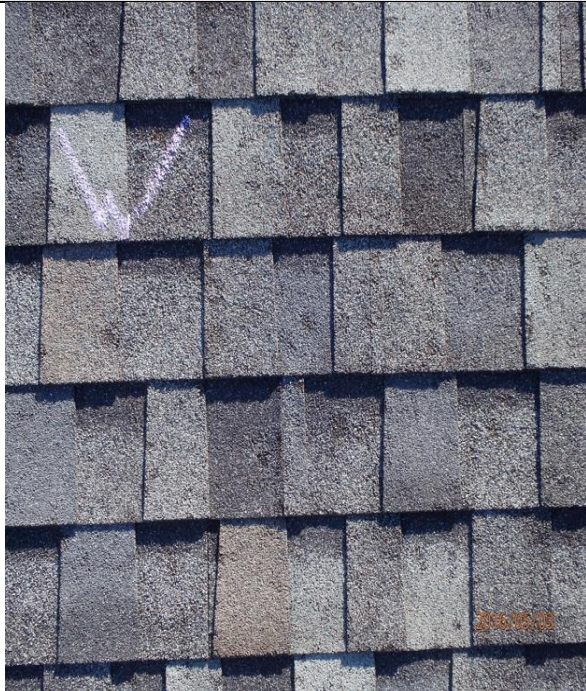
**Field units within west slope contain hailstone impact damage.**

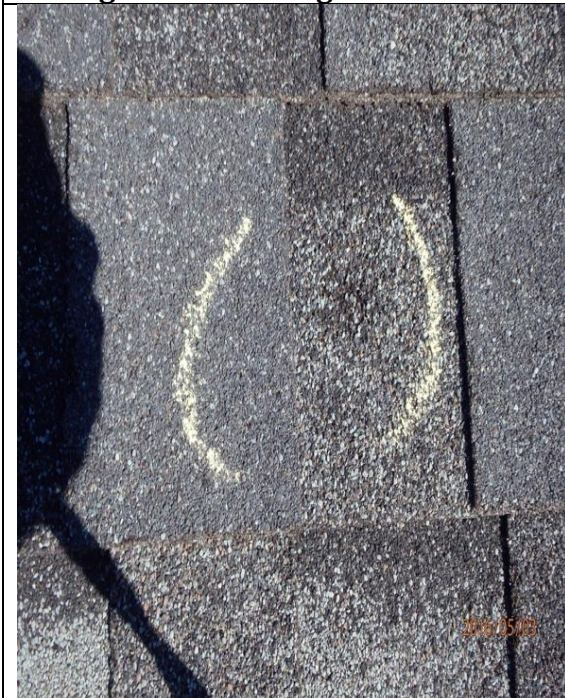
**Fracture in mat due to hailstone impact. Note: ~2.00"**

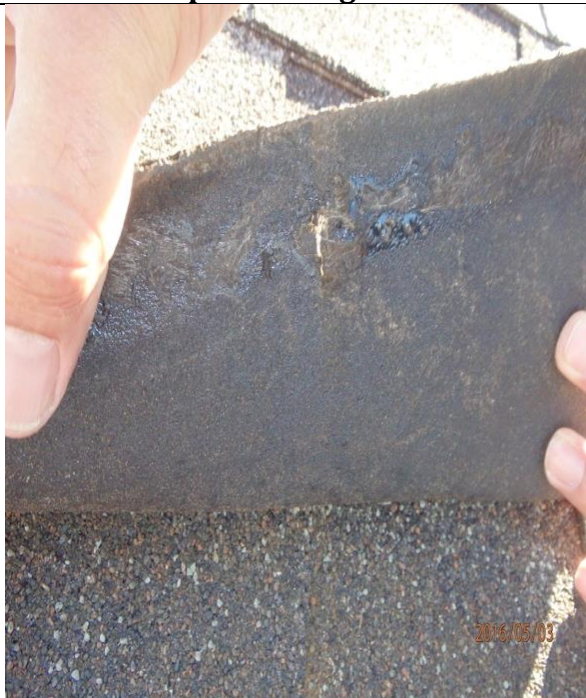
**View of backside of mat at abrasion in previous photo.**

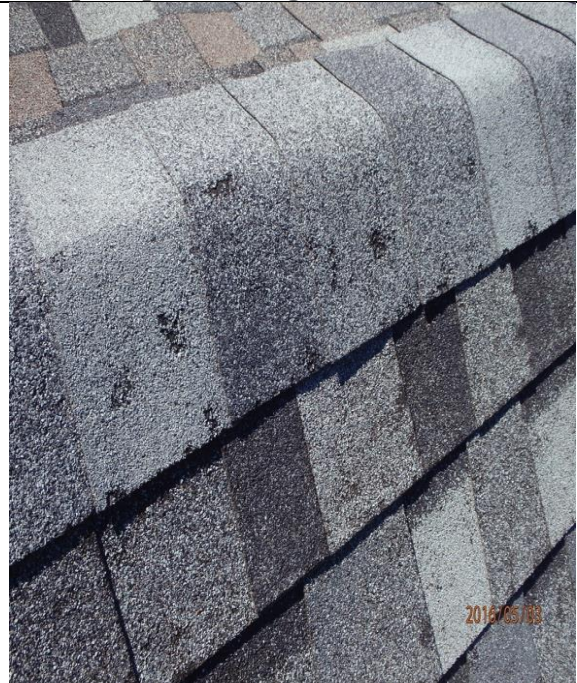
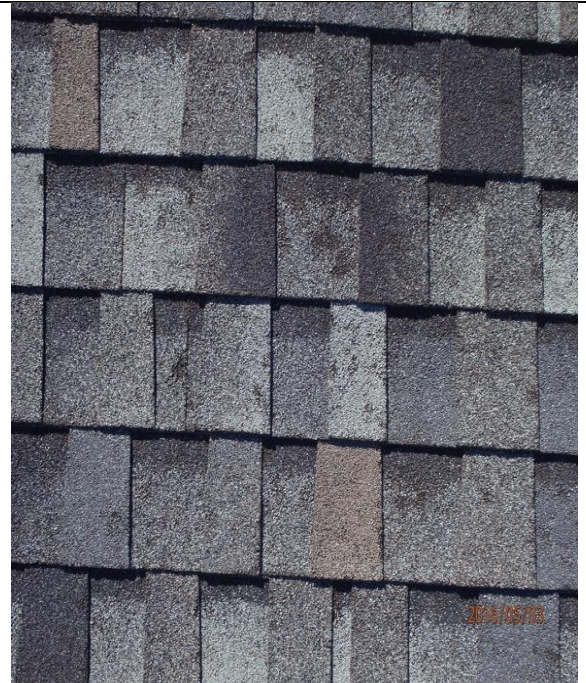
<b>Hailstone impact damage to ridge units. Note: North facing surface</b>	<b>Damaged field units on north slope</b>

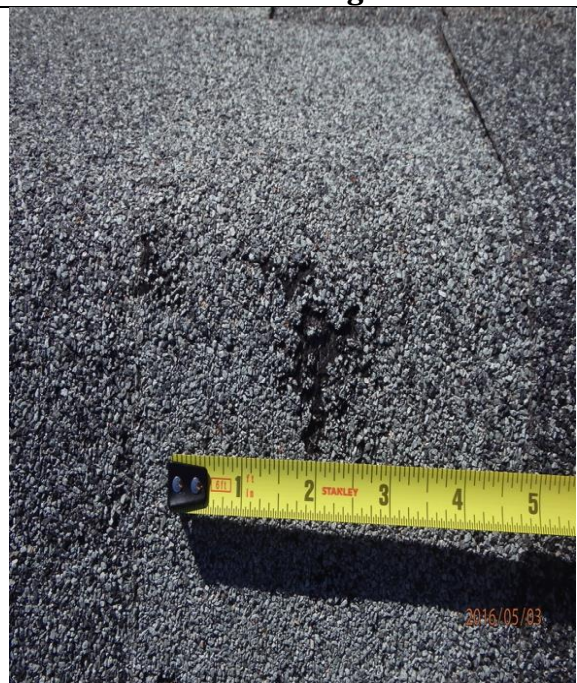
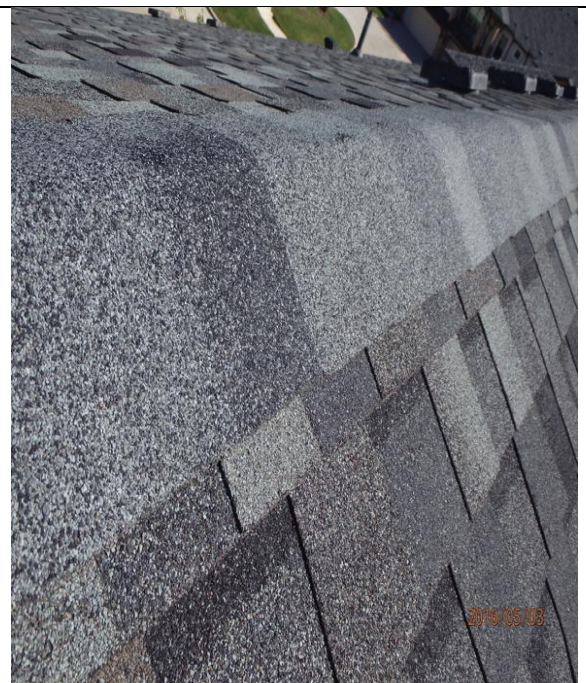
<b>Damage with scale</b>	<b>South facing surface of ridge units contain no damage</b>

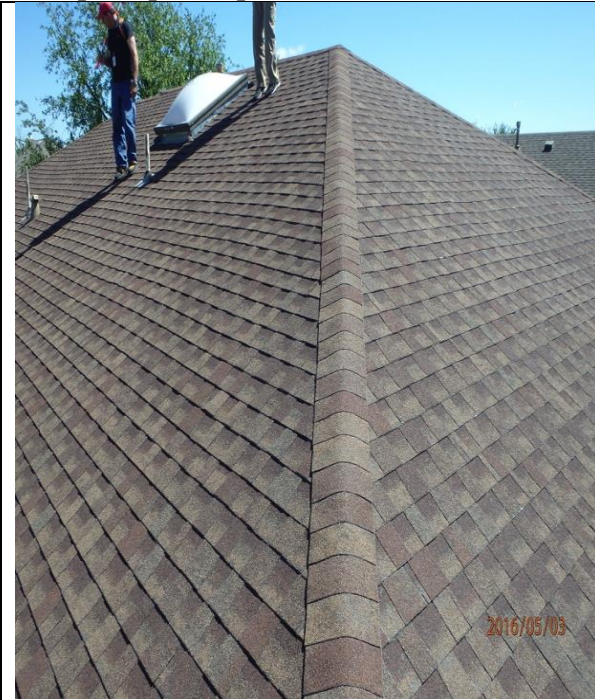
**Hip units with no damage**

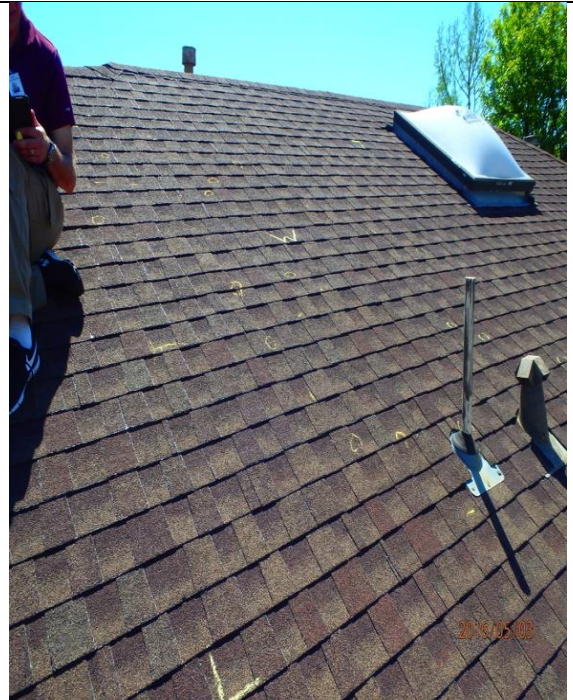
**Damaged to units on west facing slope**

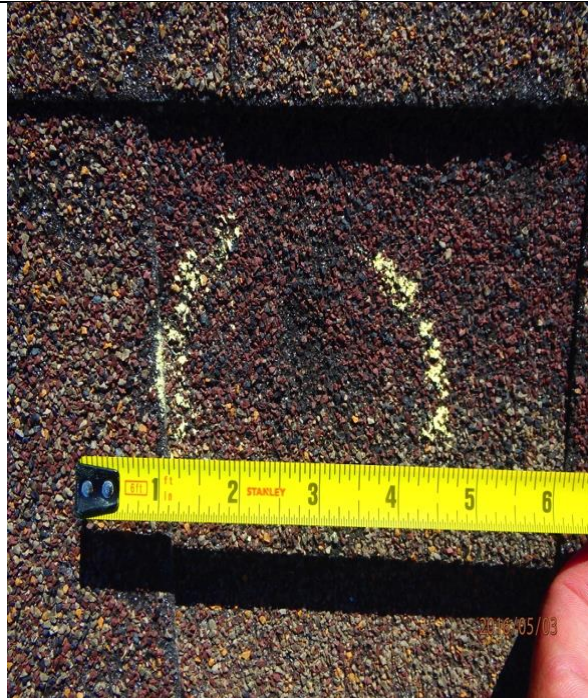
**Abrasion with scale. Note: ~1.00"**

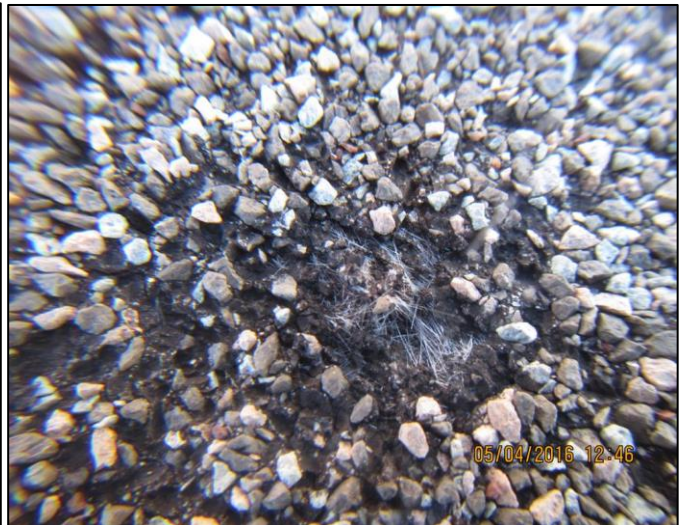
**Magnified view showing fractured mat**

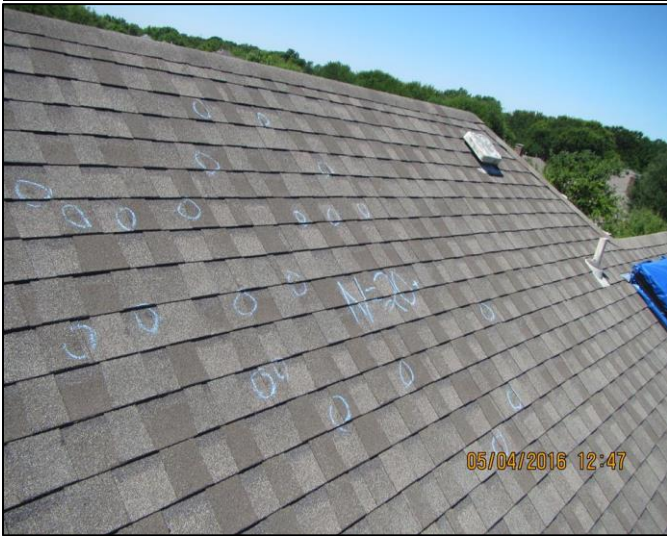
**Hits to north slope, 20+**

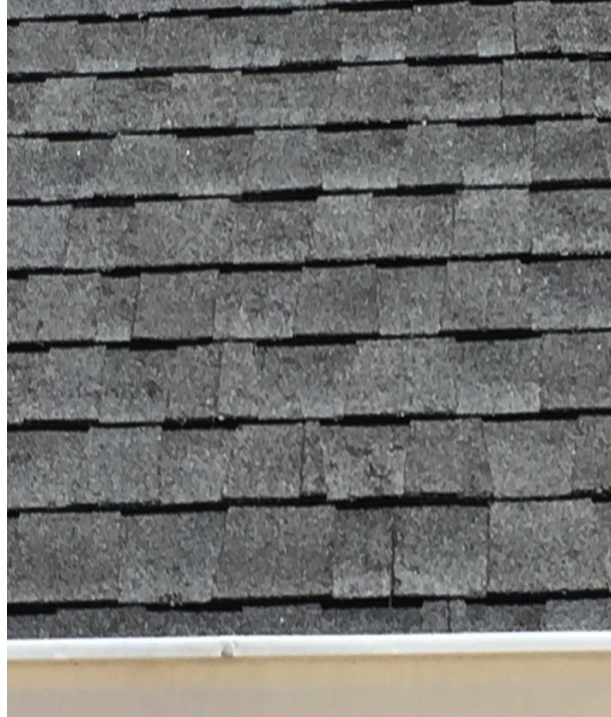
**West side damage to shingles**

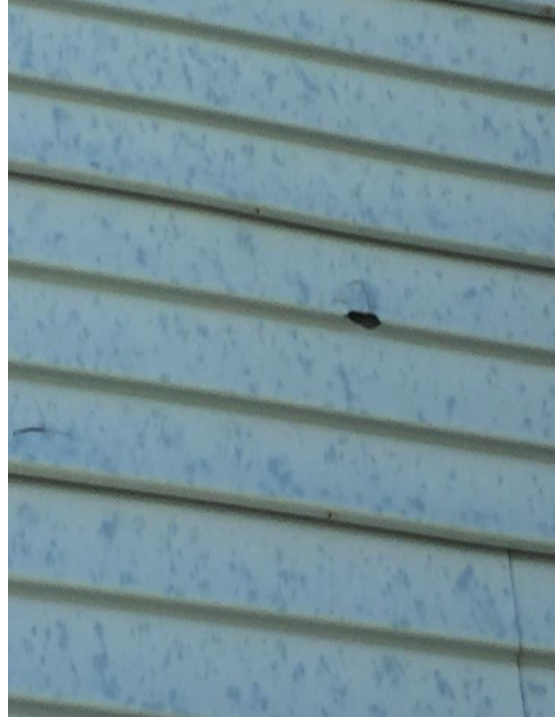
**Damage to siding on west side as well**

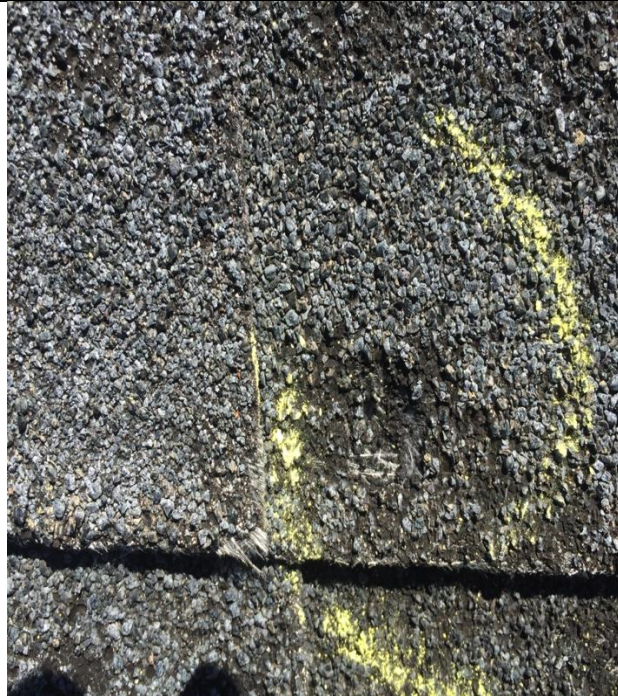
**Close up of damage through shingle**

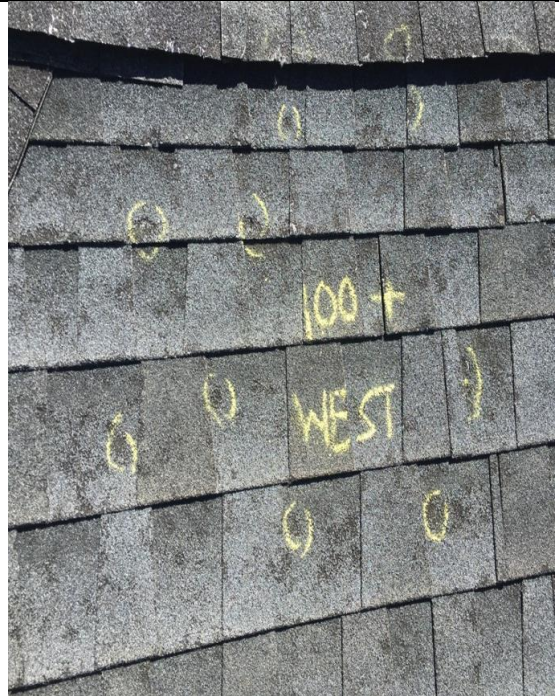
**Obvious hits are marked**

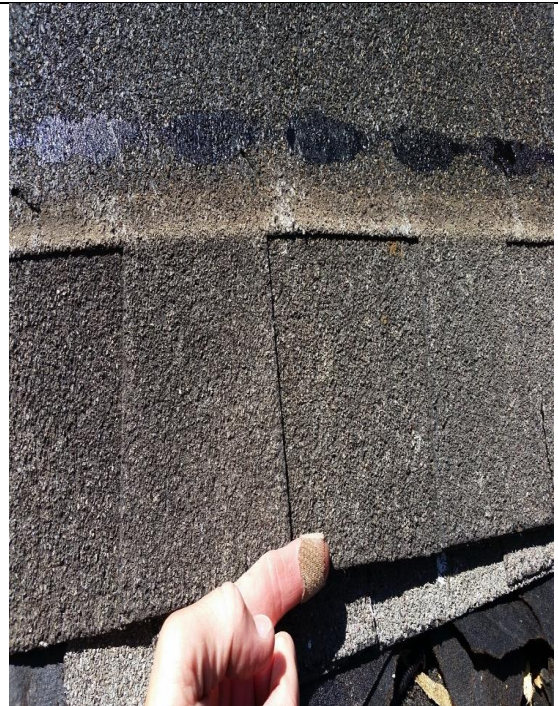
**Shingle breakage. Roof being replaced**

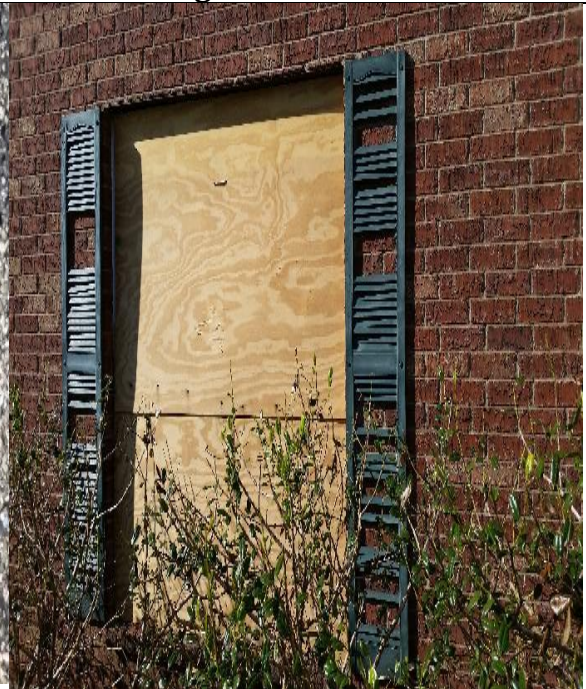
**Broken Window and damaged shutters**

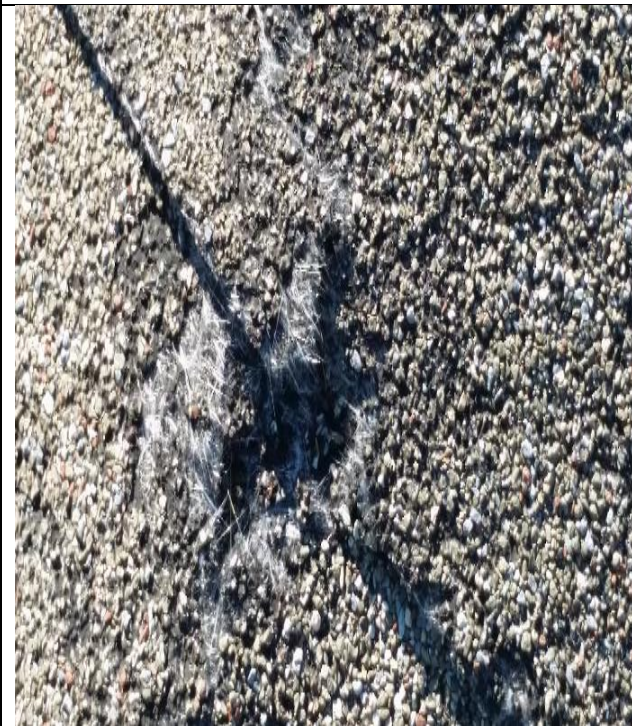
**Hail size up to 2 1/4 inches**

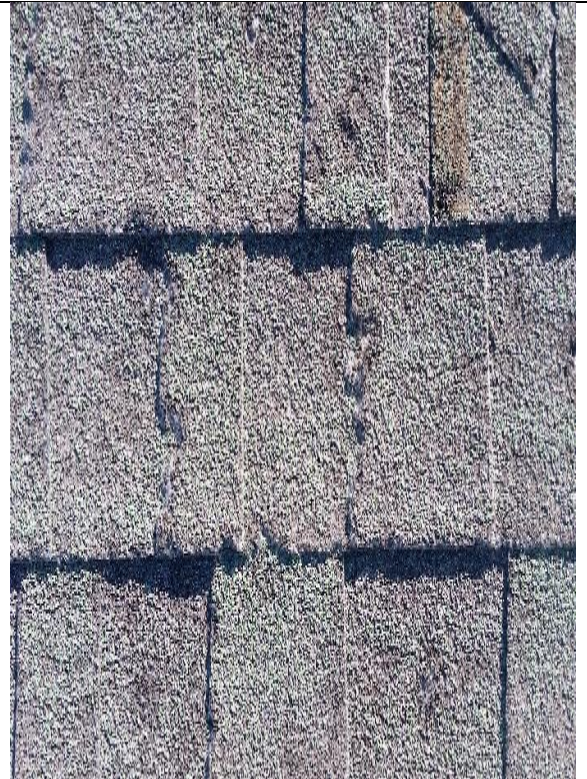
**Numerous hail hits up to 2 ¼ inch**

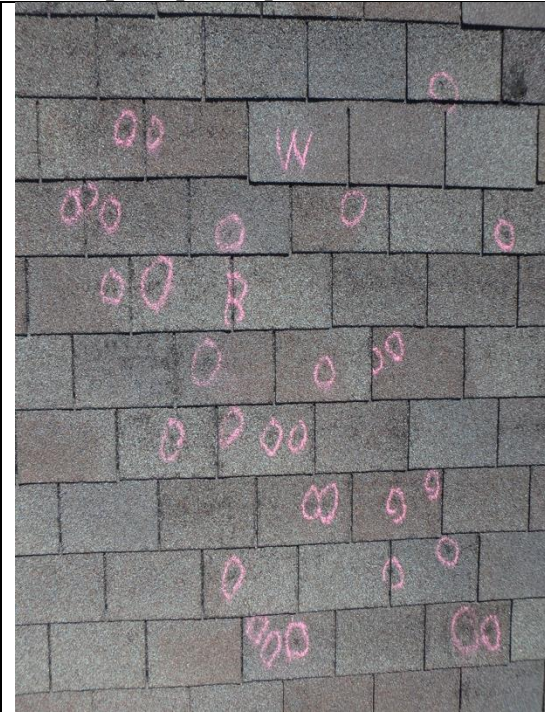
**Numerous spots of missing granules on west-facing shingles**

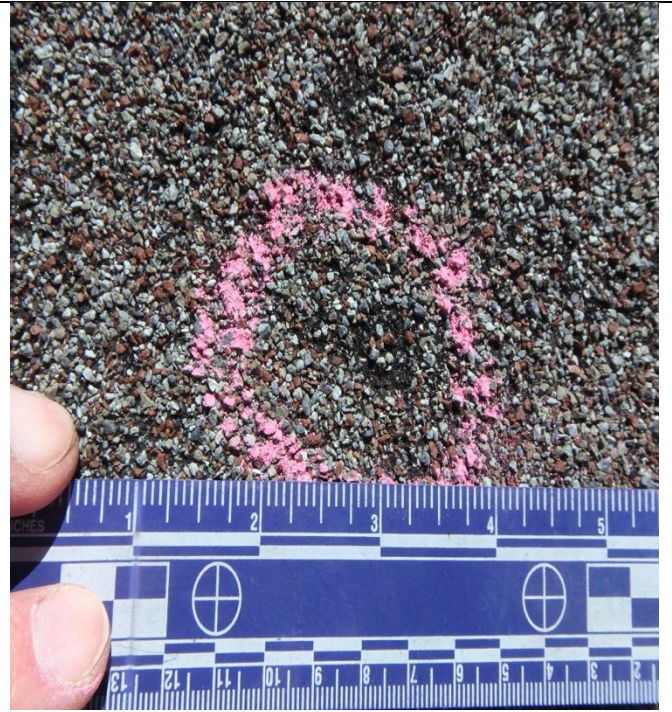
**Typical spot of missing granules.**

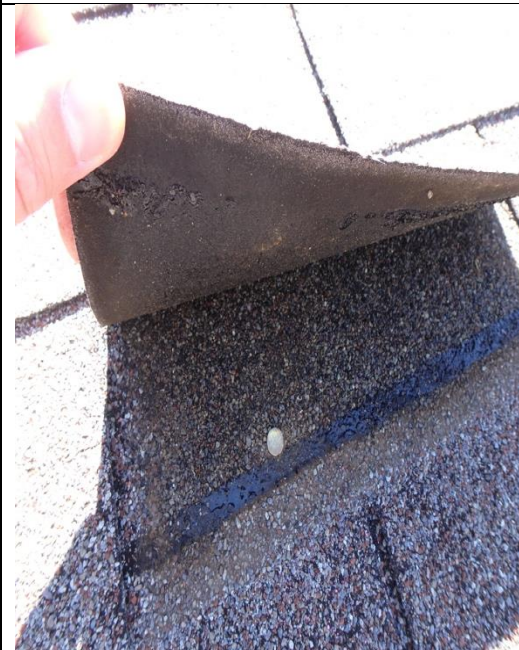
**Reinforcing mat is not punctured or bruised.**

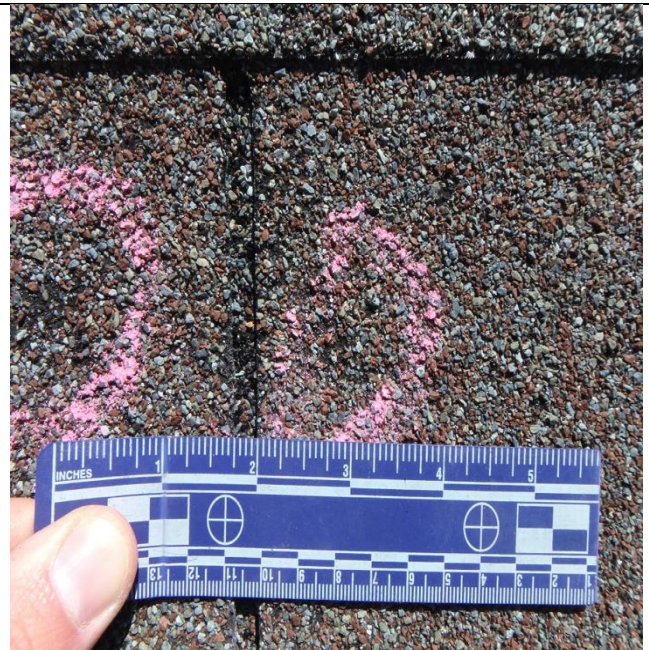
**Typical spot of missing granules.**

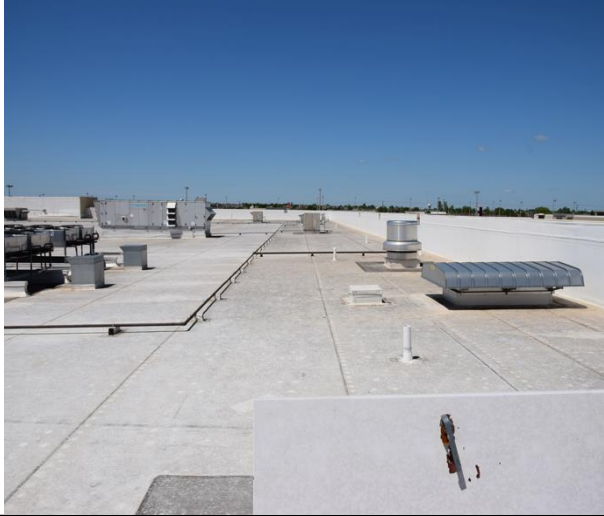
<b>Overview</b>	<b>Cracks in Membrane Around Fasteners</b>

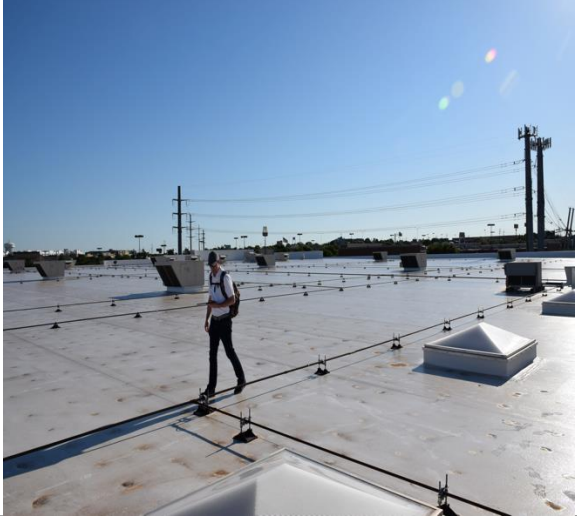
<b>Overview</b>	<b>Hail Size</b>

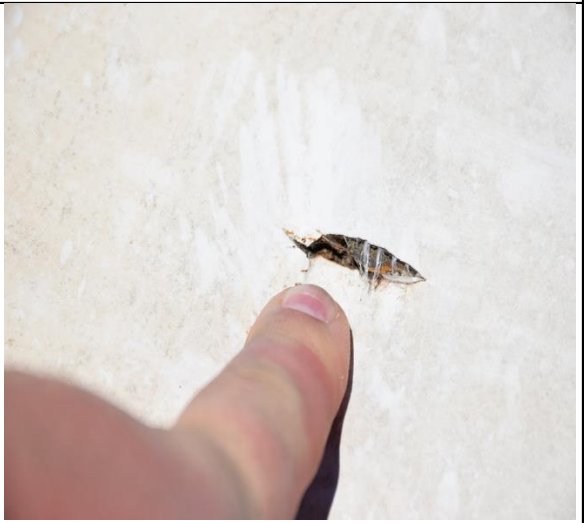
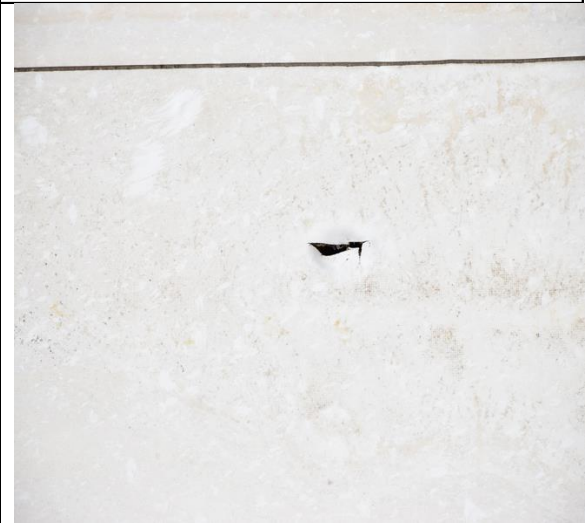
<b>Hail Damage Cut</b>	<b>Hail Damage Cut</b>

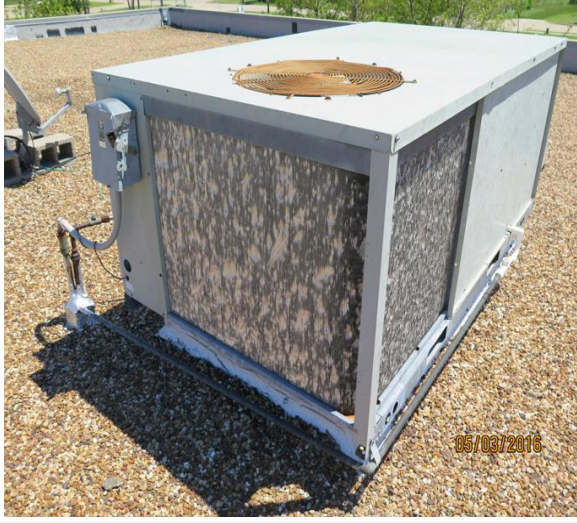
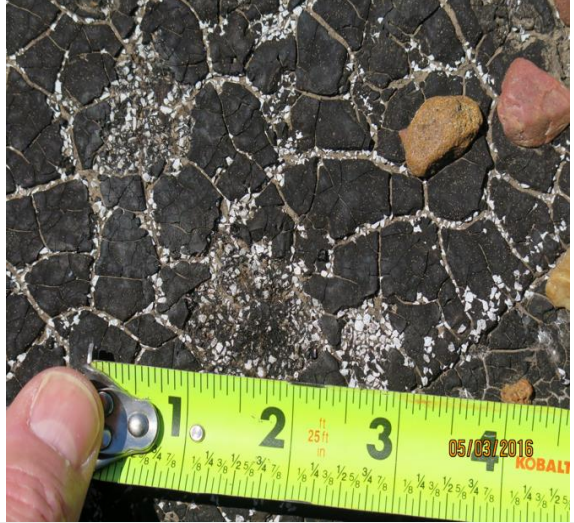
<p><b>Intensive Hail</b></p>	<p><b>BUR Damaged only in Previously Scoured Area</b></p>

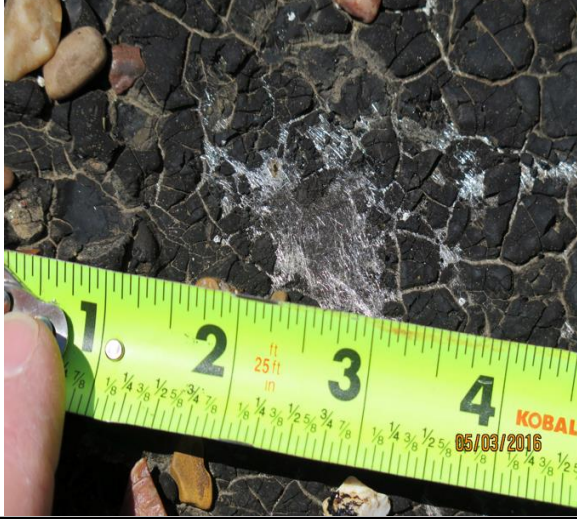
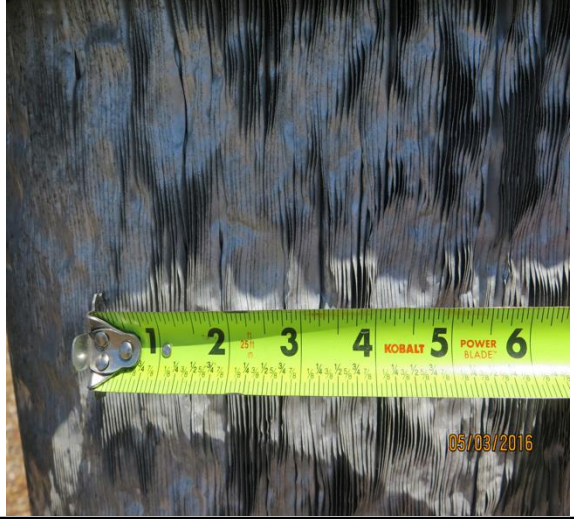
<p><b>BUR Damaged only in Previously Scoured Area</b></p>	<p><b>Intensive Hail</b></p>

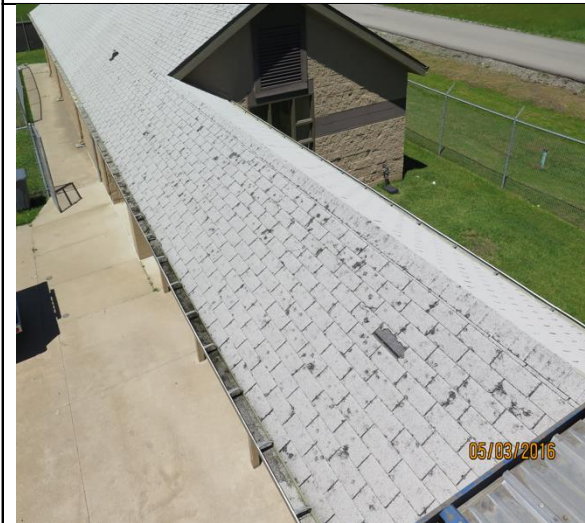
**Adjacent Asphalt Shingle**

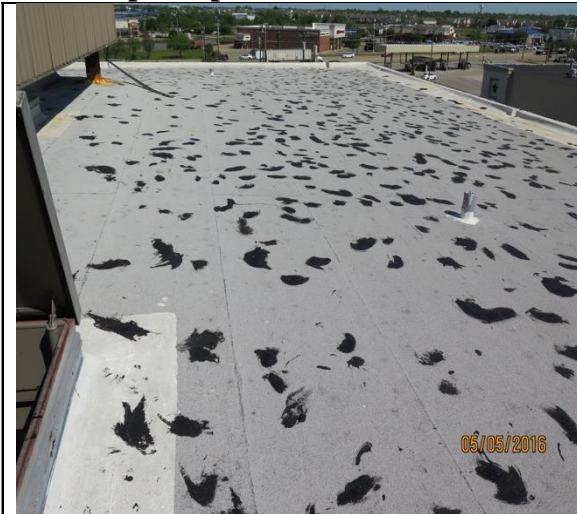
## **Low Slope Inspection Site L2-3-1**

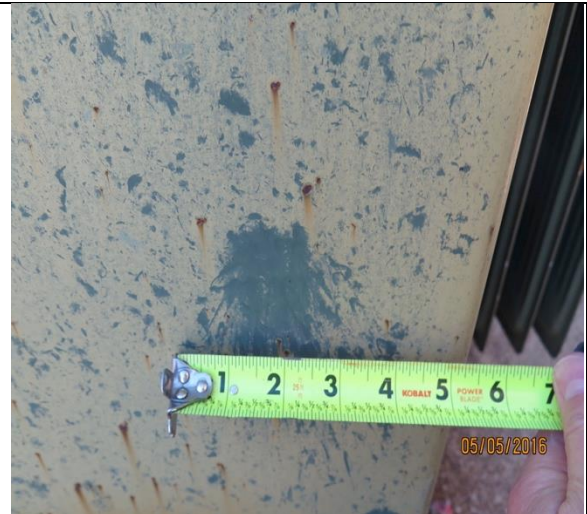
**Hail Size 1 ½ Inches**

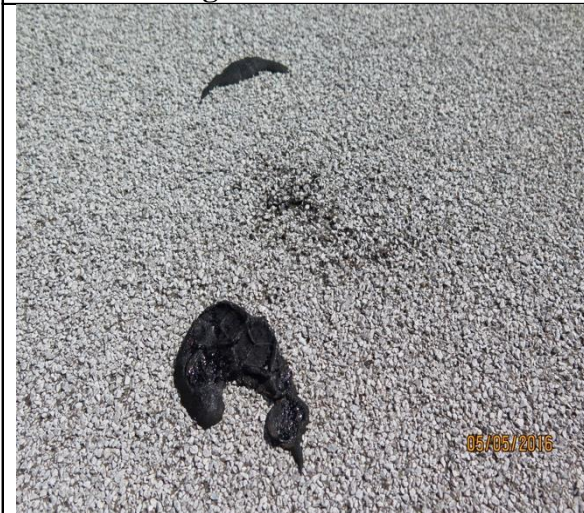
**Damaged Modified Bitumen**

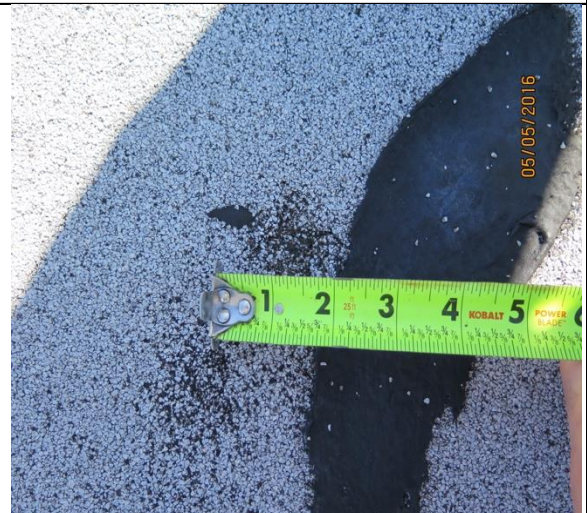
**Hail hit causing a leak**
