Hailstorm Investigation North Texas

Hail size analysis of April 11, 2016, storm courtesy of CoreLogic  
Hail photos courtesy of Sherry & Don Takak

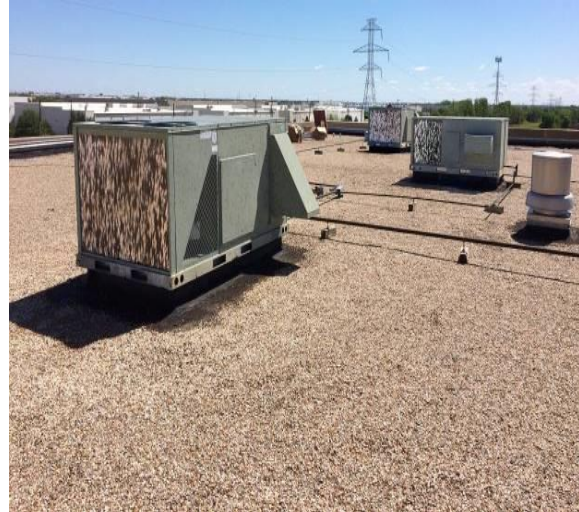
**The gravel surfacing of this built-up roof membrane apparently served as adequate protection from damage in the field.**

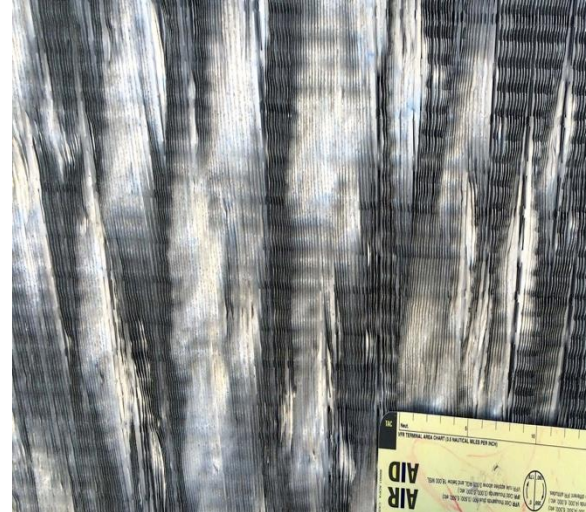
**This is a close-up view of damaged cooling fins.**

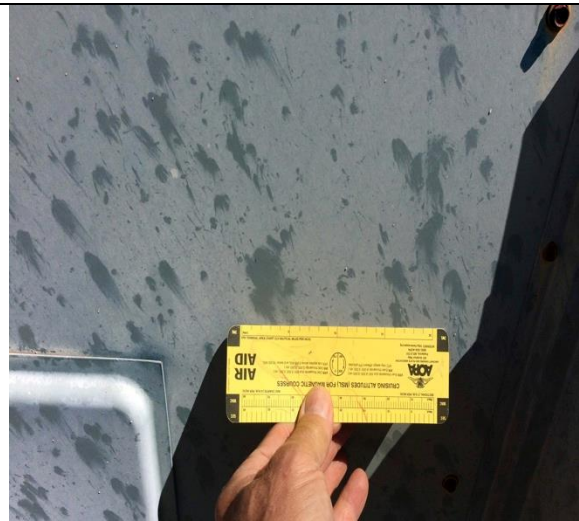
**Spatter on the side of this HVAC unit indicates hail direction of approximately 60 degrees from horizontal. Spatter size is ½" to 1".**

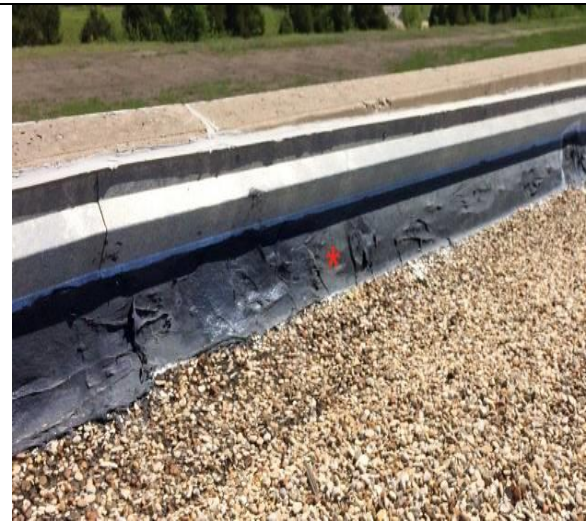
**The only visible evidence of hail damage to the roof system was the base flashings, which were temporarily patched until proper repairs could be scheduled.**

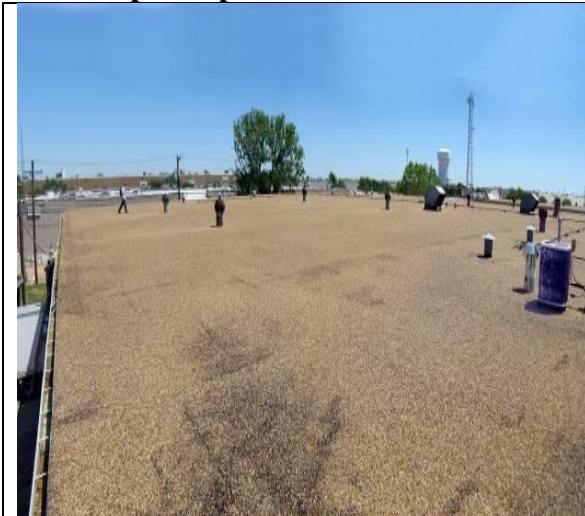
Although this built-up roof membrane appeared to be over ten years old, the gravel surfacing was likely a big factor in preventing hail damage to the membrane.

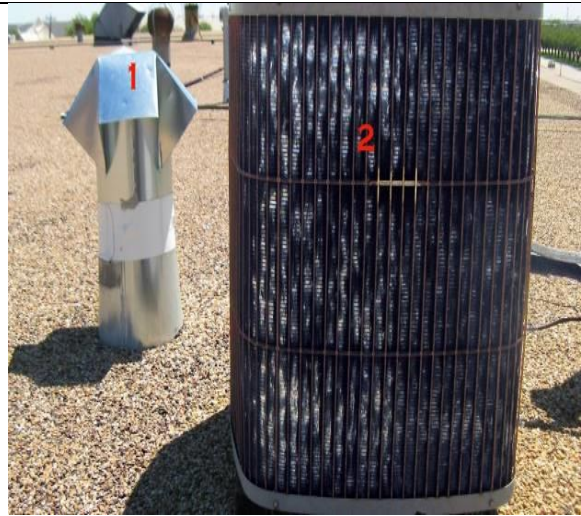
Predictably, sheet metal appurtenances (1) and HVAC cooling fins (2) exhibited the most prominent evidence of hail activity.

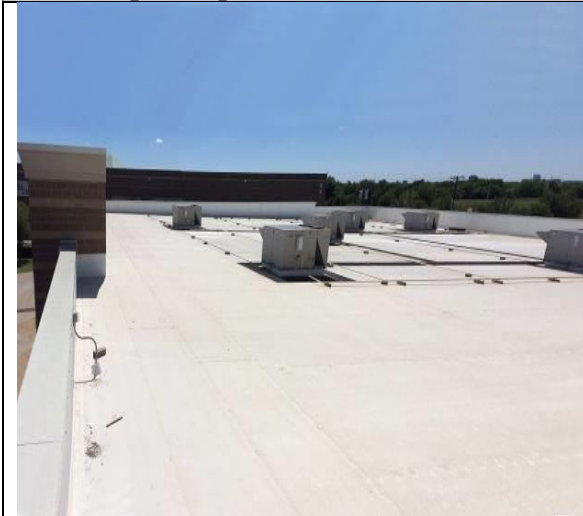
**L4-1-G No apparent damage to PVC membrane**

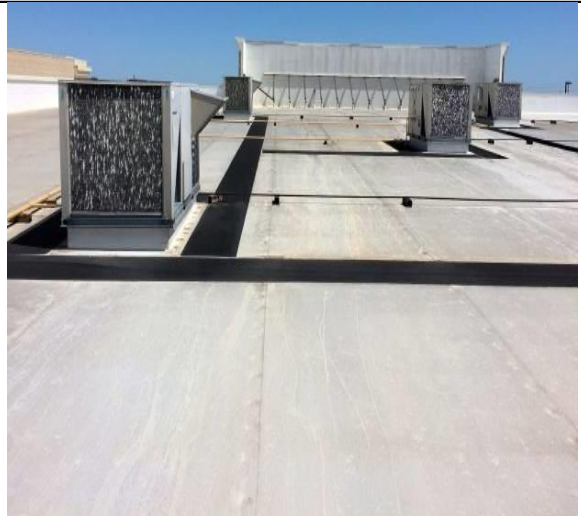
**Another view, showing multiple hail hits on air handler**

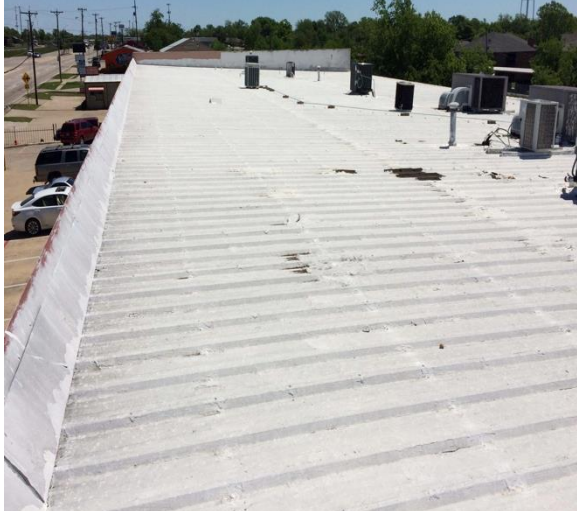
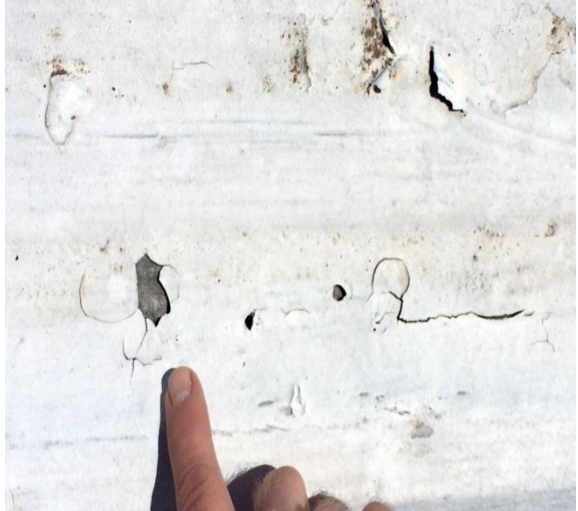
<p><b>This building was covered by an R-panel roof with white coating. No indentations were observed in the metal panels.</b></p>	<p><b>The only damage to the roof system was fracturing and displaced coating.</b></p>

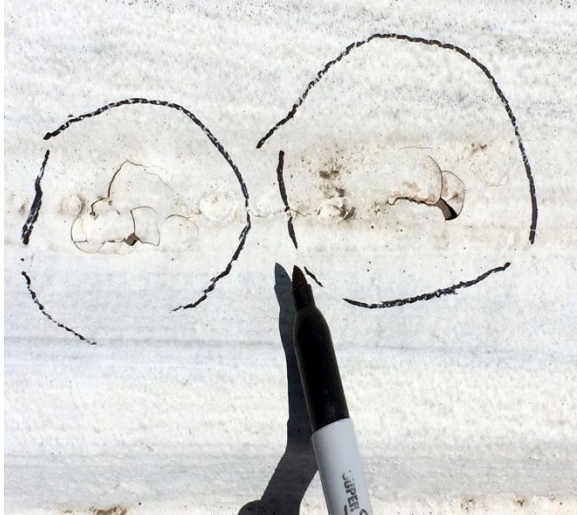
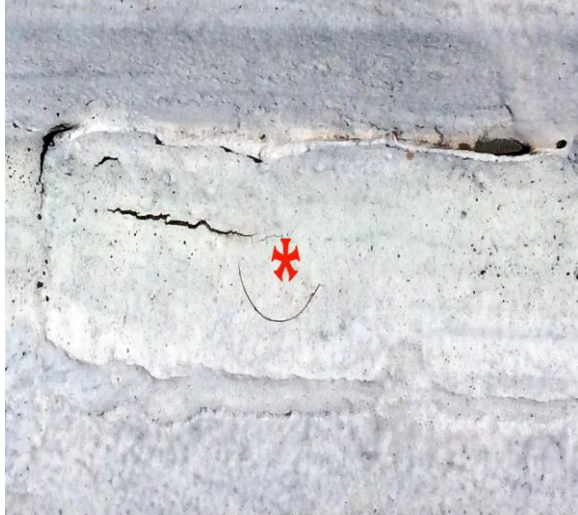
<p><b>Most visible damage appeared to be at angles where the coating may not have been well bonded or where air pockets had formed</b></p>	<p><b>The asterisk marks a semi-circular impact mark typical of what is often caused by hail strikes. Hail size was ¾ to 1 inch.</b></p>

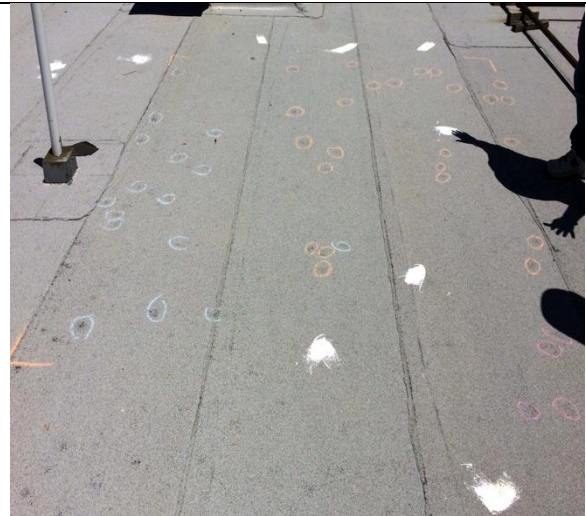
**Visible damage was encircled within a 10'x10' area.**

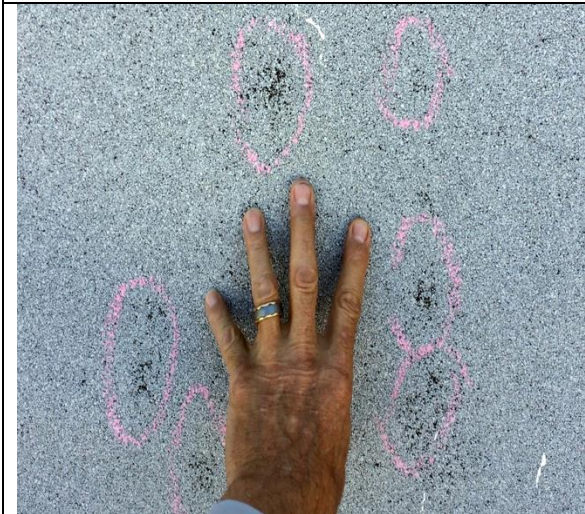
**The black scuff marks appear to be only an inch or two in diameter, although hail size was 3-4 inches.**

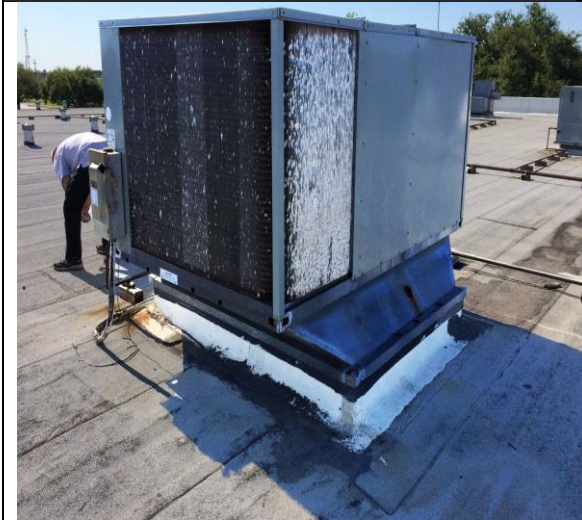
**Note the great difference in hail-damaged cooling fins on the west and north sides.**

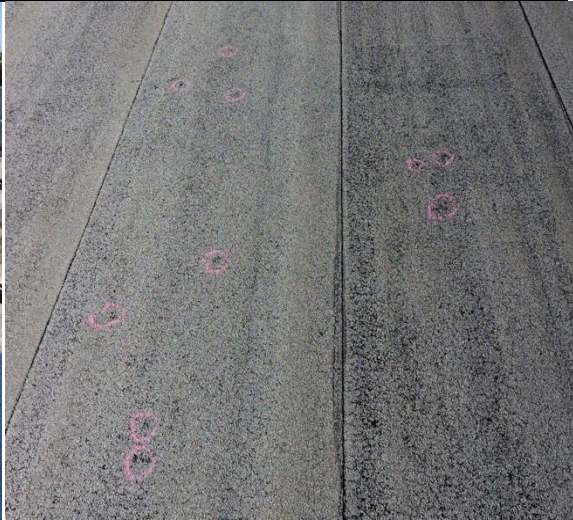
**Dark spots consistent with hail impact have been marked with pink chalk on the MB surface.**

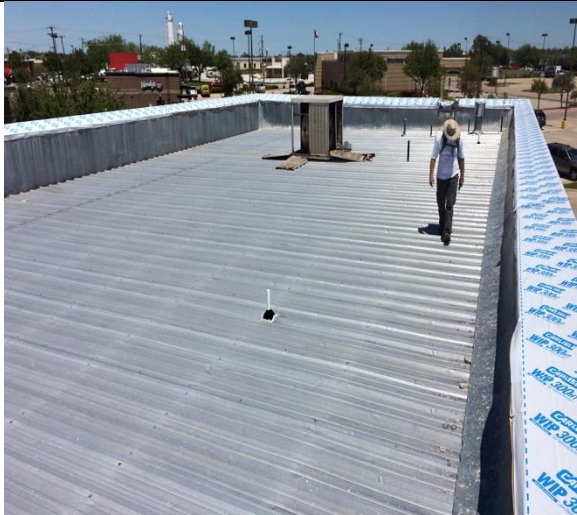
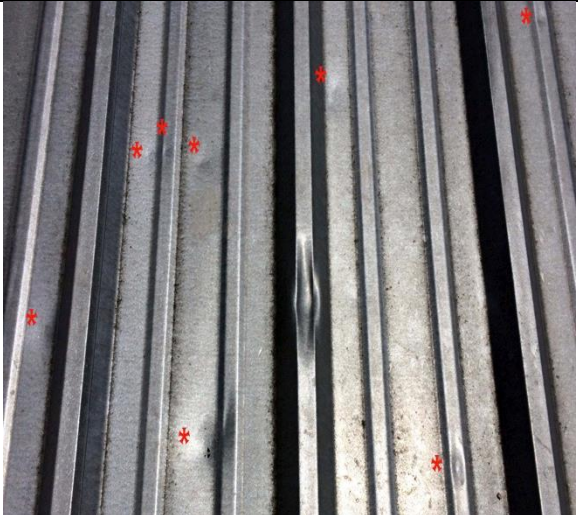
<p><b>This R-panel metal roof experienced 3-4" diameter hail. The parapets have been covered temporarily with peel-and-stick membrane due to the damaged EIFS beneath it.</b></p>	<p><b>In addition to indentations in the flat portions and minor ribs, the major ribs have been significantly deformed by hail impact.</b></p>

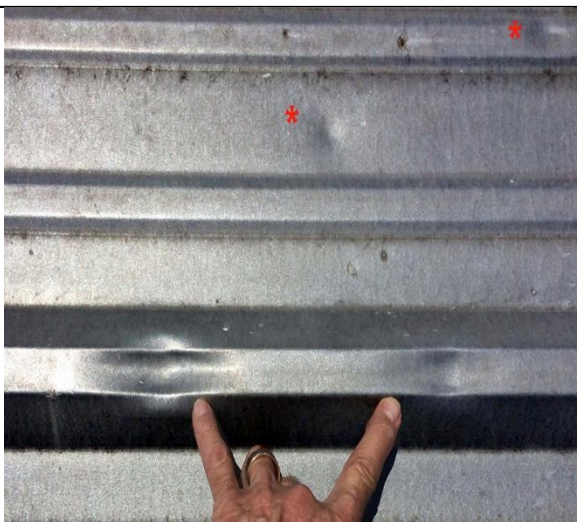
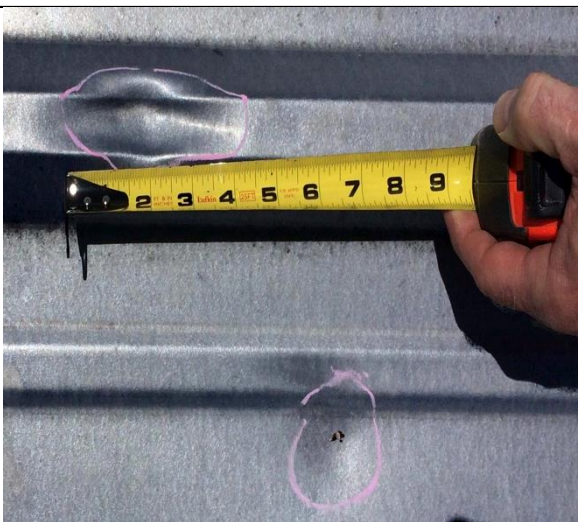
<p><b>Both minor and major indentations are visible in this photo.</b></p>	<p><b>This is a typical 4 inch hail hit</b></p>
