Hurricane Ian

Roofing Industry Committee on Weather Issues, Inc.

Storm Investigation Program

September 30, 2023

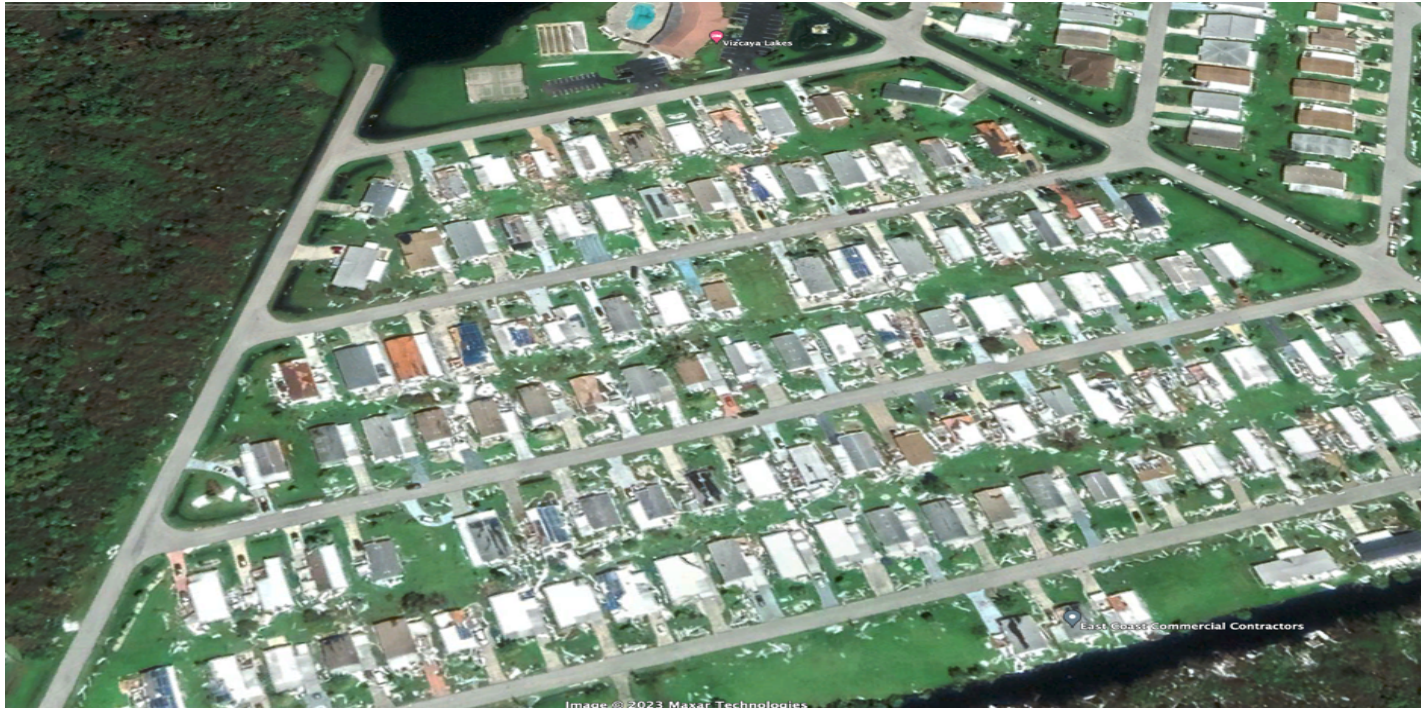
Figure 1. The view is from Google Earth on 9/29/2022 and shows significant roof and structure damage. This area of modular homes was developed between the years 1994 and 1998. This subdivision was just north of Rt 776 and in the highest wind area with projected 130 mph winds.

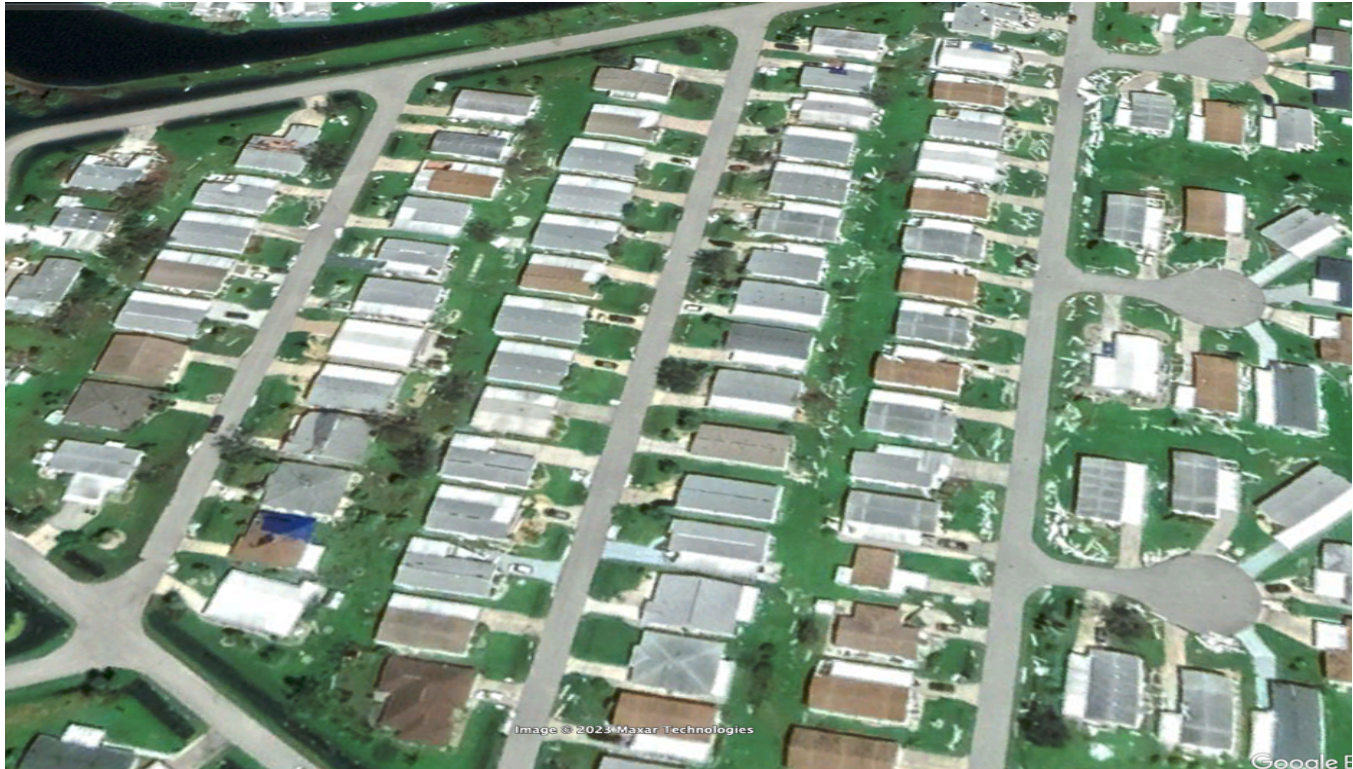
Figure 2: This is the area immediately east of that shown in Figure 1. It shows some debris but little or no roof damage. This section was developed from 2004 to 2016 with units around the cul-de-sacs built last.

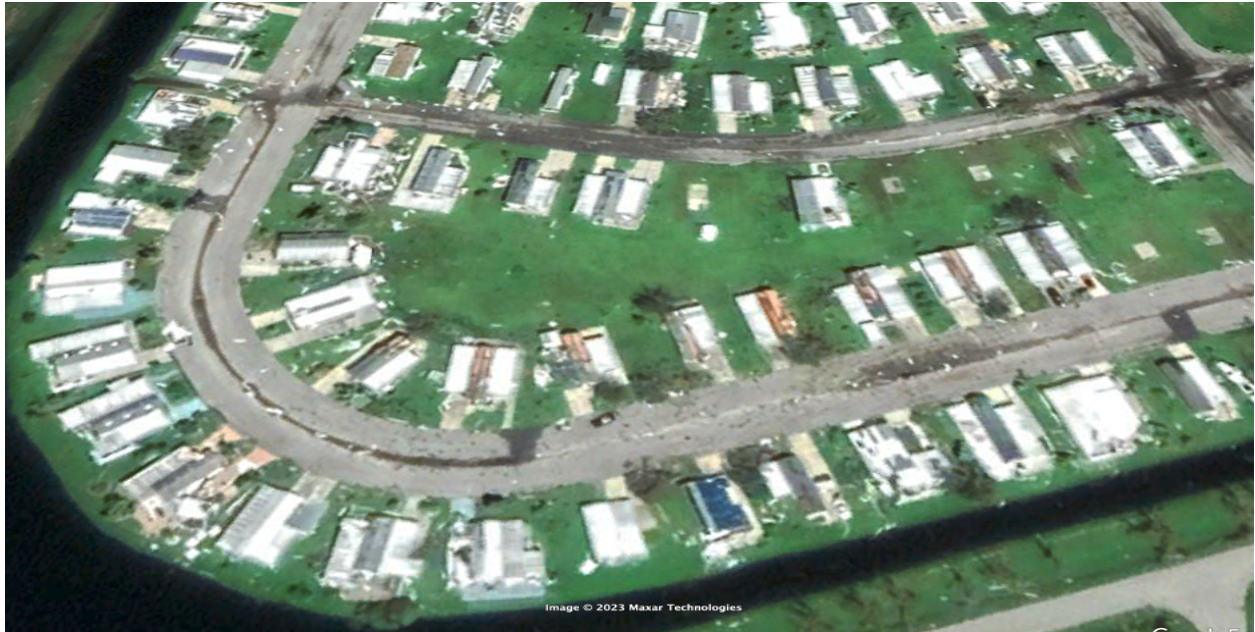
Figure 3: This photo shows the subdivision immediately east of that shown in Figure 2. There was more damage here to units that were built between 1998 and 2004. Other sections were completed after 2004.

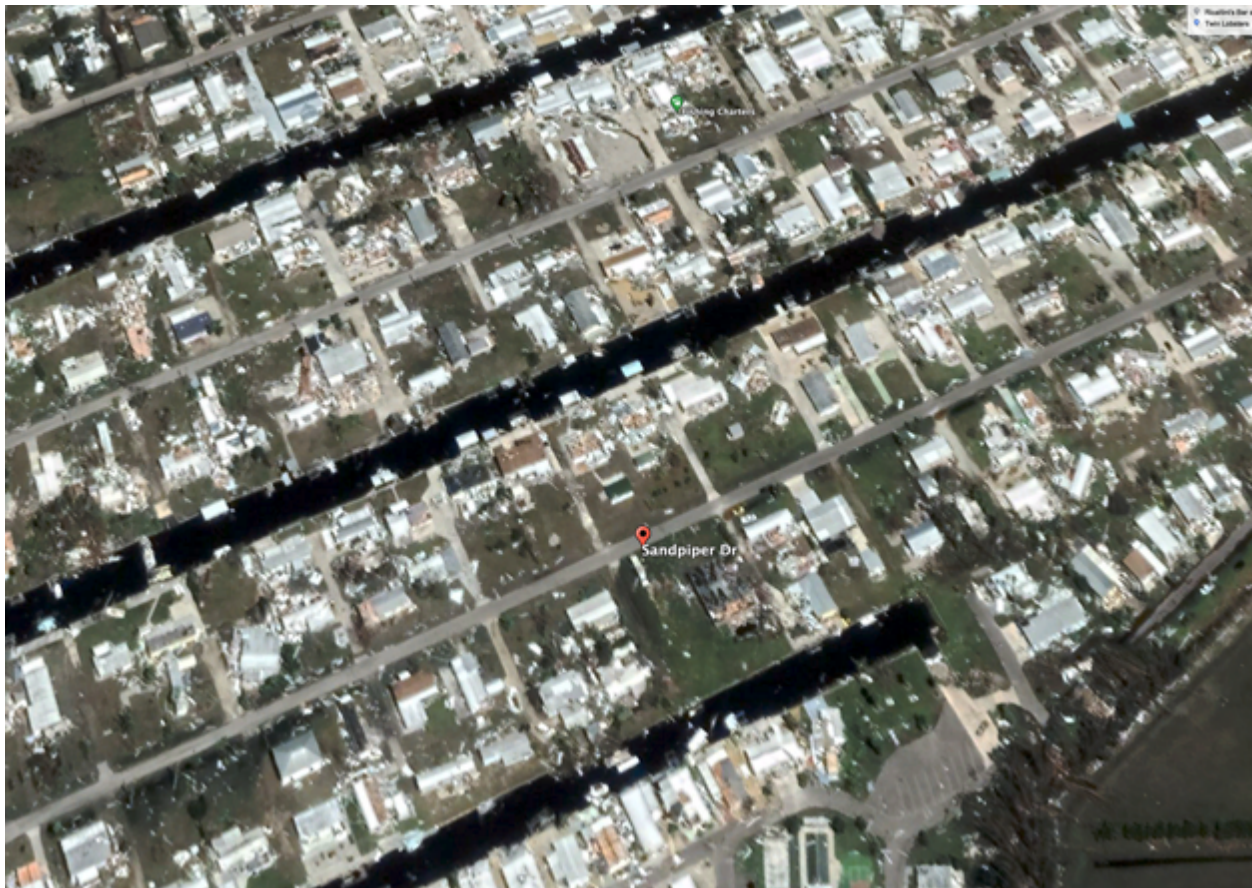
Figure 6: This neighborhood on Pine Island was mostly built between 1985 and 1995. It had significant damage from 120 mph winds and storm surge.

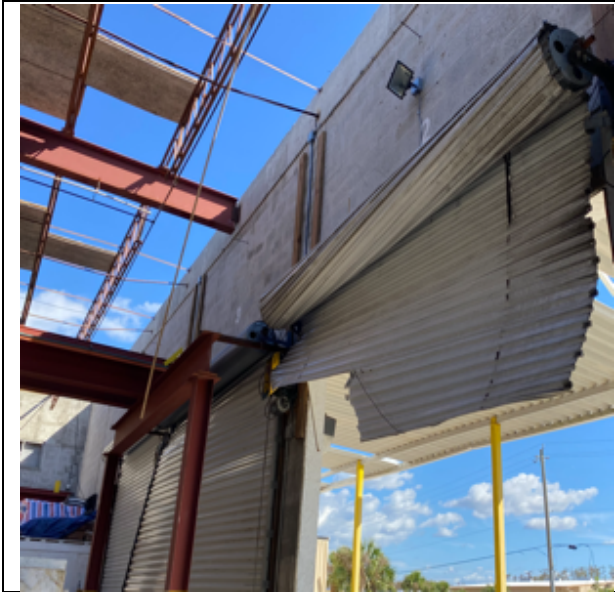
Photo 1: Stone Warehouse - One photo tells a lot. Overhead door failure caused a pressurized building, leading to blow off of cementitious wood fiber deck & membrane.

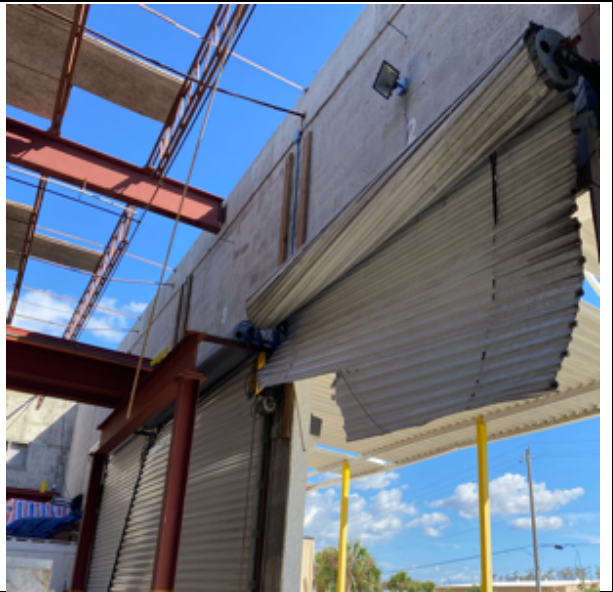
Photo 2: Stone Warehouse - Extensive loss of CWF roof deck.

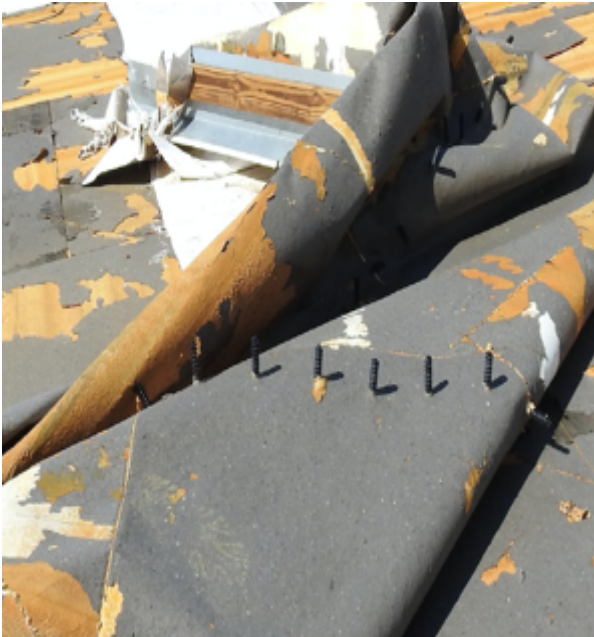
Photo 8: Close fastener placement along the perimeter appeared to be intended as a peel stop but attachment to lightweight concrete (LWC) deck was inadequate.

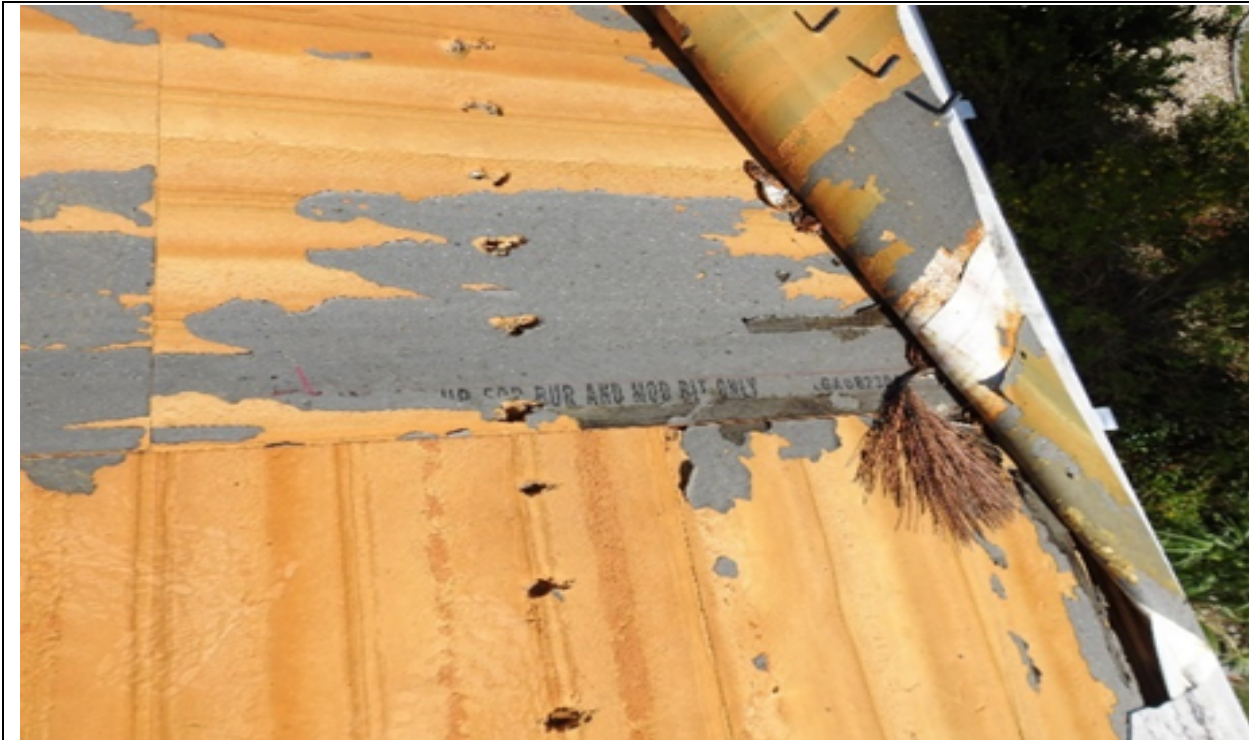
Photo 13: Improper insulation used. Insulation was marked to be used only with BUR and Mod Bit membranes

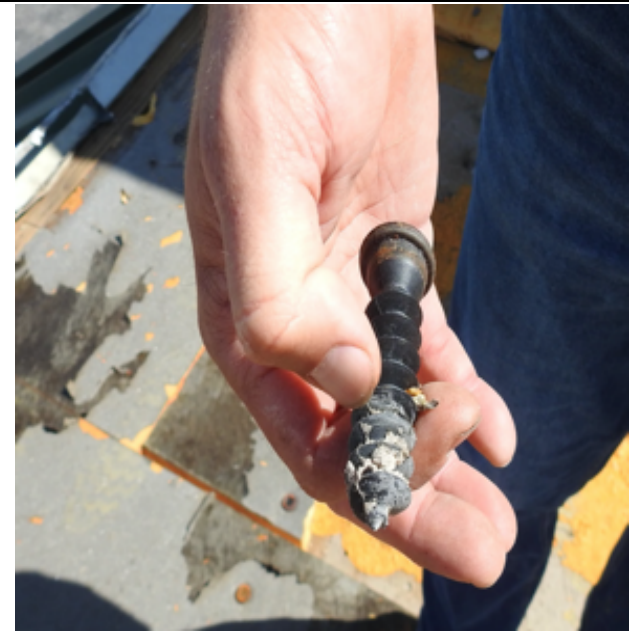
Photo 9: Fastener was not adequately embedded in LWC

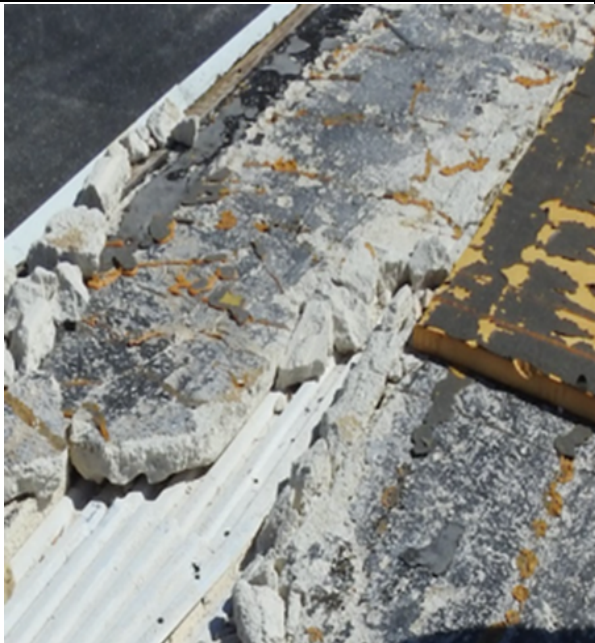
Photo 10. LWC damaged and metal edge missing.

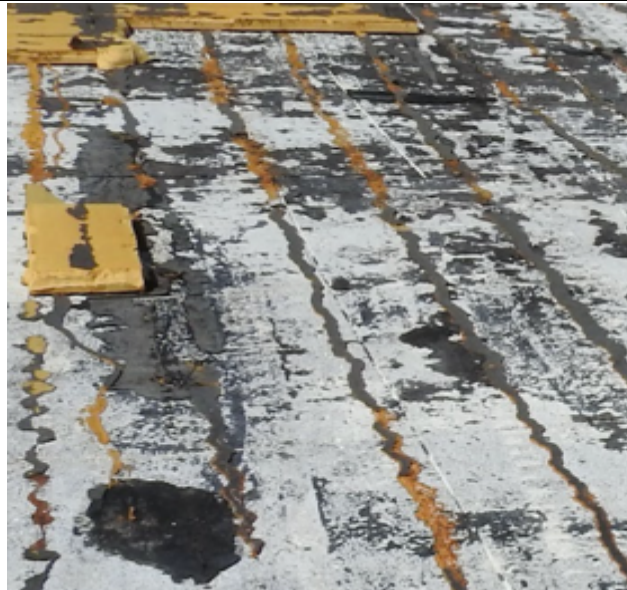
Photo 11: Limited low-rise foam resulted in inadequate wind uplift resistance.

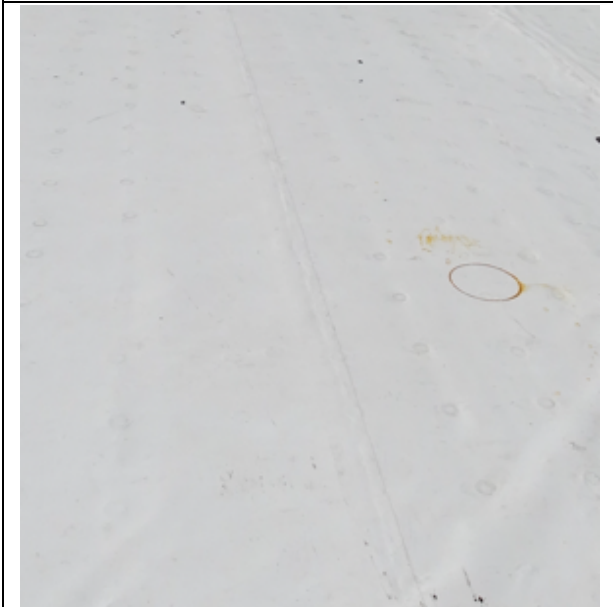
Photo 27: A tight fastener pattern is visible securing this membrane.

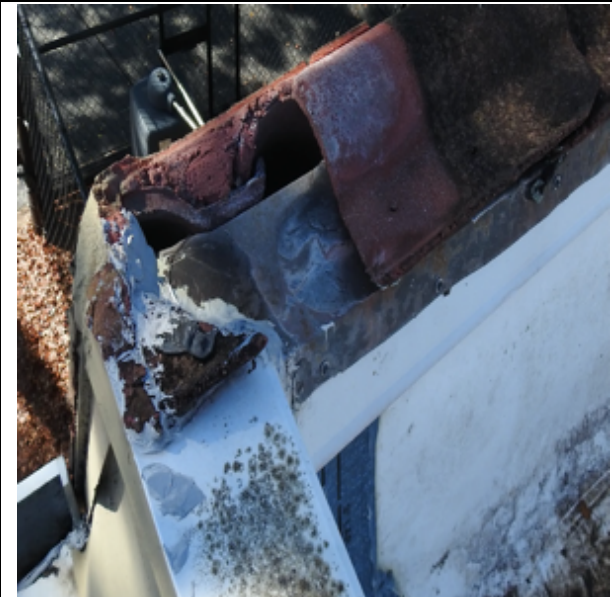
Photo 35: Damaged edge and tile, apparently from windblown projectile impact.

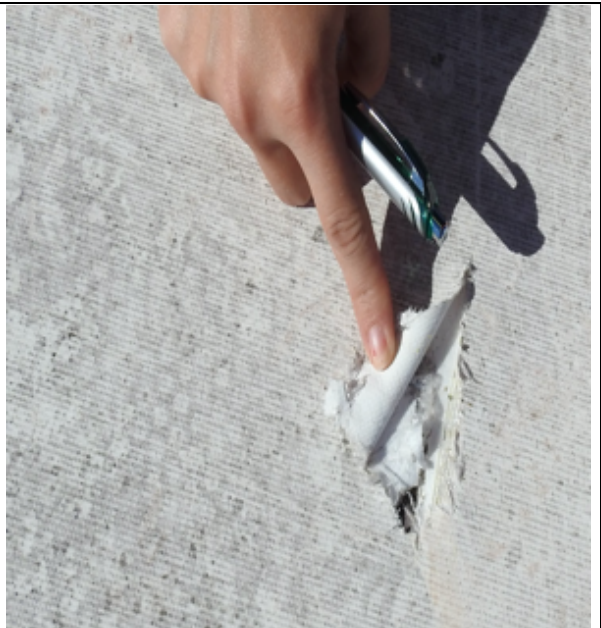
Photo 40: A typical membrane tear or cut from the traumatic impact of either a windblown projectile or wind-propelled object tumbling over the roof surface.

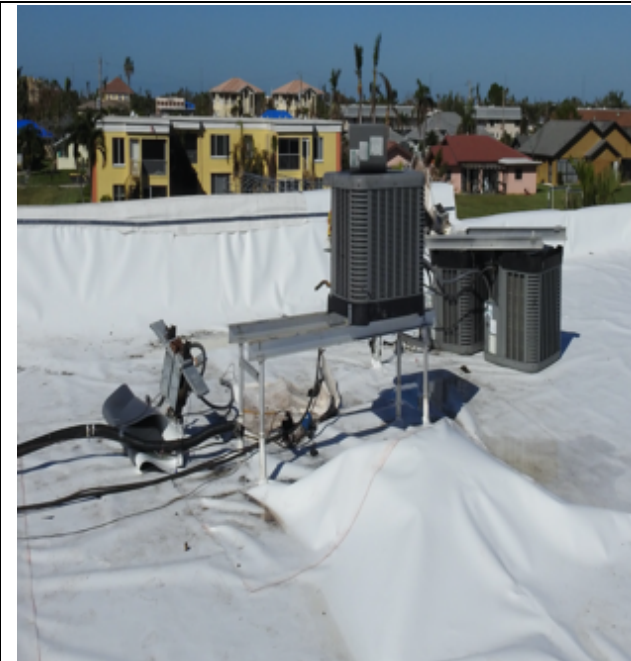
Photo 41: Typical air handler damage from storm winds blowing units from stands and/or curbs.

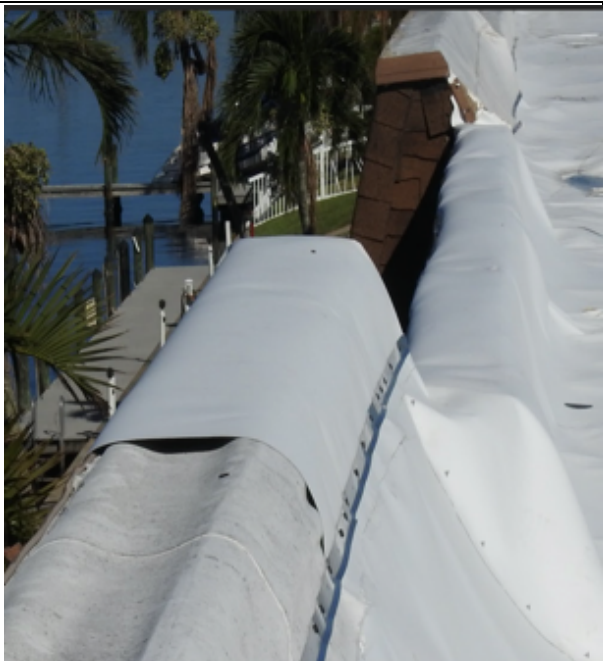
Photo 42: Some parapet damage.

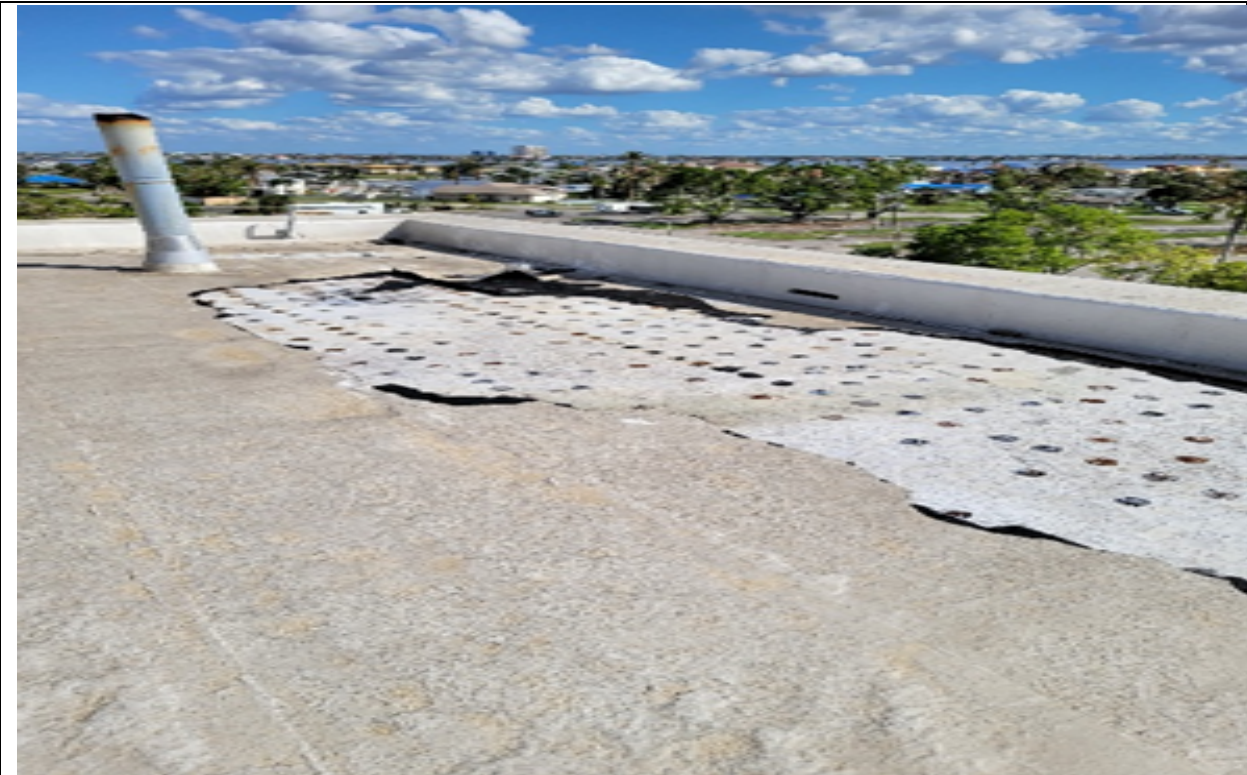
Photo [45a](#): Membrane peeling exposing the lightweight insulating concrete and fasteners and plates

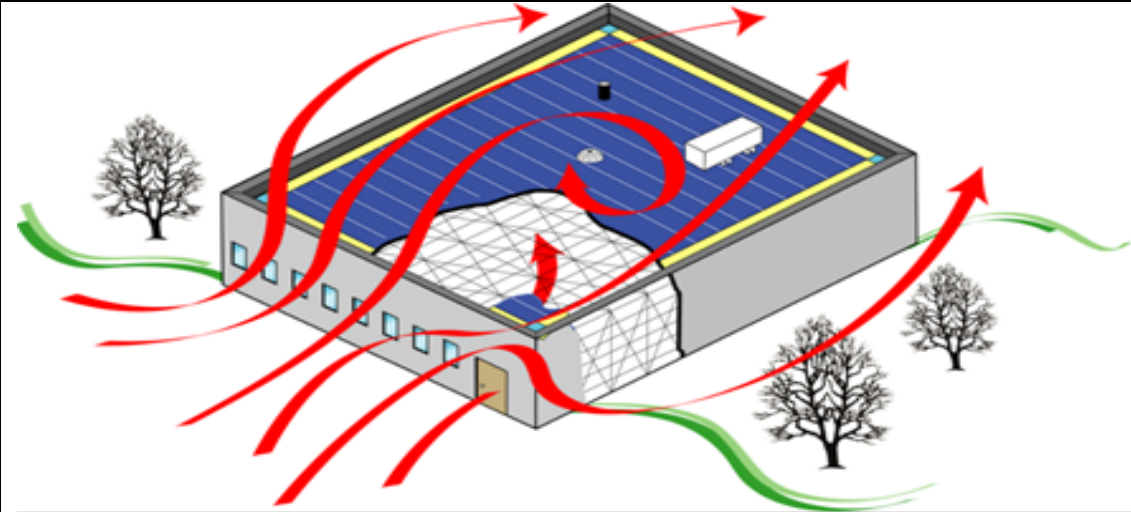
Photo [45b](#): Failure at the roof wall junction causing air intrusion from the bottom of the roof

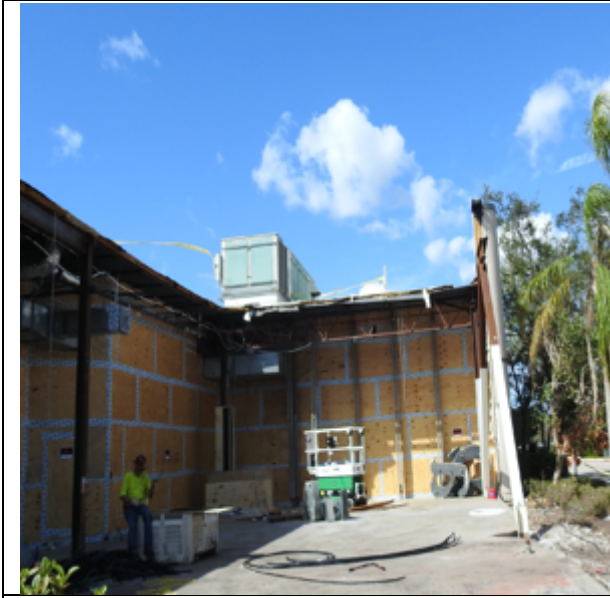
Photo 54: Structural damage

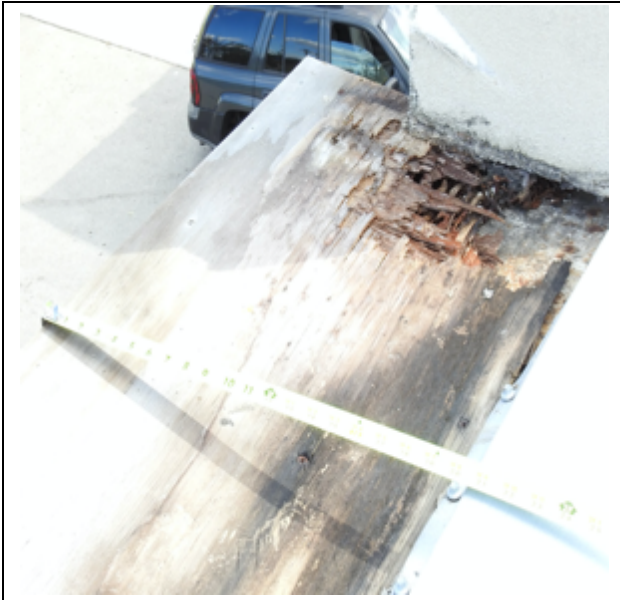
Photo 72: Top of rotted parapet, inadequately fastened coping

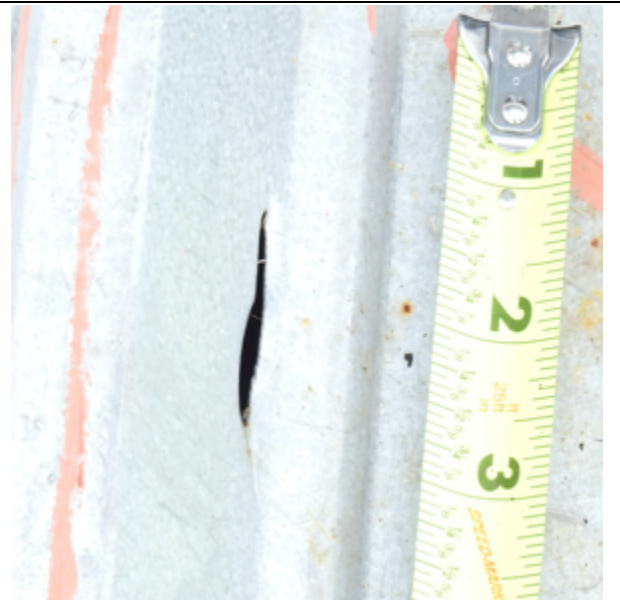
Photo 73: Damage to metal deck from coping hit.

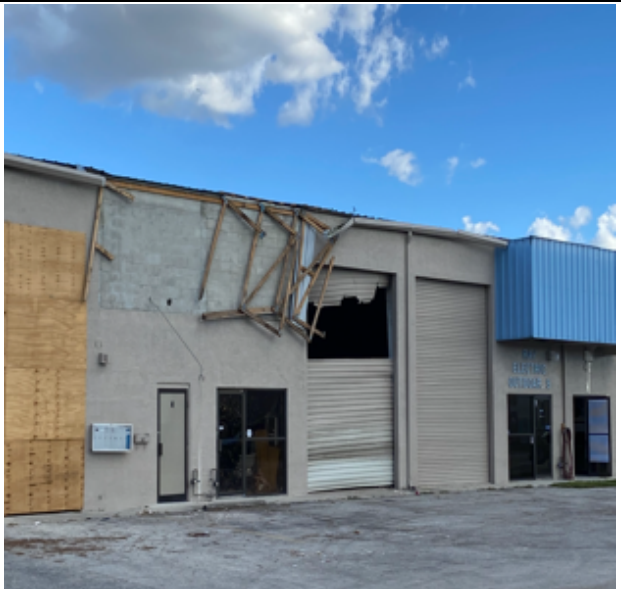
Photo 75: Decorative protective entrance cover completely missing

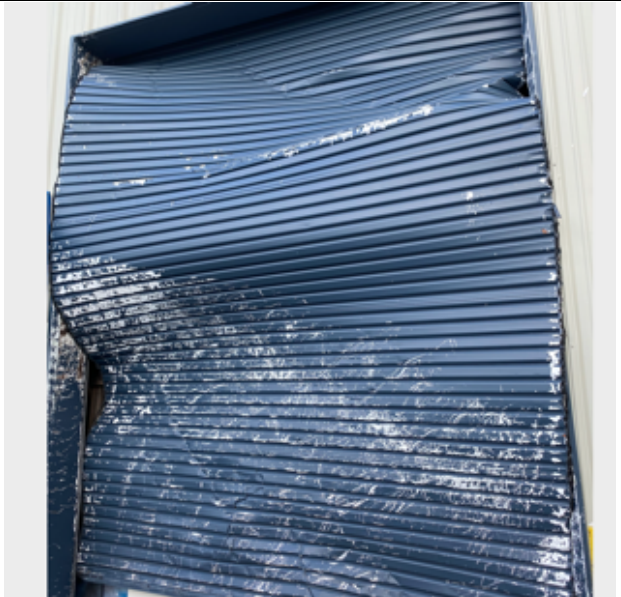
Photo 77: Another damaged door

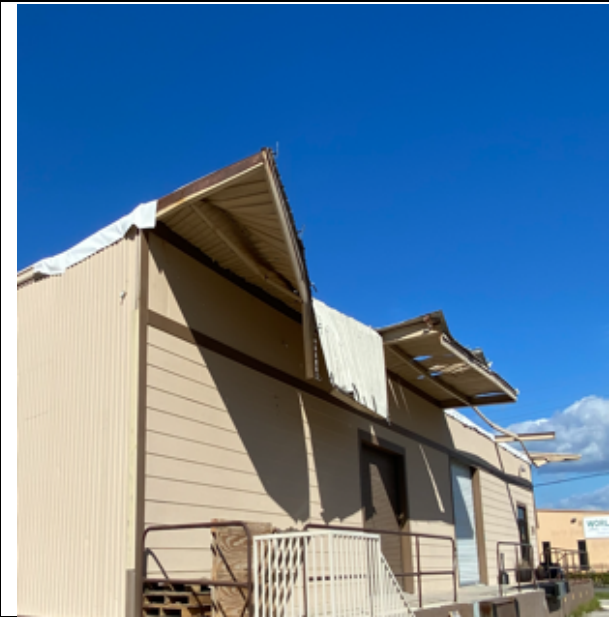
Photo 78: Overhang damage

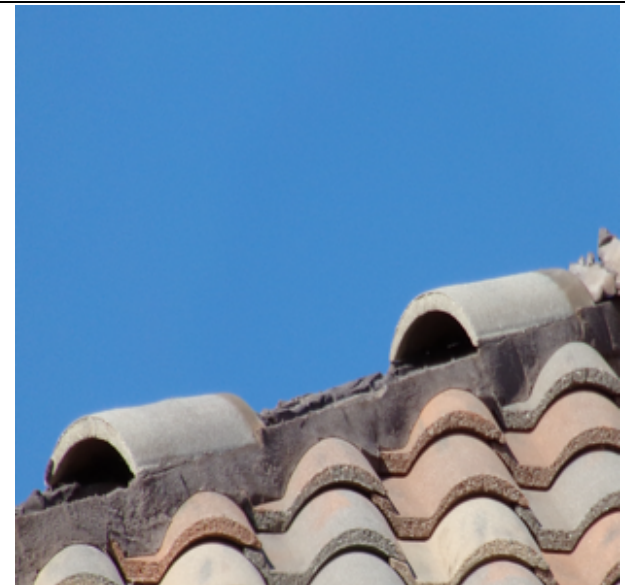
Photo 105: A few mortar-installed tiles were missing along this hip

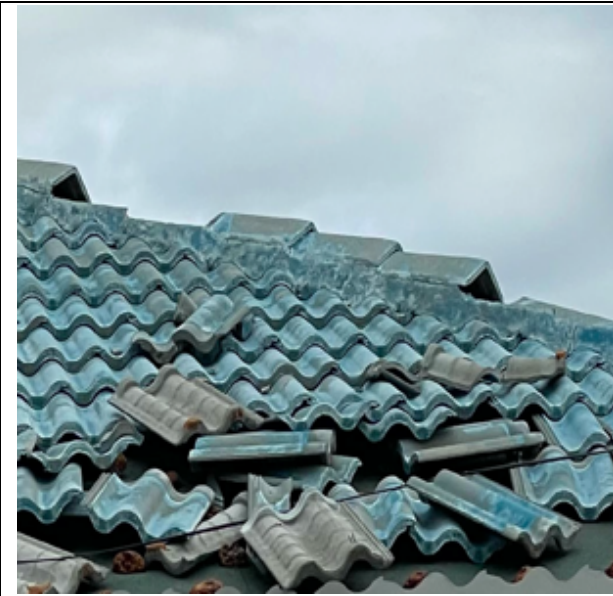
Photo 111: Older system subjected to 110 mph winds, resulting in dislodged and detached tile

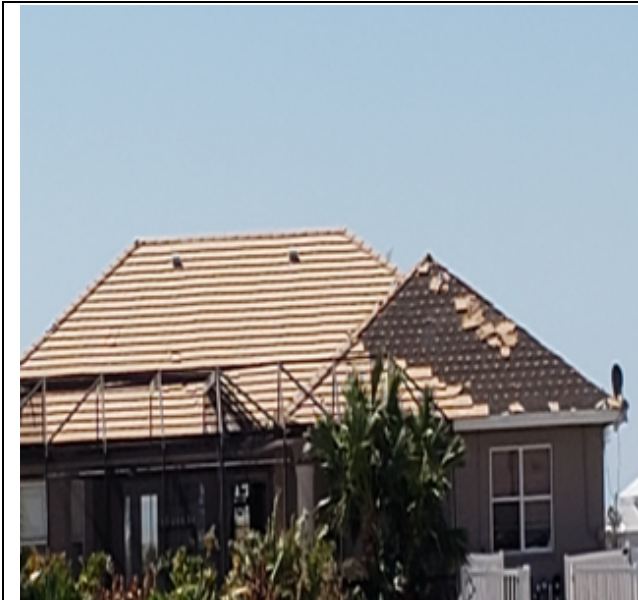
Photo 121: One example of tile loss. Cause not determined.

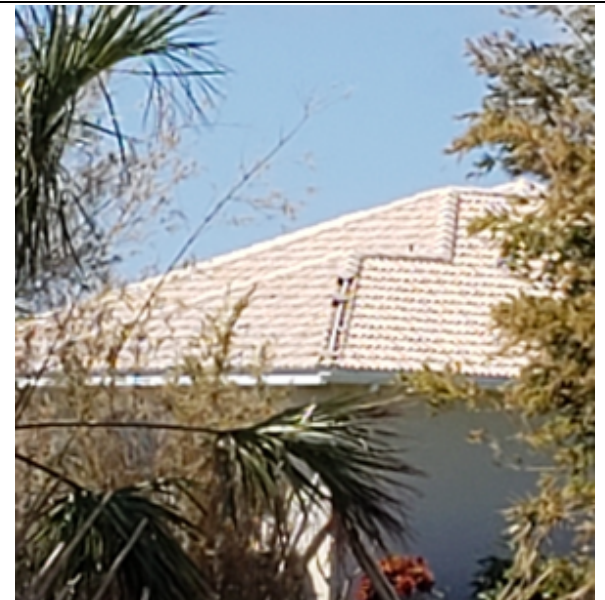
Photo 122: Small area of hip tile missing

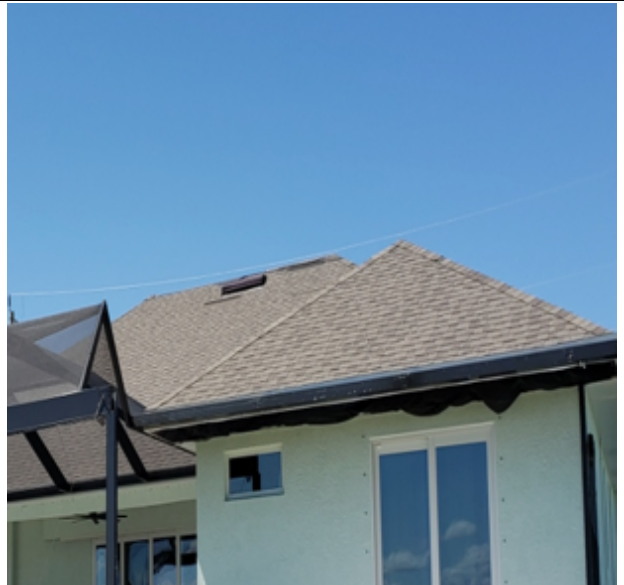
Photo 130: Small amount of hip and ridge damage.

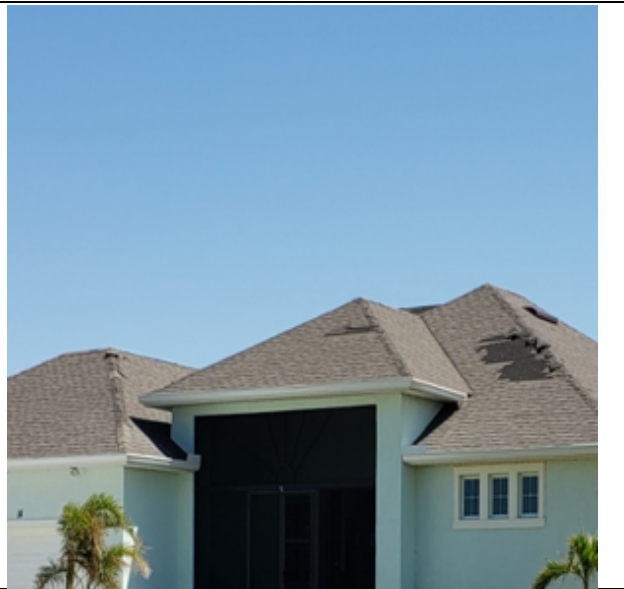
Photo 132: Some field of roof damage

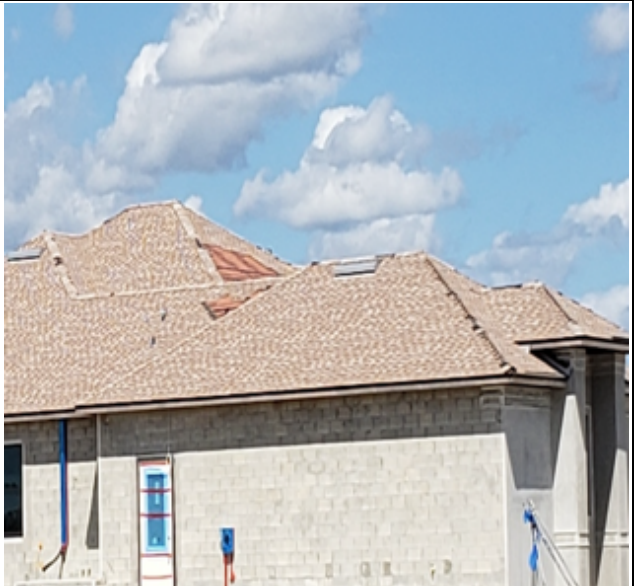
Photo 136: Hip and ridge damage that appears to have spread

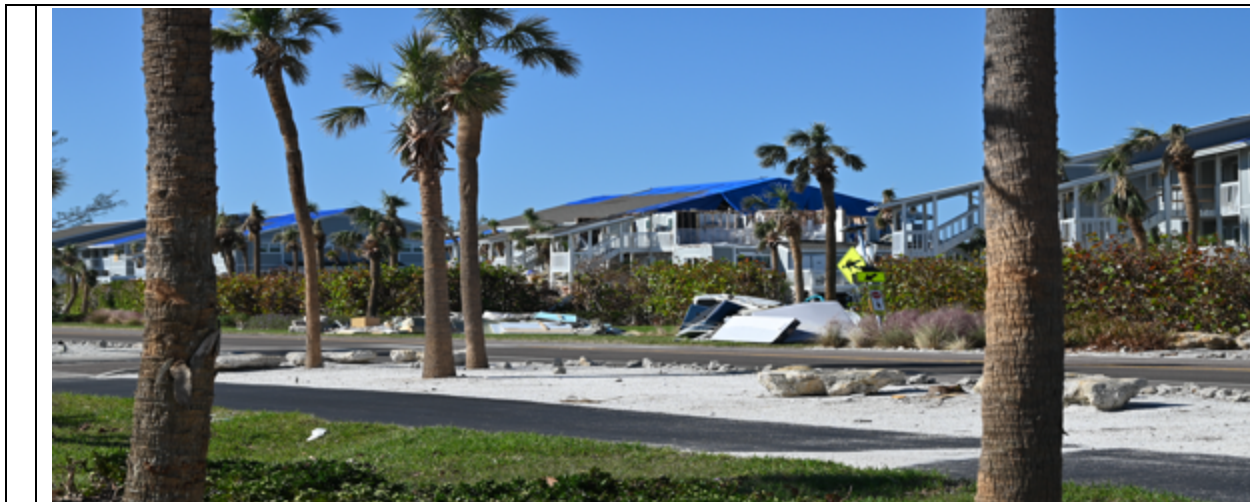
Photo 153: Difficult to diagnose damage initiation, but ridges and rake areas appeared likely to be a primary source of damage initiation.

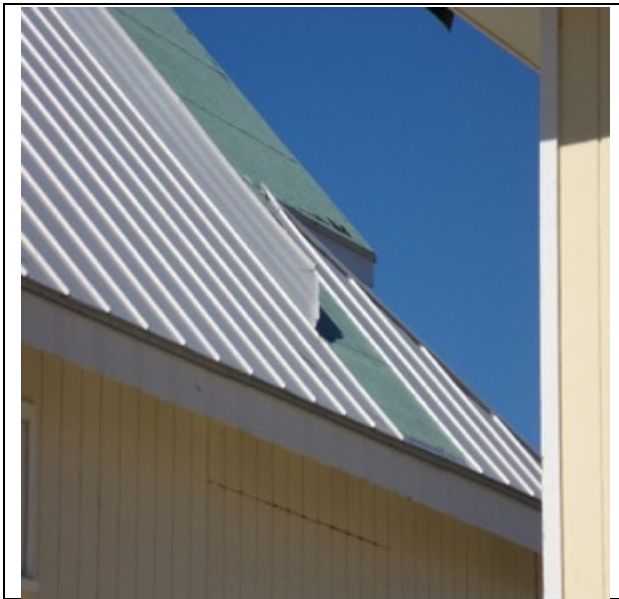
Photo 158: Edge metal damage resulting in loss of panels

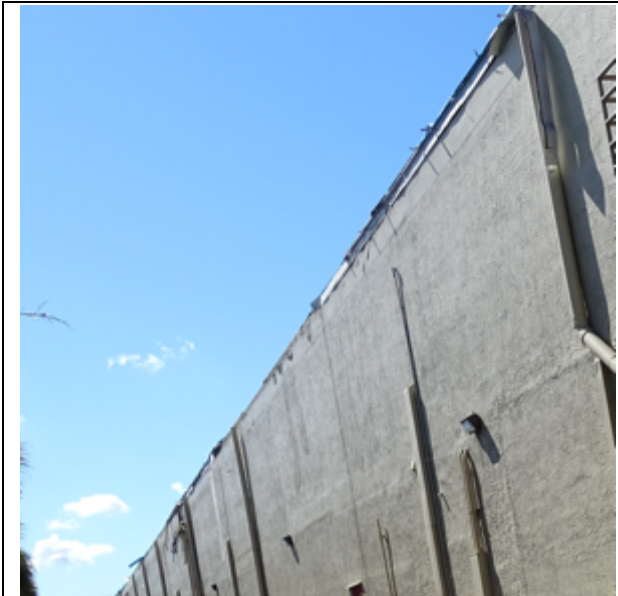
Photo 164: Missing gutters and downspouts

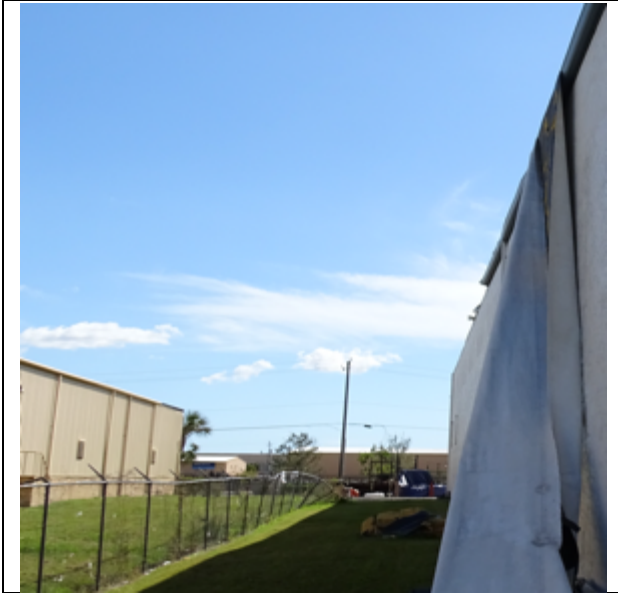
Photo 166: Gutters missing on windward (front) side of two adjacent buildings
