HAIL DAMAGE STUDY

For Selected Buildings at

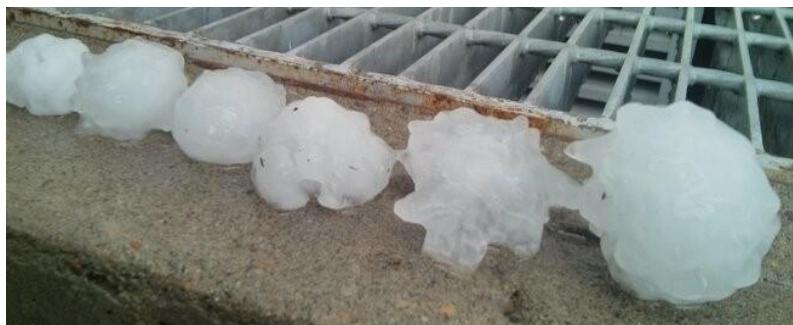
Figure 2: Varying hail sizes and shapes (smooth, jagged, spiked) from a single storm. (The Weather Network⁶)

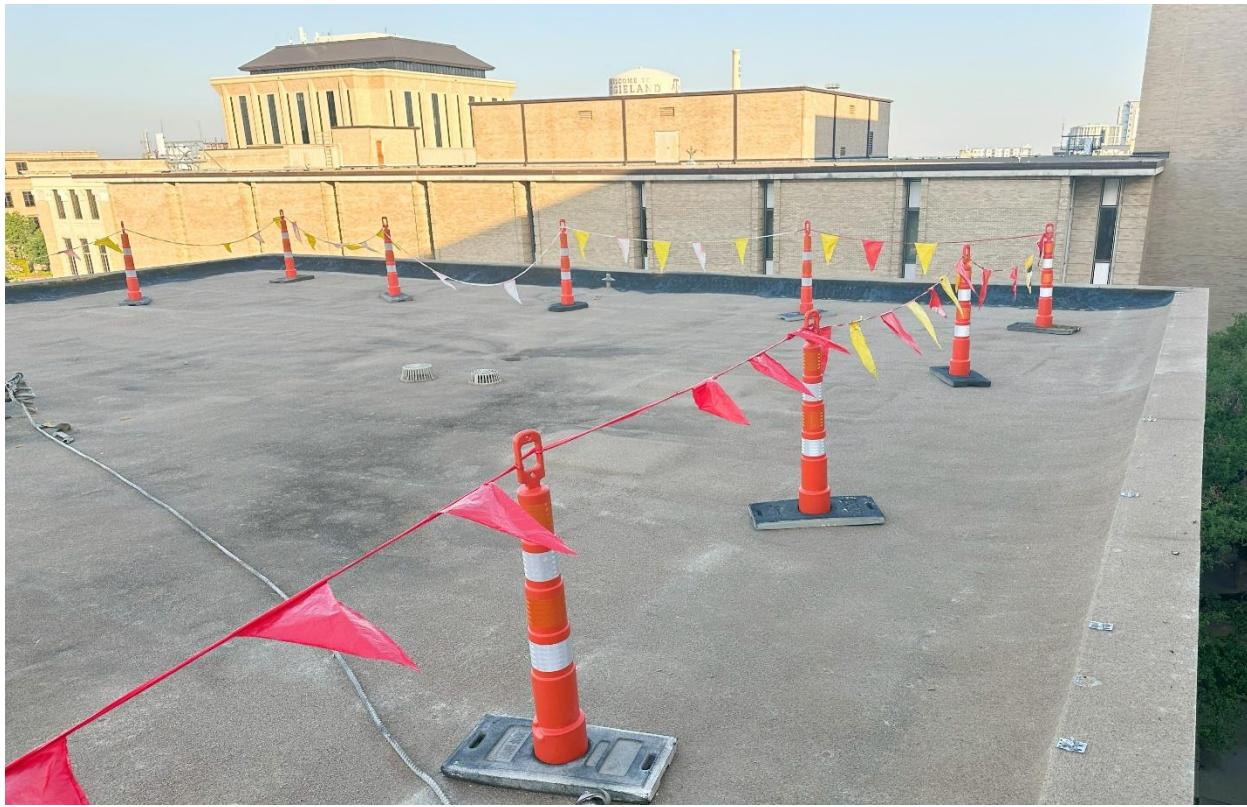
Photo 1: A wide-angle view of the NW end of the nearly completed Peterson Building SPF roof, which was divided into three sections separated by curbed expansion joints. This end was the only one covered with granules on the 3/15/2025 date of loss (DOL).

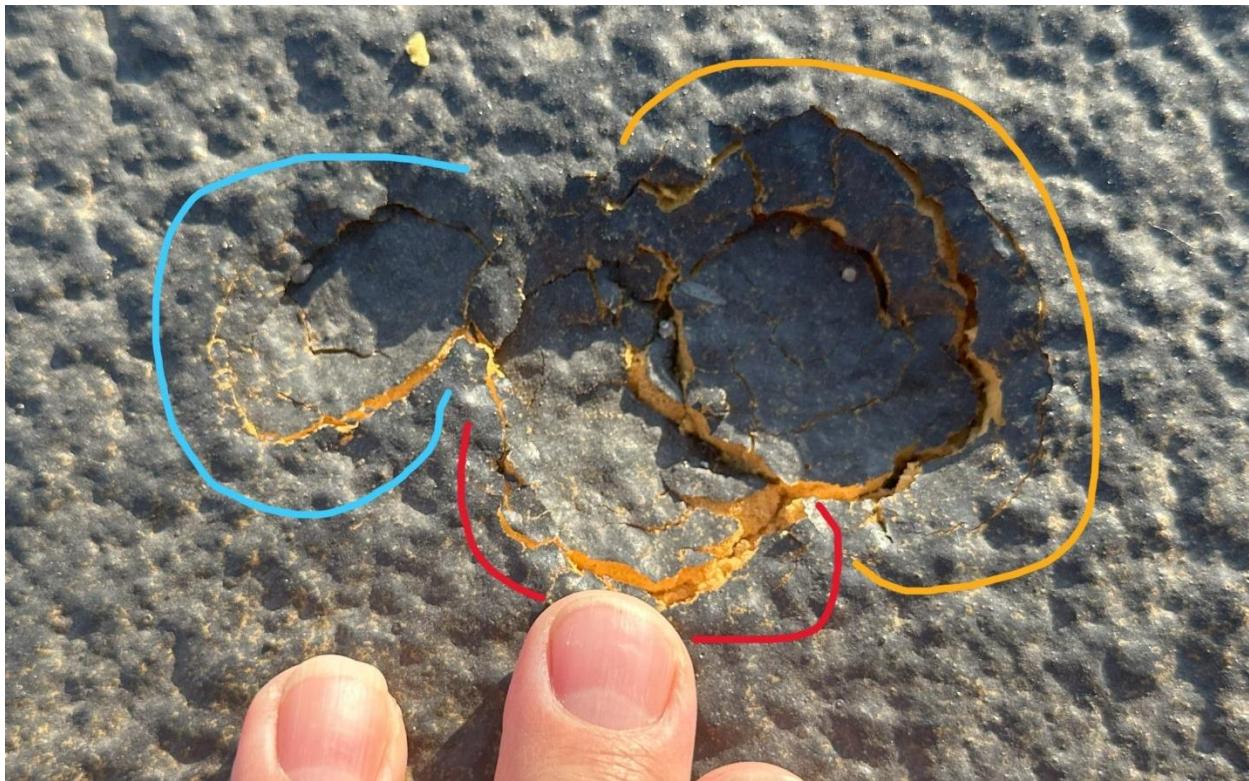
Photo 8: Blue, red, and yellow highlights indicate three different impact marks. It is not uncommon for two or more hail hits to combine impact energy and create openings that a single hailstone would not have caused.

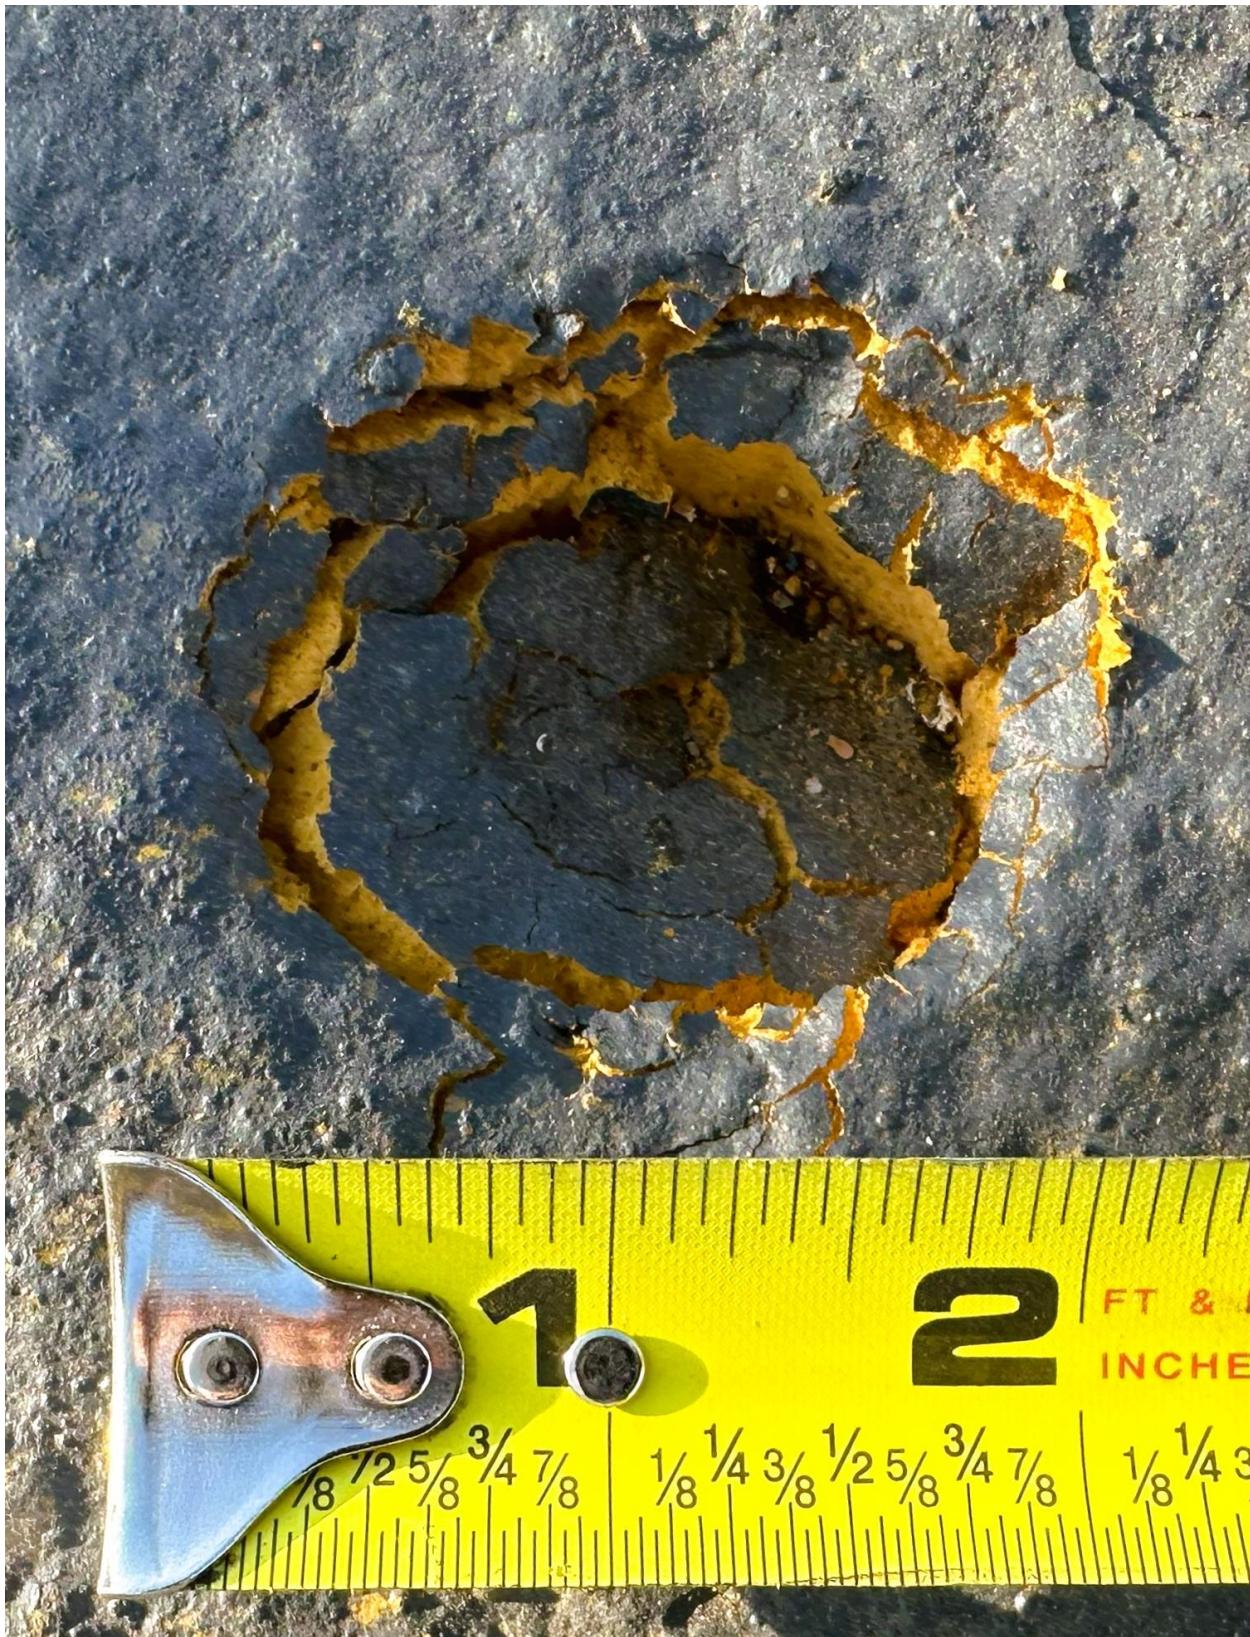
Photo 9: Hailstone openings on SPF roofs are typically close to the size of the hailstones causing damage. In this case, hailstone size was estimated to be close to two inches in diameter.

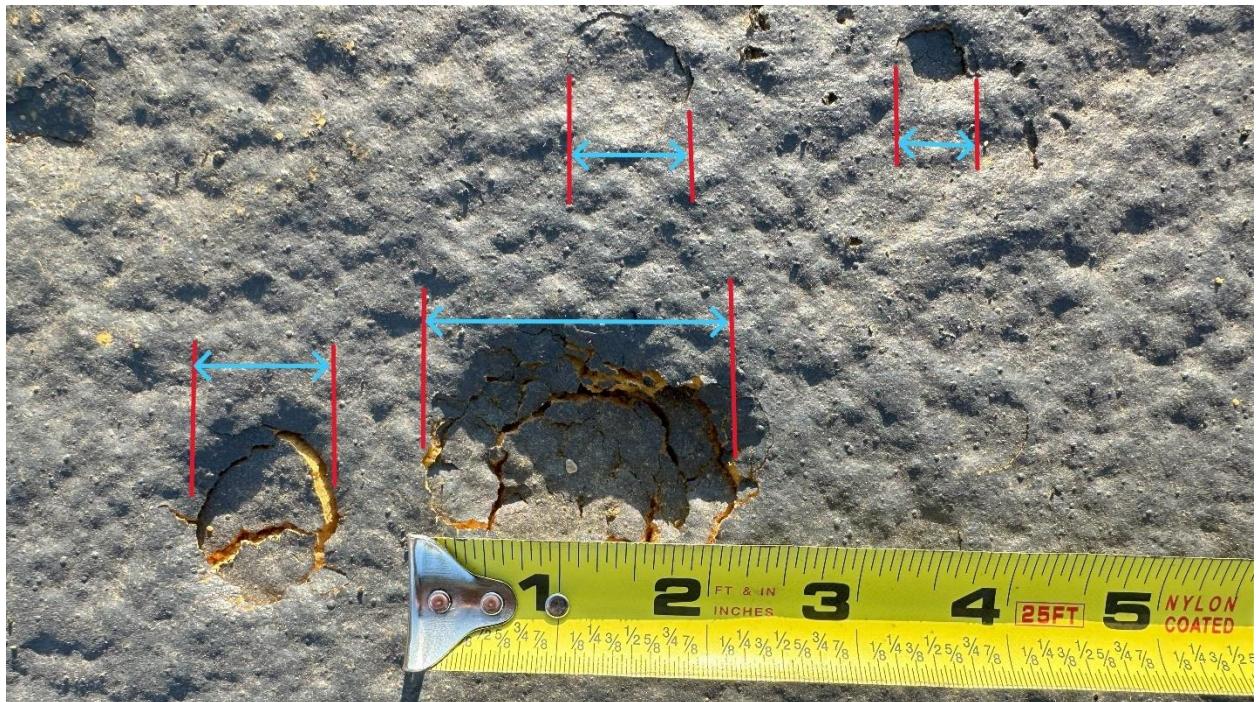
Photo 10: Both photos on this page are close-up views showing that hailstone sizes can vary from small to large from the same hail cells.

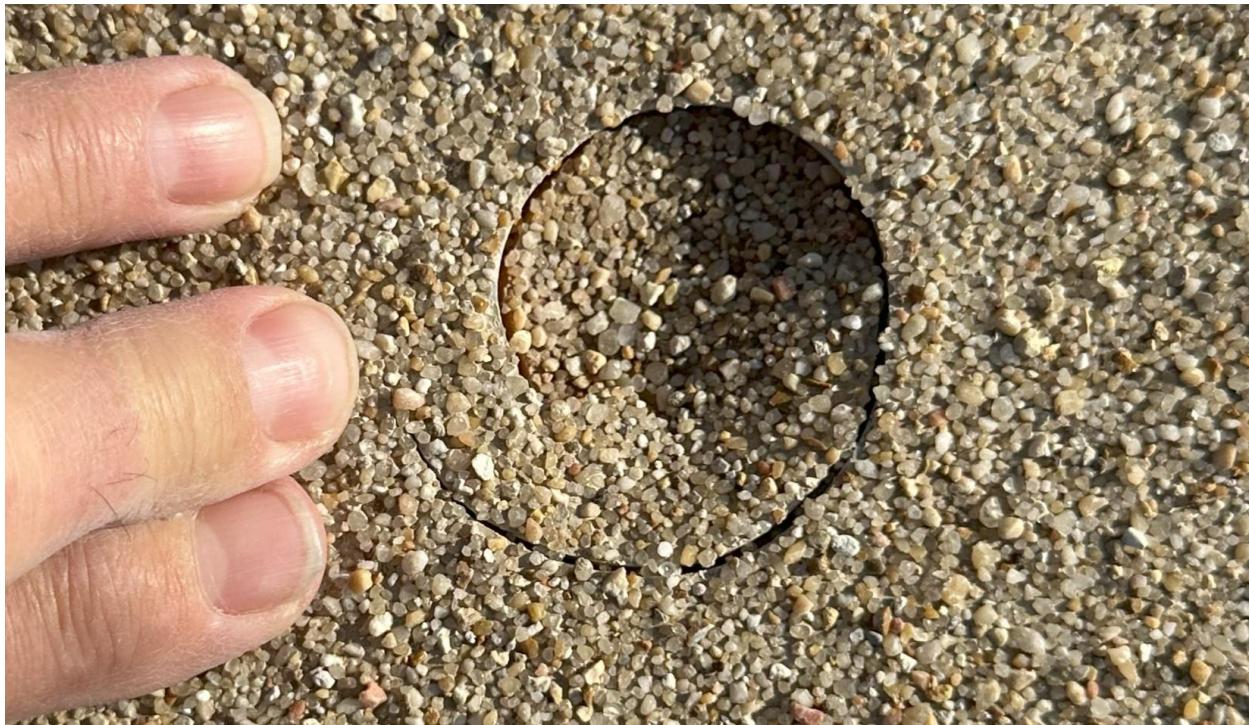
Photo 7: Both photos on this page are close-up views of hail-caused breaches in the SPF membrane.

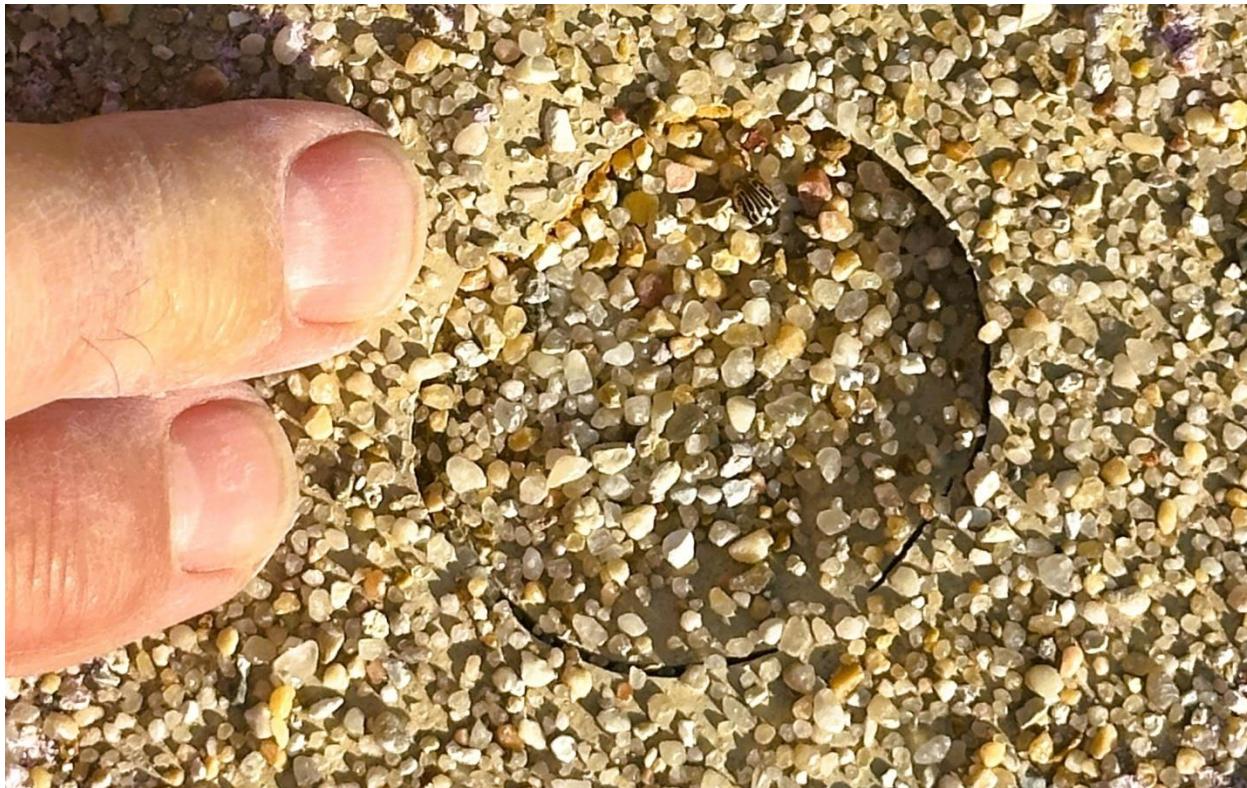
Photo 9: Both photos on this page are close-up views of hail-caused breaches in the SPF membrane.

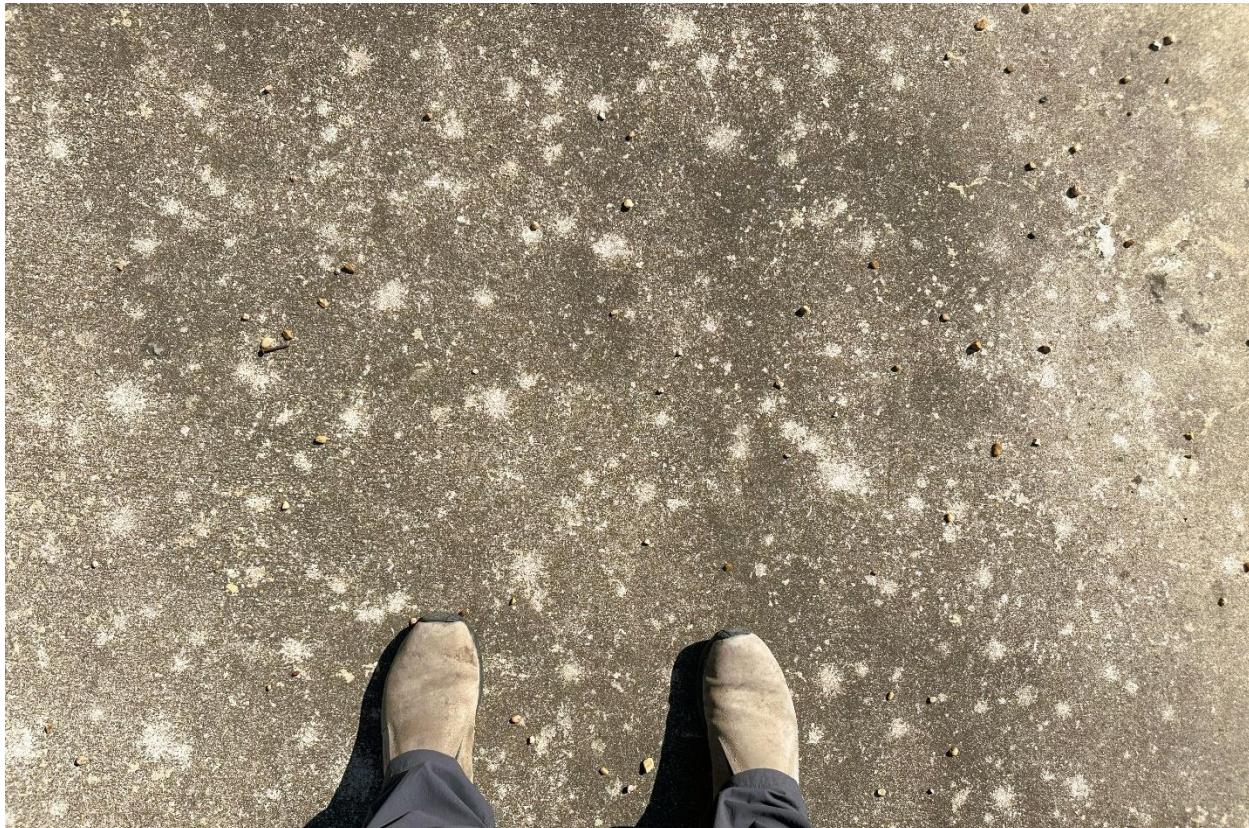
Photo 2: Widespread hail spatter (white blotches) were observed on the concrete walkway beneath these roofs. Spatter indicated hail sizes of 1-3/4-inches in diameter or larger.

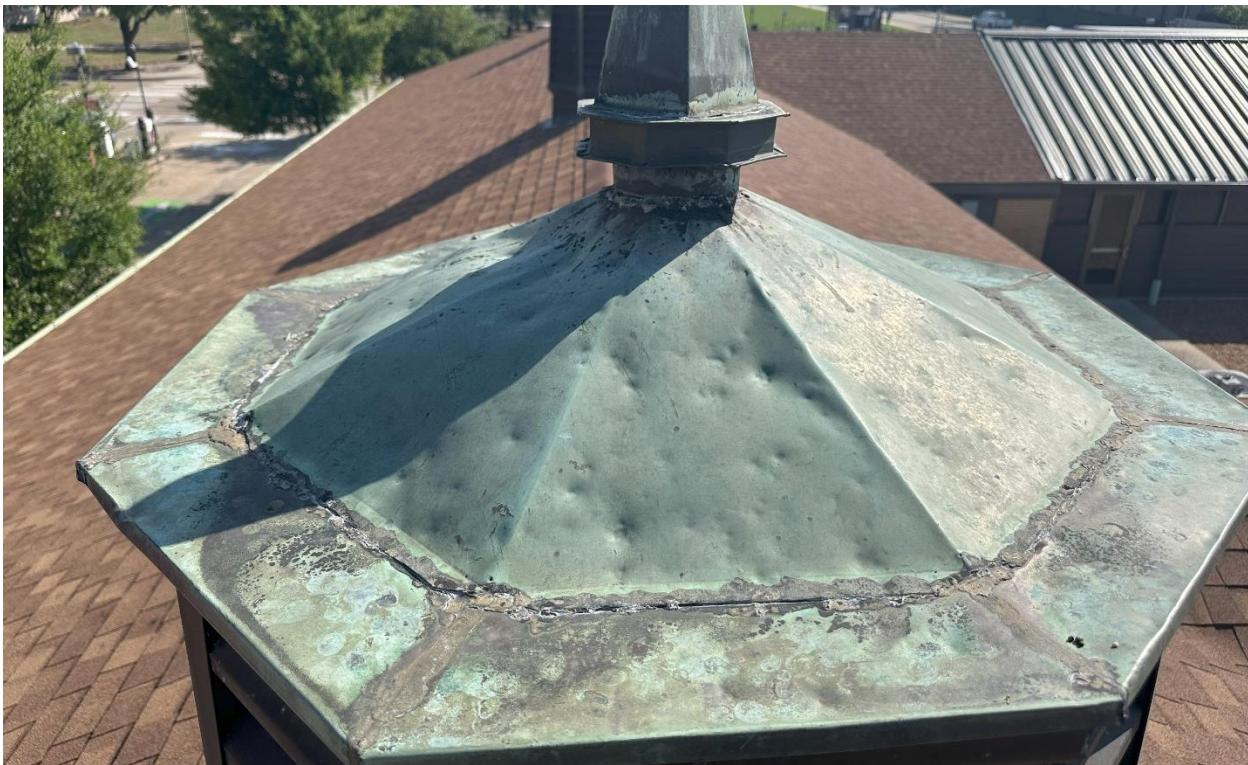
Photo 3: Both photos on this page show copper-capped exhaust vents with numerous indentations consistent with hail. However, it was not clear that these dents were from the DOL i.e., it is possible they were from a previous hail event.

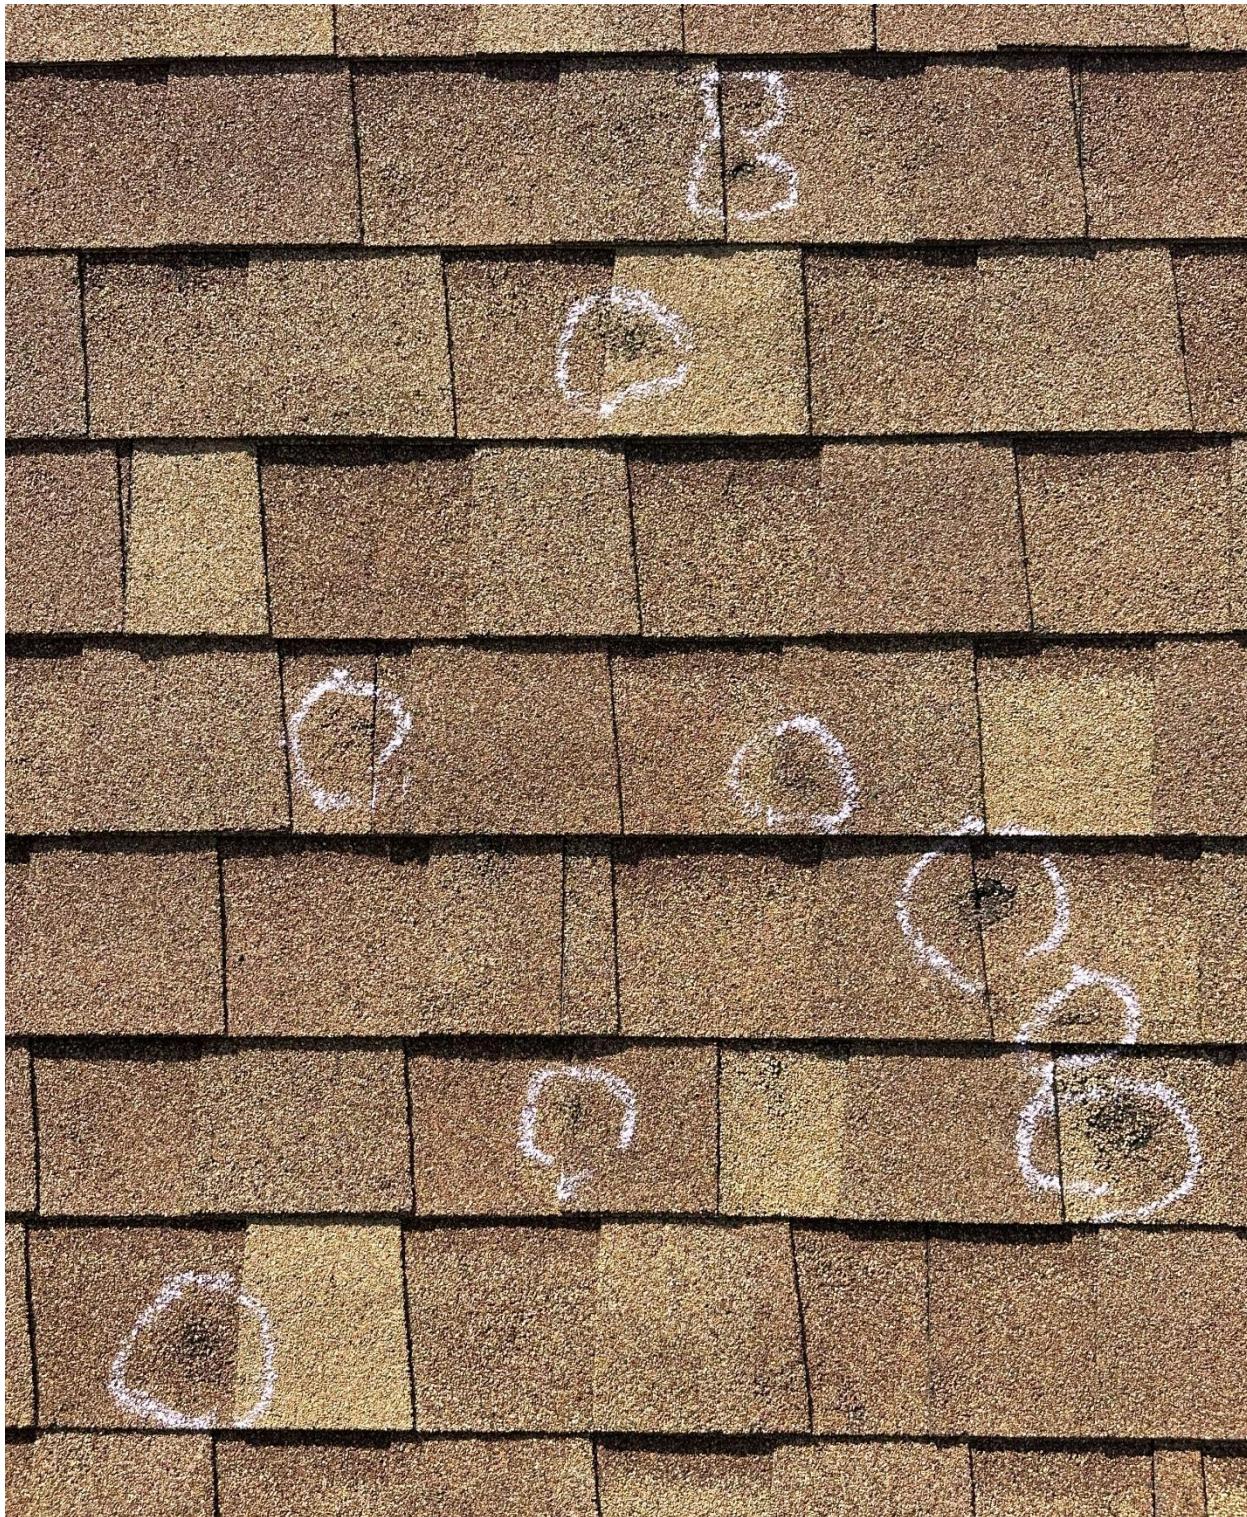
Photo 7: Numerous round dark spots were consistent with granule loss caused by traumatic impact from hail on the DOL. Even when hail does not cause fractures or holes in the mat, exposure of the asphalt to ultraviolet light triggers oxidation, which shortens roof service life. Some of these spots also were soft to the touch i.e., exhibited bruises.

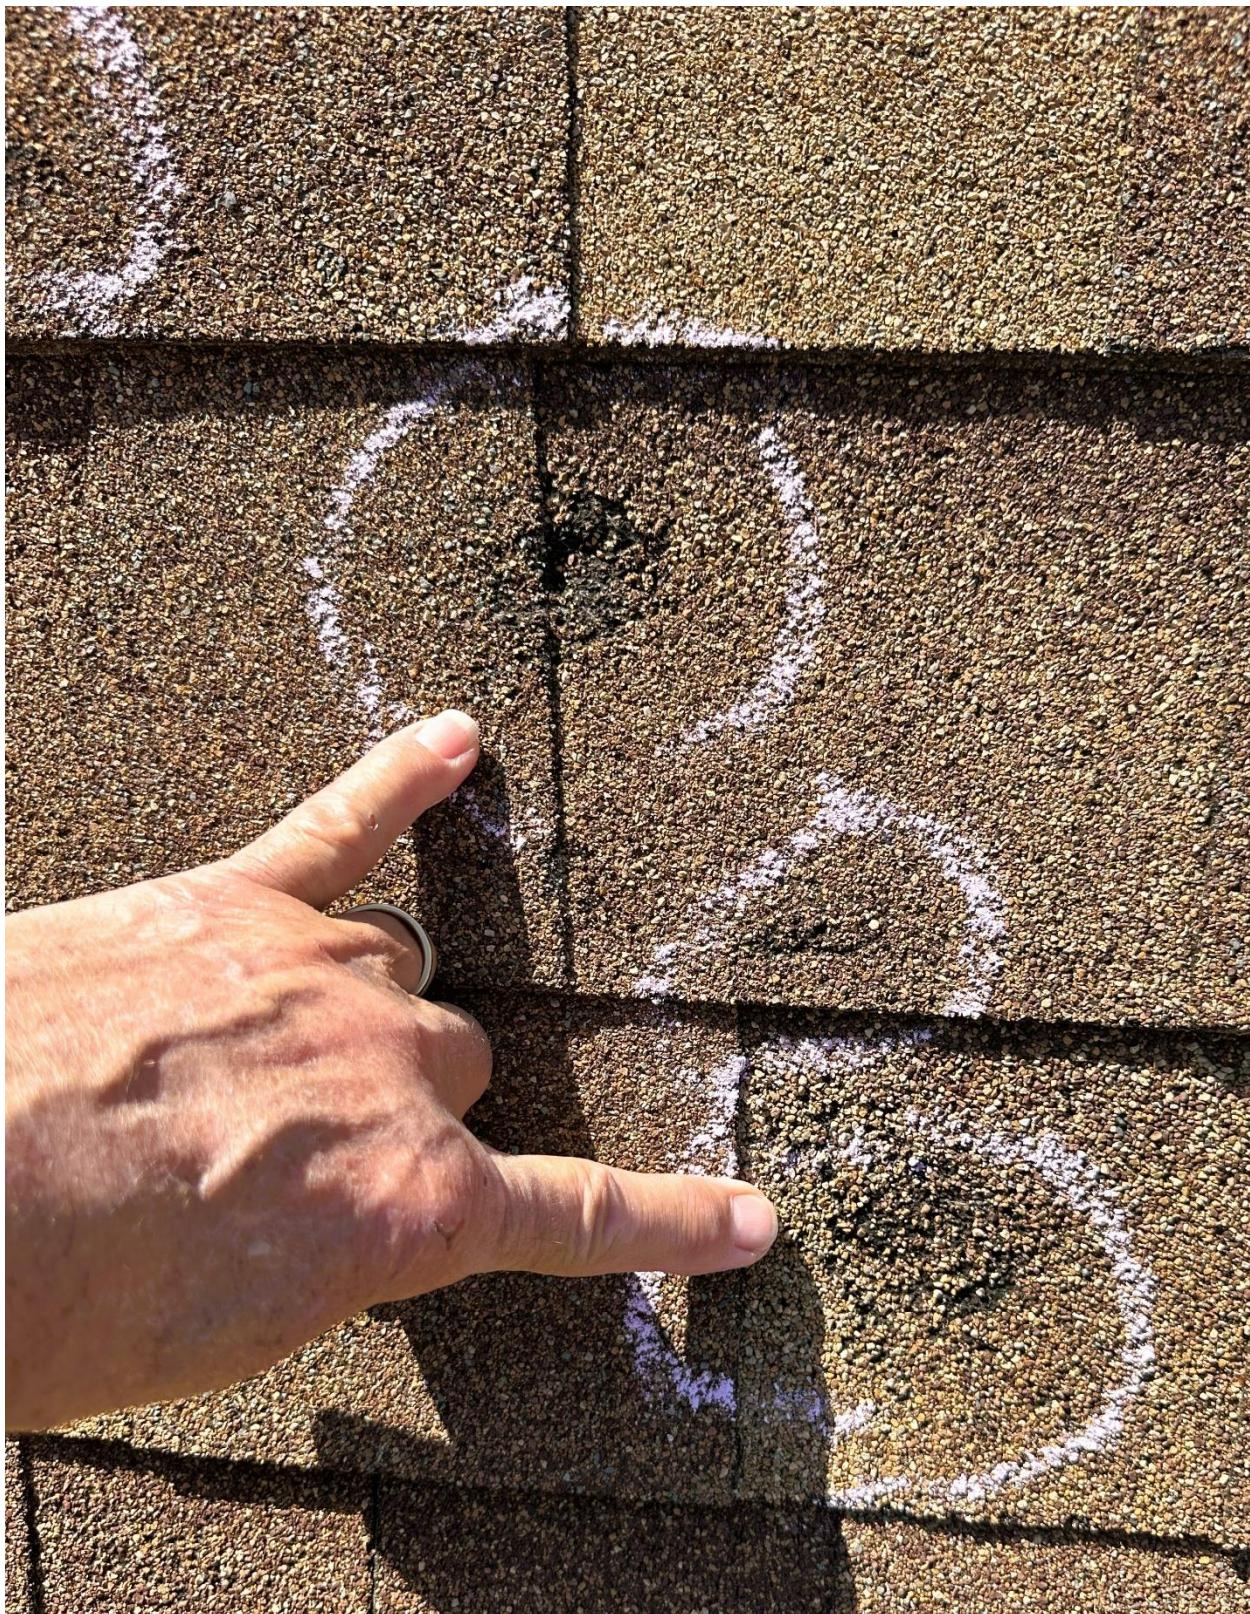
Photo 8: Close-up views of bruises and granule loss consistent with traumatic impact from hail on the DOL.

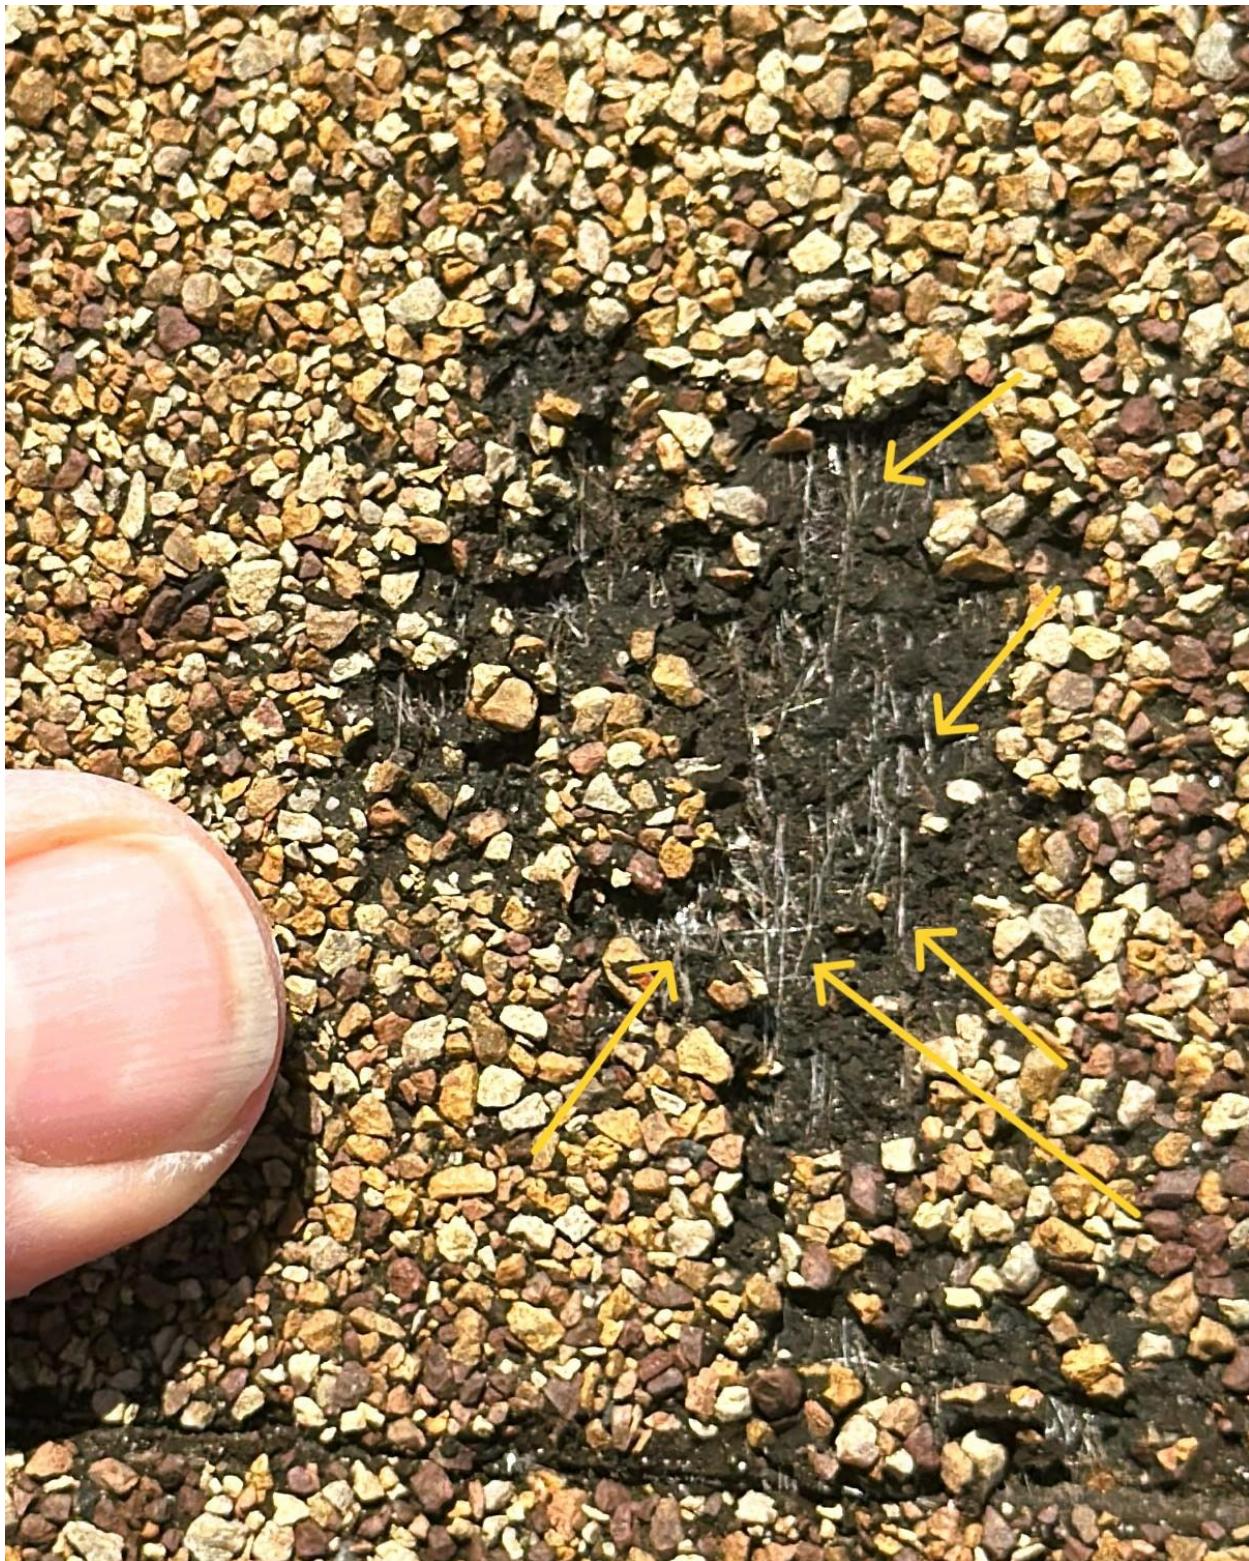
Photo 9: A close-up view of an apparent hail hit shows what appears to be slightly oxidized asphalt and glass fiber scrim (arrows) showing through, which indicate either older damage or sharper or harder hailstones, which caused detachment of the asphalt coating.

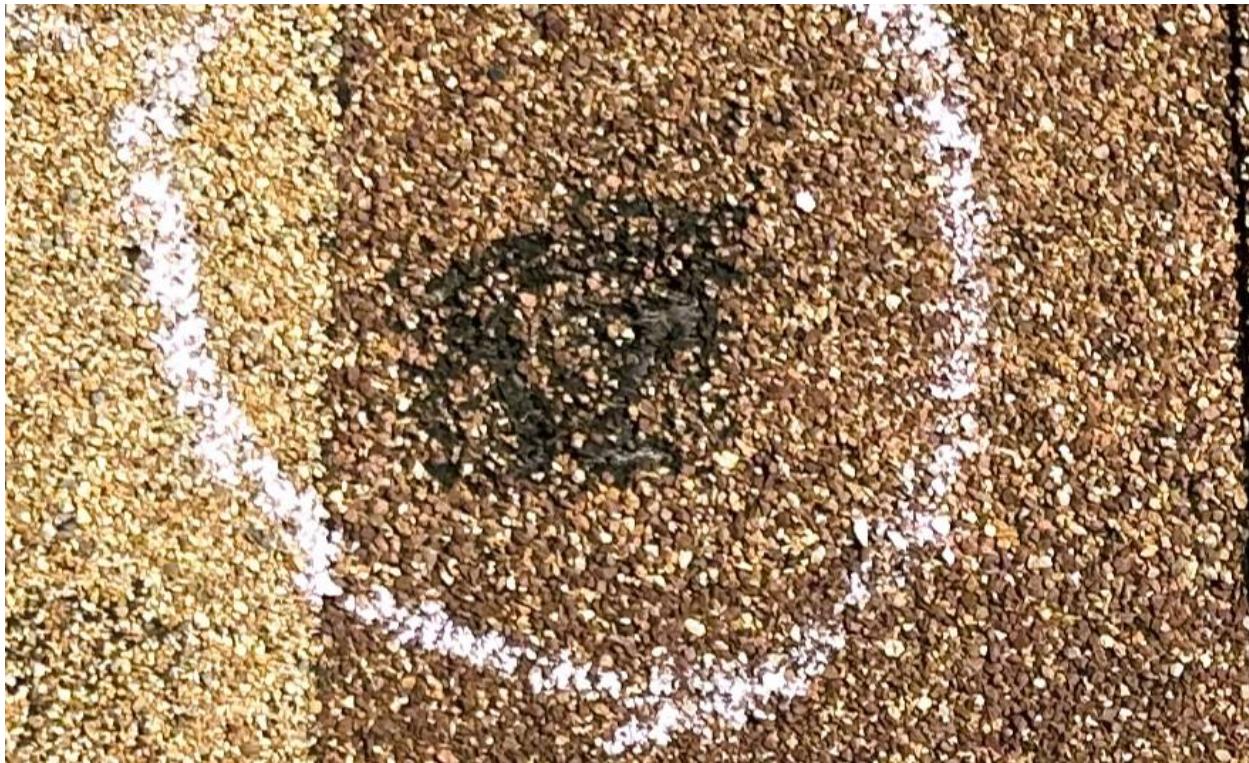
Photo 10: Both photos on this page show more anomalies (bruises and granule loss) consistent with traumatic impact from hail on the DOL.

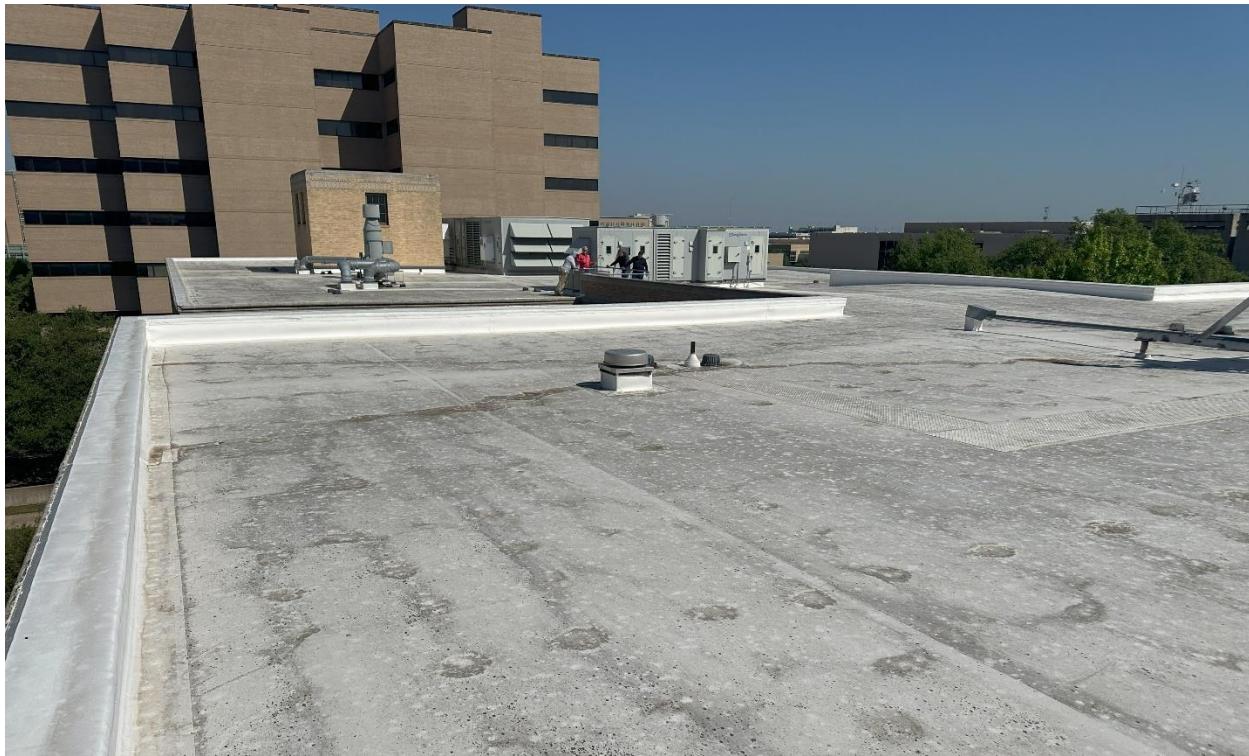
Photo 1: Both photos on this page show wide views of the TPO-covered Scoates Hall roof. Other than spatter and dents on ancillary components, the membrane had no apparent hail damage.

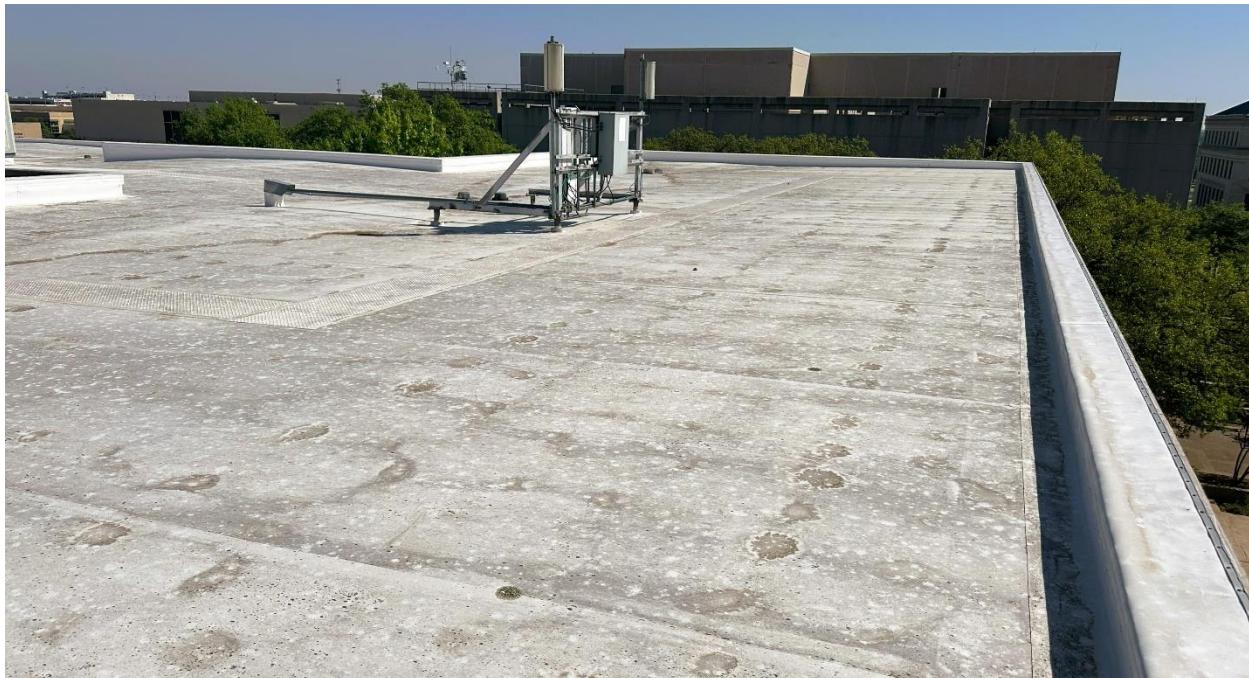
Photo 2: The symmetrical pattern of round dark spots indicate the presence of fasteners and disks beneath the TPO surface. White asymmetrical splotches indicate hail spatter.

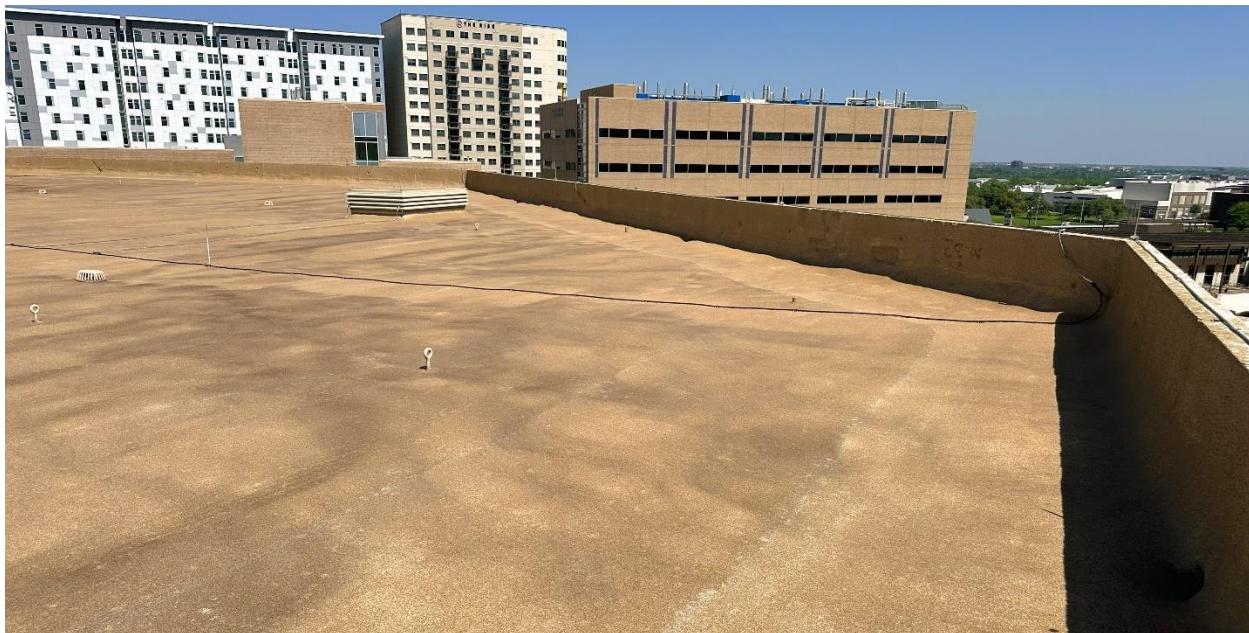
Photo 2: While wide views may seem to show pristine surfaces, closer inspection was required to identify damage that may not have been detectable otherwise.

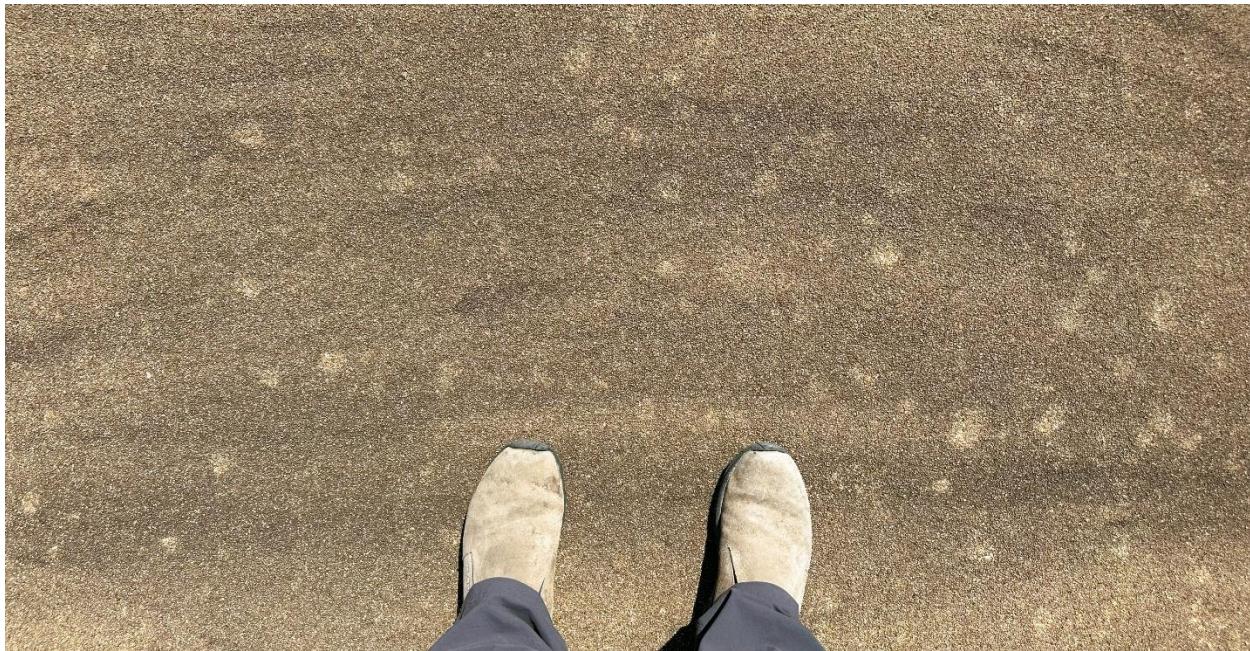
Photo 3: Both photos on this page show spatter consistent with traumatic impact from hail on the DOL. This photo shows the granule-surfaced SPF system.

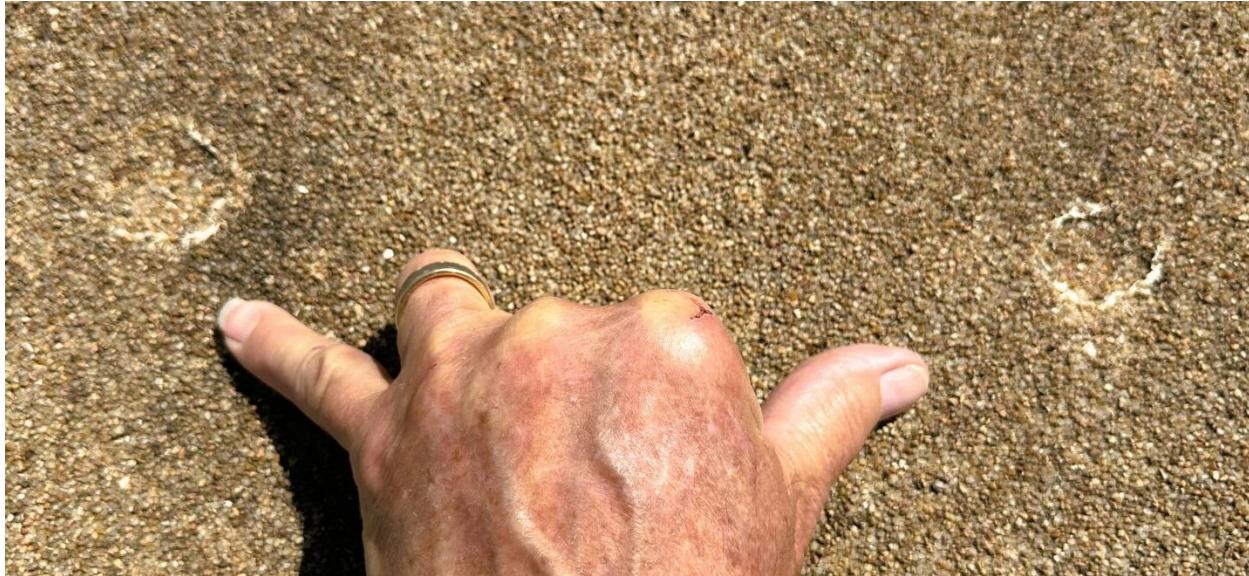
Photo 7: Both photos on this page show fractured SPF assembly consistent with traumatic impact from hail on the DOL.

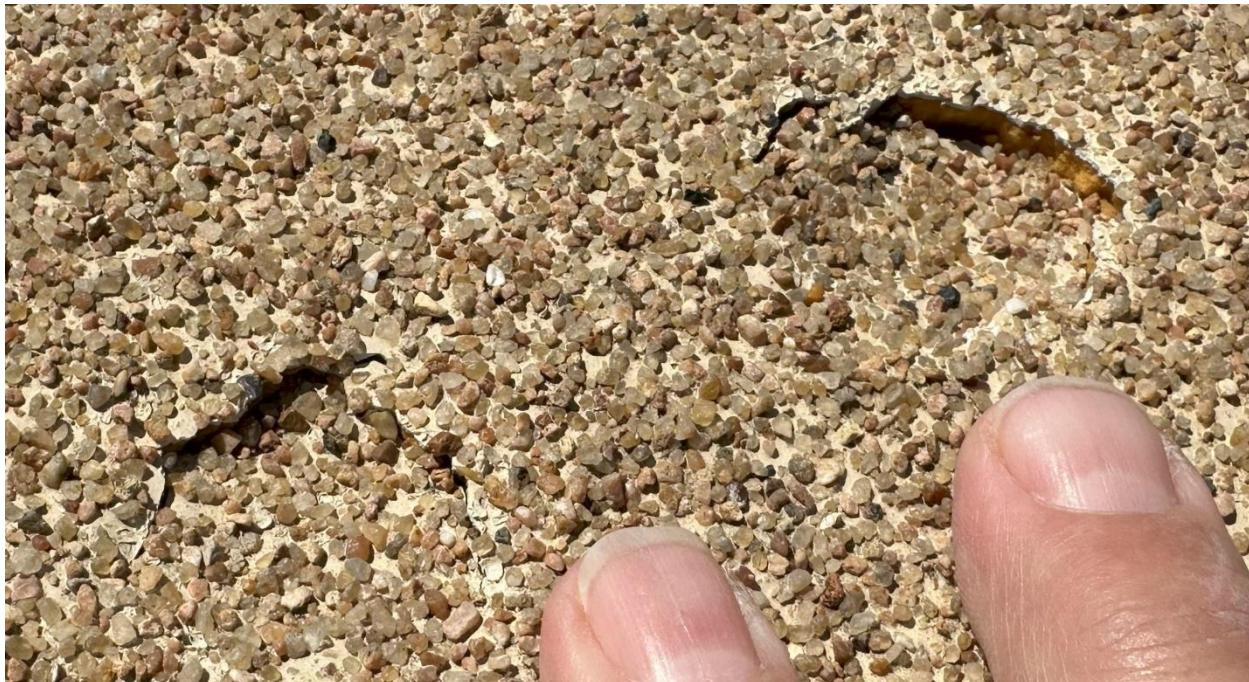
Photo 8: The breached SPF membrane on the Blocker Building did not appear to be as severe as on others inspected.
