HAIL DAMAGE STUDY

For Selected Buildings at

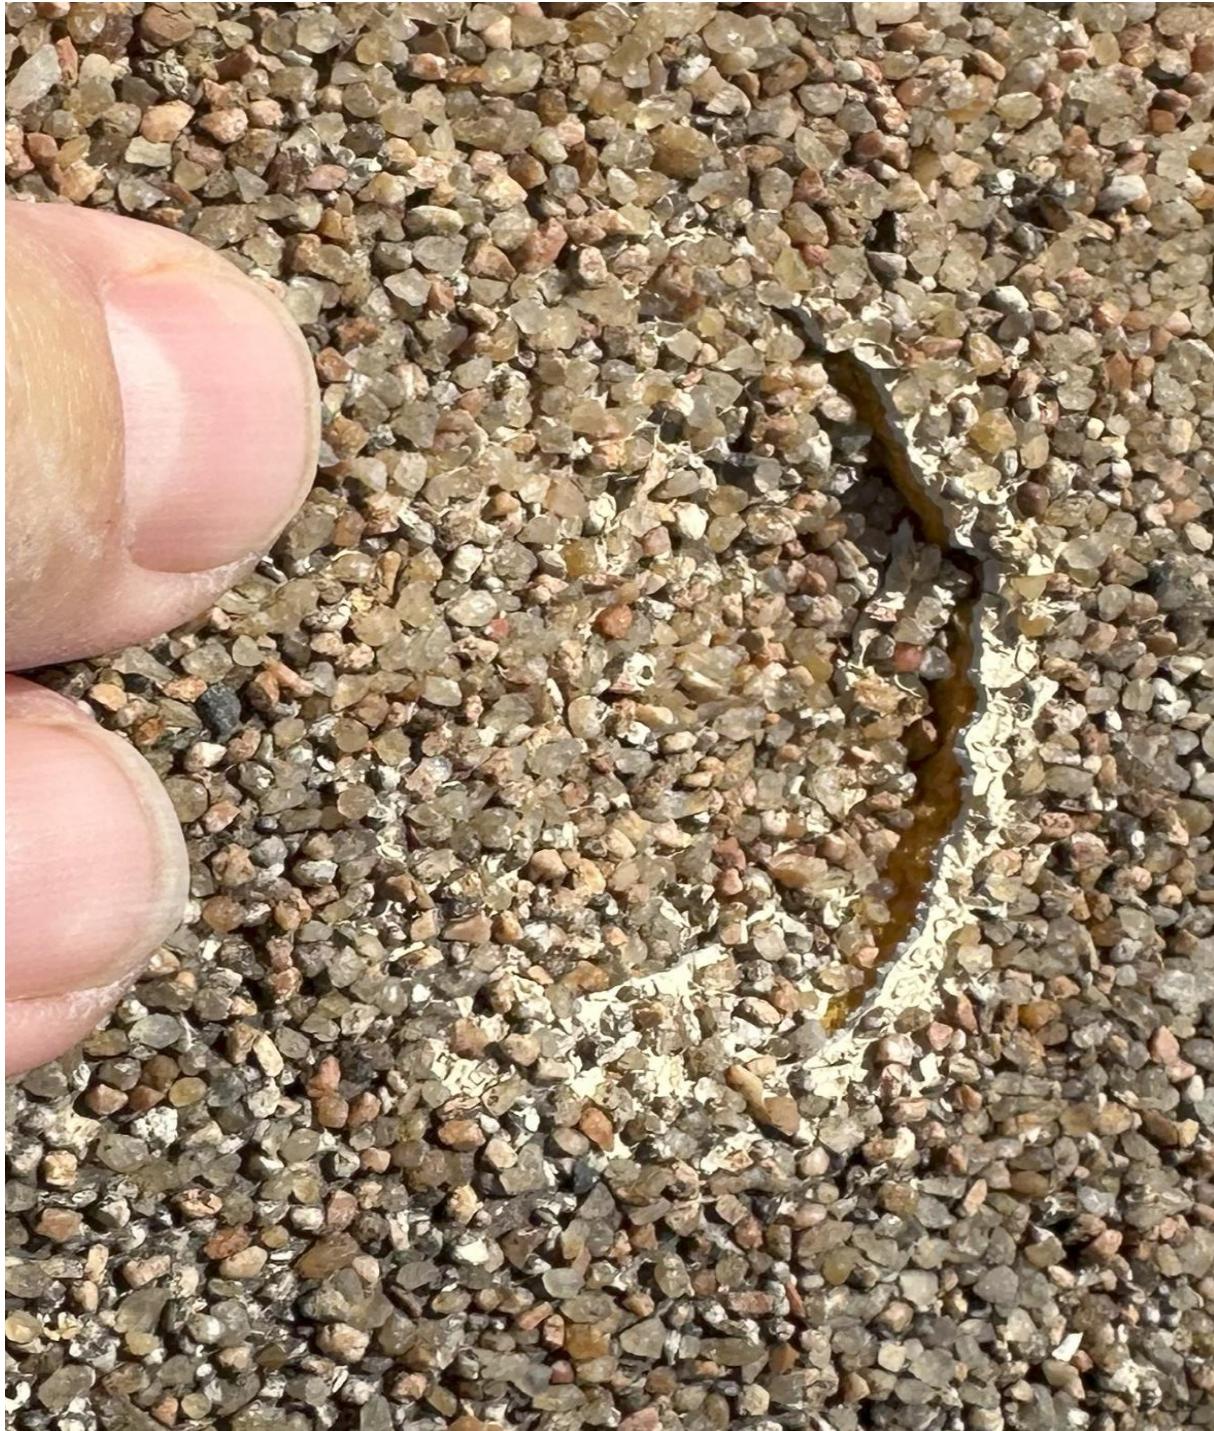
Photo 9: Another large fracture through the SPF.

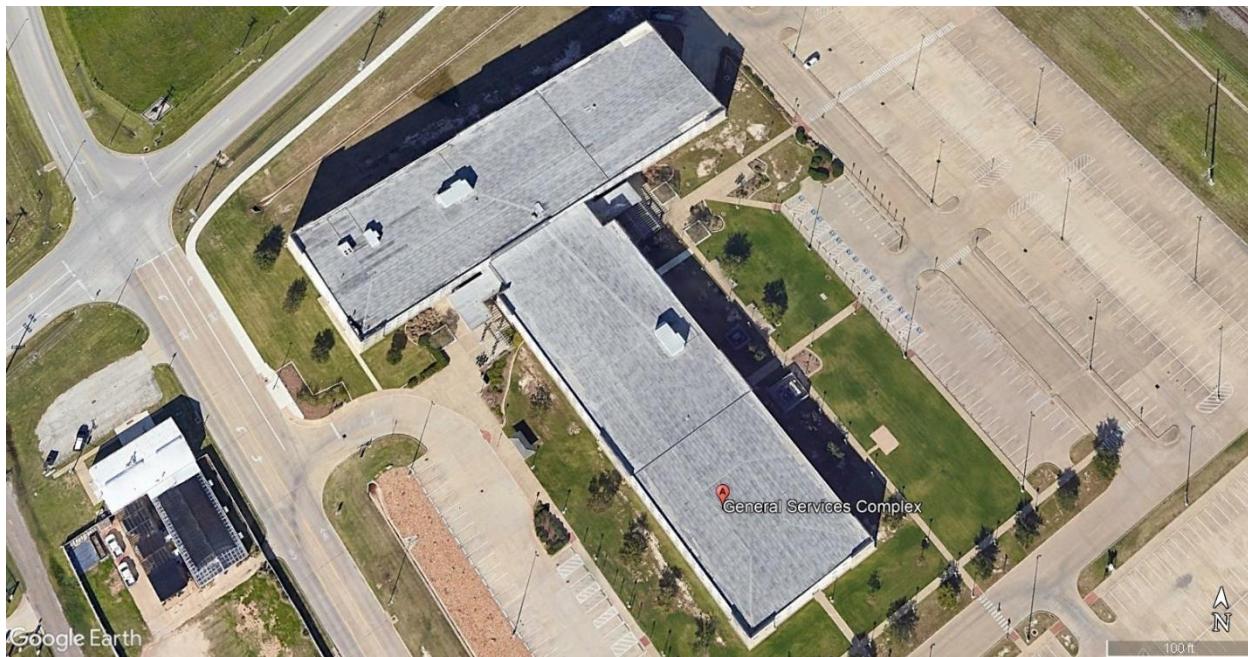
Photo 1: A Google Earth aerial view (north at top) shows a T-shaped building covered with a modified bituminous (MB) roof system.

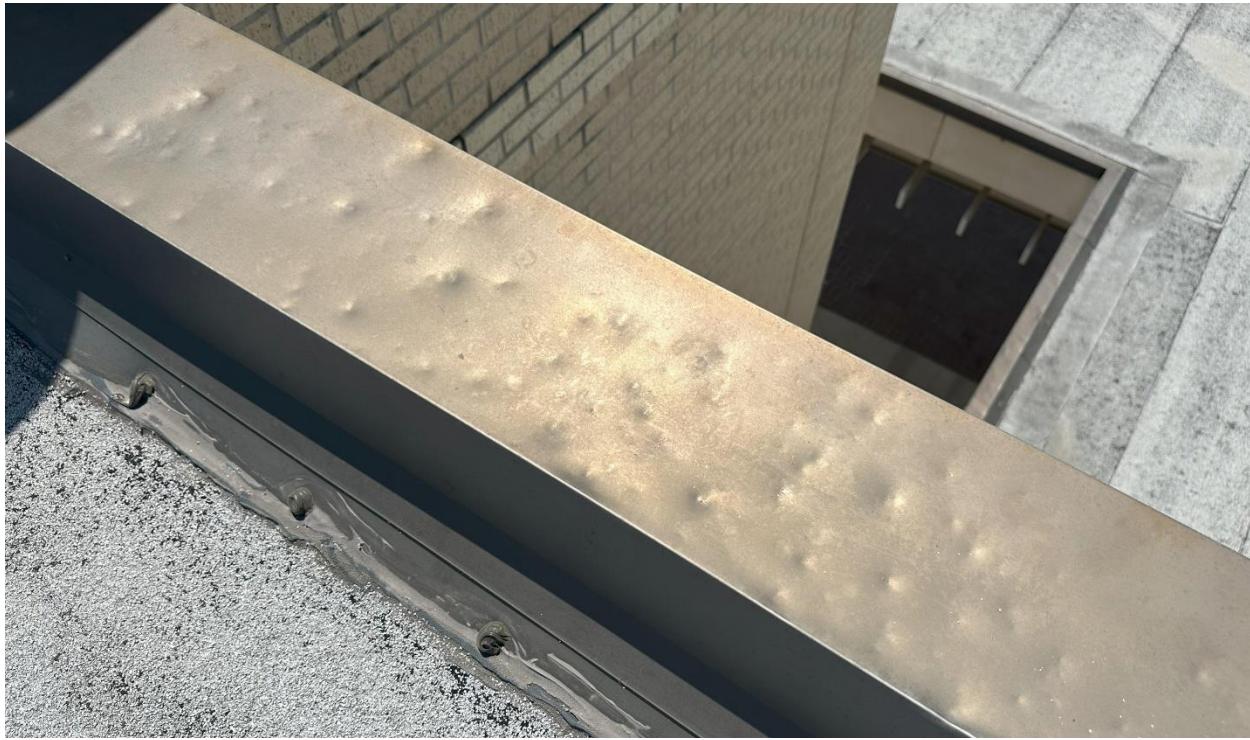
Photo 5: Both photos on this page show hail-damaged metal coping consistent with storm conditions on the DOL.

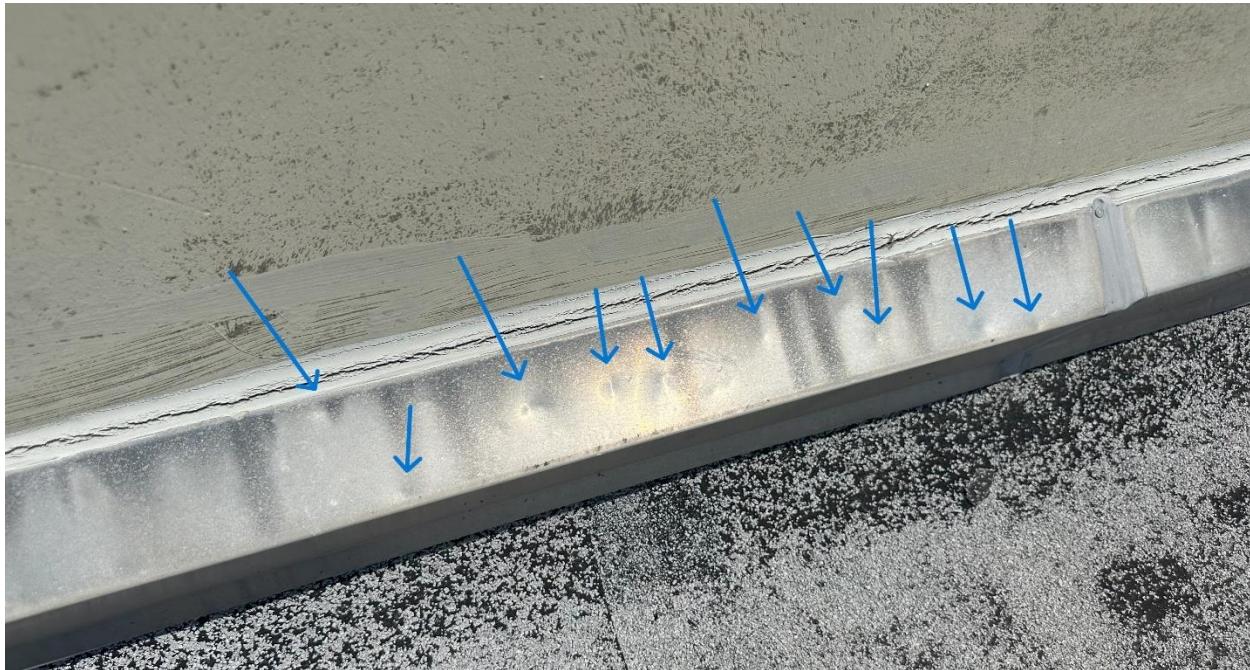
Photo 7: Both photos on this page show hail-damaged metal counterflashing consistent with storm conditions on the DOL. However, absent evidence to the contrary, many of these anomalies could be due to previous storms.

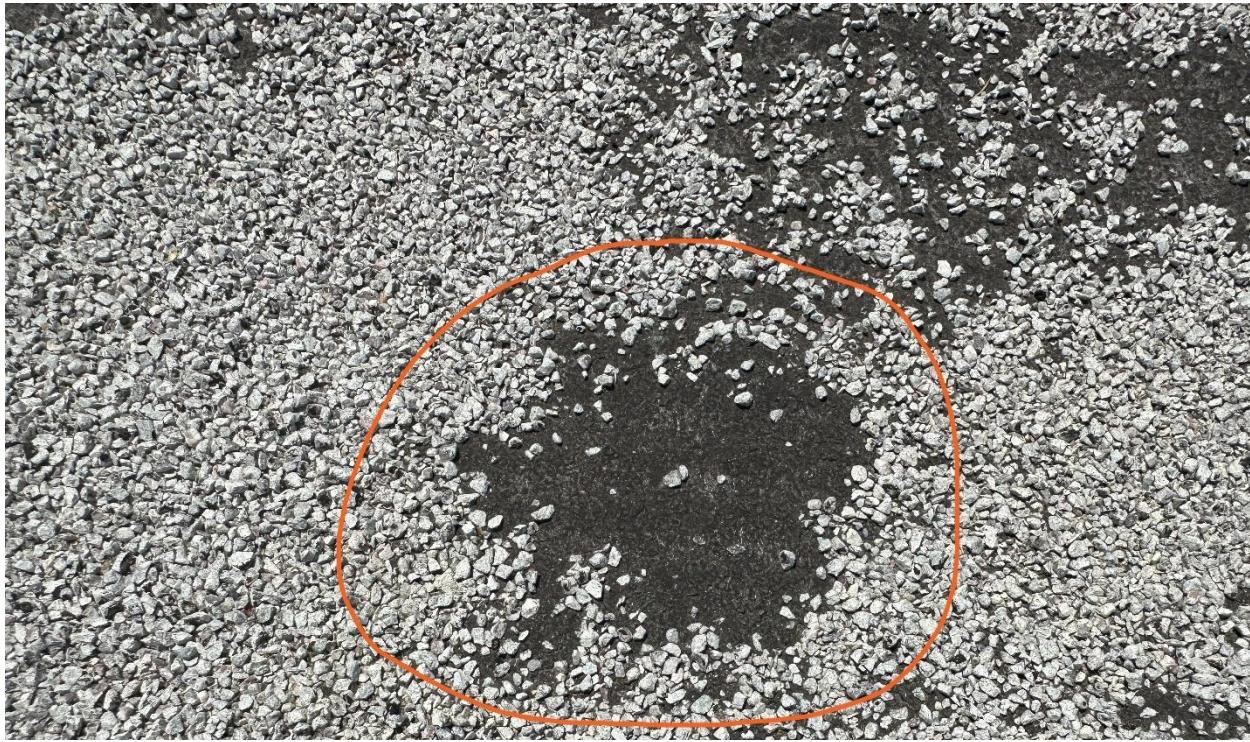
Photo 10: Both photos on this page show conspicuous dark blemishes where granules were detached in relatively large spots. This is consistent with storm conditions on the DOL.

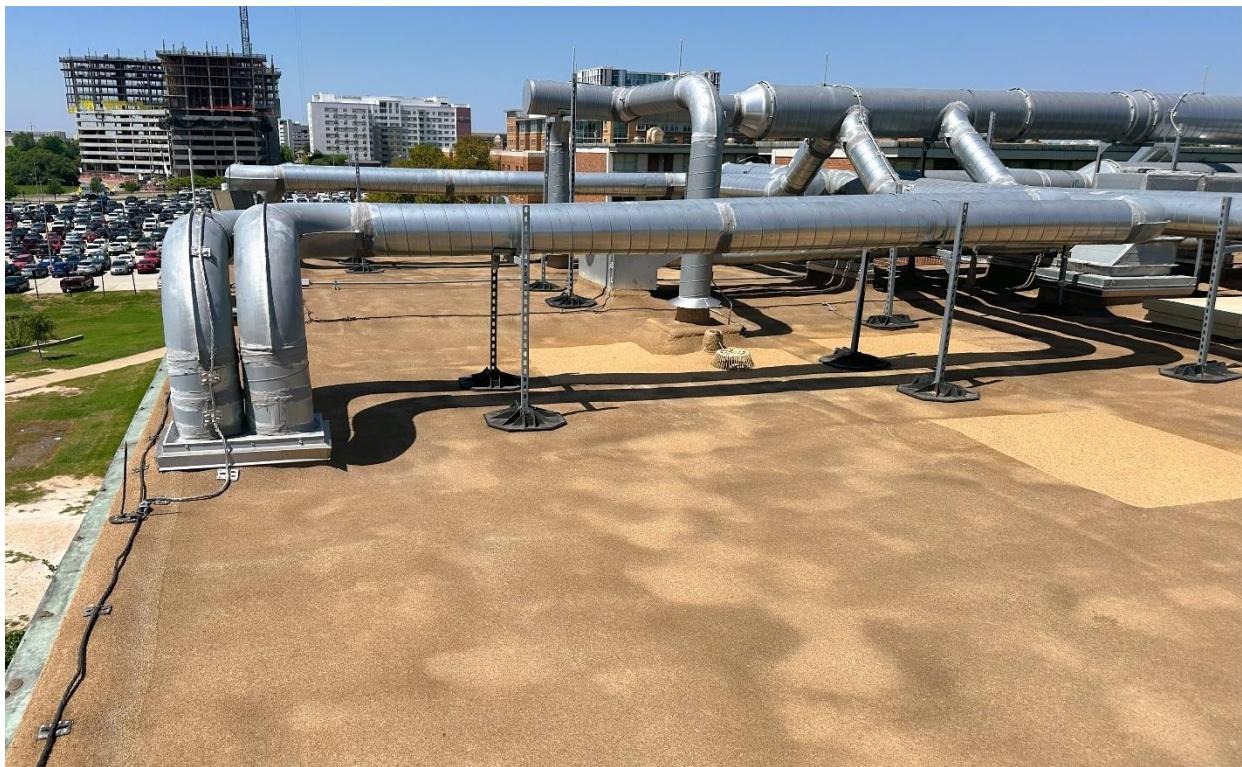
Photo 2: The SPF-covered roof appeared to be in good overall condition, despite exposure to large hail on the DOL.

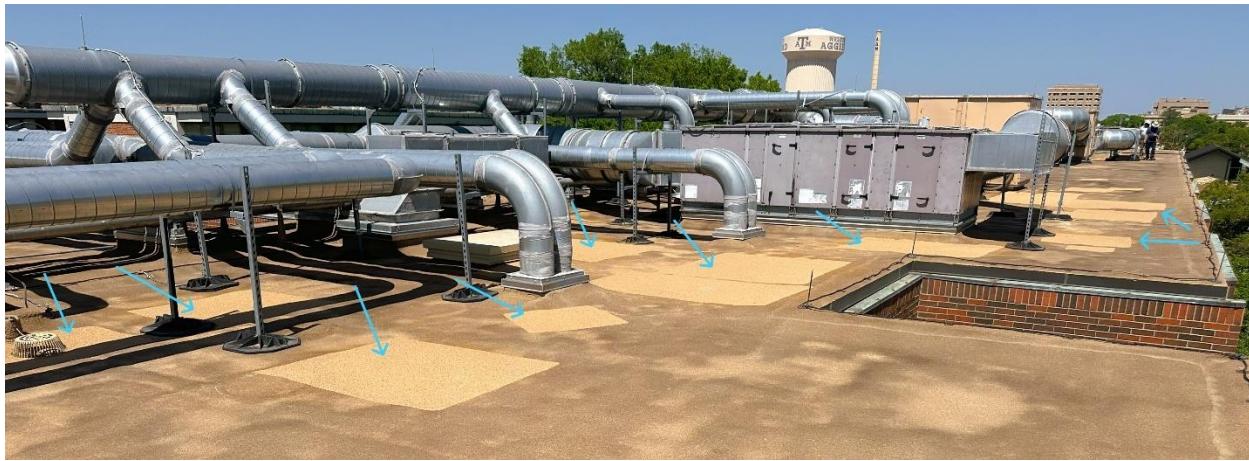
Photo 3: Light-colored rectangular spots (blue arrows) were SPF repairs applied prior to the DOL. These SPF repairs were reportedly done without polyurea coating.

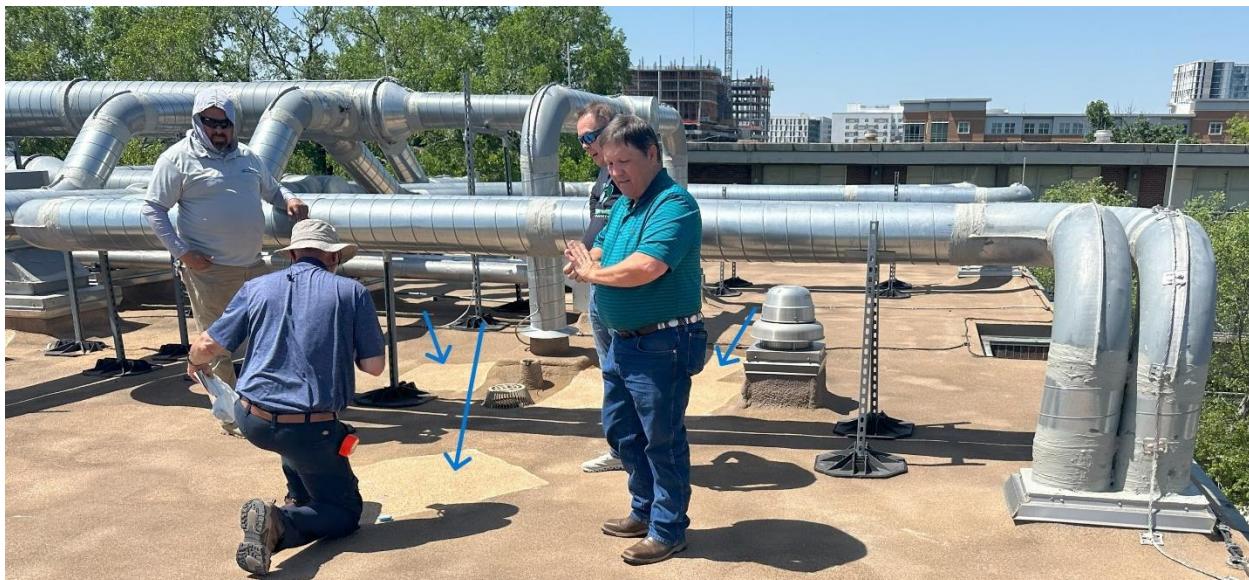
Photo 4: Another view of some pre-DOL patches (blue arrows) being inspected for storm damage.

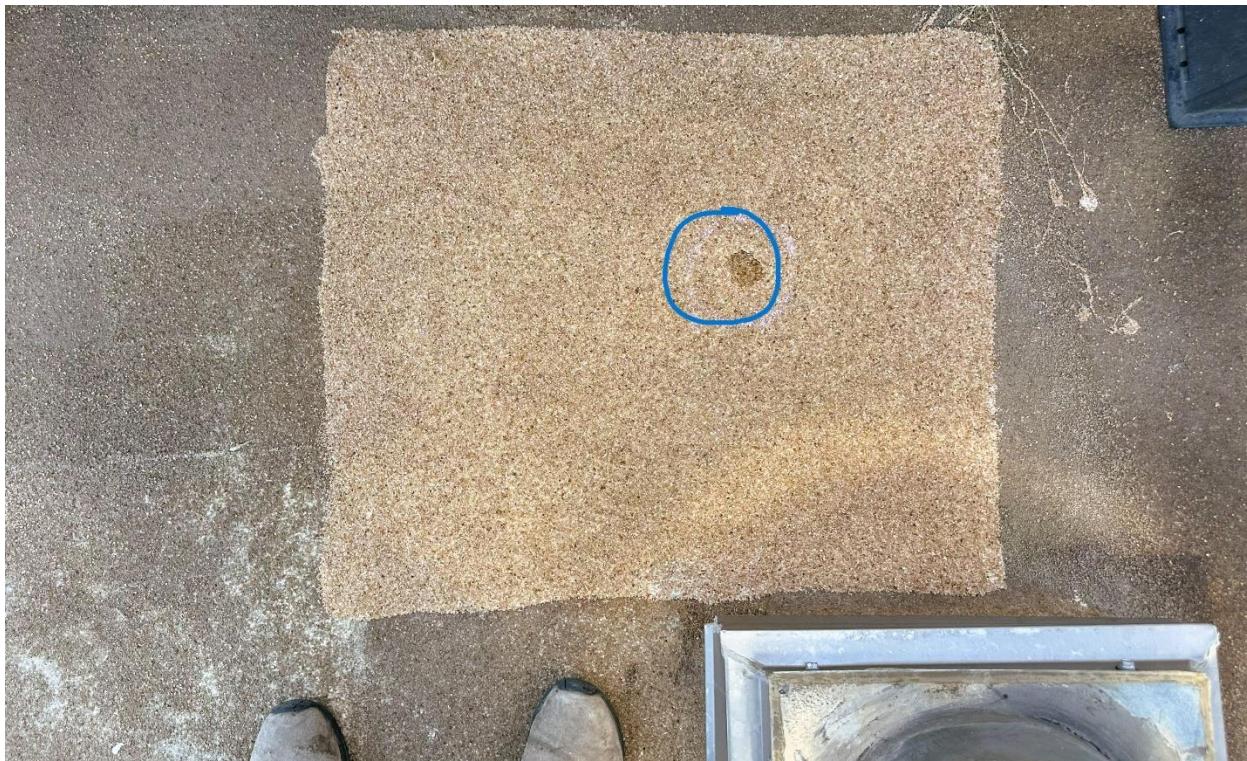
Photo 5: Both photos on this page show the same pre-DOL patch with damage that occurred on the DOL.

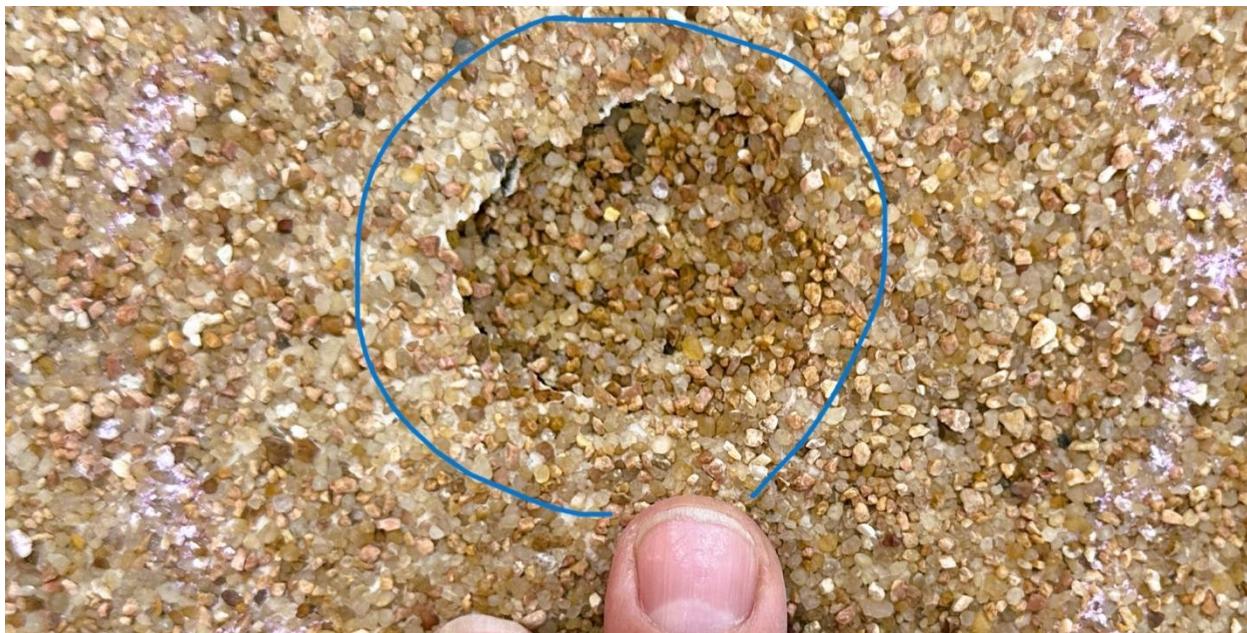
Photo 6: This hole was approximately 1.5 inches in diameter, consistent with storm conditions on the DOL. The patch was coated only with granules and silicone, but without polyurea, like the rest of the roof. This left them more vulnerable to impact damage than the adjacent Standard TAMU SPF System, which incorporated both silicone and polyurea coatings beneath the granules. This was a significant side-by-side comparison of the two similar, but not equal, systems.

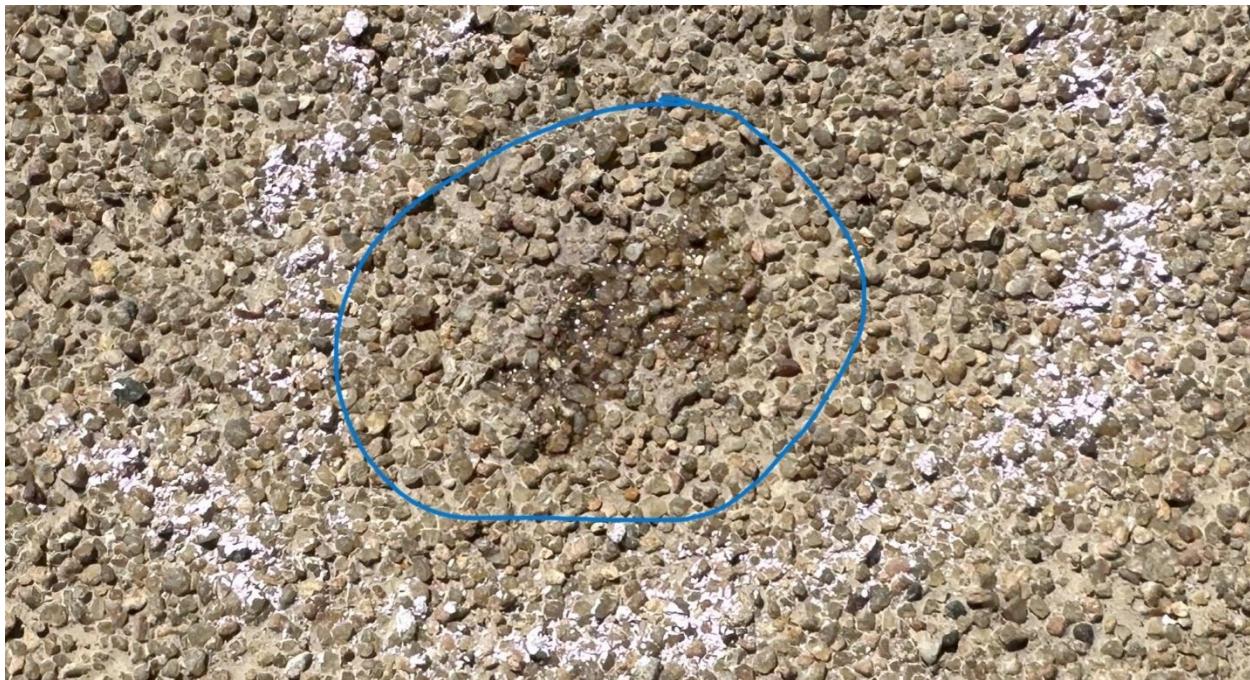
Photo 7: Both photos on this page show openings on pre-DOL patches consistent with hail on the DOL. Several openings like this were observed, all on the patches, not in STSS-covered areas.

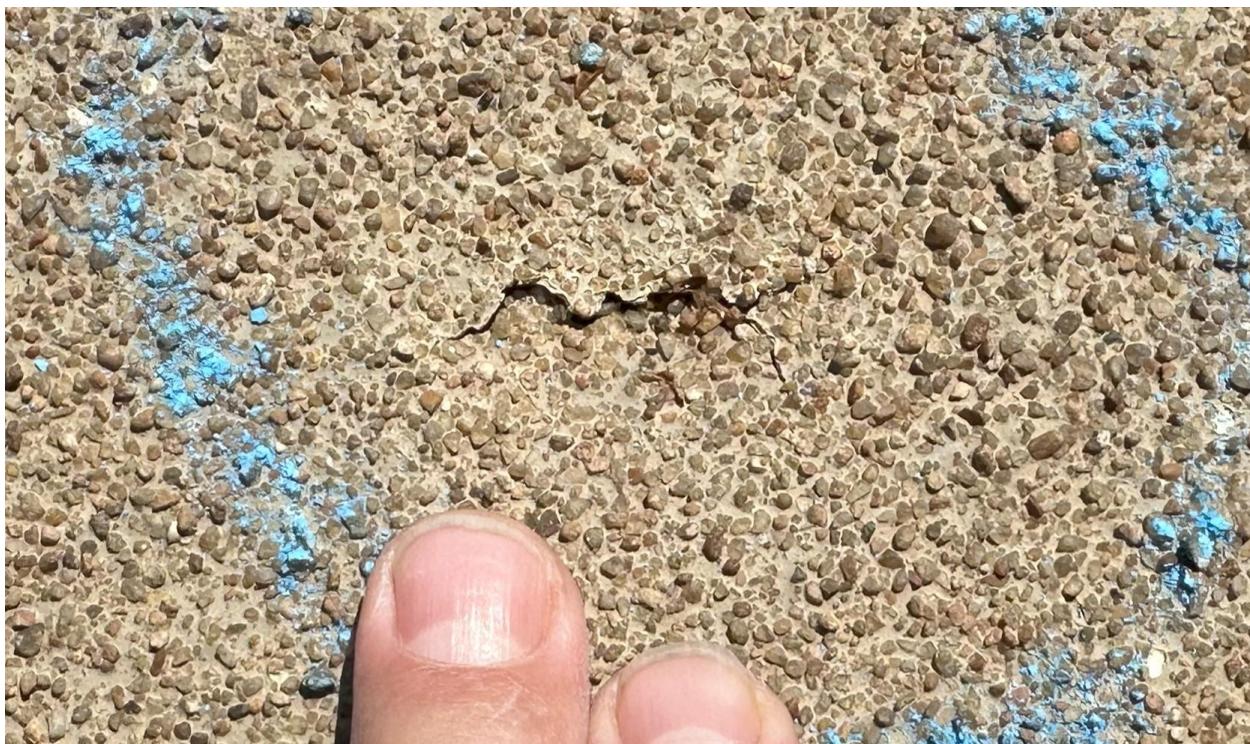
Photo 8: Water entrapped beneath the surface was expelled when hand pressure was applied next to some fractures.

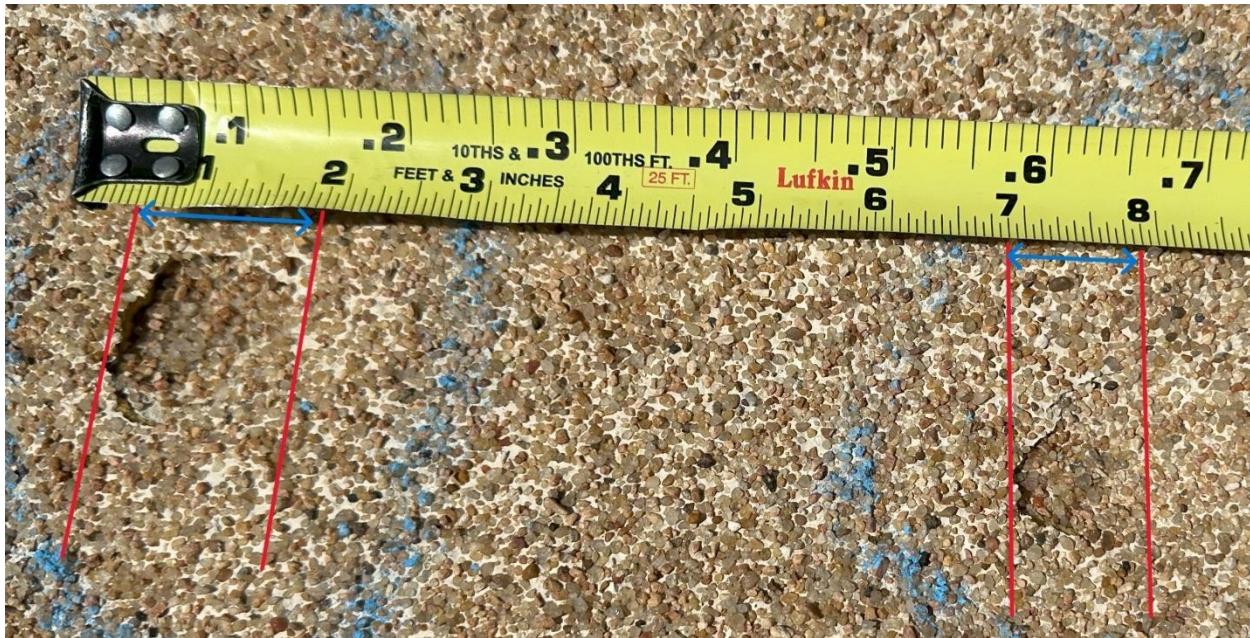
Photo 9: Two holes on a pre-DOL patch, indicating hailstone sizes 1.5-inches in diameter or larger.
