Hurricane Katrina Wind Investigation Report

HURRICANE KATRINA INVESTIGATION REPORT

August 2007

Roofing Industry Committee on Weather Issues, Inc. Powder Springs, Georgia

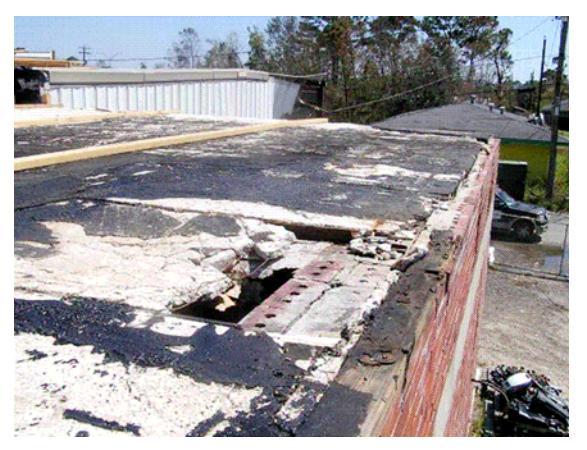
1.02.4. Commercial building. Metal edging and plywood decking were damaged at this windward corner.

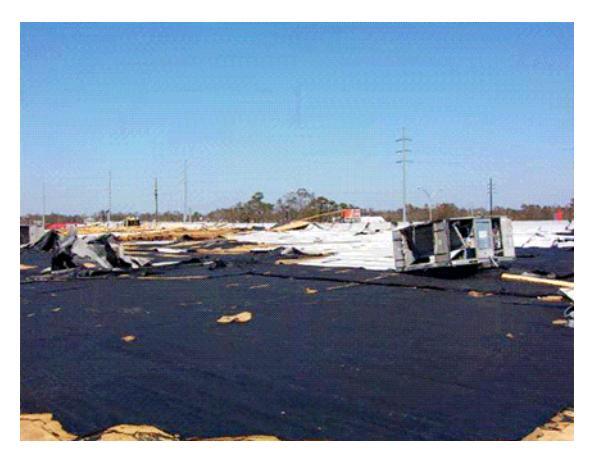
1.02-6. Commercial building. Damage shown here is separation of the plies.

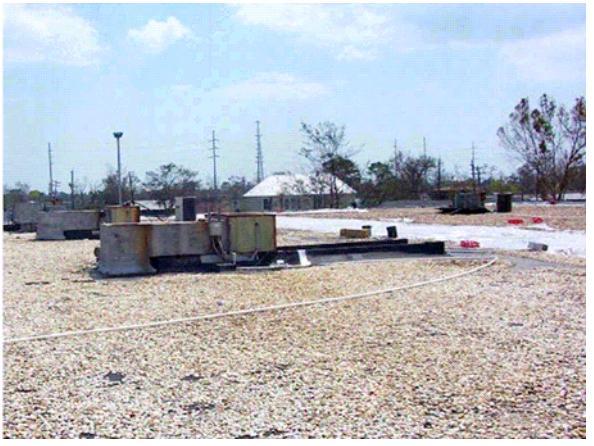
1.16-5. Pascagoula supermarket. View of the ballasted roof system. The plastic sheet covers a seam leak that occurred prior to the hurricane.

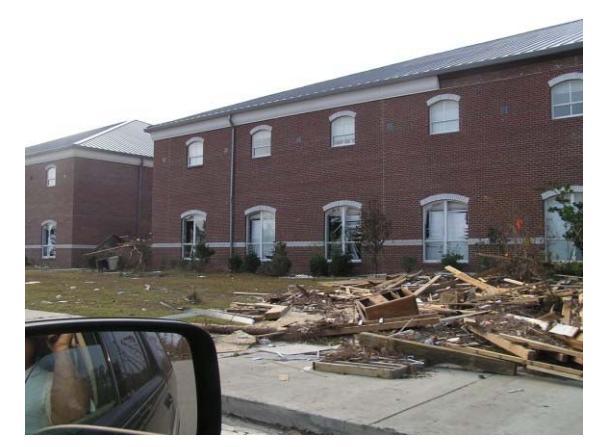
2.02(b)-3. Pass Christian HS. Soffit panels were missing on the south side.

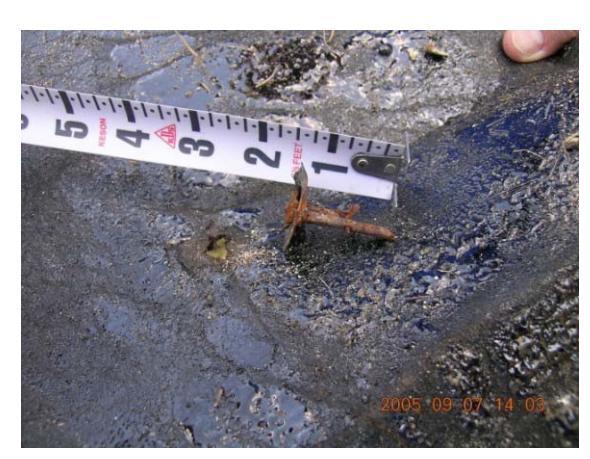
2.03(a)-5. Pineville Elementary. This is a typical corroded fastener.

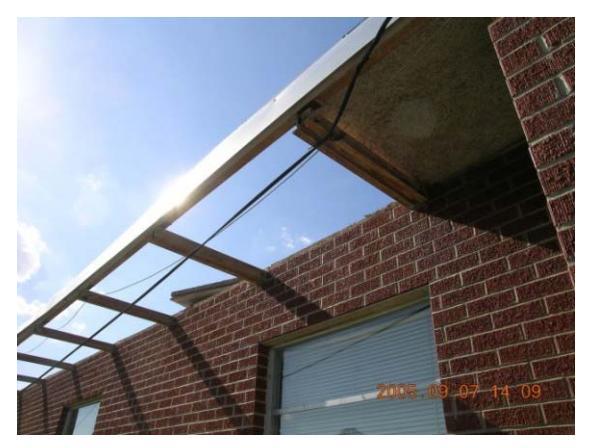
2.03(a)-6. Pineville Elementary. Panels were displaced from this overhang.

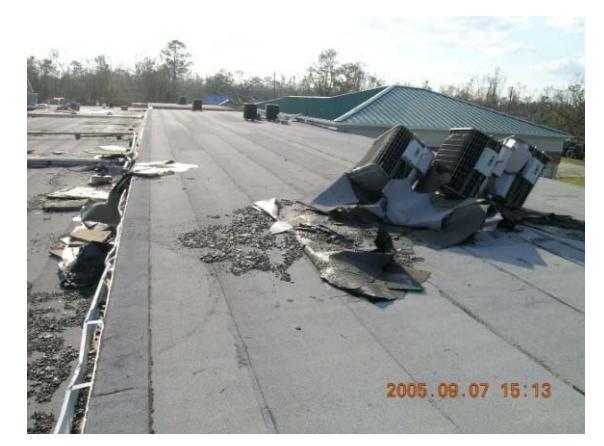
2.03(c)-5. Pineville Elementary. Evaporative coolers displaced by debris, including aggregate-surface membrane from the lower-elevation roof.

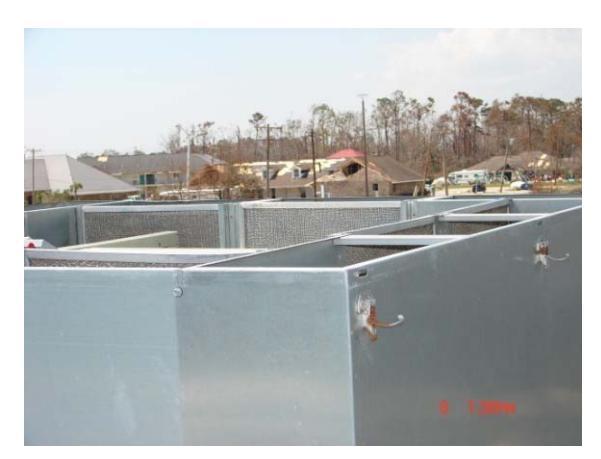
2.04(b)-5. Hancock Medical Center. The top was blown off of this air handling unit.

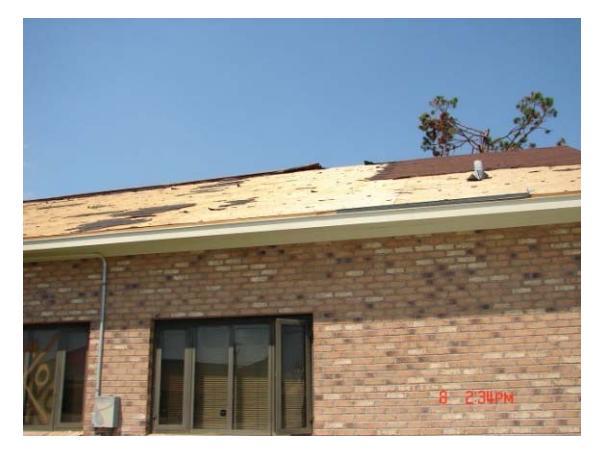
2.05-3. Fresenius Medical Kidney Center. Back (leeward) side of building; note straight line of shingle damage, indicating racked installation of shingles.

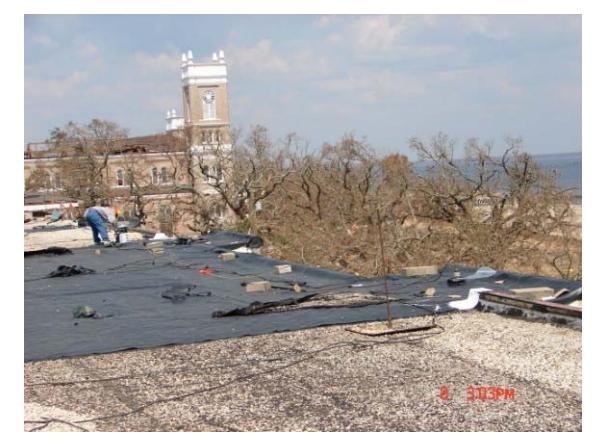
2.06(a)-1. St. Stanislaus. This membrane blowoff was located at the center of the windward wall.

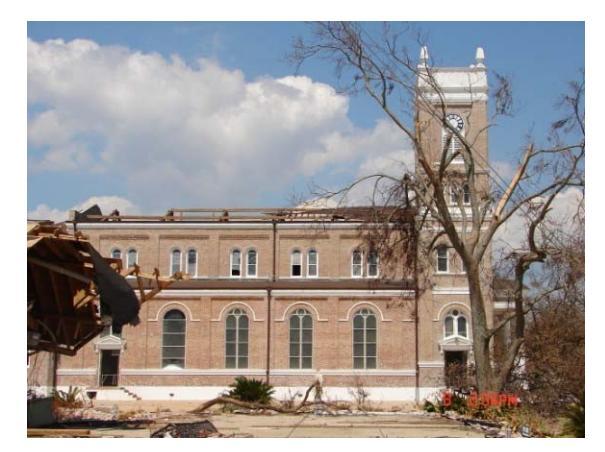
2.06(a)-5. St. Stanislaus. A nearby auditorium was missing its entire roof.

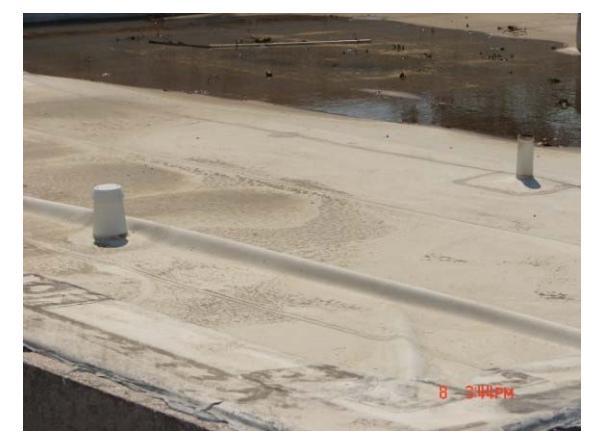
2.06(b)-3. St. Stanislaus. The membrane wrinkling visible here may be the result of loose fasteners.

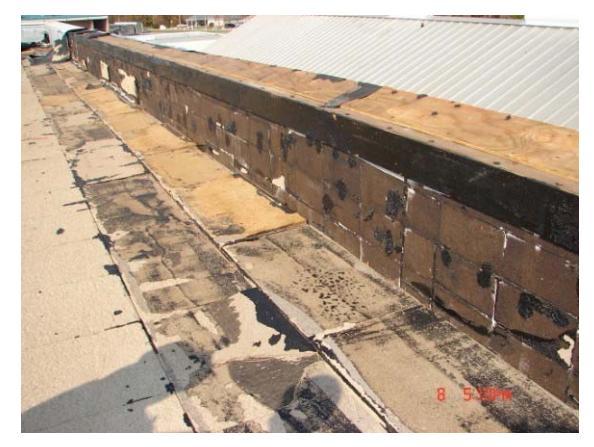
2.07-3. MaGee Auditorium. Coping and wall flashing are missing, likely blown off.

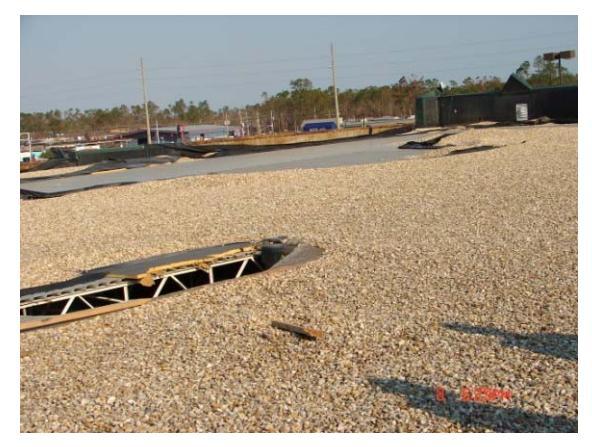
2.09-1. Sav-A-Center. Significant damage can be seen on this ballasted roof.

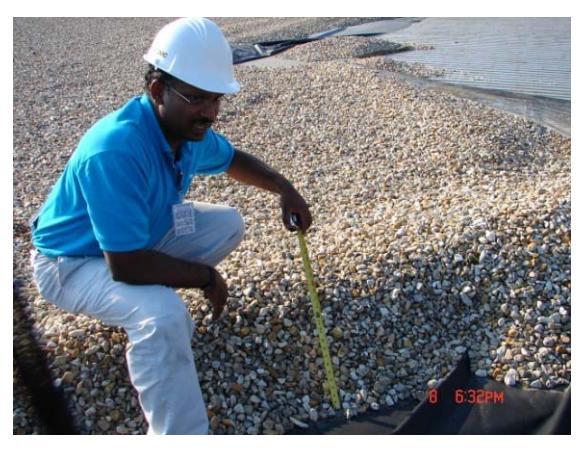
2.09-4. Sav-A-Center. This photo shows the way gravel accumulates near scoured areas. The gravel's weight helps limit the exposed damage area.

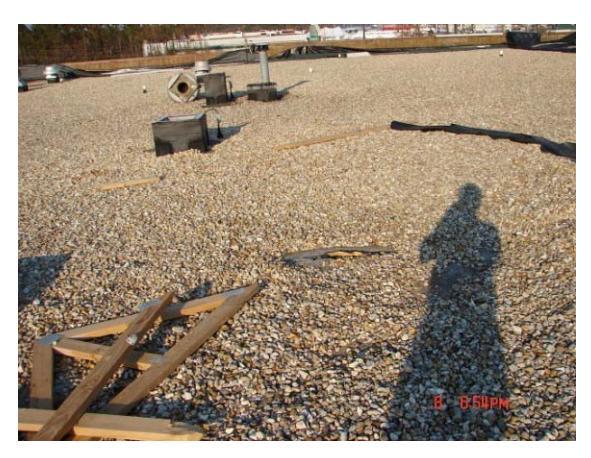
2.09-6. Sav-A-Center. Debris and related punctures were found in this area.

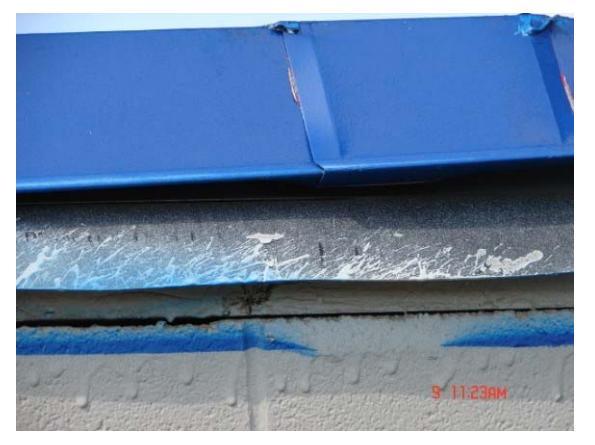
2.10-6. Manufacturing facility. Coping pulled loose from the cleat in this photo.

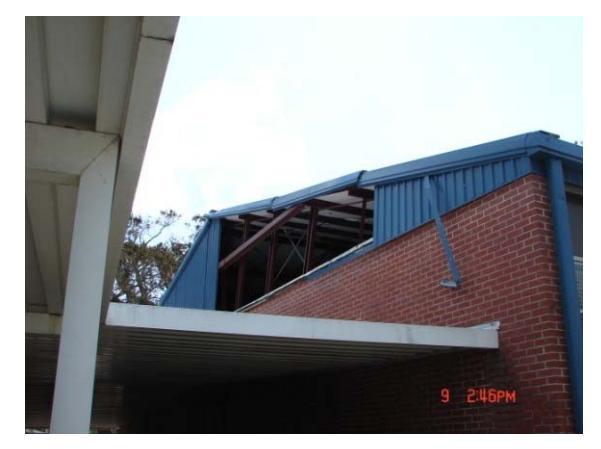
2.11-1. H. McCoughan Elementary. Wall and roof damage is visible on this building.

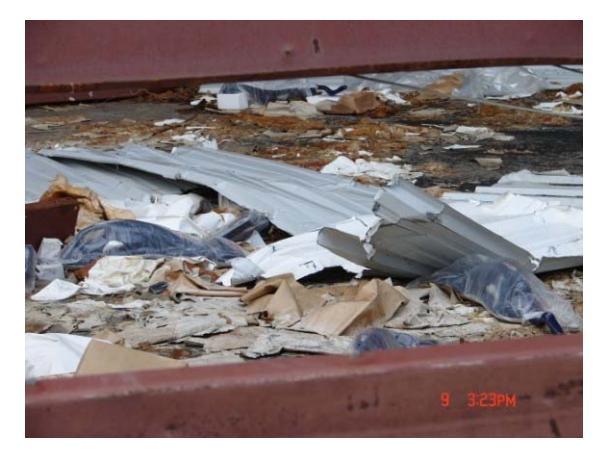
2.12-5. Commercial Exchange. This is what's left of a metal roof, with fasteners showing.

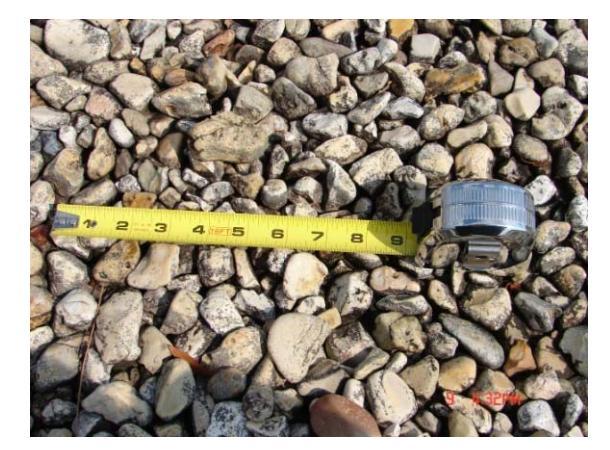
2.13-3. Sav-A-Center. This tape shows the typical stone size found here (ASTM D448#3).

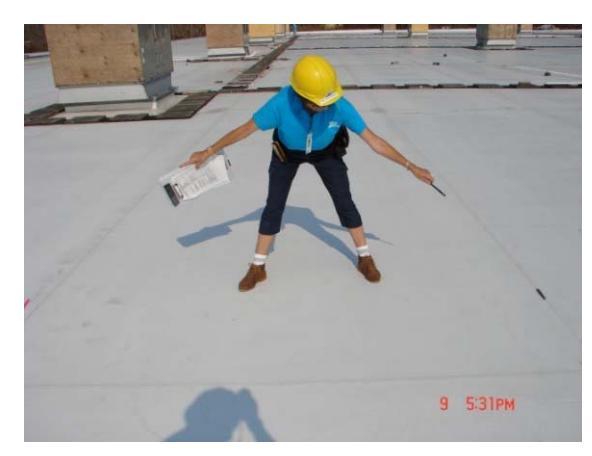
2.14-3. K-Mart. Batten bars in the field of this roof were 6 ft o.c.

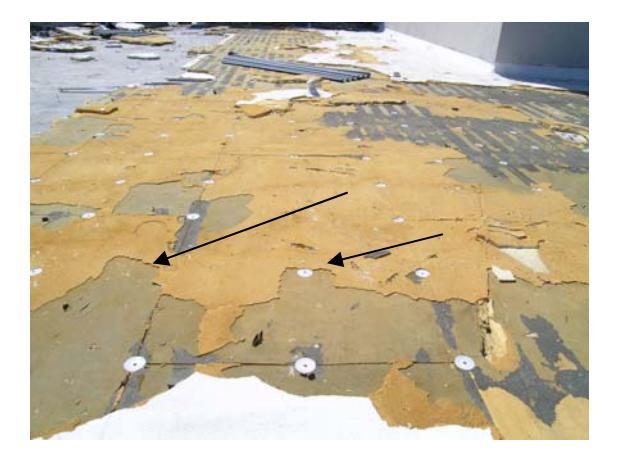
4.01-2. Imperial Palace Hotel Building 1. Plates are positioned between the 4×8 ft sheets of insulation, rather than through each board. This is an example of poor workmanship.

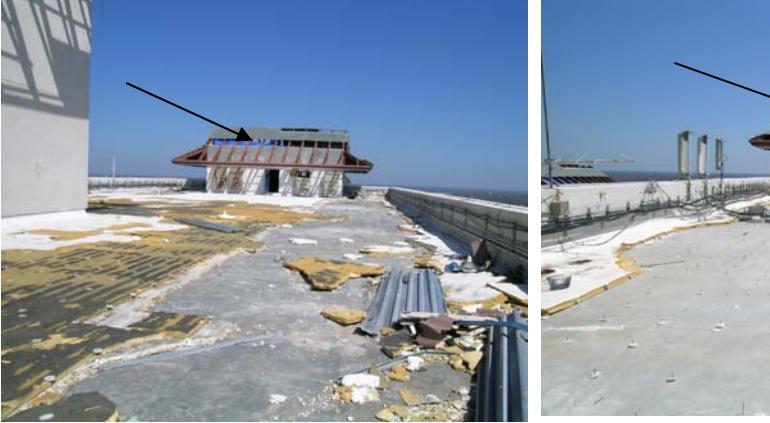
4.03-1. Imperial Palace Hotel Building 3. Damage on main roof and small building atop main roof.

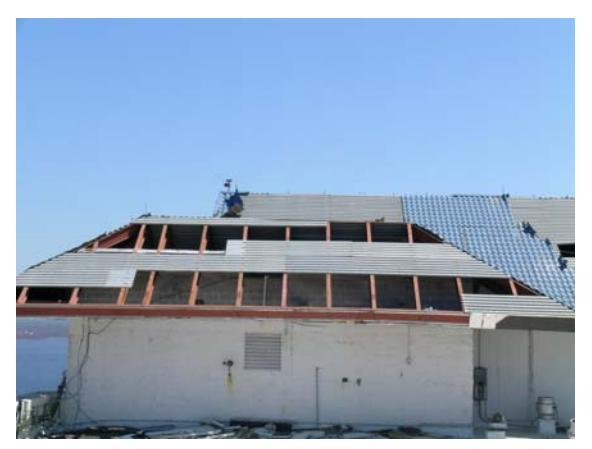
4.03-3. Imperial Palace Hotel Building 3. Steel decking and roof panel blew off. Welds failed, and steel decking and the mechanical fasteners failed at the roof panels.

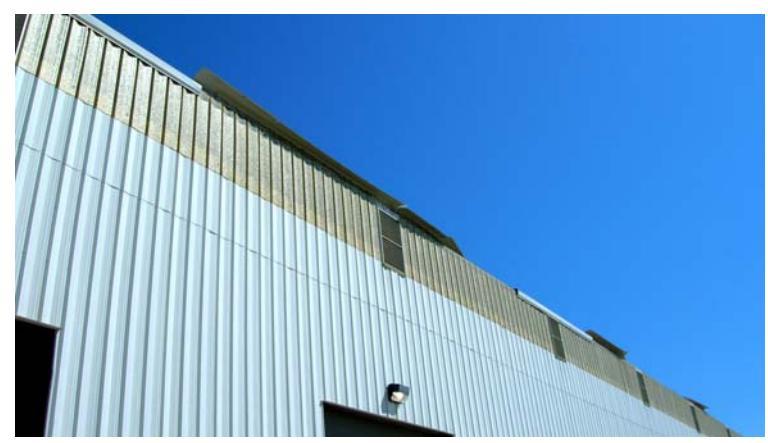
5.01-3. Keith Huber, Inc. Edge flashing failures (south wall) are visible here, but there was no damage to through-fastened roof.

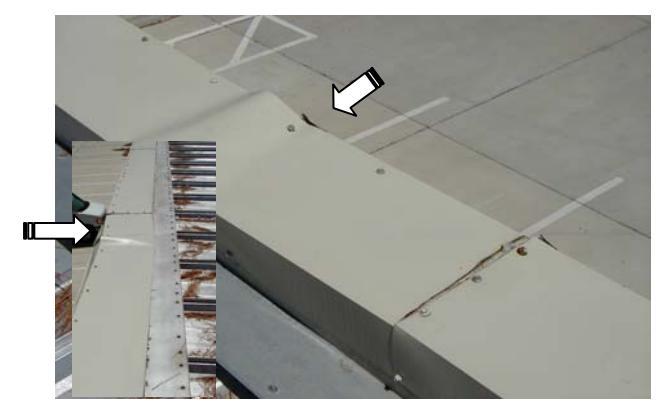
5.03-3. Kid Academy. East parapet cap flashing damage—perhaps from impact.

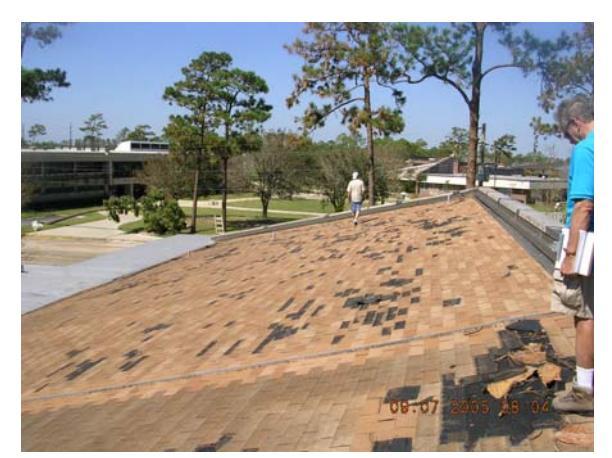
3.01-1. Gautier Library. This view of the older library roof shows damage to alternate courses. "Racking" method of installation was used; i.e., alternating courses of shingles attached with three, then four nails.

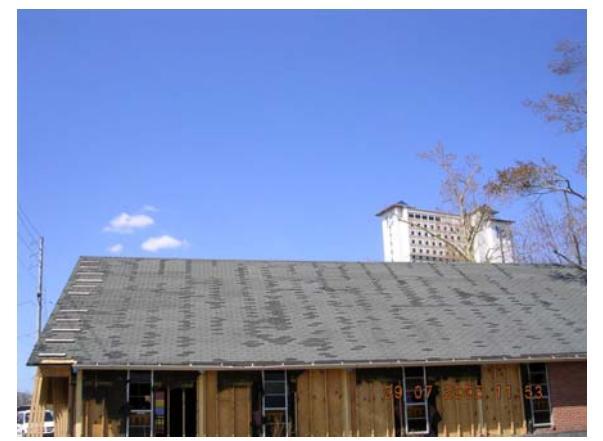
3.03-1. Living Waters Church. Torn tabs at unattached ends of shingles follow a vertical pattern.

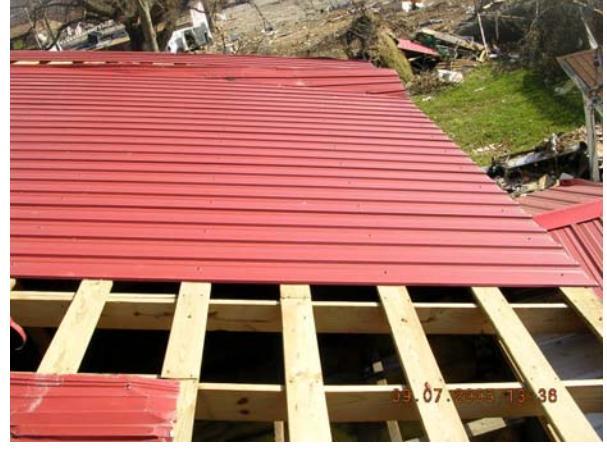
3.05-2. Church of the Vietnamese Martyrs. Three screws per panel spaced on every other board was inadequate attachment and did not resist the internal and external wind pressures of hurricane Katrina.

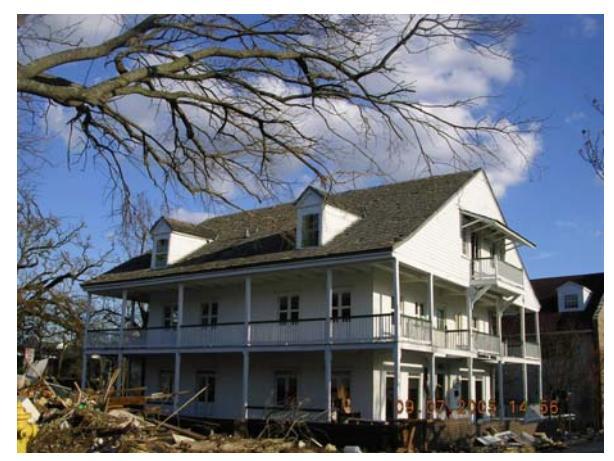
3.06-1. Magnolia Hotel. Sporadic wood shake loss was noted on this historic hotel.

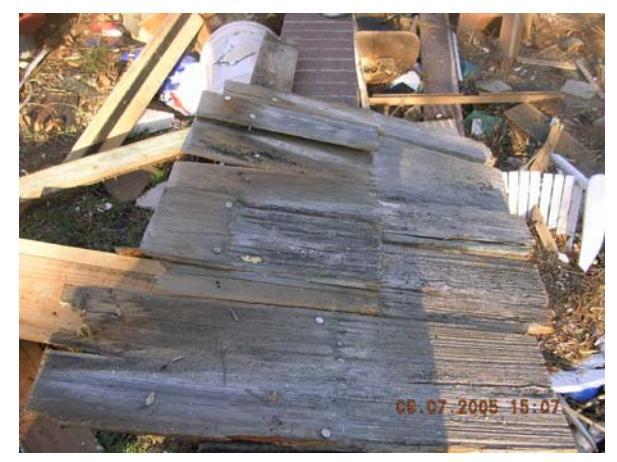
3.06-2. Magnolia Hotel. These wood shakes were installed in a way that appears to be a compromise in favor of aesthetics, rather than in a structurally sound manner.

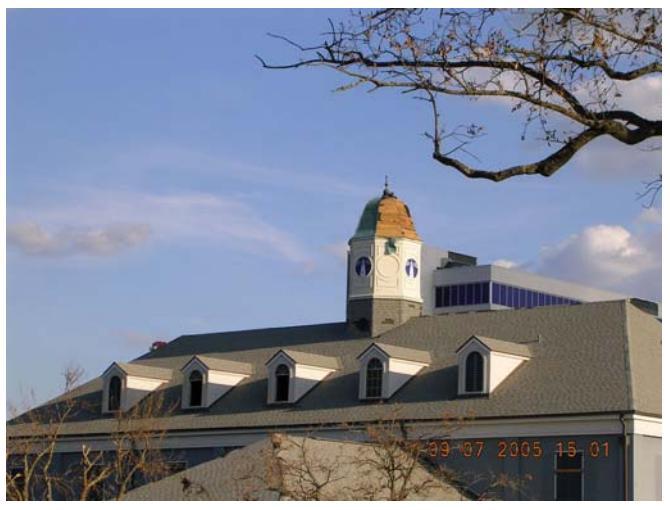
3.07-1. Hancock Bank. Damage at hips, ridges, dormers, and leading edges was noted on this shingle roof.

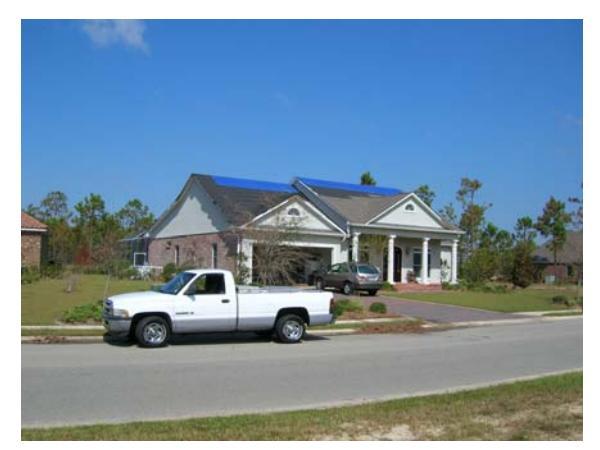
3.09-1. Residence. This is a residence with missing laminated asphalt shingles.

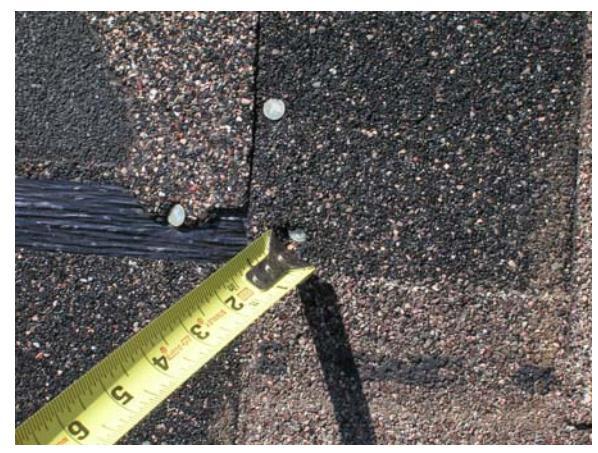
3.09-2. Residence. This is an example of inconsistent fastener placement and overdriven nails.

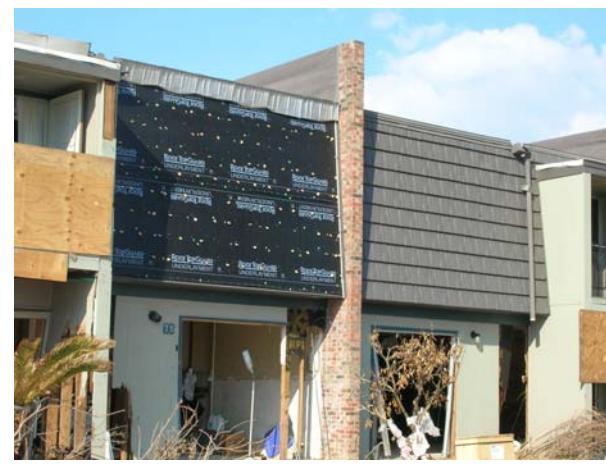
3.12-1. Gulf Oaks Multi-family Housing. Aluminum formed shake panels were missing from the mansard roof on this condominium.

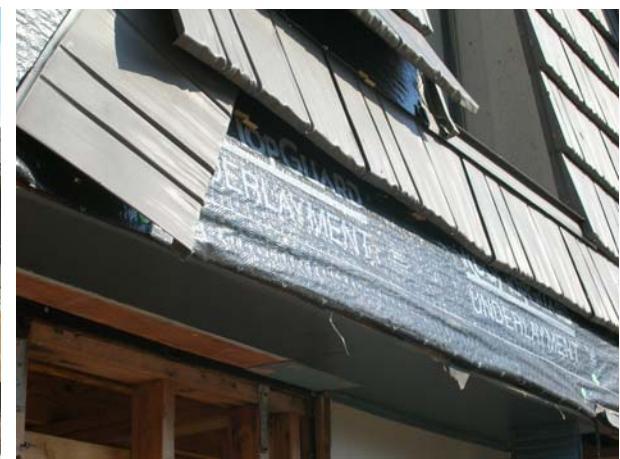
3.12-2. Gulf Oaks Multi-family Housing. Shingles disengaged at the front lip from edge metal and the rear of lapped panels.

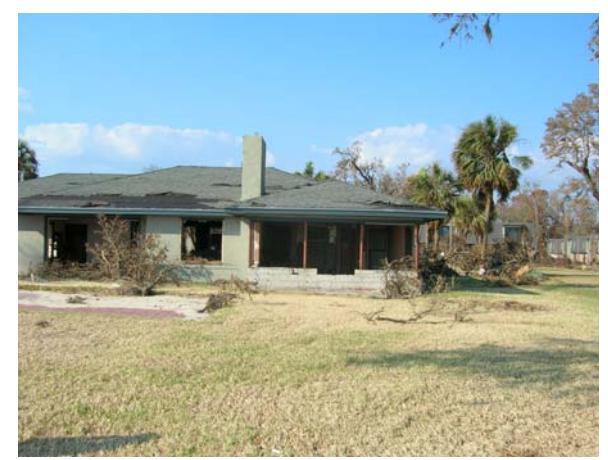
3.13-1. Residence. Ocean-front building with some shingles lost on windward side.

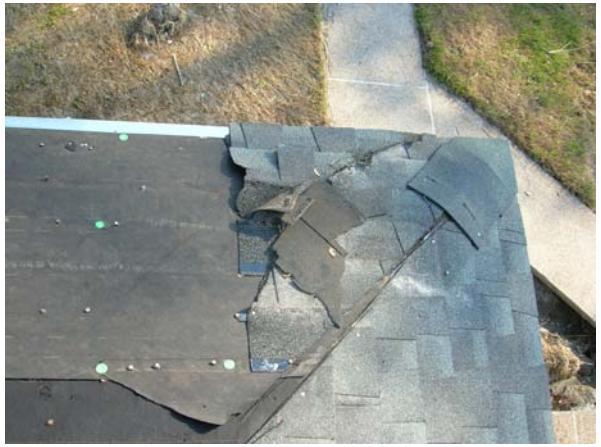
3.13-2. Residence. On this roof, shingles were torn loose from metal edge on the windward side.

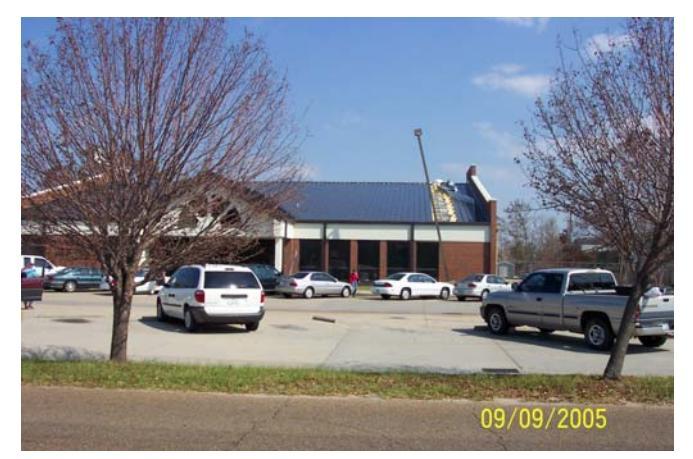
3.14-1. Post Office. This standing seam roof was missing three panels near the raised gable end wall.

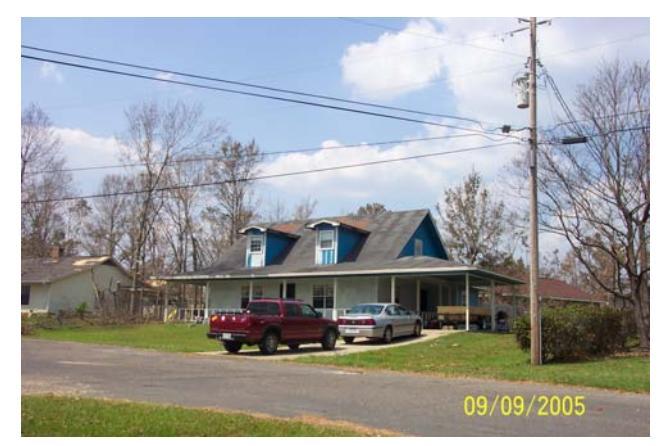
3.18-1. Residence. The vertical ("racking") method of installation caused tearing of shingles at alternating courses.

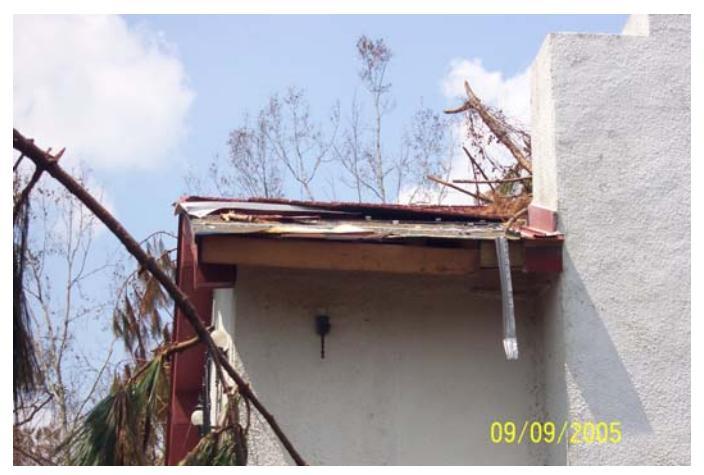
3.19-1. Residence. Metal shingles came loose when this metal edging was deformed by strong winds.

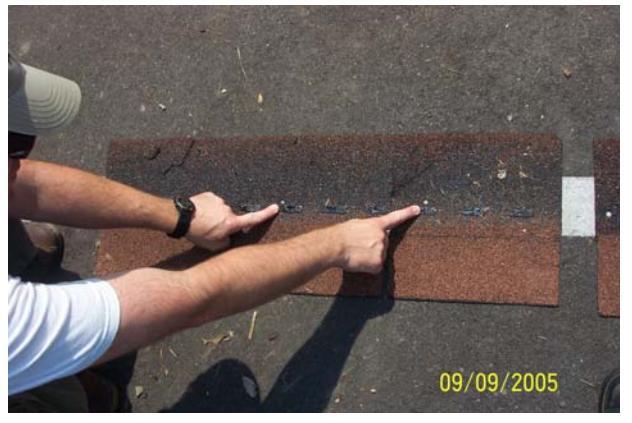
3.21-2. Lanai Village HOA. Shingles were not fastened at one end. Overdriven nails were noted in other places. Both anomalies contributed to blowoff and other damage.

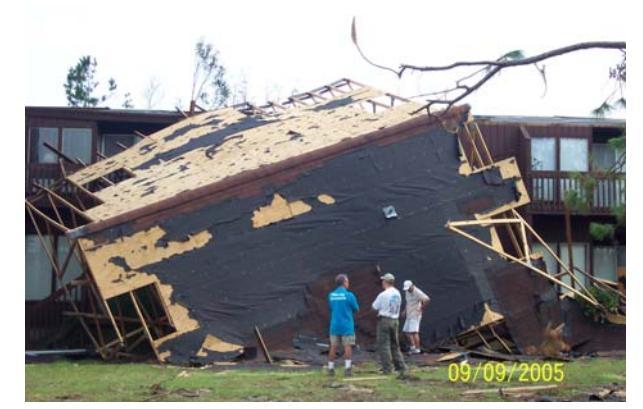
3.21-3. Lanai Village HOA. This entire retrofitted gabled roof section, originally installed as a unit, by crane, was displaced by winds.

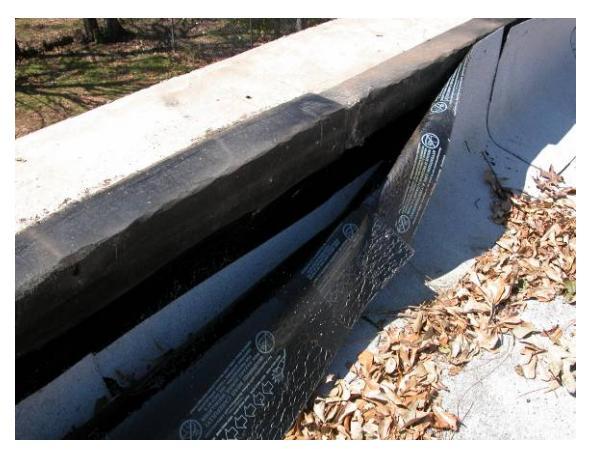
6.03-3. George County Hospital Maintenance Building. Adhesive failure of the flashing membrane to the parapet is visible.

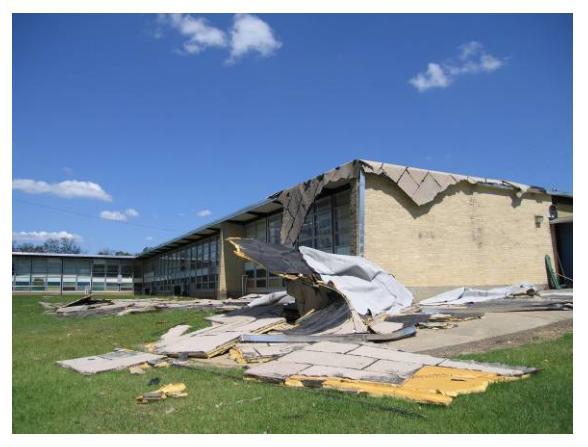
6.04 (a)-3. Stone Elementary School roof A. Roof membrane and decking material in this photo are draped over the roof edge, and lying on the ground.

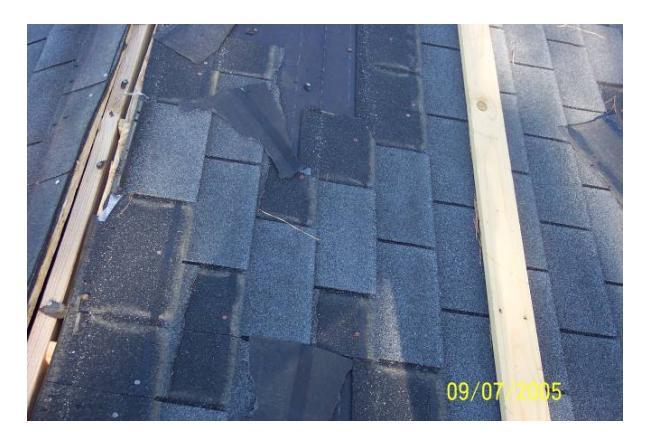
6.10-4. Baptist Church. Nails securing these wood nailers and stiffeners missed framing members, reducing pull-out strength.
