Hurricane Katrina Wind Investigation Report

HURRICANE KATRINA INVESTIGATION REPORT

August 2007

Roofing Industry Committee on Weather Issues, Inc. Powder Springs, Georgia

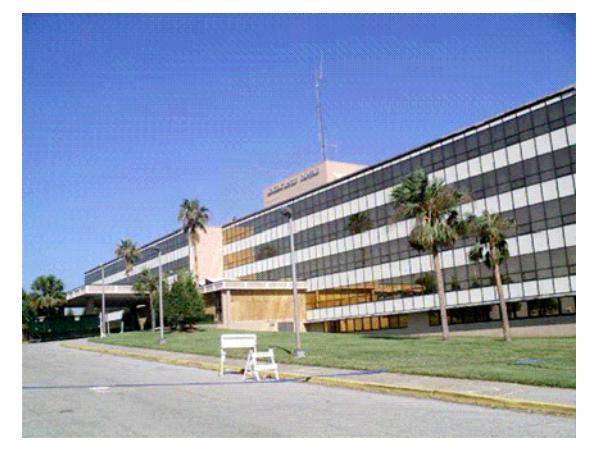
1.01-1. Singing River Hospital. View of the south face.

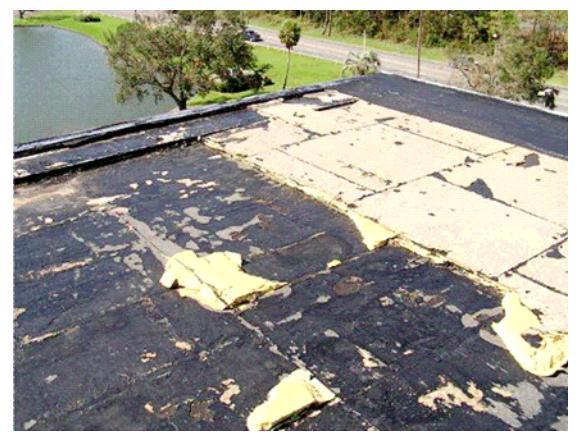
1.01-3. Singing River Hospital. Damaged insulation is all that's left after loss of the APP membrane at this roof corner.

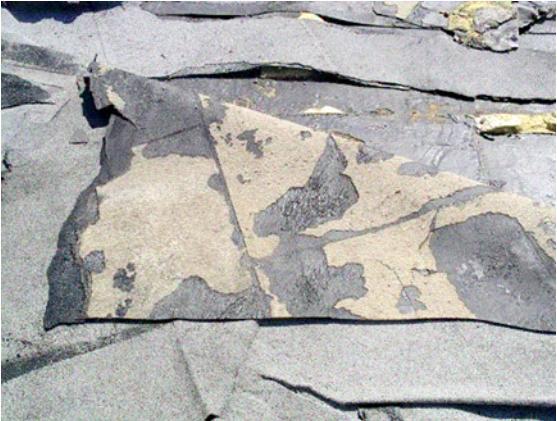
1.01-5. Singing River Hospital. A thin layer of perlite insulation is still adhered to this detached APP membrane.

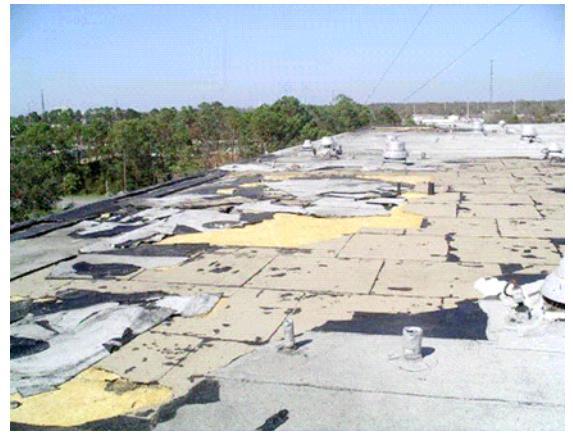
1.01-2. Singing River Hospital. Loss of the APP membrane and some perlite insulation boards is shown here.

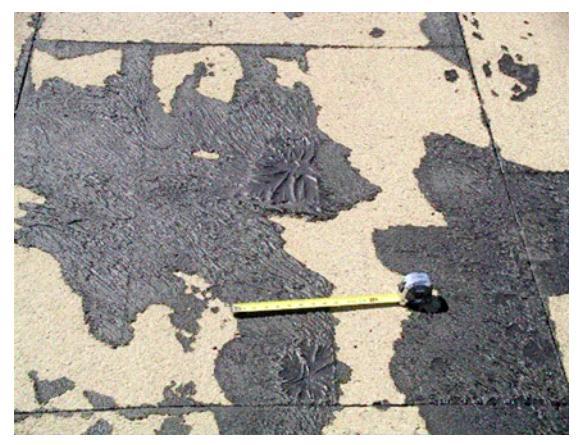
1.01-4. Singing River Hospital. Evidence of cold asphalt application. Note the shiny, wrinkled texture.

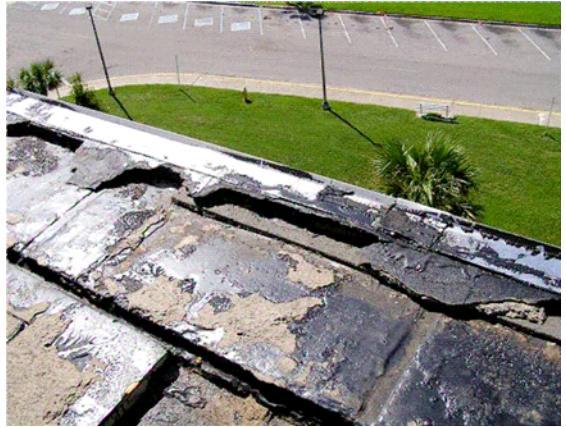
1.01-6. Singing River Hospital. Although the roof membrane blew off, the metal edge remained intact.

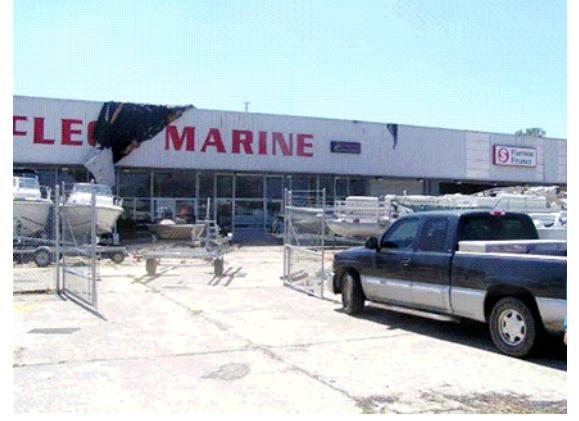
1.02-1. Commercial building. View of the front side of the marine showroom.

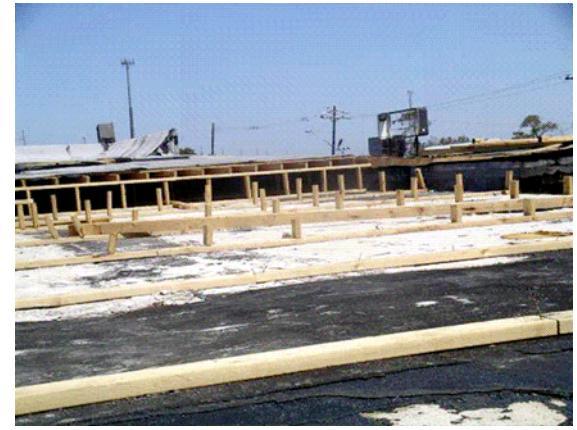
ADDITIONAL COMMENTS—According to the building owner, this roof experienced considerable damage during Hurricane Georges in 1998. As part of the roof repairs, the plywood deck was installed over the concrete deck to provide slope.

1.02-2. Commercial building. This is what is left of a plywood decking system retrofitted over the original roof to provide more slope.

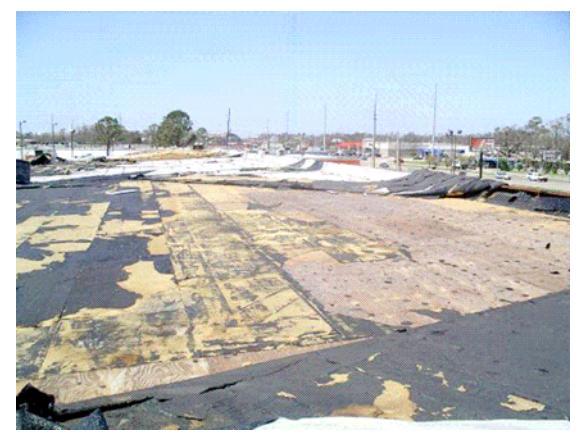
1.02.3. Commercial building. Three types of damage are shown here: tearing of felt nailed to the plywood, cohesive failure of insulation board, and delamination of the membrane.

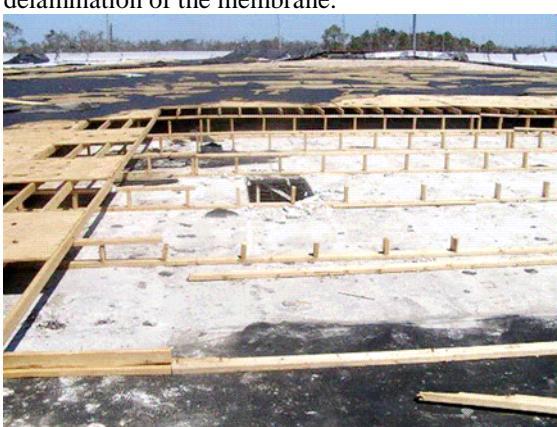
1.02-5. Commercial building. Damaged lightweight concrete decking is visible in this photo.

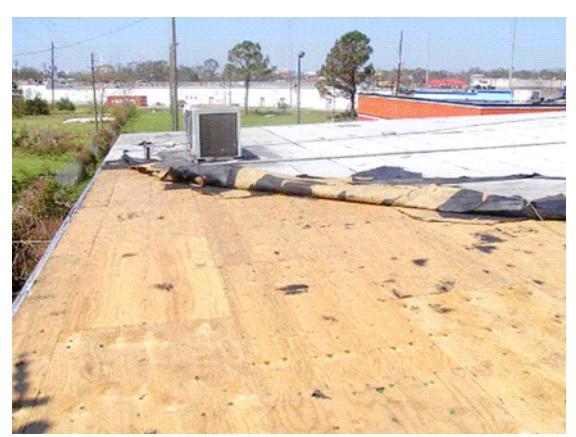
1.02-7. Commercial building. The roof assembly in this area was torn loose from the plywood deck.

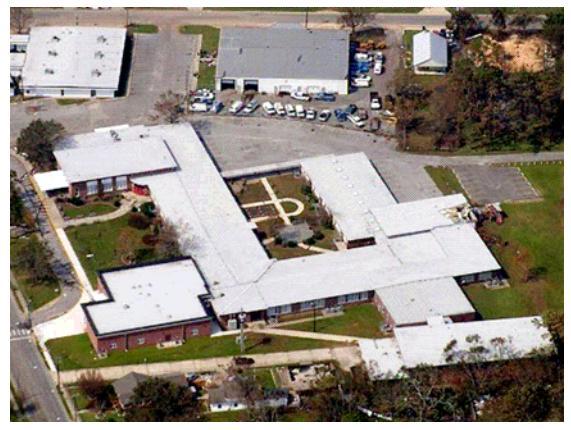
1.03-1. Trent Lott Middle School. Aerial view of Trent Lott Middle School.

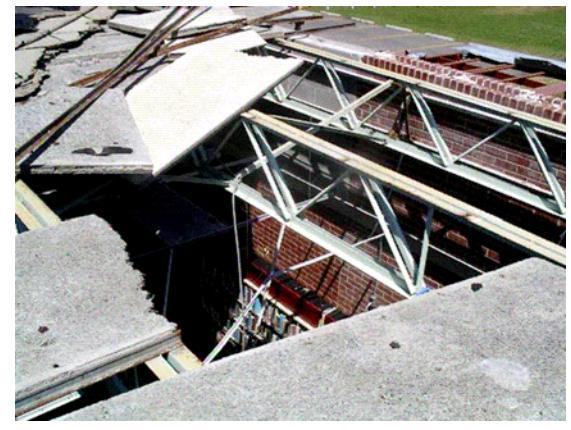
1.03-2. Trent Lott Middle School. CWF deck panels and bulb Ts were displaced because they were not anchored to the joists.

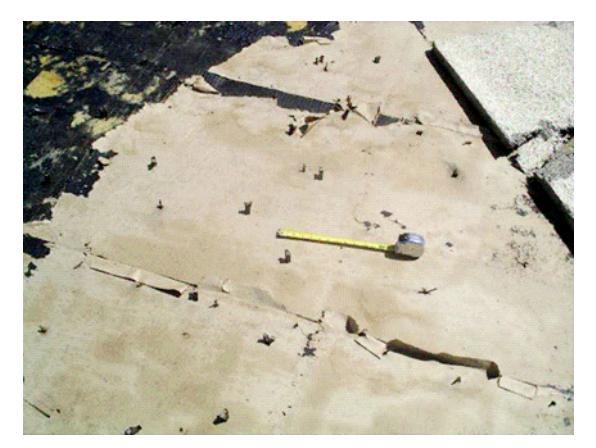
1.03-3. Trent Lott Middle School. Underside of the membrane-insulation assembly that peeled from the deck.

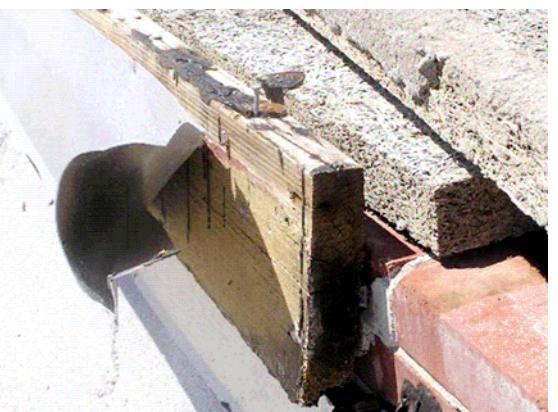
A two-piece metal edge detail may also have played a role in the blowoff of the roof section, as its fascia was not well secured to the wall. First, a bottom fascia strip was nailed along the wall to a 2×8 ft wood nailer, which was also installed along the side of the wall. The second metal edge assembly consisted of a coping and fascia section that was secured to the coping with its fascia section. It was secured along the coping with its fascia section clipped to the bottom fascia strip, which was nailed to the 2×8 ft nailer.

1.03-4. Trent Lott Middle School. Damaged edge flashing.

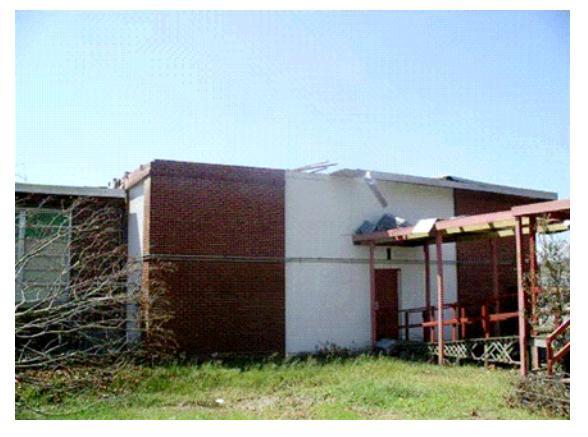
1.03-5. Trent Lott Middle School. The wall area at the damaged roof section showed no evidence of flashing attachment.

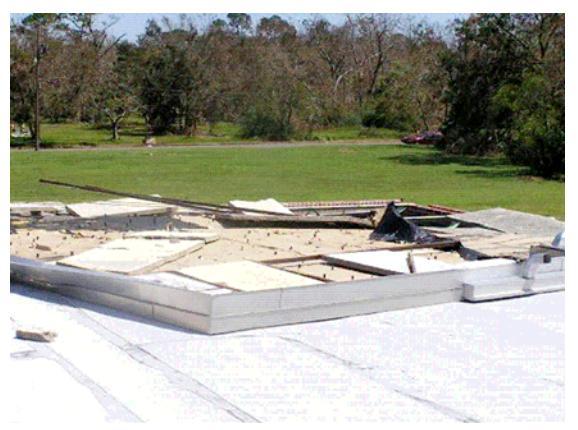
1.03-6. Trent Lott Middle School. Overall view of the damaged roof section.

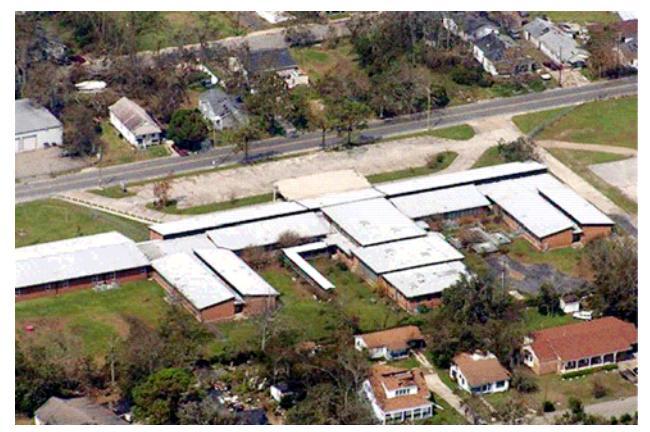
1.04-1. Central Elementary School. Aerial view shows an undamaged SBS membrane system.

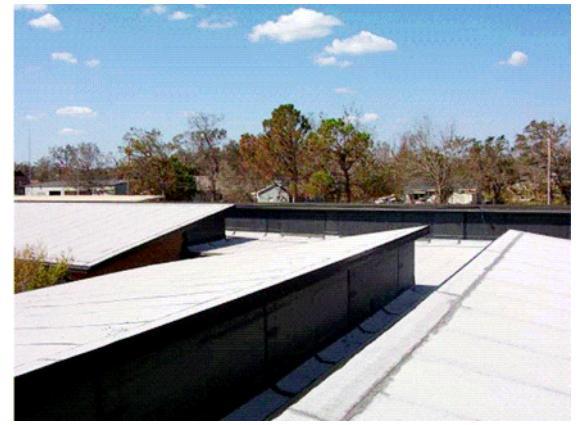
1.04-2. Central Elementary School. This photo shows a closer view of the undamaged SBS membrane system.

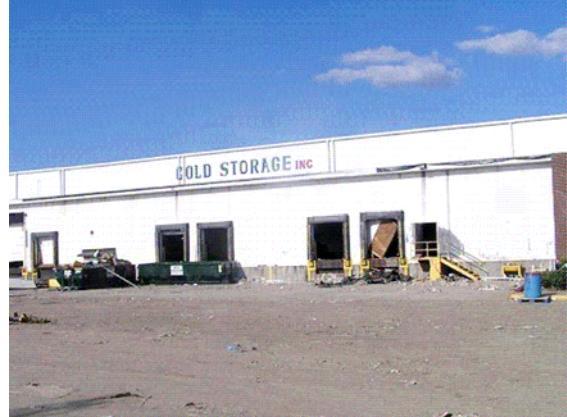
1.05.1. Commercial building. Front view of the commercial freezer plant.

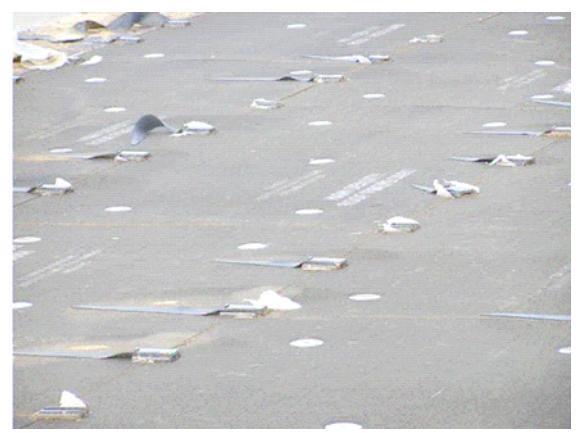
1.05-3. Commercial building. Only small, shredded strips of damaged membrane remain from where blowoff occurred. The EPDM either tore around fasteners or pulled the top sections of the fasteners loose.

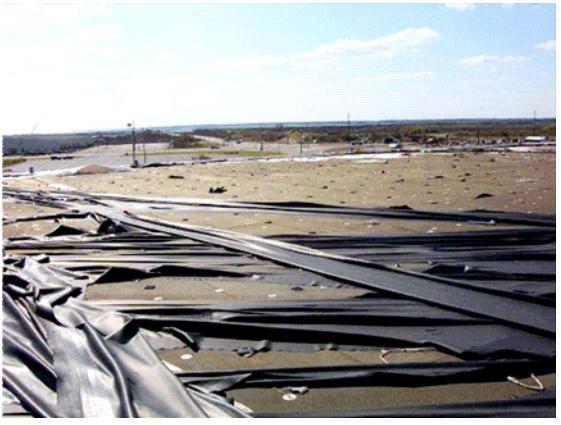
1.05-2. Commercial building. Overview of the roof damage.

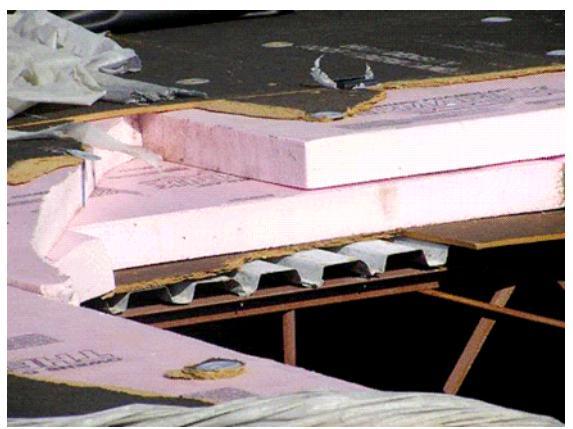
At the southeast edge of the building, approximately 1200 ft^2 of the roof deck was blown off, whereas the membrane remained intact. This damage was attributed to pressurization below the roof deck. Loss of decking occurred when screw attachment to the structural members failed, either from screws pulling out or from the steel deck ripping away from the screws (which were still attached to the structural members). It was estimated that as many screws were still attached to the structural members as were pulled from them. Pressurization was also blamed for blow-out of the entire northwest wall.

1.05-4. Commercial building. Exposed insulation is visible in this photo showing where decking was blown off.

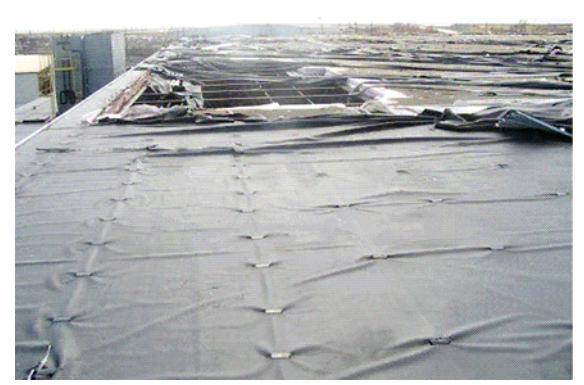
1.05-5. Commercial building. Section of undamaged membrane (with non-penetrating fasteners in place) next to a section of blown-off decking.

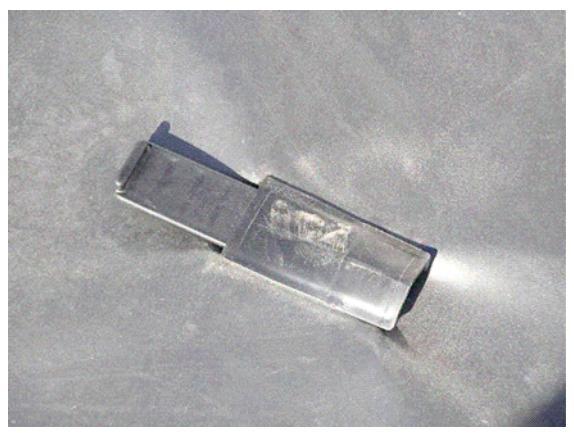
1.05-6. Commercial building. Top view of a non-penetrating fastener.

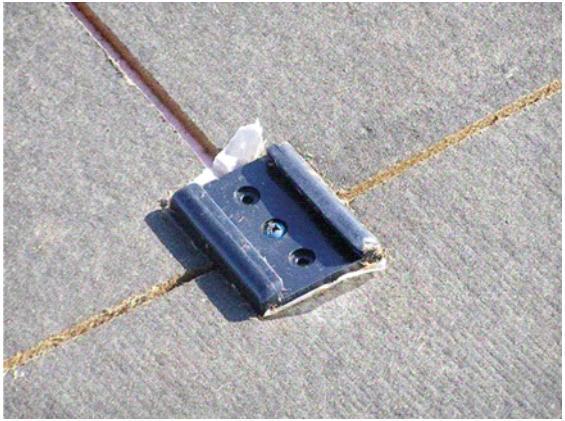
1.05-7. Commercial Building. Bottom piece of a damaged non-penetrating fastener secured to the steel deck.

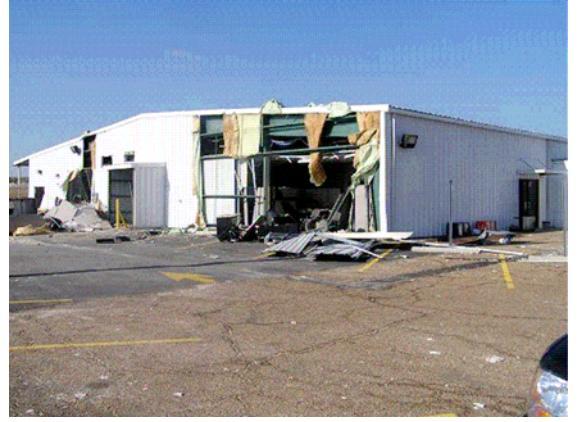
The building was apparently pressurized, as evidenced by a blow-out of a section of the east wall.

1.06(a)-1. Commercial building. Blown-out east wall of this commercial computer facility.

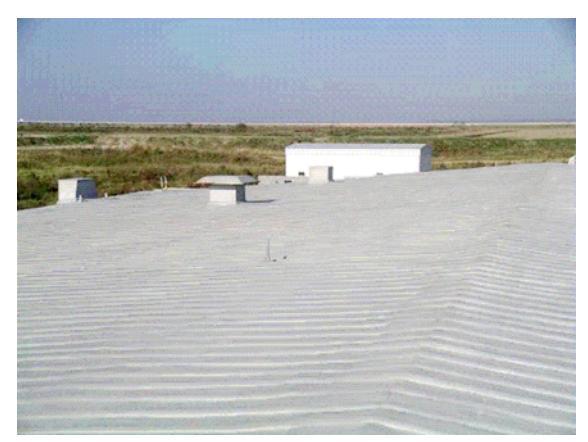
1.06(a)-2. Commercial building. View of the undamaged SPF roof, which had been well maintained.

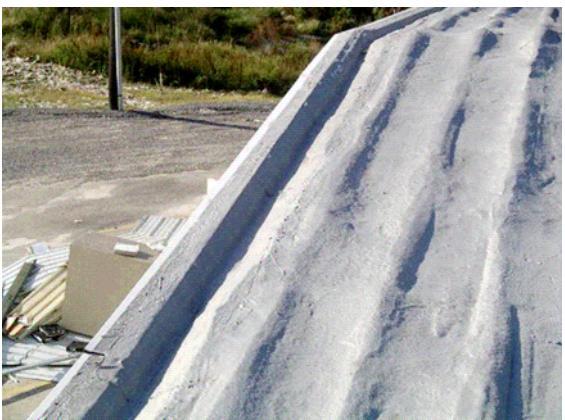
1.06(a)-3. Commercial building. Edge detail of the undamaged SPF roof.

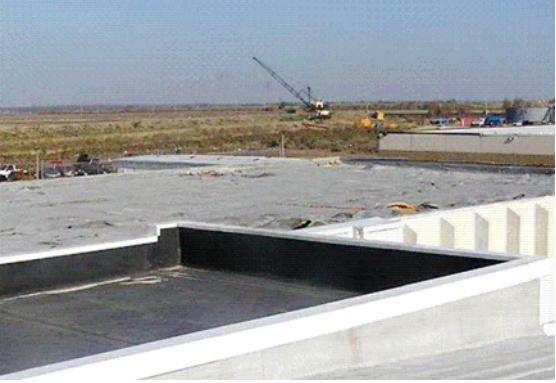
ADDITIONAL COMMENTS—The spray foam on this roof was the original installation, over 20 years ago. Little roof maintenance had been performed over the years, as evidenced from its deteriorated condition, which included large interlaminar blisters and sections of delaminated coating.

1.06(b).1. Commercial building. View of the undamaged, but poorly maintained, SPF roof covering.

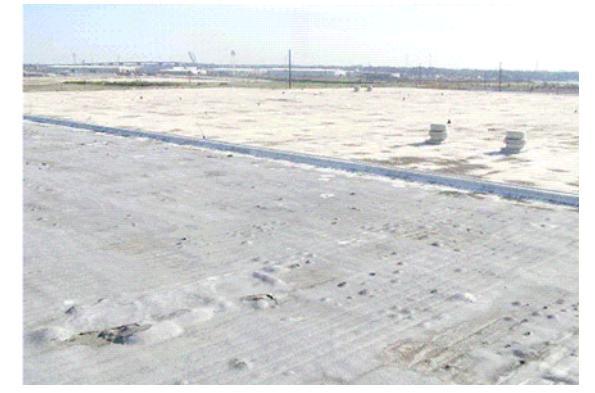
ADDITIONAL COMMENTS—This SPF roof was more than 20 years old, and some sections had been poorly maintained. In those sections, the roof showed evidence of SPF sprayed over moisture and exhibited blistering and UV degradation. Hurricane-induced damage was not observed in those areas.

1.07-1. Commercial building. Well maintained SPF (background) and poorly maintained SPF (foreground) roofing on the administration building.

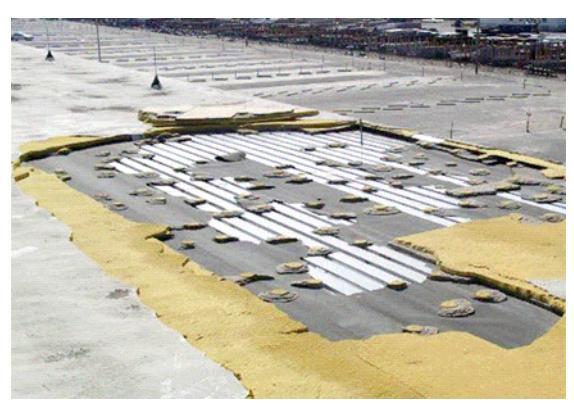
DAMAGE INITIATION AND PROPAGATION—The base ply, wood fiber insulation, and SPF detached from the deck, leaving fasteners in place. Insulation boards tore around the fasteners. About 10% of the damaged area at the east end had no fasteners. No evidence was observed to indicate that fasteners had been installed at that location.

1.07-2. Commercial building. Damaged section where SPF had been applied over mechanically attached wood fiber board. No fasteners were installed in the far corner of the damaged area.

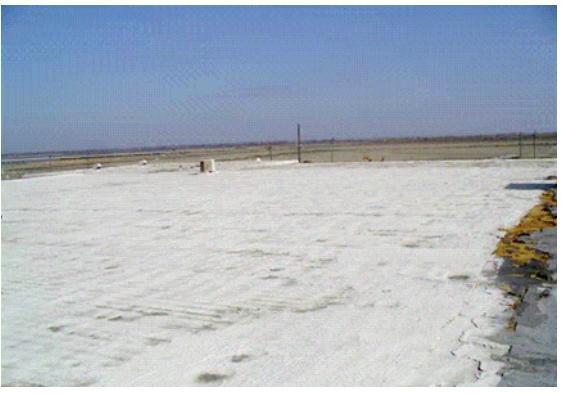
1.07-3. Commercial building. An area of well maintained SPF roof lies next to a section that was poorly maintained. However, the poorly maintained areas were not damaged by Katrina.

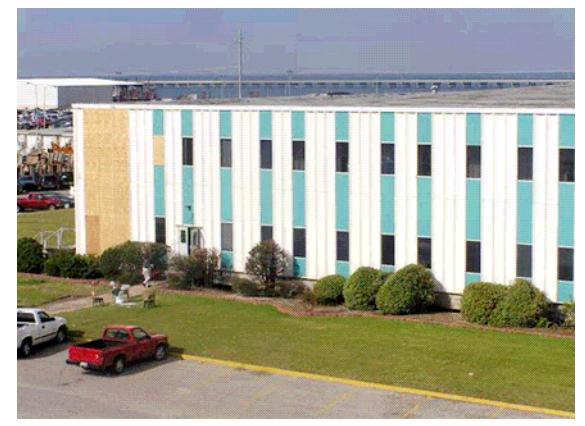
1.08-1. Commercial building. East wall of building.

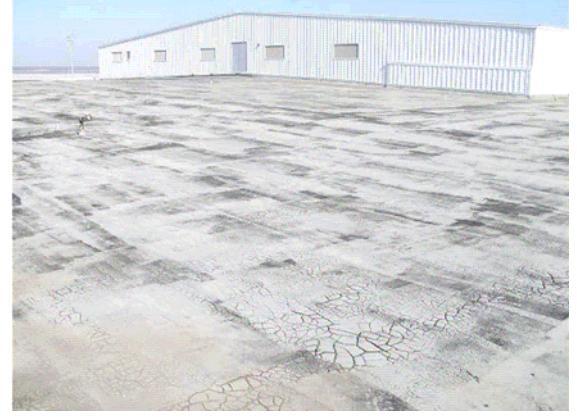
1.08-2. Commercial building. View of the undamaged BUR membrane with coating.

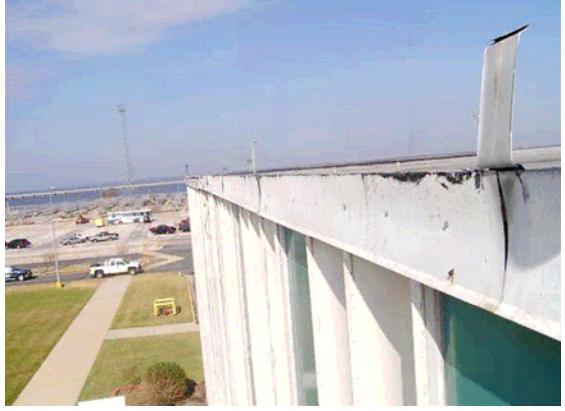
NOTED DAMAGE—At a few locations along the outside of the perimeter flashing, metal strips covering joints between fascia sections were bent upward.

1.08-3. Commercial building. Bent cover strips at joints between sections of metal fascia.

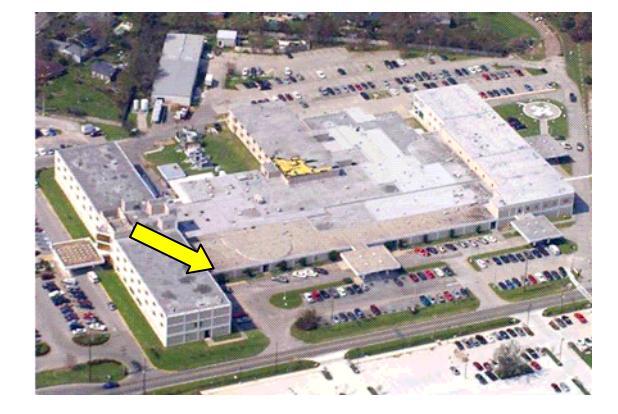
1.09(a)-1. Ocean Springs Hospital. Aerial view.

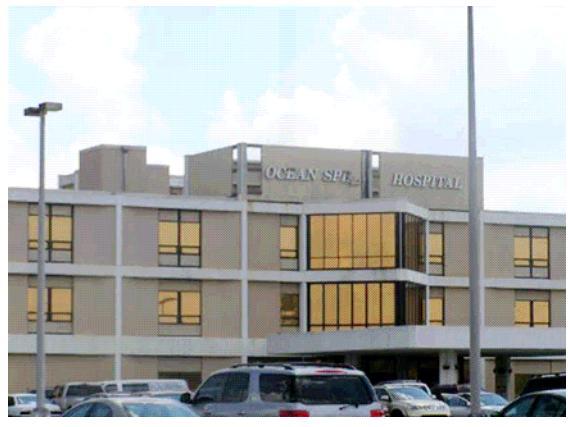
1.09(a)-2. Ocean Springs Hospital (front side). The screen at the top of this building (surrounding rooftop mechanical equipment) was damaged.

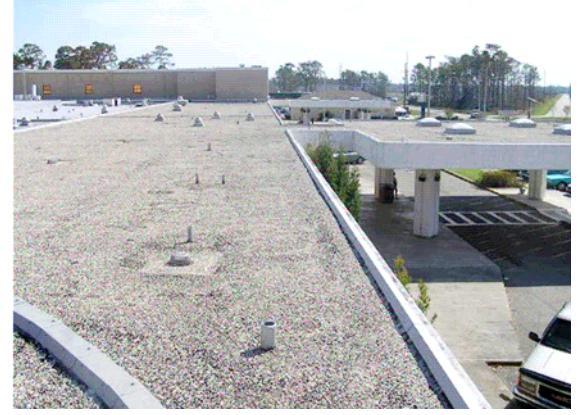
ADDITIONAL COMMENTS—No Katrina storm damage was observed on this roof section. The aggregate-surface BUR was judged to be in very good condition with very good edge details. The gravel guard was well secured in a reglet on top of a curbed concrete-panel fascia. A 2 in. thick nailer was secured to the inside face of the curb. A cleat nailer was fastened to this nailer for securement of counter-flashing.

1.09(a)-3. Ocean Springs Hospital. Overview of the undamaged aggregate-surface BUR.

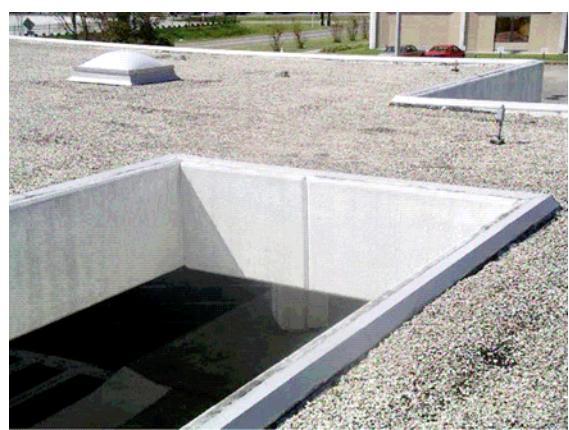
1.09(a)-4. Ocean Springs Hospital. View of a typical perimeter edge detail.

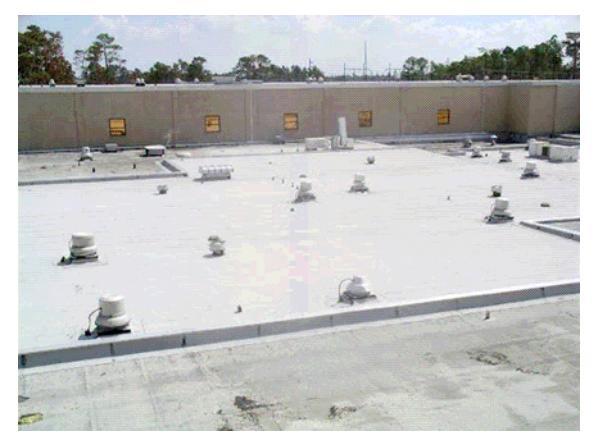
An adjacent section of roofing with a mineral-surface SBS membrane was also undamaged.

1.09(a)-5. Ocean Springs Hospital. This photo shows an SBS modified bitumen membrane system that was undamaged.

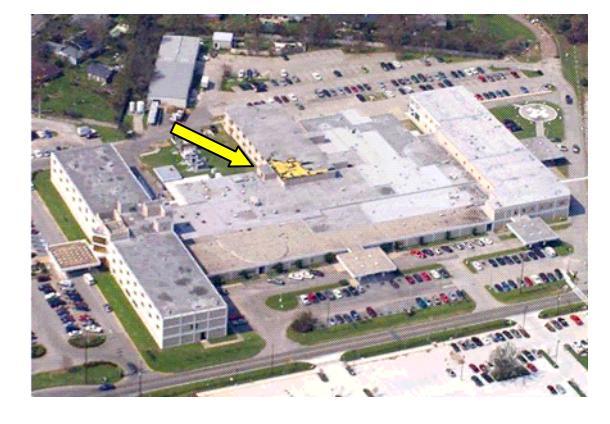
1.09(b)-1. Ocean Springs Hospital. Aerial view.

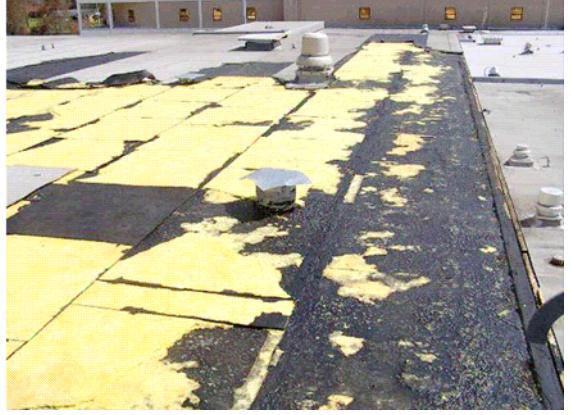
NOTED DAMAGE—Edge flashing was detached at the corner. Sections of membrane and re-cover board were also blown off.

DAMAGE INITIATION AND PROPAGATION—The damage may have started at the edge flashing, which was not well attached at the perimeter. Where the edge detail blew off, there were two contributing causes: (1) inadequate nailing of the 1×4 in. nailer to the 2×8 in. wood fascia board and (2) no face attachment of the metal, i.e., no cleats.

About 20% of the SBS membrane system was damaged. Damage consisted of peeling of the membrane at the southwest corner, extending 50 ft along the western side and 60 ft along the southern side. Three modes of membrane-system damage were observed: (1) the glass fiber re-cover boards

detached from the original BUR (over about 20% of the damaged area), (2) the bottom ply of the recover membrane detached from the fiberglass cover board over about 75% of the damaged area, and (3) the cap sheet peeled away from the ply sheet below it, apparently as a result of cold asphalt application (over about 5% of the damaged area).

1.09(b)-2. Ocean Springs Hospital. Damage to the SBS membrane and edge flashings.

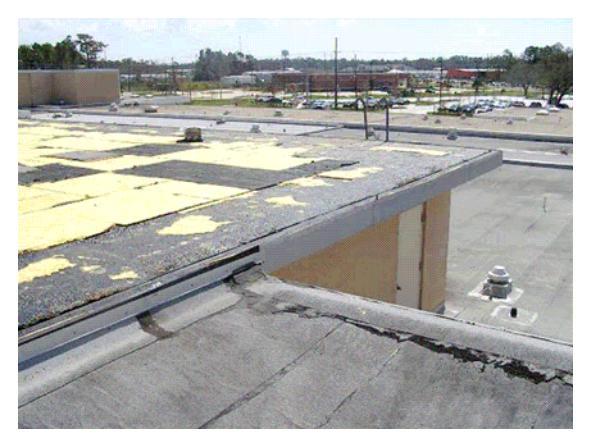
1.09(b)-3. Ocean Springs Hospital. The roof at left shows loss of re-cover board, as well as of flashing details along the edge of the SBS roof assembly.

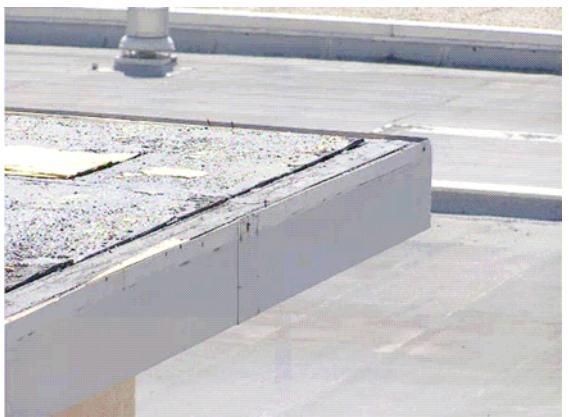
1.09(b)-4. Ocean Springs Hospital. No evidence of face attachment (cleats) of the edge flashing.

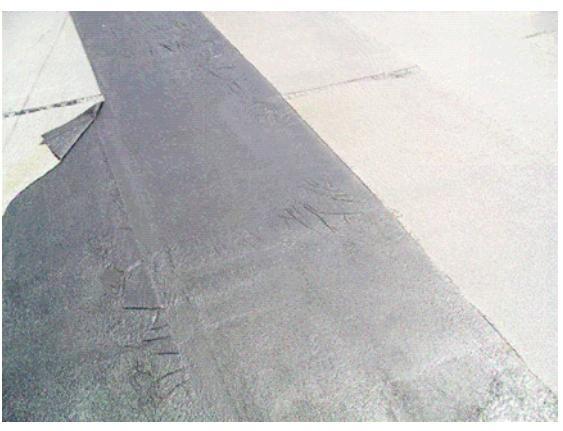
1.09(b)-5. Ocean Springs Hospital. Example of SBS cap sheet that delaminated from the built-up roofing plies below it. This appeared to be due to improper (too cold) asphalt application.

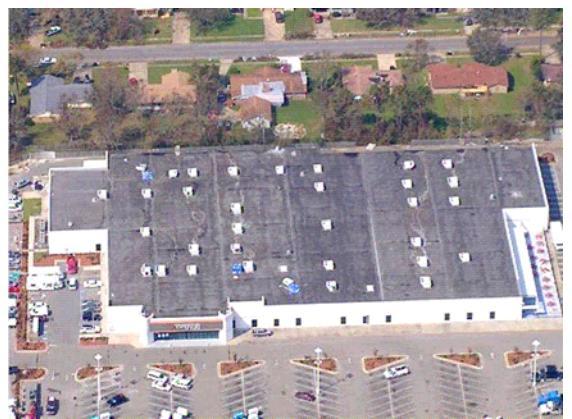
1.10-1. Commercial building. Aerial view of the Ocean Springs commercial building.

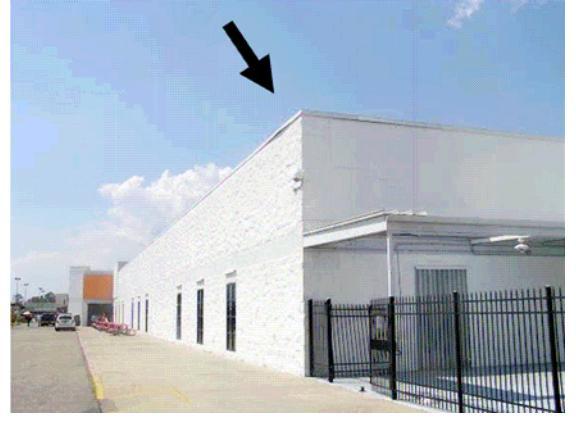
NOTED DAMAGE—No damage to the membrane system was observed. A 5 ft section of metal edge fascia on the windward southeast corner bowed slightly outward. Some rooftop equipment was also damaged.

1.10-3. Commercial building. Outward bowing of the edge metal (arrow) can be seen in this photo of the southeast corner.

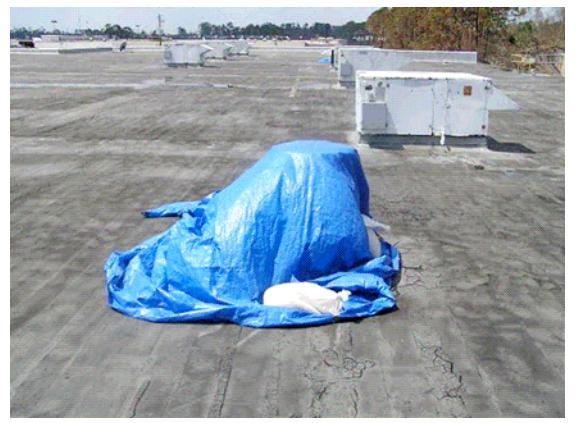
1.10-2. Commercial building. Damaged rooftop equipment was covered with plastic.

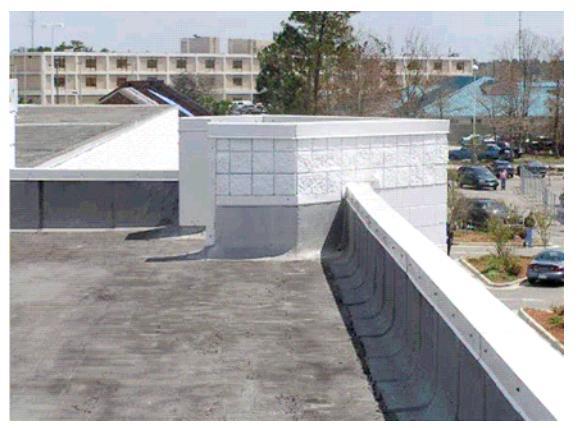
1.10-4. Commercial building. A parapet wall and flashing metal coping are shown in this photo of the front side of the building.

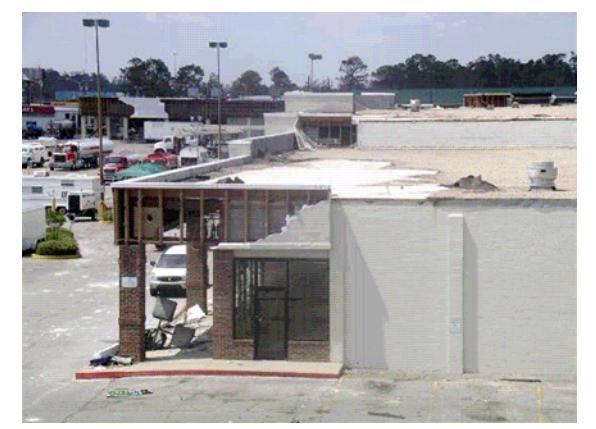
NOTED DAMAGE—Glass at the front of the building was blown out. The membrane above the glass damage was blown off.

1.11-1. Strip mall. Damaged roofing is visible.

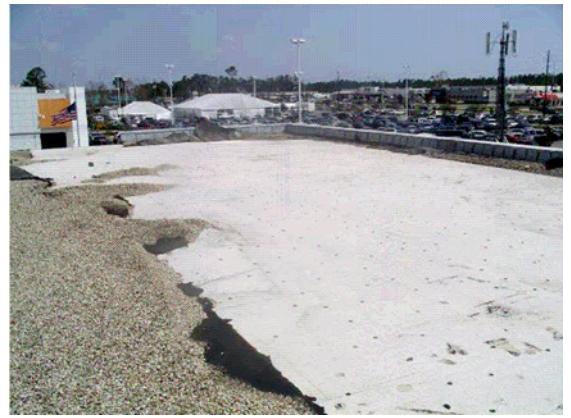
A contributing factor may have been the pressurization at the corner due to loss of the glass wall. There was an opening between the roof and the room below at the southeast corner of the building. This opening may have allowed the underside of the roof membrane to be pressurized. It was noted that the edge flashing at the damaged section was mostly intact with the exception of a short length of base flashing that may have pulled away when the membrane released.

1.11-2. Strip mall. Damaged corner section. Note the exposed lightweight concrete decking.

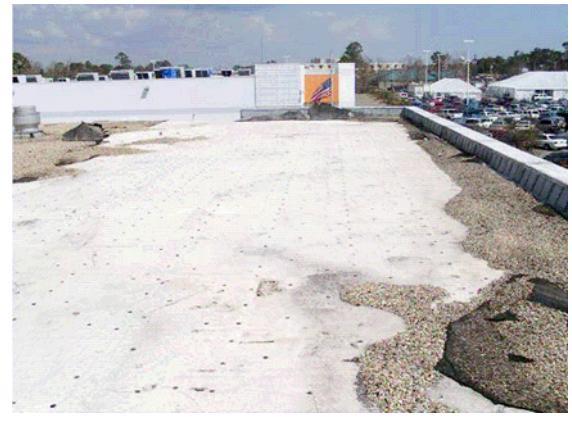
DAMAGE INITIATION AND PROPAGATION—The roof assembly lifted away from the deck, leaving most fasteners in place. Although little remained of the roof membrane for examination, it was apparent that the base sheet tore around the expandable fasteners, allowing the BUR to blow away.

1.11-3. Strip mall. Fasteners remained in the deck. Coping at parapet is intact.

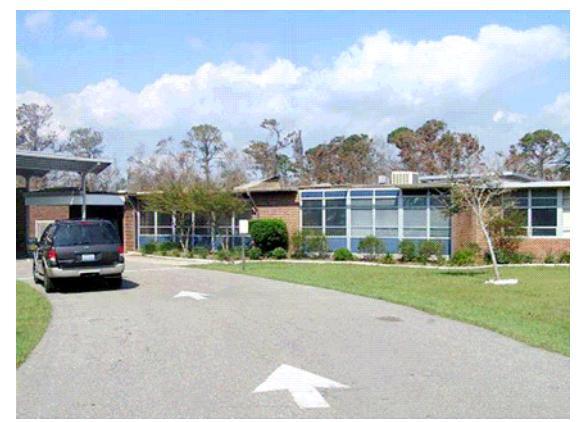
1.12(a)-1. Pecan Park Elementary School. Entrance.

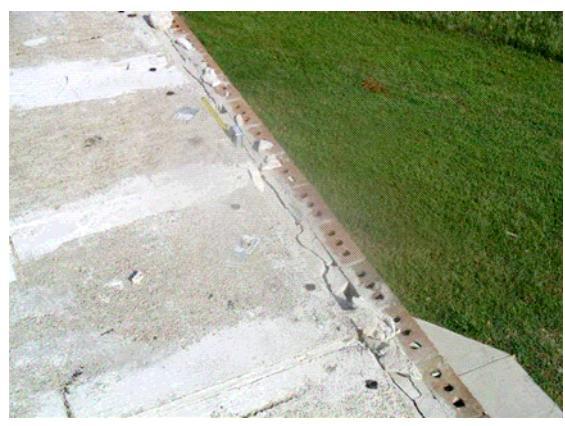
There was no overhang at the southeast corner of the damaged section. Here, the base nailer detached from the masonry wall because bolts pulled out of the mortar. The bolts were severely corroded. The CWF panels remained in place, but the membrane released.

1.12(a)-3. Pecan Park Elementary School. Damage at the southeast corner of the building, where bolts attaching a nailer pulled out of the mortar.

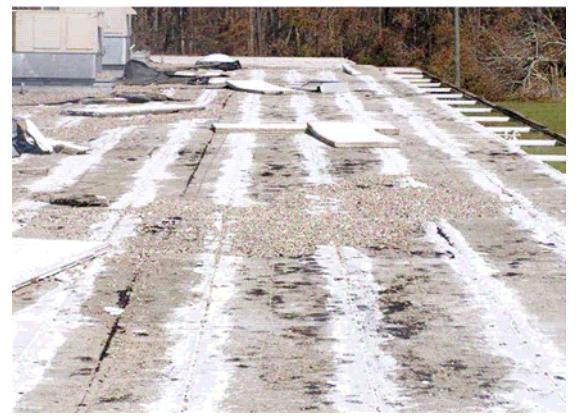
Along the south edge of an overhang, an entire row of CWF panels blew off. The damage was attributed to lack of attachment of panels to supports, since they were held in place only by their own weight. Back from the displaced panels at the overhang, the BUR detached from CWF panels, which remained in place. Fasteners holding the base sheet were severely corroded, causing most of them to pull loose from the CWF panels. It was noted that there were two rows of fasteners in some sheets. The individual fasteners were set 3 ft apart and staggered. Other sheets had an additional row of fasteners down the center, which also were set 3 ft apart.

1.12(a)-2. Pecan Park Elementary School. Damage was found along the southern edge of the roof.

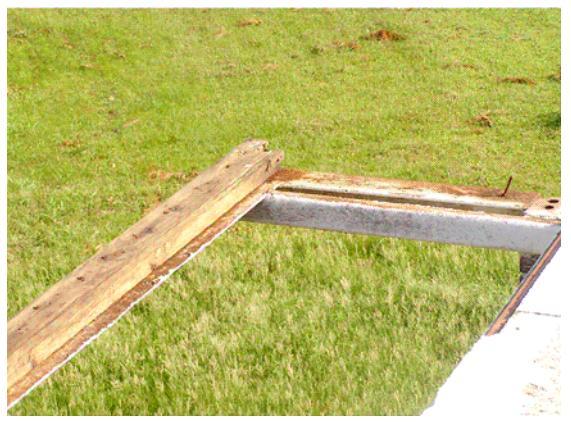
DAMAGE INITIATION AND PROPAGATION—There was poor attachment of the perimeter edge detail. At the overhang, four layers of nailers were observed. The nailer layer attached to the angle supports for the CWF panels remained attached because it was bolted in place. Damage typically occurred within the second layer of nailers, since they were not bolted in place. In fact, it was difficult to determine how the second nailer was attached to the bolted nailer. In addition, the metal frame supporting the CWF panels was severely corroded.

1.12(a)-4. Pecan Park Elementary School. This is an example of damaged edge detail at an overhang.

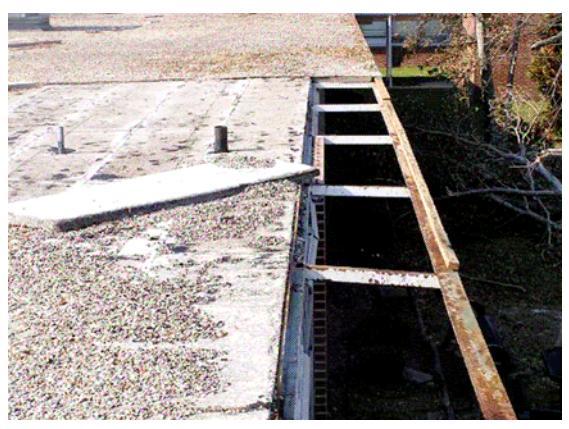
The east side of the roof section had a 2 ft overhang. A 25×20 ft wide section of BUR was damaged. The CWF panels and nailer assembly blew off along the overhang. It was unclear how the missing nailer was attached. There were no bolts in the metal angle support indicative of mechanical fastening of the nailer. There was window damage below this roof section, suggesting that the membrane peeled after the overhangs failed.

1.12(a)-5. Pecan Park Elementary School. Damaged roof section at an overhang along the eastern edge of the building is shown here.

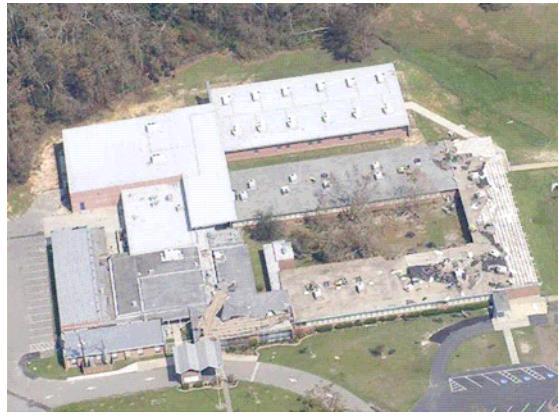
1.12(b)-1. Pecan Park Elementary School. Aerial view of the school.

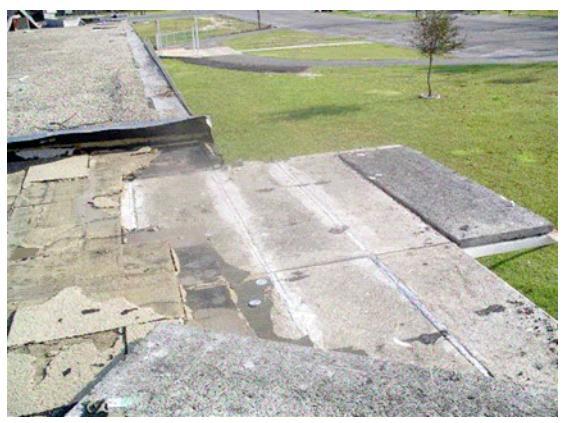
One cause was an inadequate edge detail at the overhang, which may have initiated the blowoff. Prior to blowoff, three wood nailers were attached to each other and to the base nailer bolted to the metal frame supporting the CWF panels. The bottom nailer appeared to be very old and was severely rotted in places. Only one severely corroded bolt was found securing the bottom nailer to the metal frame. However, bolt holes were observed that were 24-36 in. apart. Rust stains were observed in the bolt holes and structural metal. The middle and top nailers (1×4 and 2×4 in., respectively) were nailed to each other and appeared to be new wood. To these nailers, a 2×8 in. fascia board was nailed into the side of the 2×4 in. nailer. This nailer assembly came off in the damaged areas. Also, a 4 ft section of the southern wall at the southwest corner lost the edge nailer assembly, but two bolts set 3 ft apart in the brick mortar remained in place.

1.12(b)-2. Pecan Park Elementary School. Damage at the southwest corner occurred at the overhang shown here at upper right.

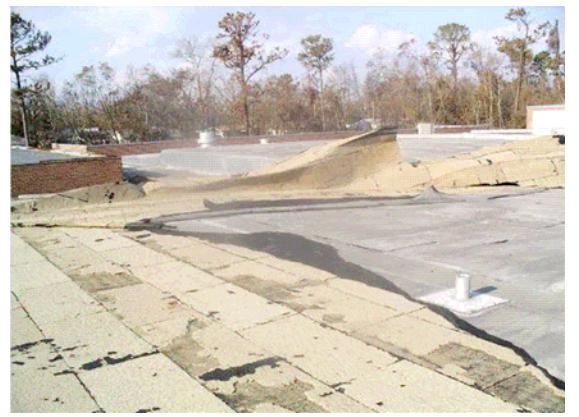
approximately 15% of the membrane damage. (3) There was a cohesive failure of the perlite insulation just below the top surface of the topmost board. Where this damage occurred, a thin layer of perlite insulation remained attached to the bottom of the membrane. This mode was approximately 70% of the membrane damage.

1.12(b)-3. Pecan Park Elementary School. Cohesive failure of the perlite insulation in this photo is associated with membrane blowoff.

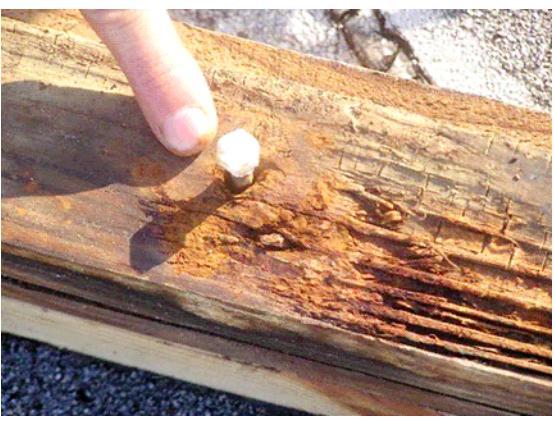
1.12(b)-4. Pecan Park Elementary School. A rotted section of this wood nailer could have instigated nailer detachment from the structural members.

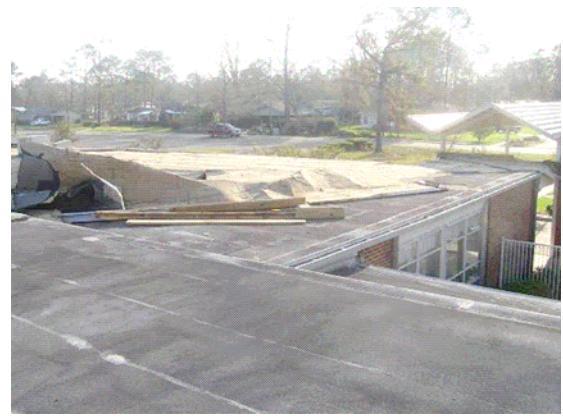
1.12(b)-5. Pecan Park Elementary School. Sections of blown-off wood nailers from the western edge of this roof section.

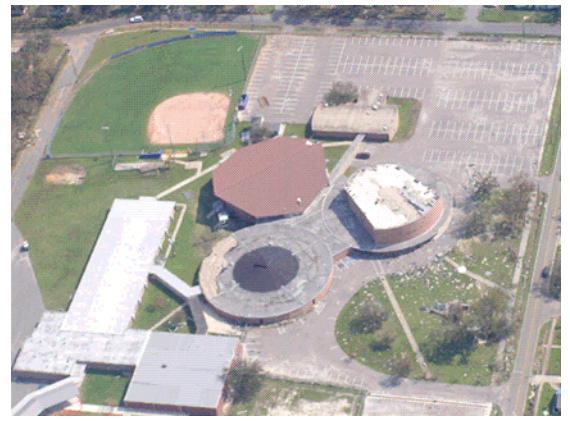
1.13-1. Ocean Springs High School. Aerial view.

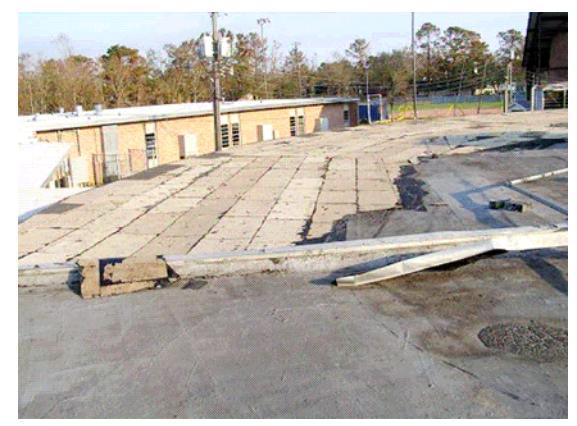
NOTED DAMAGE—Missing edge detail and roof membrane (on the circular building)

DAMAGE INITIATION AND PROPAGATION—Detailed analysis of roof system and damage modes was difficult because repairs were under way when the roof was inspected. Damage likely started as edge detail failure with subsequent peeling of the membrane. The majority of perlite insulation boards (about 90%) remained in place, although some replacement boards had been installed at the edge of the damaged section. Roof damage consisted of delamination within the top layer of the perlite boards (cohesive failure) just under the surface of the membrane.

1.13-2. Ocean Springs High School. Overview shows the damaged BUR assembly.

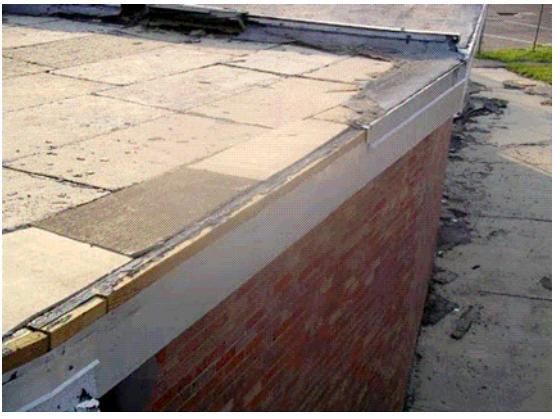
1.13-3. Ocean Springs High School. Damaged edge flashing is visible here. No evidence of proper fastening of the metal edge fascia to the wall was observed.

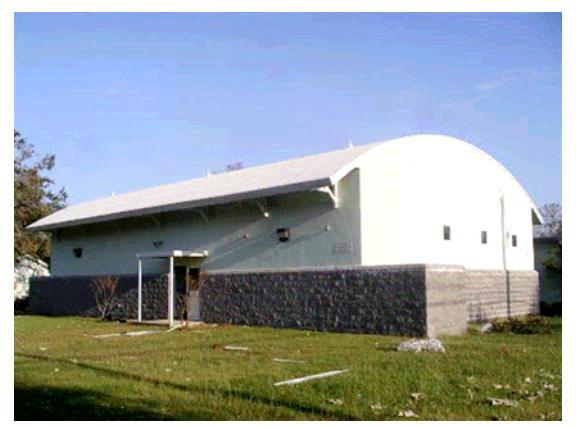
1.14.1. Beach Elementary School. Barrel roof.

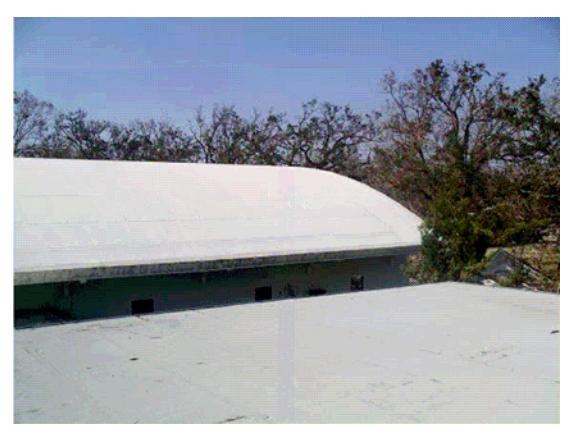
1.14-2. Beach Elementary School. Overview at the barrel roof.

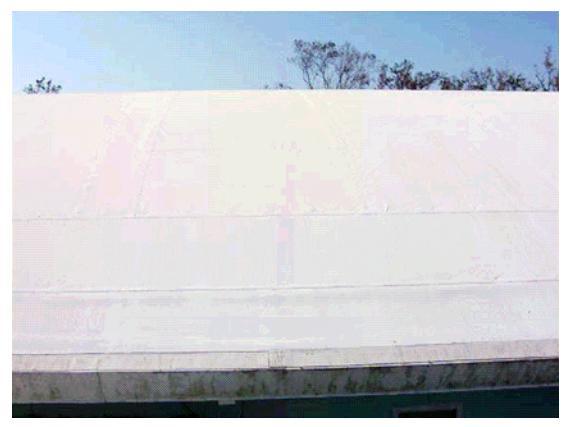
1.14-3. Beach Elementary School. Seams of the single ply membrane can be seen in this photo.

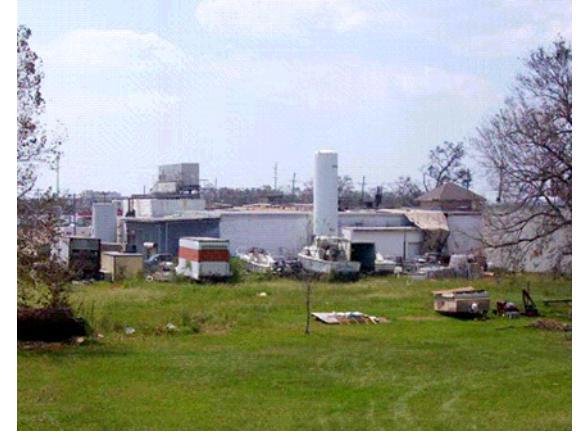
NOTED DAMAGE—Loss of edge detail and membrane system

1.15(a)-1. Freezer plant. View of the commercial freezer plant shows damaged membrane hanging over the side of the building.

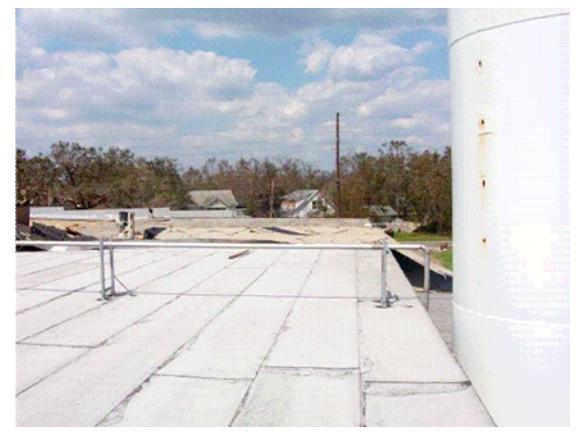
DAMAGE INITIATION AND PROPAGATION—In some areas, the edge metal failed as a result of inadequate attachment to the wood nailer. The fastening pattern was not determined. Additionally, the base sheet (and the insulation and membrane assembly attached to it) released from the CWF panels. The anchors pulled loose from the panels. In other sections of the damaged roof, the system failed because of cohesive failure within the perlite board.

1.15(a)-2. Freezer plant. Overview shows the damaged SBS membrane system.

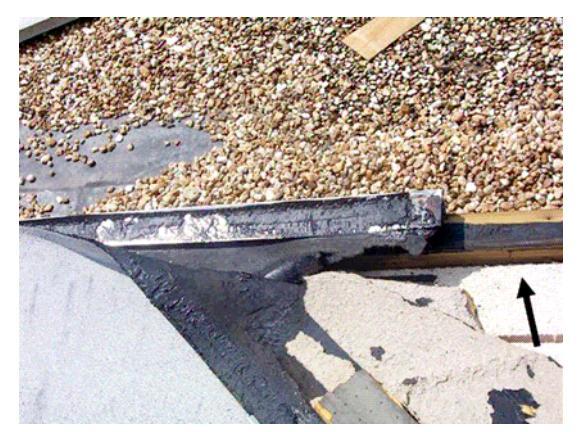
1.15(a)-3. Freezer plant. Damaged edge metal is visible in this photo. Note that it released from the nailer (black arrow), which remained in place.

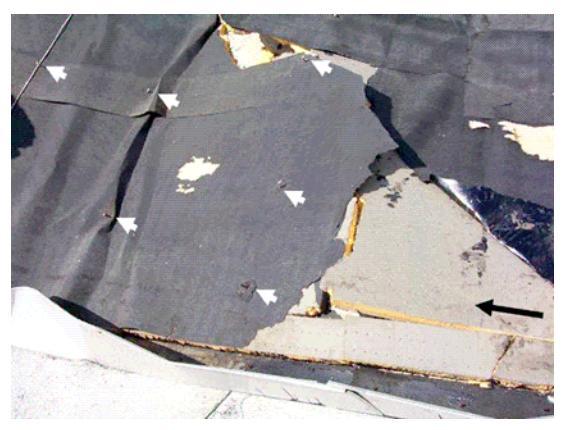
1.15(a)-4. Freezer plant. Underside of the membrane shows fasteners that remained in the base ply (white arrows). Note insulation board that is devoid of asphalt (black arrow) indicating spotty membrane attachment.
