Hurricane Katrina Wind Investigation Report

HURRICANE KATRINA INVESTIGATION REPORT

August 2007

Roofing Industry Committee on Weather Issues, Inc. Powder Springs, Georgia

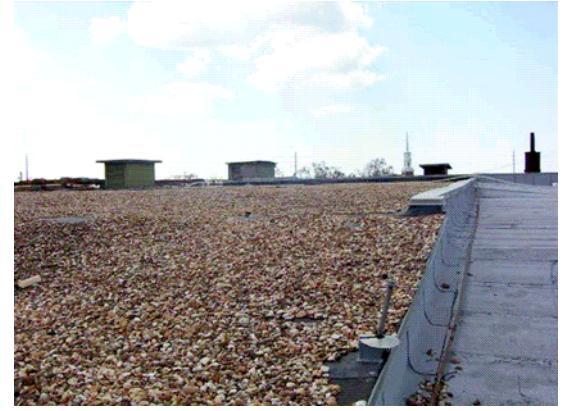
ADDITIONAL COMMENTS—This EPDM membrane system was approximately 20 years old and did not appear to be adequately maintained.

1.15(b)-1. Freezer plant. Overview of the ballasted EPDM system.

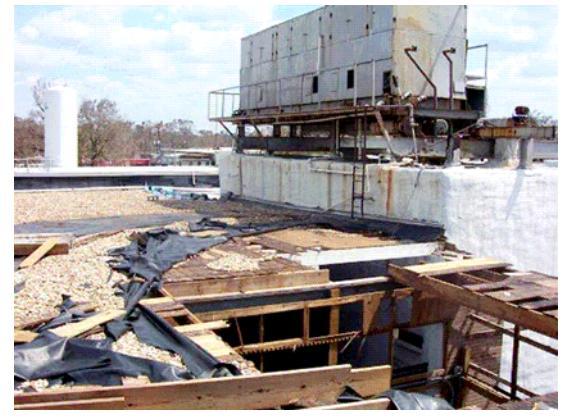
NOTED DAMAGE—The membrane and deck blew off a section of the roof; there was also loss of membrane and some gravel scour.

1.15(b)-2. Freezer plant. Photo shows an area where the decking and the roof assembly uplifted from the force of internal pressurization.

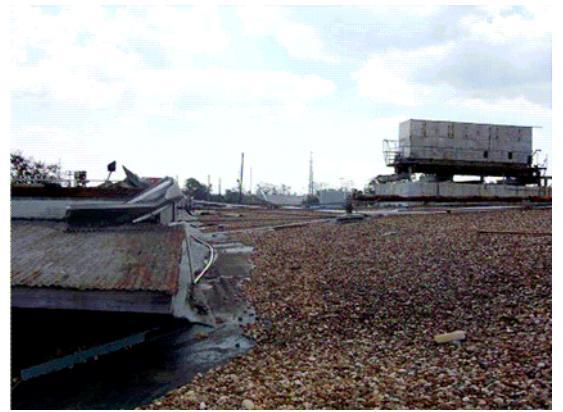
- The membrane was blown back from the roof edge. This occurred to about 30% of the damaged area.
- There was gravel scour in three roof sections including the west, east, and south sides. This occurred to about 20% of the damaged area.

1.15(b)-3. Freezer plant. Ballast scour is visible here along the east edge of the roof system.

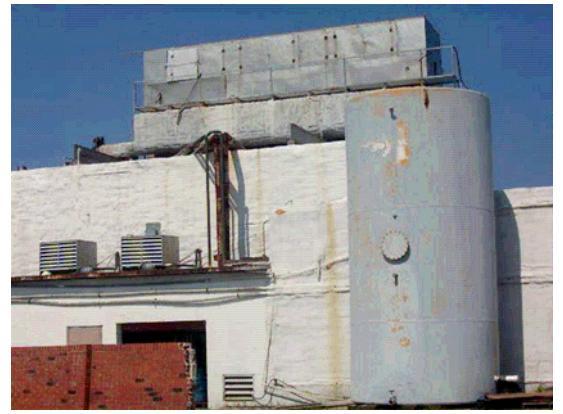
1.15(c).1. Freezer plant. South side of the plant. SPF on these walls was estimated to be 15–20 years old.

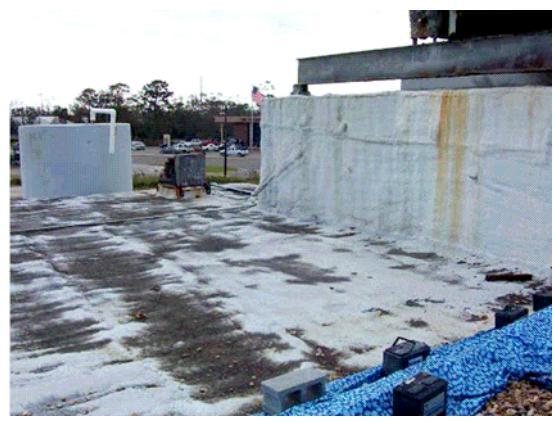
1.15(c)-2. Freezer plant. This is a view of the undamaged 15–20 year old SPF roof.

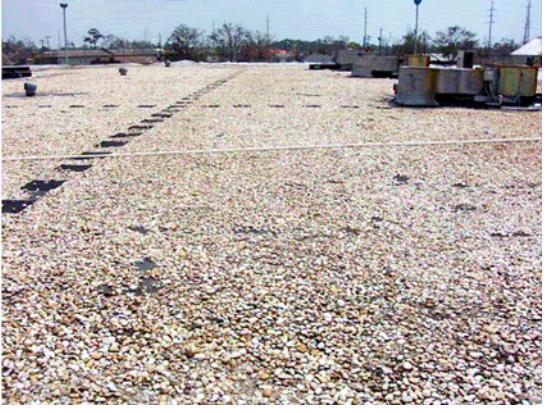
1.16-2. Pascagoula supermarket. Overview shows the field of the ballasted EPDM membrane system.

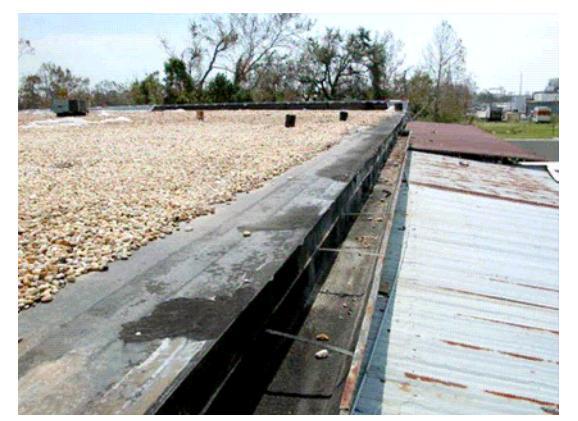
Ballast was missing in some areas. It appeared that the missing ballast had been pushed aside to look for or to repair leaks. It was not determined whether any displaced ballast was due to hurricane wind scour, as opposed to leak repair activities.

1.16-3. Pascagoula supermarket. View along the northern edge of the roof. Shows where ballast had apparently been pushed back to facilitate perimeter repair.

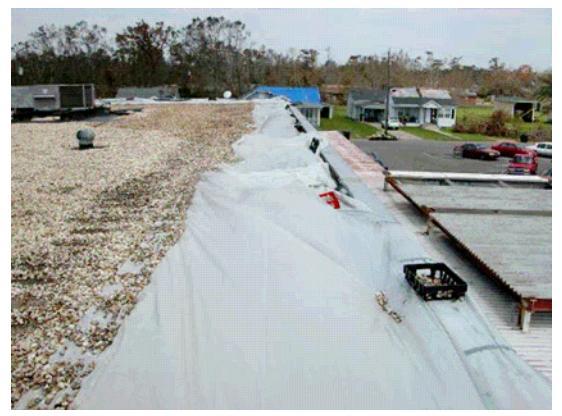
ADDITIONAL COMMENTS—There was considerable evidence of past and present leaks, which were attributed primarily to age, deterioration, and inadequate maintenance. Membrane shrinkage was noted at many perimeter locations. Leakage was obvious in these areas. Many repairs had been made, in all areas, to punctures, seam delaminations, and membrane tears. The types of repair materials were not always apparent. In some cases, asphaltic materials (i.e., felts and mastics) were used. Many seams, as well as penetrations and edge flashings, were covered with plastic sheets. The owner said sheets were used to stop leaks, which he said were not hurricane related.

1.16-4. Pascagoula supermarket. Plastic sheets were used to cover perimeter flashings. They were intended to protect against leaks that had not been caused by the hurricane.

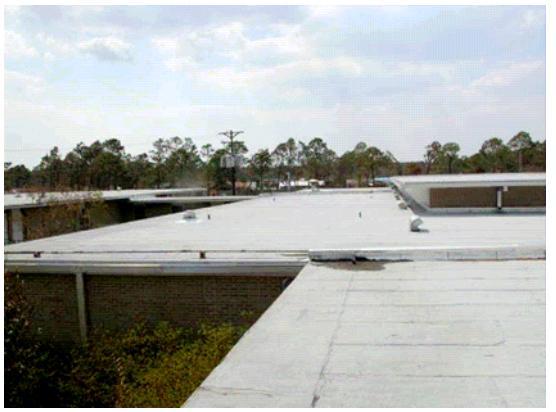
1.17-2. College Park Elementary. Undamaged SBS membranes were common on inspected buildings.

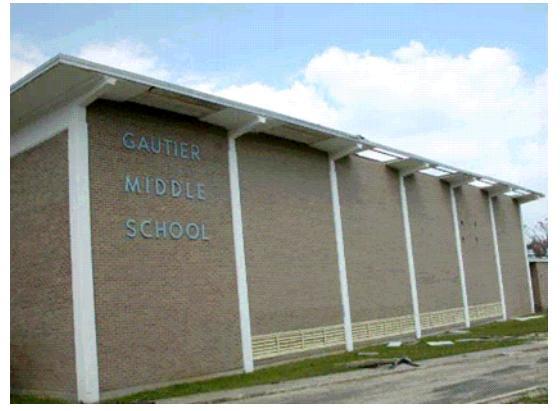
NOTED DAMAGE—Roof assembly, some CWF deck panels, and flashings blew off.

1.18-1. Gautier Middle School. This is the south side of the damaged building.

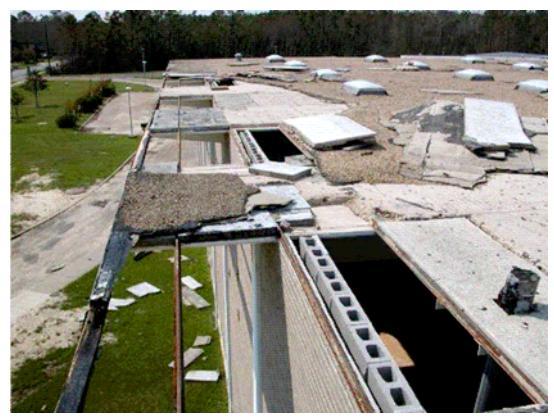
1.18-2. Gautier Middle School. Another view of roof damage along south side of the building.

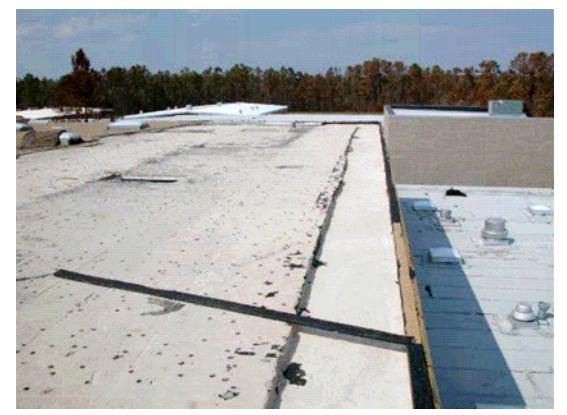
ROOF DAMAGE—Damage occurred at the windward southeast corner of the building. Perimeter edging on the south side of the roof was blown off, along with some CWF panels. The roof edge at this location had a 4 ft wide overhang. CWF panels were missing at the overhang or immediately next to it. On the east side of the roof, the edge metal was missing, although some loosely secured nailers were still in place on the concrete Ts. Also on the east side, a 4 ft wide roof section was missing the leveling fill, perhaps either LWC or perlite insulation board, on the pre-cast concrete Ts. The top surface of this concrete T was remarkably clean; i.e., it was not clear that the fill material had ever been adhered or fastened to the concrete T surfaces. In sections where the membrane blew off, failure occurred at the interface of the bottom ply sheet with the LWC or the CWF panels. Fasteners were pulled from these substrate materials along with the membrane. Some debris piles contained edge flashing nailers and metal gravel stops that were still connected to the displaced membrane.

1.18-3. Gautier Middle School. Roof damage along the east side of the building is visible in this photo.

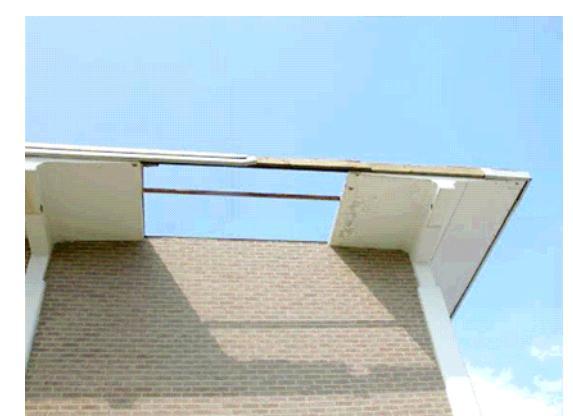
DAMAGE INITIATION AND PROPAGATION—In summary, the roof was damaged at the southeast corner because of the generally poor attachment of key system components, including weak attachment of upper layers of wood edge curb to the well-secured bottom nailer layer fastened to the deck; lack of attachment of CWF panels (held in place only by gravity); inadequate mechanical fastening of the bottom ply sheet to the LWC.

1.18-4. Gautier Middle School. Southeast corner of the roof. The CWF panels (forming the deck between the concrete single Ts) are missing.

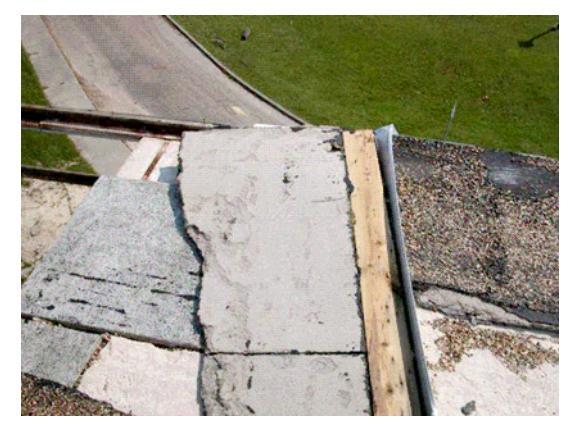
1.18-5. Gautier Middle School. Damage to the edge detail at the east side of the building is shown here. It was not apparent how the perlite board was secured to its substrate at this location.

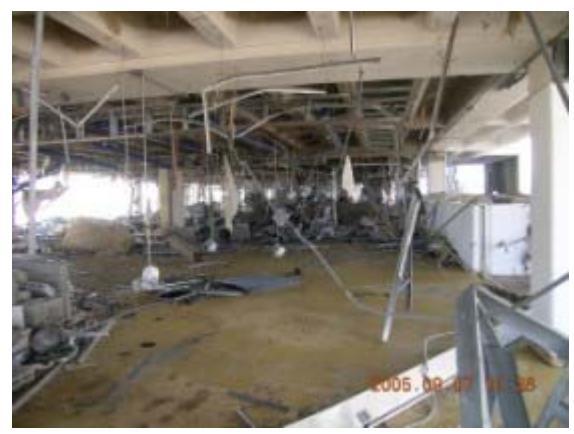
2.01-3. Gulfshore Assembly. Storm surge damaged this interior area.

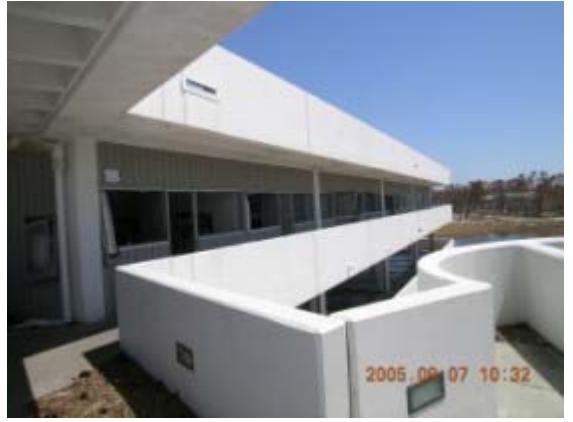
2.01-2. Gulfshore Assembly. The water line on this wall indicates a 28 ft storm surge.

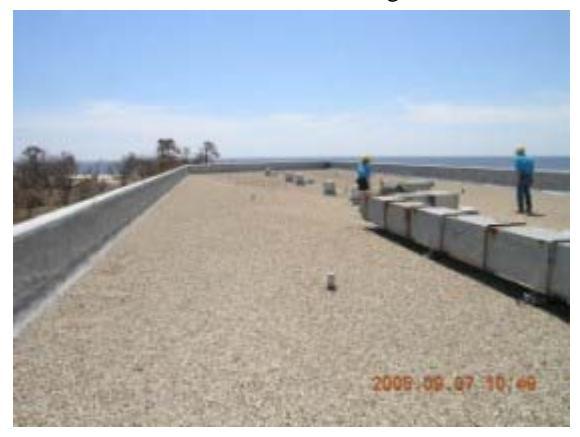
NOTED DAMAGE—Roof assembly was basically intact with no apparent wind damage to membrane. Medium-size aggregate surfacing was scoured on all roof areas, but there were no signs of gravel blown off roof. Aggregate scour was stopped by height of parapet and lower expected lift forces on the membrane and surfacing because of the parapet heights. Parapet heights ranged from 42 to 48 in. In the initial upwind direction, there were double parapets, with a unique grillwork between the first and second parapet. Scour patterns indicated that strong winds hit the building from several directions. Lightning air arresters in most cases were undamaged. Three exhaust fans were displaced from curbs, and several air conditioners were toppled. The two lower floors of the building interior were severely damaged from the storm surge, which was officially measured by the U.S. Geological Survey team at 28 ft from ground level (5 ft above sea level), with water at least ½ in. deep on the third floor. The first two floors had 100% wall openings, and the third floor had 30% wall openings—all due to storm surge.

2.01-4. Gulfshore Assembly. An aggregatesurfacing scour pattern and high parapet can be seen on this roof.

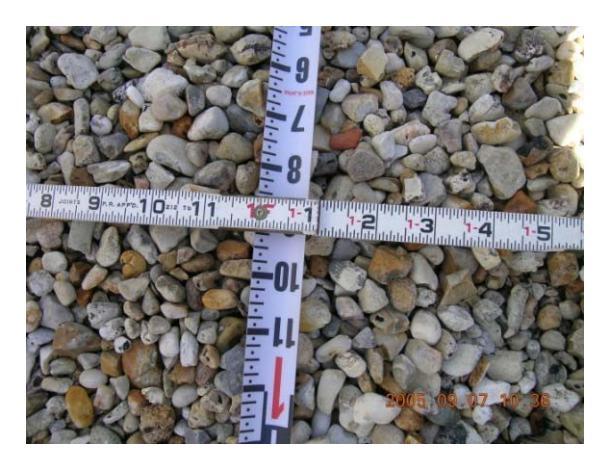
2.01-5. Gulfshore Assembly. Aggregate size was ¹/₂ in. or less.

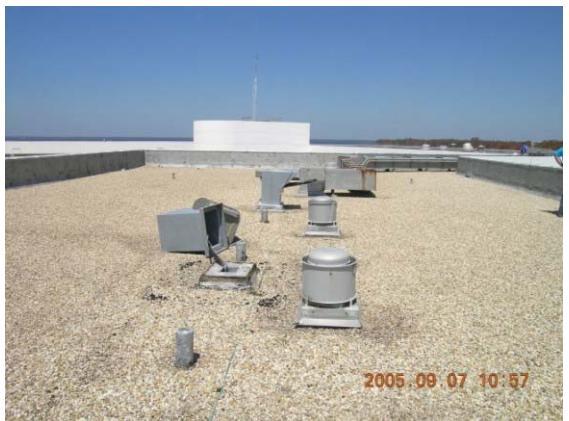
2.01-6. Gulfshore Assembly. This was typical of air-handler damage. Note the limited aggregate-surfacing scour.

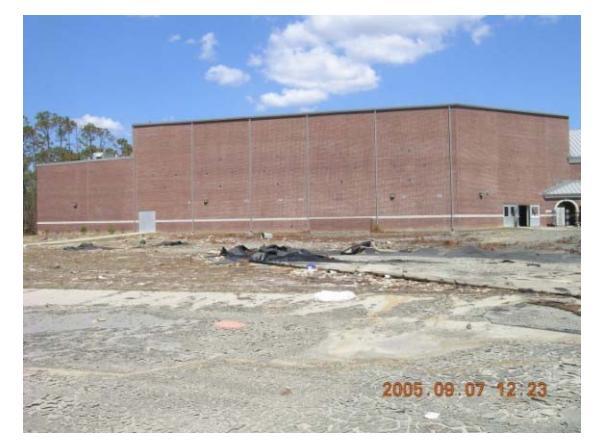
NOTED DAMAGE—Approximately 40% of the roof membrane was blown completely off the building. Edge securement was missing on most of the eastern side of the roof and the eastern half of the diagonal southeast edge. Although it was more than a mile inland, the building was subjected to significant storm surge, with the interior flooded up to approximately 8 ft deep. Edge failure included the top layer of bricks on the southeast corner.

2.02(a)-1. Pass Christian HS. This is the west side of the gym, showing the roof membrane from the east slope on the ground.

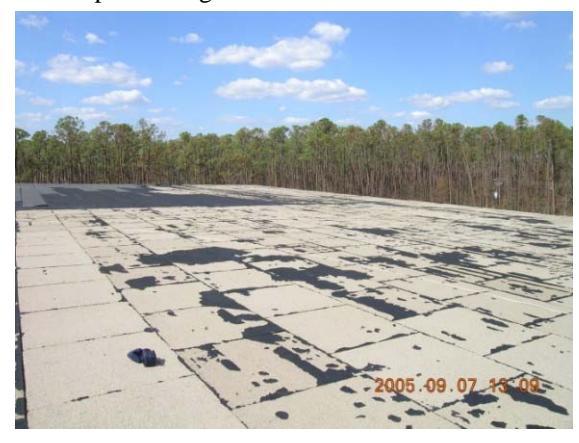
2.02(a)-3. Pass Christian HS. High winds caused the membrane to peel free from insulation in this area.

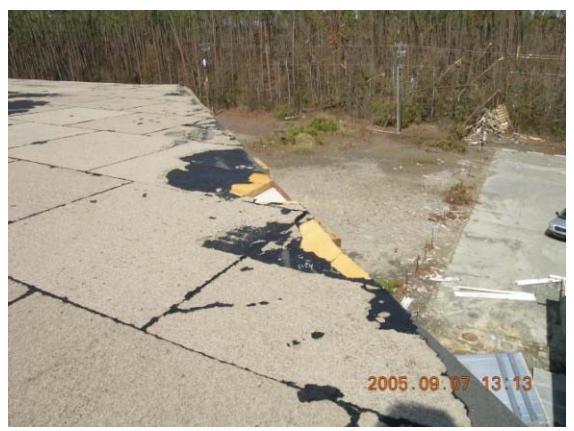
DAMAGE INITIATION AND PROPAGATION—It appears that edge failure led to peeling away of the membrane until a significant change in attachment occurred. The membrane peel stopped at the point of change from sloping toward the eastern edge of the roof to sloping toward the western edge. The east perimeter nailer was not well attached to the building. The metal gutter had spacer straps but no rigid supports; it relied on the gutter flange, which bent, creating a sail that caught the wind and pulled the nailer apart and off at the base. To further add to pressurization forces, the wood nailer was discontinuous—the installation used wood blocks approximately 2 ft long, over which was a continuous nailer. Therefore, the space between the brick and the blocked-up nailer could allow air flow infiltration. The top layer of the brick wall also became dislodged in the upwind northeast corner.

2.02(a)-5. Pass Christian HS. Edge failure typically begins at the weakest point, where the membrane peels free of the perlite insulation.

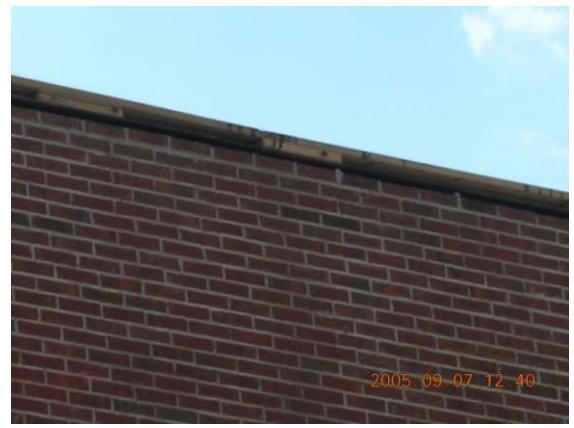
2.02(a)-2. Pass Christian HS. A look at the gym's east side shows where brick, spaced up nailer blocks, and edge metal are missing.

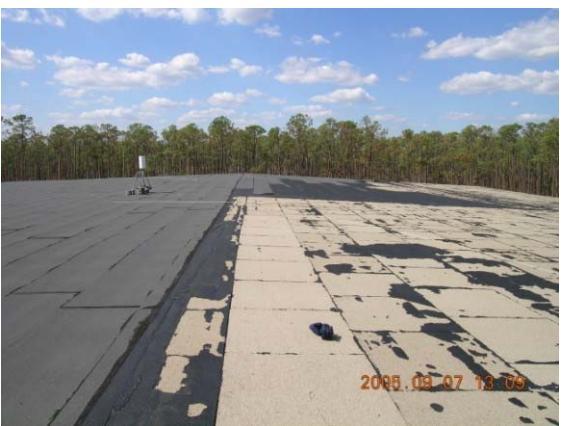
2.02(a)-4. Pass Christian HS. The membrane peel stopped at the center of this roof, likely a construction tie-in.

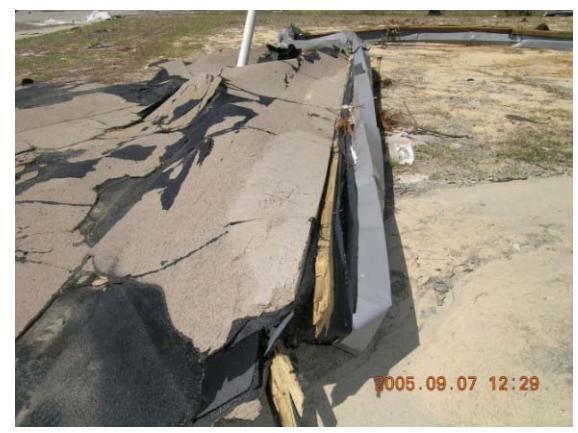
2.02(a)-6. Pass Christian HS. A common cause of edge failure is poor anchoring of wood blocking layers to each other or to the substrate. Membrane is on the ground to west of building.

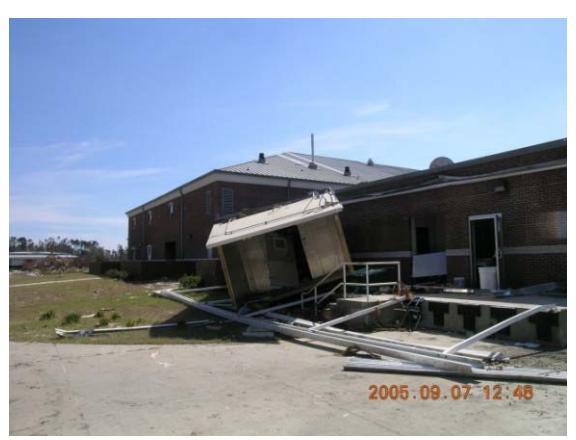
NOTED DAMAGE—Two 16¹/₂ in. snap-lock panels were blown off and there was a small amount of hip and ridge damage; remainder of field of roof was okay.

DAMAGE INITIATION AND PROPAGATION—Metal panels unzipped on exposed roof area.

2.02(b)-2. Pass Christian HS. A view of the north exposure toward the east side shows missing panels.

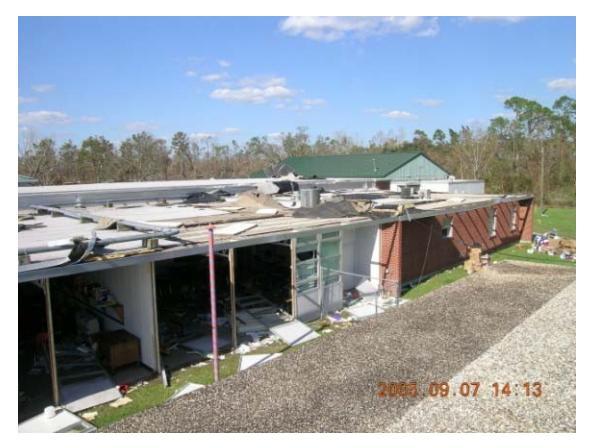
NOTED DAMAGE—Large area of complete displacement of membrane and insulation. Edge metal damaged, torn, and missing. Exhaust fans were displaced, building was subjected to a low-elevation storm surge. Debris from this roof damaged the upper elevation roof membrane and cooling equipment.

2.03(a)-1. Pineville Elementary. This photo shows a large area of the damaged roof and window and panel sections.

ADDITIONAL COMMENTS—This re-covered roof demonstrates the need to assess the condition of the existing system before reroofing. The initial securement was rusted and not able to withstand the uplift loads because of the age of the original roof. A portable uplift tester might have identified this problem, and the problem might have been correctable with new fasteners, new base sheet, or a complete reroofing (tear off and replacement of the existing membrane with new materials).

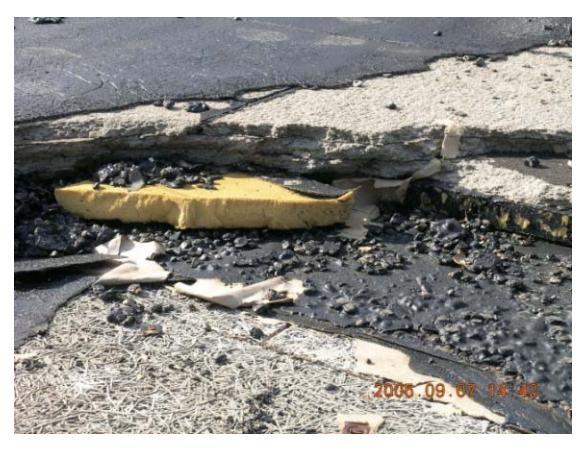
2.03(a)-2. Pineville Elementary. From the bottom up, this assembly consists of CWF decking, original membrane with aggregate surfacing, asphalt, polyisocyanurate foam insulation, perlite board and modified bitumen membrane.

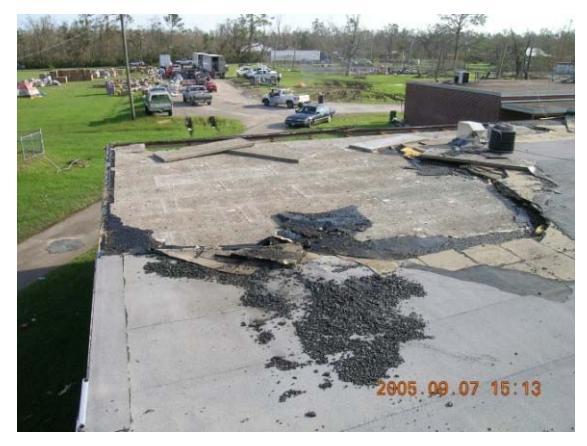
DAMAGE INITIATION AND PROPAGATION—CWF deck is somewhat air-permeable, resulting in pressure between the CWF and the membrane in the overhang area. The pressure on the underside of the membrane (positive pressure) and the uplift found the weakest link to be the rusted fasteners that secured the original membrane. Once there was an initial failure, the base sheet proved to have inadequate resistance to prevent nail pull-out ("pull-through"). The spread of the damage stopped where the uplift forces were reduced, e.g., away form the roof corner. Several of the CWF panels were blown off in the overhang area, and in the corner, both the steel structure and the brick wall were damaged.

2.03(a)-3. Pineville Elementary. This corner view shows displacement of roof covering and CWF panels and SBS membrane delaminated from perlite.

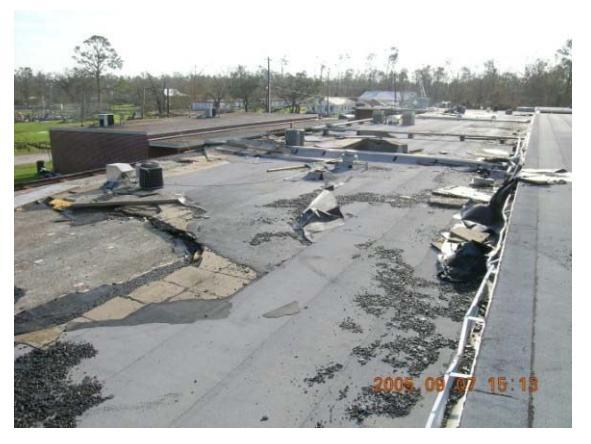
2.03(a)-4. Pineville Elementary. This damage pattern is what would be expected from an oblique cornering wind load.

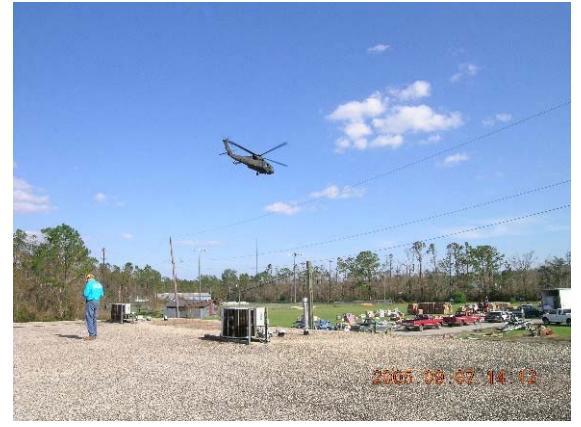
NOTED DAMAGE—Some scour of aggregate surfacing. No other damage was noted.

DAMAGE INITIATION AND PROPAGATION—Not all of the aggregate surfacing was embedded in asphalt. Some was displaced, but it was not noted where it went; since there were no parapets, the gravel may have left the roof.

2.03(b)-1. Pineville Elementary. This is an overview of a roof where a cornering wind occurred.

ADDITIONAL COMMENTS—This roof was performing its main function of keeping the building watertight. There would be no need to repair this section, whereas adjacent roofs with less exposure had significant damage. Re-dispersing the aggregate surfacing would be recommended.

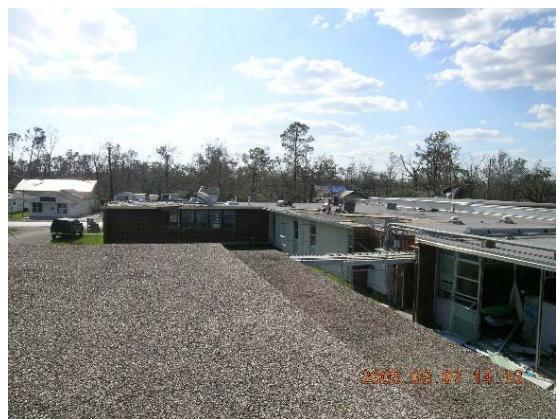
2.03(b)-2. Pineville Elementary. This is a view of the same roof from the opposite side.

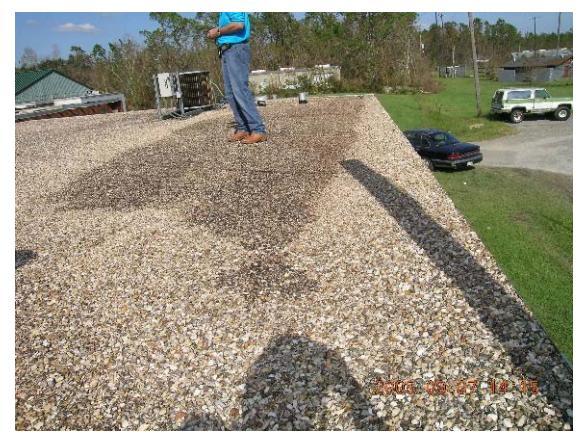
2.03(b)-3. Pineville Elementary. This is a typical scour pattern.

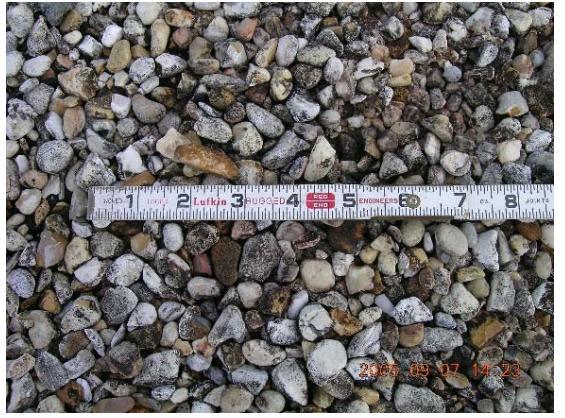
2.03(b)-4. Pineville Elementary. Average aggregate size about ½ in., a slightly larger than common aggregate for surfaced BUR.

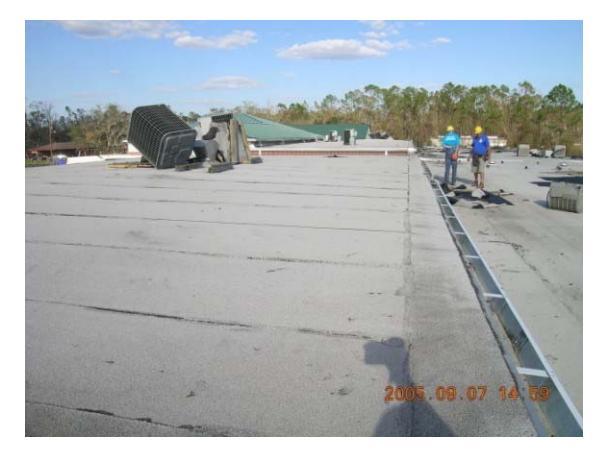
ADDITIONAL COMMENTS—The basic roof covering was intact and would require only minor repairs to relatively few damaged spots. An identical roof section was damaged in the same way. Both roofs could have been quickly made watertight. A nearby metal storage building was undamaged, and the architectural metal roof on the entrance of the building had only minor cosmetic damage.

2.03(c)-1. Pineville Elementary. This modified bitumen roof was in relatively good condition overall.

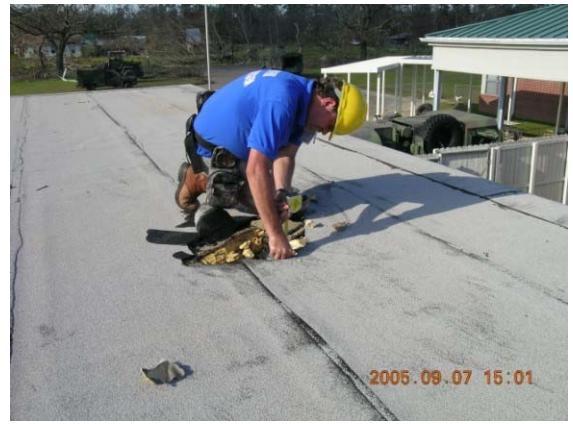
DAMAGE INITIATION AND PROPAGATION—Evaporative coolers were on exposed wood sleepers that were not attached to the deck. Large pieces of airborne debris from the lower-elevation roof membrane and deck described in 2.03(a) hit the gutter, cooler units, and membrane; punctured membrane and insulation; and landed beyond this roof on the ground.

2.03(c)-2. Pineville Elementary. A gouge on this roof was apparently caused by windblown debris.

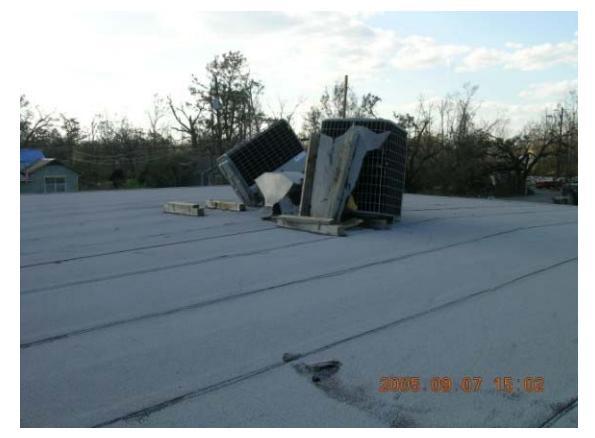
2.03(c)-3. Pineville Elementary. Wood supports in this photo were not secured to the deck. This resulted in HVAC displacement and roof punctures.

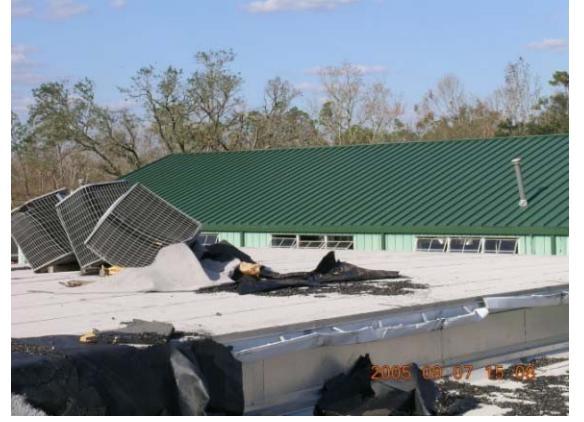
2.03(c)-4. Pineville Elementary. In foreground, edge damage, HVAC damage, and a membrane blown from an adjacent roof are all visible. In the background is an undamaged storage building roof.

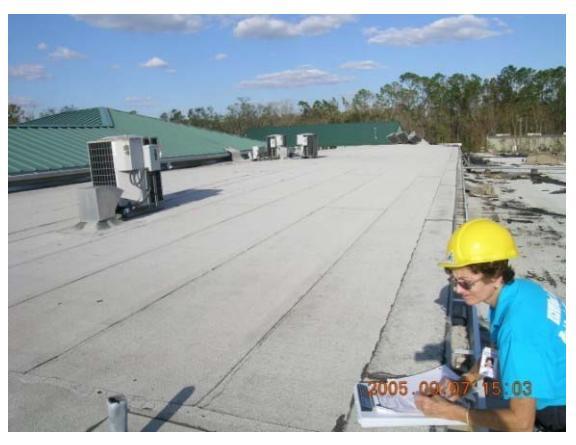
2.03(c)-6. Pineville Elementary. No damage is seen on this roof area.

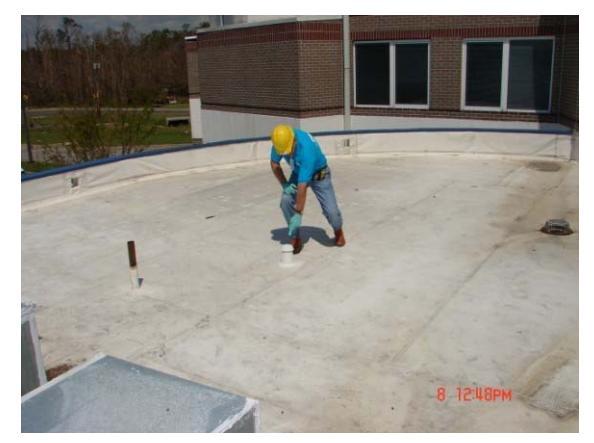
ADDITIONAL COMMENTS—This roof had some small sections exposed to the primary wind but was not damaged, even though the system does not appear to be secured to manufacturer's standards for this wind zone (120–130 mph). It apparently survived because there was little or no air infiltration.

2.04(a)-1. Hancock Medical Center. This photo shows a mechanically fastened thermoplastic single ply membrane with no damage.

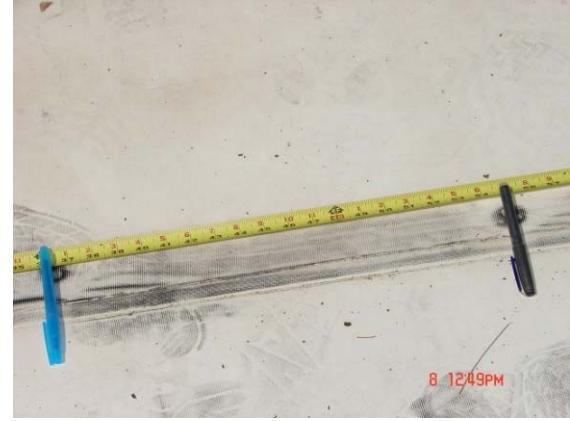
2.04(a)-2. Hancock Medical Center. Fastener spacing in this area was 18 in. o.c.

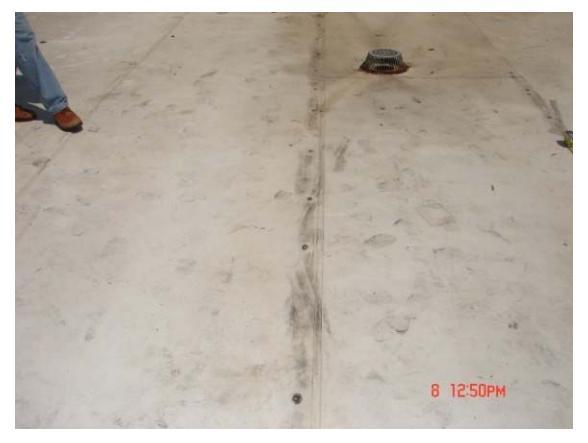
2.04(a)-3. Hancock Medical Center. Fastener rows were spaced 5 ft o.c.

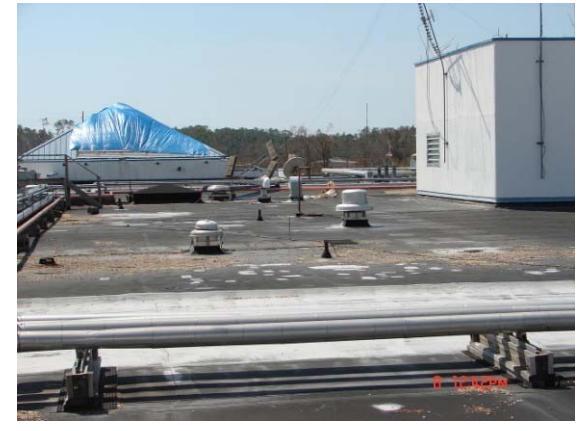
NOTED DAMAGE—The membrane was in good shape and, except for 19 penetrations from debris, there was no blowoff damage. One section of an HVAC unit came off, an air handler penthouse lost edge metal, and one air handler lost its top.

2.04(b)-2. Hancock Medical Center. The white spots are temporary repairs to membrane punctures.

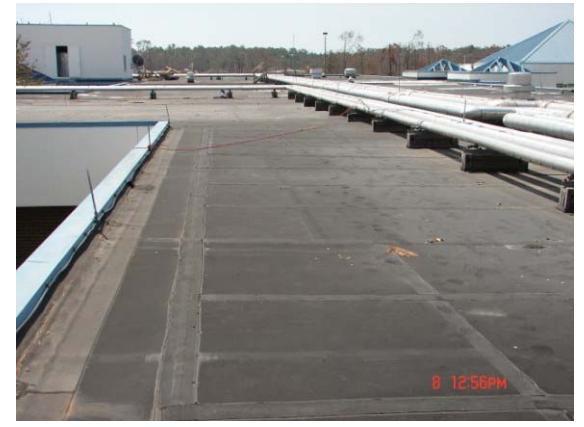
2.04(b)-3. Hancock Medical Center. This perimeter fastening is designed for high wind resistance.

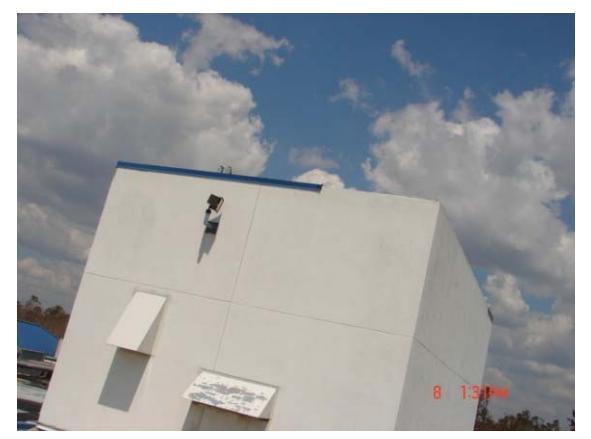
2.04(b)-4. Hancock Medical Center. Edge metal is missing from this penthouse.

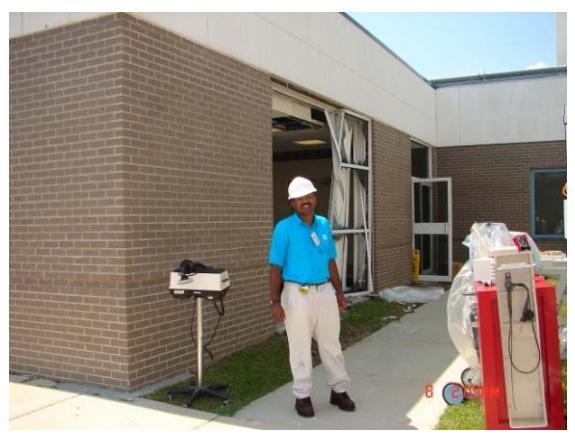
2.04(b)-6. This window wall failed as a result of excessive wind pressure.

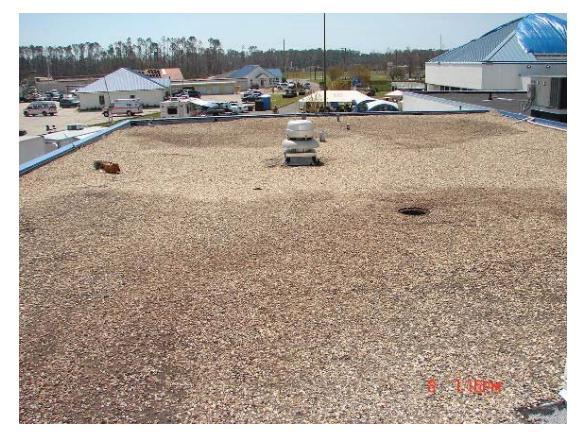
DAMAGE INITIATION AND PROPAGATION—Pea gravel was not fully embedded and was scoured from the high wind uplift areas.

2.04(c)-1. Hancock Medical Center. Gravel scour in this photo was caused by the change in direction and velocity of the wind hitting the roof edge and penthouse.

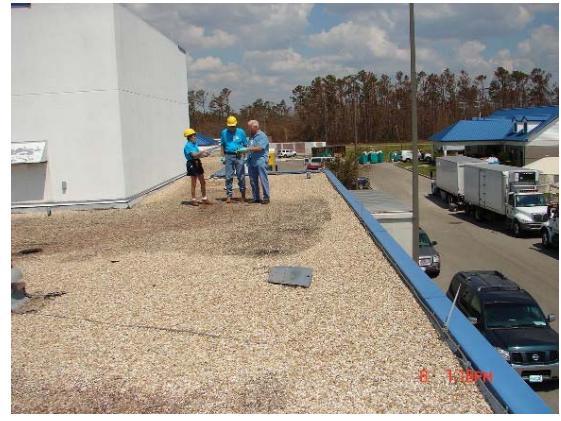
2.04(c)-2. Hancock Medical Center. Scour around the penthouse shows a wind burst pattern. This can occur when wind accelerates around the penthouse.

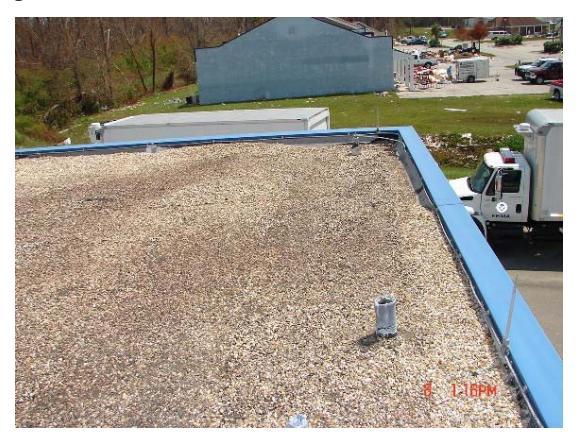
2.04(c)-3. Hancock Medical Center. Gravel scour in this photo shows a change in pattern from a second direction.

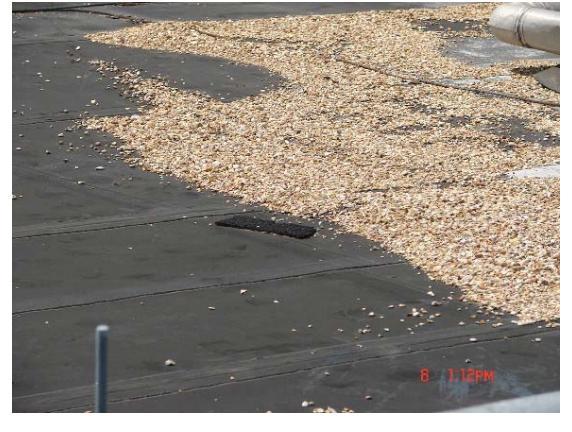
2.04(c)-4. This smooth-surface roof was downwind from the gravel-surface roofs.

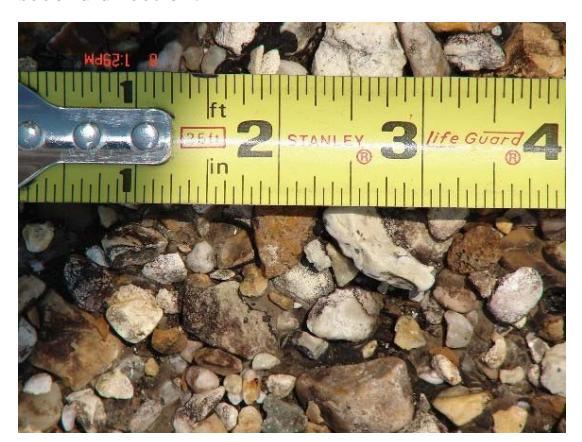
2.04(c)-5. Hancock Medical Center. The aggregate found here was larger than typical pea gravel.

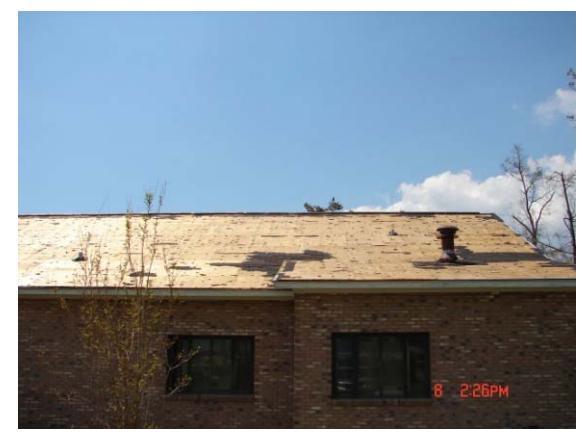
NOTED DAMAGE—All roof covering on windward side of roof was blown off; most roof covering on leeward side was blown off. Wall covering on gable ends was missing.

DAMAGE INITIATION AND PROPAGATION—Asphalt shingles lacked nails, and nails were improperly placed. The roof was installed using the racking method that often limits the shingles to three nails, whereas six nails were required by the building code when this roof was installed.

2.05-1. Fresenius Medical Kidney Center. Almost every shingle was stripped.

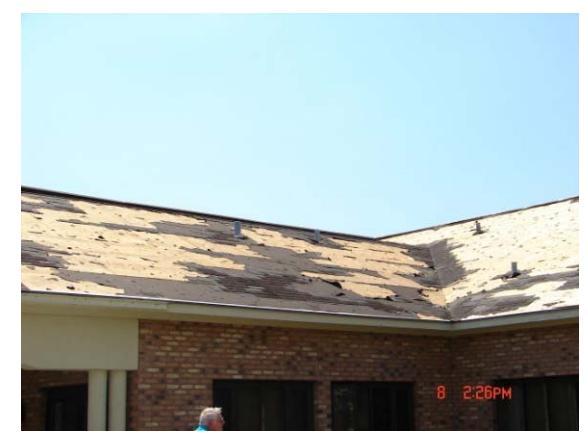
2.05-2. Fresenius Medical Kidney Center. Shingles and underlayment missing from windward side.

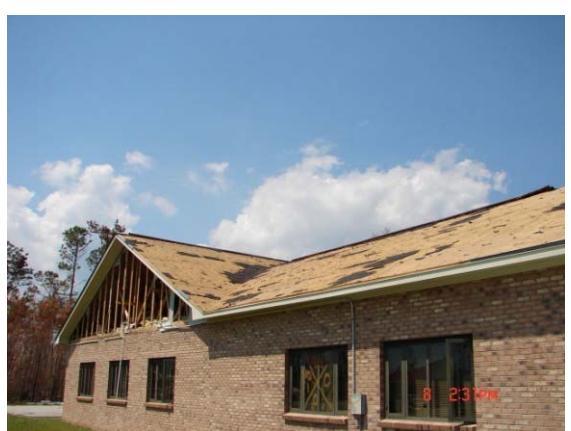
2.05-4. Fresenius Medical Kidney Center. Cladding removed from gable end; however, deck remains in place.

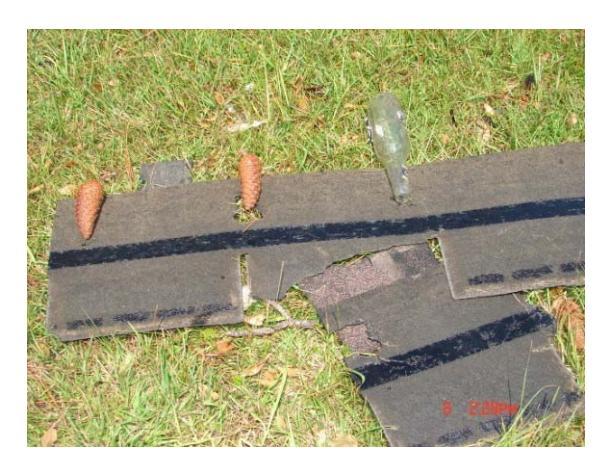
2.05-5. Fresenius Medical Kidney Center. Only three nails in shingles, high nailing.

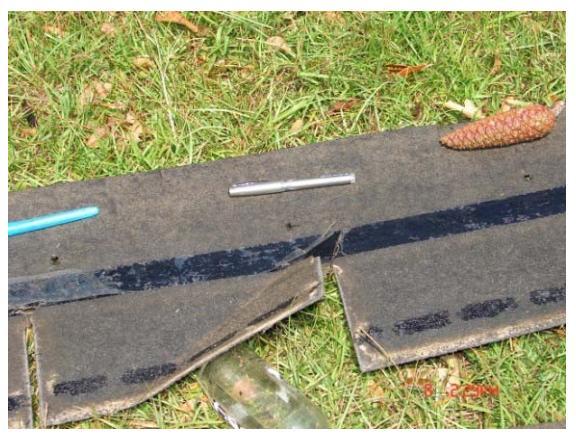
2.05-6. Fresenius Medical Kidney Center. Only three nails in shingles.

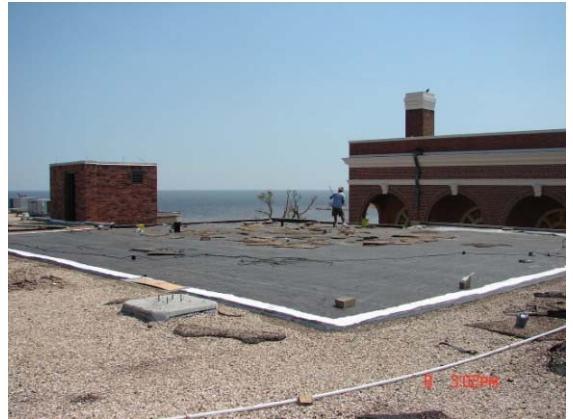
DAMAGE INITIATION AND PROPAGATION—Blowoff areas were due to roof edge failure. Typically, edge sections where blowoff occurred were not adequately fastened to roof deck.

2.06(a)-2. St. Stanislaus. This large area is being temporarily repaired from the corner back. Note its proximity to the open ocean.

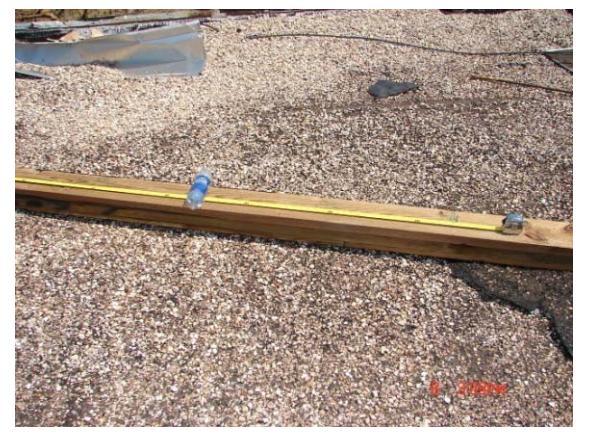
2-06(a)-3. St. Stanislaus. Wood blocking is shown here with fasteners spaced approximately 36 in. o.c.

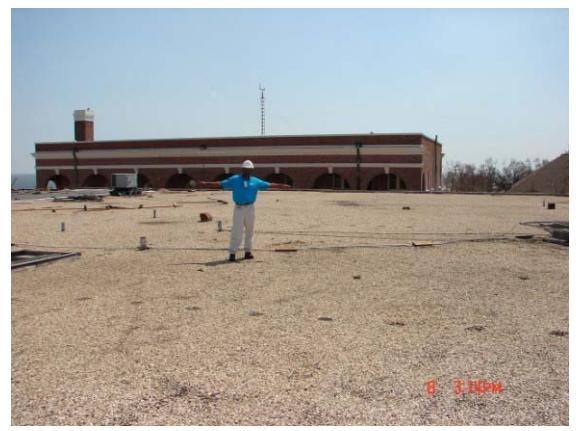
2.06(a)-4. St. Stanislaus. A large roof area appears undamaged, although an HVAC unit was displaced from attachment at left to spot at right.

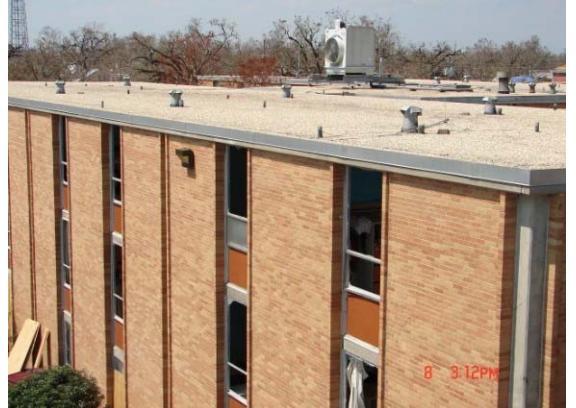
2.06(a)-6. **St. Stanislaus.** An adjacent building showed no apparent roof damage.

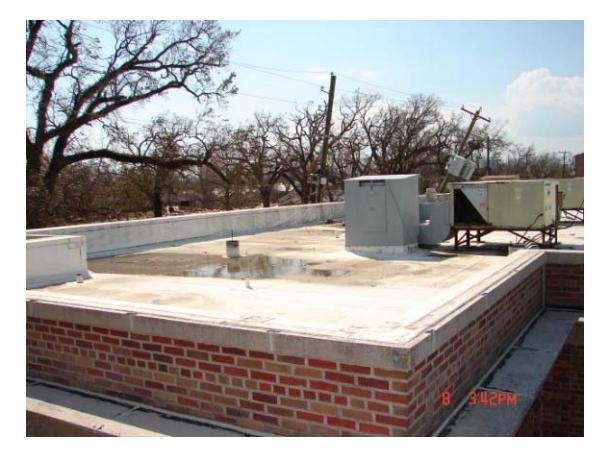
2.06(b)-1. St. Stanislaus. This mechanically fastened single ply membrane appeared undamaged.

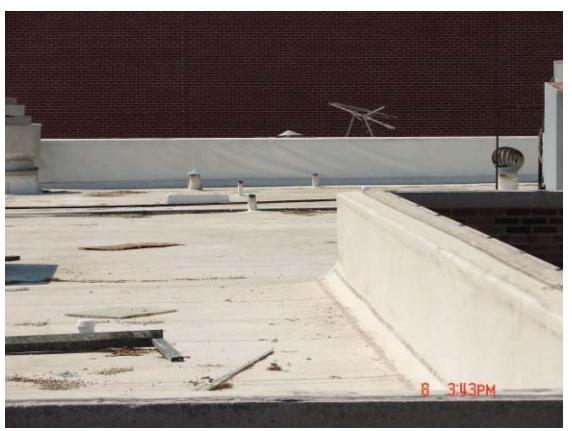
2.06(b)-2. St. Stanislaus. The debris shown here may have caused punctures to the roofing membrane.

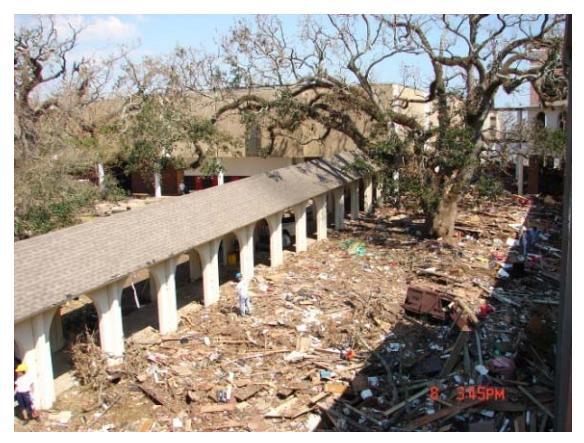
2.06(b)-4. St. Stanislaus. In the courtyard is storm debris, in contrast to an undamaged asphalt shingle roof over the relatively protected corridor.

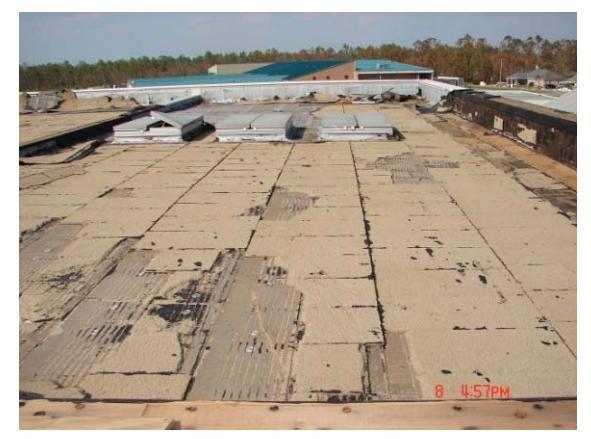
NOTED DAMAGE—The entire roof was damaged. In most areas, membrane and some insulation were blown completely off the roof. Coping was missing on entire upwind corner and one side.

DAMAGE INITIATION AND PROPAGATION—Garage door behind stage in auditorium was blown in, which pressurized the roof from the building interior. A drain directly above this area lifted and broke bonds in the system. The roof system failed primarily in the top perlite insulation layer as the weakest point. Fasteners were mostly intact, although the coping was blown off; it is unlikely that the latter initiated the roof damage.

2.07-1. MaGee Auditorium. The membrane has blown off the insulation layer in this area.

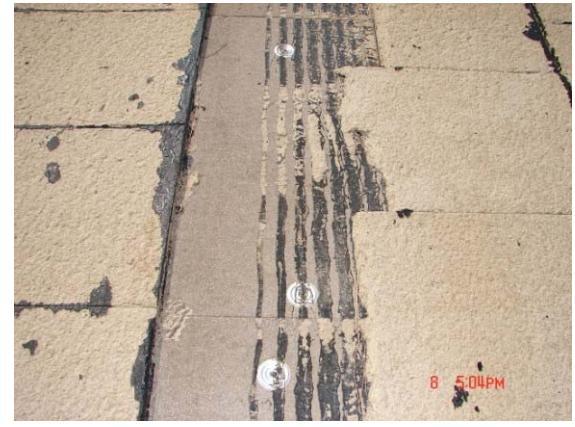
2.07-2. MaGee Auditorium. The bottom layer of perlite was screwed down; the top layer was stripmopped with asphalt. Excessive uplift force probably caused adhesive failure of the asphalt.

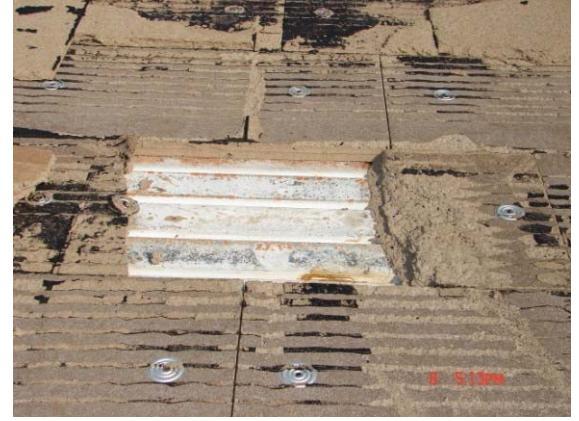
2.07-4. MaGee Auditorium. Only perlite insulation and decking remain on this roof; i.e., no membrane.

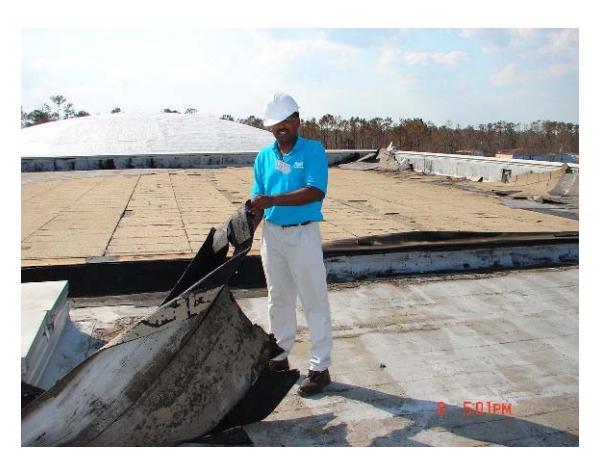
2.07-5. MaGee Auditorium. Some membrane remained on this roof. A polyurethane foam dome in background had no apparent damage.

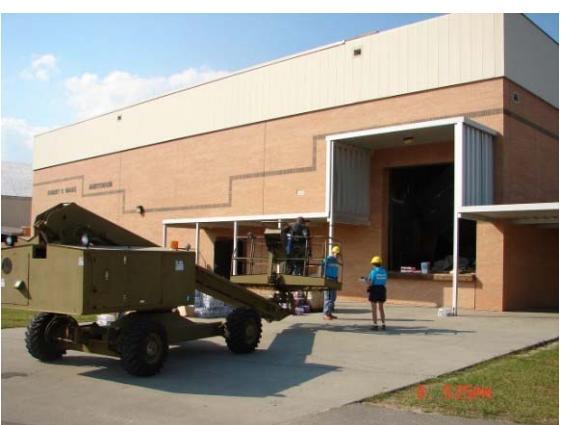
2.07-6. **MaGee Auditorium.** This garage door was blown in.

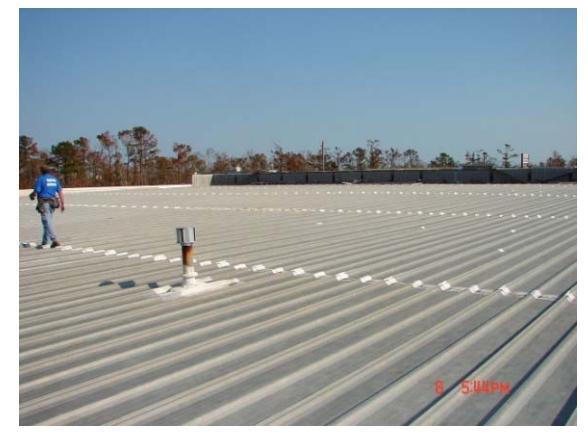
2.08-1. Winn Dixie Strip Mall. This is a wide-angle view of the main roof.

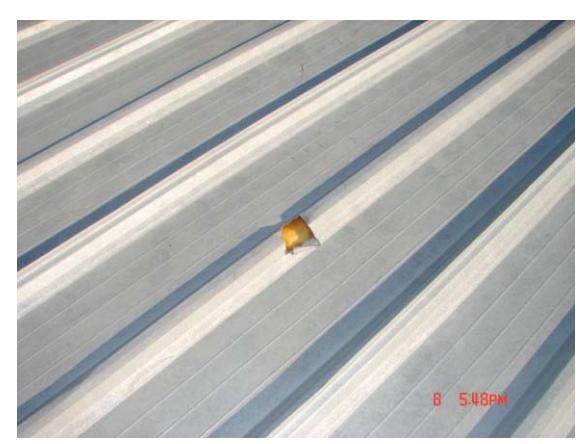
DAMAGE INITIATION AND PROPAGATION—Punctures through steel were caused by sharp debris. The section that blew off was pressurized when the glass wall failed, likely as a result of airborne debris. The metal clips were unable to withstand this additional load.

2.08-2. Winn Dixie Strip Mall. A torn metal rib can be seen.
