Hurricane Katrina Wind Investigation Report

HURRICANE KATRINA INVESTIGATION REPORT

August 2007

Roofing Industry Committee on Weather Issues, Inc. Powder Springs, Georgia

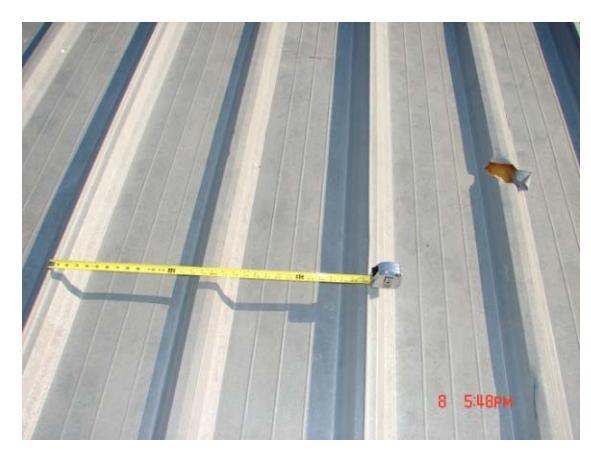
2.08-3. Winn Dixie Strip Mall. A tape measure shows rib spacing.

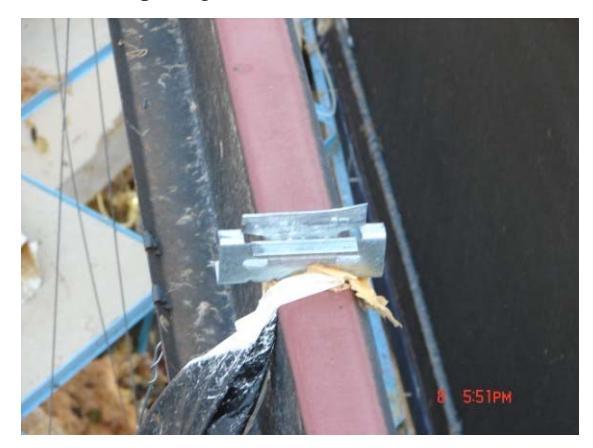
2.08-5. Winn Dixie Strip Mall. A clip is still attached to the purlin in this photo.

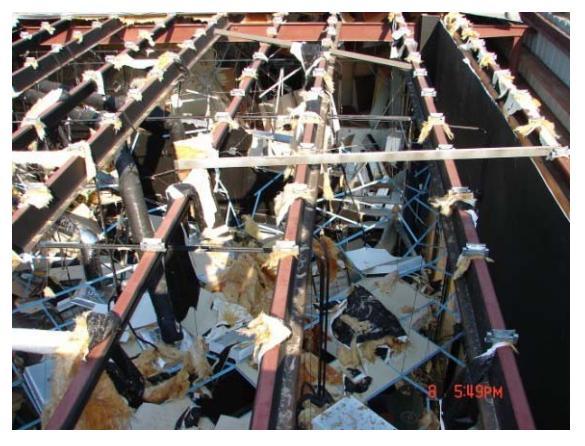
2.08-4. Winn Dixie Strip Mall. This is what a complete blowoff looks like in this corner area.

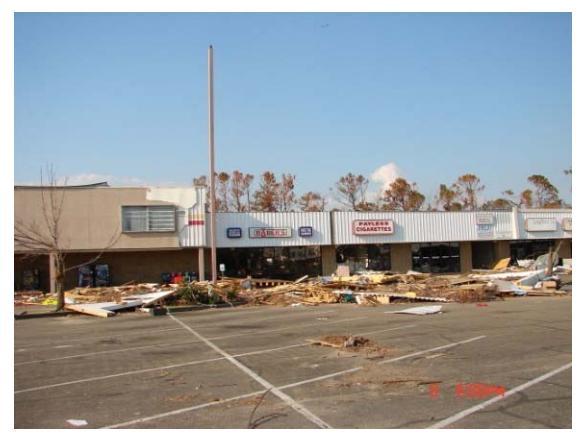
2.08-6. Winn Dixie Strip Mall. This is a corner area where the roof blew off.

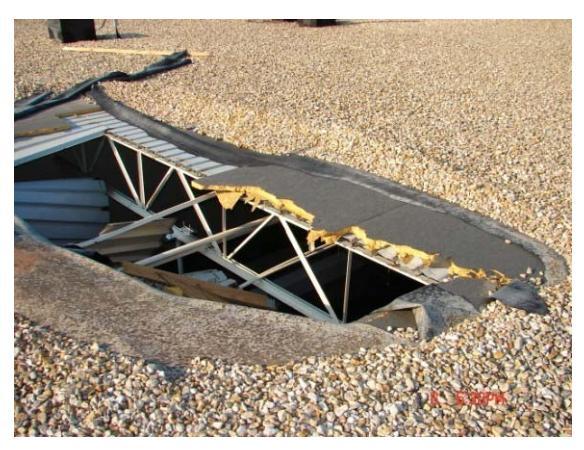
2.09-2. Sav-A-Center. The large hole was apparently caused by part of a mansard that traveled about100 ft.

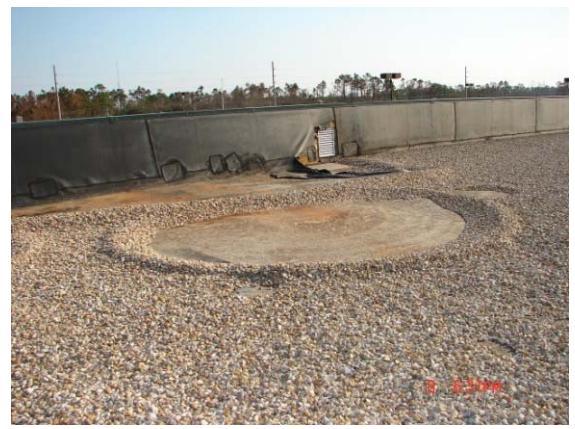
2.09-3. Sav-A-Center. The unusual scour pattern is likely from a vertical vortex (small tornado or unusual wind pattern due to the high parapet). The brown spots appear to be due to sun exposure prior to Katrina. Figure 2.09-5 also supports the vertical vortex theory.

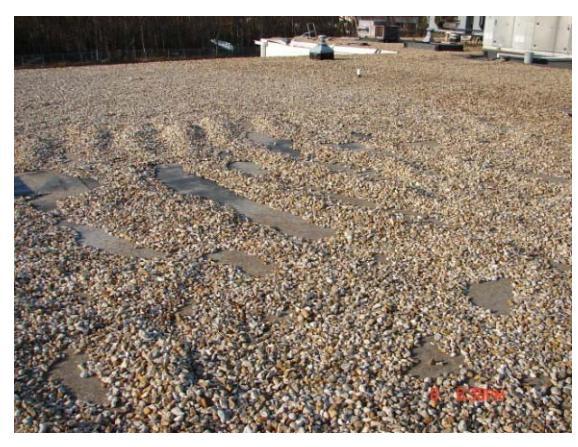
2.09-5. **Sav-A-Center.** Here is another unusual scour pattern. This pattern suggests a vertical vortex.

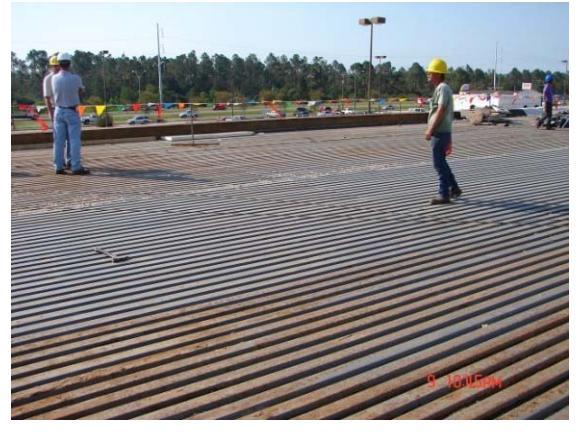
2.10-1. Manufacturing facility. This is an area where the membrane has been removed.

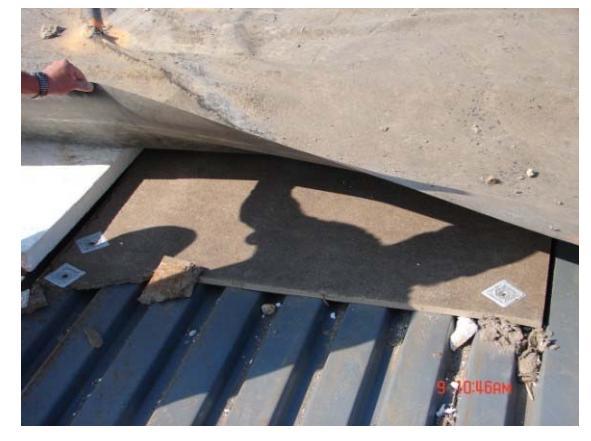
2.10-2. Manufacturing facility. An underlying tapered insulation system is visible here.

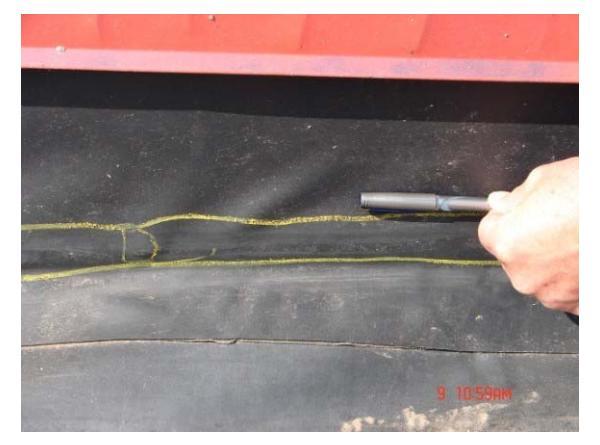
DAMAGE INITIATION AND PROPAGATION—Wind scour of ballast and air entering through parapet wall ballooned membrane, leading to blowoff and other damage.

2.10-3. **Manufacturing facility.** Perimeter securement high on this wall allowed air pressurization at the wall/roof interface.

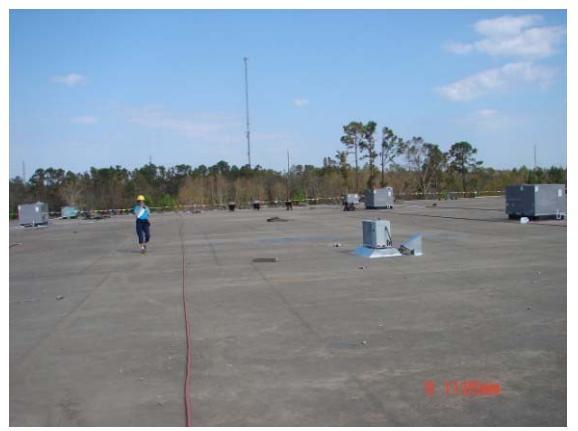
2.10-4. **Manufacturing facility.** This is a large area of undamaged roof.

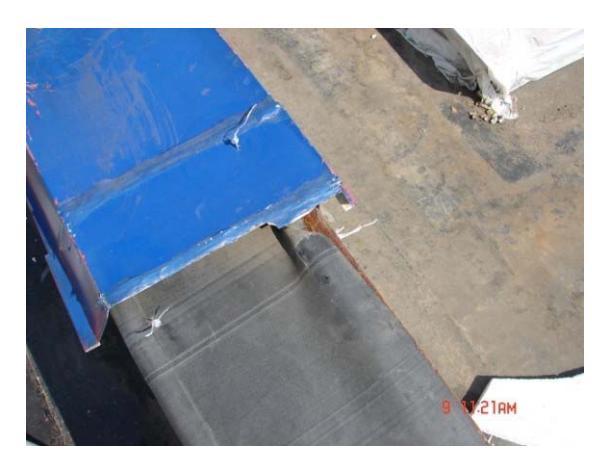
2.10-5. **Manufacturing facility.** Coping was displaced from this parapet.

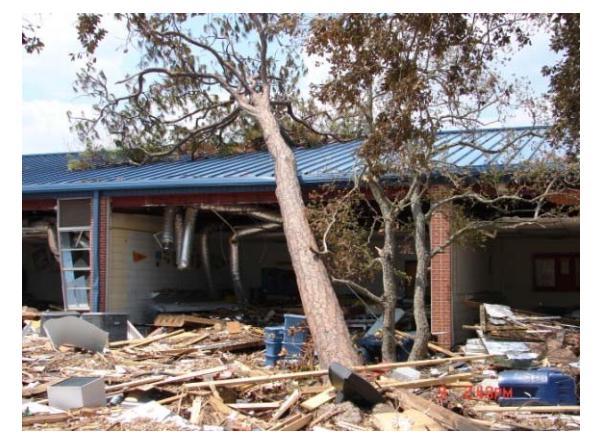
2.11-3. H. McCoughan Elementary. Trees were damaged by both high winds and storm surge.

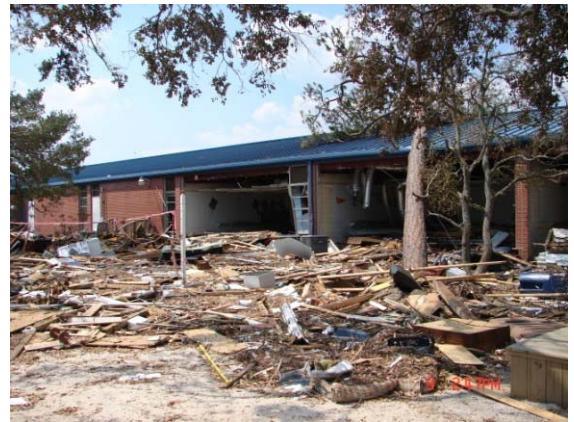
2.11-2 H. McCoughan Elementary. Storm surge debris covered the grounds around this building.

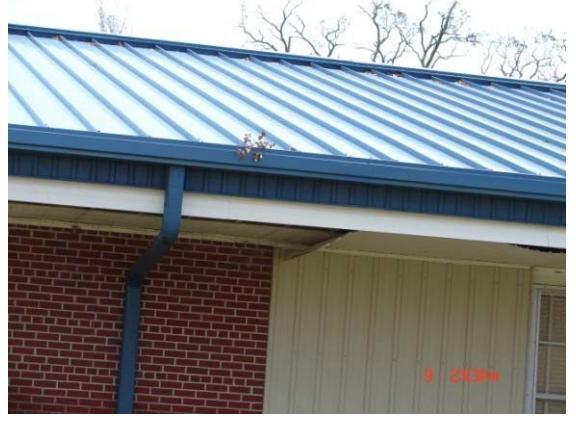
2.11-4. **H. McCoughan Elementary.** This was a typical roof condition at this site.

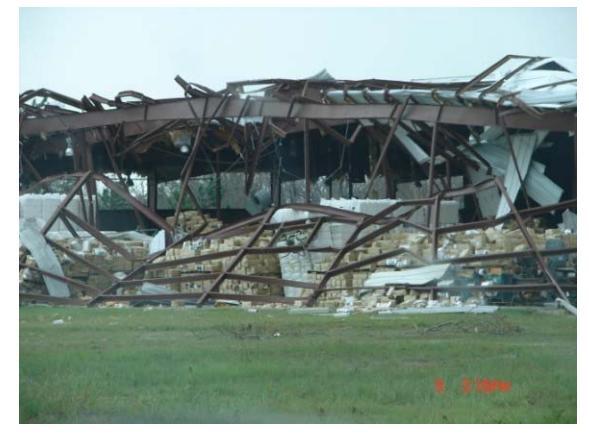
DAMAGE INITIATION AND PROPAGATION—Apparent wall failure led to building pressurization and final destruction.

2.12-1. Commercial Exchange. This photo shows the total collapse of a storage building.

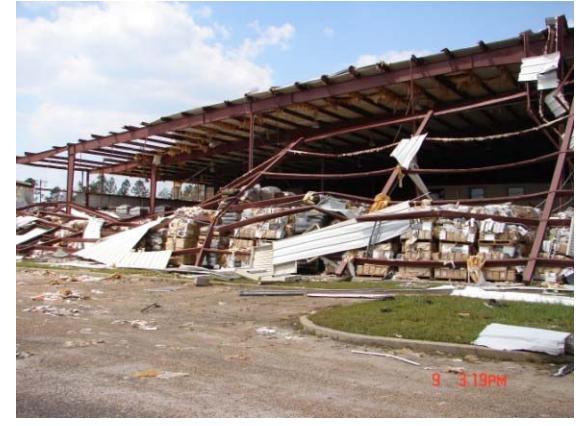
2.12-2. Commercial Exchange. Missing roof and wall sections are conspicuous here.

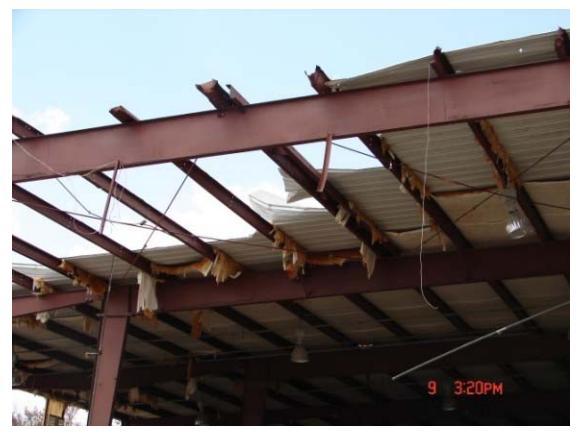
2.12-3. Commercial Exchange. Structural damage is visible in this photo.

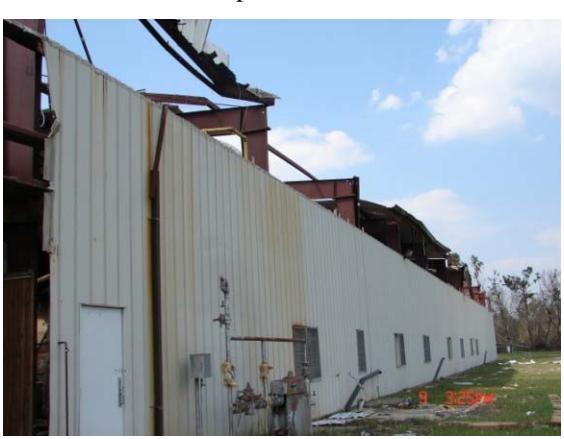
2.12-4. **Commercial Exchange.** Portions of the sidewall and roof are missing from this building.

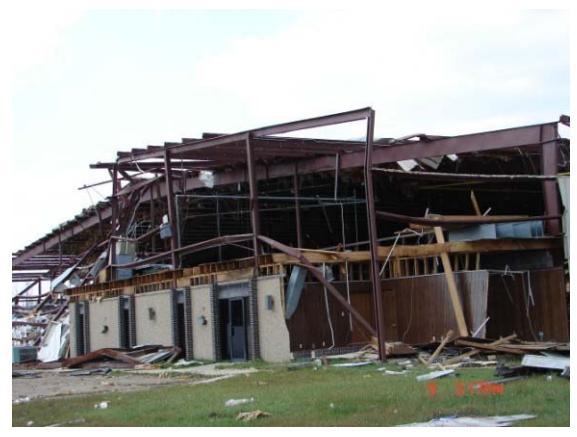
2.12-6. Commercial Exchange. Only the doors remain in place on this building.

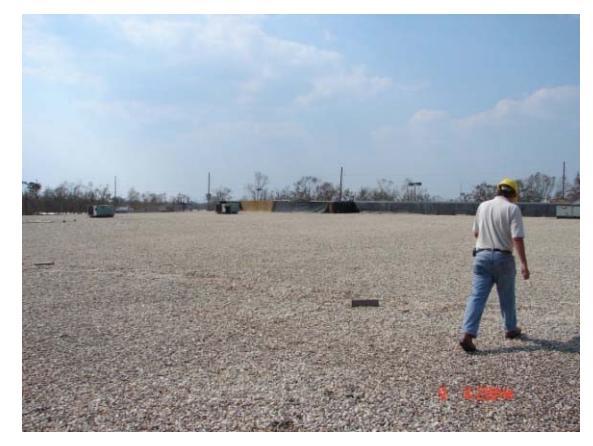
2.13-1. Sav-A-Center. This photo is typical of the roof areas at this site.

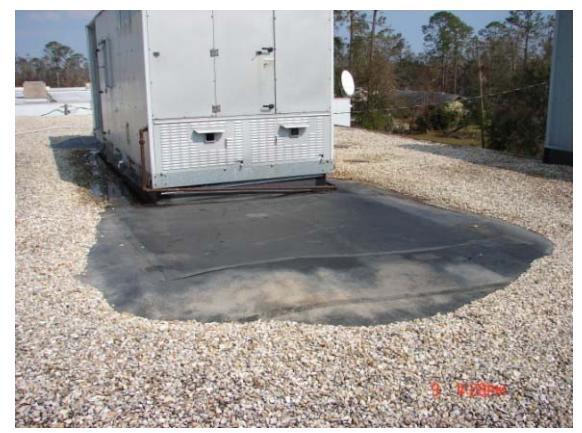
2.13-2. Sav-A-Center. This scour pattern was typical of what was found here. Wind blowing from the far side united to displace gravel on the near side.

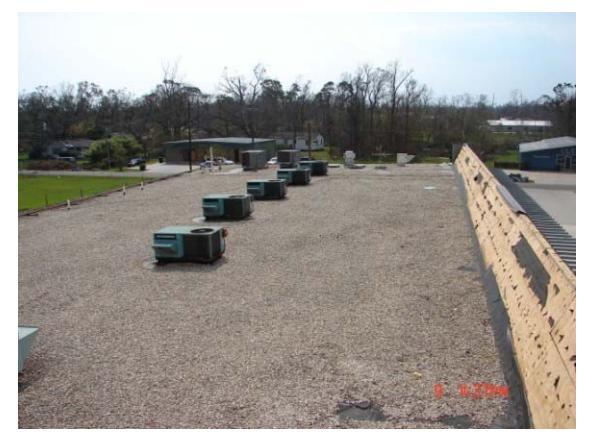
2.13-5. Sav-A-Center. More damaged wall flashing was noted here, although the membrane was intact.

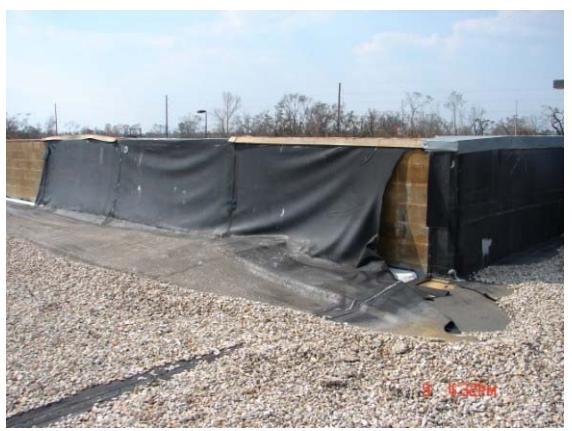
DAMAGE INITIATION AND PROPAGATION—Air gaps at the roof perimeter pressurized a space under the membrane. This led to detachment of wall flashing from the parapet in several areas, primarily in the downwind parapet/façade area.

2.13-4. Sav-A-Center. Damaged wall flashing and coping are visible here.

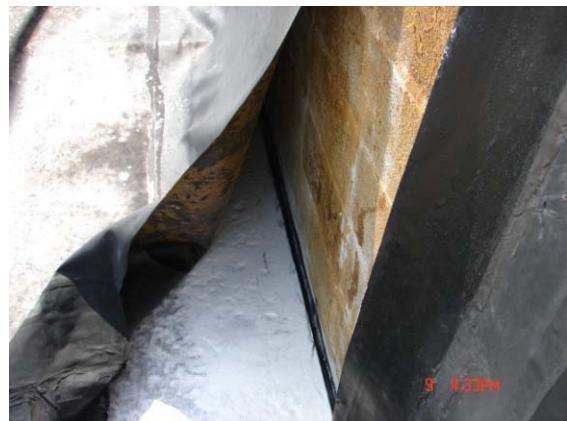
2.13-6. Sav-A-Center. The air gap at this wall can result in internal pressure blowing off the roof.

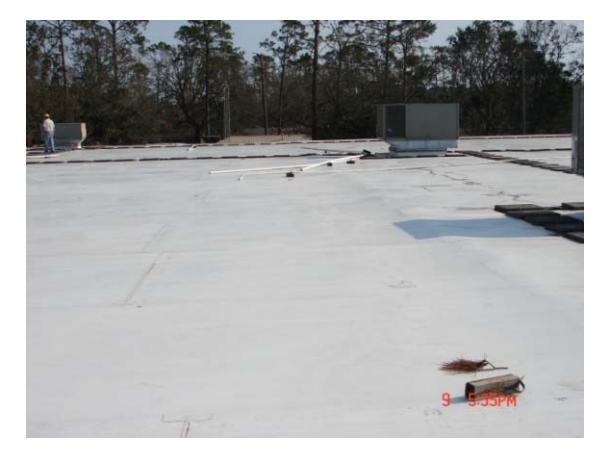
2.14-1 K-Mart. This roof exhibited no apparent damage.

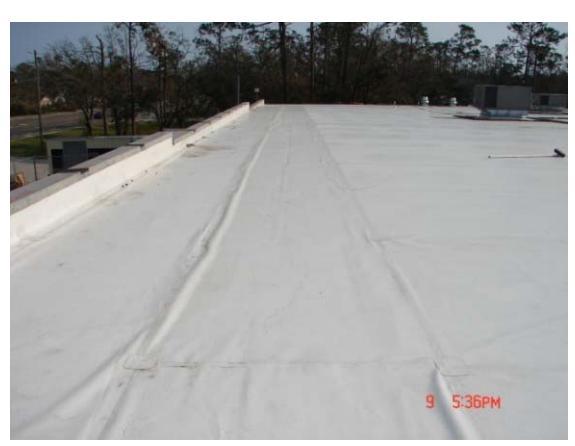
2.14-2. K-Mart. Slight wrinkling was found here.

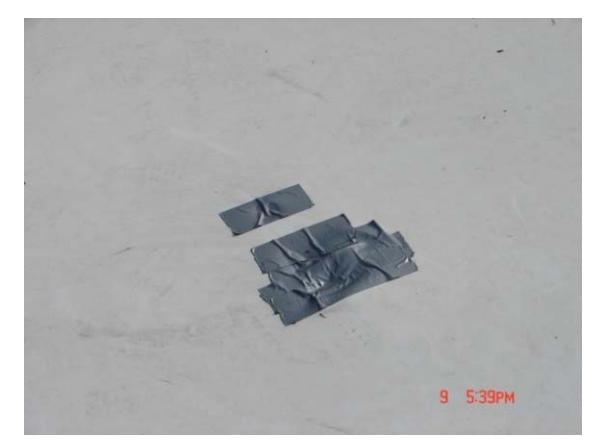
2.14-5. K-Mart. This is a temporarily patched puncture.

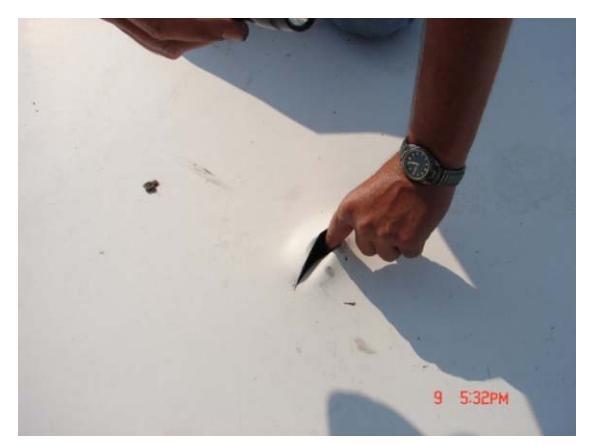
DAMAGE INITIATION AND PROPAGATION—Debris hitting roof

2.14-4. K-Mart. This photo shows a punctured single ply membrane.

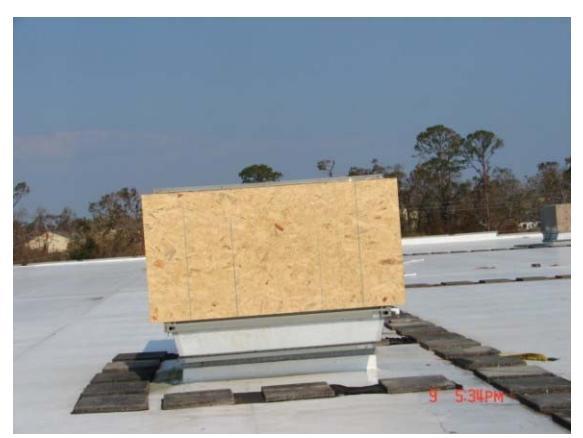
2.14-6. K-Mart. Plywood protects this HVAC unit encircled by pavers that were still in place.

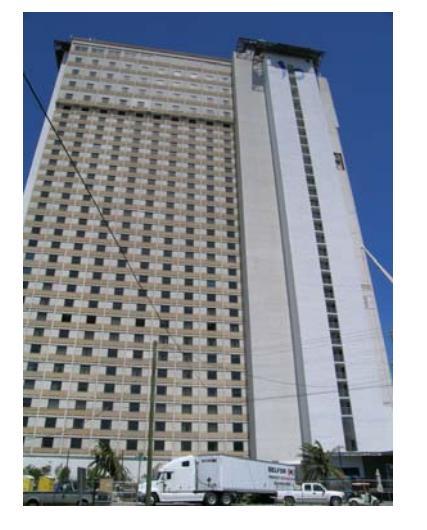
NOTED DAMAGE—Over 50% of the roof surface was completely stripped off the roof assembly with only plates, screws, and concrete deck remaining. Sheet metal exhaust units were also displaced by winds.

DAMAGE INITIATION AND PROPAGATION—Inadequate fastener quantity and improper fastening methods caused facer delamination, which resulted in total loss of roof assembly over much of the roof surface.

4.01-1. Imperial Palace Hotel Building 1. Southern exposure. Note the penthouse and the missing wall panels in the upper right.

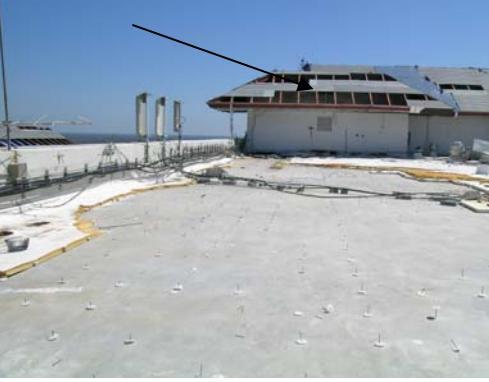
DAMAGE INITIATION AND PROPOGATION—Corroded puddle welds and weld burn-through appear to have led to failure of the connection of steel decking to purlin. Metal panels were blown off as their structural supports were compromised by wind uplift forces. As steel decking lost its attachment to purlins, the entire roof assembly blew off.

4.03-2. Imperial Palace Hotel Building 3. Damage on main roof and small building atop main roof.

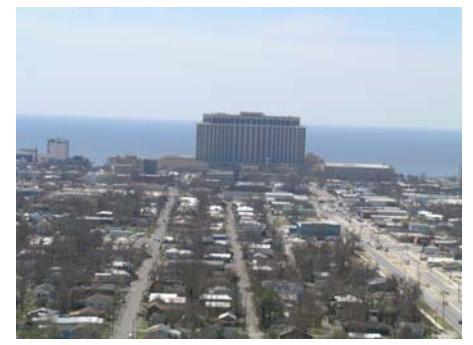
NOTED DAMAGE—Approximately 5% of the roofing membrane was damaged (torn), and 30% of the perimeter wood blocking (edge nailer) was detached. An expansion joint was exposed as a result of the cover's becoming detached. Lightweight concrete plates were detached from the lightweight concrete. Exhaust equipment was ripped out of place and lay dislodged on the roof.

DAMAGE INITIATION AND PROPAGATION—Exhaust equipment apparently was blown the length of the roof, damaging the membrane as it dragged along the rooftop.

4.04-1. Beau Rivage Hotel. Overview.

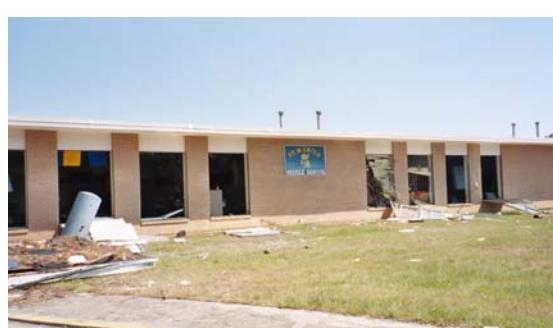
DAMAGE INITIATION AND PROPAGATION—The building was internally pressurized because the windows had blown in. This resulted in failure of the base sheet, membrane, and deck panels to remain attached to the structure. Wind pressure forced H-clips to pull free of the bar joints. Close inspection confirmed that remaining H-clips were not secure and were easily removed from the bar joint. Base sheet fasteners were inadequate to hold the base sheet in place.

4.05-1. Saint Martin Middle School. Windows blown inward at south elevation caused interior to be pressurized.

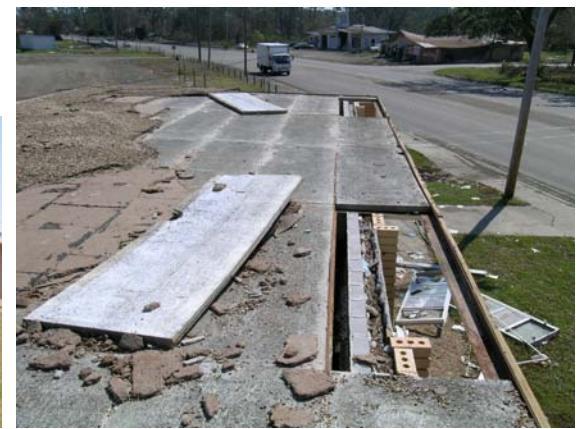
4.05-2. Saint Martin Middle School. Roof blew off along southern exposure toward the Gulf. CWF deck panel was blown off with the sheet metal at the perimeter.

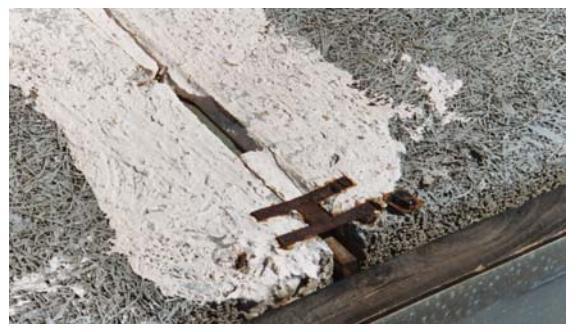
4.05-3. Saint Martin Middle School. Rusted "H" clip. Age, corrosion, and inadequate spacing, along with the internal pressurization, possibly caused the deck losses.

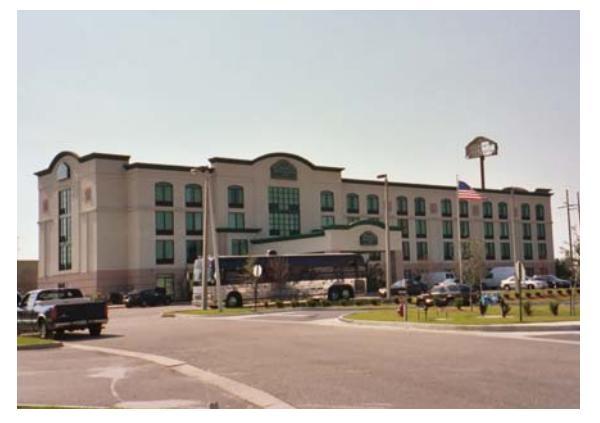
NOTED DAMAGE—Damage was limited to one corner and eave—approximately 3% of the roof area. There was no original metal flashing on the parapet.

DAMAGE INITIATION AND PROPAGATION—The membrane had been fully adhered at the parapet, but a witness said it lifted and billowed up, pulling loose from the corner and parapet. The exterior EIFS wall at rooftop and parapet was blown out from internal building pressurization. Blowout damage occurred at the southwest corner, beginning at the exterior wall and eave.

4.06-1. Wingate Hotel. North elevation.

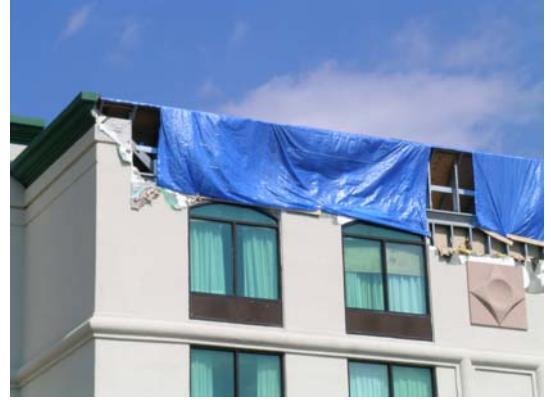
4.06-2. Wingate Hotel. Southern elevation parapet façade made of EFIS on metal studs failed from internal pressurization (inside the façade) from the roof side of the parapet.

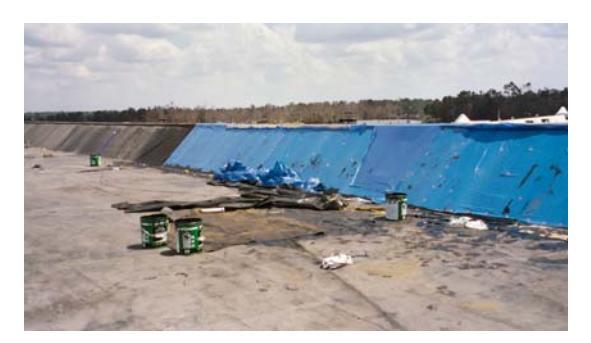
ADDITIONAL COMMENTS—Temporary repairs were done using an asphalt-based product that specifically states it should not be used on EPDM surfaces. Plastic tarpaulins were in use to temporarily cover and protect damaged spots. The parapet was 4 ft high.

4.06-3. Wingate Hotel. Temporary repairs.

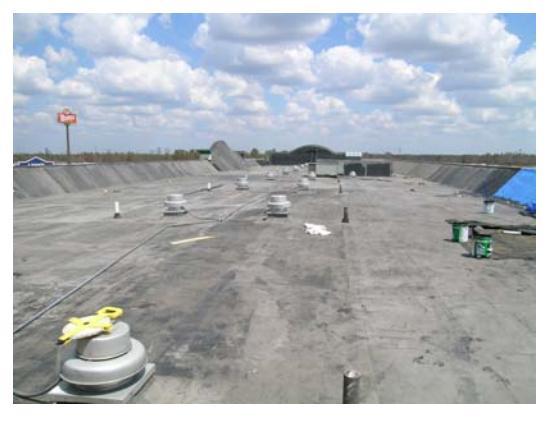
4.06-4. Wingate Hotel. Most of the roof had no damage.

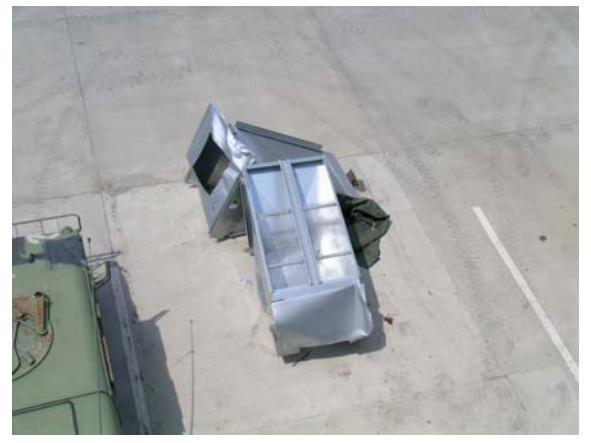
DAMAGE INITIATION AND PROPAGATION—Exhaust equipment in three areas blew off its supports and dragged across the roof, causing dents and scrapes. The exhaust unit housing was secured with only six screws, and they either tore through the sheet metal or sheared off. The exhaust equipment was found on the ground.

4.07-2. National Guard Airport. Large HVAC unit, curb, and duct blown off the roof.

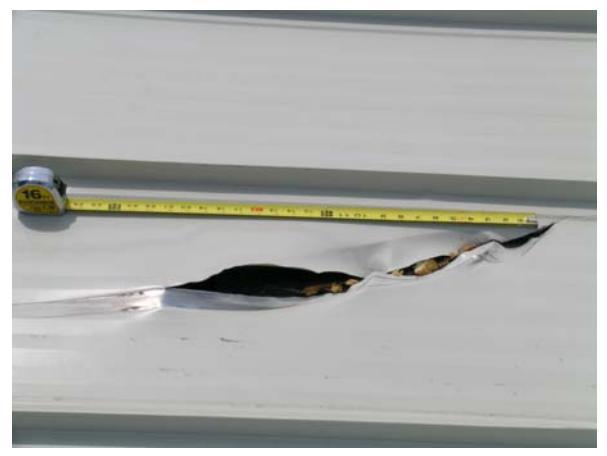
NOTED DAMAGE—One percent of the roof was damaged. Metal roof panels were damaged in two areas, and the underlying insulation was visible. Some edge details and gutters were detached and missing. Dents and scrapes were noted in several areas. Exhaust equipment was detached from its supports in three areas. Some building contents were damaged.

4.07-3. National Guard Airport. Large gash in the standing seam metal roof panel from the HVAC unit depicted in 4.07-2.

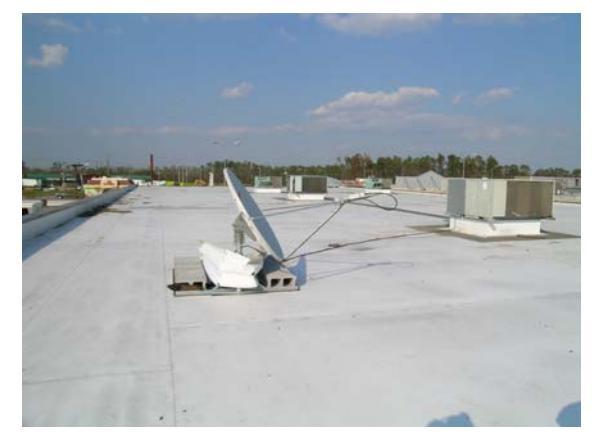
NOTED DAMAGE—Minor (1%) damage to membrane at eave edge. There was a 10 in. tear in the perimeter of the TPO membrane. The eave had minor damage, and some ponding was observed.

DAMAGE INITIATION AND PROPAGATION—Sheet metal was blown around on the roof and wedged into the satellite dish. The sheet metal cut the membrane as it was blown across the roof.

4.08-2. Burke's Outlet Building 1. Field of the roof shows small amount of sheet metal debris lodged in the satellite dish.

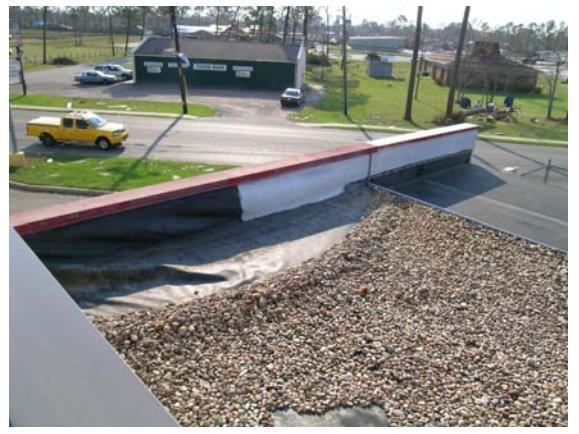
ADDITIONAL COMMENTS—This roof was the lowest one of the strip mall's connected roofs and stores. The membrane was entirely intact with little gravel remaining. However, the pea gravel was scoured in one corner. The system was 100% watertight.

4.09-2. Burke's Outlet Building 2. Wind scour in the southwest corner of the building.

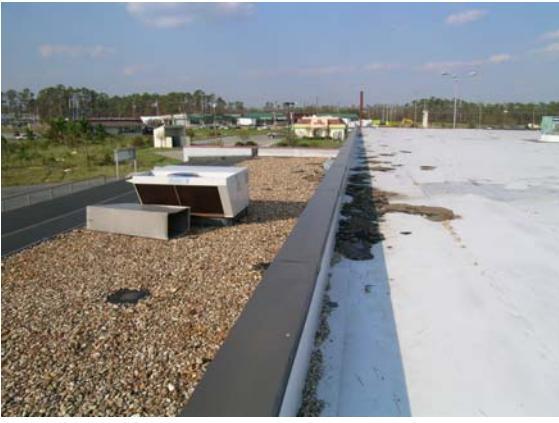
4.09-3. Burke's Outlet Building 2. Debris from the adjacent roof.

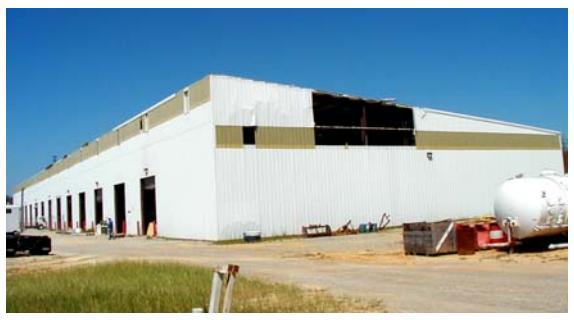
DAMAGE INITIATION AND PROPAGATION—It appeared that damage to the overhead rolling doors occurred initially. Next, an upper section of the east wall and some wall light-transmitting panels (LTPs) blew out (photo 5.01-1). This likely prevented roof blowoff despite internal pressurization because pressure was significantly reduced when the wall and LTPs blew out.

5.01-1. Keith Huber, Inc. This photo shows the southeast corner, which was in the face of the approaching wind.

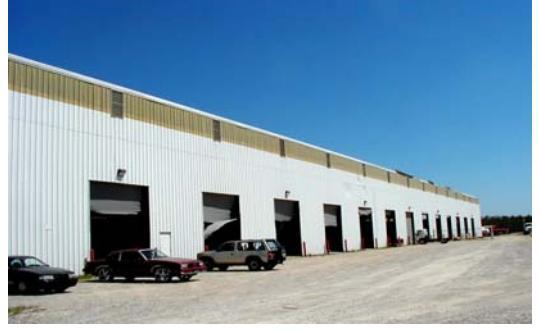
NOTED DAMAGE—All 14 overhead rolling doors (14×16 ft) blew in on the south wall of the building. (photo 5.01-2) Edge flashing was damaged in several locations (photo 5.01-3). Flashing fastener spacing was 3 ft o.c.

5.01-2. Keith Huber, Inc. All 14 of these overhead rolling doors on the south wall blew in.

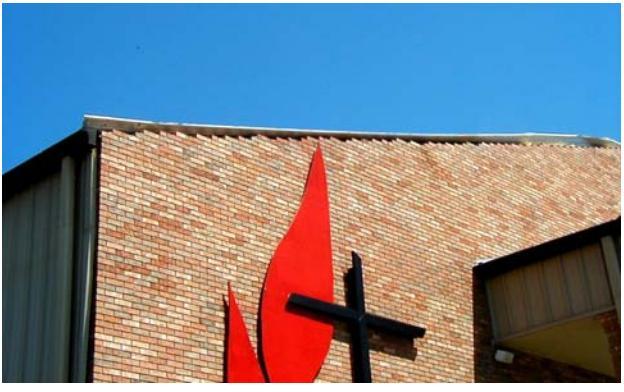
NOTED DAMAGE—The only observed roofing damage was to the rake flashing at the interface with the brick veneer front (photo 5.02-3).

DAMAGE INITIATION AND PROPAGATION—There did not appear to be any attachment of the rake flashing to the brick veneer. Consequently, the flashing detached because of the high winds.

5.02-3. Gateway United Methodist Church. Rake flashing damage is visible at the brick veneer front.

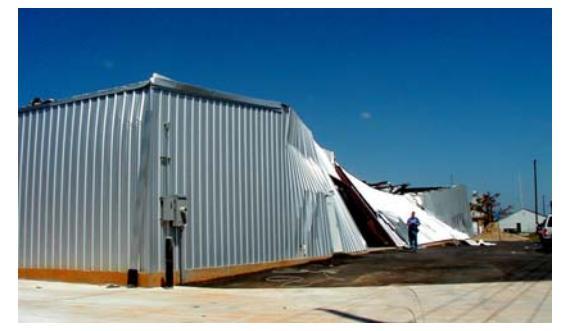
NOTED DAMAGE—The end bay roof structure was lifted up and folded back onto the roof. The end wall then blew into the building. The end wall that was damaged was facing east. The rest of the building had no damage. The building was well constructed except for the connection of purlins to end wall rafters.

5.04-1. Warehouse on Creosote Rd. Front (south) wall that failed inward.

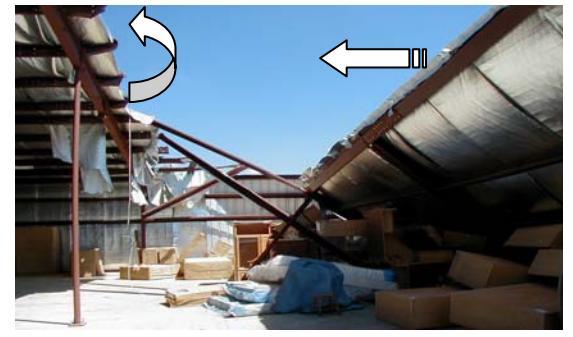
5.04-2. Warehouse on Creosote Rd. This front wall collapsed inward, then the roof purlins rolled back over the next frame.

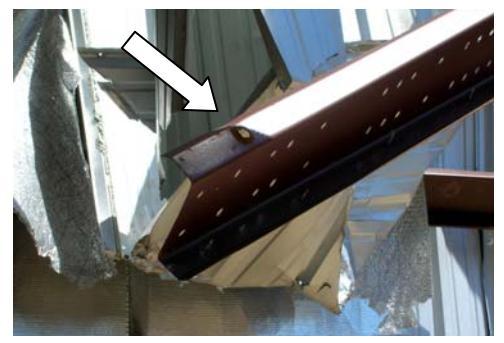
DAMAGE INITIATION AND PROPAGATION—The end bay roof structure was lifted up by the storm and then folded back onto the roof. The torch-cut holes in purlins were too large for the bolt heads. Some of the torch-cut holes showed no sign of deformation due to pulling over the bolt heads, indicating that the hole size was too large and washers were not used. Bolts were still attached to the end wall rafter.

ADDITIONAL COMMENTS—Incompatible components (possibly from more than one source) may have been the underlying cause of this sequence of damage.

5.04-3. Warehouse on Creosote Rd. A torchcut hole in this purlin is where failure occurred at an end wall connection.

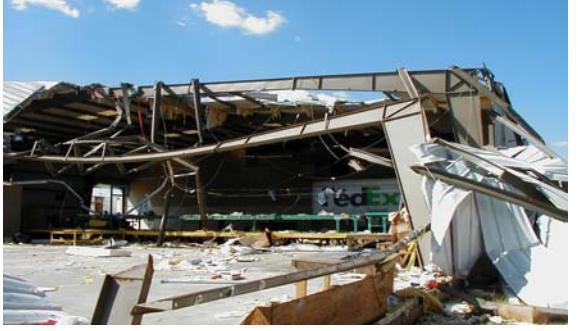
NOTED DAMAGE—Building 1 had two damaged end bays. Roof sheets were missing in the end bay and in one-half of the next bay. Building 2 had some wall sheets blown off the building at the south end and the southeast corner.

DAMAGE INITIATION AND PROPAGATION—It was difficult to determine how the damage initiated in Building 1. It is possible that the strut purlins in the end bay failed from combined axial and bending loads.

5.05-1. FedEx Warehouse. Building 1 with severe damage to the end wall.

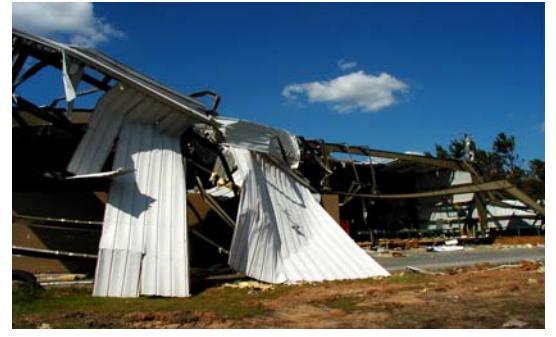
5.05-2. FedEx Warehouse. Another view of wall damage.

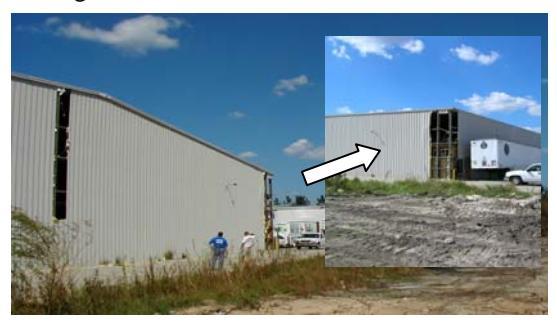
5.05-4. FedEx Warehouse. Building 2 with minor end wall and corner wall damage.

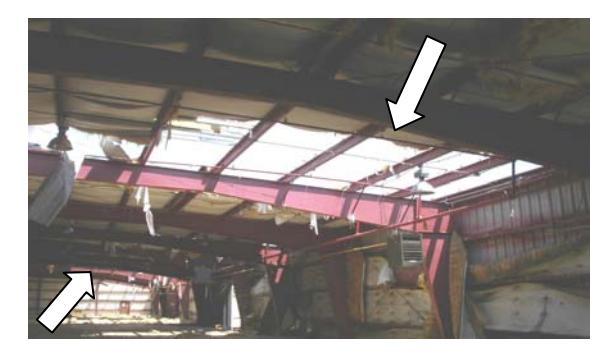
5.06(a)-1. Keesler Warehouse Bldg. 4422. This view from below shows two areas of missing roof at the corner (left) and middle of the building.

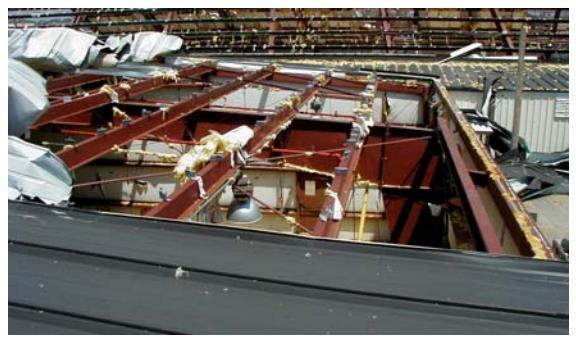
NOTED DAMAGE—The roof at the southeast corner peeled back about halfway to the peak. This damage appears to be due to failure of the eave detail.

DAMAGE INITIATION AND PROPAGATION—Roll-up overhead doors on the south side of the building blew in, causing internal pressurization that likely initialized peeling back of roof panels.

5.06(a)-2. Keesler Warehouse Bldg. 4422. The windward corner of the building is shown with the standing seam roof peeled back.

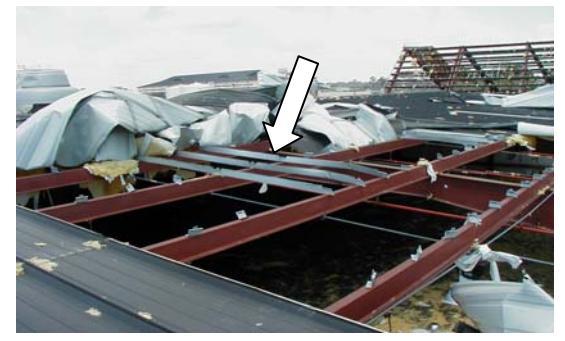
5.06(a)-3. Keesler Warehouse Bldg. 4422. This blowoff included some unusual metal panel failure along the rib. The arrow indicates where the vertical leg of the rib is still attached after the rest of the panel was torn off.

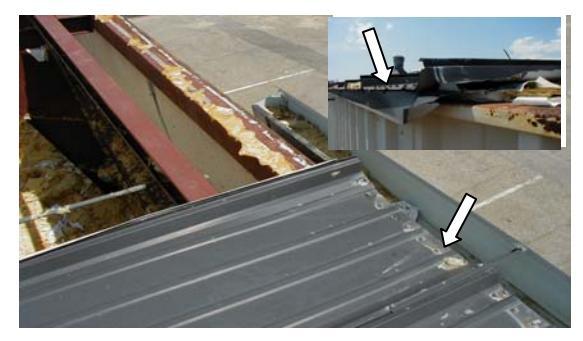
5.06(a)-4. Keesler Warehouse Bldg. 4422. These two views of poor eave detailing show that fasteners did not penetrate the eave strut.

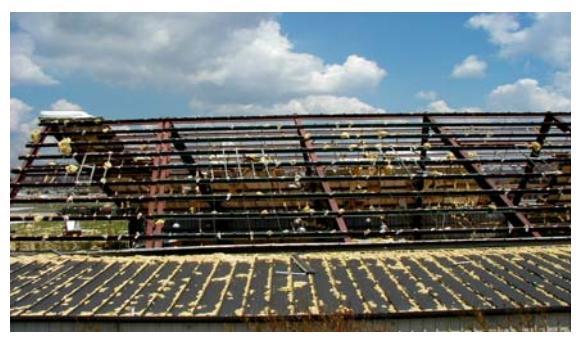
NOTED DAMAGE—Most roof panels were missing and the building was leaning toward the north end wall. The north end wall had detached from the rest of the building and was on the ground.

DAMAGE INITIATION AND PROPAGATION—Connection of the end wall column to the roof system was through one 3 in. long fillet weld, which was of poor quality. This is likely the reason the end wall detached from the building.

5.06(b)-1. Keesler Maintenance Bldg. 4423. This standing seam roof was totally blown away. This older building suffered severe damage.

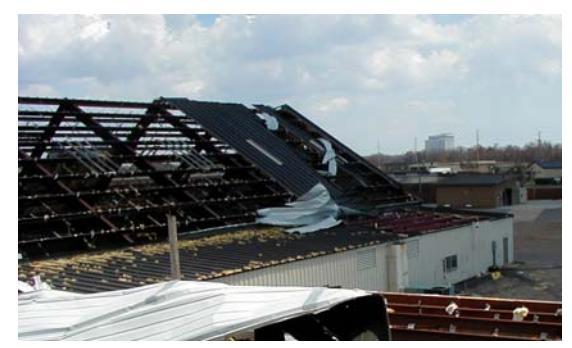
5.06(b)-2. Keesler Maintenance Bldg. 4423. Another view of standing seam roof failure on an older building.

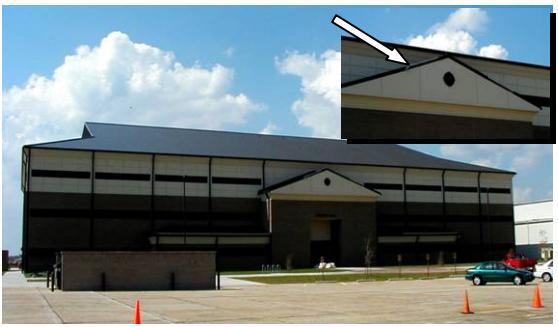
5.06(c)-2. Keesler Thomson Hall (Bldg. 4213). The only damage noted was to the trim on this roof (see inset).

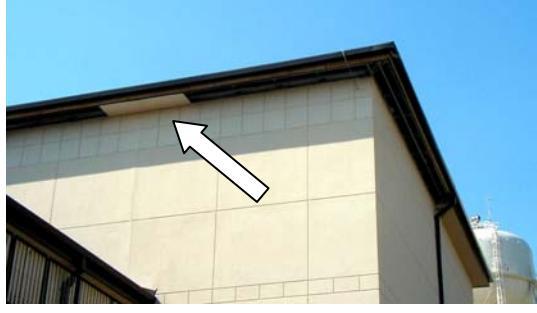
5.06(d)-3. Lott Hall. Soffit damage can be seen.

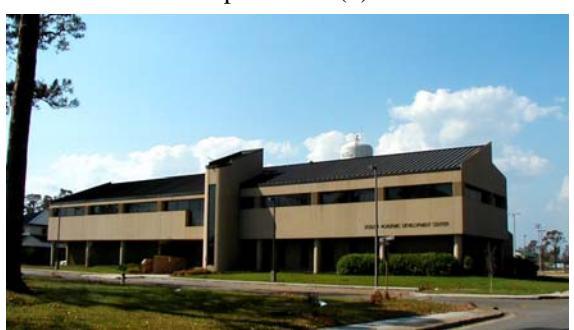
5.06(d)-4. Vosler Hall. The only damage noted on this architectural standing seam roof was to the trim, as shown in photo 5.06(d)-5.

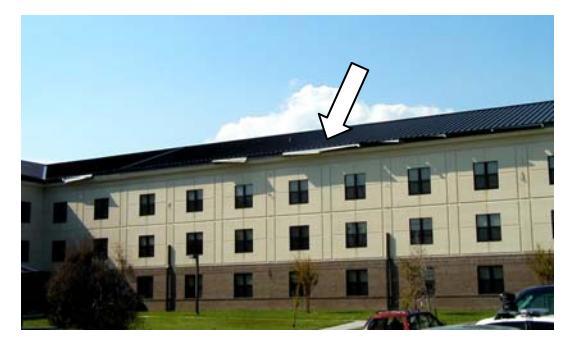
5.06(e)-2. Student Dormitory. Gutter damage is visible (at arrow).

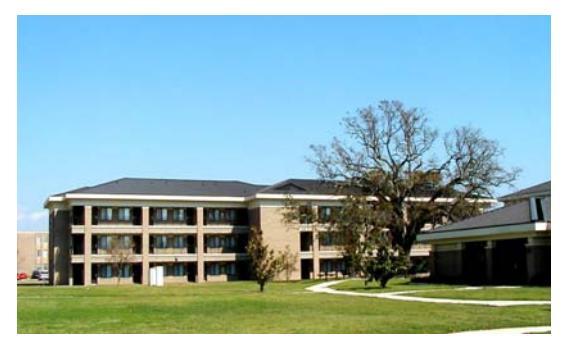
5.06(f)-2. Keesler Building 2505. No roof damage was observed on this architectural standing seam roof.

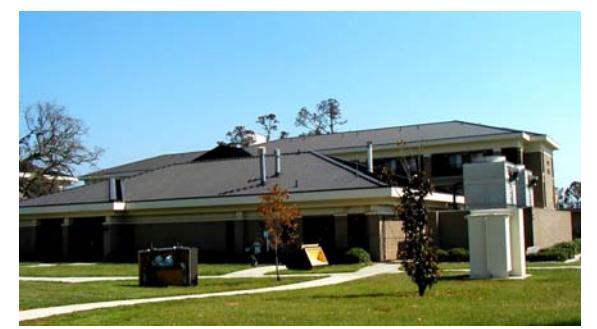
5.06(f)-3. Keesler buildings near 2505. No roof damage was observed on these architectural standing seam roofs.

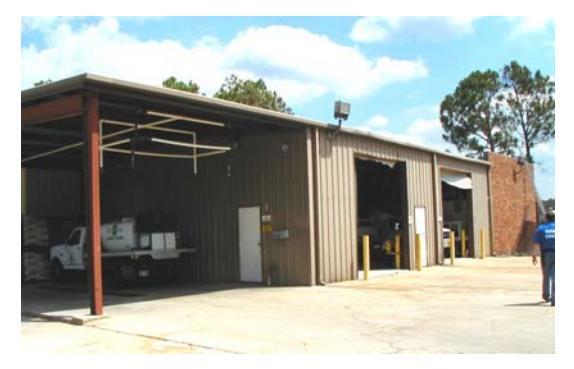
These buildings ranged in age from 2 to 12 years, with an average age of 6 years. Overall, the roofs performed very well, and only one had serious damage (Superior Optical). Of the 17 metal buildings inspected, 8 lost at least one overhead door, resulting in internal pressurization of the buildings. Only two of these eight buildings, however, suffered roof damage that seemed related to the internal pressurization. It is interesting that these two were both standing seam roofs. The six buildings that experienced internal pressurization (due to loss of overhead doors) but did not experience roof problems were all through-fastened roof systems.

5.07-1. Sunplex Industrial Park. The overhead doors at this Liqui-Chem building failed as a result of high winds.

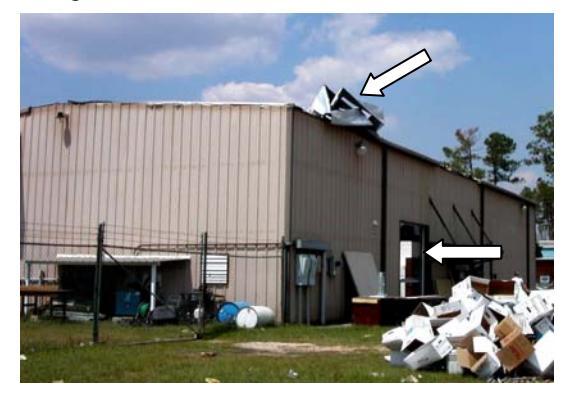
5.07-3. Sunplex Industrial Park. Superior Optical experienced substantial standing seam roof blowoff (upper arrow). The lower arrow shows a failed overhead door.

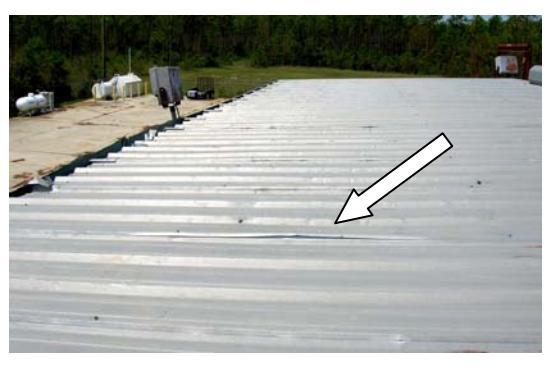
5.07-2. Sunplex Industrial Park. On this Liqui-Chem building, several standing seams blew open as a result of high internal pressure.

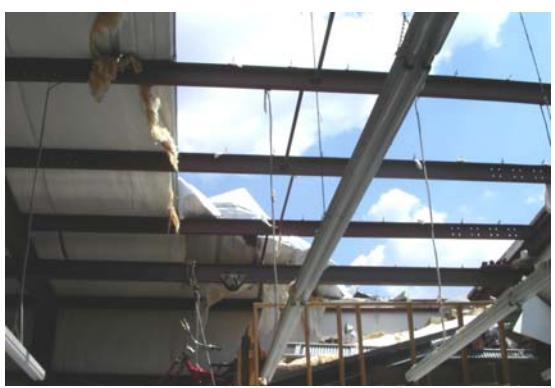
5.07-4. Sunplex Industrial Park. This photo shows a standing seam roof failure at Superior Optical. Clips remain attached to purlins.

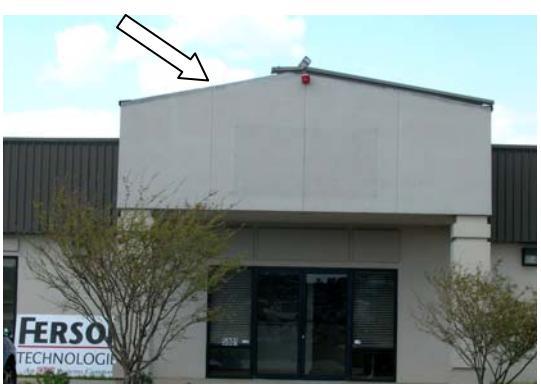
5.07-5. Sunplex Industrial Park. At the Ferson Building, failed flashings can be seen.

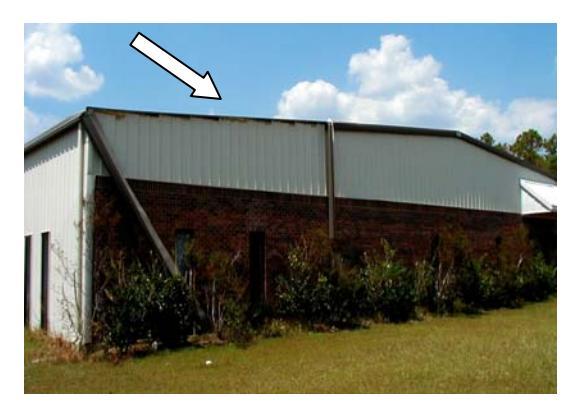
5.07-6. Sunplex Industrial Park. The RTS Building gutter and flashing failure occurred at the front of the building.

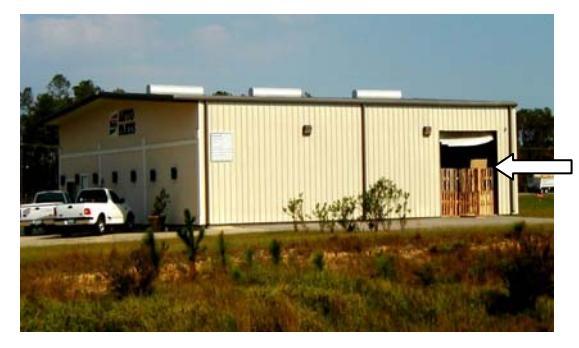
Conclusion: It appears that through-fastened roofs may be more resistant to the sudden pressurization of a building than are standing seam roofs.

5.07-7. Sunplex Industrial Park. Mighty Auto Parts had a failed overhead door, but the through-fastened roof survived intact.

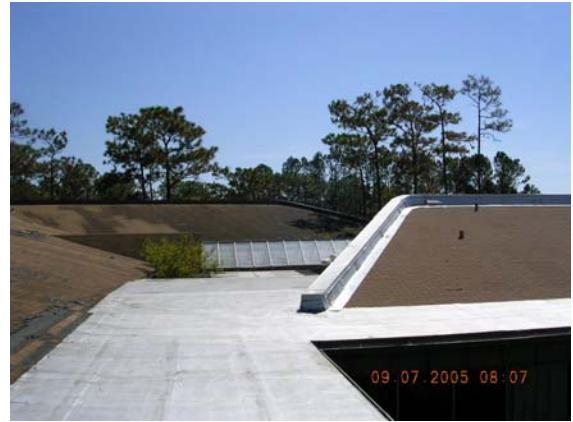
3.01-2. Gautier Library. This is the newer, undamaged library roof next to the older (damaged) roof.

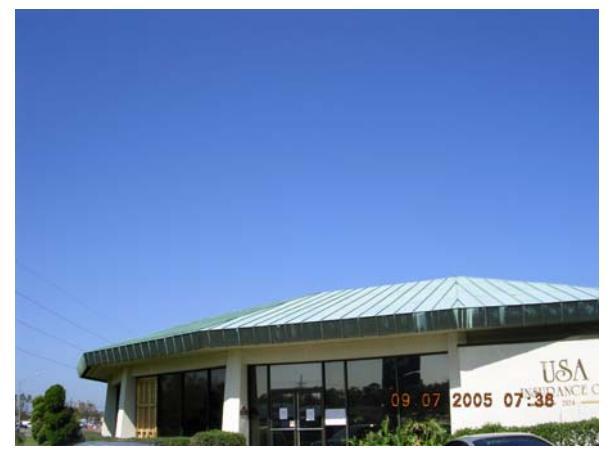
TYPE OF STRUCTURE—Commercial EXPOSURE—C SITE COORDINATES—N30° 39'15" W88° 64' 24" WALL CONSTRUCTION—Stucco finish ROOF TYPE—Copper raised seam over wood trusses spaced 2 ft o.c. SLOPE—4–6 : 12 DECK—Plywood WIND SPEED—110–120 mph BUILDING CONSTRUCTION—Wood rafters METHOD OF ATTACHMENT—Unknown NOTED DAMAGE—None

ADDITIONAL COMMENTS—Building is located in proximity to other roofs that sustained damage.

3.02-1. USA Insurance Building. An undamaged raised-seam copper roof. Neighboring roofs did sustain damage.

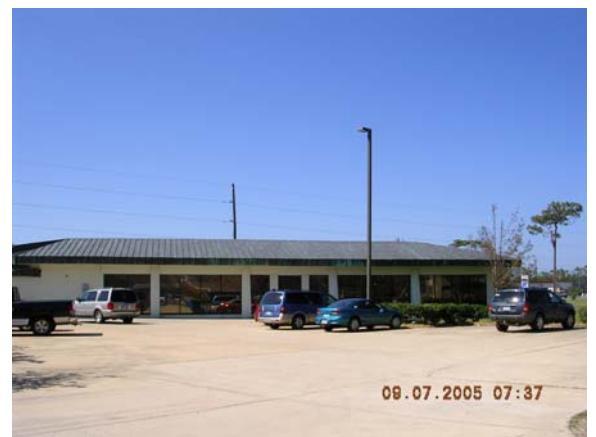
3.02-2. USA Insurance Building. This is another view of the undamaged copper roof.

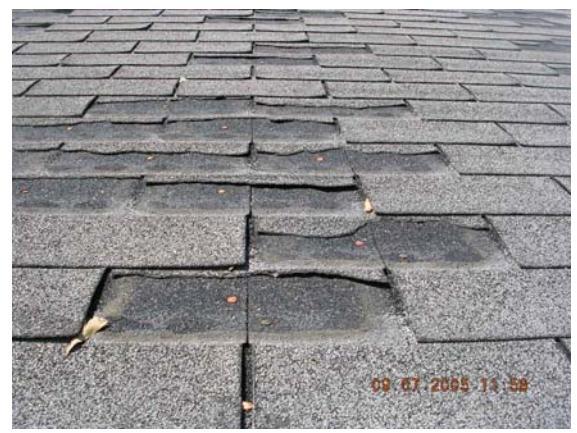
NOTED DAMAGE—Shingles torn off in vertical patterns

DAMAGE INITIATION AND PROPAGATION—Shingles fastened with three nails were loose at one end and tore off.

3.03-2. Living Waters Church. A closer view of torn shingles shows missing nails in alternating courses.

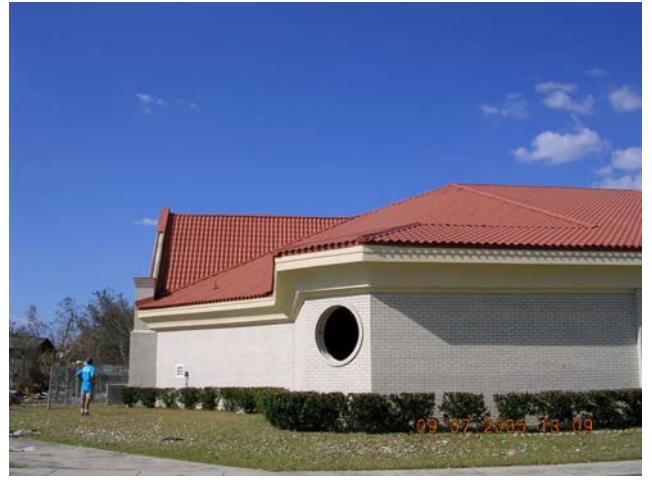
NOTED DAMAGE—A metal coping flashing piece was lost on an otherwise undamaged roof.

DAMAGE INITIATION AND PROPAGATION—A flashing piece was lost as a result of an attachment issue.

3.04-1. Church of the Vietnamese Martyrs. A steel "simulated tile" roof was installed on this church. Damage was limited to a missing coping flashing.
