Hurricane Katrina Wind Investigation Report

HURRICANE KATRINA INVESTIGATION REPORT

August 2007

Roofing Industry Committee on Weather Issues, Inc. Powder Springs, Georgia

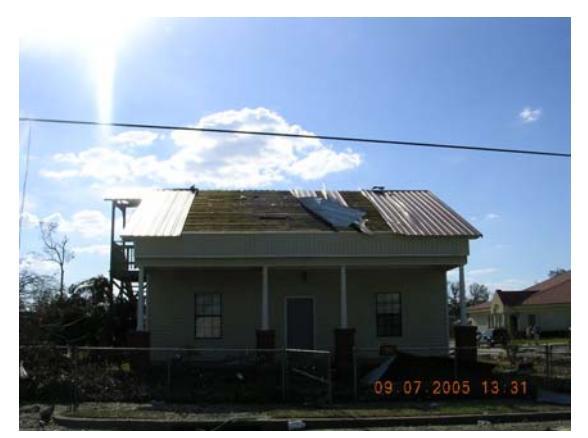
NOTED DAMAGE—Approximately half of the vertical panels were blown off the roof.

DAMAGE INITIATION AND PROPAGATION—Damage initiated from the perimeter edge and was aided by internal pressurization through spaced board sheathing.

3.05-1. Church of the Vietnamese Martyrs. This photo shows steel "R" panels pulled loose from spaced sheathing boards.

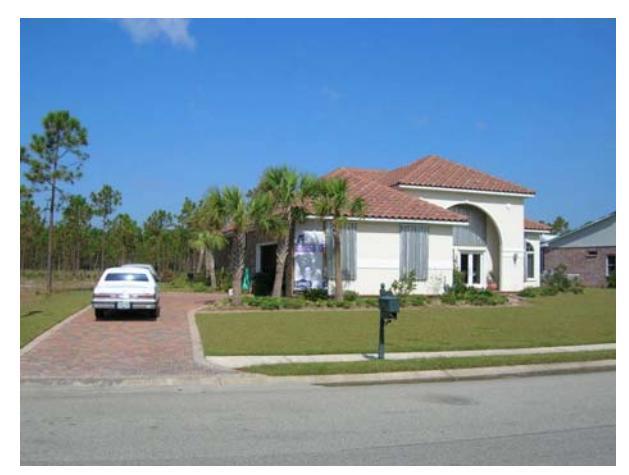
NOTED DAMAGE—None

3.08-1. Residence. A surviving concrete tile roof is shown here.

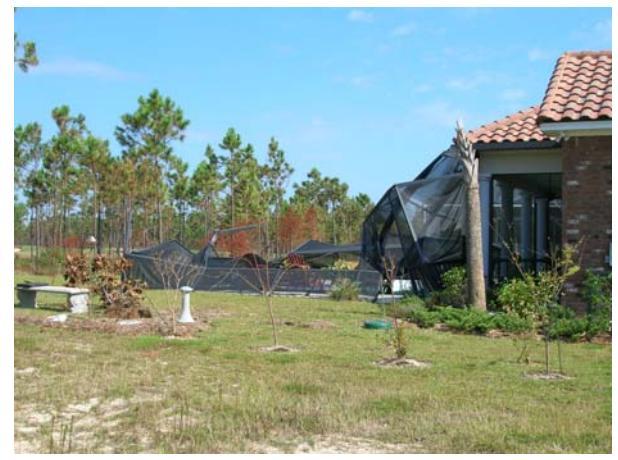
ADDITIONAL COMMENTS—Pool screen at rear of house and an adjacent shingle roof were damaged.

3.08-2. Residence. This photo shows a destroyed pool screen formerly connected to this undamaged concrete tile roof.

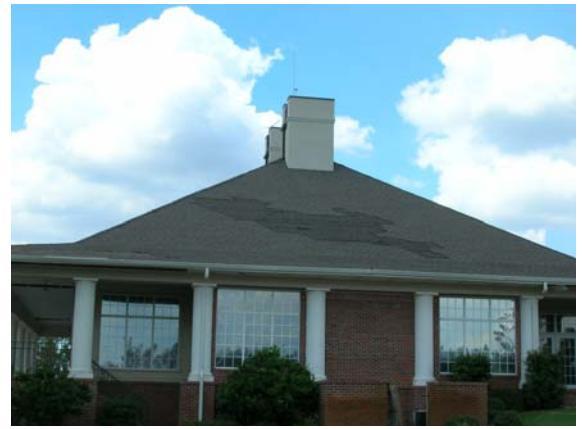
NOTED DAMAGE—Shingles missing from eave edge and field; hip shingles folded over and detached.

DAMAGE INITIATION AND PROPAGATION—Nails missing from one end of shingles resulted in loose attachment and subsequent deformation and/or detachment resulting from high winds.

3.10-1. Gulf Landing CC Clubhouse. This clubhouse roof lost shingles between the eave and the chimney.

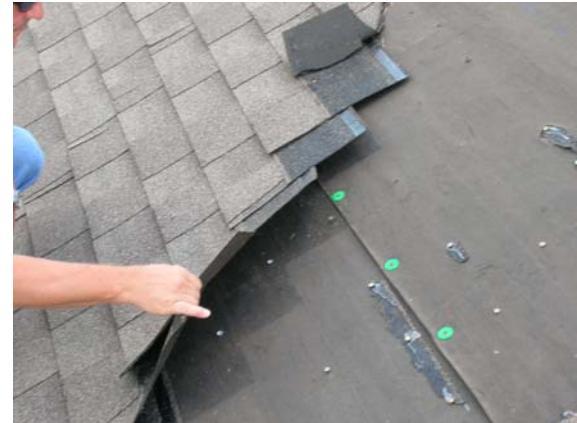
ADDITIONAL COMMENTS—Missing nails resulted in shingle losses.

3.10-2. Gulf Landing CC Clubhouse. Shingles in the field of this roof were loose because of missing nails.

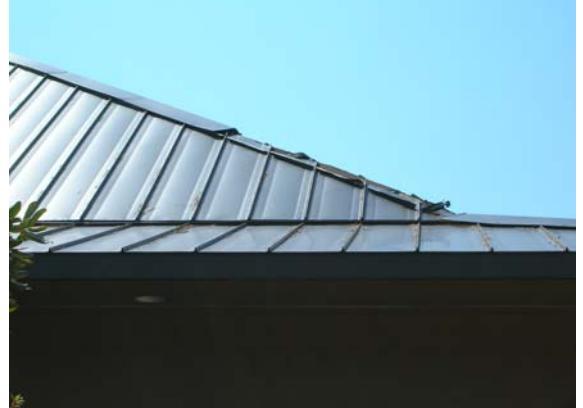
NOTED DAMAGE—Two hip panels were missing.

3.11-1. News Office Building. This "snap-lock" standing seam roof survived mostly intact, other than losing two hip panels.

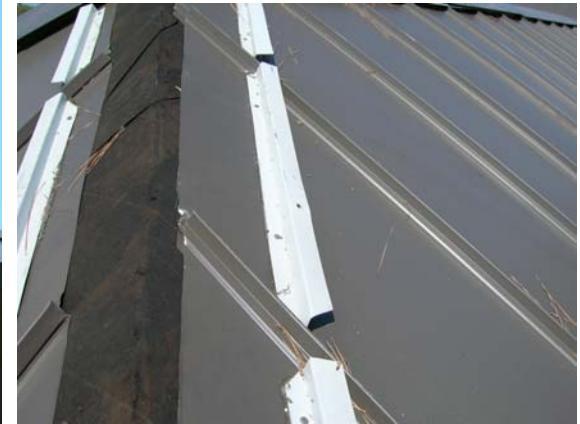
DAMAGE INITIATION AND PROPAGATION—The hip pieces came loose from Z-members that were not spaced sufficiently apart to engage hip pieces.

3.11-2. News Office Building. These "Z" supports were spaced too closely to adequately secure trim pieces.

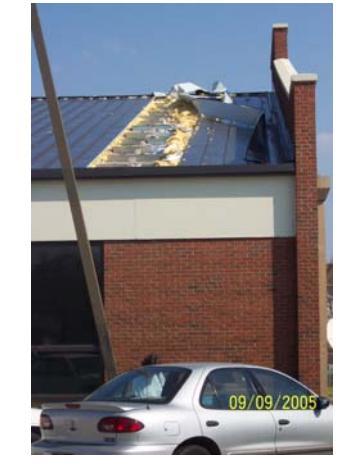
NOTED DAMAGE—Three panels were lost. Panel clips were attached to steel studs running horizontally across the old metal roof. New metal roof was installed over the old one.

DAMAGE INITIATION AND PROPAGATION—Mechanical seaming stopped 18 in. from the eave; i.e., seaming was incomplete.

3.14-2. Post Office. A closer view of the panel seam delamination shown in previous photo.

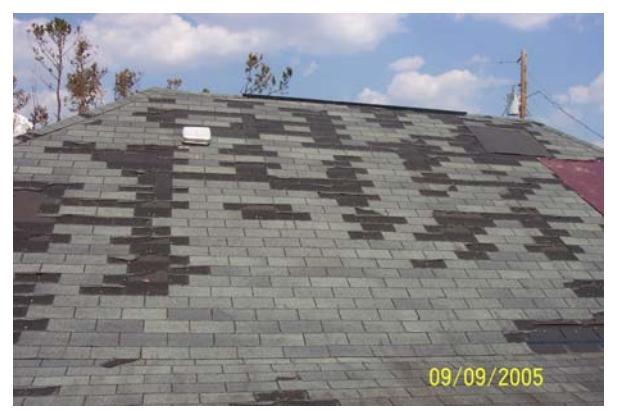
NOTED DAMAGE—Shingle edges of every other course were not fastened and ripped loose.

DAMAGE INITIATION AND PROPAGATION—Un-nailed shingle edges ripped tabs loose.

3.15-1. Residence. This roof was installed using a vertical "racking" installation method, which resulted in significant damage to many of the 3-tab shingles.

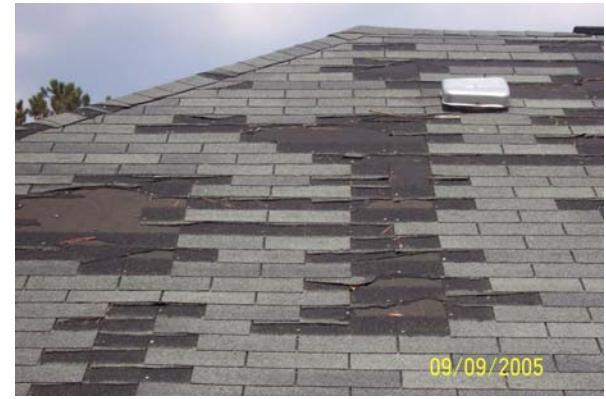
3.15-2. Residence. Fasteners were missing on alternating courses of shingles.

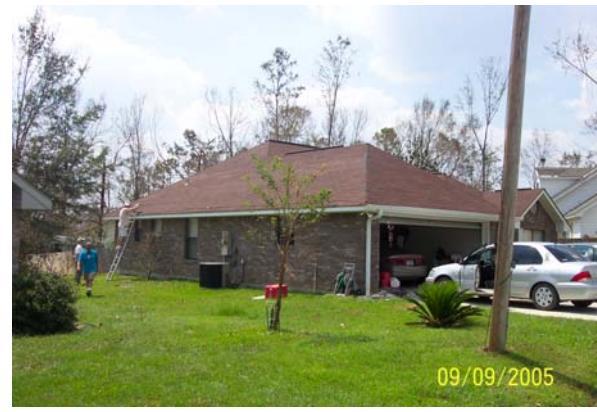
NOTED DAMAGE—Some shingles were missing around perimeter and hips.

ADDITIONAL COMMENTS—The 1¼ in. long nails were not long enough to secure hip pieces.

3.16-1. Residence. This overlay shingled roof lost shingles from leading edges and hips.

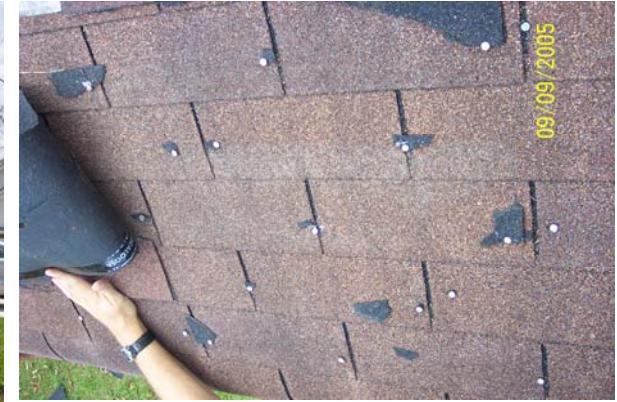
DAMAGE INITIATION AND PROPAGATION—Shingles tore loose from leading edge.

3.16-2. Residence. Shingles on this section and others tore from nails at leading edge.

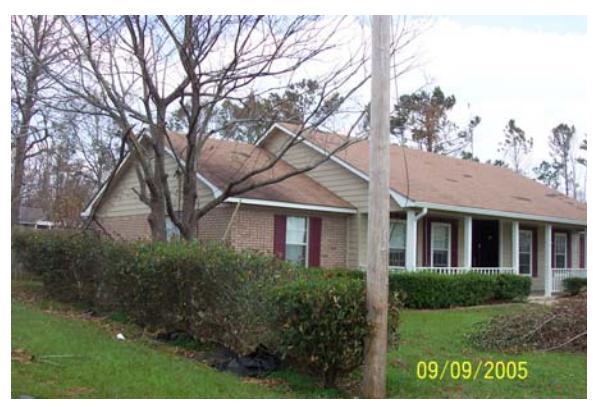
NOTED DAMAGE—A few missing shingles

DAMAGE INITIATION AND PROPAGATION—Damage was limited to a few tabs lifting and tearing loose.

3.17-1. Residence. A few shingles were missing from this 4-year-old roof.

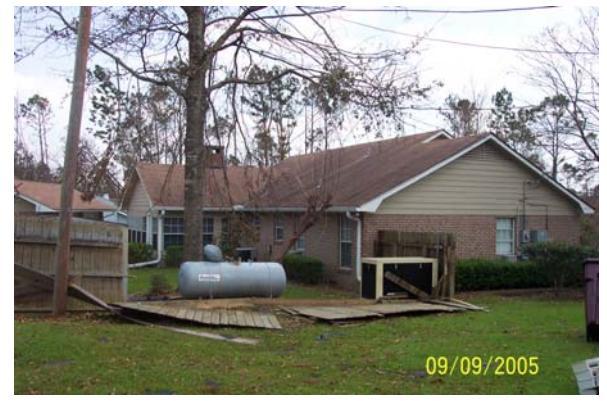
ADDITIONAL COMMENTS—Wind knocked down fencing and damaged adjacent roofs.

3.17-2. Residence. Fence damage at this residence.

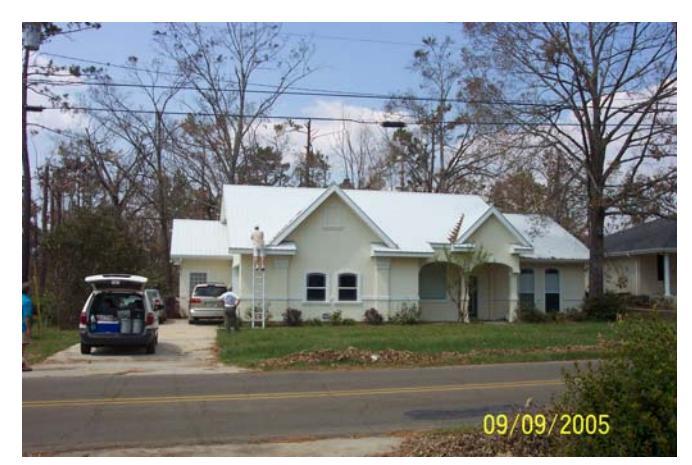
NOTED DAMAGE—A few loose screws and a missing rake (siding) cover piece

3.20-1. Residence. This steel panel roof appears to be undamaged.

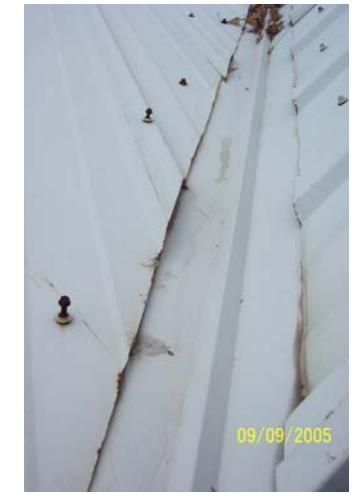
DAMAGE INITIATION AND PROPAGATION—Panel vibration probably loosened some screws.

3.20-2. Residence. The loose fasteners are the result of the cyclic nature of the loading in the hurricane winds.

ADDITIONAL COMMENTS—Essentially roof performed well because of adequate fastener spacing. Some fasteners need replacement.

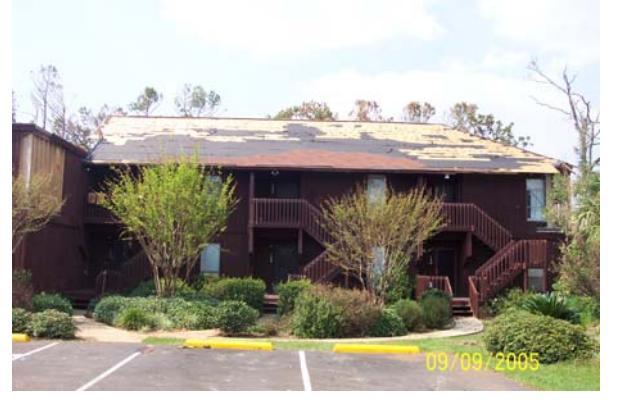
NOTED DAMAGE-Major roofing and structural damage

DAMAGE INITIATION AND PROPAGATION—Damage initiated from wind pressurization through gable ends.

ADDITIONAL COMMENTS—Pitched roof section was prefabricated and was shipped to area by barge and then set in place via crane. This entire roof section was blown off as a result of inadequate attachment; i.e., the pitched roof was attached to the top plate with 16d nails. The gable end of this roof section was directly exposed to the wind. The truss section pressurized from the gable end and lifted off. The roof section opposite the gable end was a hip design. Shingles were also noted to have been nailed irregularly; i.e., high nailing, insufficient fastener quantity, overdriven nails, and shingle ends left loose. Plywood was nailed to rafters with 6d nails spaced 6 in. o.c. at ends and 12 in. o.c. in the field. In summary, shingles, plywood, and framing became detached both separately and as an

3.21-1. Lanai Village HOA. Major roofing damage is visible on this two story homeowner's association building.

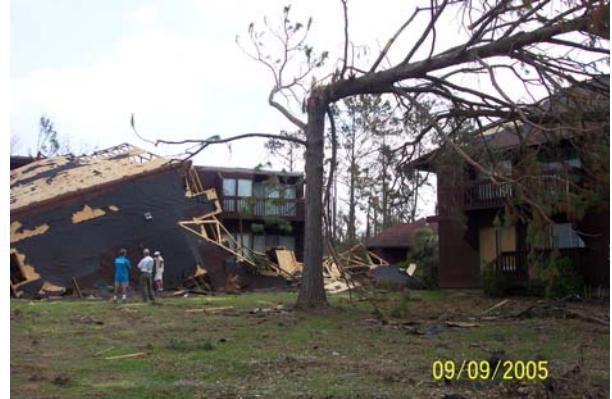
3.21-4. Lanai Village HOA. This is a wider view of the same roof section (at left). An adjacent hip roof, at right, remained in place despite the strong winds.

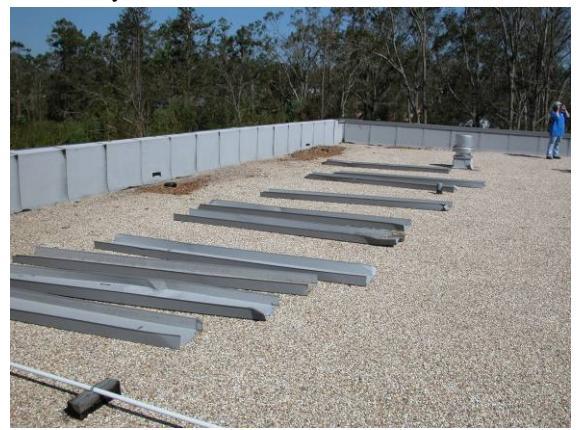
6.01-3. Community Medical Center. Recovered sheet metal coping pieces were stored on the roof.

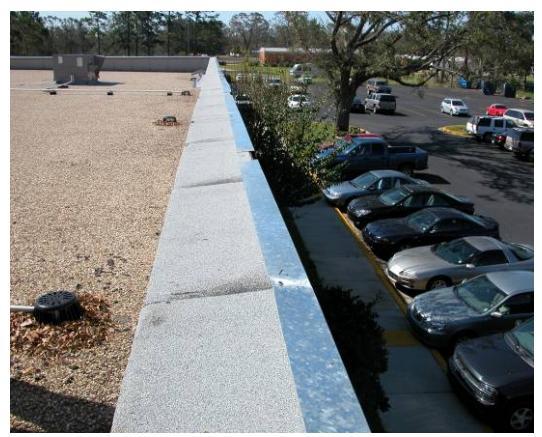
NOTED DAMAGE—Parapet coping became detached and portions of flashing were found in the northern parking lot; coping was attached with 1in. screws (see photo 6.01-5).

DAMAGE INITIATION AND PROPAGATION—Primary cause of damage was blowoff of the northern downwind side (rear) parapet metal coping.

6.01-2. Community Medical Center. Metal coping was missing from the parapet.

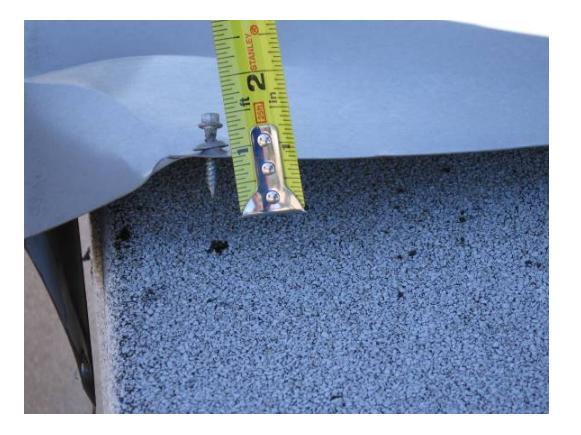
ADDITIONAL COMMENTS—This building was located on hilly terrain. The parapet metal coping was fastened with three 1 in. screws (on roof-facing side) into wood blocking. The front face of the coping was clipped onto a 26-gauge galvanized cleat (too light for this purpose), fastened 4 ft o.c. (should be continuous) with 1½ in. shingle nails on top of the parapet nailer. The modified bitumen membrane, used for wall flashing, remained intact on the wall and was wrapped over the parapet nailer and front face.

6.01-5. Community Medical Center. Close-up of a fastener used to hold coping in place.

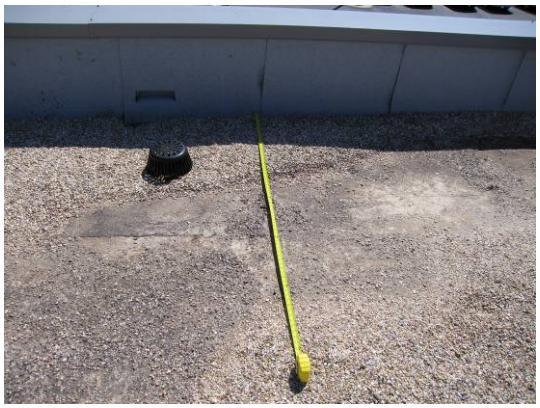
6.01-6. Community Medical Center. Evidence of wind scour damage to aggregate layer is evident.

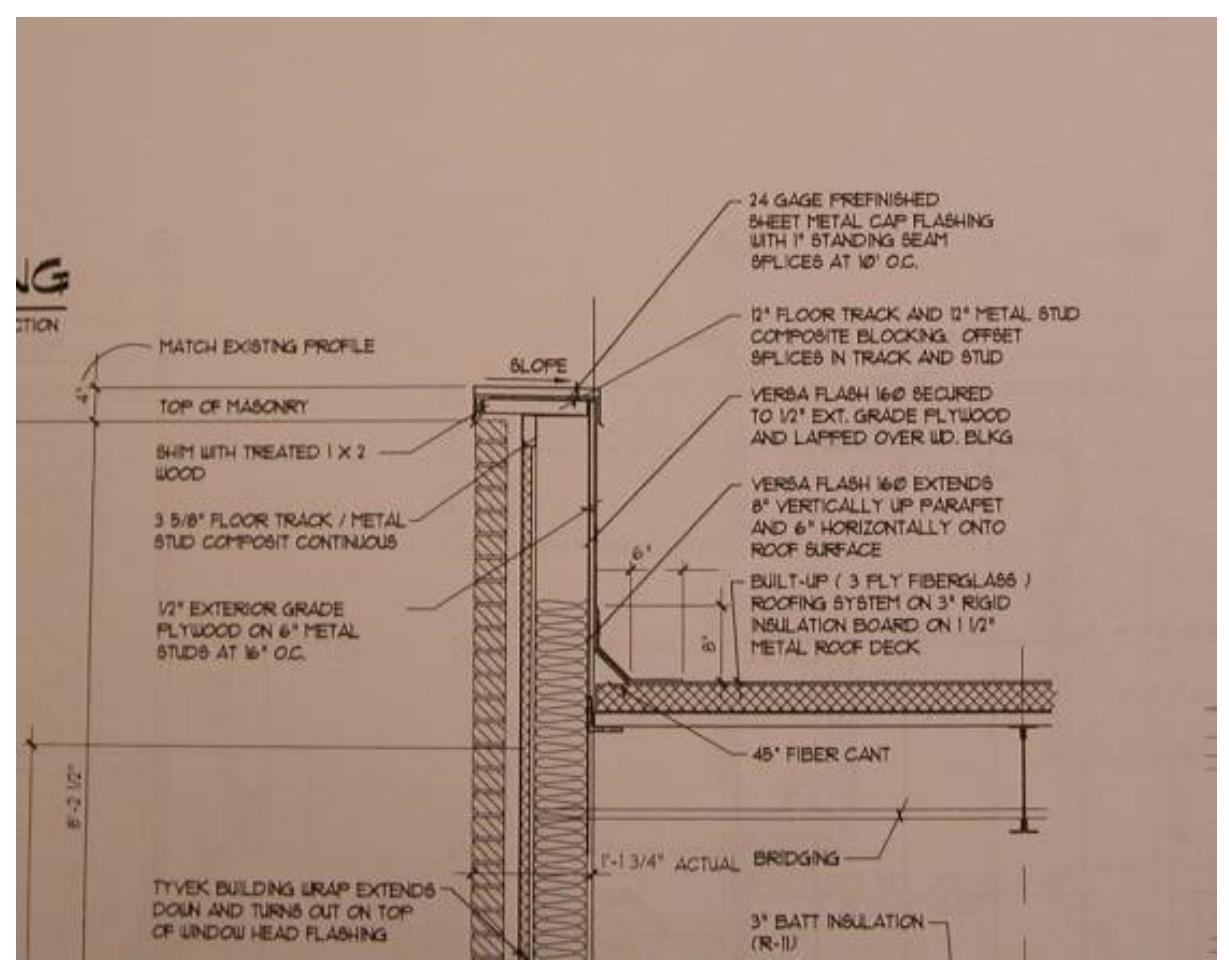
6.01-7. Community Medical Center. An architectural detail of the metal coping.

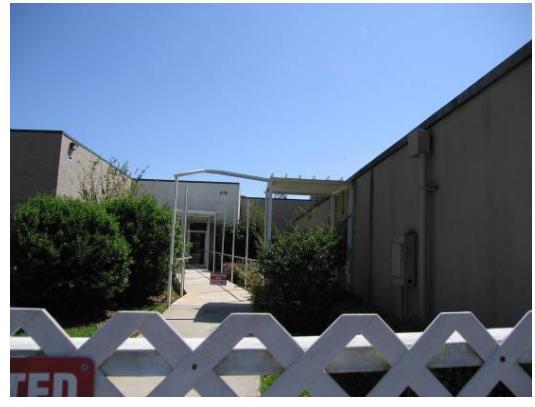
NOTED DAMAGE—No damage to the hospital building or roof, as it was located between, and partially sheltered by, the Medical Center and the Maintenance Building. The covered walkway behind the main structure was constructed of lightweight aluminum panels and was damaged.

6.02-2. George County Hospital. The covered walkway structure shown is missing its roof covering.

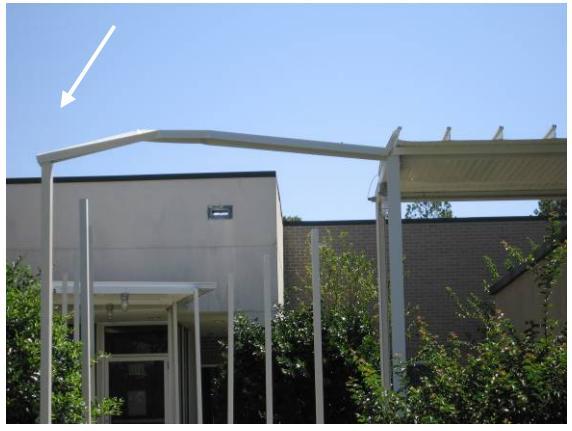
6.02-3. George County Hospital. Close-up of the covered walkway structure, showing both intact and missing roof covering sections.

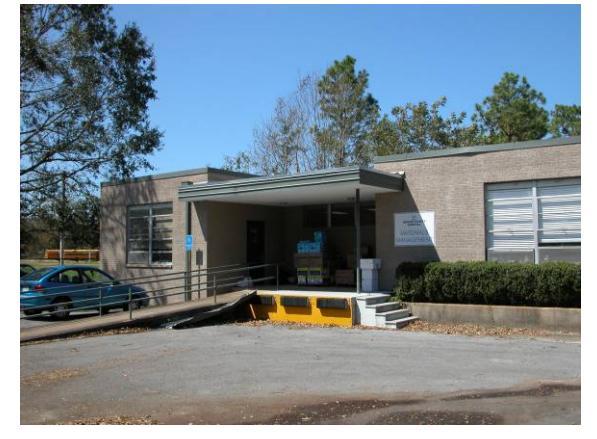
6.03-1. George County Hospital Maintenance Building. View of the front elevation. Note beginning of coping failure to the right of the canopy.

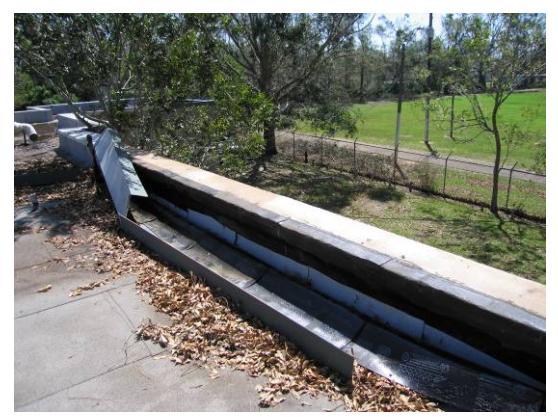
NOTED DAMAGE—Metal coping and wall flashing at the southeast corner; loose membrane in the field of the roof.

DAMAGE INITIATION AND PROPAGATION—Air infiltration at the wall/deck juncture caused wall flashing to pressurize, followed by blowoff of some of those components. This infiltration appears to have been exacerbated by a poor bond of APP flashing membrane to parapet.

6.03-2. George County Hospital Maintenance Building. Photo shows coping and flashing attachment failure along this section of parapet.

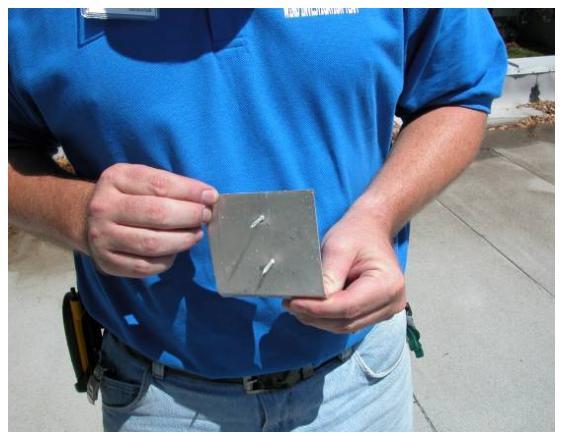
ADDITIONAL COMMENTS—The torch-grade granulated flashing membrane was loose-laid on the wall and tacked in place 4 ft o.c. with a 4×4 in. aluminum plate and two 1 in. concrete screws. This construction method is inadequate for a hurricane zone.

6.03-4. George County Hospital Maintenance Building. Pull-out failure was seen in clips such as this one that were used to attach flashing to brick. Flashing was modified bitumen membrane to the concrete cap. This .032 aluminum clip was also used as the catch cleat, 4 ft o.c., for the aluminum coping cap that blew off.

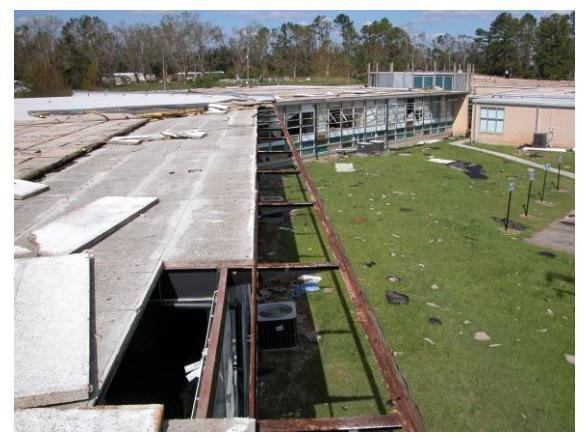
NOTED DAMAGE—Lower classroom section of Roof A [photos 6.04(a)-1 thru 6.04(a)-4]; southeast rear section; southwest middle section.

DAMAGE INITIATION AND PROPAGATION—CWF deck panels in the classroom roof section A [photos 6.04(a)-1 thru 6.04(a)-4] with membrane attached blew completely over the width of the roof and landed upside down in front of the building. The membrane was separated from the perlite as a result of a combination of strong uplift forces and cohesive failure of this inherently weak insulation material. The separated membrane peeled away and was expelled into the front yard. *Observation:* 2-ply SBS membrane delaminated from the perlite cover board interior roof; perimeter edge base sheet insulation and modified membrane blew off 18 ft back from the perimeter.

6.04 (a)-1. Stone Elementary School roof A. Southwest corner damage is visible, including missing deck panels. (Note: the gymnasium is located to the right, just out of this photo.)

In repairing the system, the CWF should be attached more securely, and provision should be made to limit air infiltration that causes pressurization under the SBS finished roof membrane.

Recommended repairs to the lower classroom roof would start with removal of all remaining roofing assembly down to the CWF decking and then properly securing all CWF deck panels.

Hot-mopping or slow-rise adhesive foam application of a membrane to the Tectum deck to stop air infiltration will mitigate future wind uplift damage to the roof assembly; then a new roof could be installed.

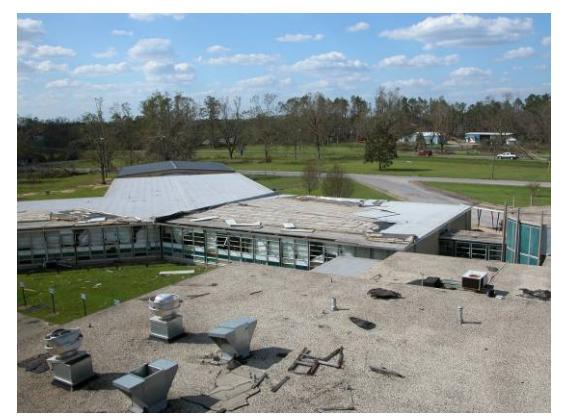
6.04 (a)-2. Stone Elementary School roof A. Southwest corner damage is shown from a different angle. Note the damaged HVAC units on the roof of the gymnasium (foreground).

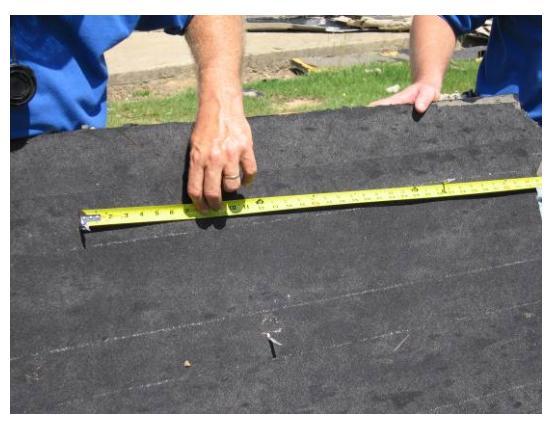
ADDITIONAL COMMENTS—The building was located on generally smooth and level terrain. The perimeter edge did not have a secure perimeter termination nailer for the membrane and the gravel stop edge. Lower classroom structural attachment of CWF panels at the perimeter eave overhang was deficient.

6.04 (a)-4. Stone Elementary School roof A. Fasteners pulled out of Tectum.

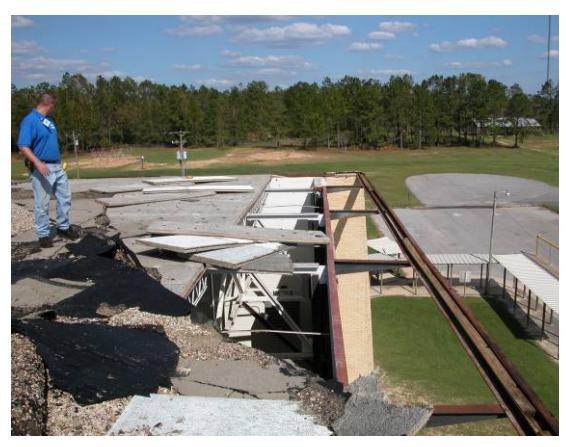
The upper gymnasium roof (35 ft high) was damaged at the southeast corner. Along the south and east overhangs, CWF panels (and attached roof membrane and insulation) were pulled out of the bulb Ts structural framework, folding the entire assembly back onto the roof edge. Unlike the lower sections, the upper gymnasium roof folded back onto itself a short distance from the perimeter edge.

DAMAGE INITIATION AND PROPAGATION—Perimeter overhang of CWF decking blew back with two roof assemblies. On top, there was no hot-mopping of the top roof's insulation boards to the underlying gravel surface; i.e., the second roof was loose-laid, making it more prone to blowoff.

6.04 (b)-2. Stone Elementary School Gymnasium roof B. Southeast corner damage, including missing deck panels, is shown.

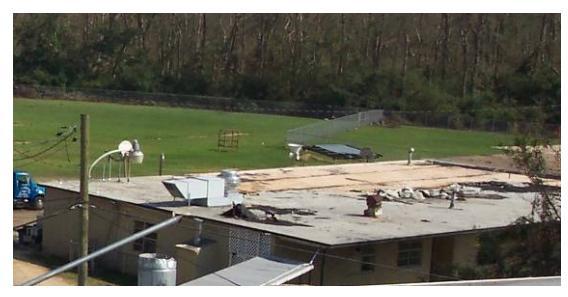
NOTED DAMAGE—Approximately 25% of the roof membrane was damaged.

6.05-1. Lumberton School. Looking down from the administration building, large areas of roofing are missing below.

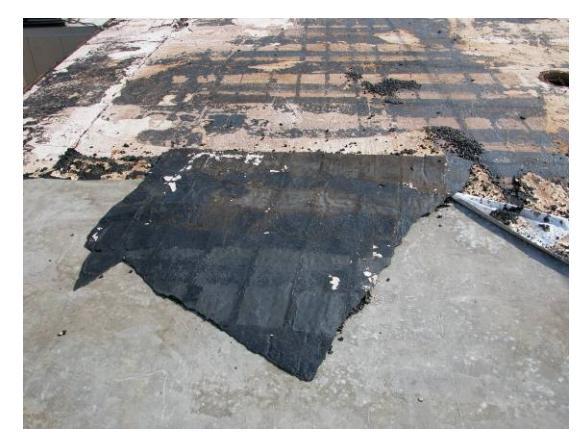
DAMAGE INITIATION AND PROPAGATION—It appears that the BUR on the south half of the building separated from the substrate, starting at the southeast edge, then peeled back. The separation was likely due to poor adhesion of the BUR to concrete.

ADDITIONAL COMMENTS—The concrete deck surface had no evidence of concrete primer, and less than 10% of asphalt remained adhered to the concrete. Primer is normally used to ensure good adhesion.

6.05-3. Lumberton School. View of the BUR peeled back from the decking.

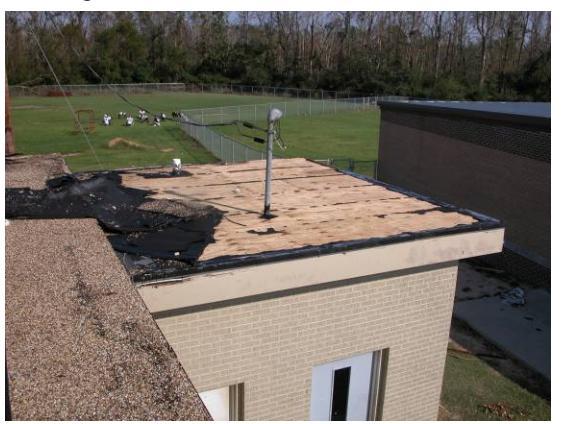
6.05-6. Lumberton School. This entrance roof was blown off.

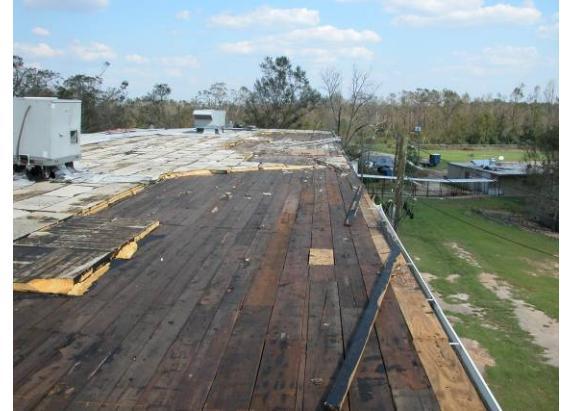
NOTED DAMAGE—Approximately two-thirds of the roof membrane was blown off the roof. About one-third of the tapered roof insulation was blown off. No deck damage was noted. There was significant interior water damage.

6.06-4. Lumberton School Administration Building. Looking west to east, considerable roof damage is visible.

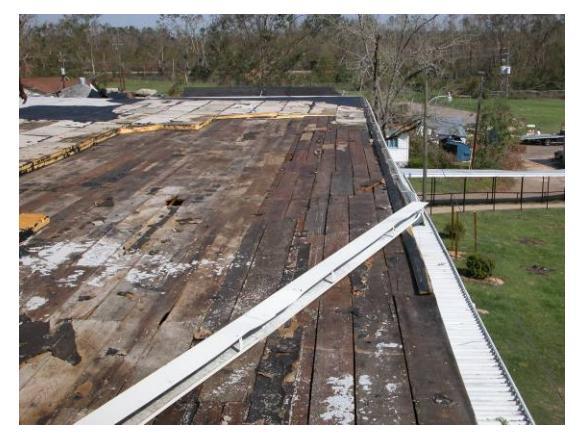
DAMAGE INITIATION AND PROPAGATION—Initial failure appears to have occurred at the south roof edge where approximately 25 ft of gutter and edge nailer separated from the structure. A vented 3 ft deep soffit may have contributed to the damage by pressurizing the space between deck and roof assembly. However, the roof assembly may have been pressurized by failure of the south roof edge.

6.06-5. Lumberton School Administration Building. South side roof edge failure is visible.

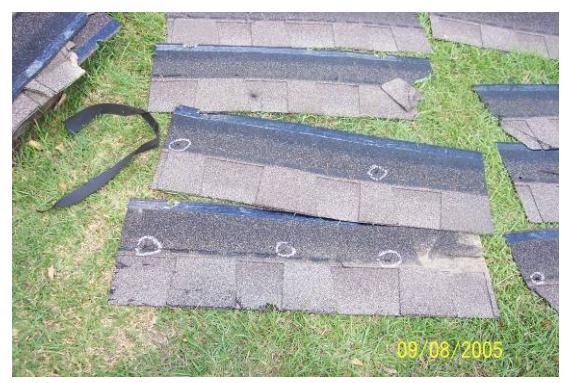
DAMAGE INITIATION AND PROPAGATION—Some of the asphalt shingles that blew off appeared to have been inadequately fastened, with only two or three nails per shingle in some cases. This does not allow the seal strip to function adequately to resist the wind loads.

6.07-3. **Residence.** Encircled spots show where shingles pulled free of nails and the lack of nails.

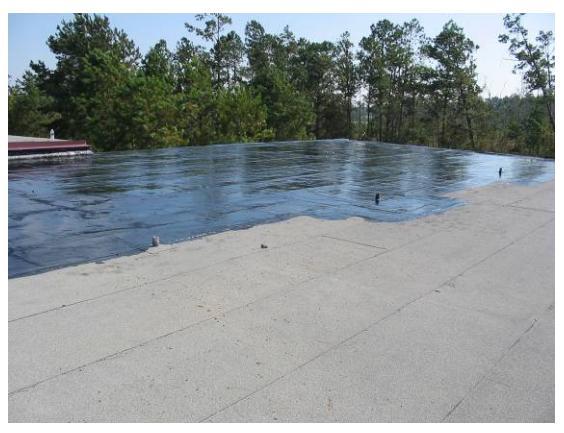
NOTED DAMAGE—Roof membrane blowoff on east section of the main campus building. Repair work had already begun. Damage area was less than 10% of the total roof area on the main building. There was also interior water damage.

DAMAGE INITIATION AND PROPAGATION—Damage began at the northeast corner gravel stop, which was not anchored to a cleat. Edge metal pulled free of the nailer and peeled back the BUR and cap sheet membrane in a 20×30 ft area.

6.08-2. Perry County High School. This is a southwest to northeast view of damaged roofing. The mineral-surface cap sheet (foreground) appeared relatively undamaged.

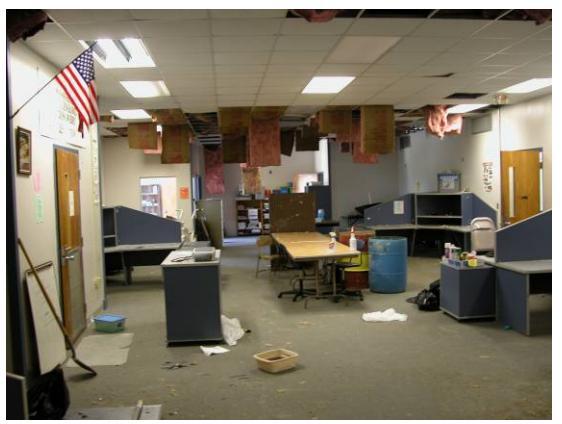
6.08-6. Perry County High School. Interior water damage is visible.

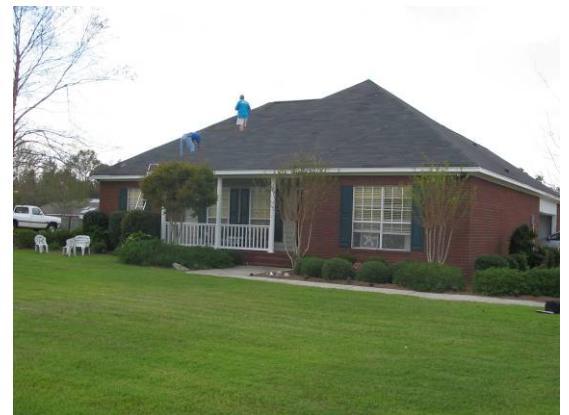
6.09-1. Residence. A west-facing view.

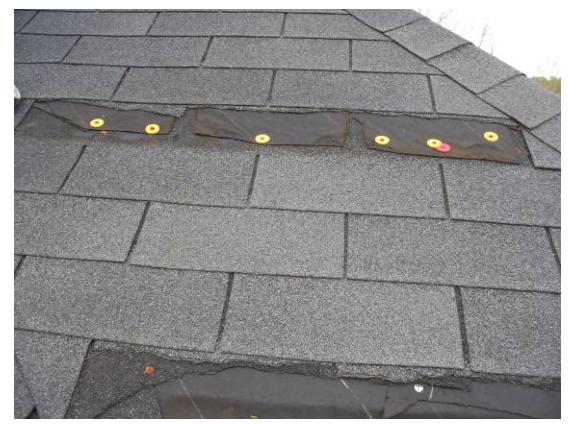
NOTED DAMAGE—Shingle damage was limited to between 10 and 25% of the total roof area. No other damage was noted, other than possible screen damage at the rear patio.

6.09-4. Residence. Ripped shingle tabs have been temporarily repaired in this photo.

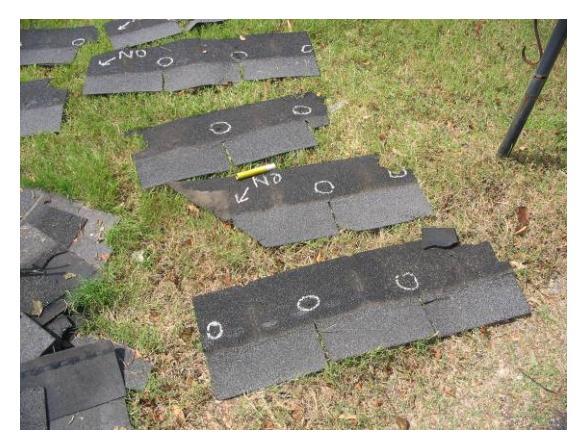
DAMAGE INITIATION AND PROPAGATION—Missing nails resulted in excess stress on shingle seal strips. This is an example of the typical failure due to the racking method of installation that often limits the shingles to three nails. The shingles are installed in a pattern that starts at the bottom of the slope and goes to the top of the roof in a vertical line, instead of the diagonal stair-stepped pattern recommended by manufacturers.

6.09-5. Residence. Missing nails and nail pull-through anomalies are marked with chalk.

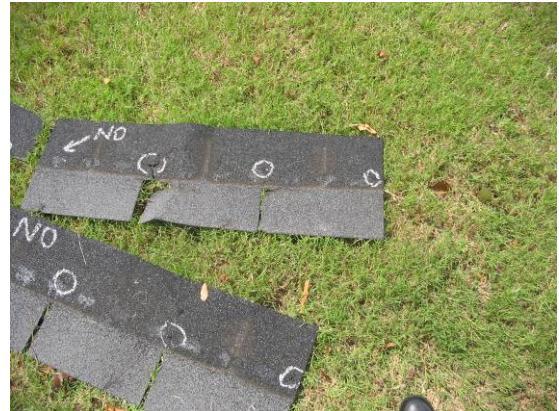
6.09-6. Residence. Missing nails and nail pull-through spots help determine cause of failure.

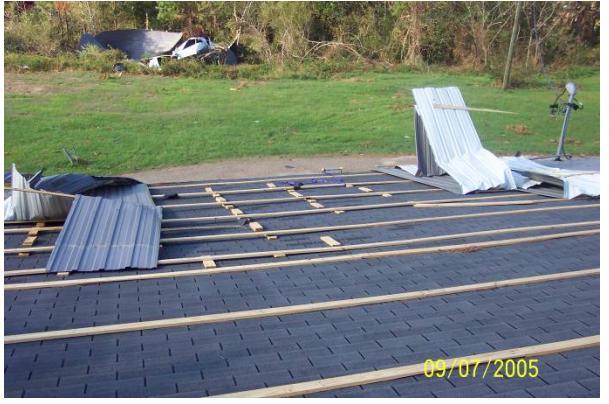
Failure appears to have been inadequate fastening of nailers to the deck. Loss of nailers was due to the combination of insufficient fasteners and their low pull-out resistance. Nailers were attached to the deck only with pairs of nails at 4 ft intervals. Since the metal roof panels were only connected to nailers 4 ft o.c. vertically, each pair of nails had to resist uplift forces developed over approximately 16 ft².

to the metal roof sections on the leeward side.

6.10-1. Baptist Church. Nailers are seen still attached 6.10-2. Baptist Church. Boards remaining on the roof were "stiffeners" between nailers lost to wind.

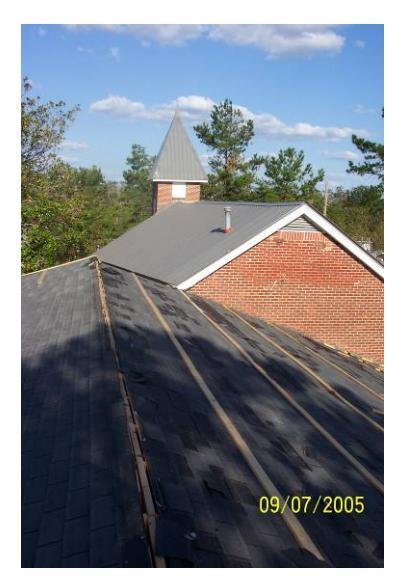
NOTED DAMAGE—Main church roof had no damage. Church annex roof was a total loss. The metal roofing was completely uplifted on the windward (south) side, and many panels were missing on the leeward side. Some older shingles (underlying roof covering) were uplifted, primarily on the windward side.

Performance of the annex metal roof can be compared with performance of the metal roof on the connected main church building and with the performance of the asphalt shingles over which the annex metal roof was applied. The main and annex roofs had ridges running in the same direction and had the same directional exposure and approximately equal heights and similar slopes. The metal roof on the church had no damage; the metal roof covering on the annex was lost.

6.10-3. Baptist Church. The annex roof with no remaining metal panels. The metal roof on the adjoining church (in background) sustained no damage.

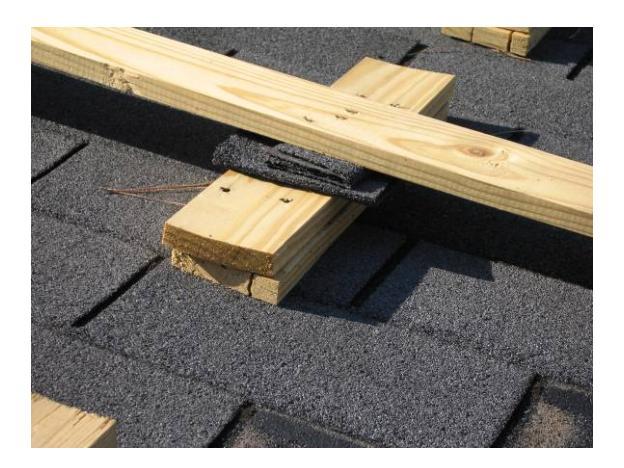
loss of shingles, rather than loss pre-dating application of the metal roof. This performance was in spite of deviations from typical installation recommendations, for example, improperly placing nails above asphalt shingle self-sealing strip and away from cutout.

6.10-5. Baptist Church. The underlying shingle roof appeared to have low spots. Nailers were shimmed out in an unorthodox manner (with scrap asphalt shingles) to provide a level base for the metal roofing.

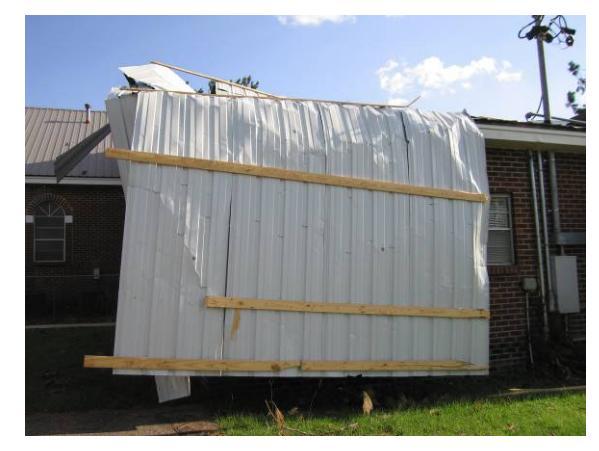
6.10-6. Baptist Church. In one location, the nails used to secure nailers pulled free, leaving nailers attached to the metal roofing. This was a good lesson in proper fastener selection and placement.

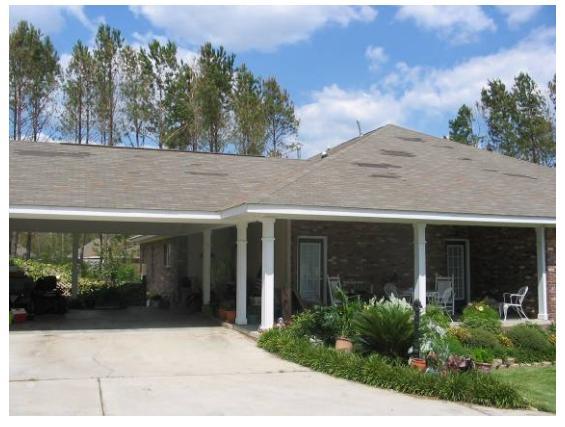
NOTED DAMAGE—There was minor roof covering damage. Fewer than 5% of the shingles were missing. No underlayment was lost and no roof deck exposed. Missing shingles were generally not near eaves or ridges. It is unknown whether there was any interior water damage. Shingle damage was limited to the south side of the roof.

DAMAGE INITIATION AND PROPAGATION—Based on maximum winds from the east, failure likely started at the bottom corners of shingles with wind blowing upward. The seal strip may not have been strong enough to resist the uplift on the shingle tabs. Once shingle corners lifted, numerous shingle tabs bent upward and broke off.

6.11-2. Residence. A view facing north. Shingle damage can be seen clearly.

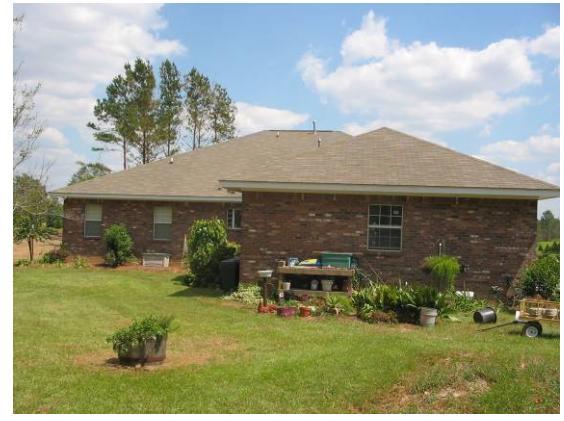
6.11-3. Residence. Facing east, these sections show no roof damage.

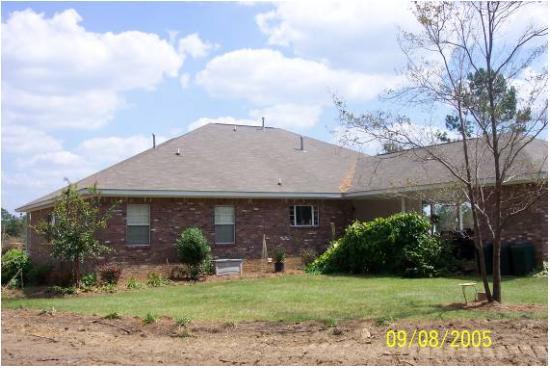
6.11-4. Residence. Facing northeast, this residence also shows no obvious damage.

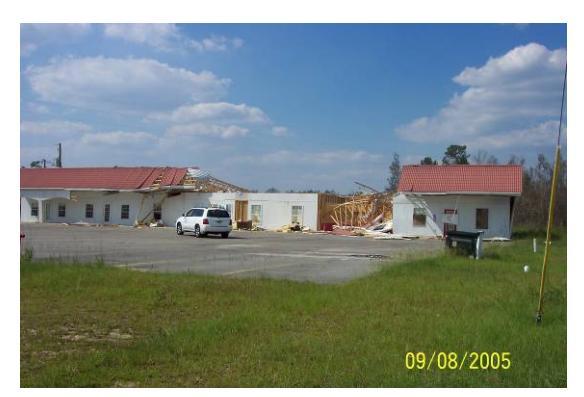
NOTED DAMAGE—The building suffered major structural damage. Large portions of the metal roofing were blown off. Some trusses were displaced. A middle portion of the building collapsed.

6.12-1. Strip mall. Facing north, damaged buildings are clearly in evidence.

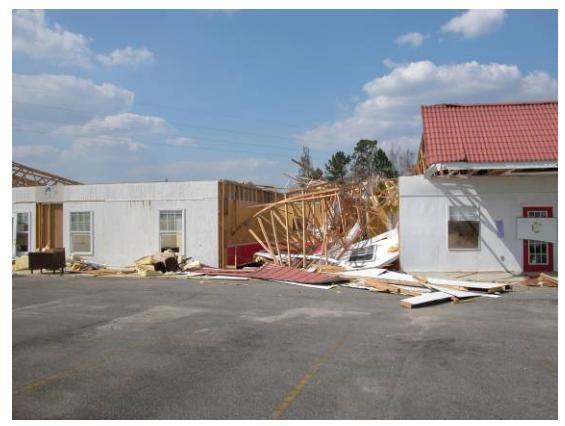
DAMAGE INITIATION AND PROPAGATION—It is likely that wind from the south collapsed the lightweight metal soffit over the front elevation. This caused uplift over the roof. The combined forces of uplift (negative pressure) from wind blowing over the structure and wind blowing up on the bottom side of the roof (positive pressure) caused the wood roof trusses to separate from the tops of the bearing walls. Separation of trusses from walls caused the center portion of the building to collapse.

6.12-2. Strip mall. The center section collapse on the south elevation can be seen in this closer view.

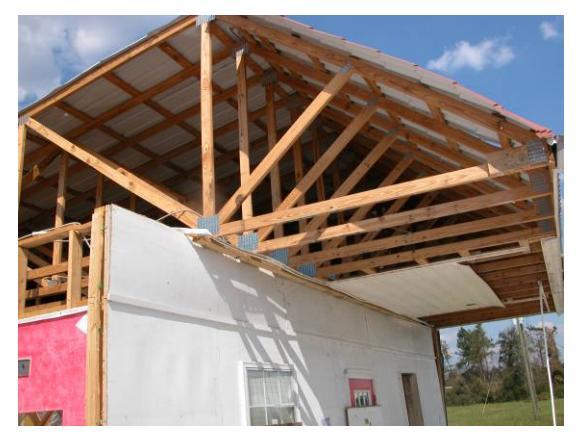
The lightweight soffit materials appear to have played a major role in this building failure. However, if they had not blown in, other cladding elements, like the metal roofing, may have failed at some point.

6.12-3. Strip mall. The soffit damage on the south side is visible in this photo.

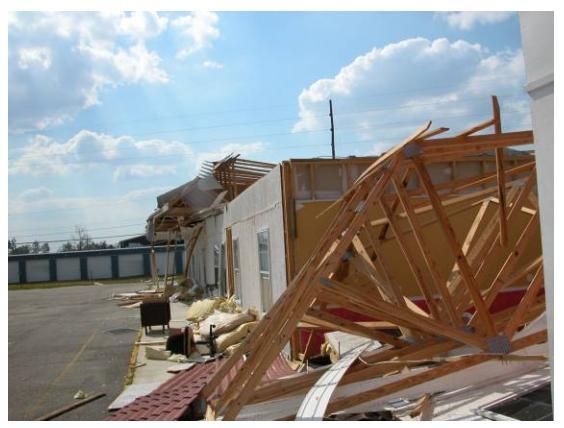
6.12-5. Strip mall. Damage was severe to this strip mall.

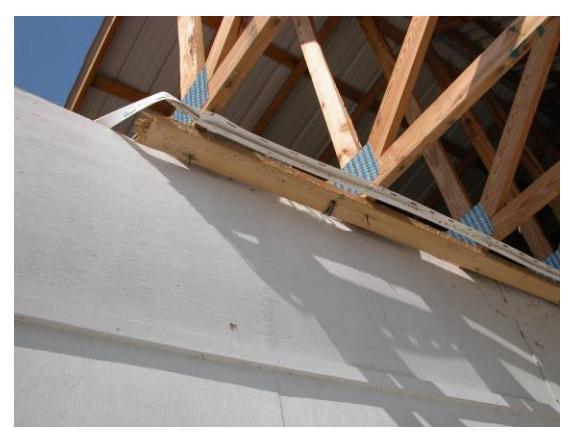
Where the major building collapse occurred, the truss-to-wall connection failed for one of two reasons:

- Direct withdrawal from the end grain of the wood studs; i.e., the double top-plate, to which the trusses were toe-nailed, separated from the wood studs. This type of connection is assumed to have no uplift resistance.
- As a result of separation of the double top-plate, the top 2×4 in. separated from the bottom 2×4 in. because the nails joining them pulled loose because of uplift.

6.12-4. Strip mall. This photo shows a wall topplate failure.

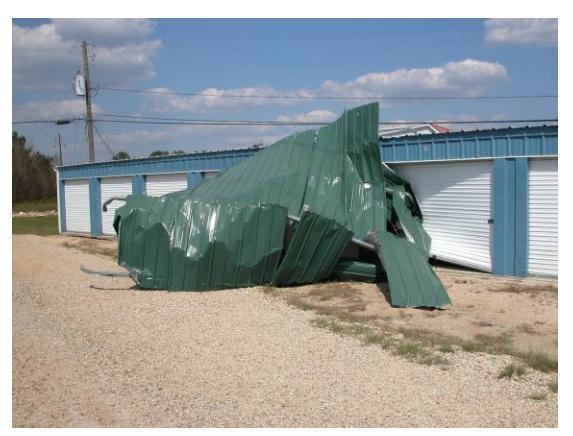
In other locations, the metal roofing came loose from trusses and blew out into the adjacent areas. The roof trusses remained upright. In some of these portions of the building, roofing separated from the top chord of the roof trusses.

6.12-6. Strip mall. A large section of metal roofing came to rest against a nearby storage locker facility.
