Hurricane Ian

Roofing Industry Committee on Weather Issues, Inc.

Storm Investigation Program

September 30, 2023

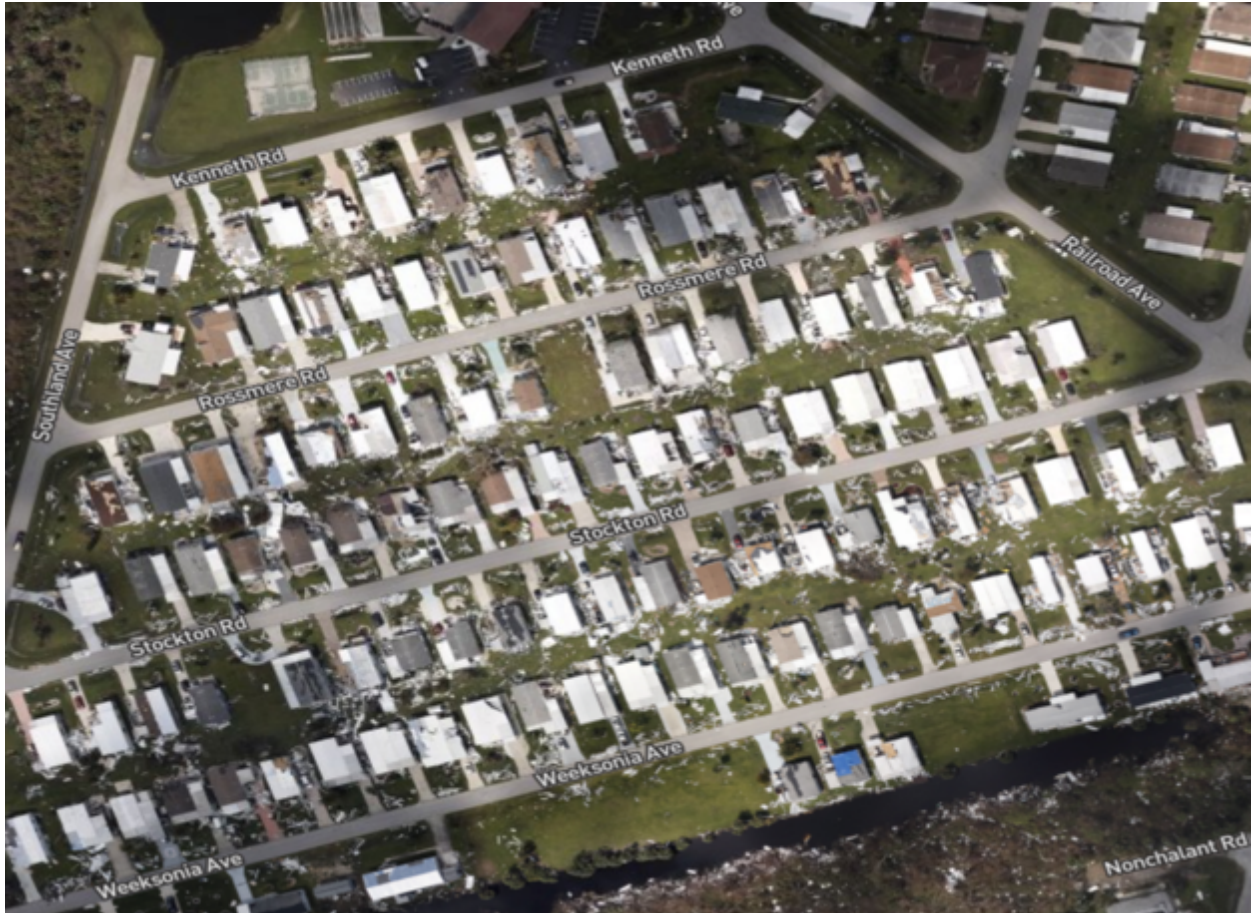
Figure 4: This photo is from NOAA flyovers of the same areas shown in Figure 1.

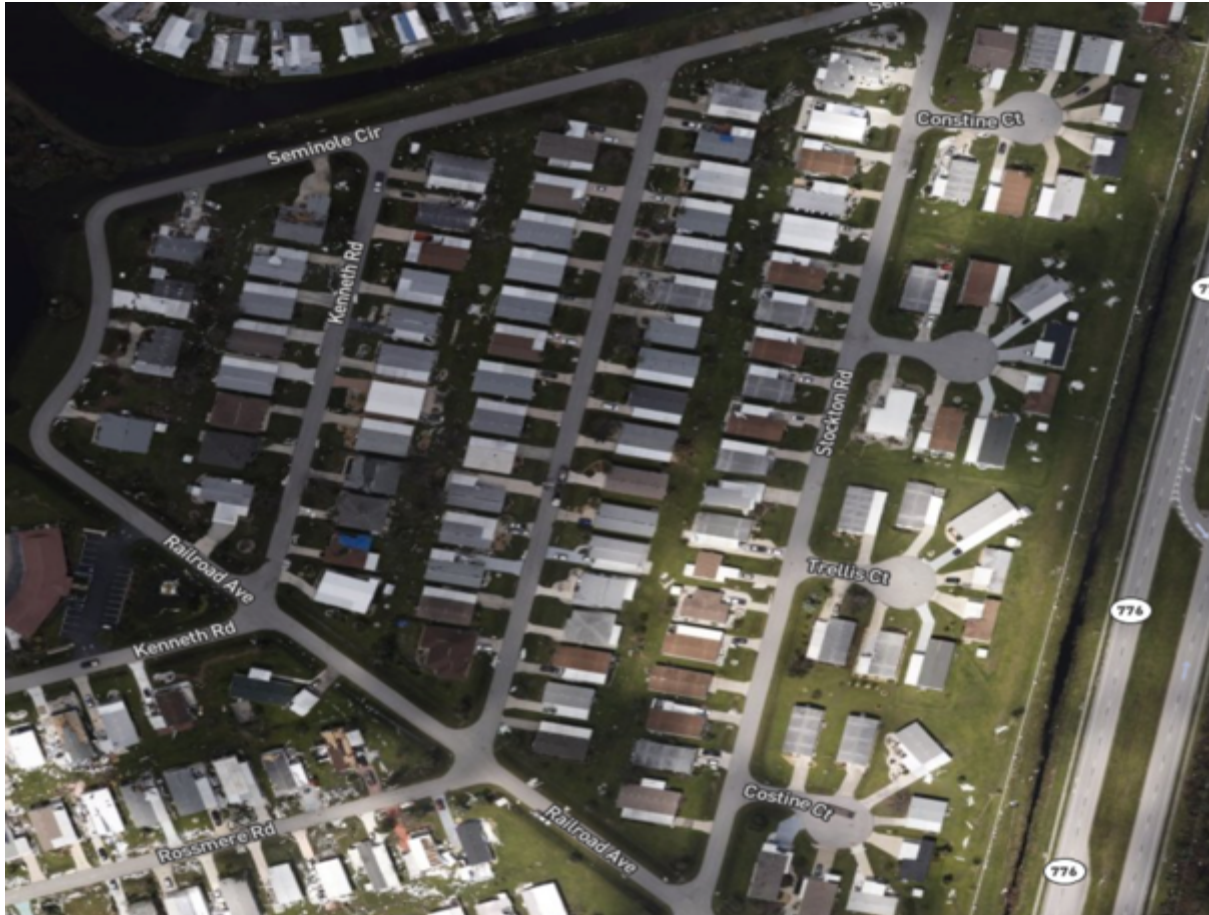
Figure 5: This photo is from NOAA flyovers of the same areas shown in Figure 2.

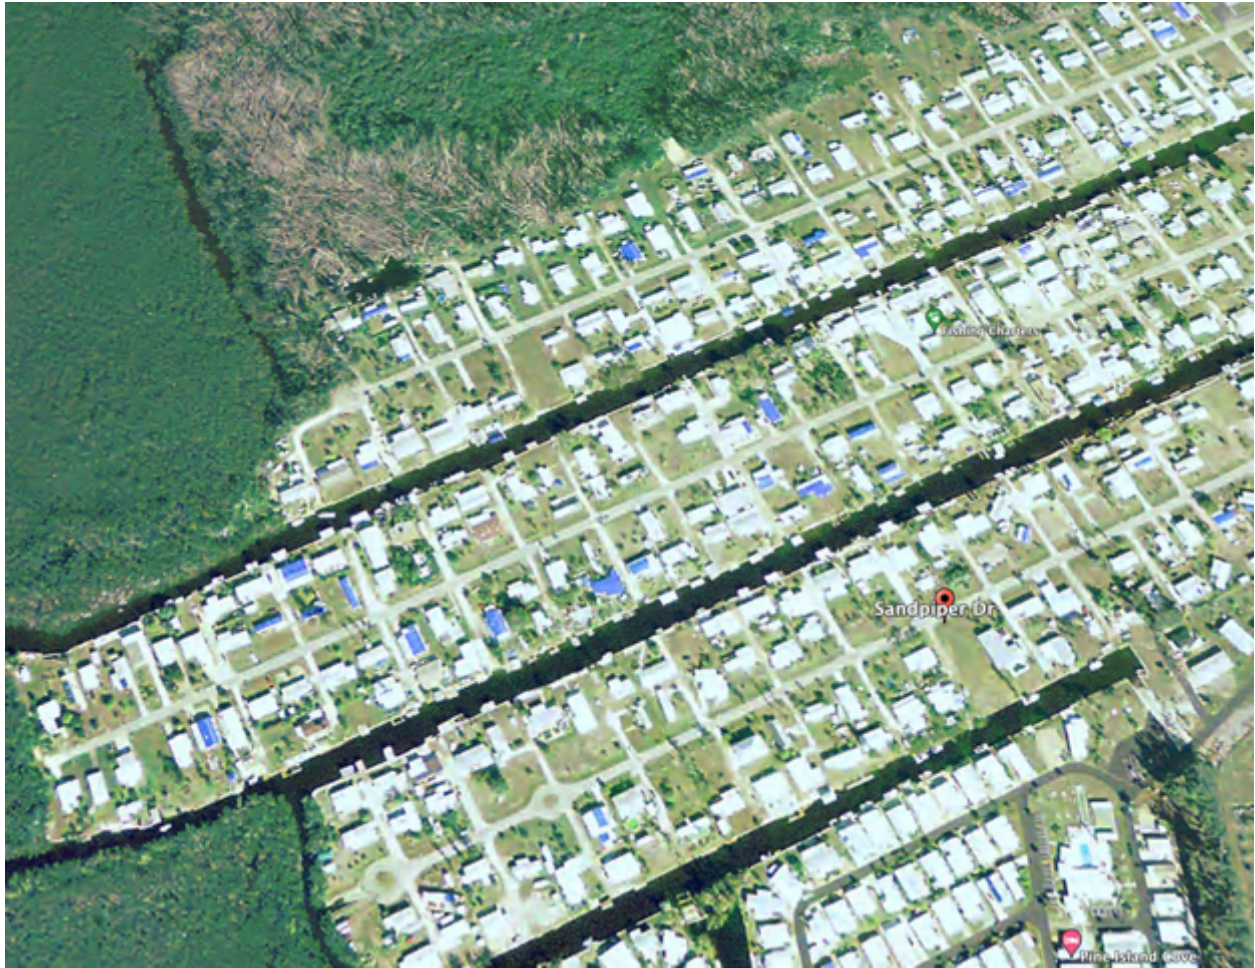
Figure 7: A Google photo from December 2004 of the same areas as shown in Figure 6. Note the blue tarp-covered roofs and the devastated forest, all caused by Hurricane Charley’s 140 mph winds. It is likely that much damage had already been remediated, as the storm was three months before this photo was taken.

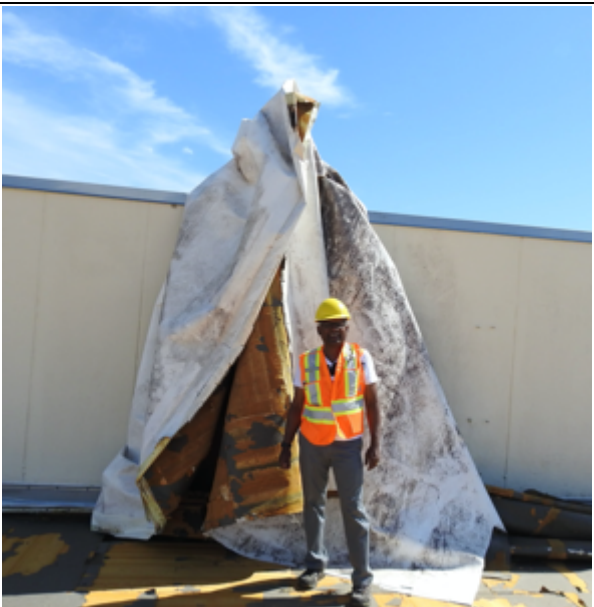
Photo 6: A large piece of membrane was left hanging over the roof edge.

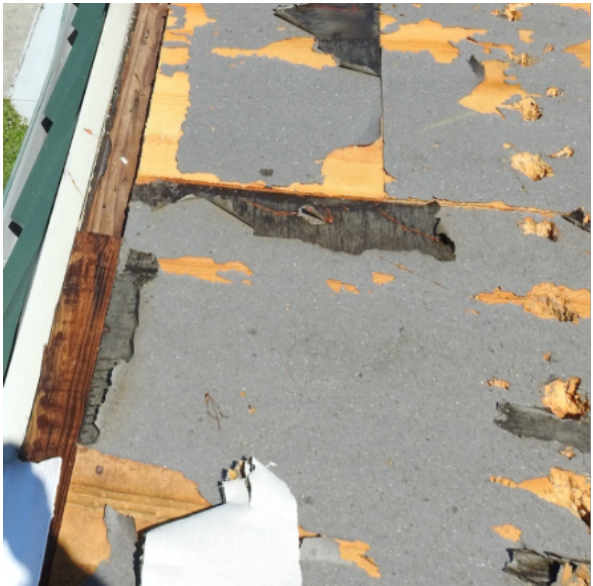
Photo 7: Loss of edge securement was a key factor in membrane blow off.

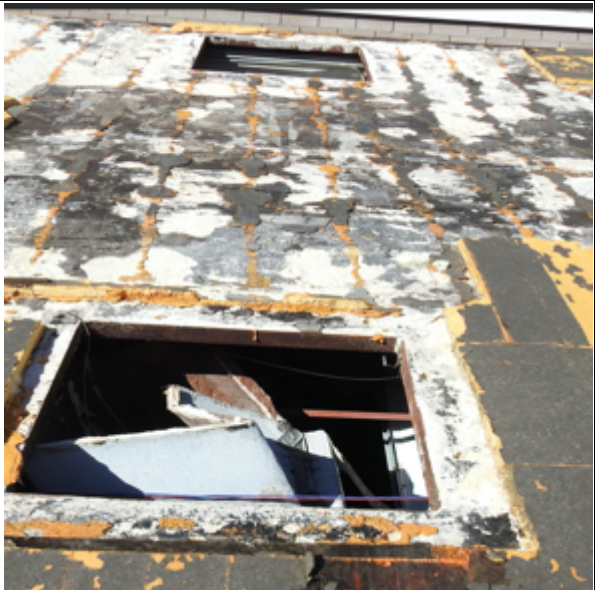
Photo 12: Sky lights became detached along with insulation and AHU's

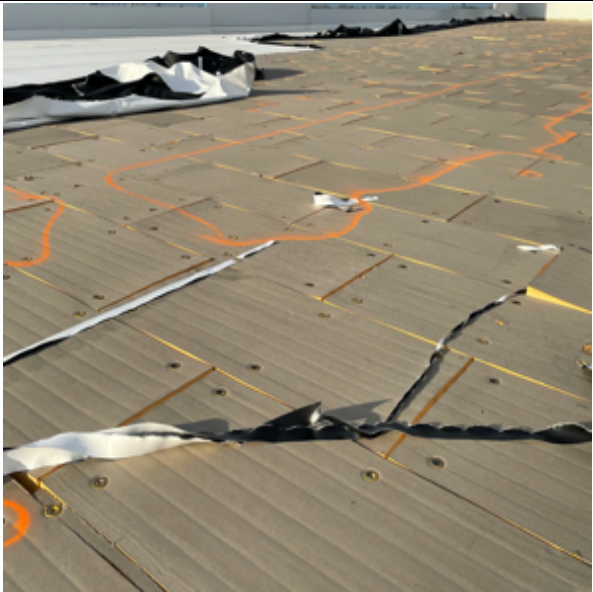
Photo 13: Near total blow off of a mechanically attached single ply system. It originated at a roof corner where ground-floor window damage caused a breach in the metal deck and pressurized the roof.

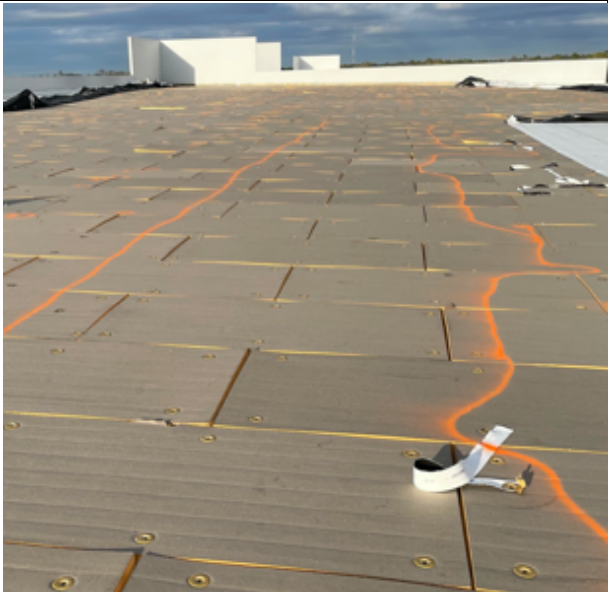
Photo 14: There were large areas where the induction welds to fasteners were completely missed or poorly done, making them more vulnerable to blow off.

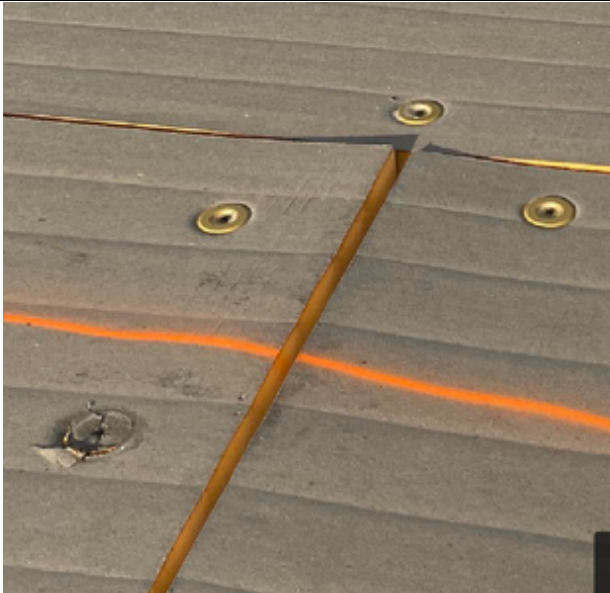
Photo 15: A fastener with a good weld and fasteners with incomplete welds.

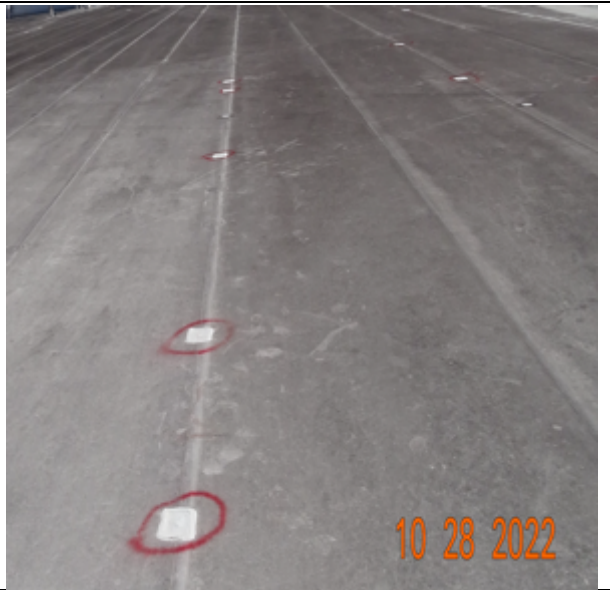
Photo 18: Punctures from air handler parts that became windblown projectiles.

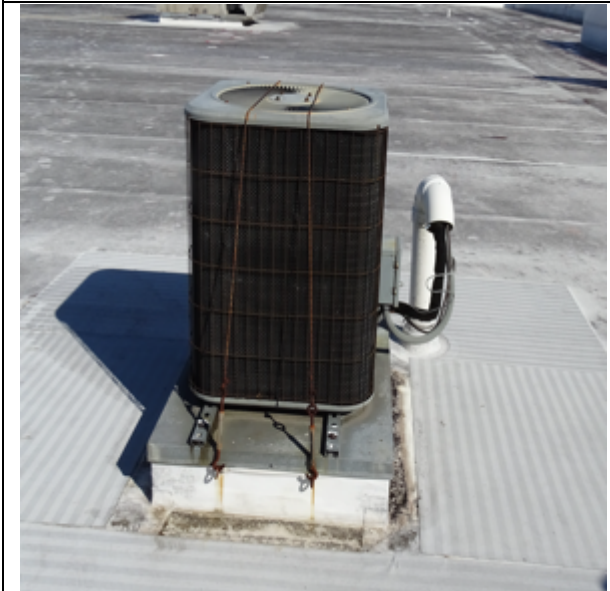
Photo 19: A secure air handler still attached.

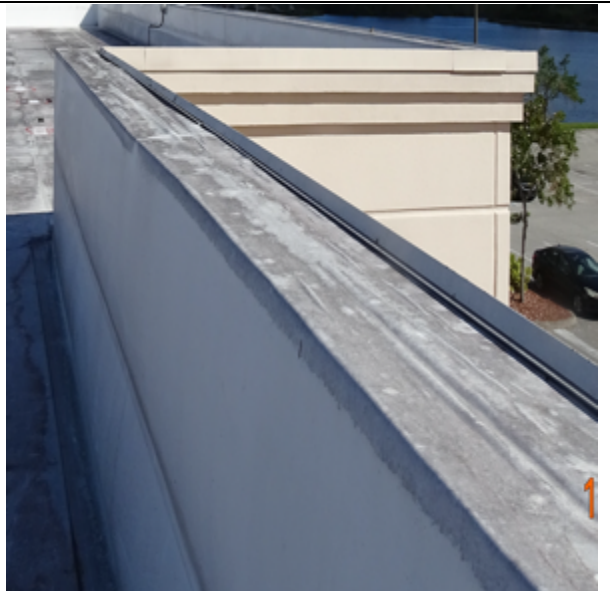
Photo 20: Coping that is undamaged.

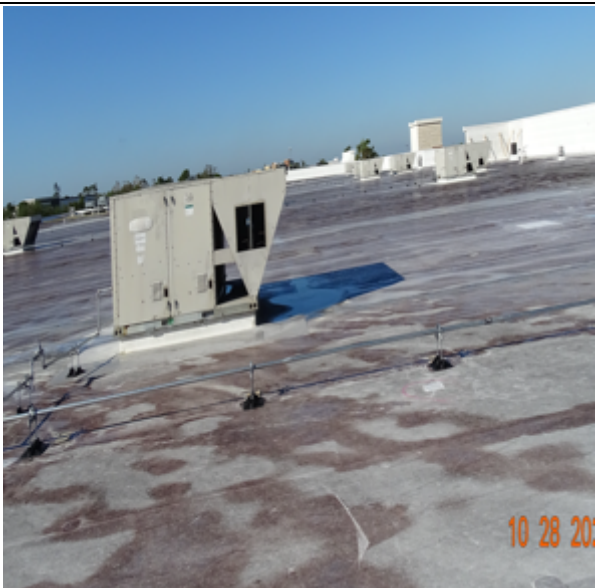
Photo 21: Overview of the CASE STUDY 6 roof.

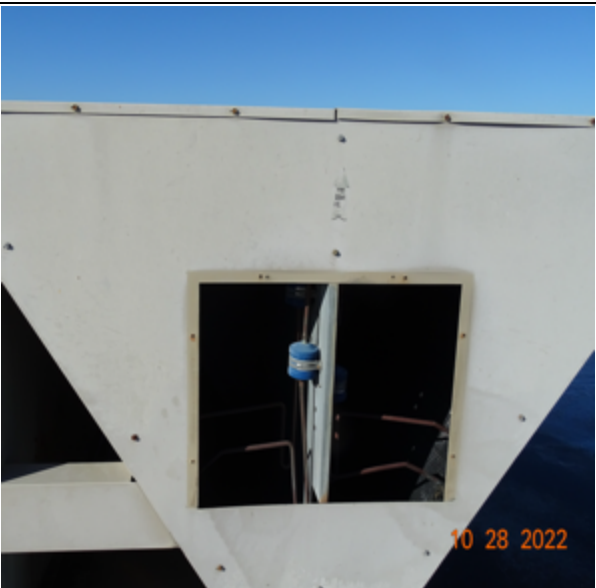
Source of much of the roof damage i.e., when inspection panel detached it became a windblown projectile with sharp corners.

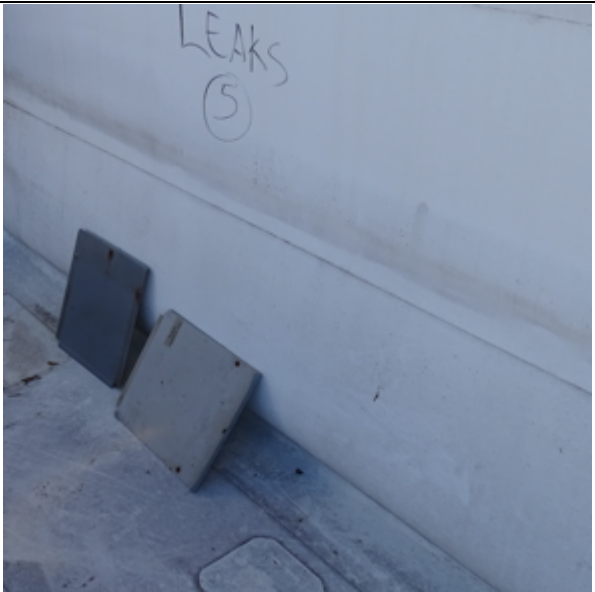
Photo 23: Detached metal panels that were dislodged and created many cuts in the membrane on this roof.

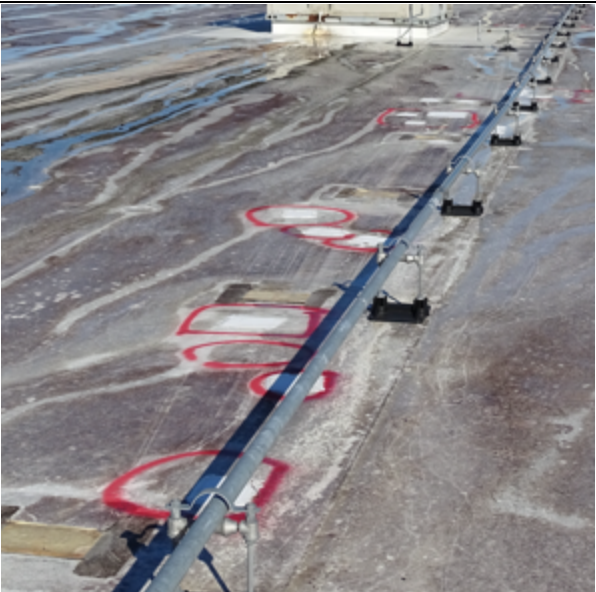
Photo 24: Pipe was moved by wind, tearing the membrane.

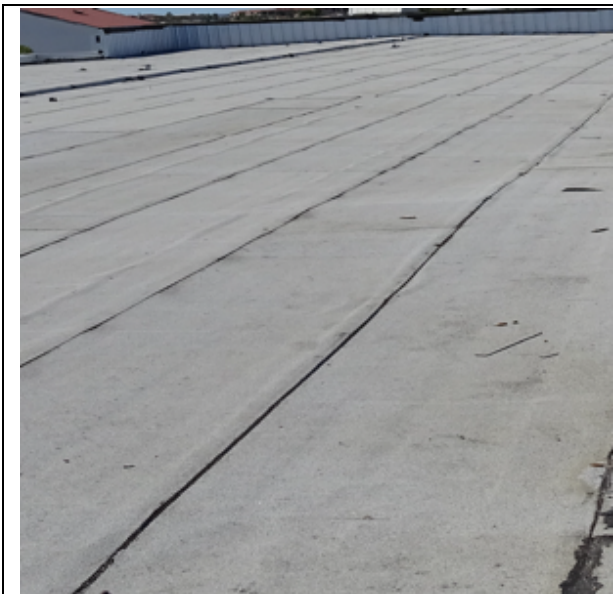
Photo 25: Temporary roof over entire building.

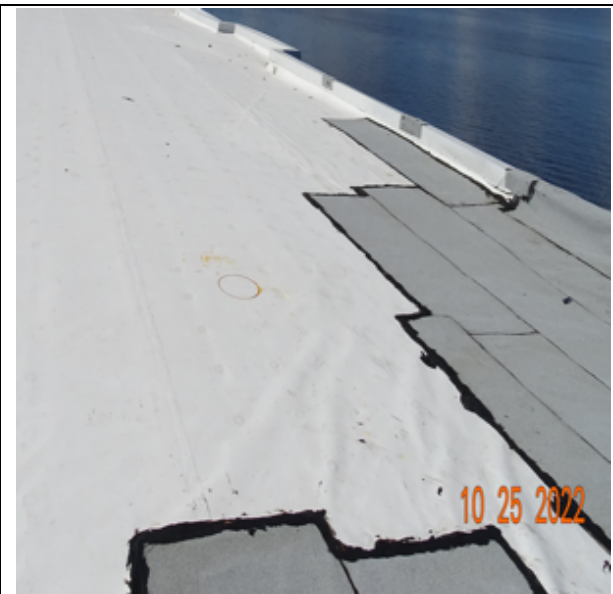
Photo 26: Emergency (temporary) repairs to adjacent building.

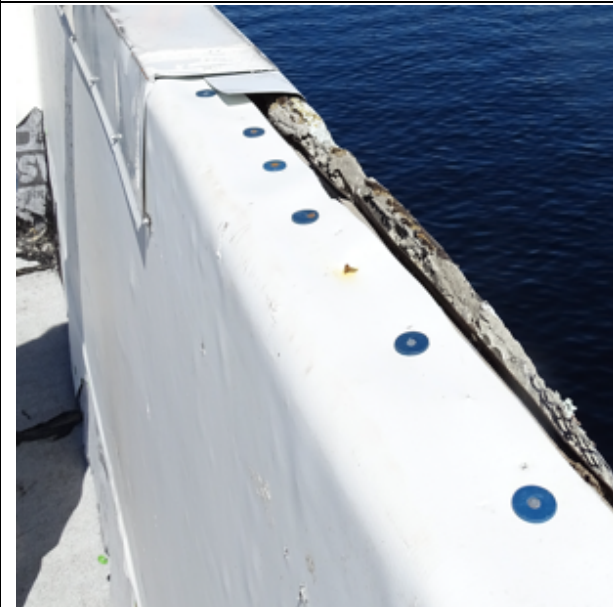
Photo 28: All three buildings had significant coping and edge metal detachment.

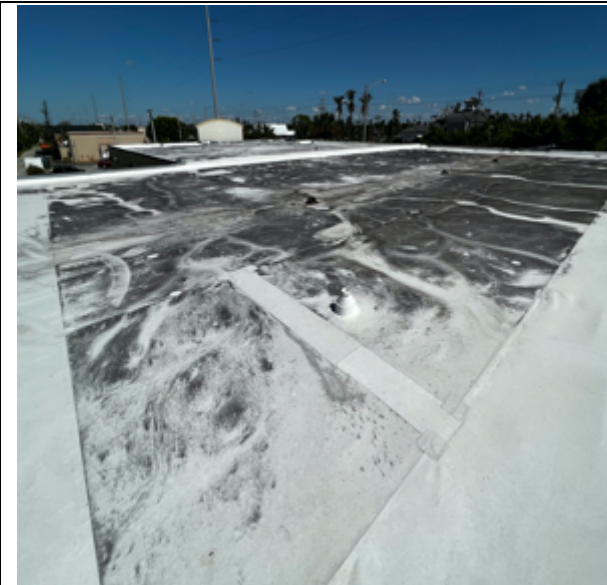
Photo 29: Overview with repaired sections shown as newer/cleaner membrane.

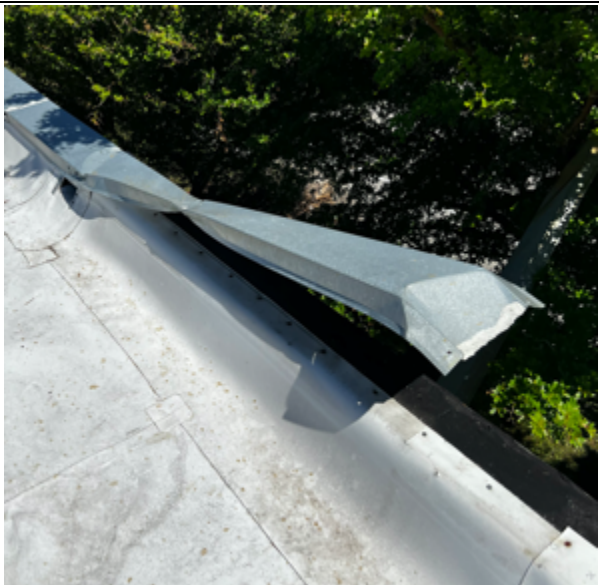
Photo 30: Metal coping partial detachment.

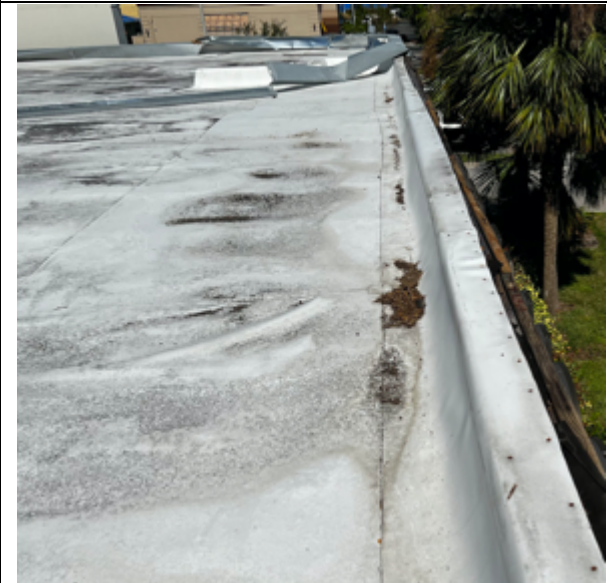
Photo 31: Extensive metal coping detachment left openings for water intrusion between membrane and deck.

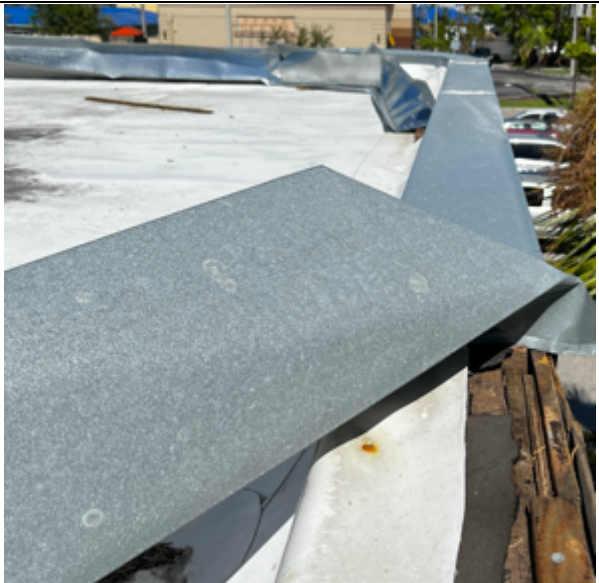
Photo 32: Lack of edge metal fasteners caused coping to have inadequate wind resistance and contributed to detachment.

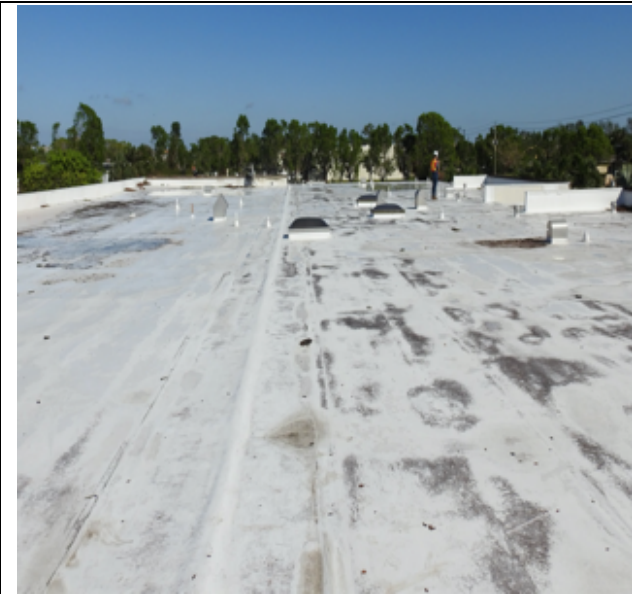
Photo 33: An overview shows that the field of the roof appears largely undamaged.

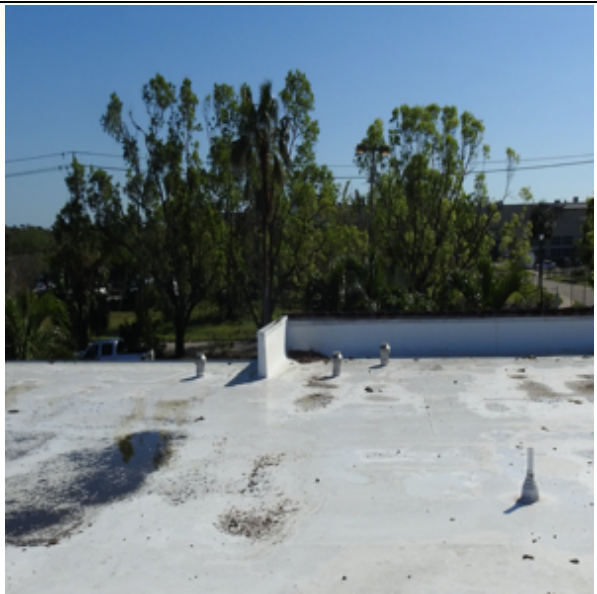
Photo 34: Intact edges indicate that much of the roof was relatively undamaged.

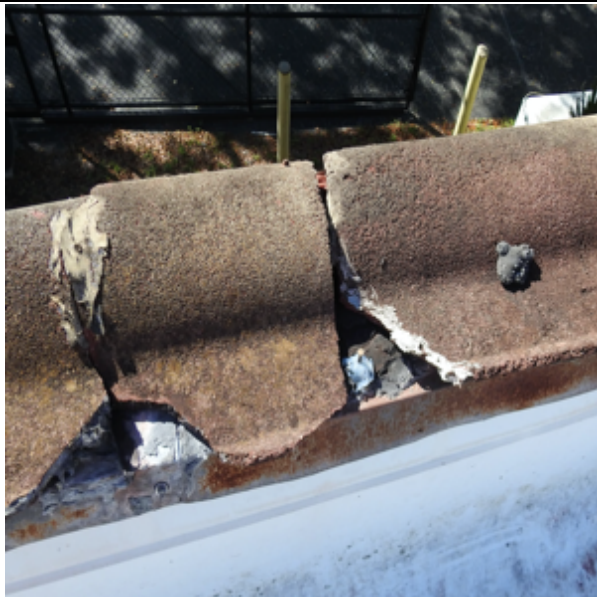
Photo 36: Damaged tile, from windblown projectile impact or wind-induced vibration.

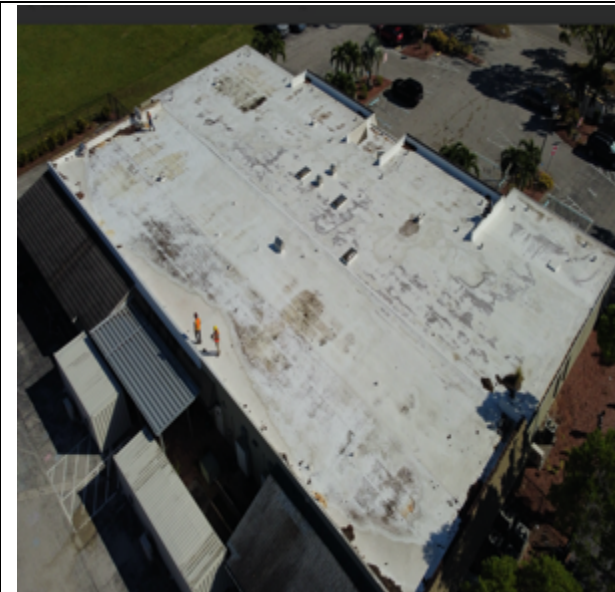
Photo 37: A drone view of the Pace Center roof shows the field largely undamaged.

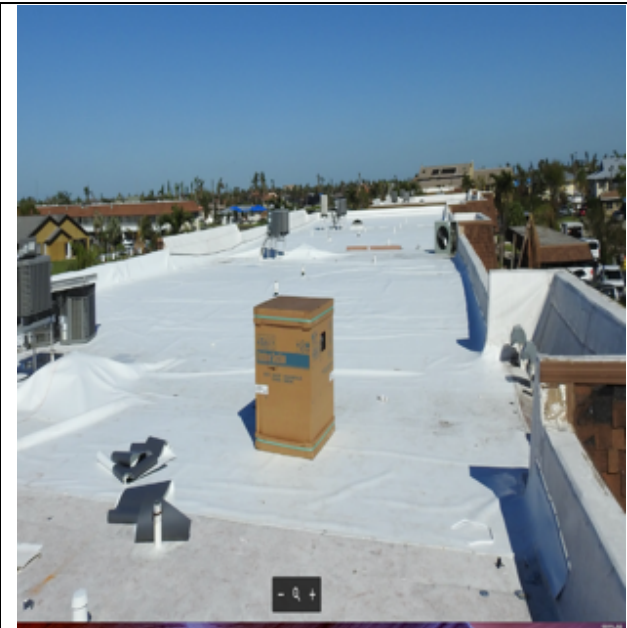
Photo 39: Overview shows ongoing temporary repairs.

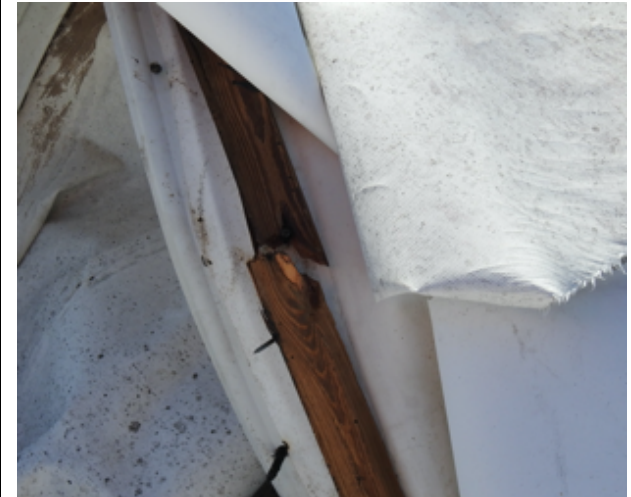
Photo 43: Edge damage like this may allow water intrusion through openings between roof membrane and deck.

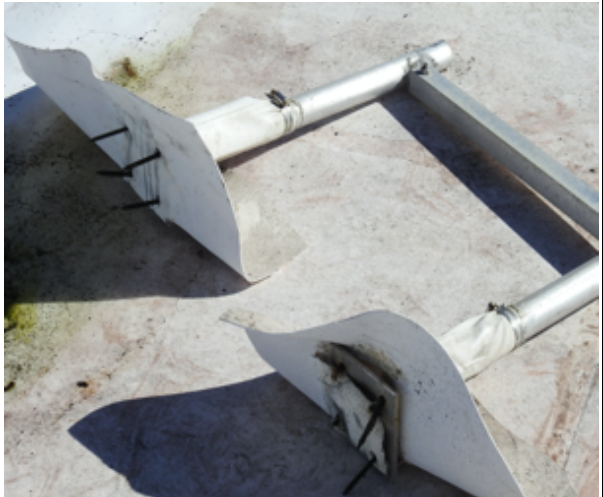
Photo 44: Typical air handler stanchion damage, which often causes punctures, gouges, cuts, or tears in the membrane

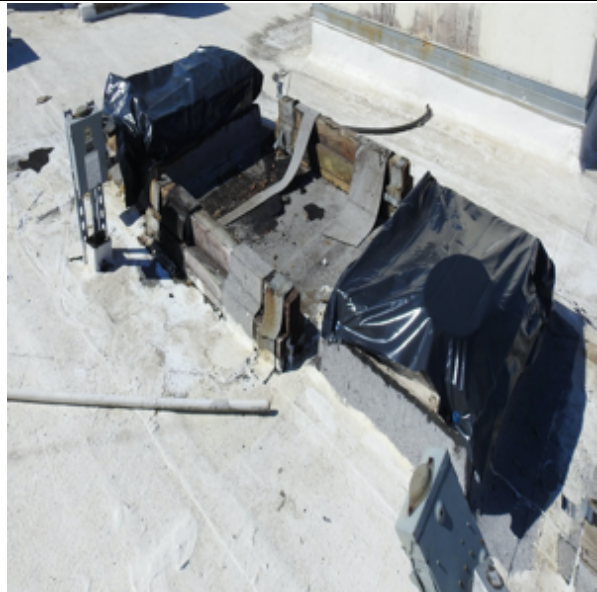
Photo 41: Air handling unit displaced

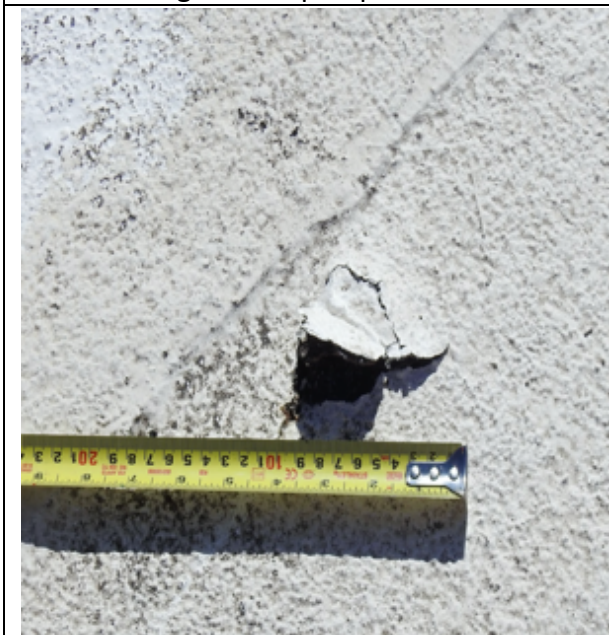
Photo 42: Cut from debris

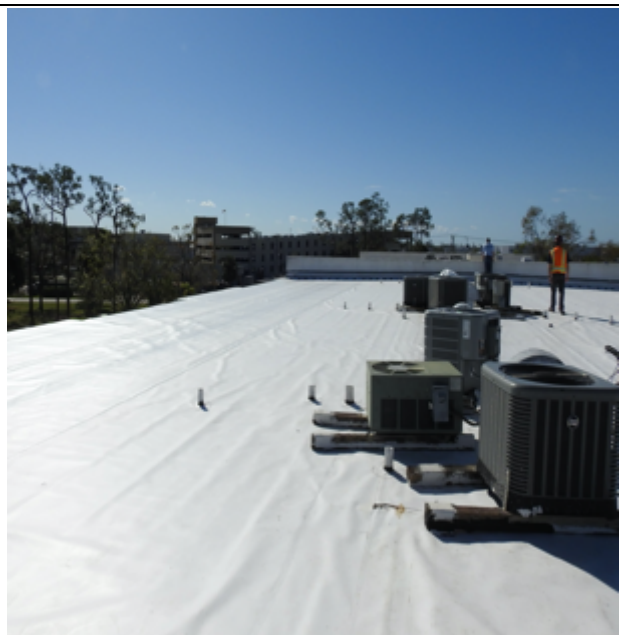
Photo 43: Roof section with temporary recover

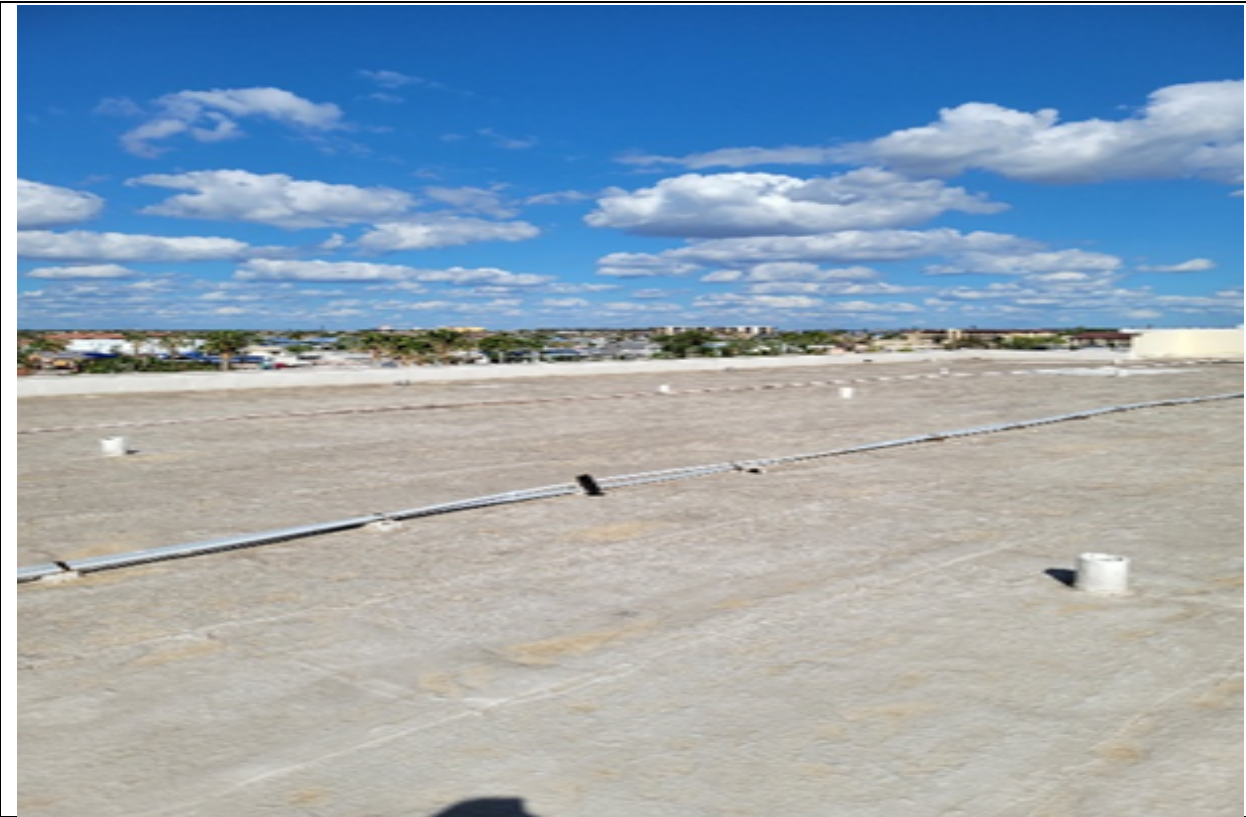
Photo 45c: The rest of the roof was not damaged

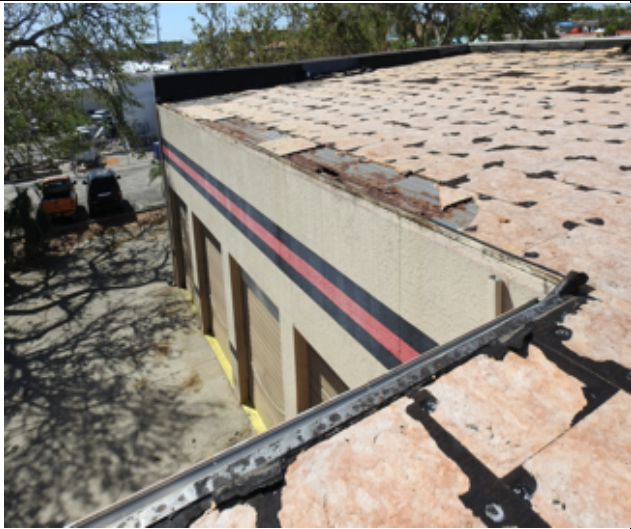
Photo 46: Adhered Mod Bit damage

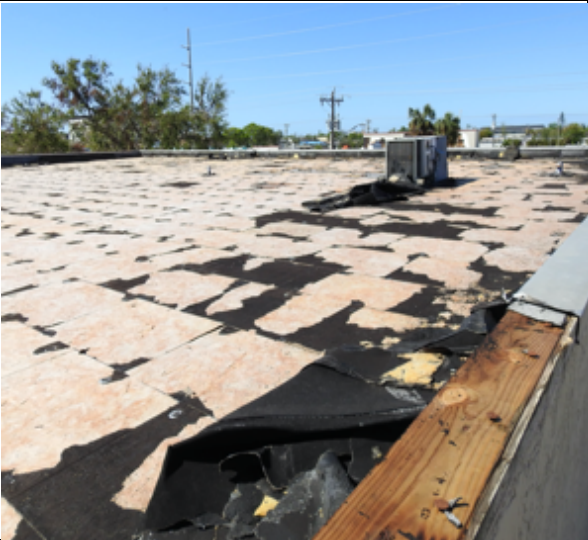
Photo 47: Some parapet damage

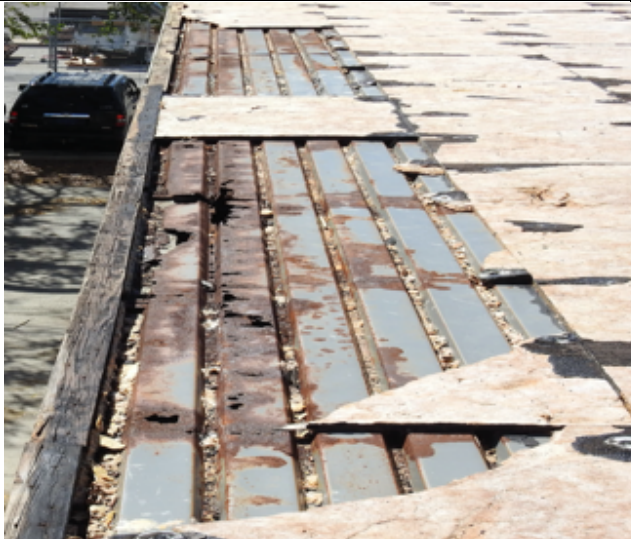
Photo 48: Rusted deck main source of blow off

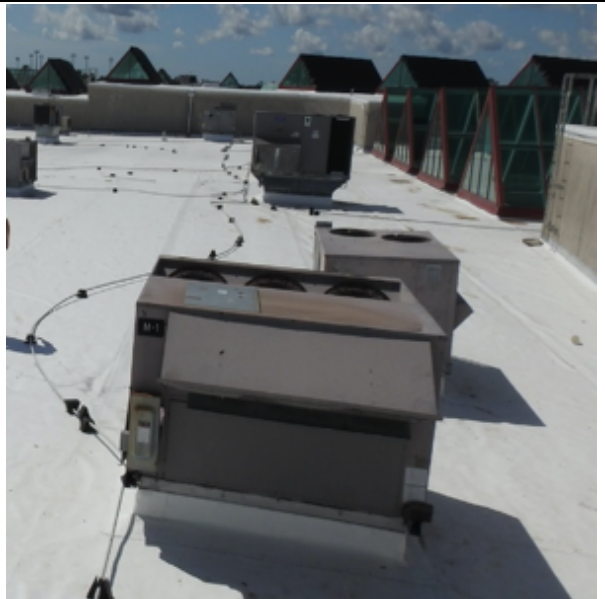
Photo 53: Loose lightning arrester wire

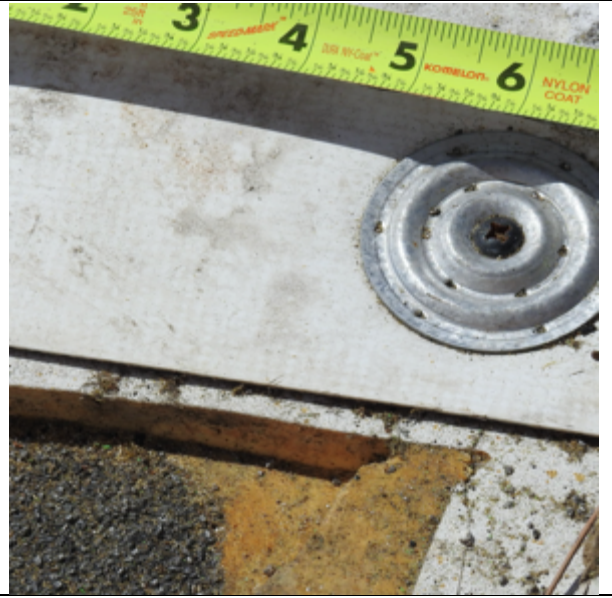
Photo 55: Initial fastening over BUR roof.

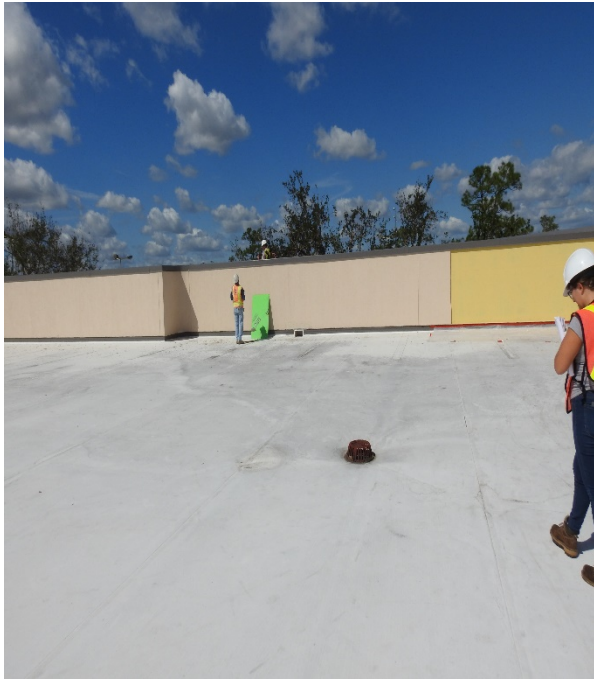
Photo: 55a the rest of the roof had 5ft parapets and was not damaged

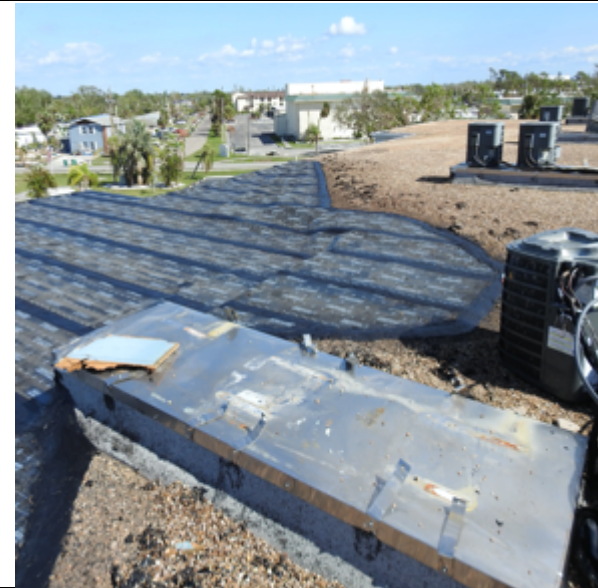
Photo 56: Temporary patch in corner

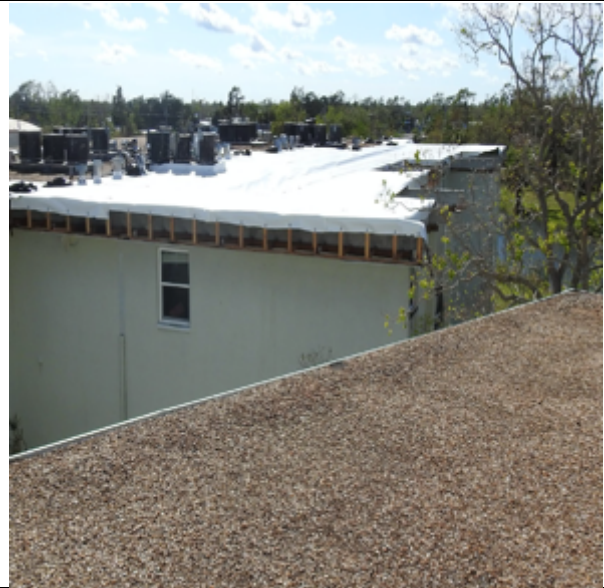
Photo 57: Another roof section with a temporary roof. Note no parapet or gravel stop. Also, soffit damage.

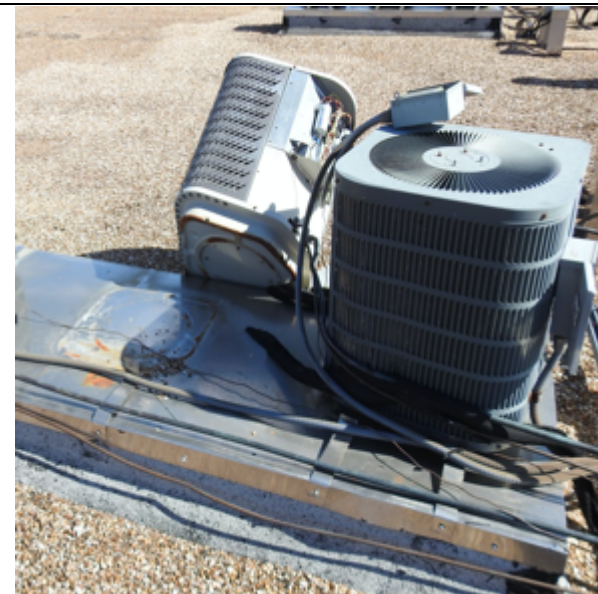
Photo 58: Damaged air handling unit

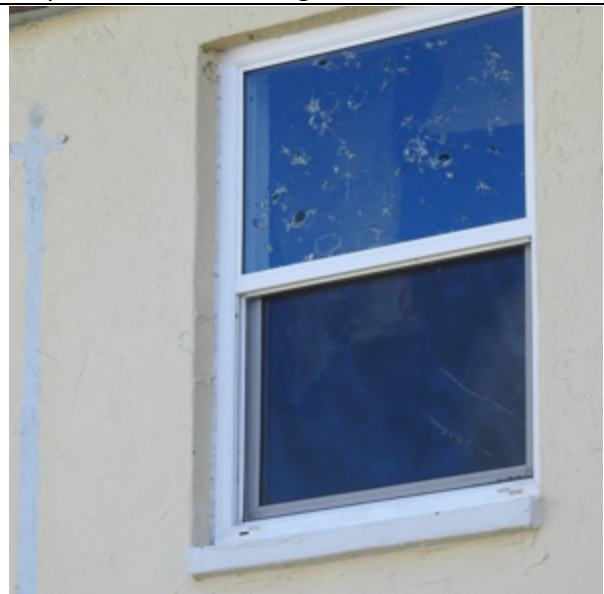
Photo 59: Missing down spout, and debris damaged window

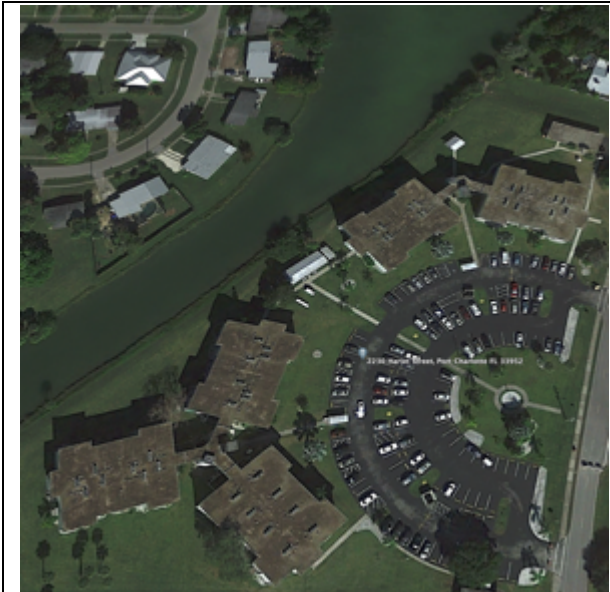
Photo 59: Google earth view (2021) water facing units had most damage

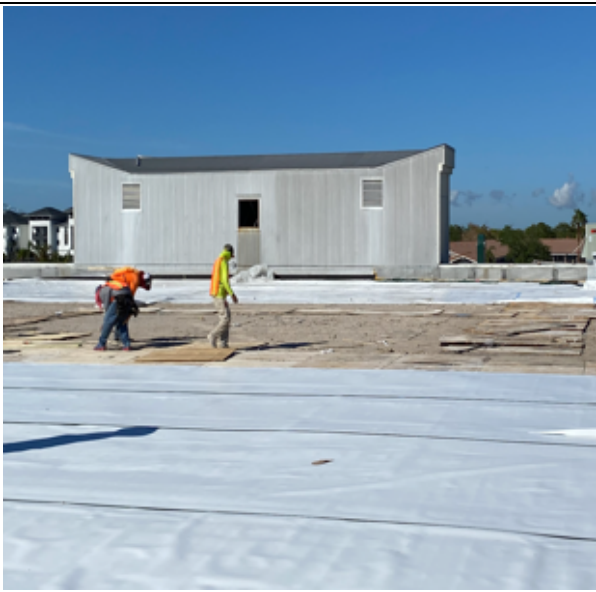
Photo 61: Temporary(?) Roof installation. Plywood being placed between membrane and lightweight concrete, both to separate and provide a safe (?) walking surface.

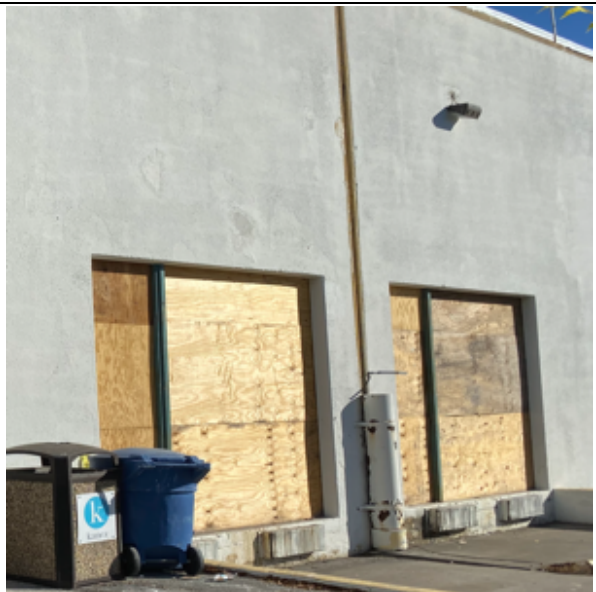
Photo 62: Primary source of roof damage, door failure pressurizing the roof.

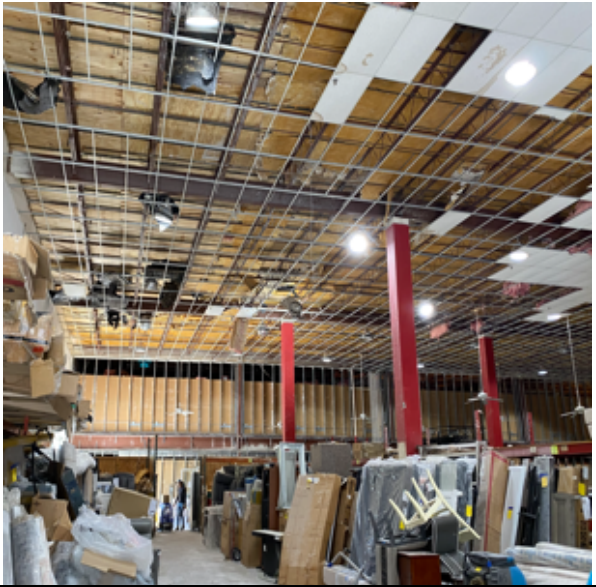
Photo 62: Significant interior and product damage

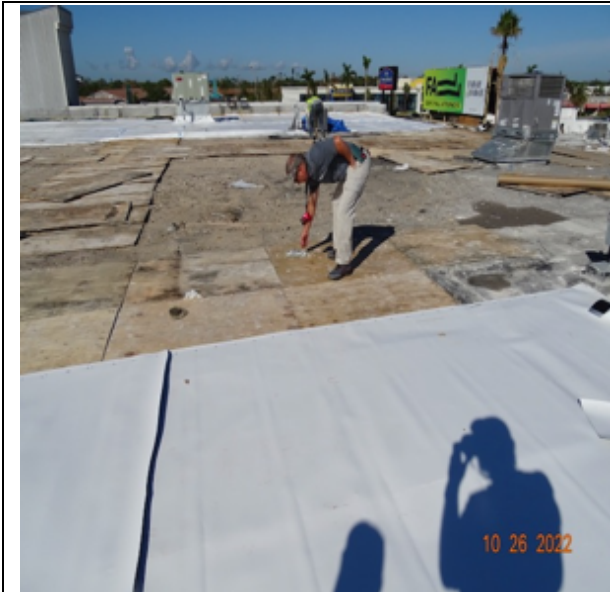
Photo 64: Temporary fastening to deck

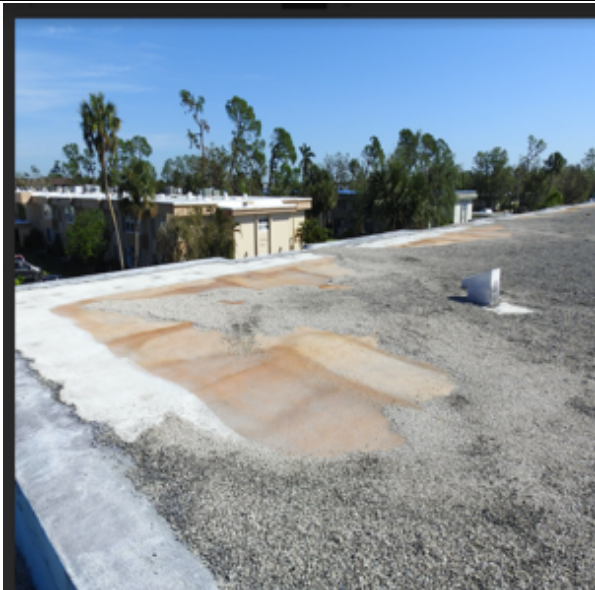
Photo 66: Foam is intact, significant scour

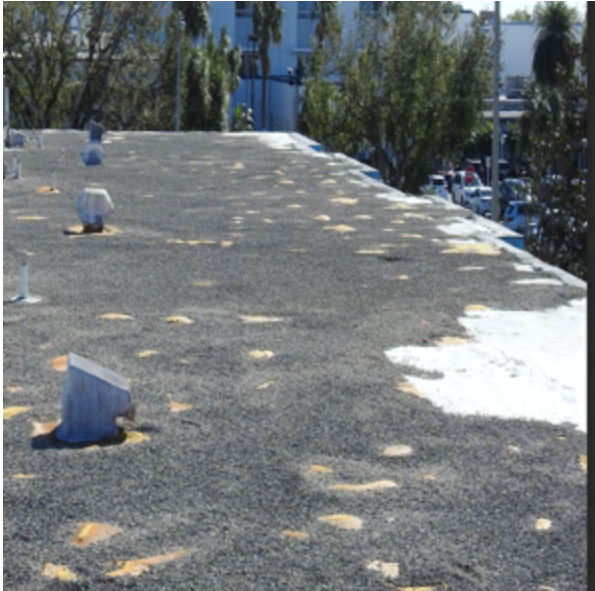
Photo 68: No parapet or gravel stop. Wind scour at all perimeters. Notice widespread blisters are also scoured.

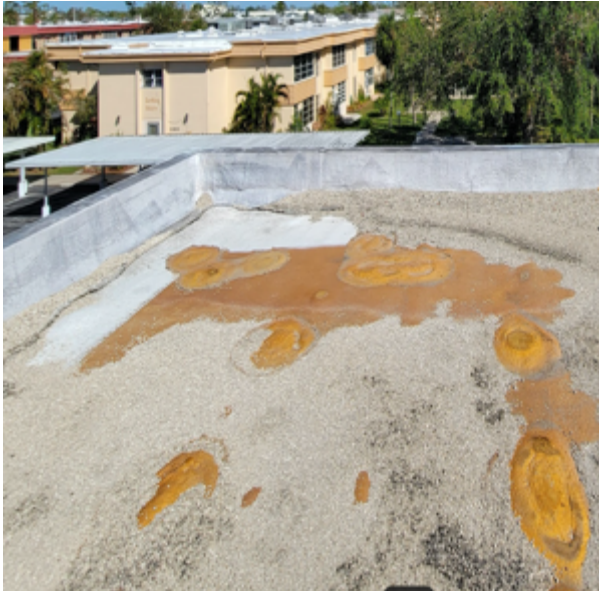
Photo 69: Upwind low parapet typical wind scour of small aggregate.

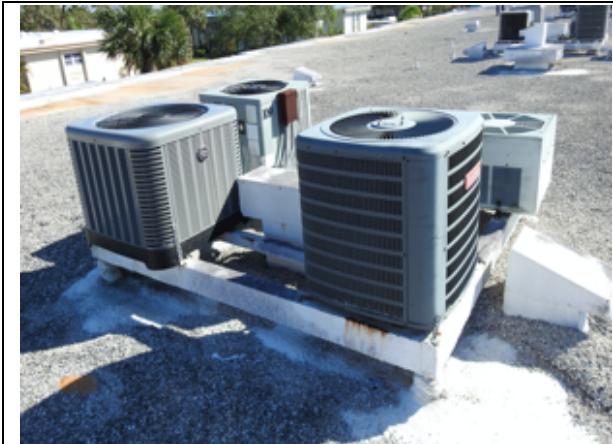
Photo 70: Intact air handlers

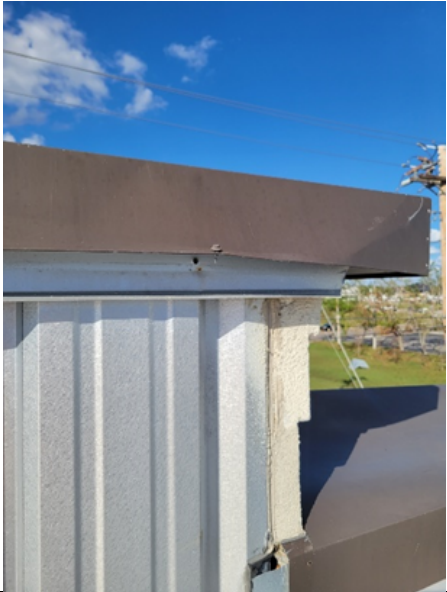
Photo: Fastener pulled out of the coping
