Hurricane Ian

Roofing Industry Committee on Weather Issues, Inc.

Storm Investigation Program

September 30, 2023

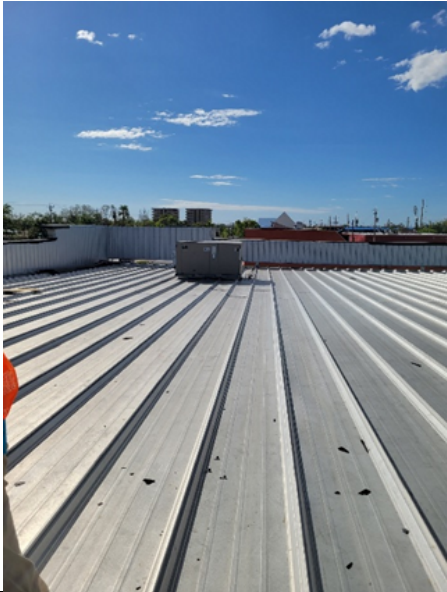
Photo: The right of the roof was mostly undamaged

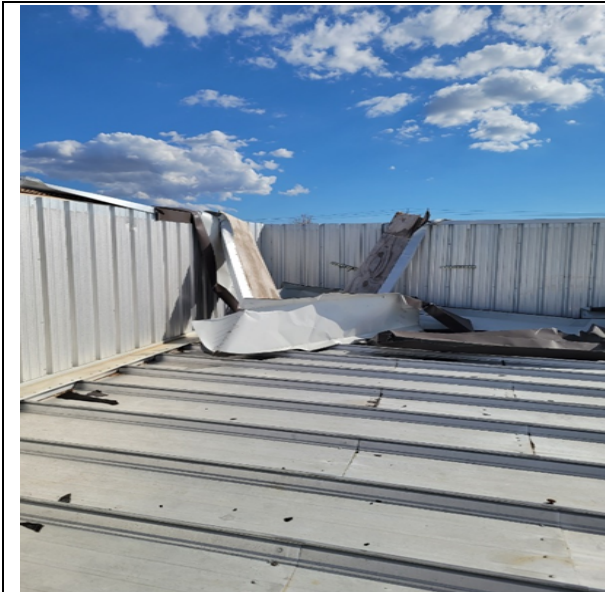
Photo: Damaged edge metal and 1/2 inch plywood sheet

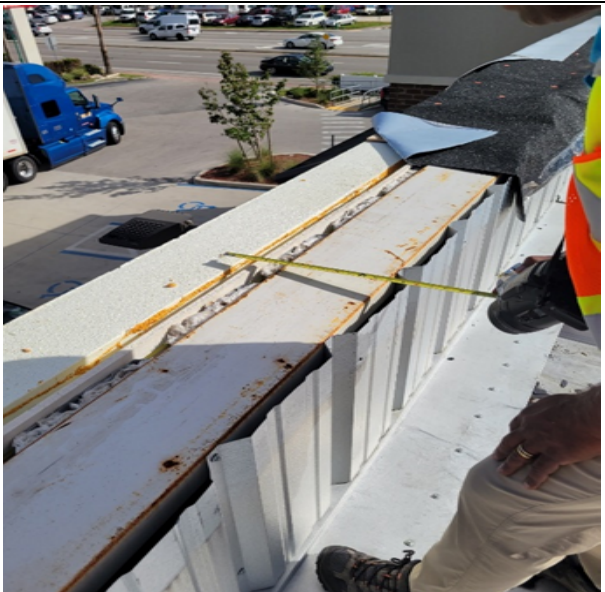
Photo: Missing coping increasing risk of water infiltration

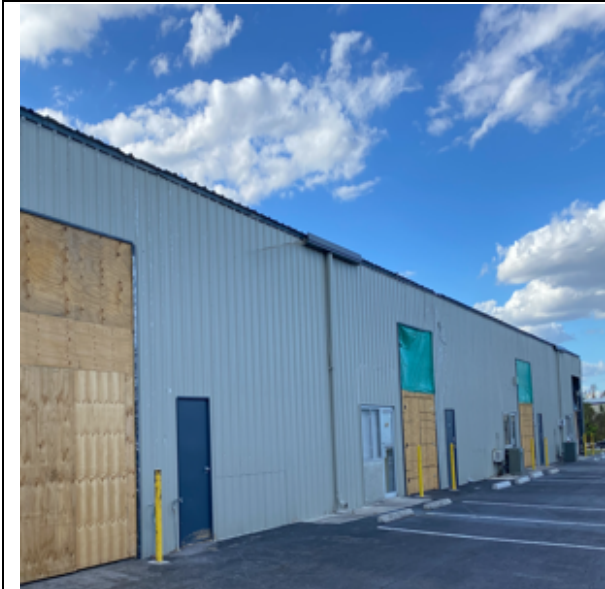
Photo 74: Metal roofed building with minimal roofing loss, with gutter damage

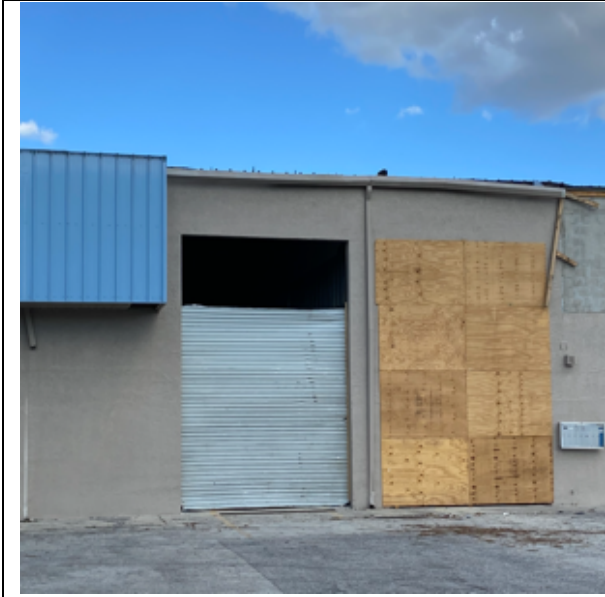
Photo 76: Intact entrance cover, door damage

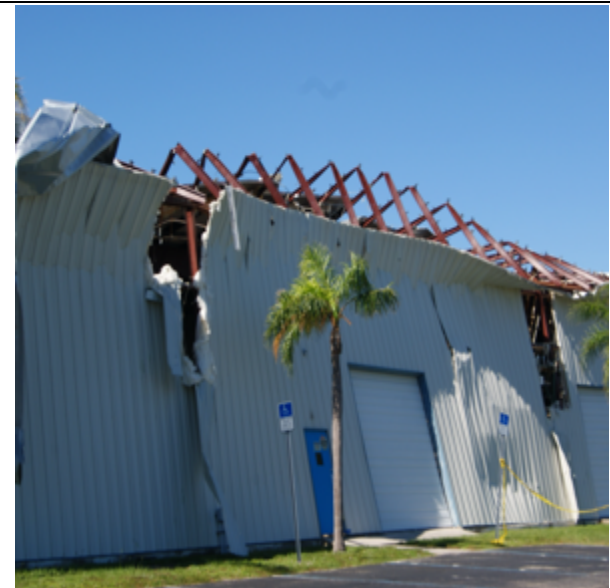
This is included as it is an unusual result. The building is at Punta Gorda airport and likely had wind gusts of 130 mph. It also had little obstruction between the building and the open airfield. The building built in the 1980's appears to not have been damaged by Hurricane Charley in 2004. Other significant structural damage was not noted in the RICOWI field investigations.

Photo 81: This wall faces Northeast, where the greatest wind speed gust in Hurricane Ian is likely.

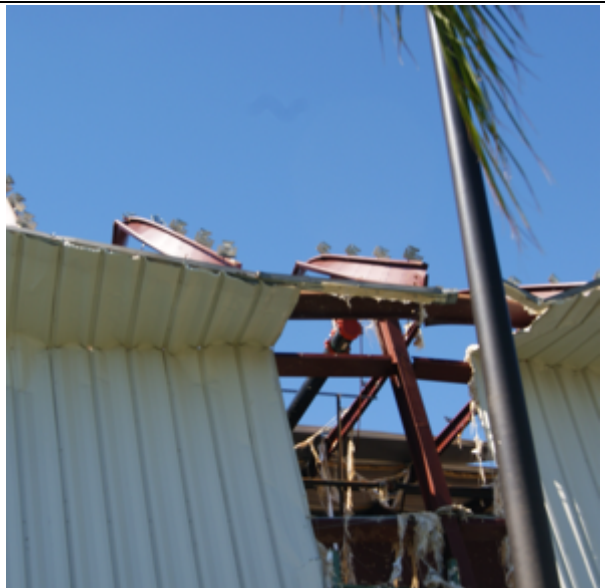
Photo 82: Wall is breached

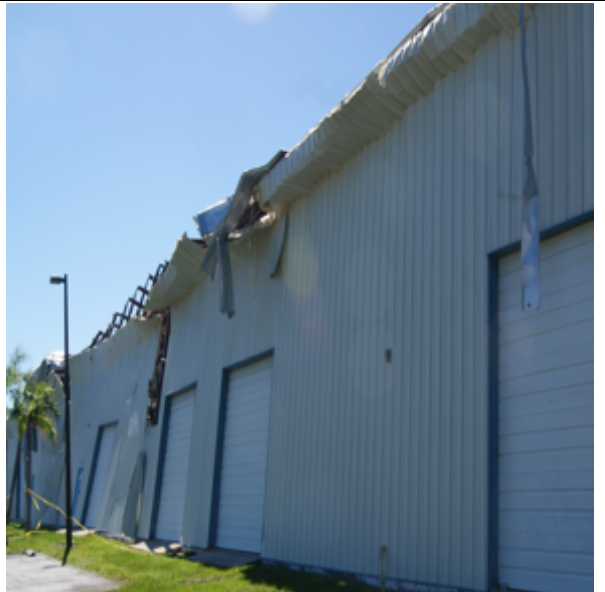
Photo 84: Doors resisted the winds.

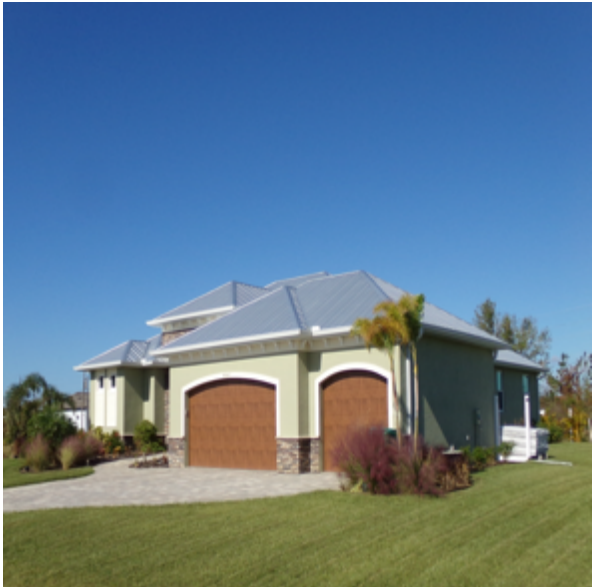
Photo 85: Through fastened metal Roof Survivor of 130 mph winds. Open terrain.

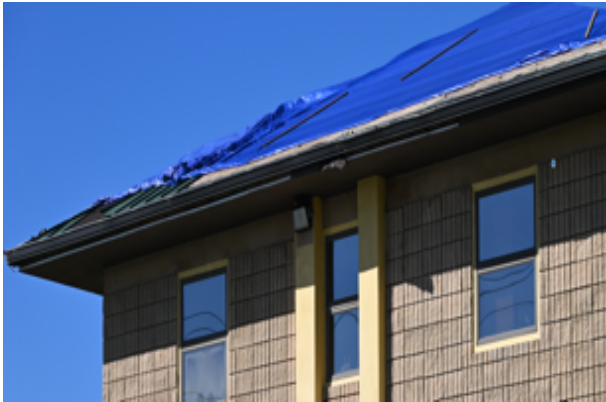
Photo 87: About half this metal roof may have been damaged

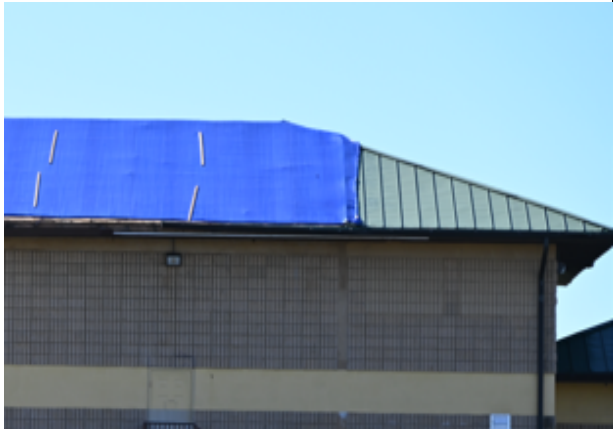
Photo 88: Tarps cover most of the roof

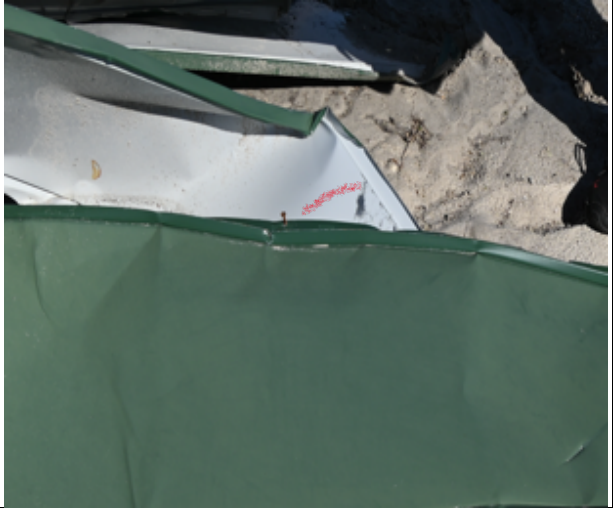
Photo 90: This tiny fastener did not hold the metal

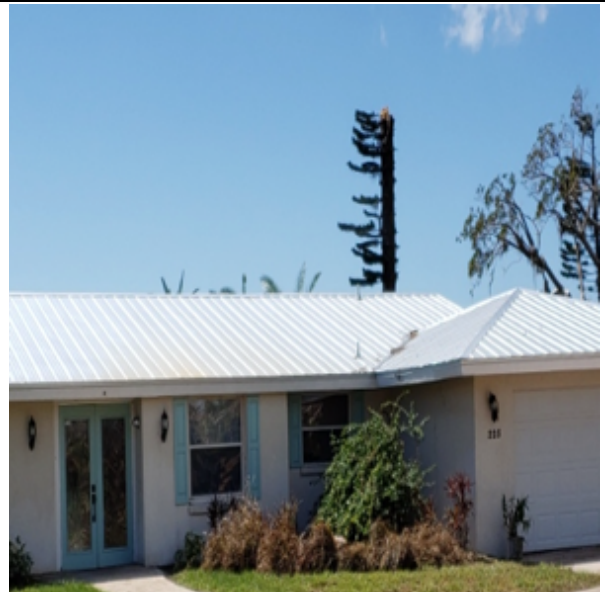
Photo 92: Successful older installation, 120 mph wind

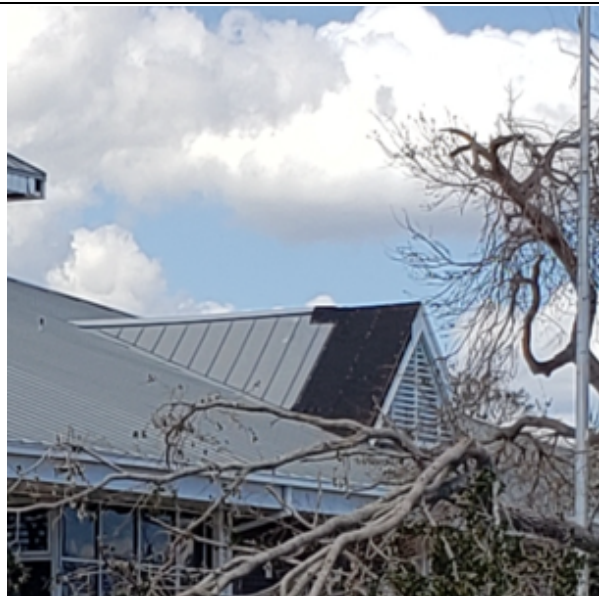
Photo 93: Damaged roof in 130 mph windspeed. Inadequate edge fastening

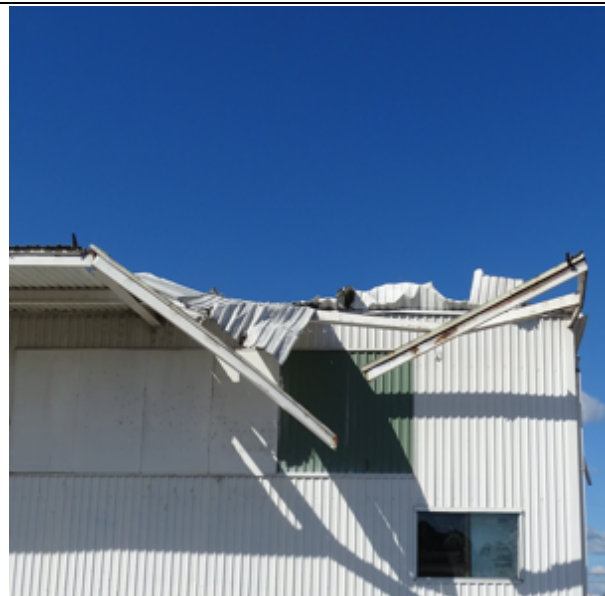
Photo 94: Overhangs are vulnerable, more bracing was needed, 110 mph winds.

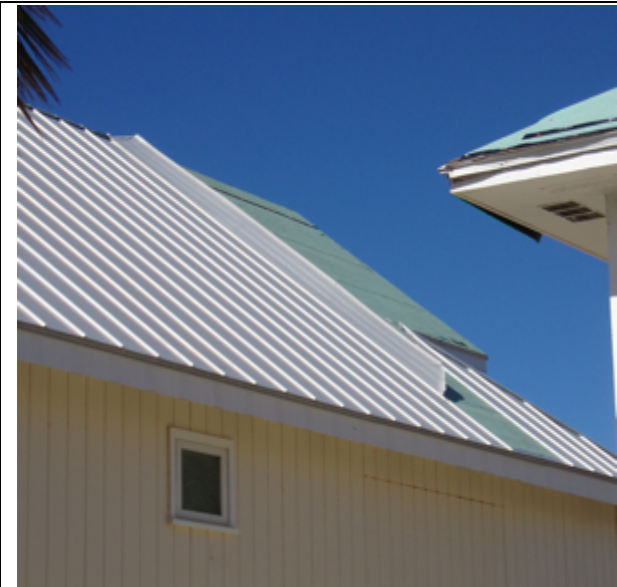
General observations: Most roofs were metal and performed well. One roof in the area was a nail strip with seams 16" O.C and fastening 10" O.C., minor roof failure due to fastener pull out and pull over. Hip flashing failure due to rivets being spaced at 30" O.C. to cleat.

Photo 95: Panels missing on rake edge

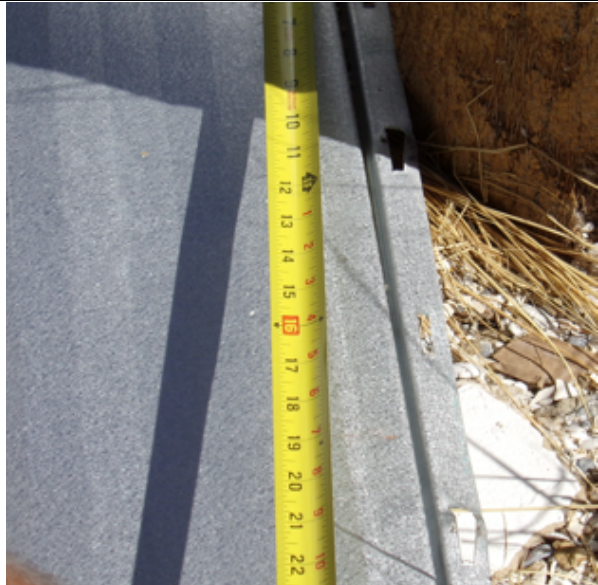
Photo 97: This roof had seams 16 O.C. and fastening 10" O.C.

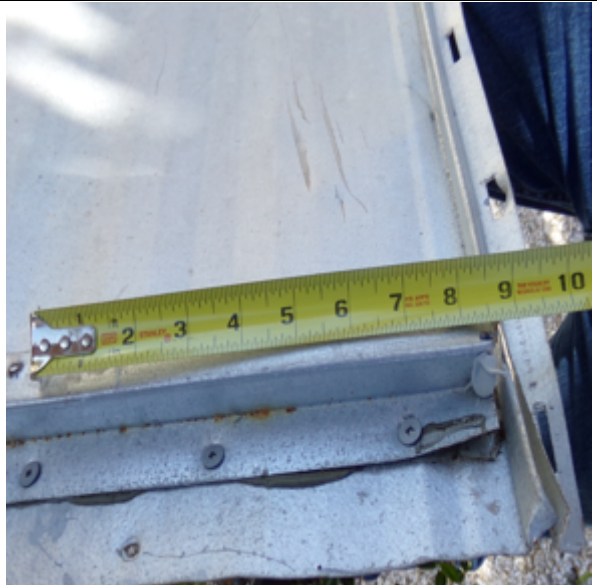
Photo 97: Hip flashing failure due to rivets being spaced at 30" O.C. to cleat.

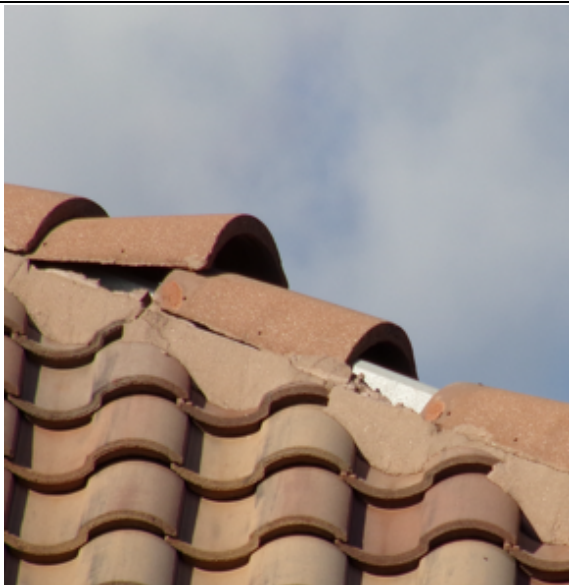
Photo 106: This was a frequent scene with a few hip tiles not contacted with SPF

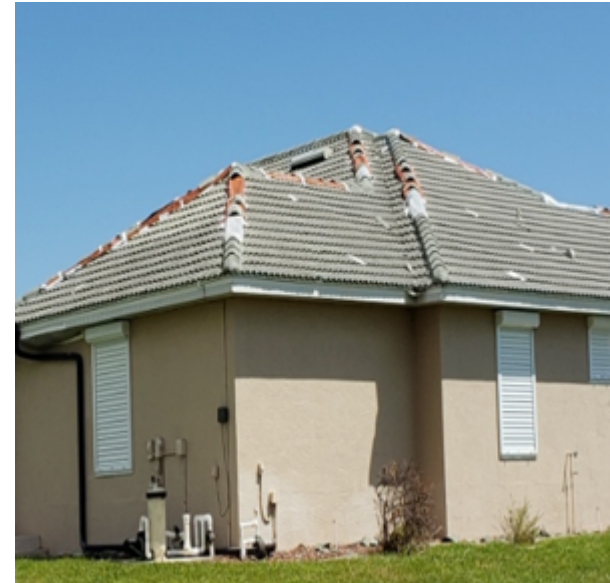
Photo 107: Lack of full foam contact at the hip and allowed ridge tiles to become detached, becoming windblown projectiles, and further damaging the roof.

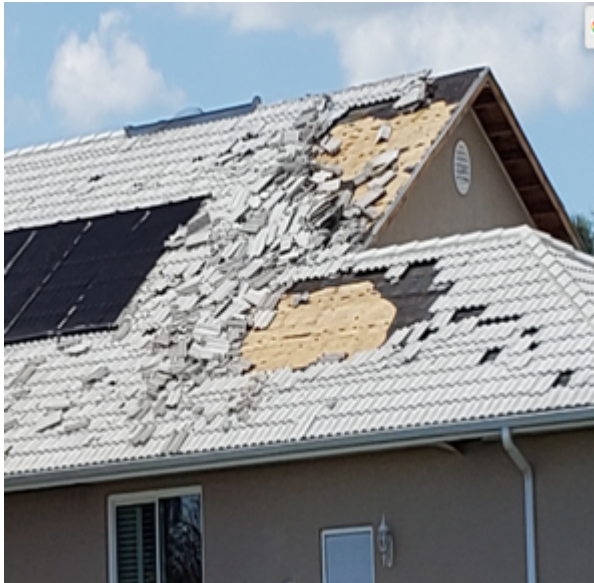
Photo 108: This is an extreme case of tile and underlayment detachment. Tiles were nailed.

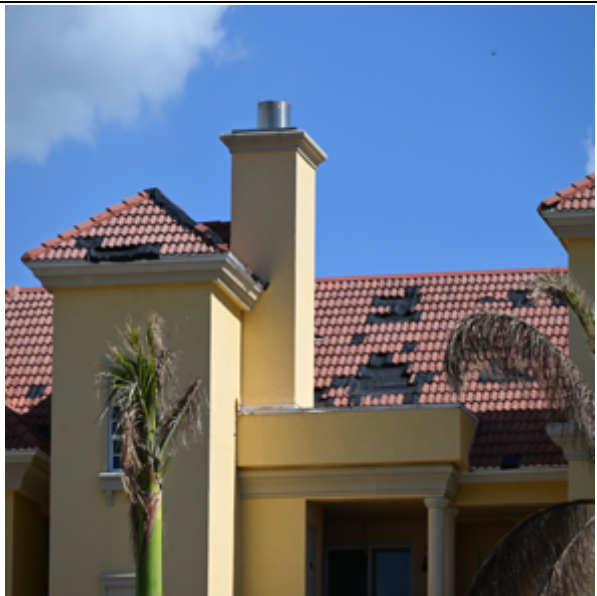
Photo 110: Random impact damage from windblown projectiles; underlayment intact.

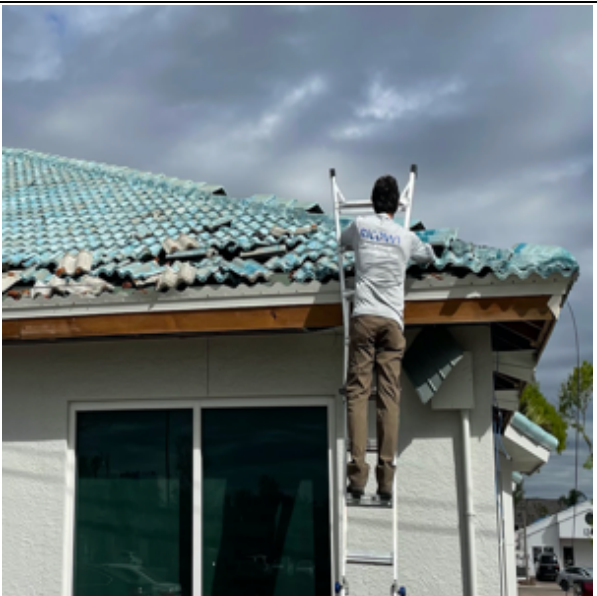
Photo 112: Area of damage, along roof edge

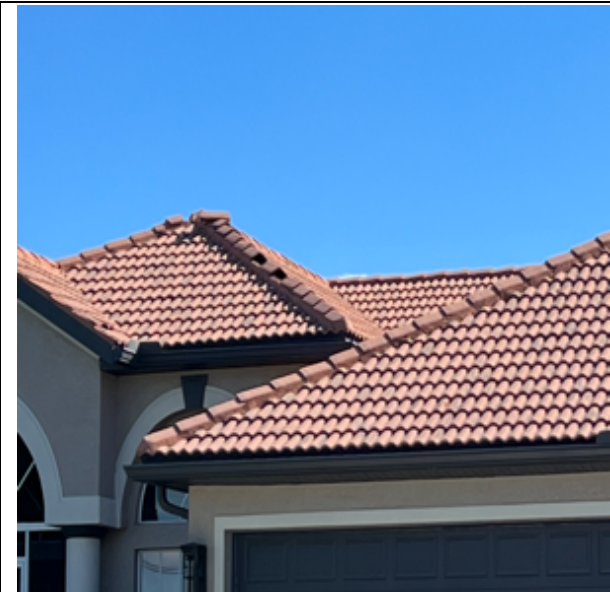
Photo 113: SW 39th Ave Cape Coral A tile roof subjected to 110 mph exhibited some hip damage.

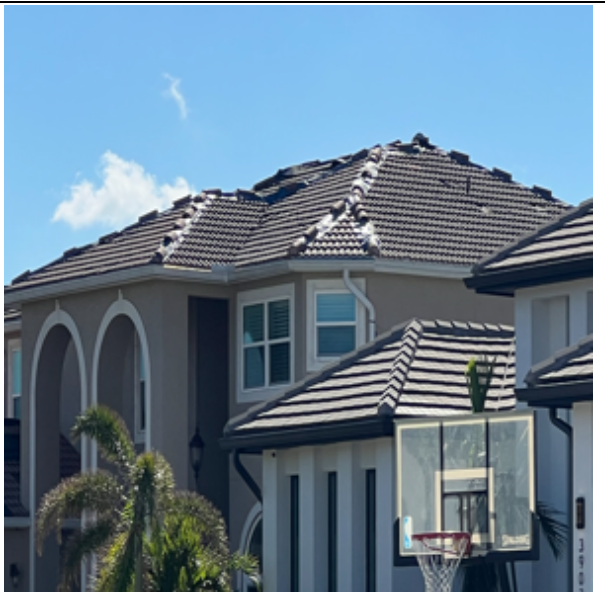
Photo 114: Another tile roof subjected to 110 mph winds, causing dislodged/detached hip tiles.

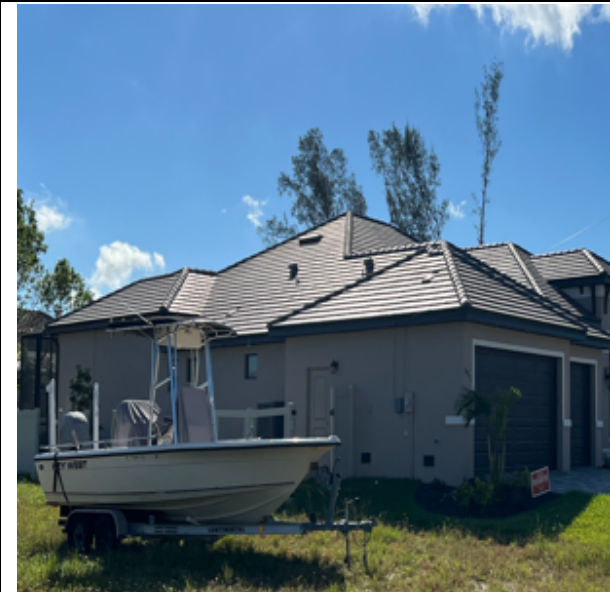
Photo 115: SW 39th Ave Winds of 110 mph. No damage observed

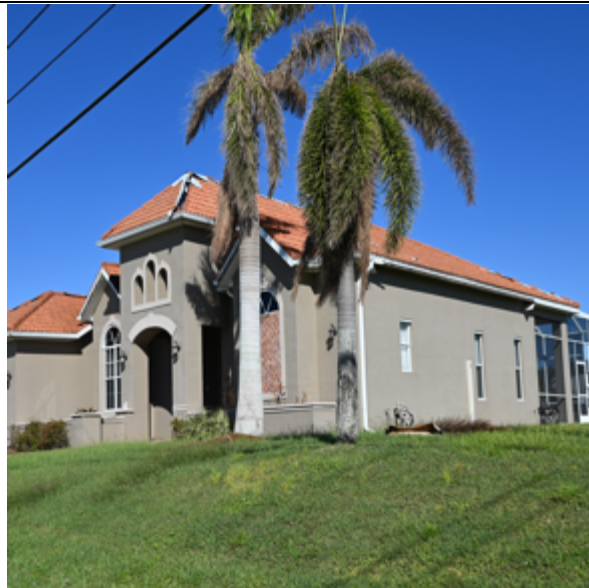
Photo 117: Typical missing tile on hip

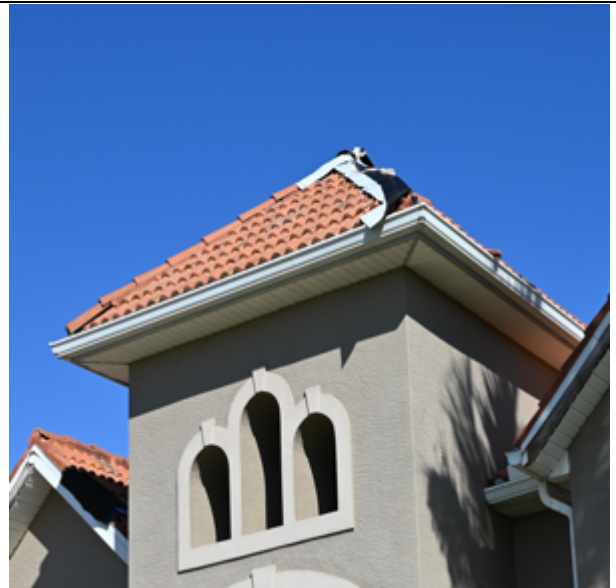
Photo 118: Tile missing from high hip

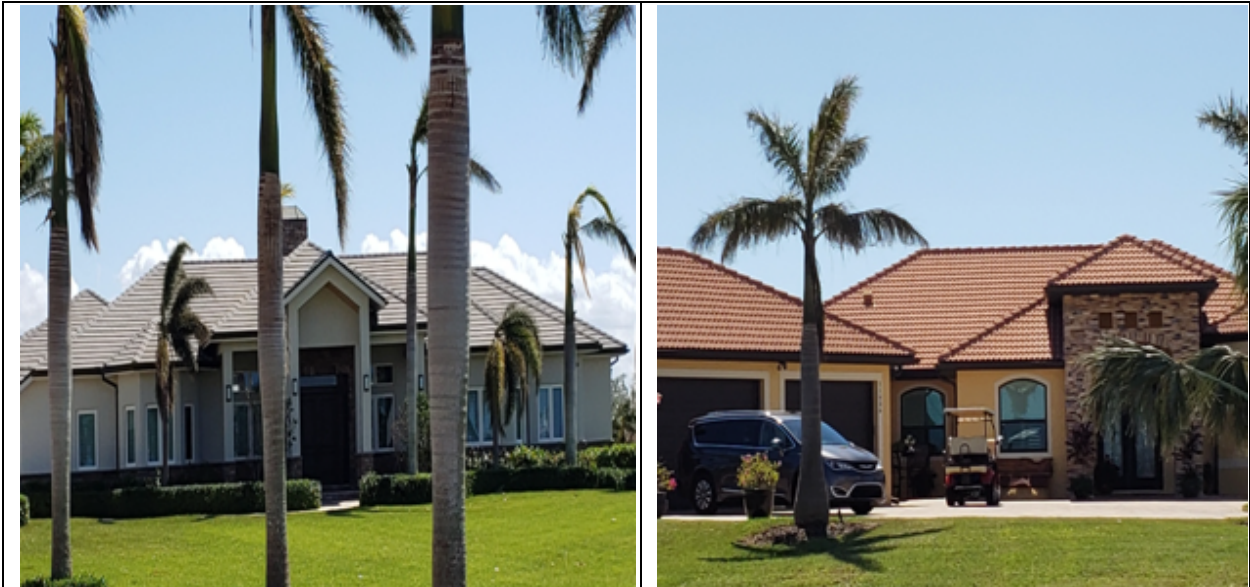
Photos 125 & 126: These roofs appeared undamaged despite Class C wind exposure and 130 mph winds so neatly cleaned up.

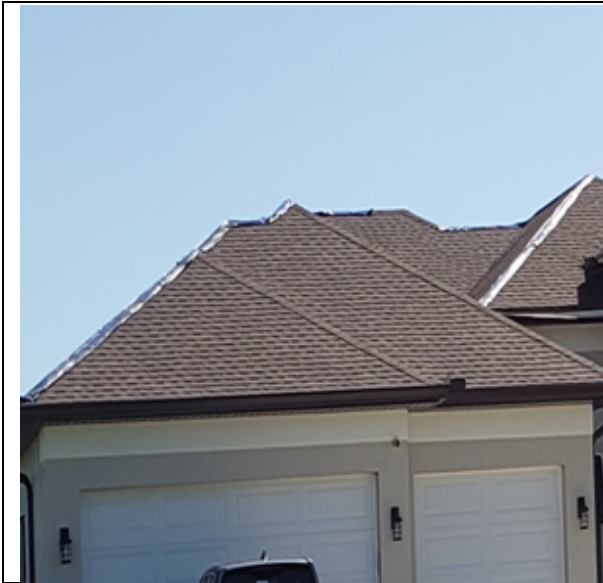
Photo 127: Ridge and hip damage

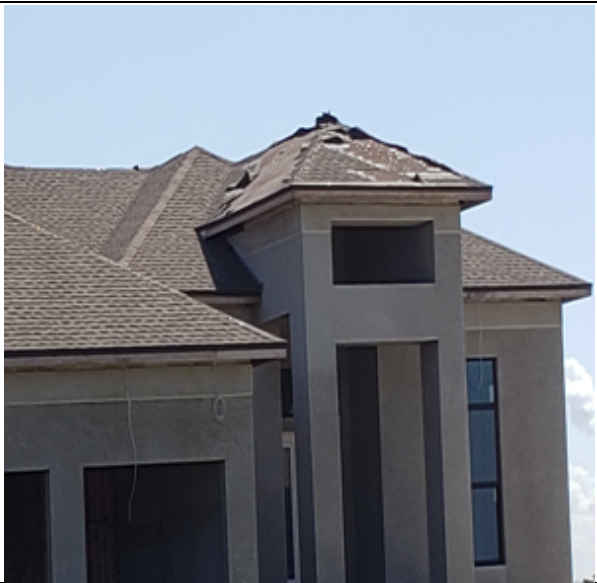
Photo128: Some damage on high roof

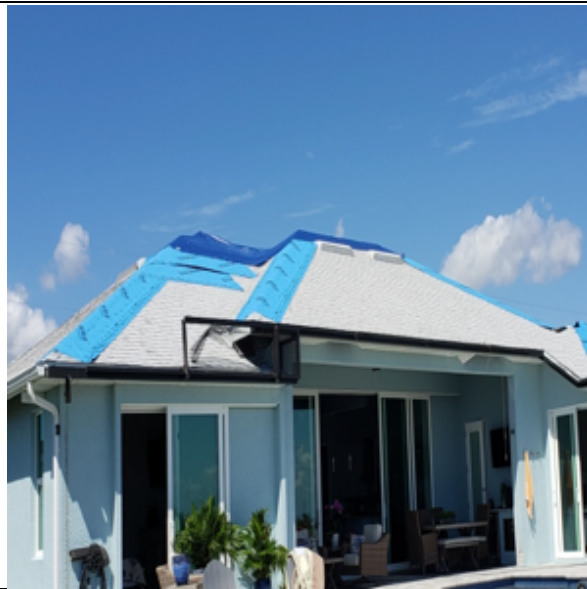
Photo 131: Hip and ridge damage

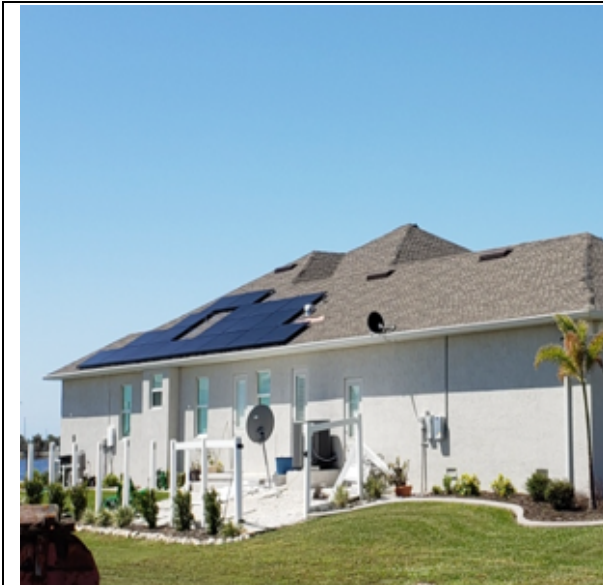
Photo 133: Solar array undamaged

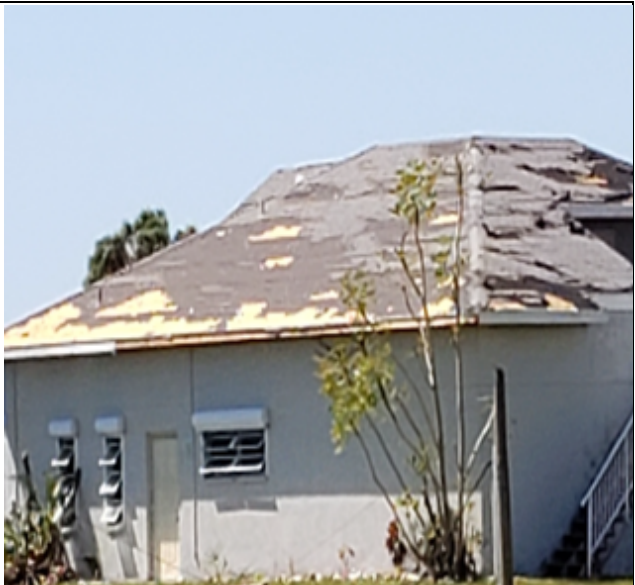
Photo 134: Older asphalt shingles

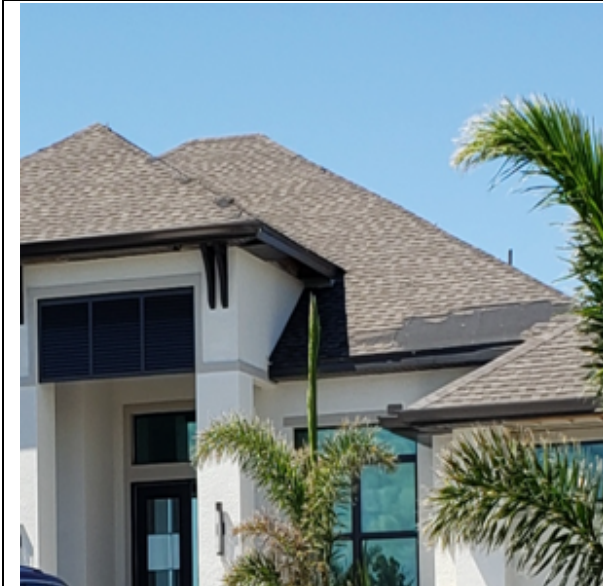
Photo 135: Unusual damage location on hip and eave

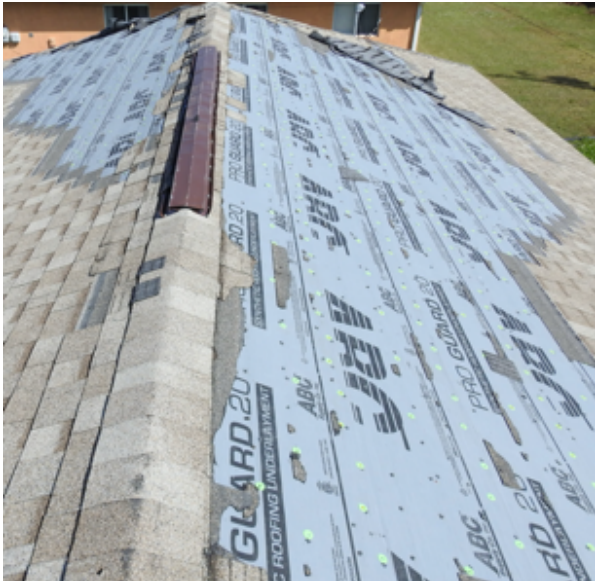
Photo 137: Shingle detachment on a roof constructed in 2022, exposed to 110 mph windspeed.

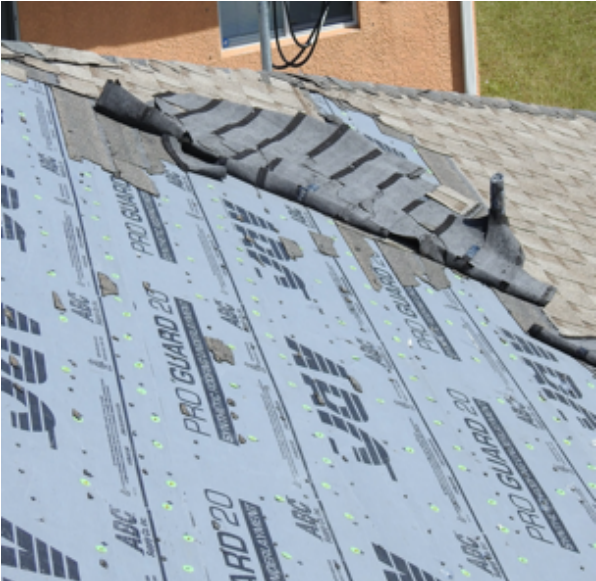
Photo 138: Note that the shingles were still bonded together, exhibiting low loss of sealant strip adhesion. Inadequate nailing may have contributed to detachment.

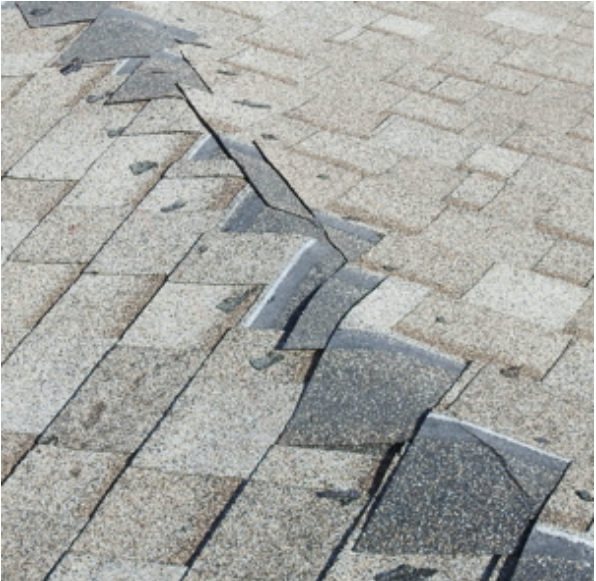
Photo 140: Hip shingles were inadequately adhered.

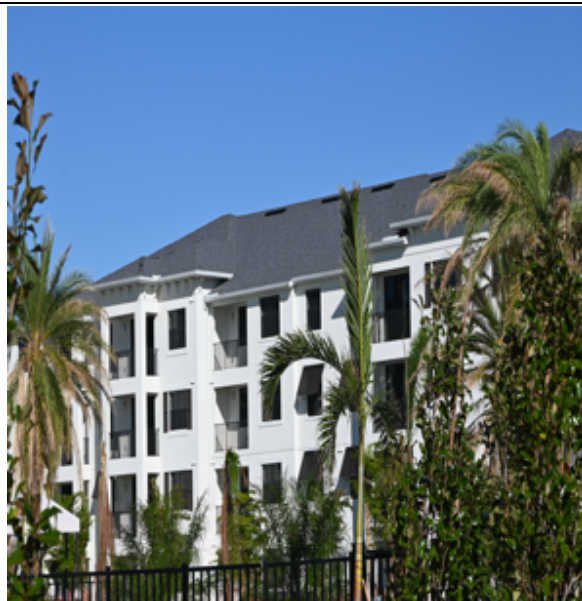
Photo 141: New construction and asphalt shingles

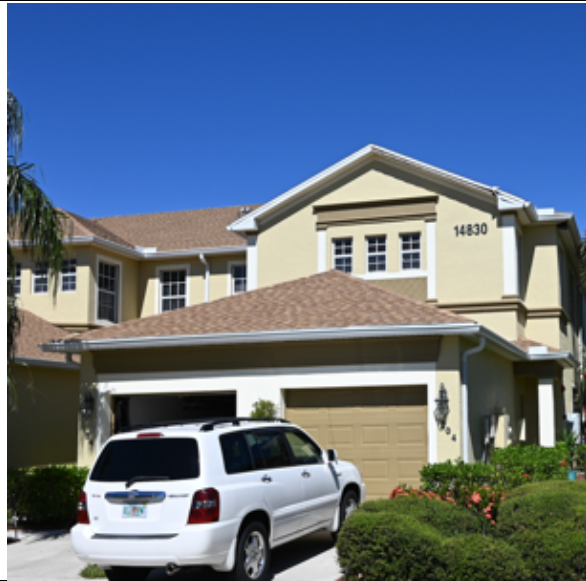
Photo 143: Many asphalt roofs in this area were intact. This neighborhood was built in 2005 and it appears to have been reroofed about seven years prior to the hurricane.

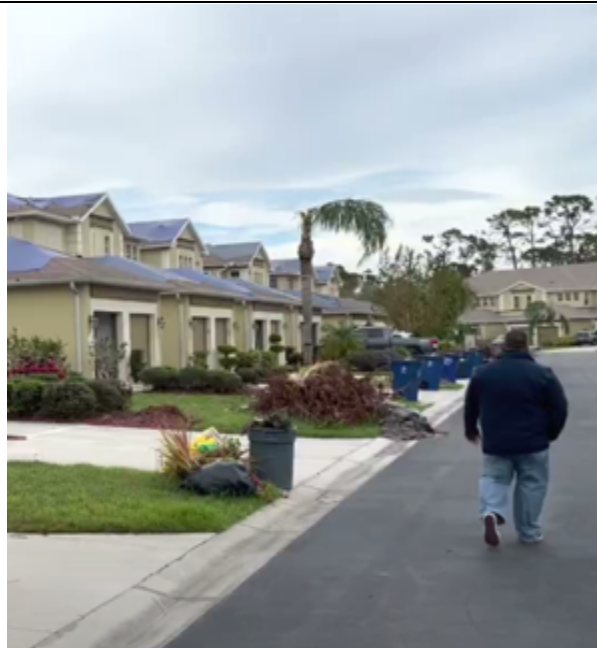
Photo 145: The opposite side of the street had many tarped roofs. Residents reported that houses on this side of the street had not been reroofed. They are likely original roofs installed around 2005.

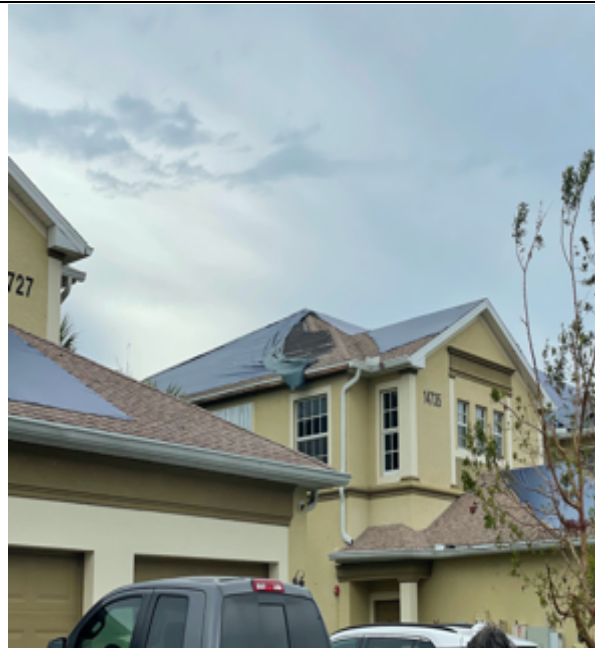
Newly replaced shingles (within six months) performed well. A twenty-year-old building appeared to suffer most of the damage. Evidence of “high nailing” found in debris pile. Easterly winds created the most damage.

Photo 146: These asphalt shingles were detached from roofs on the west side of the street.

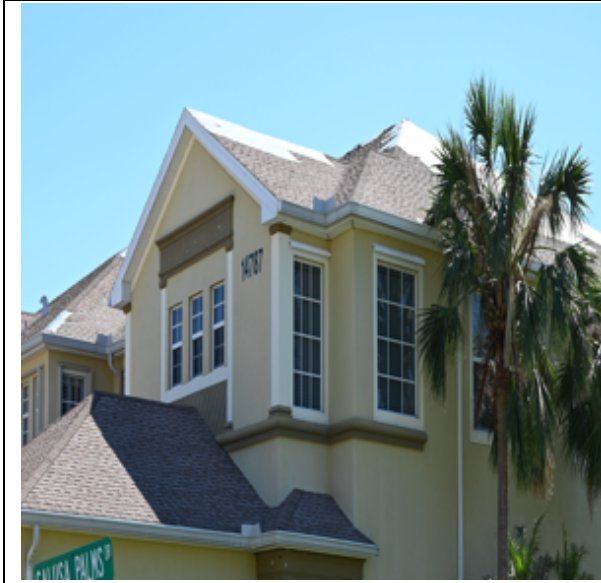
Photo 147: The roof had ridge damage and some field damage

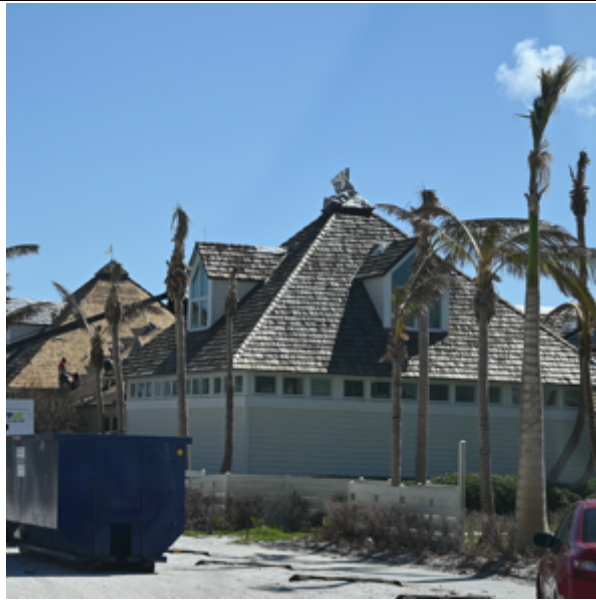
Photo 154: Wood shake roof, being repaired

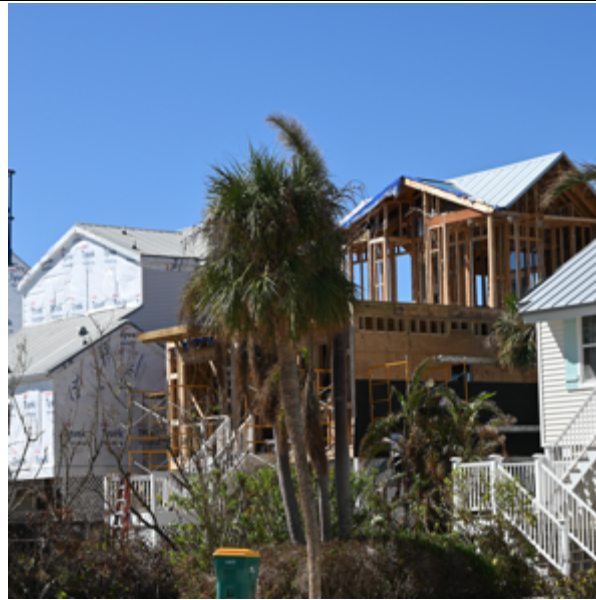
Photo 155: Appears to be siding and roof damage

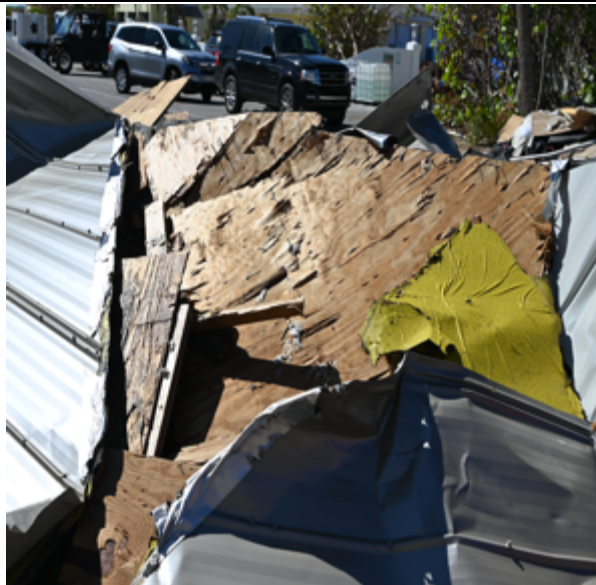
Some metal roof failure occurred due to deck failure (see photos). Some minor damage on nail strip (clipless concealed fastener). Nail strip panels observed appeared to be of decent fastening methods.

Photo 156: Detached deck and metal roof

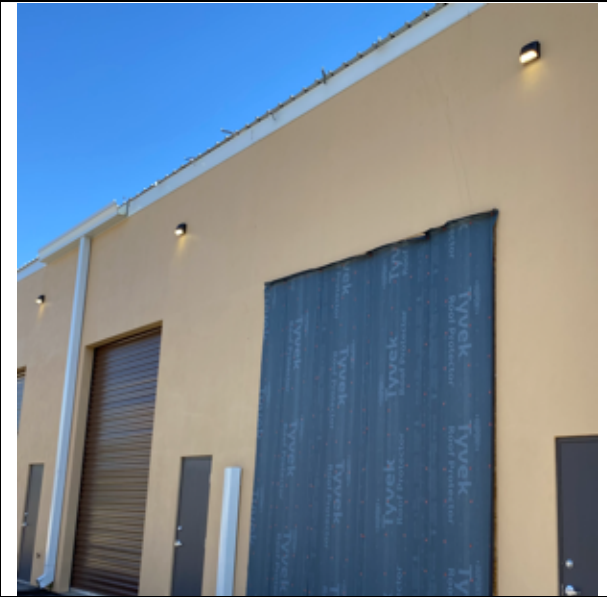
Door Gutter and coping damage following 100 mph windspeed in Fort Myers.

Photo 160: Missing door and gutter

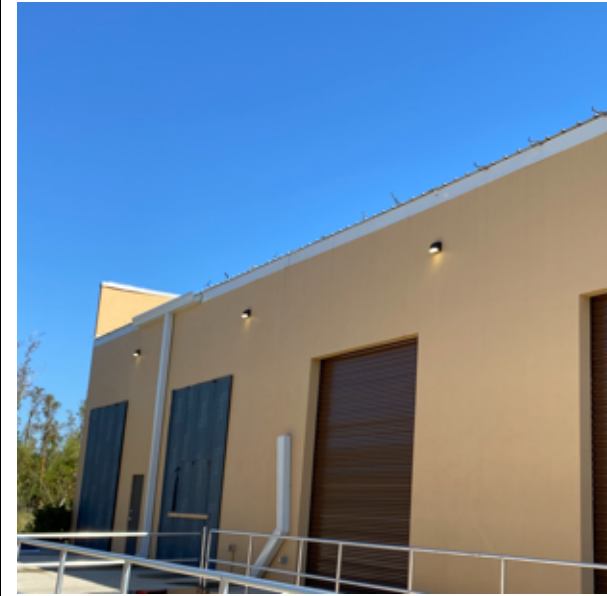
Photo 162: More missing doors and gutters

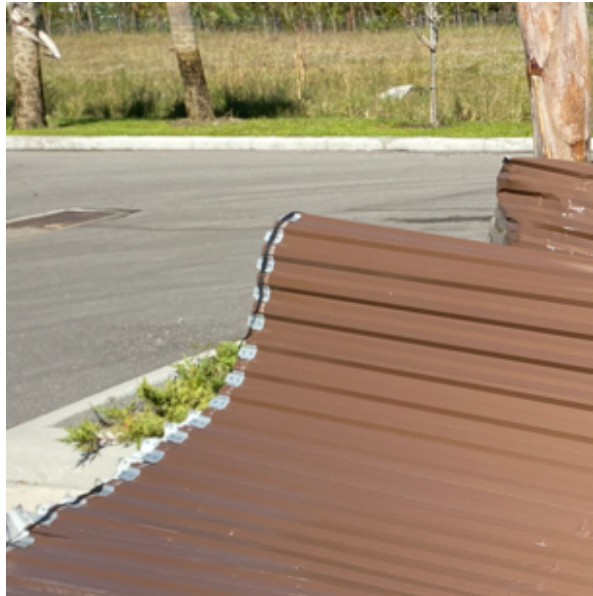
Photo 163: Missing overhead (roll-up) door

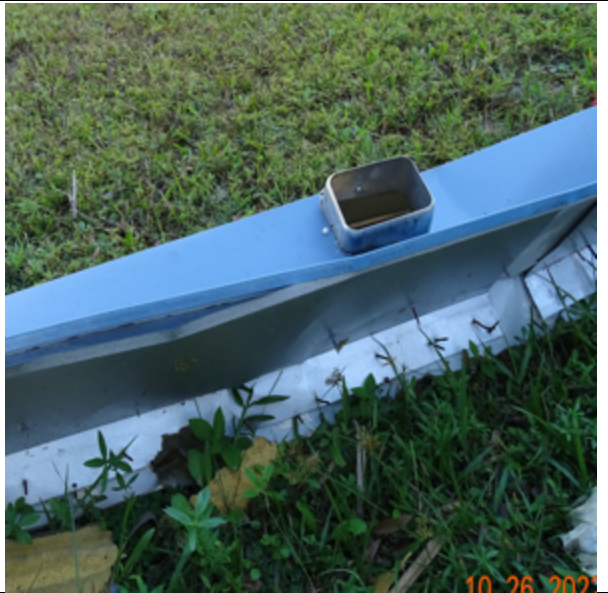
Photo 167: Detached edge metal and gutter
