Hurricane Ian

Roofing Industry Committee on Weather Issues, Inc.

Storm Investigation Program

September 30, 2023

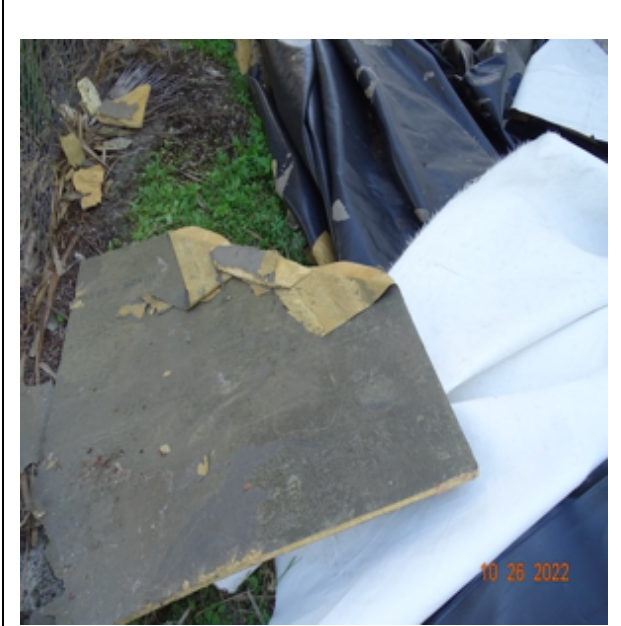
Photo 3: This was insulation/cover board retrofit over a CWF deck.

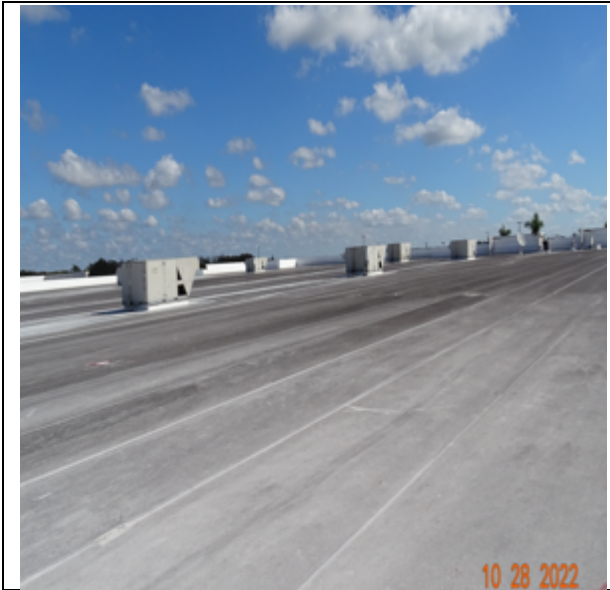
Photo 17: Overview of a 14-year-old roof.

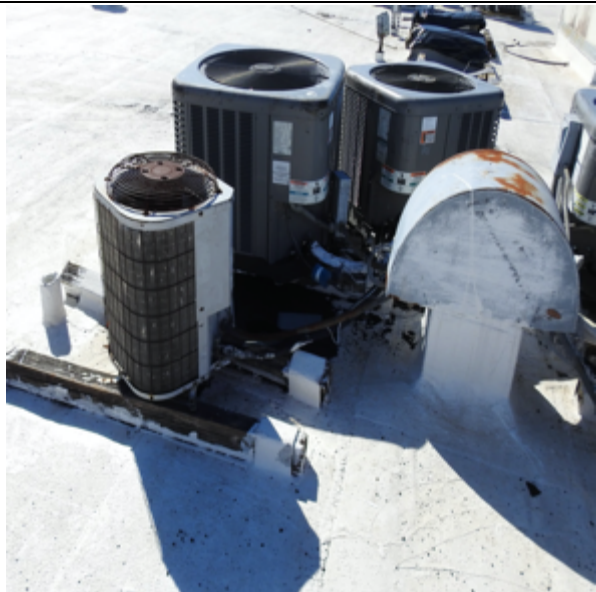
Photo 45: Displaced AHU

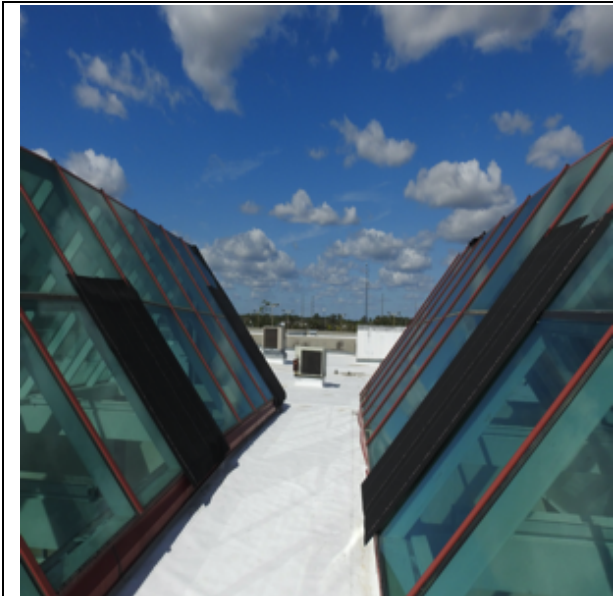
Photo 50: Damaged Skylights

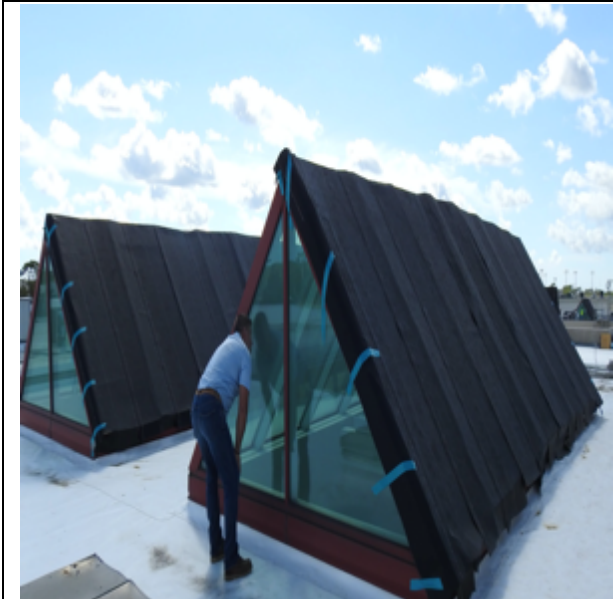
Photo 52: Skylights

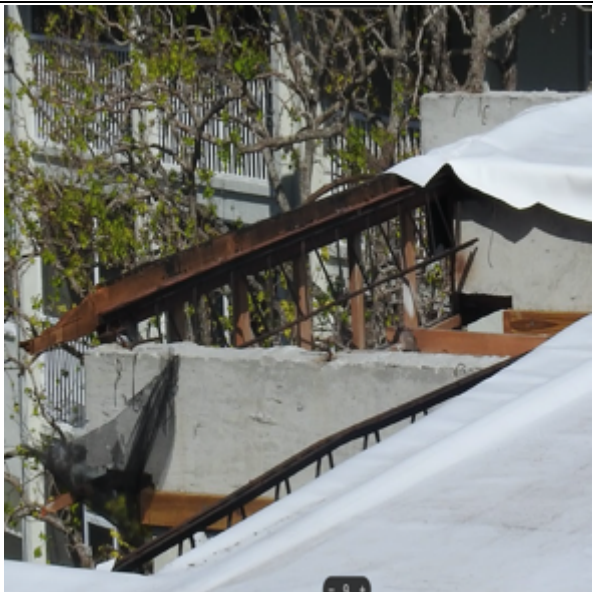
Photo 60: Structural damage

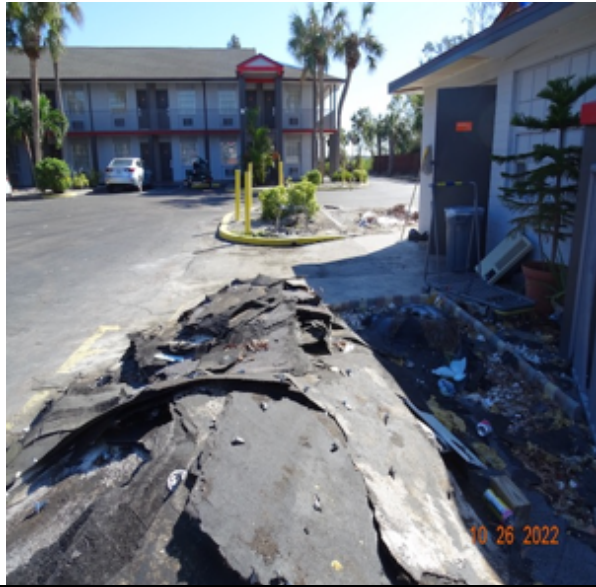
Photo 63: Membrane debris

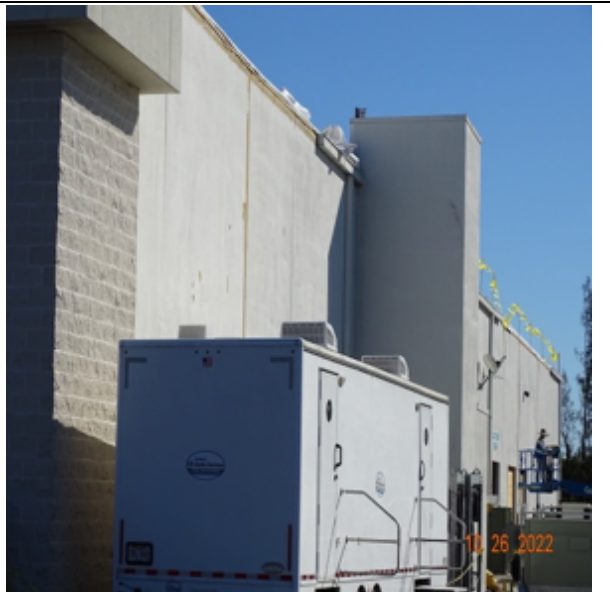
Photo 65: Missing gutters

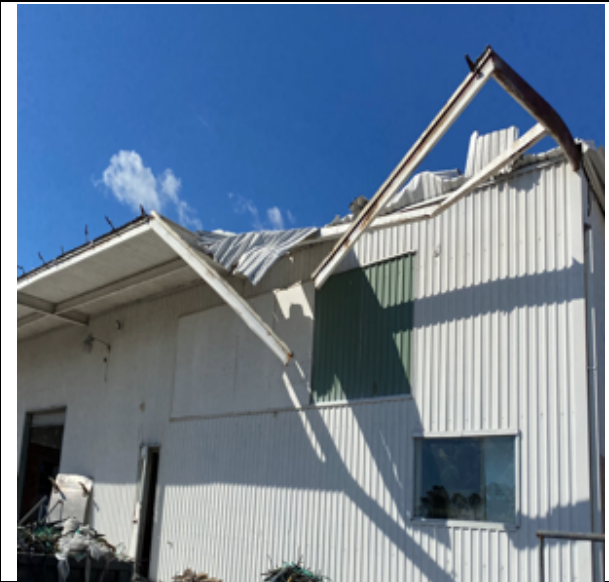
Photo 79: Adjacent building

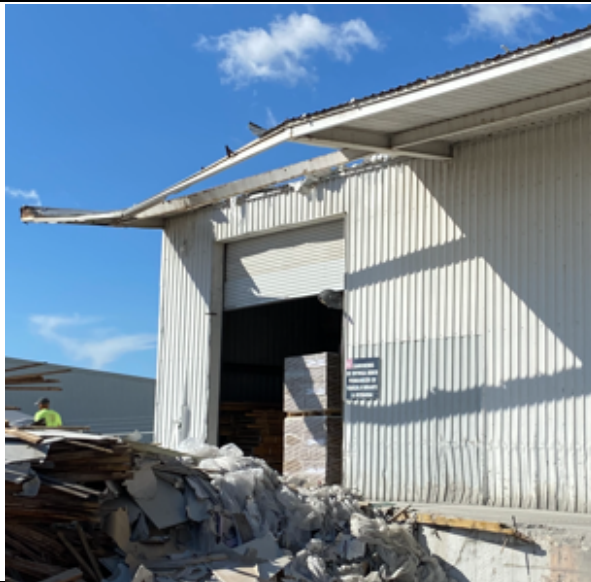
Photo 80: Same result

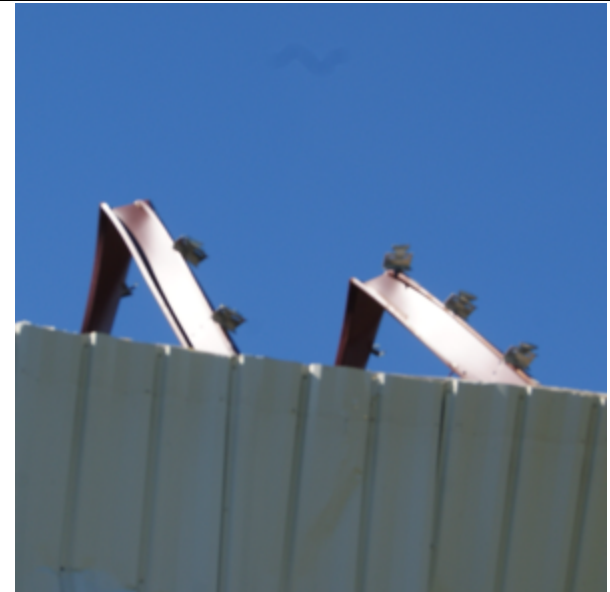
Photo 83: Standing seam clips attached to purlins, but released from seams

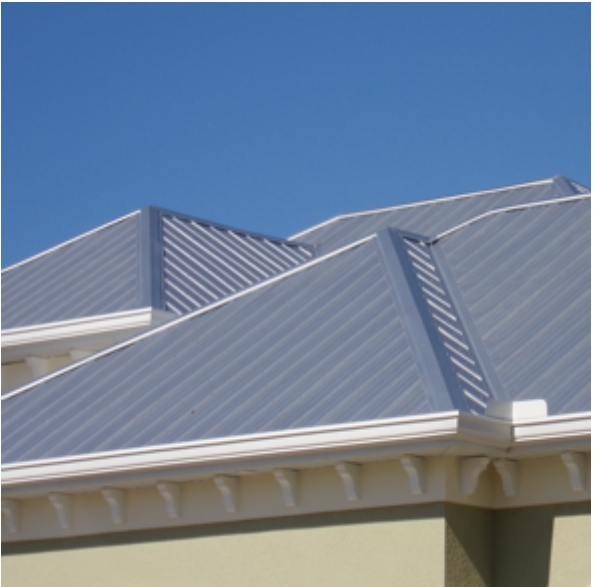
Photo 86: Good detail and installation

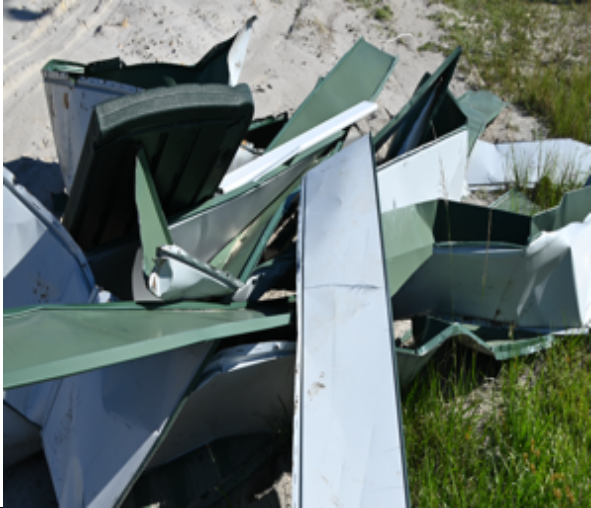
Photo 89: The debris pile shows lack of fasteners

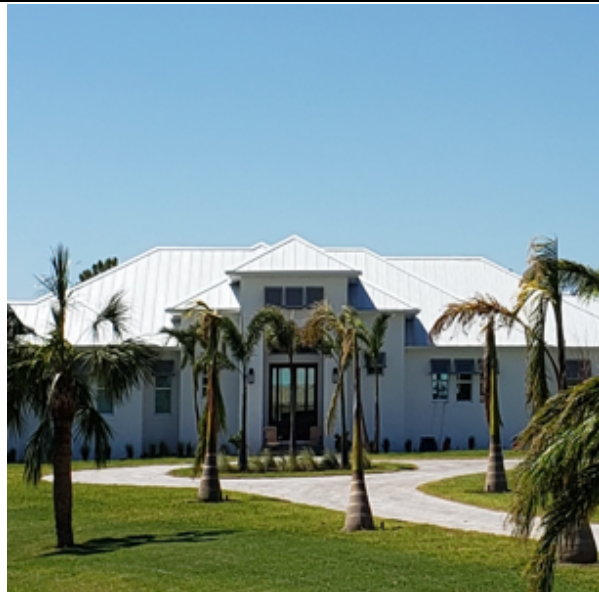
Photo 91: Total survival of 120mph winds

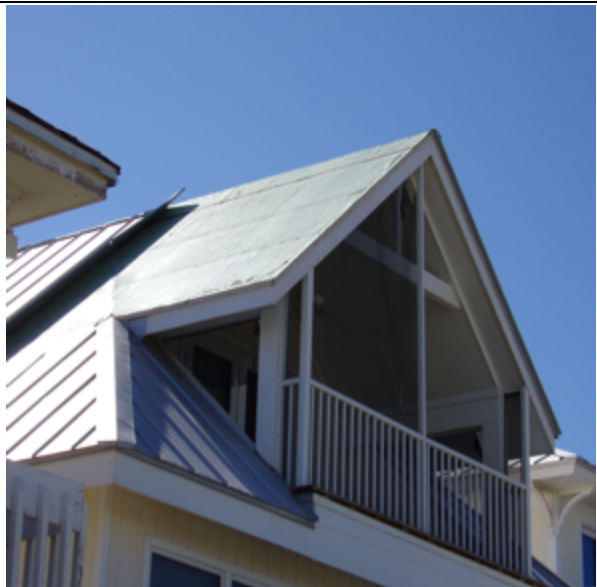
Photo 96: Another view

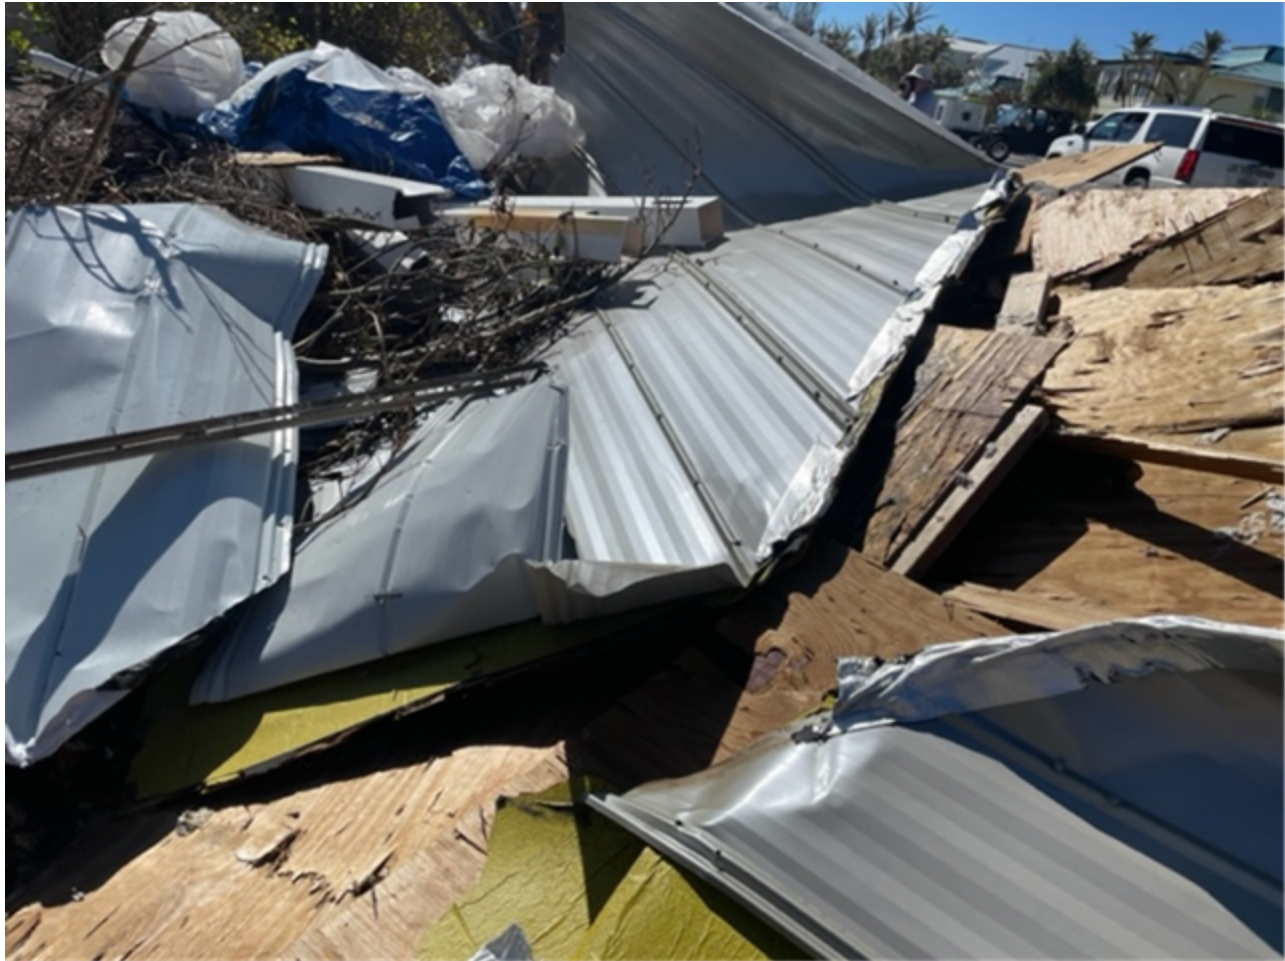
Case Study 25: Inspection 2-5
 3025 Gulf Blvd. Port Boca Grande, FL 26 44 21 N/82 15 47 W
 Project information: Metal 5V crimp on ½" plywood experienced complete deck failure due to re-roof with staples and smooth nails for fastening of plywood.

Photo 98: Debris pile

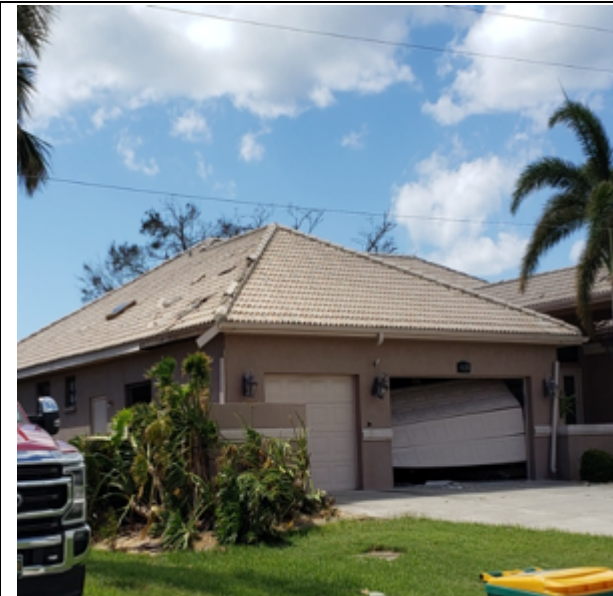
Photo 109: Some hip tiles were dislodged and/or detached.

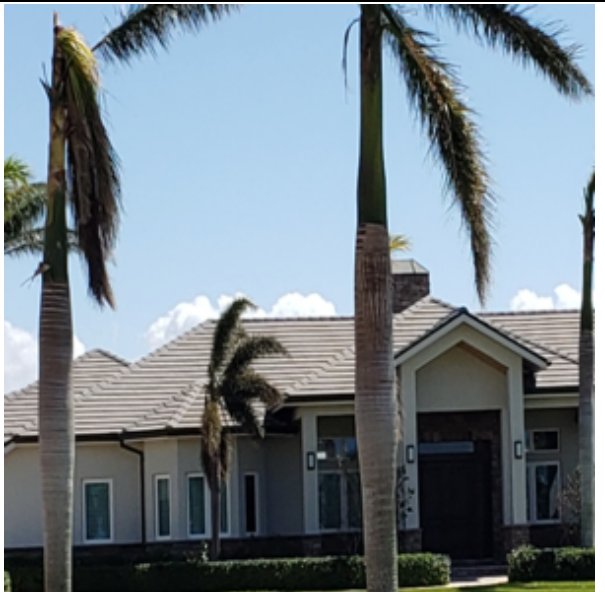
Photo 116: Winds of 120 mph or greater with no damage observed.

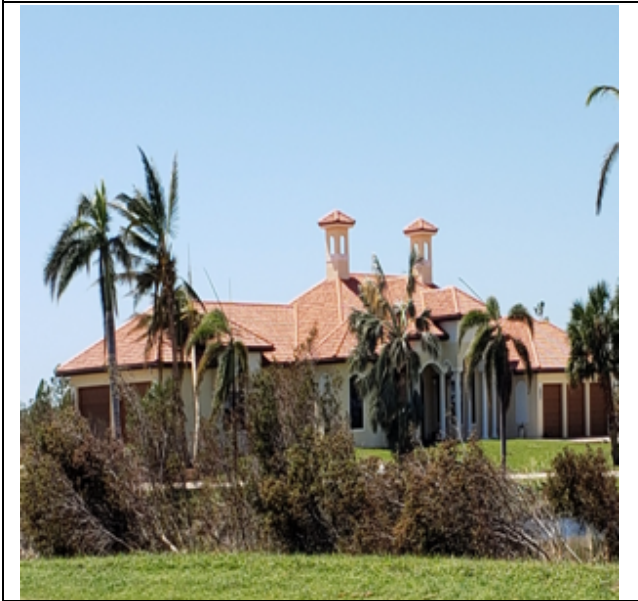
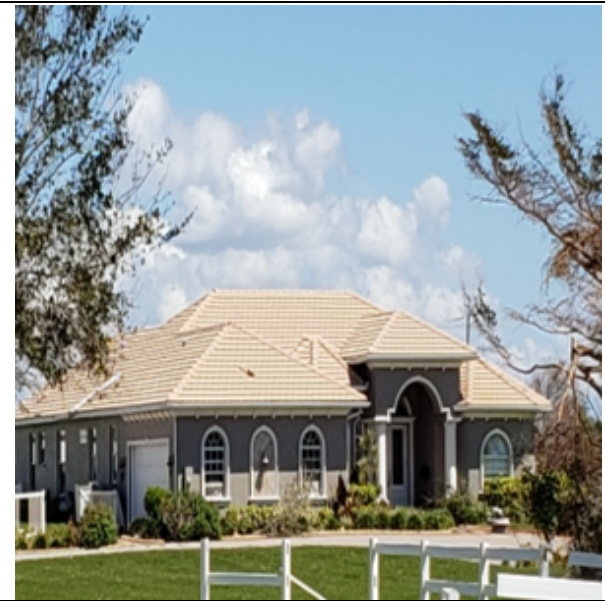
Photos 123 & 124: These roofs appeared undamaged despite 130 mph winds and are in very flat terrain with few obstacles i.e., likely Class C wind exposure.

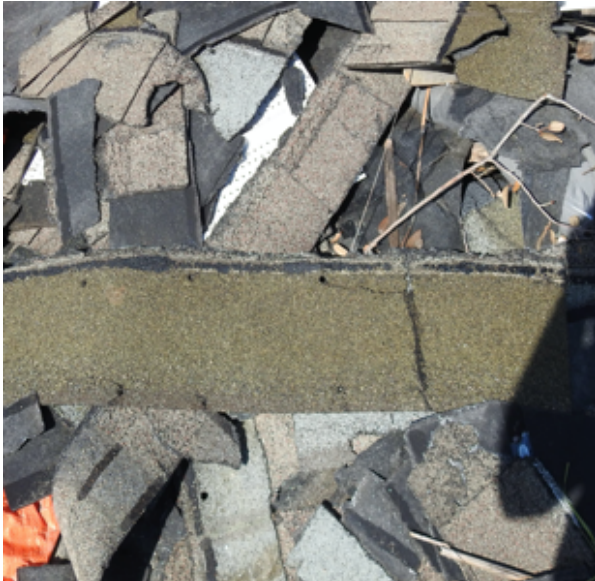
Photo 139: Debris pile

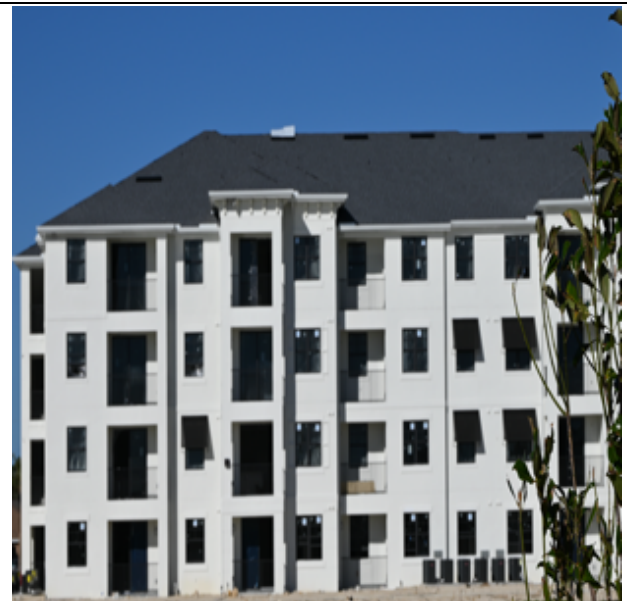
Photo 142: New construction and asphalt shingle roof

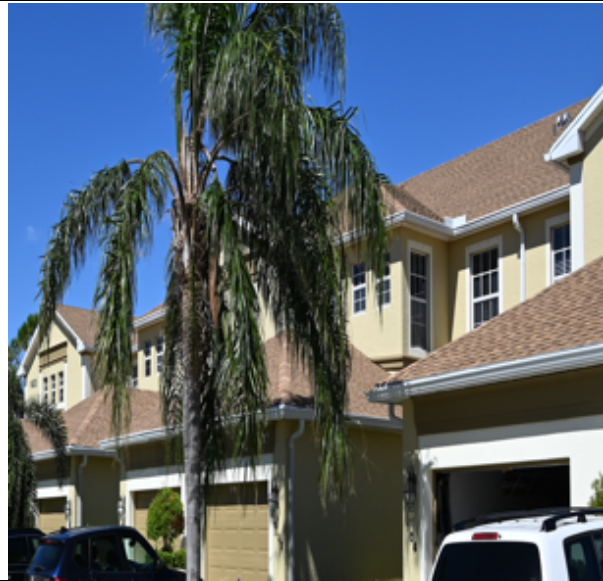
Photo 144: This area had a windspeed of 110 mph.

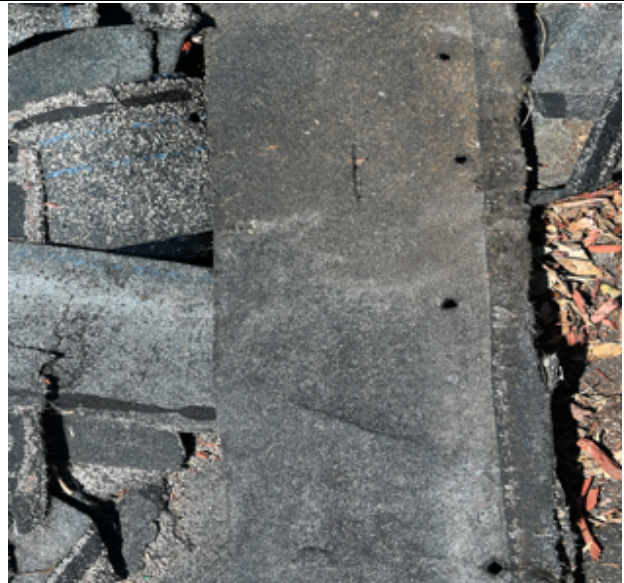
Photo 148: The debris

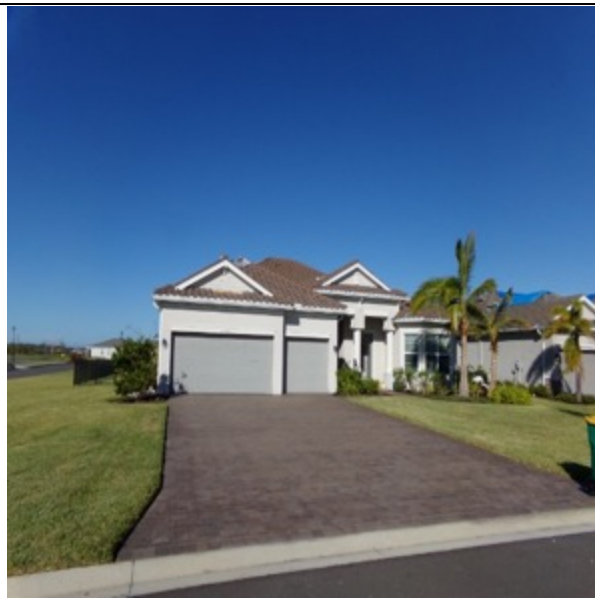
Photo 149: Typical hip and ridge tile dislodgement/detachment

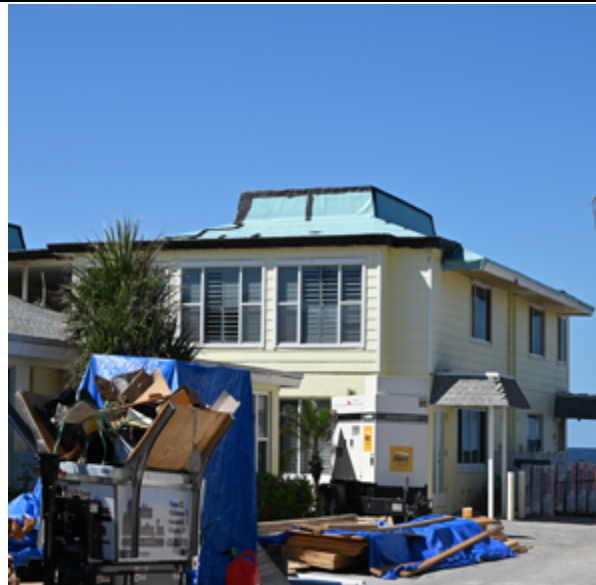
Photo 157: Source of debris

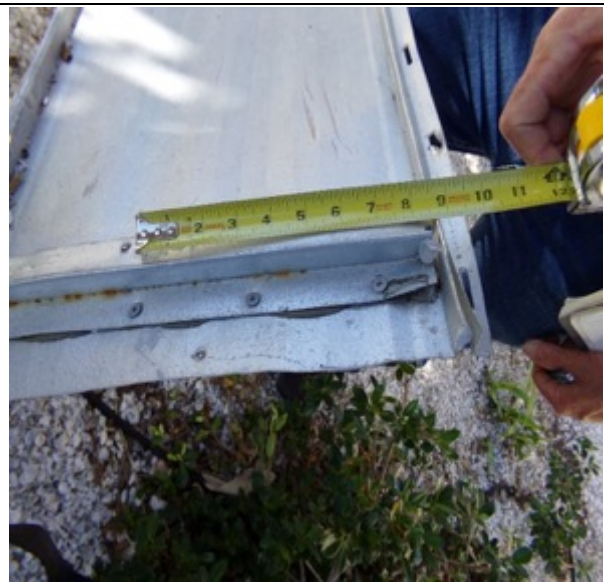
Photo 159: Inadequate fastening

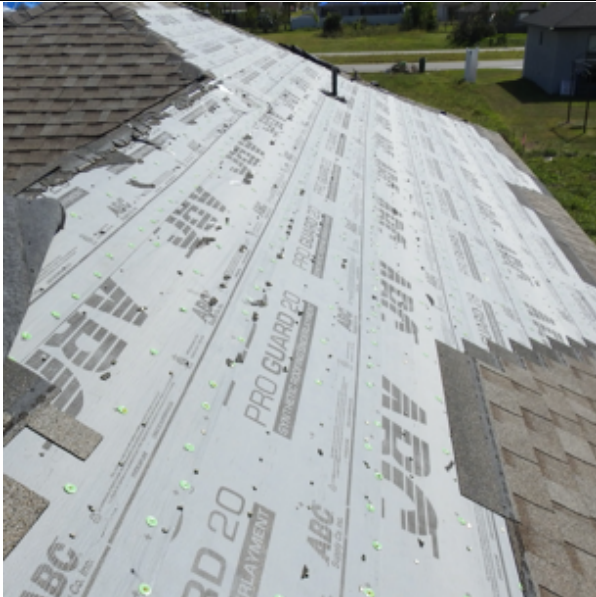
Photo 156: Although the shingles were missing, the underlayment in most cases kept the building dry.

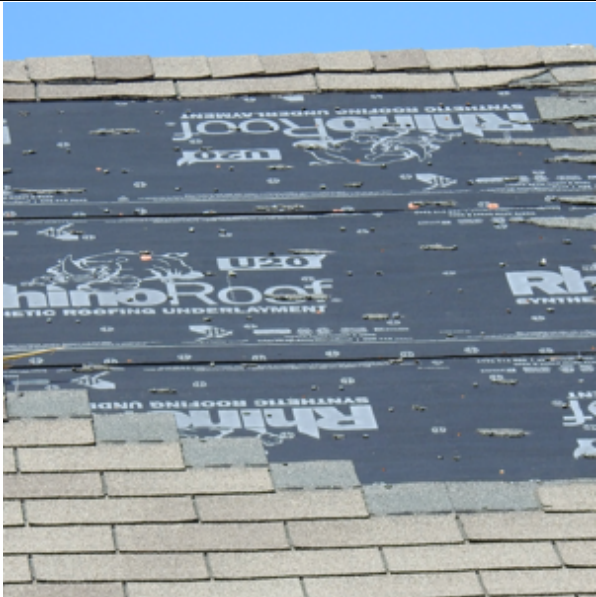
Photo 157: Fully intact underlayment

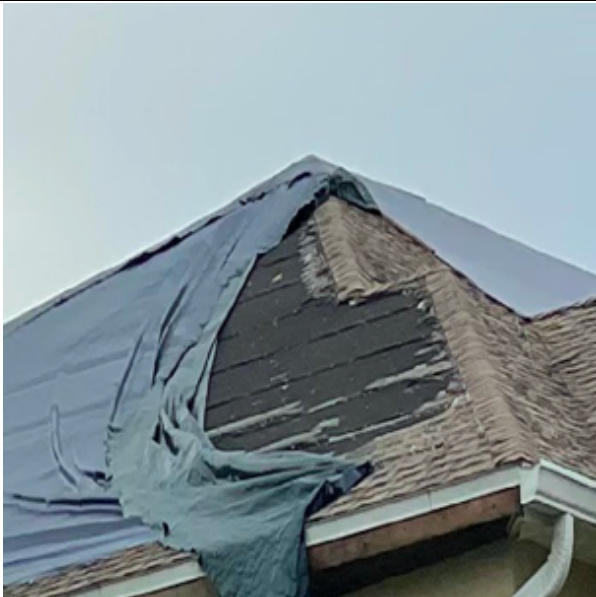
Photo 158: Asphalt impregnated felt underlayment appeared intact.

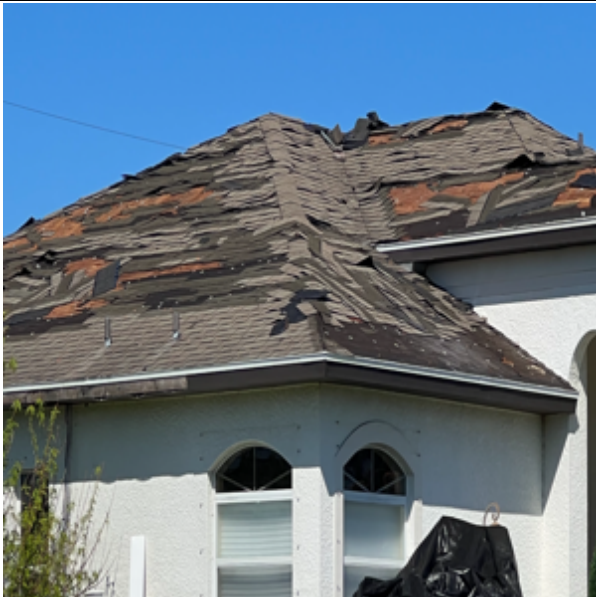
Photo 159: Some damaged underlayment was observed on this older asphalt shingle roof.

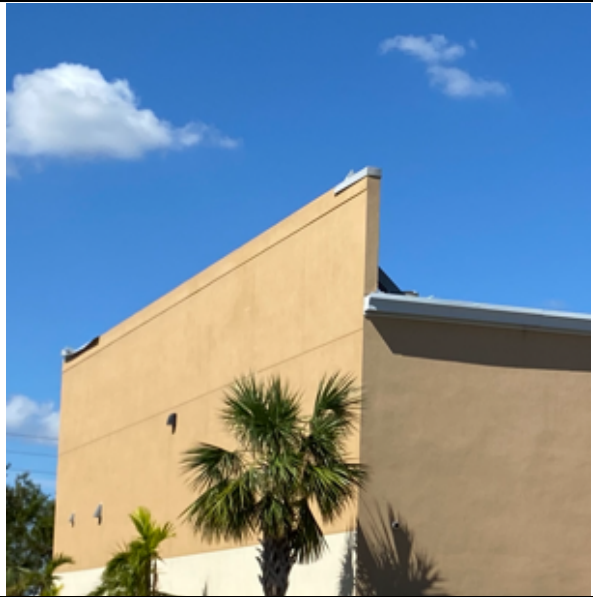
Photo 161: Missing coping

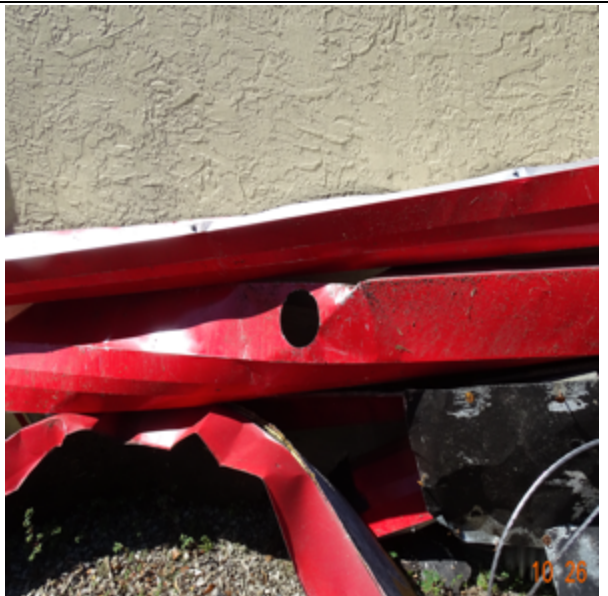
Photo 165: Approximately 18" O.C. Fastening

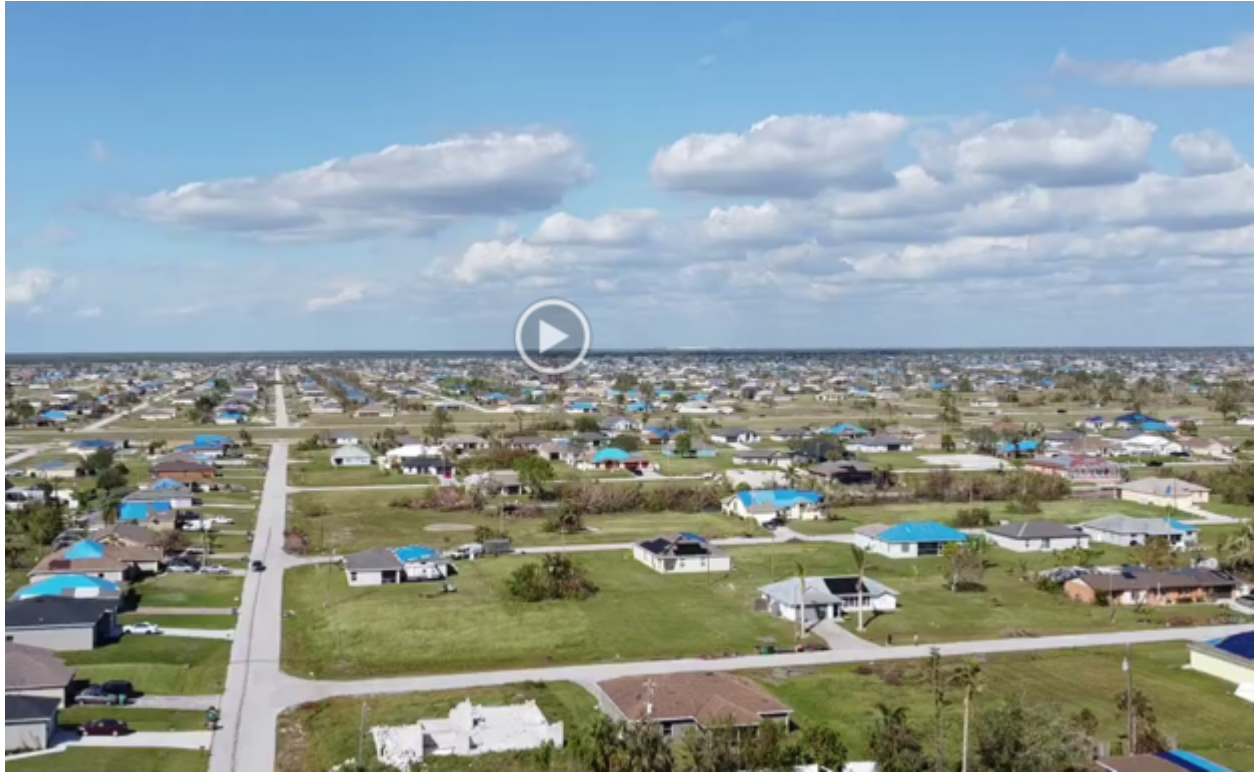
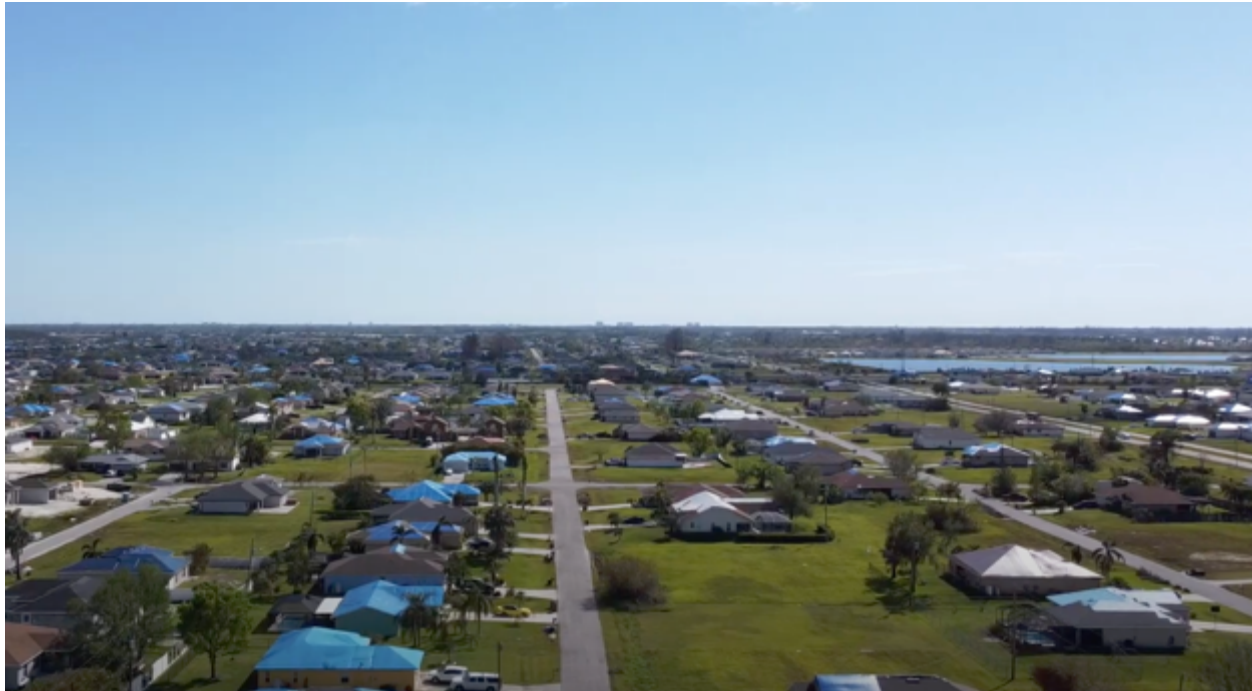
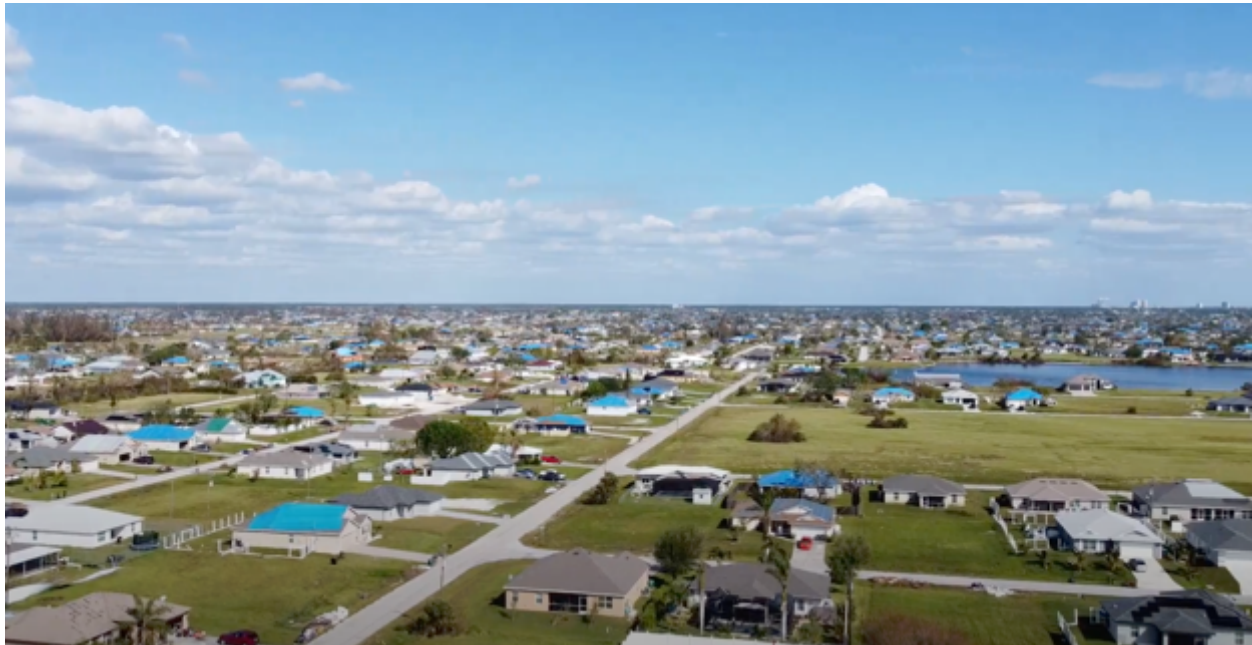
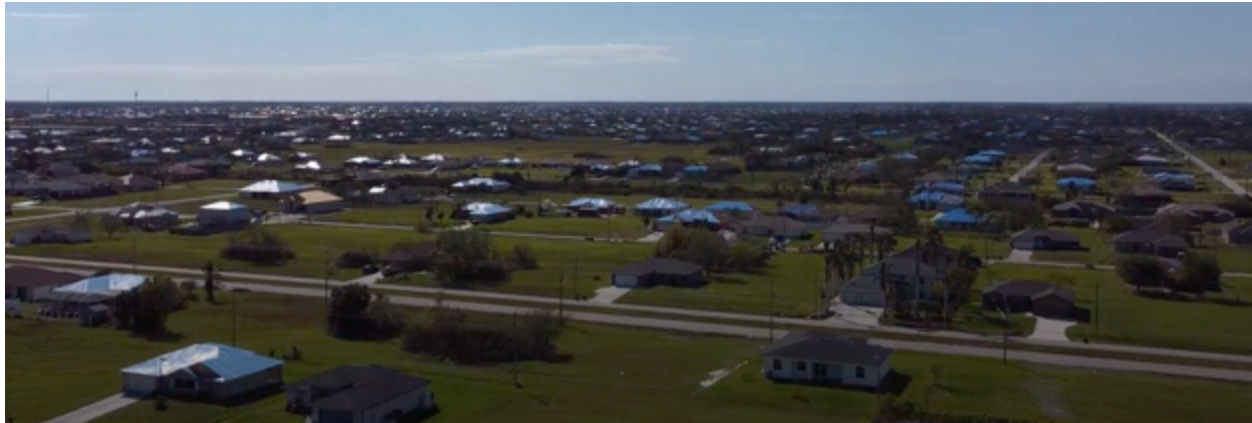
Drone flights in a residential area. This area of Cape Coral was built between 1998 and the present. Primarily, asphalt shingle roofs were installed. As the photo below shows there were many blue or black tarps covering damaged roof areas. Observed damage was primarily to hips and ridges, sometimes spreading inward from rake edges.
